**OUTBUILDING AT LONGBARNS COTTAGE, SCHOOL LANE
ABBESS RODING
ESSEX**

HISTORIC BUILDING RECORDING

Field Archaeology Unit

June 2006

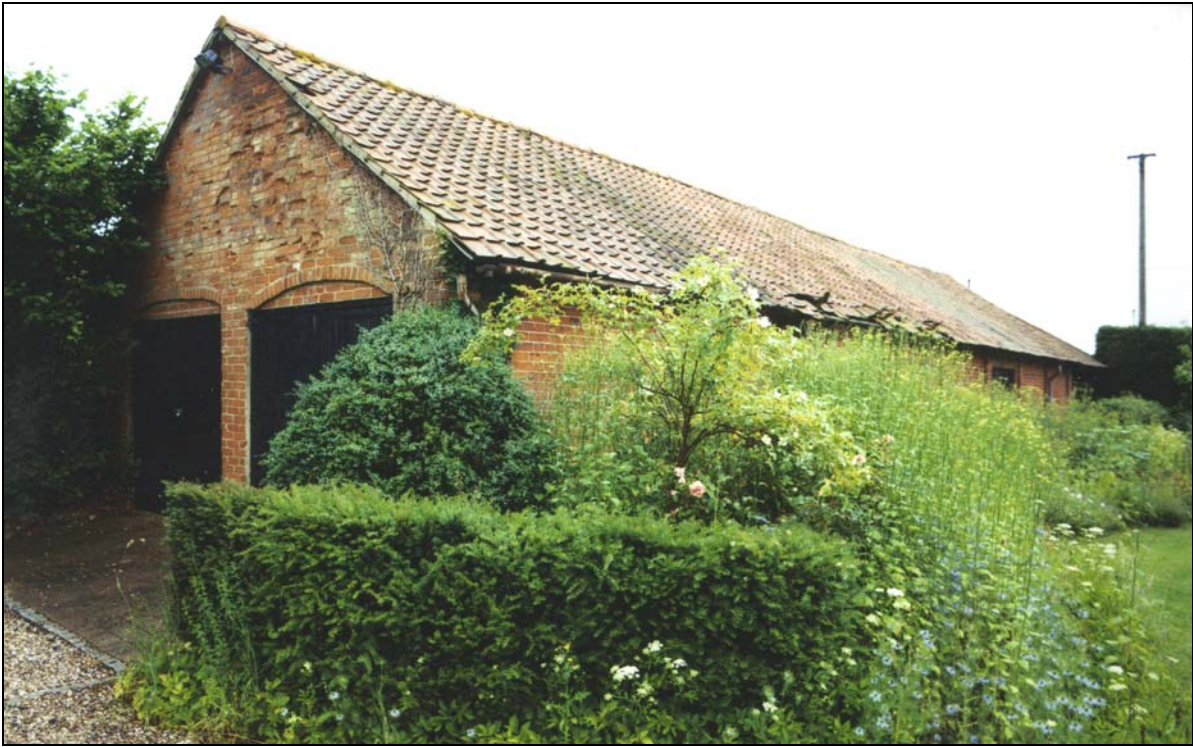
Plate 1 Cart shed viewed toward north-east

The subject of the survey (plates 1 and 2) is a linear, mainly brick-built, structure arranged on a roughly east to west alignment, in accordance with the layout of the farm. The walls are buttressed, reflecting the layout of the bays inside (fig. 4), and topped by a pantile roof, gabled to the west but half-hipped to the east over the stable area, whose sagging roof has been rebuilt in recent times.

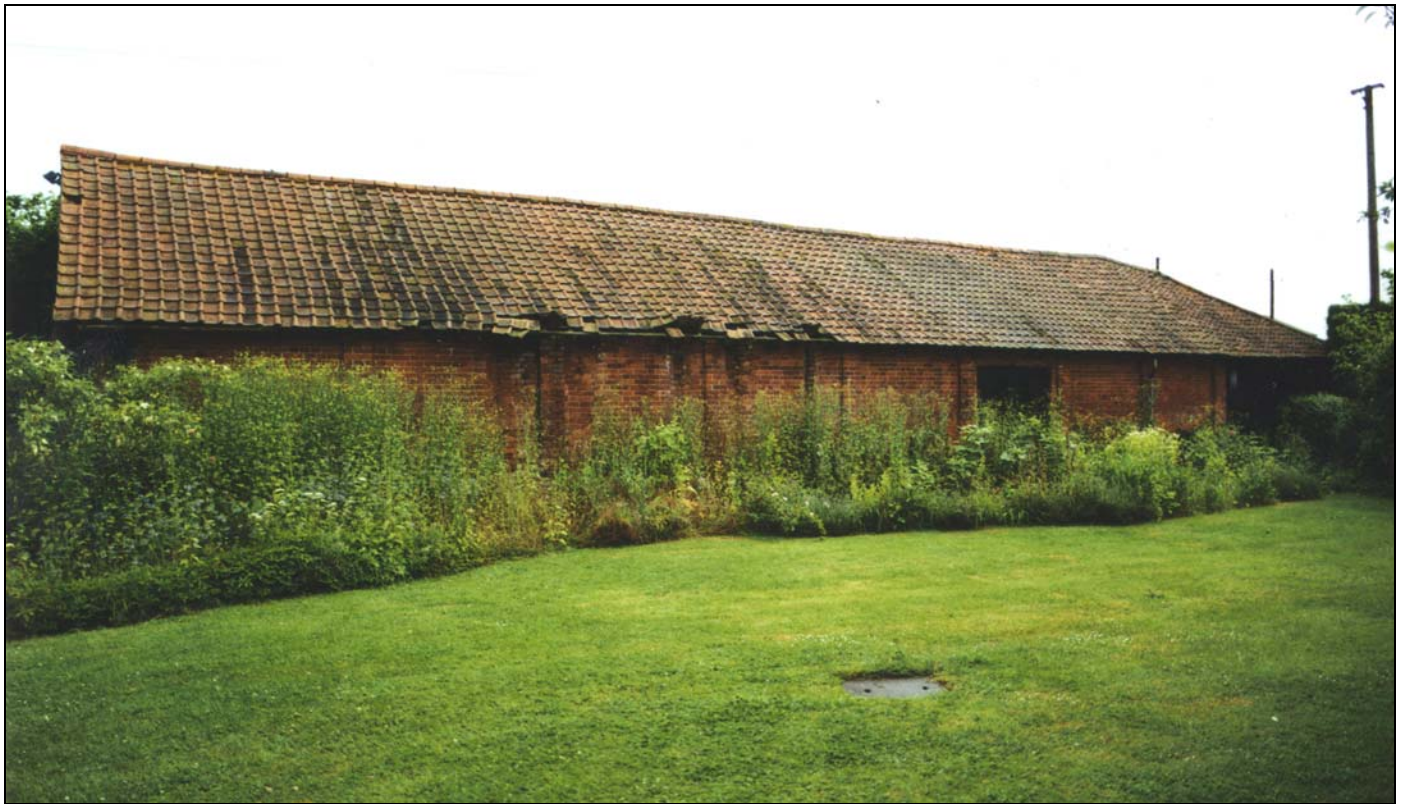
Plate 2 South elevation

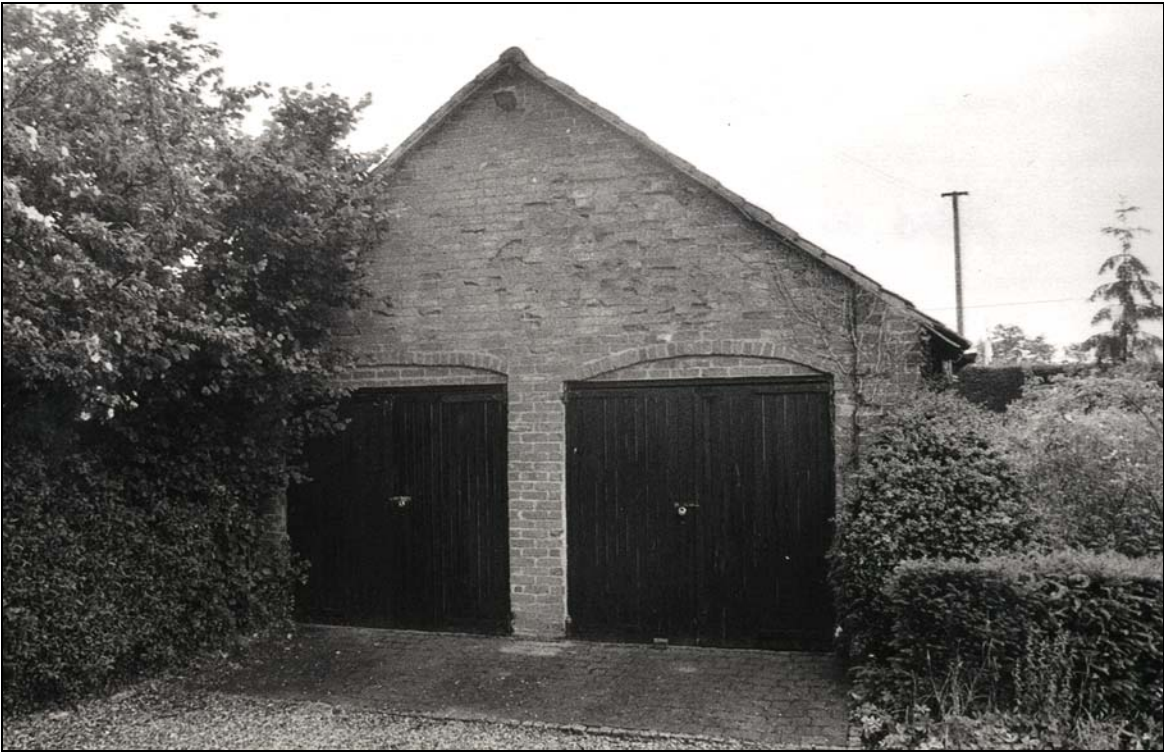
Plate 3 Inserted garage doors on west elevation

The bottom section of the west elevation was largely removed to fit two pairs of double doors for the garage, the wall scars of which can still be seen against the original fabric (although this is not clear on the photographs). Segmental headed brick arches have been built over each entry point, with varying degrees of success (left arch in plate 3,). Between the doors the central portion of brickwork is also modern. A steel lintel provides load-bearing capacity to the wall internally. The doors themselves are identical, ledged and braced, and similar to those recorded as the rear cattle doors on the shelter sheds (Cooper-Reade 1997) and

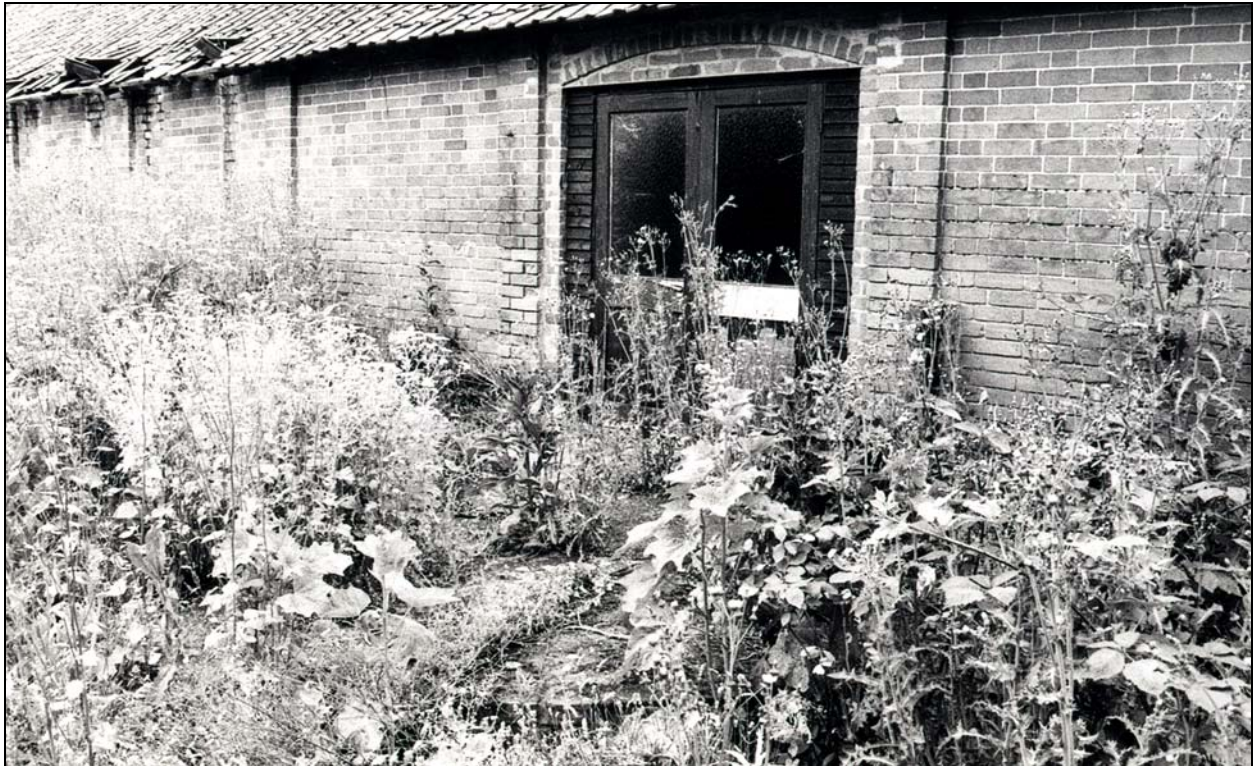
Plate 4 Modern entrance into cart shed, possibly a later insertion

The other doors, on the south elevation of the cart shed and stable are modern utility doors, probably fitted into original apertures (fig. 4). However, there is some rebuilding around the central entrance, into the cart shed (plate 4), that, in this case, gives a measure of doubt. This doorway leads out onto a low external semi-circular brick-lined and stone-slabbed platform whose function is unknown, but is probably a garden feature. Only limited analysis was possible due to the amount of overgrowth here.

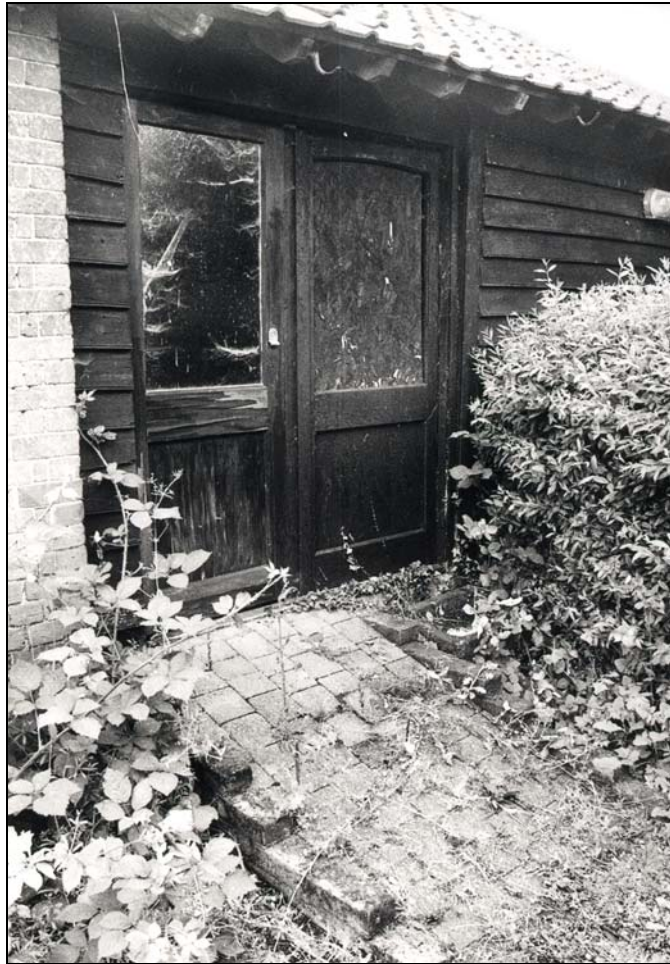
Plate 5 South elevation of stable

A modern brick sett ramp leads up to the stable at the east end (plate 5). The stable is enclosed in horizontal clap board on a light softwood frame and brick plinth, of similar characteristics as those in the main build. As a decorative statement, the clap board is beaded rather than plain like that on the in-filled north (front) elevation. The boarding wraps itself around the stable. On the prominent eastern elevation, facing onto the road, it is laid vertically (plate 6). A single paned base-hinged window gives the only natural light into the room, apart from modern glass in the door, whose fitting has removed any earlier fixtures and fittings. On the north elevation (plate 7), there is a clear distinction between the beaded boarding of the stable and the plain in-filled cladding across the front of the building (plate 8).

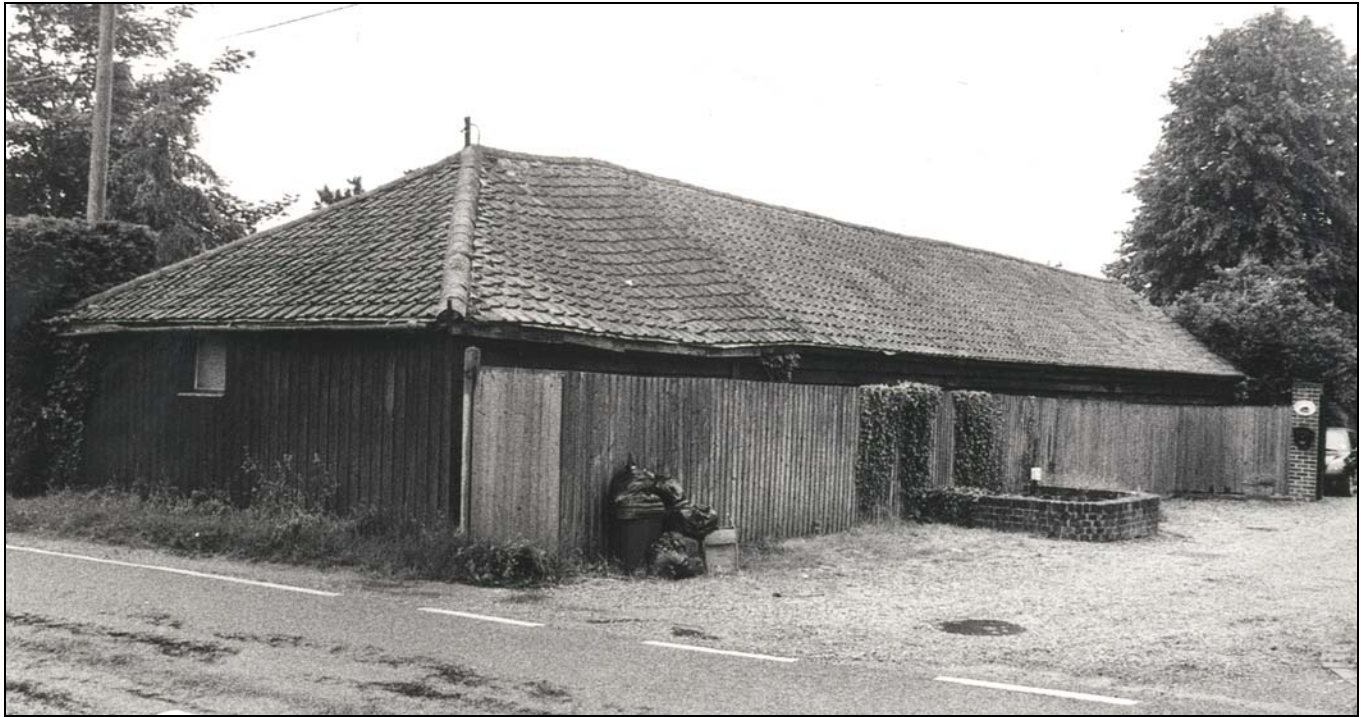
Plate 7 Cart shed viewed to south-west

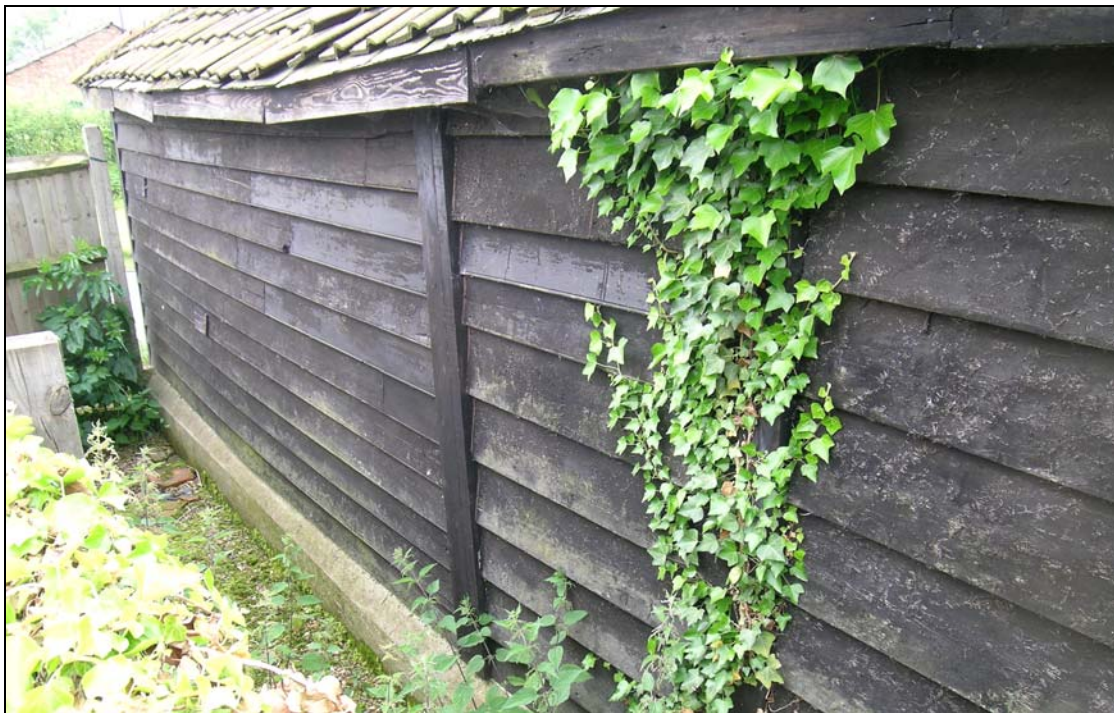
Plate 8 Later plain clap board infill of cart shed (right) compared with beaded covering to stable (left)

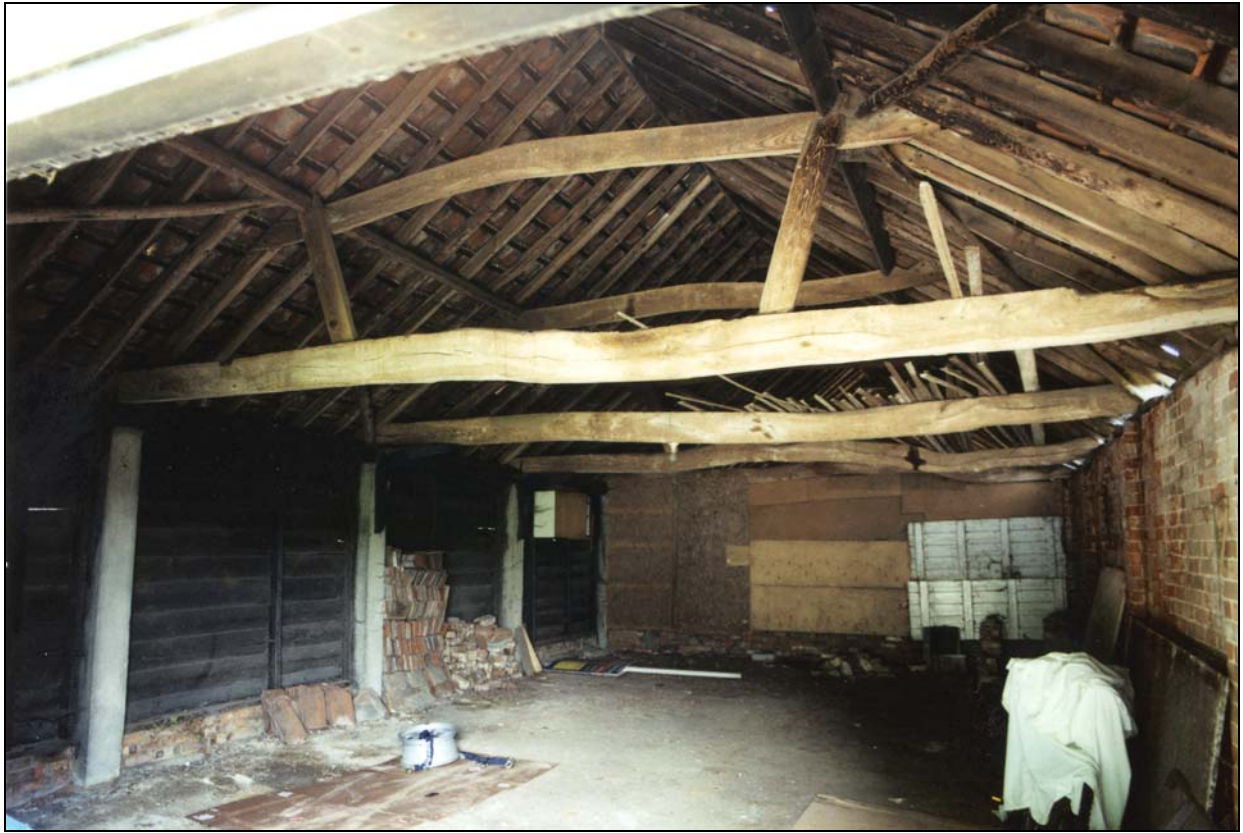
Plate 9 Interior of cart shed viewed to east and modern partition

The interior (plates 9 and 11) of the cart shed is eight bays long, divided in the middle by a modern boarded partition, creating a garage and rear storage area, now vacant. The bays are consistent in size at 2.25m, except for the end bays, which are slightly wider (fig. 4). Overall dimensions including the stables are 6.5 x 27.5m, the stable being equivalent of two bays in the main part of the structure. Traces of a crushed mortar floor remain, also recorded in the main survey of the farm. During the 1960s and 70s grants were available for flooring agricultural buildings in concrete. Their lack may signal that the farm became redundant before this date, which is suggested by the splitting of the farmhouse into two units in the 1950s.

From the interior, it can be clearly seen that the clap board is infilling to an original open-sided structure. On the formerly open (northern) side, the original bays posts have been replaced by thick concrete posts and the original bolted knee braces transferred over (plate

9), to spread the load of the heavy roof. Mortice holes are evident in the wall plate soffit where the pegged timber post tenons previously sat (plate 10). The scantling of the wall plate on this side is quite thick at 15 x 18cm and over each post, where visible, a pegged face-halved and bladed scarf joint is displayed (plate 10), a common post-medieval method of joining long sections of timber. In comparison, the opposite (brick) wall plate is only 11 x 15cm and is joined by basic pegged side-halved scarf joints. Such a difference suggests that the front wall plate originates from a post-medieval building cleared to make way for the model farm in the 19th century.

The roof framing (plate 9) is collared with raking queen posts and nailed and trenched purlins, a style of construction mirrored in the surviving 17th-century barn, again suggesting reuse. The rafters are regular and semi-regular in shape, as are the interlinking wind braces. Both are more typical of late 18th- or early 19th-century or earlier structures, built before machine-sawn timber became widespread. There are no suggestions that the minor roofing elements are reused. Construction style is consistent in both ends. None of the tie beams are cut straight, and have quite a curve, especially that in the final eastern bay (plate 11). Each of the end brick walls have timber ledges built into the walls with rows of nails for hanging ropes and probably tools. There are no other such fixtures and fittings present. The burnt headers in the end wall form a pattern in the brickwork (plate 11).

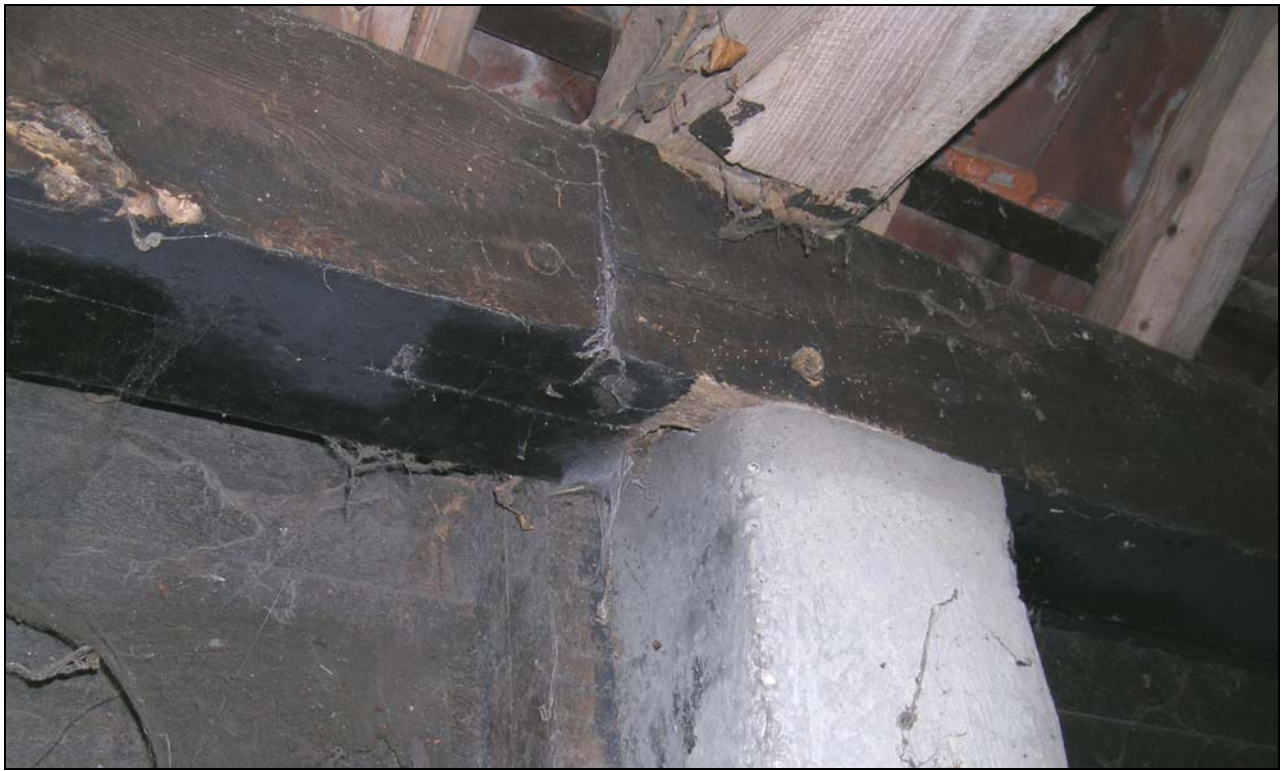
Plate 10 Concrete bay post partly obscuring empty mortise on wall plate soffit. Edge-halved and bladed scarf joint over

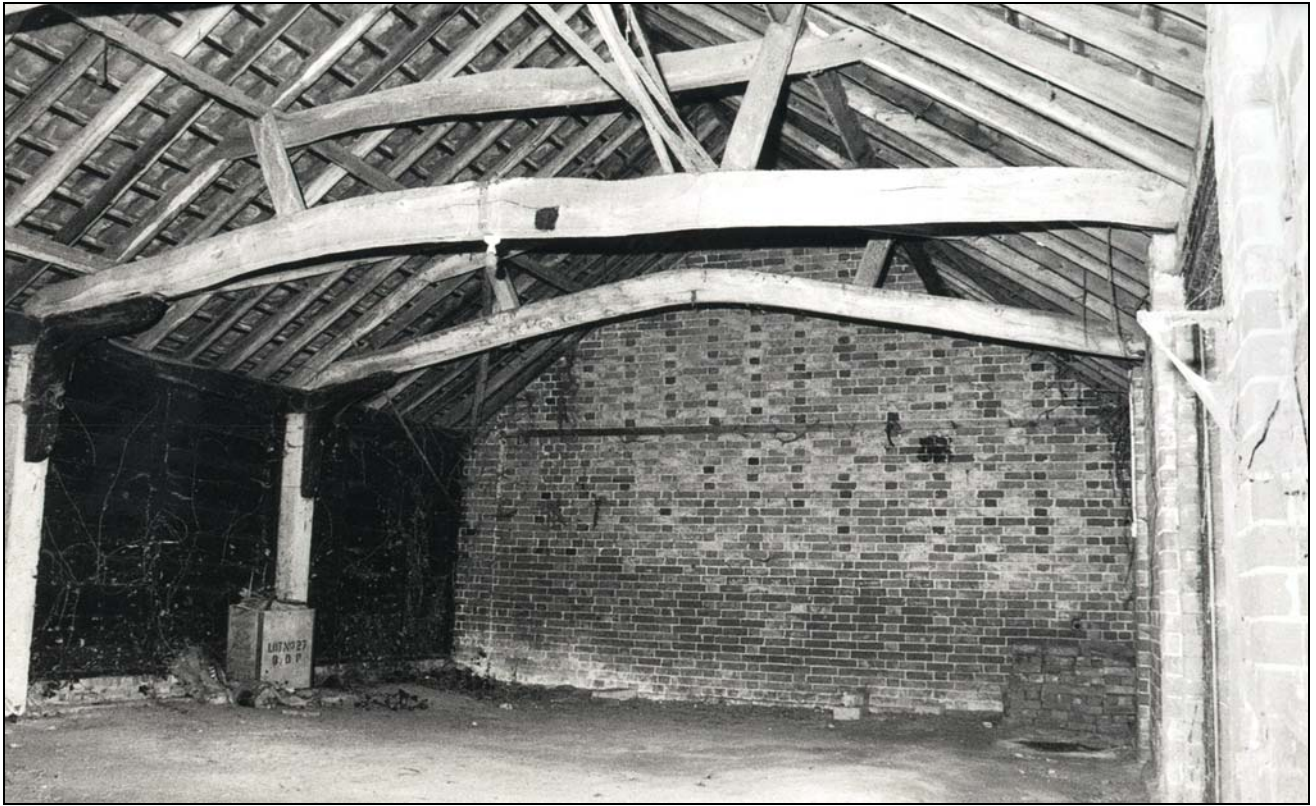
Plate 11 East wall of cart shed

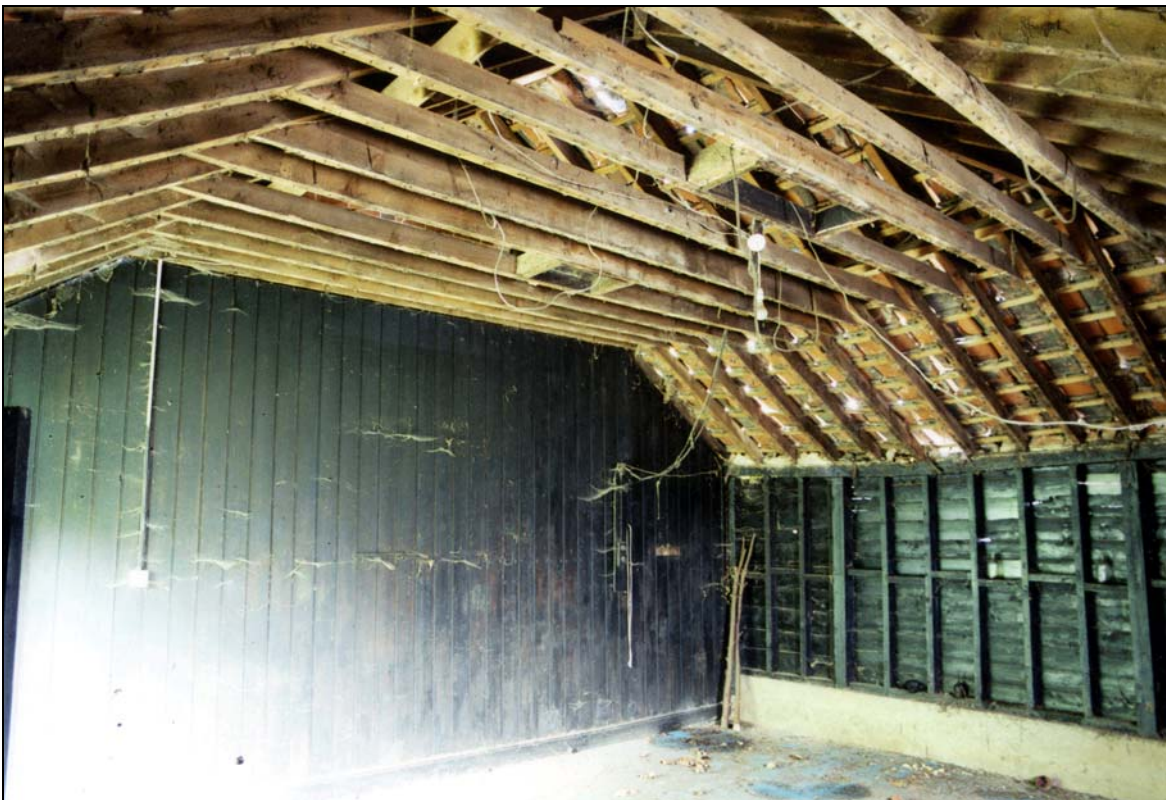
Plate 12 West wall of stable

The single-bay stable was originally panelled to walls and ceiling, signalling a higher level of ornamentation than the cart shed. Inside there is a concrete floor and cement-rendered plinth walls, suggesting its primary function continued later than the main area. The eastern plinth wall has been rebuilt in modern bricks. Vertical 6" beaded pine panelling, the same as that used for the exterior, lines the room, apart from the north wall. There are remains of a high beaded skirting retained on the west wall (plate 12).
