**ALL SAINTS' CHURCH
GREAT CHESTERFORD
ESSEX**

ARCHAEOLOGICAL MONITORING AND EXCAVATION

Essex County Council

August 2006

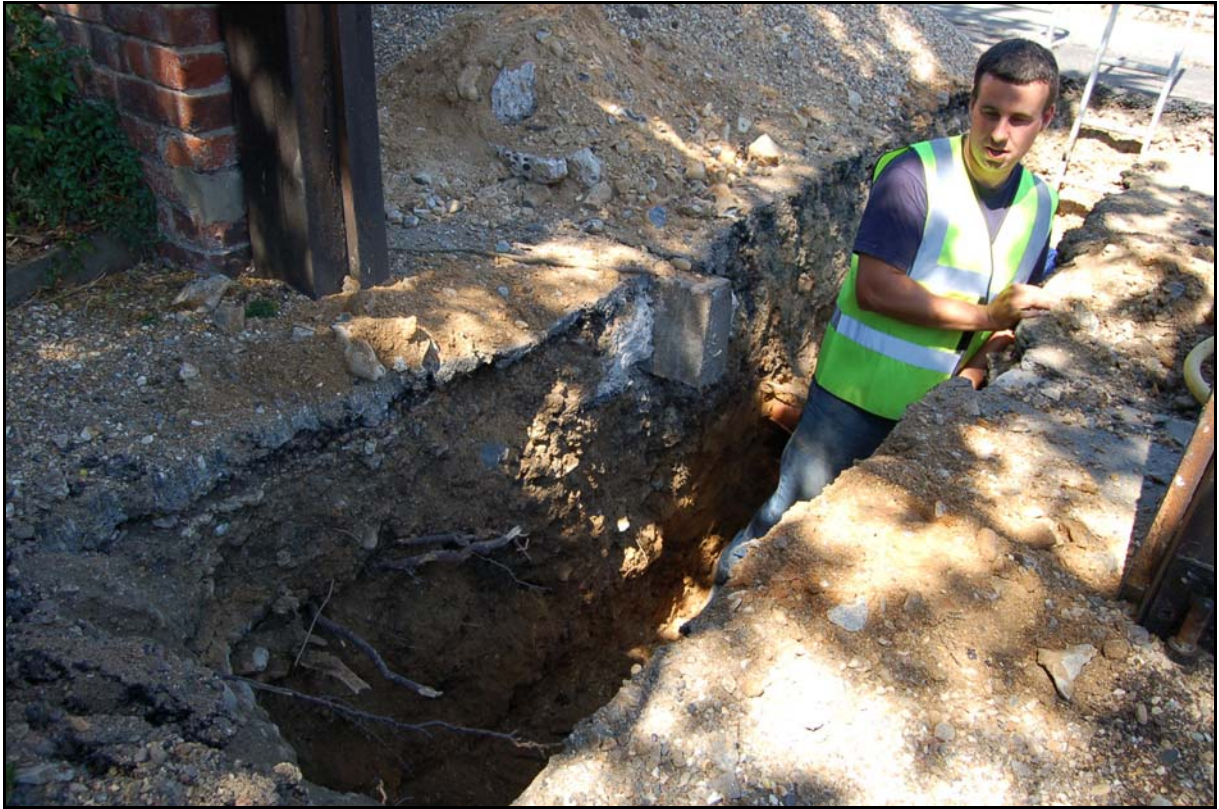
A modern kerbstone and concrete and c. 0.5m of modern disturbance above natural were revealed at the point in the sewer trench where the wall foundation for the postulated Roman enclosure was expected to be present (Plate 1). There were no archaeological deposits, features or finds in that location.

Plate 1. Sewer trench at point of postulated Roman enclosure wall foundation

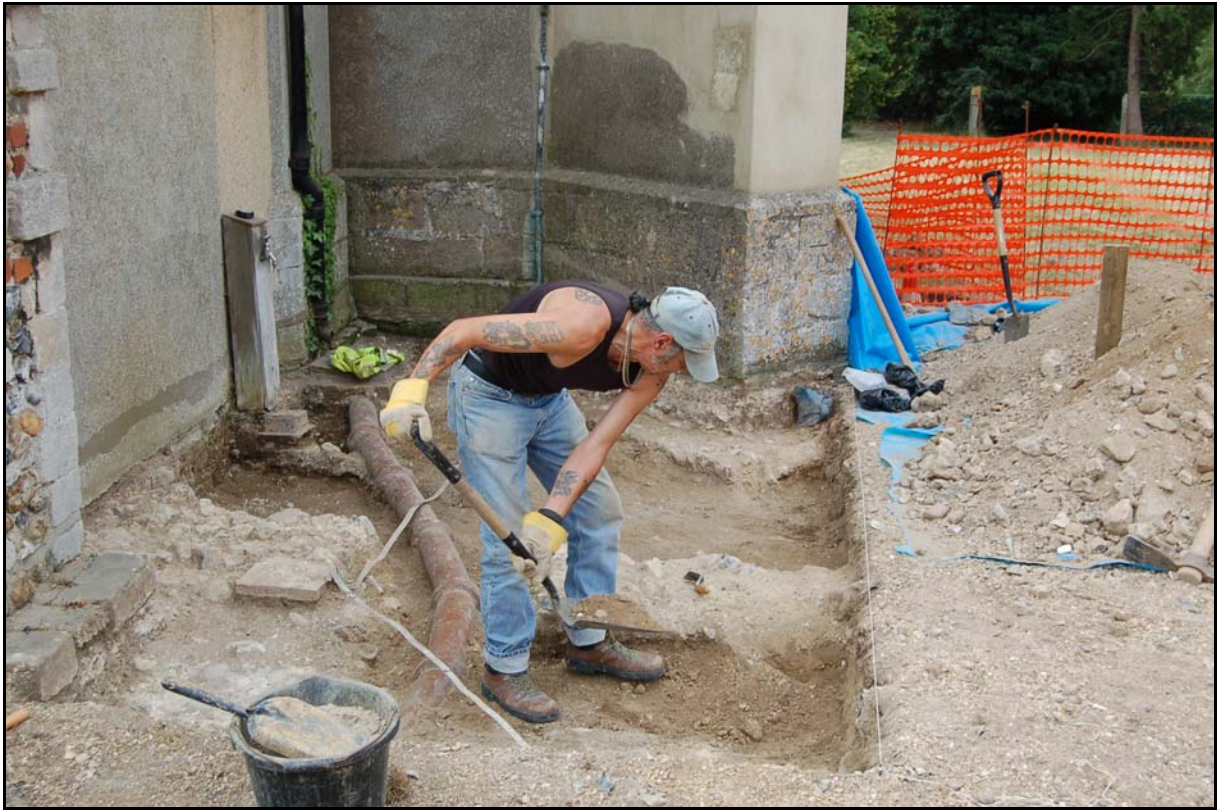
Wall 14 ran east-west across the site. It stood about 0.2m high and was 0.8m wide (Plates 2 and 3). The centre of the wall was cut by the trench for a ceramic drainage pipe (25), and the west end by a pit (12) for the earthing-point for a lightning conductor. Within the fabric of the wall, which consisted of brownish-white lime-based mortar (2),

were large flint nodules, pieces of limestone and a large fragment of Roman brick. Some of the limestone pieces were faced.

Plate 2. Footprint of proposed toilet facilities, looking south towards church tower

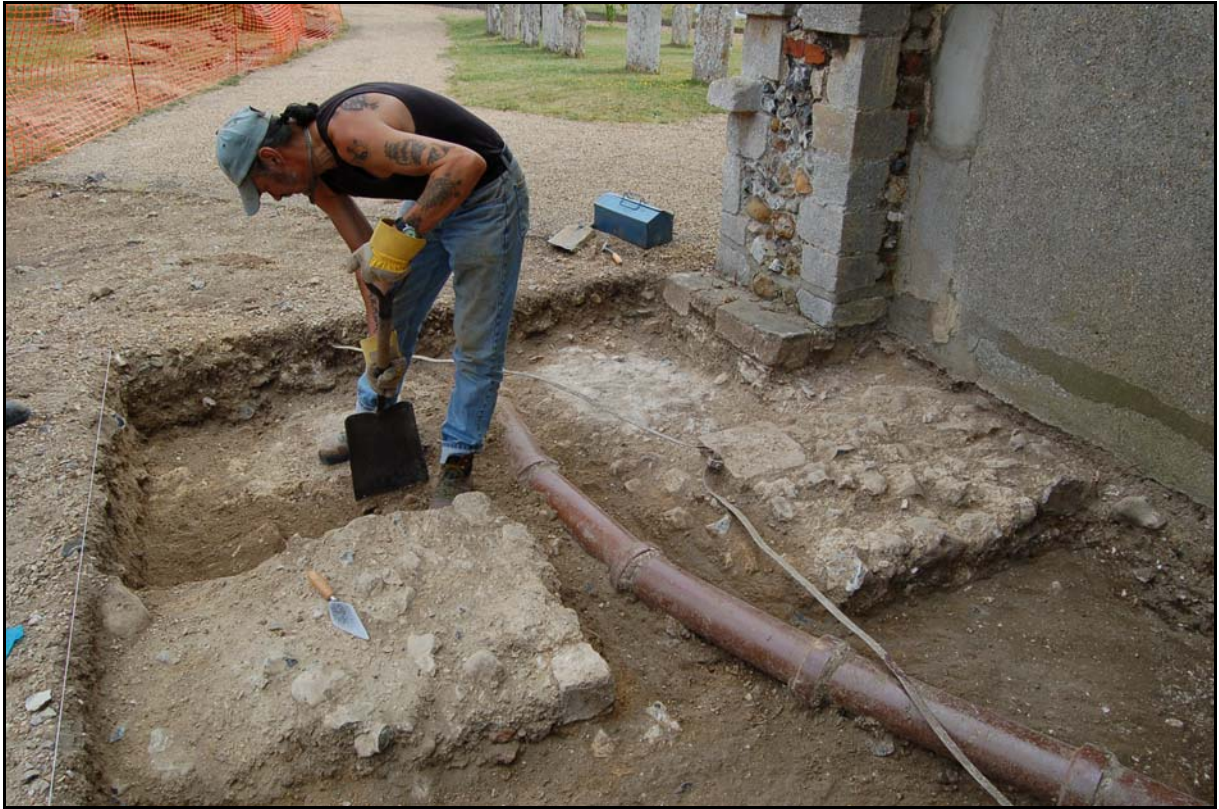
Plate 3. Footprint of proposed toilet facilities, wall 14, looking north

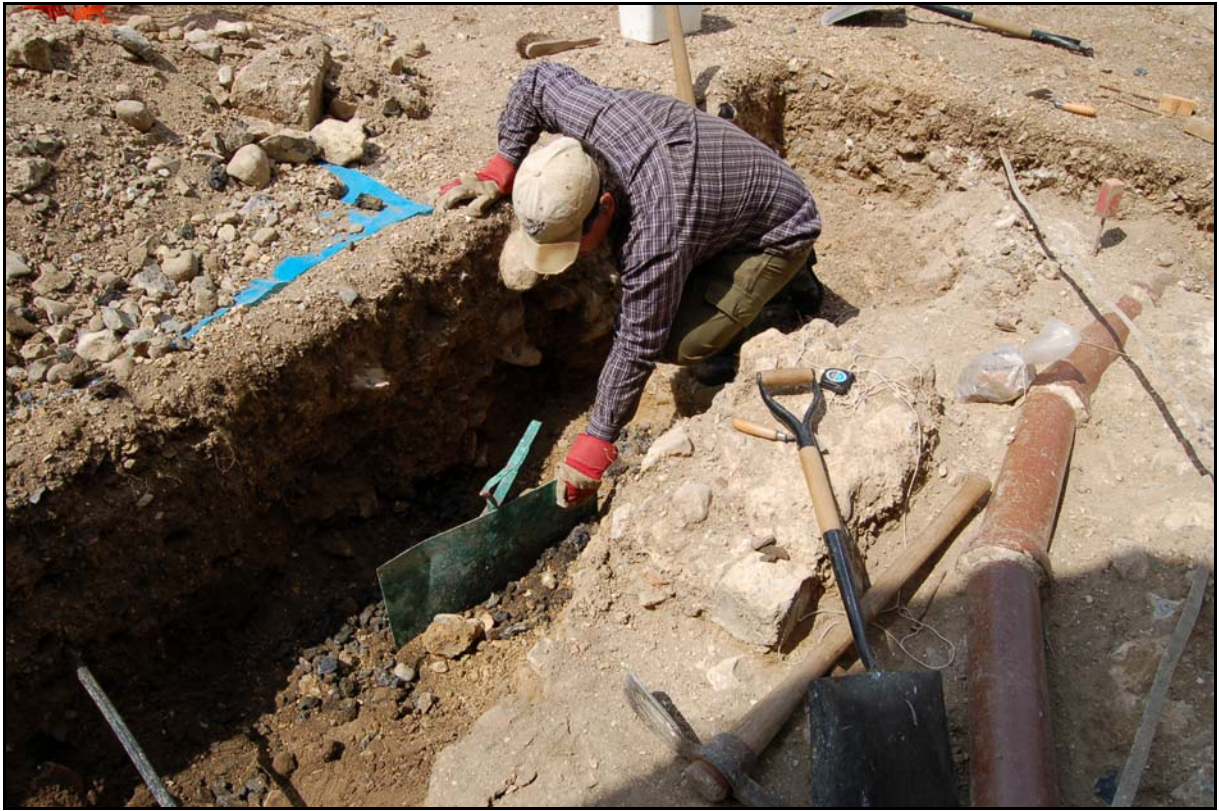
The existing and the previous lightning rods extended into the site. Both lightning rods consisted of copper strips, and were approximately 2.5cm wide. The existing rod extended off the north wall of the tower and traversed the length of the site. The previous rod began at the base of the tower, and ran towards a large pit (12). Inside the primary fill of pit 12, which consisted of loose clinker (22), was the earthing-point for the lightning conductor. The earthing-point consisted of a copper plate and was 0.6m square (Plate 4). It was attached to the end of the lightning rod.

Plate 4. Copper-alloy plate, earthing point for lightning conductor

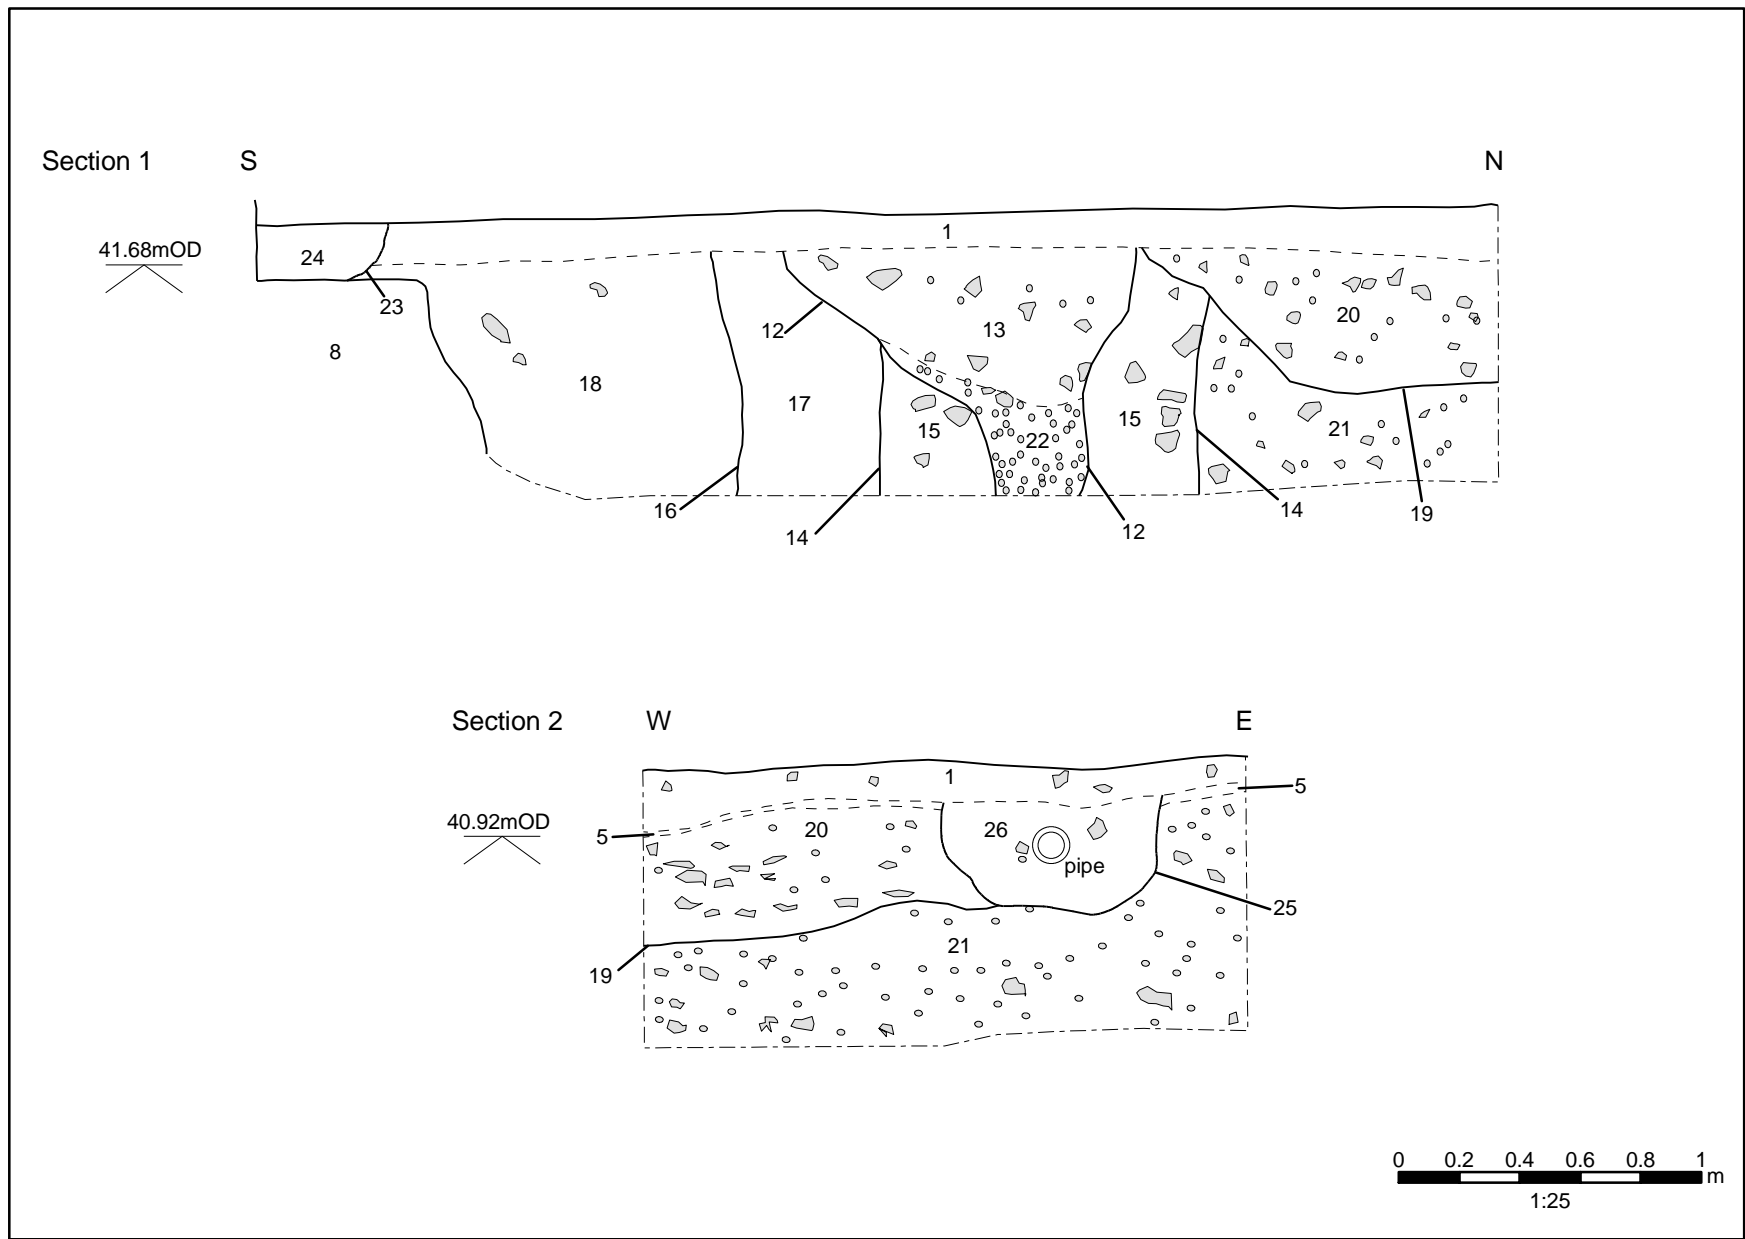
Fig.3. Sections

The archaeological excavation of the footings for the toilet facilities revealed the foundation deposits for the adjacent sections of the tower and lobby (6, 7 and 8); a modern drain and drainage pipe (25); a wall constructed from stone, tile and flint (14); two lightning conductors; a probable grave cut (16); a cut with an unknown function (19), and a small rectangular feature that may have been a grave for a neonate (10). Overlying all these deposits and features were 0.15m of overburden (1), and a modern damp course of loose gravel (23).

The wall rested on a foundation deposit of yellowish-brown clay sand (15), which had vertical sides and was at least 0.9m deep. It contained occasional flint nodules and fragments of limestone, and infrequent pieces of Roman tile. No construction cut for this wall foundation was identified

The function of cut 19, which was identified in section, is not known. It cut deposit 21 and part of the north side of wall 14, and extended beyond the edge of the site. The single fill (20) of the feature contained flint nodules, infrequent pieces of limestone, and small amounts of Roman and medieval/post-medieval tile.

Cut 16 was identified in section and is conjectured to be a grave alongside wall 14. It had near-vertical sides and was more than 0.9m deep. No human bones were present in the excavated part of the feature. The single fill (17) comprised greyish brown clay silt sand and gravel.
