**THE CHAPEL
CASTLE STREET, SAFFRON WALDEN
ESSEX**

**ARCHAEOLOGICAL EVALUATION
AND
HISTORIC BUILDING RECORDING**

**Essex County Council
Field Archaeology Unit**

August 2006

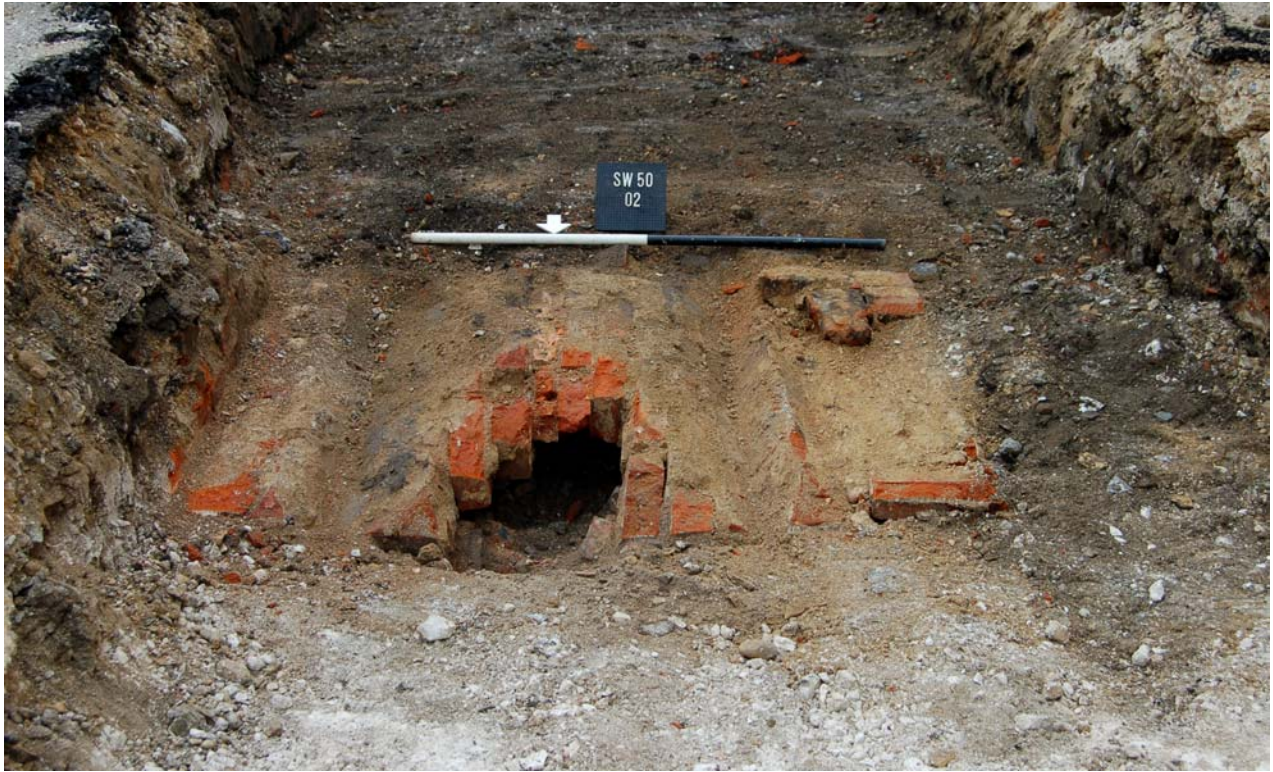
Construction cut 24 was dug into the hard chalk of the north cellar wall to contain a vaulted brick foundation pier (context 2) that helped support the rear of the late 19th-century cottage (context 1). The cut extended 0.9m northwards and continued eastwards beyond the limit of excavation obliterating much of the cellar wall on this side. The structure inside measured 1.15 x 0.90m in plan (fig. 6) and fitted snugly within the cut. It consisted of a curved central portion, 0.70m wide, running approximately north/south, with 0.35m wide parallel walled abutments either side, one of which extended partially outside the eastern edge of excavation (fig. 7). Its depth could not be established. The foundation appears to have been built on the chalk floor of the open cellar and the cellar backfilled prior to further construction of the 19th-century cottage.

The vaulted foundation supported partial remains of the former street frontage cottage, context 1, and associated internal floor surfaces (fig. 6 B, plate 1). The back wall of the cottage was defined by brick foundations, again dated to the 19th-century and sharing identical dimensions and character to context 2. Context 1 formed the south-west corner of the building. A second robbed-

Plate 1 Curved brick foundation pier viewed from north

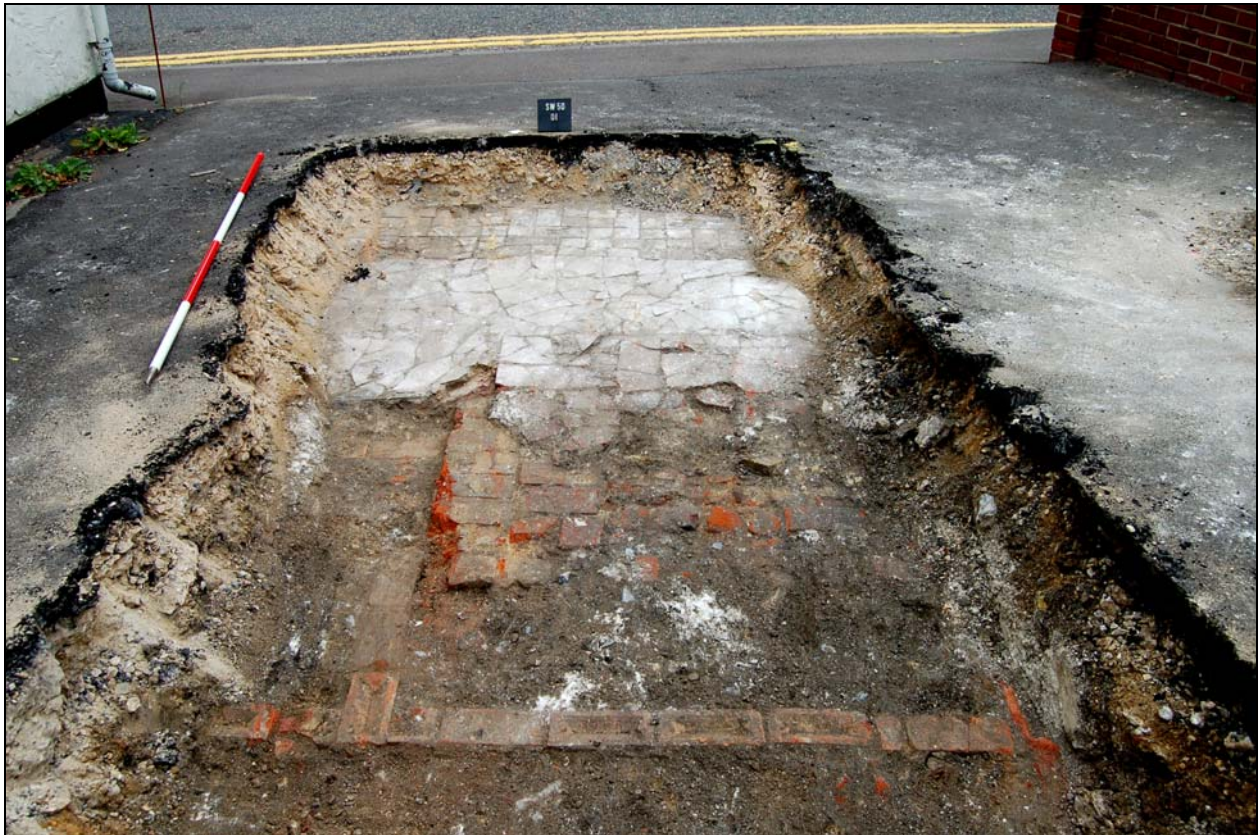
Overlying part of the foundations to the north were two contemporary external surfaces (context 23) post-dating the cottage demolition. They comprised areas of yellow stock floor bricks and broken tile on a mixed mortar bedding and continued beneath the edge of excavation on three sides. It is likely that they are associated with a light Fletton brick-built structure, context 14, constructed in the 20th-century.

Plate 2 Wall foundations to former street frontage structure and later paved surfaces

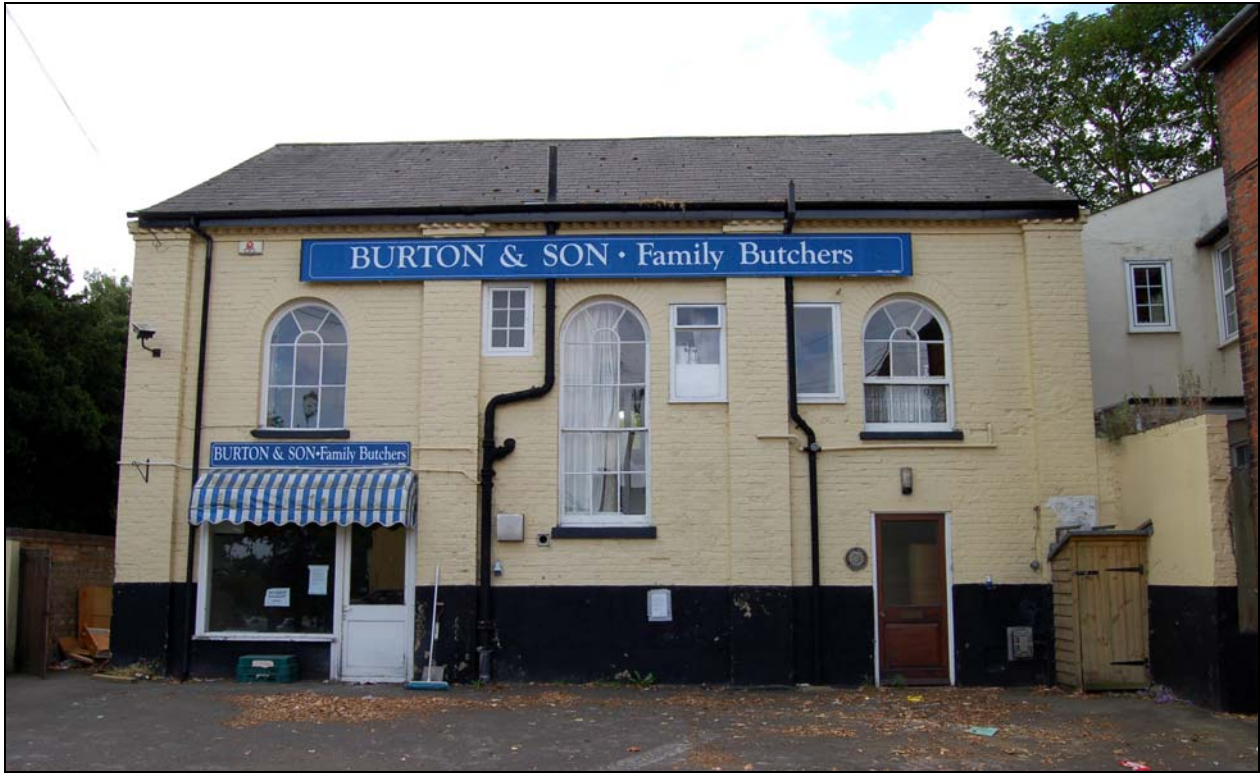
The chapel stands at the rear (south end) of the plot on an east to west alignment facing the car park. It is brick-built in Flemish bond with white brick dressings, best seen on the south and east elevations, which have not been painted over. The bricks are partly creased red bricks of a standard size (c.22 x 10.5 x 7cm), both early 19th-century characteristics consistent with a 1836 (or later) build date. They are placed within a lime mortar partially repointed in cement. Prominent contemporary elevations face the two roads to north and east (plates 3 & 4), the former of which contains the shop front facing onto the car park. Both elevations have painted brickwork and 'Burton & Sons Family Butchers' signs. That to the east bears a partially observed earlier sign underneath (plate 4), alluding to the former printers or ice cream makers here. Evenly-spaced buttresses define three bays, the tops of which are decorated with dog-tooth corbelling that continues across at eaves level (plate 6). The roof appears to be clad in slate with gables pitched at 40° with plain stepped brick corbels. Set centrally in each are blocked circular windows that formerly lit the roofspace and are best seen in plate 5.

Plate 3 North elevation of chapel

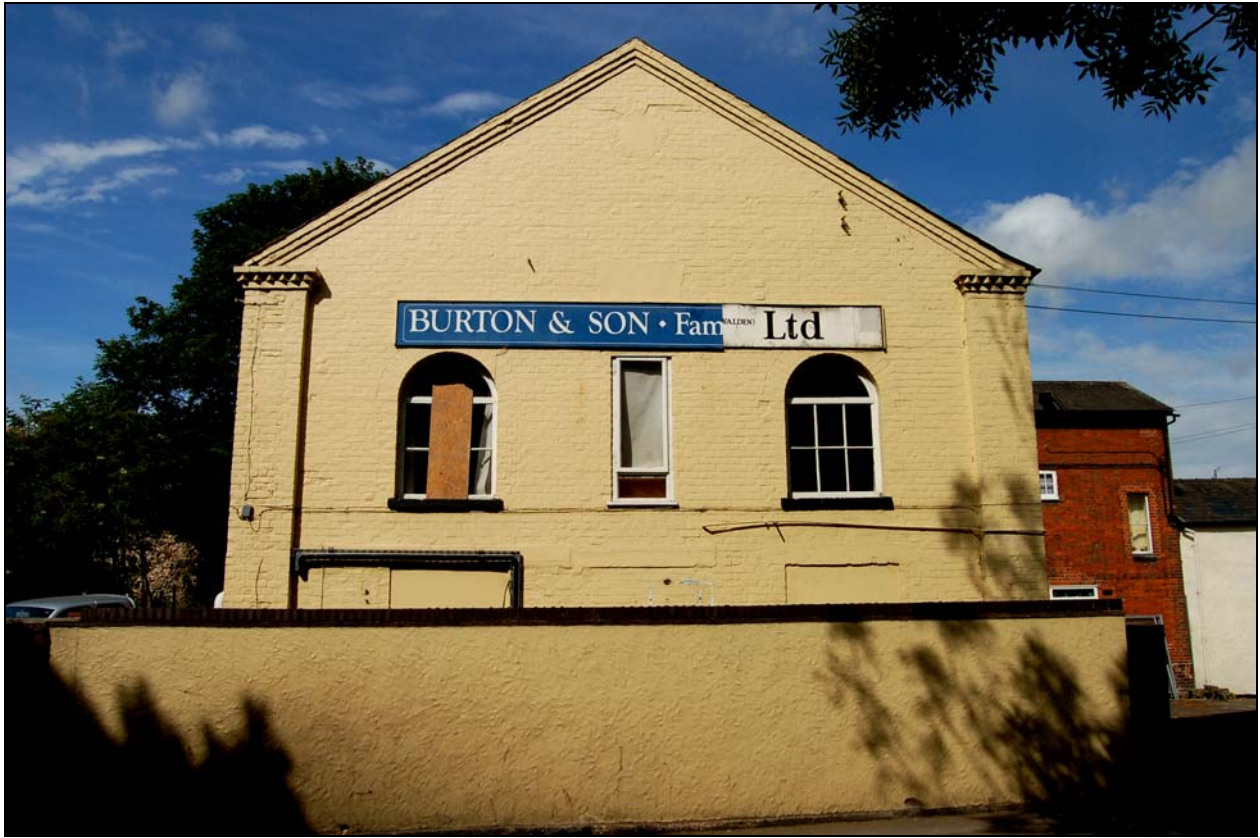
Plate 4 East elevation of chapel

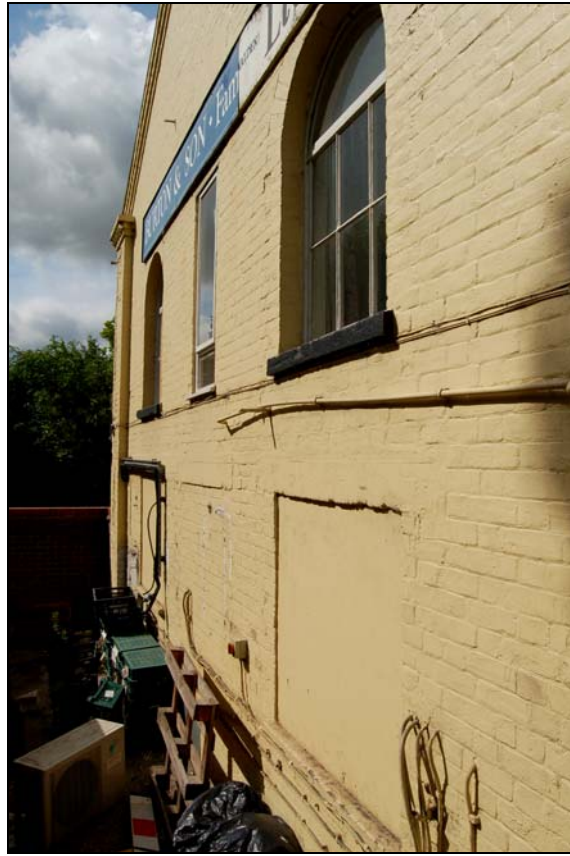
Plate 5 Blocked central doorway and modern windows on east elevation

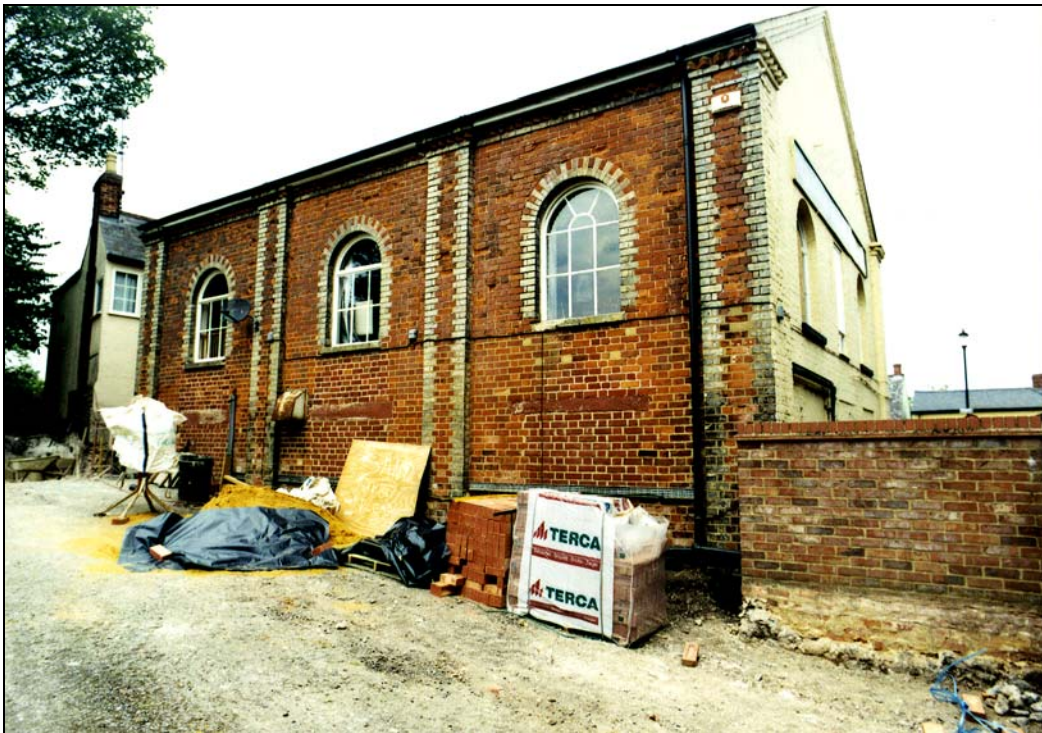
Plate 6 Exposed brickwork on south elevation of chapel

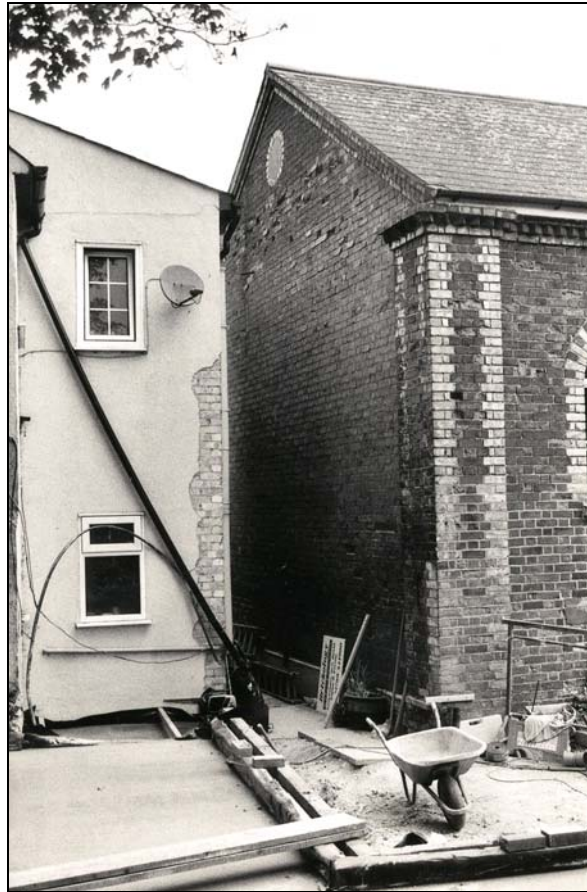
Original well-proportioned and attractive round-headed windows light the top floor on all elevations except that to the west, which due to its proximity to no. 4 Castle Court (fig. 1) was, apart from the gable light, built blind (plate 7). Additional modern windows have been fitted on the north and east elevations, with the division of the top floor into a flat above the shop. Apart from the long central window on the north elevation (plate 3), no original windows remain at present ground floor level, and it is possible there were none originally. There are several blocked apertures for square windows on the south and east elevations (plates 5 & 6), whose spacing and proportions may indicate a contemporary date, but whose concrete lintels suggest later work. A blocked central doorway on the east side is likely to have been the main entrance, leading from Castle Hill, although it is not a particularly wide entry point (fig. 9a, plate 5). There is no evidence for a removed porticoed entrance. A rear doorway led from the north side and was remodelled to become the flat entrance. The window above is slightly shorter to allow room for the doorway (plate 3). Any other original apertures were removed when the butcher's shopfront was inserted into the wall fabric.

Plate 7 Blocked gable light on west elevation during building works

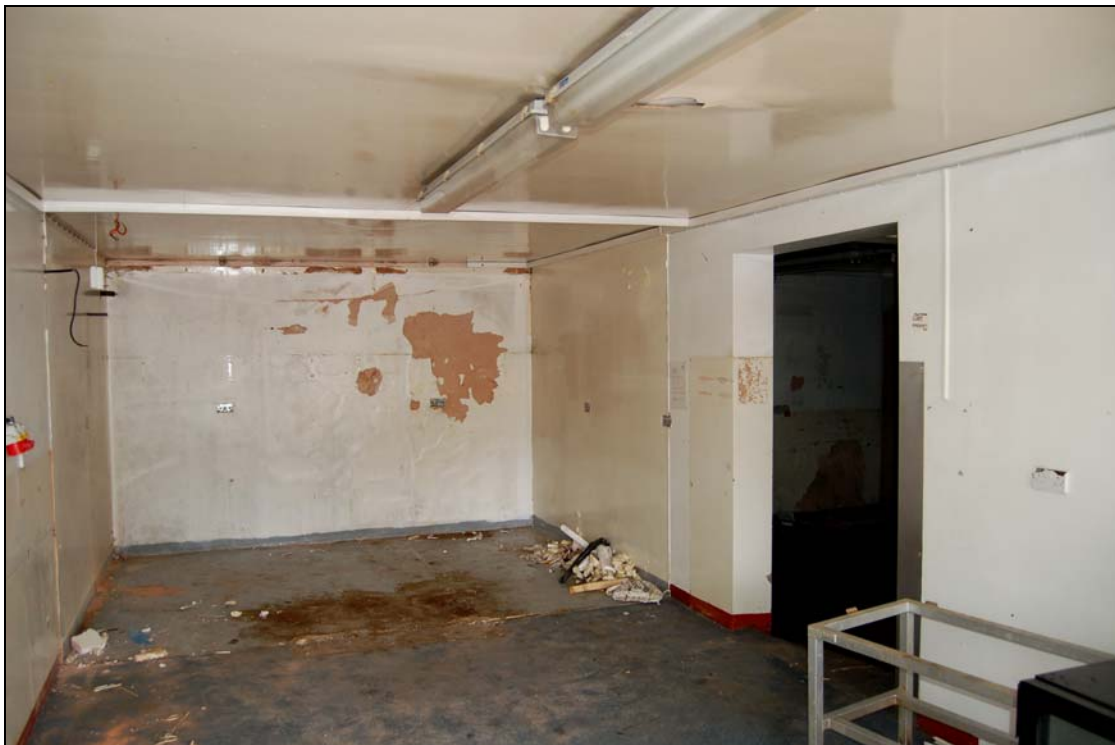
Internally, the ground and first floors are completely stripped of any earlier fixtures and features, to create the working and living areas shown on fig. 9. Plate 8 shows the stripped-out shop and plate 9 the kitchen upstairs. The round headed windows are original features that mainly open inwards from the arched top (plate 10). A few windows are fixed or vertical sashes, but all are contemporary in materials and style. Their positions are shown in fig. 9b. The most prominent window is the long central one on the north elevation, a vertical sliding sash that retains its wheeled rope pull (plate 11), in use before the first floor was added.

Plate 8 Stripped-out shop interior

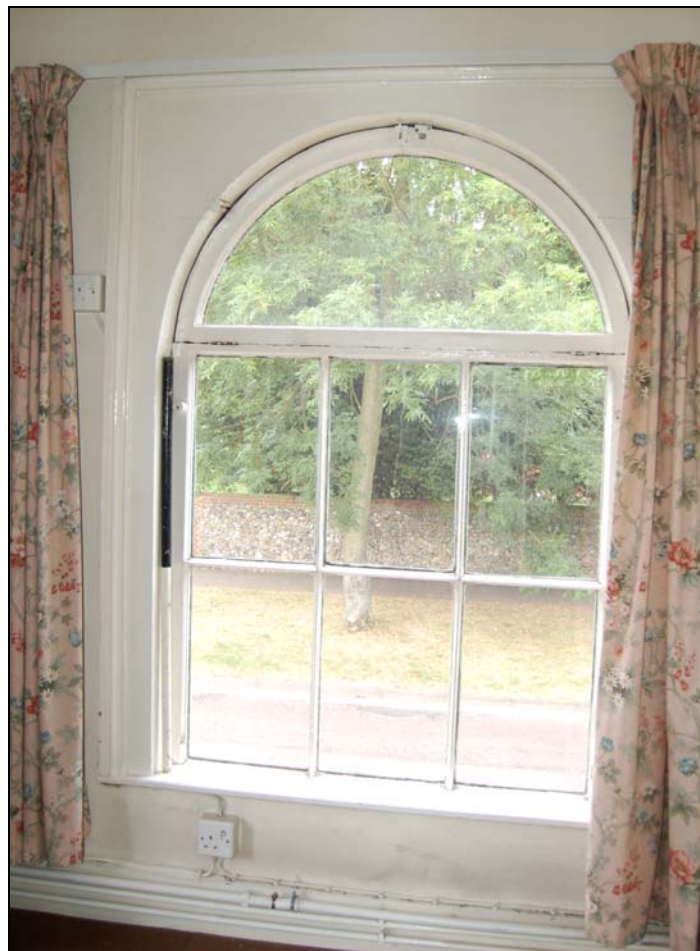
Plate 10 Top-opening window on east elevation

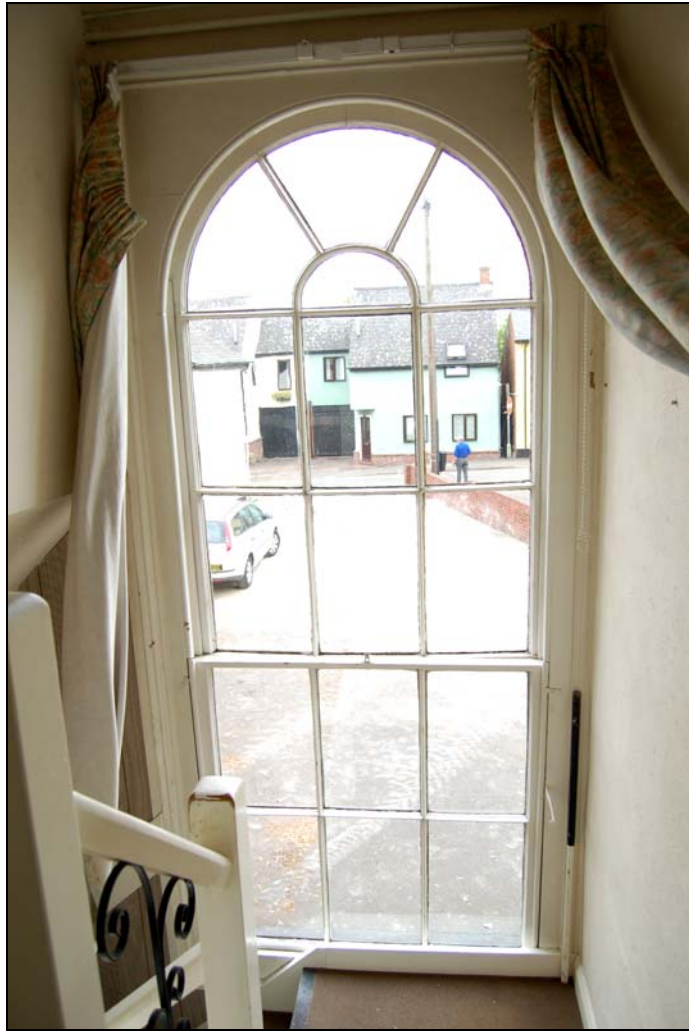
Plate 11 Stair window on north elevation

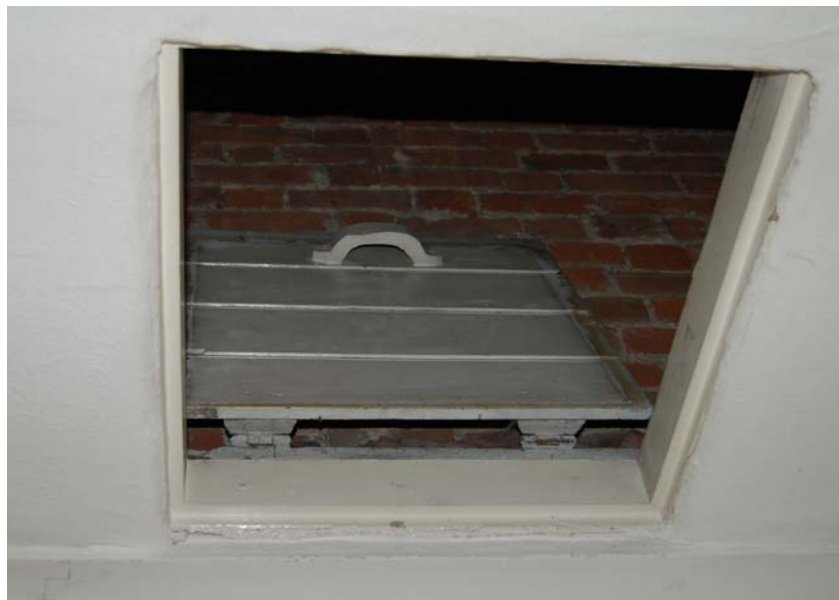
A machine-sawn softwood king post strut roof frame can be seen through the loft hatch in the bathroom ceiling (plates 12 & 13). Some of the rafters appear to have been replaced. The wooden frame in the foreground of plate 13 supports a modern water tank.

Plate 12 Loft hatch in bathroom

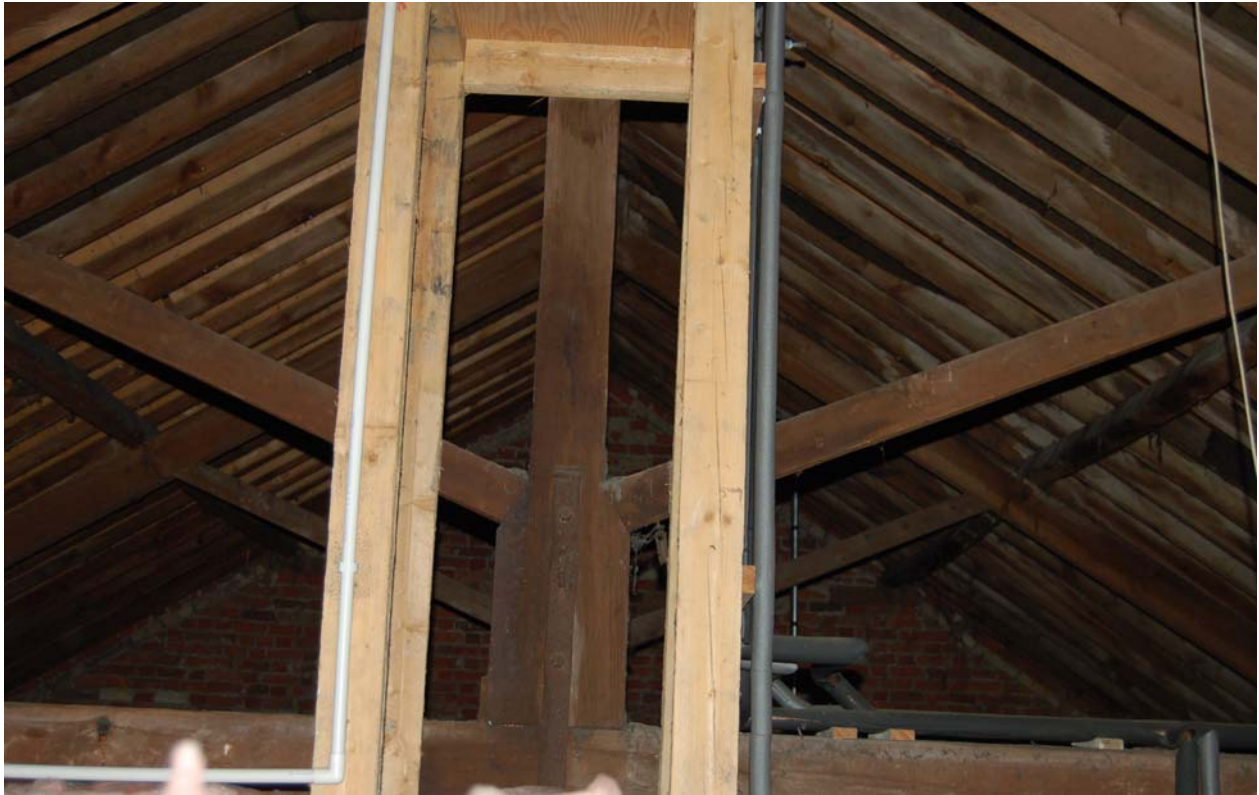
Plate 13 King post strut roof truss
