NORTH BATTLESBRIDGE TIDAL DEFENCE IMPROVEMENTS ESSEX

ARCHAEOLOGICAL MONITORING

NOVEMBER 2006

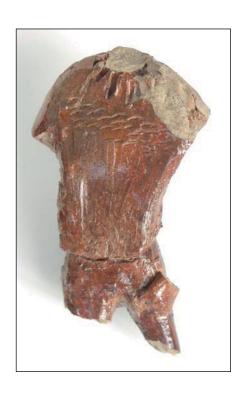
Front cover: ?16th century figurine from the riverbank

Of interest is part of a moulded figurine, found unstratified on the riverbank to the west of the bridge during ecological work (Fig. 1). The object comprises the headless torso of a male figure in brown-glazed stoneware, the head and limbs having broken-off in antiquity (see front cover illustration). He is dressed in a tunic and tights, and the remains of the left hand can be seen resting on the hip. A band of incised dashes across the chest may represent a pattern on the tunic. There are also incised lines radiating below the neck which may represent a collar. The figure is crudely-made and somewhat flat, suggesting that it could have been part of a frieze, with other figures and a background of some sort. However, the incised lines of the collar continue around the back of the figure and there is also some texturing on the reverse of the tunic, equally suggesting that he was intended to be viewed from both sides. The method of manufacture is rather odd, the stumps of the limbs showing that clay was wrapped around pre-formed rods of ceramic that provided a framework for the figure.

No parallel can readily be found, but stoneware figurines and anthropomorphic jugs were made in Rhineland Germany during the 16th century. A jug in the shape of a man, manufactured at the Rhenish production centre of Frechen, is dressed in a tunic and shows a very similar-shaped hand resting on the hip; although otherwise the figures are unalike. The Frechen figure, published in the Frechen Ceramics Museum guidebook, is dated to around 1570. Female figurines were also produced at the nearby production centres of Aachen and Raeren, dating to *c*.1500-40, and a very small number of such figurines have been excavated in this country (Gaimster 1997, 228-9, fig.78). Unlike German stoneware jugs, which were imported in great quantities, figurines are rare objects. As Battlesbridge is on a tidal river

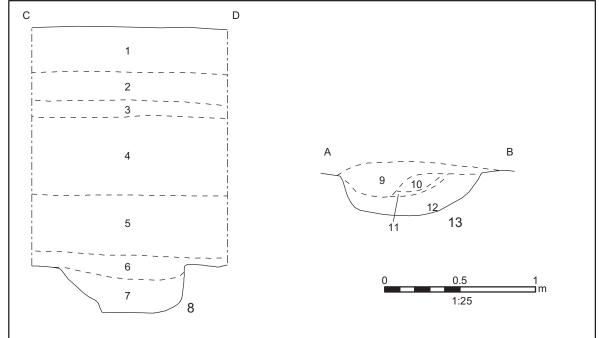
Fig.2. Piper's pond plan and sections

No archaeological features were identified in the initial topsoil strip. Two archaeological features (8 and 13) were observed and subsequently excavated during machine-removal of deposits from within the footprint of the new pond. Both were located at an approximate Ordnance Datum of 1.2m. Pit 8 was sub-circular in plan with a near vertical side to east and south and a 45° side to the west. Hard baked clay at the base of the pit was indicative of insitu burning. The pit was filled with light grey clay (7) containing numerous flecks and pieces of charcoal and small lumps of baked clay. One 12 litre soil sample was taken from this fill for analysis. This sample produced further charcoal and baked clay but no carbonised ecofactual material. The top of the pit was overlain by an indistinct layer of charcoal flecked greyish brown clay (6).

Pit 13 was located some 3m south-west of pit 8. It was oval in plan with concave sides and base. Reddish baked clay, indicating in-situ burning, was noted around the exposed edges of the pit. The base of the pit was filled with grey clay (12) that contained occasional flecks of charcoal. Above were two small lenses of grey (11) and dark grey brown (10) clay. The top of the pit was overlain and in-filled with speckled dark grey clay (9) that contained charcoal and baked clay flecks.

Both features were overlain by thick, naturally-accumulated, deposits of grey (5) and brown (4) clays. Layer 4 was sealed by dark grey brown clay (3) that was probably a buried former topsoil. This, in-turn, was sealed beneath re-deposited clay (2) and modern topsoil (1). In total the archaeological deposits were sealed beneath approximately 1.5m of overburden.

Additional monitoring of the pond excavations revealed the presence of two features of probable prehistoric or Roman date situated in the eastern half of Piper's Pond, some 50m north of the existing course of the River Crouch. These were sealed beneath estuarine clays at a depth of 1.5m below the present ground surface. Evidence of in-situ burning suggests that these features may be fire-pits or hearths possibly associated with the process of winning salt from sea water. These features are often accompanied by large mounds of baked clay salt-making debris know as 'red hills' (Fawn *et al* 1990) and are found on the peripheries of saltmarshes and in estuarine locations around the Essex coast.

Full excavation of Piper's Pond revealed that the two fire-pits were cut into a former land surface situated about 0.5m above a natural gravel deposit, which was in total located some 2m below the ground surface. It is possible that salt extraction activities took place upon localised firm ground as the presence of clay, to the north-west of the gravel, suggests that the surrounding terrain may have been marshier.

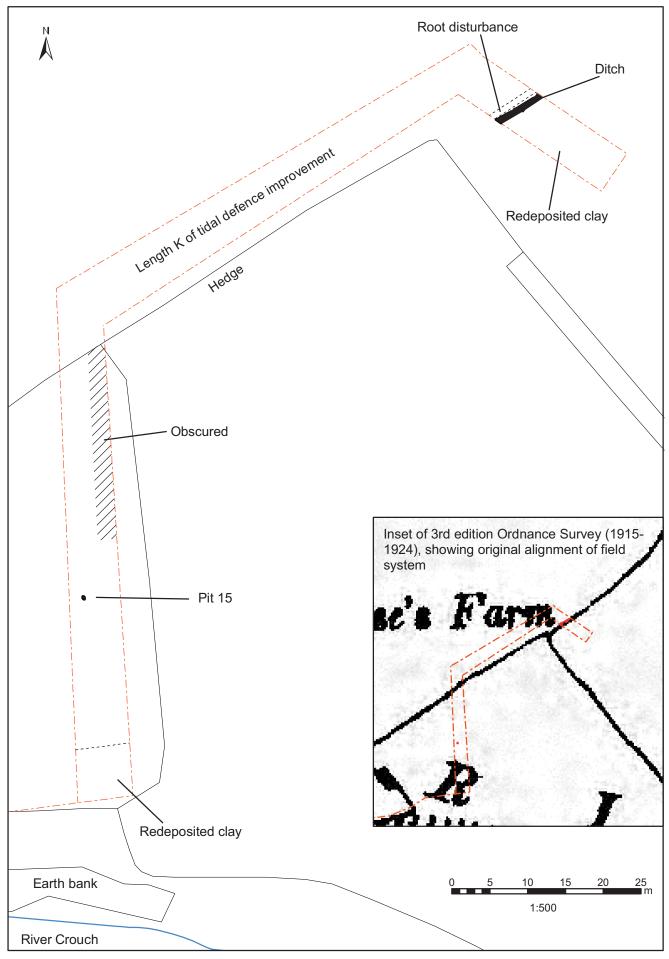
Fig.3. Length K monitored area

The topsoil strip was monitored along the c.150m extent of length K. A north-east/south-west aligned field boundary ditch was identified at the east-end. The ditch was filled with modern debris, including brick rubble and plastic, and was partly sealed beneath a layer of redeposited clay. A vague, ill-defined, greyish brown silt feature running parallel with the ditch probably represented root disturbance from a former hedge-line. The position of the ditch matched exactly with a 19th-20th century boundary depicted on the 1st to 3rd editions of the Ordnance Survey map.

One shallow, oval, pit (15), probably of fairly recent origin, was excavated in the middle of the north-south leg of length K. Occasional charcoal flecks were noted in the dark grey clay silt fill (14) but no dateable artefacts were recovered. At the south end of the stripped area the clay subsoil was overlain by re-deposited brown clay and soil in excess of 0.5m thick. These deposits appeared to be part of the existing embankment along the edge of the river.

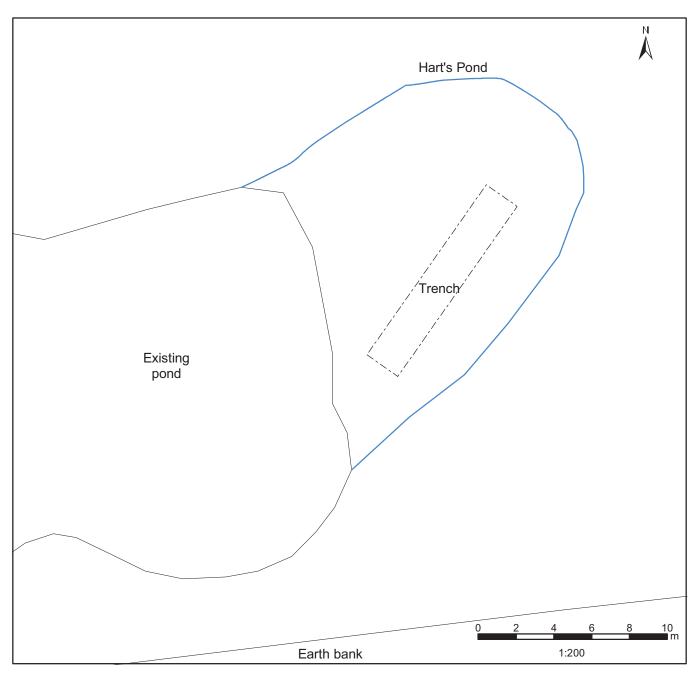
The topsoil strip was monitored at the eastern extension to Hart's Pond. No archaeological features were identified. The east side of the pond extension was disturbed and built-up with modern brick rubble. An 11m-long trial trench, c.0.9m deep and orientated north-east/south-west, was dug through the middle of the pond extension to investigate and characterise the underlying deposits. These deposits comprised mixed grey and brown clay with occasional lenses of dark grey organic grassy material. No archaeological features were observed.

Given the presence of buried archaeological deposits in Piper's Pond, the possibility of further deposits was investigated by trial trench within the footprint of the extension to Hart's Pond. However no archaeological features were encountered. The Hart's Pond extension was much shallower than Piper's Pond, c.0.9m in depth as opposed to 2m, and it may be that the archaeological horizon (if present) was not reached.

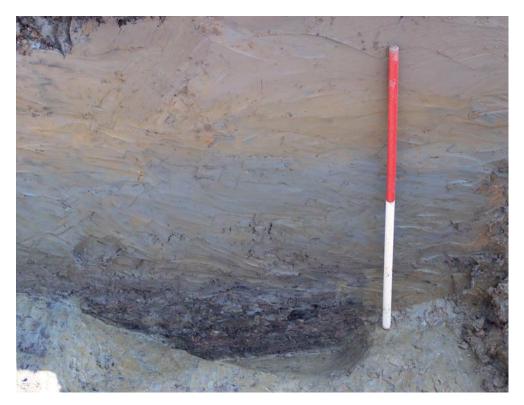
Plate 1 Pit 8, looking north-east (1m scale)

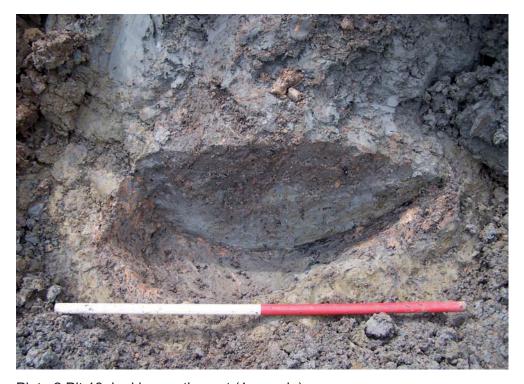
Plate 2 Pit 13, looking north-west (1m scale)
