**WATER PIPELINE REPLACEMENT
THE STROOD CAUSEWAY
WEST MERSEA
ESSEX**

ARCHAEOLOGICAL MONITORING

MARCH 2007

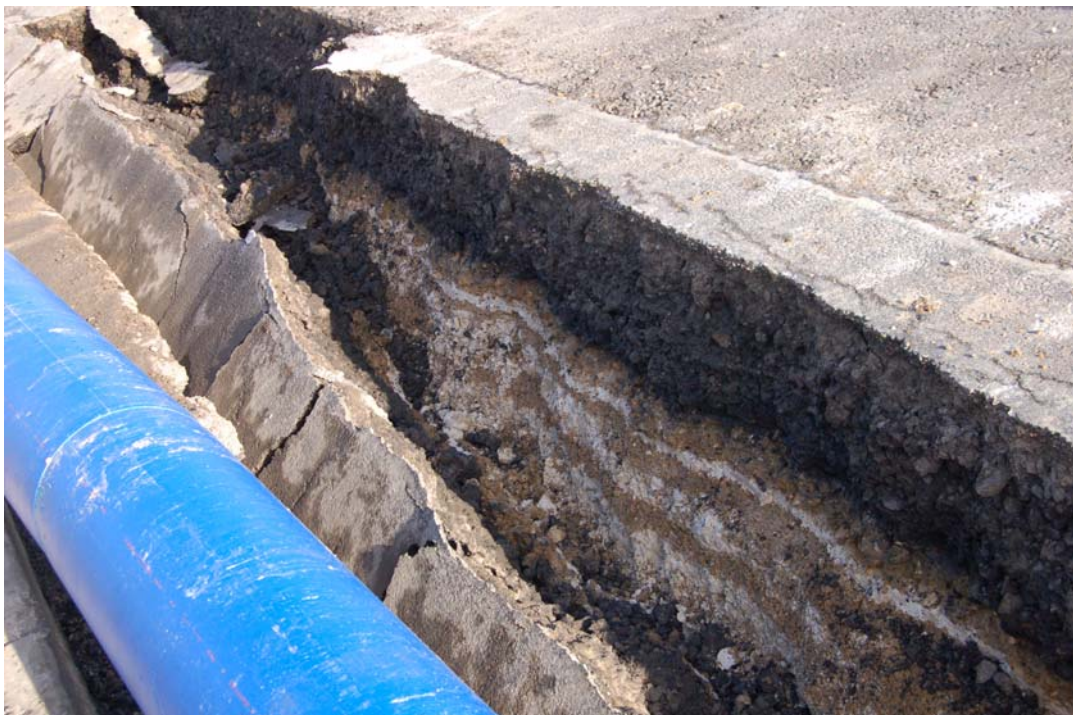
On dry land, either side of the channel and its flanking marshes, mid-brown clay underlay approximately 0.6m of modern road make-up. On the causeway itself the depth of the road make-up was approximately 0.7m, with alternate consolidation layers of chalk and gravel below, to a depth of approximately 1.2m (Plates 1 and 2). At the southern end of the causeway dark grey/black gravel silts were noted immediately below the below the

stabilisation layers. However, these were not significantly intruded into by the works and were only observed along the base of the pipe trench.

Plate 2. Detail of Causeway construction deposits
