**HISTORIC BUILDING RECORD OF
THE FORMER MALTINGS (FYFE WILSON WORKS)
STATION ROAD, BISHOP'S STORTFORD
HERTFORDSHIRE**

Field Archaeology Unit

May 2007

Client: Mantle Projects Ltd.

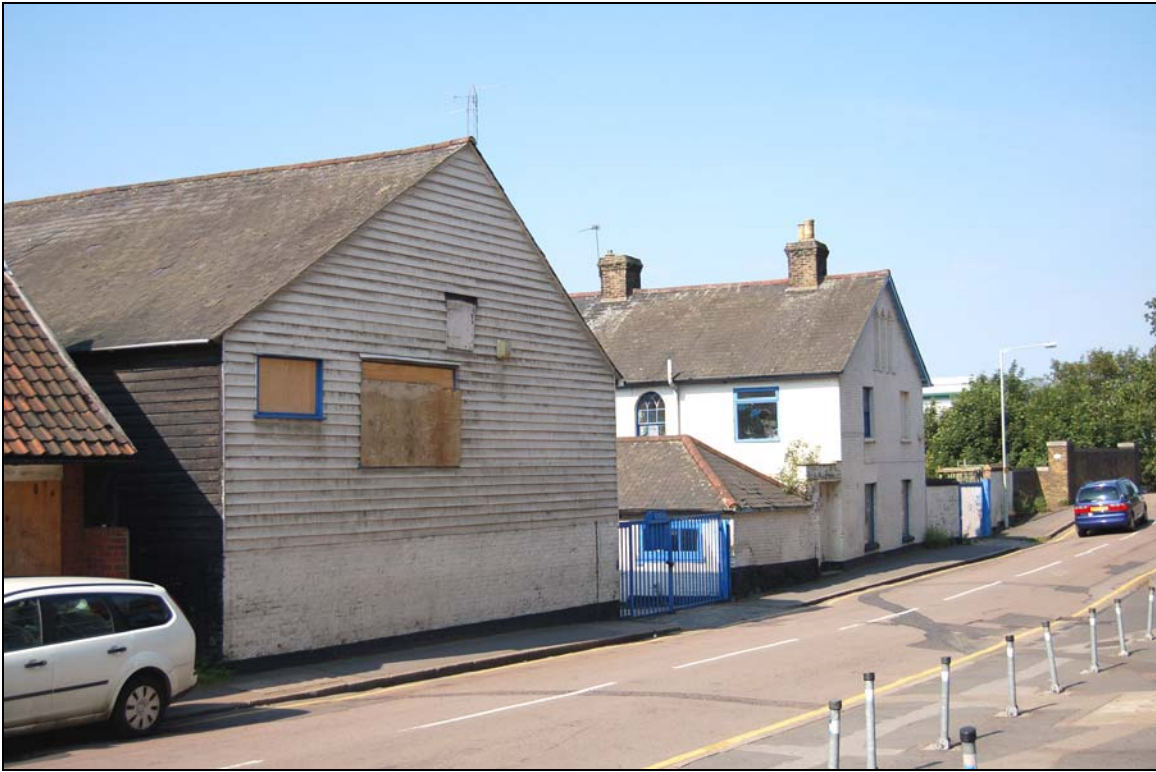
Plate 1 Malting viewed from Station Road to north-west

The prominent elevations of the malting range are painted a clean white with blue dressings (plates 1 & 2). The east elevation, hidden from view by the car showroom next door, is painted black (plate 3), while the rebuilt maltstore shows bare brickwork (plate 5).

on the north elevation inside the gable at loft level (plate 1). Other boarded-up apertures on this side are likely to be later in date.

The house is two-storied and brick-built with gabled, slate-clad roof and twin chimney stacks (plates 1, 30 & 31). It is painted in the same blue and white colour scheme as the industrial structures, some of which obscure the east and south sides (plate 30). The windows have mainly been replaced, but there are some sliding sash windows remaining on first floor level. The gables are decorated with blind tripartite gothic-style lancet windows, pointed to the north and rounded to the south. The interior appears to be stripped-out and was not entered.

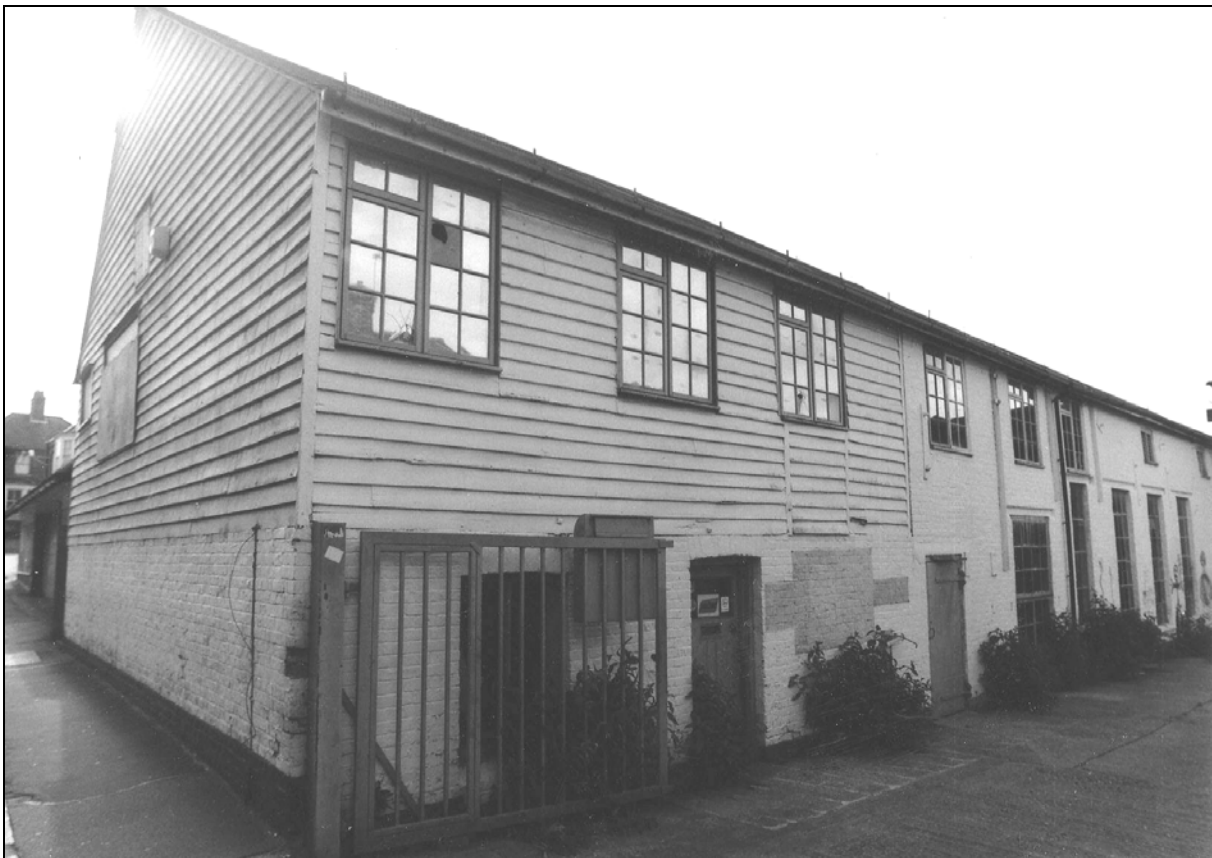
Plate 2 North end of barley store and germinating floors viewed from north-west

On the west elevation (plate 2), the windows and barley store entrance with segmental headed arches remain on the ground floor with inserted modern fittings. Nicely-proportioned 16-pane wooden casement windows have been inserted at first floor level to light the office area. On the opposite side (east elevation) there remains a single ground level iron-grilled window (plate 7), that was used throughout the malting range, but only survive here and in the germinating floors. This one was blocked internally when the modern stairs were inserted, but would have been equipped with internal shutters to regulate the air flow.

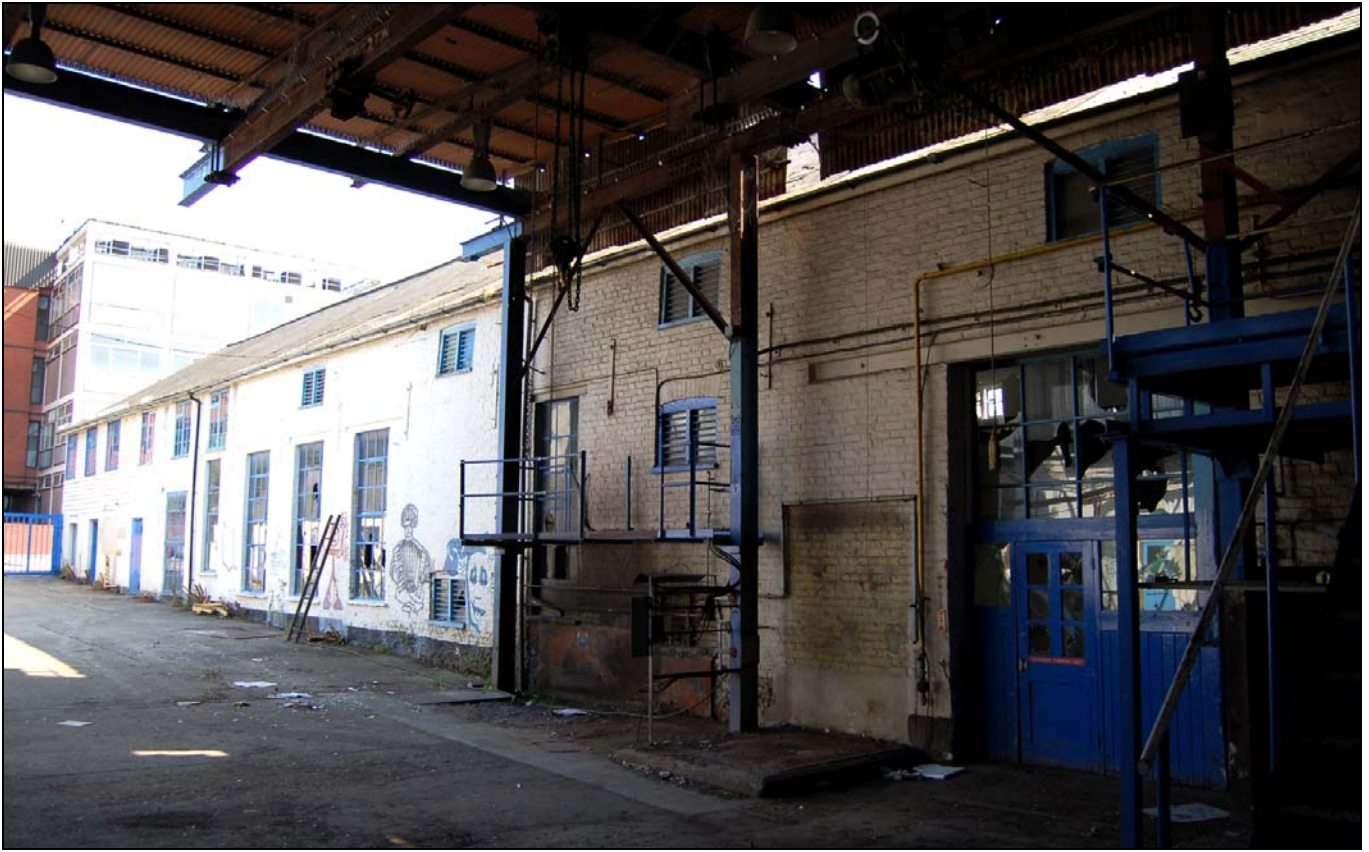
Plate 3 South end of barley store and germinating floors viewed from south-west

Much of the west elevation is hidden from view by the adjacent large canopied loading bay that housed a second travelling crane built in the modern period (plates 3, 4 & 32). A single grilled window, like those seen in the germinating floors, stands in shadow in front of the steps in plate 4. The difference in height between this window and those in the germinating floors shows the floor levels were different in the kiln, which is normal. It also indicates the location of the roasting floor. The window on the other side is a replaced modern casement.

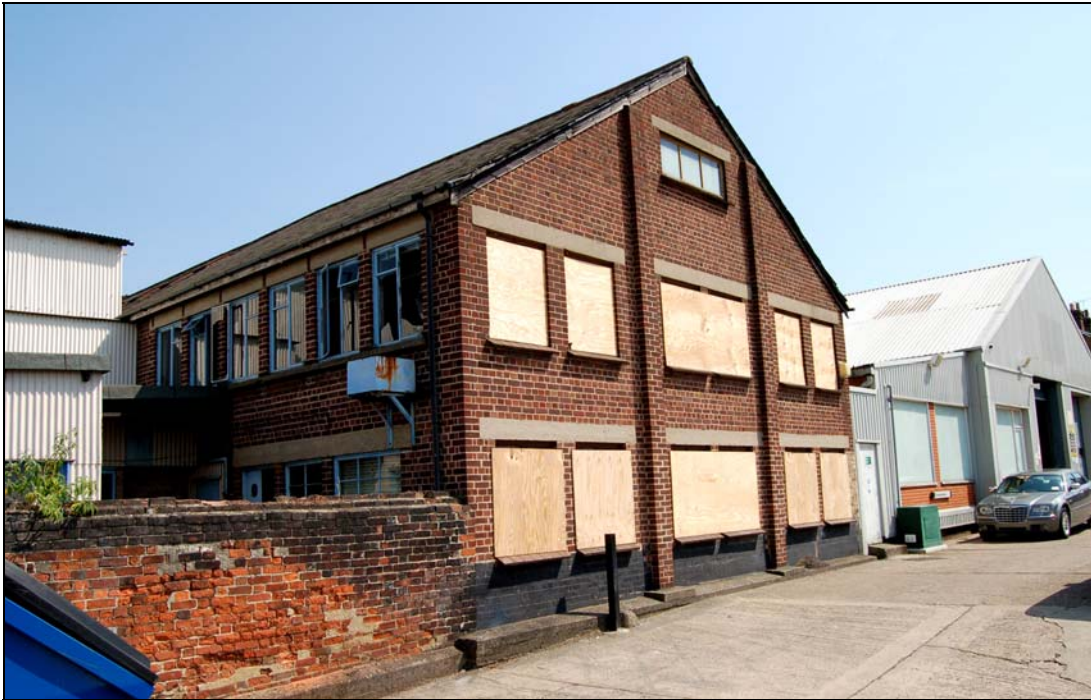
Plate 5 Rebuilt maltstore from south-west

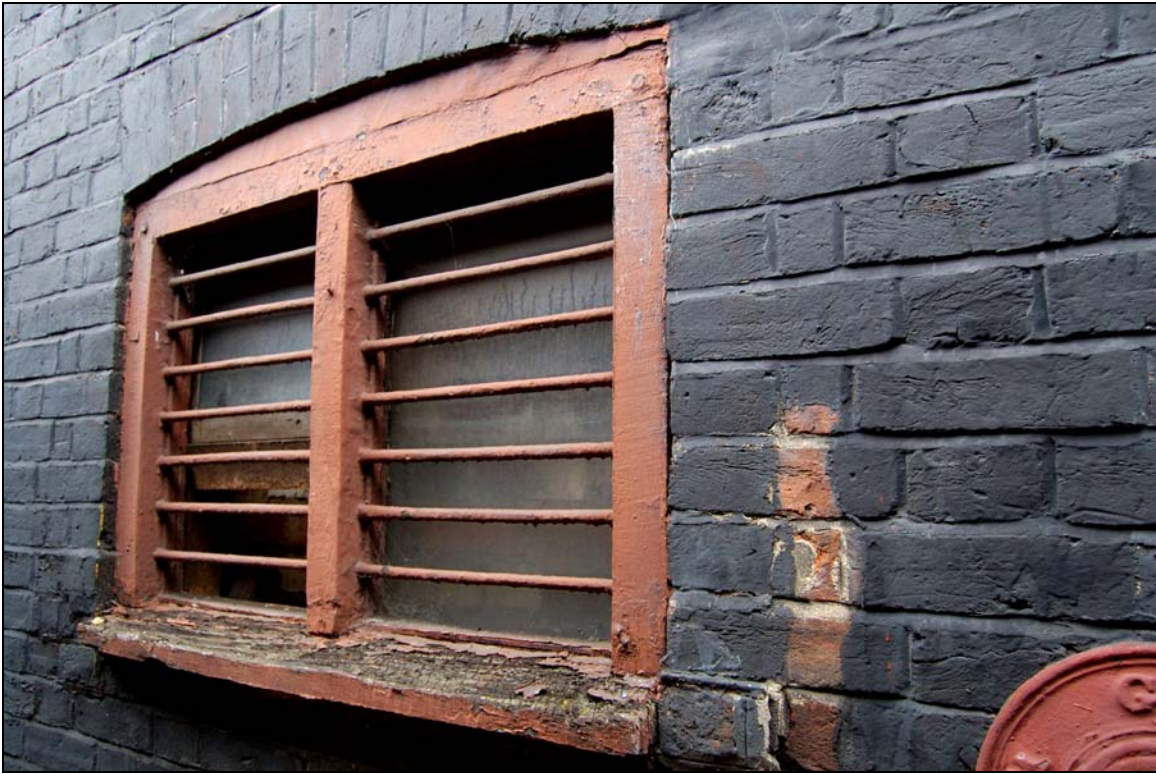
Plate 7 Original window to germinating floors

The inserted modern floor that surrounds the working floor is on the same level as the first floor store areas, whose levels have not been altered. Segmental arch wooden-framed windows are the original form of fenestration throughout (plate 7) and survive relatively intact on the east elevation. Where unaffected, they are arranged in rows of three, reflecting the number of original floor levels (fig. 8, plate 13). The original windows are on every alternate bay so that none of the gridded windows face another, thus limiting cross-ventilation. Some have been blocked and others lost to modern fenestration, especially at the barley store end. More are retained on the east side of the germinating floor where, to some extent, the proximity of the car dealership negates the benefits of new windows. Because of the sloping ground to the west, the east side is built into the slope, with the lower set of windows lit by a linear light well set into the surrounding concrete and now covered by boarding (plate 13). This may have been caused by levelling the land to the west when the garage was added.

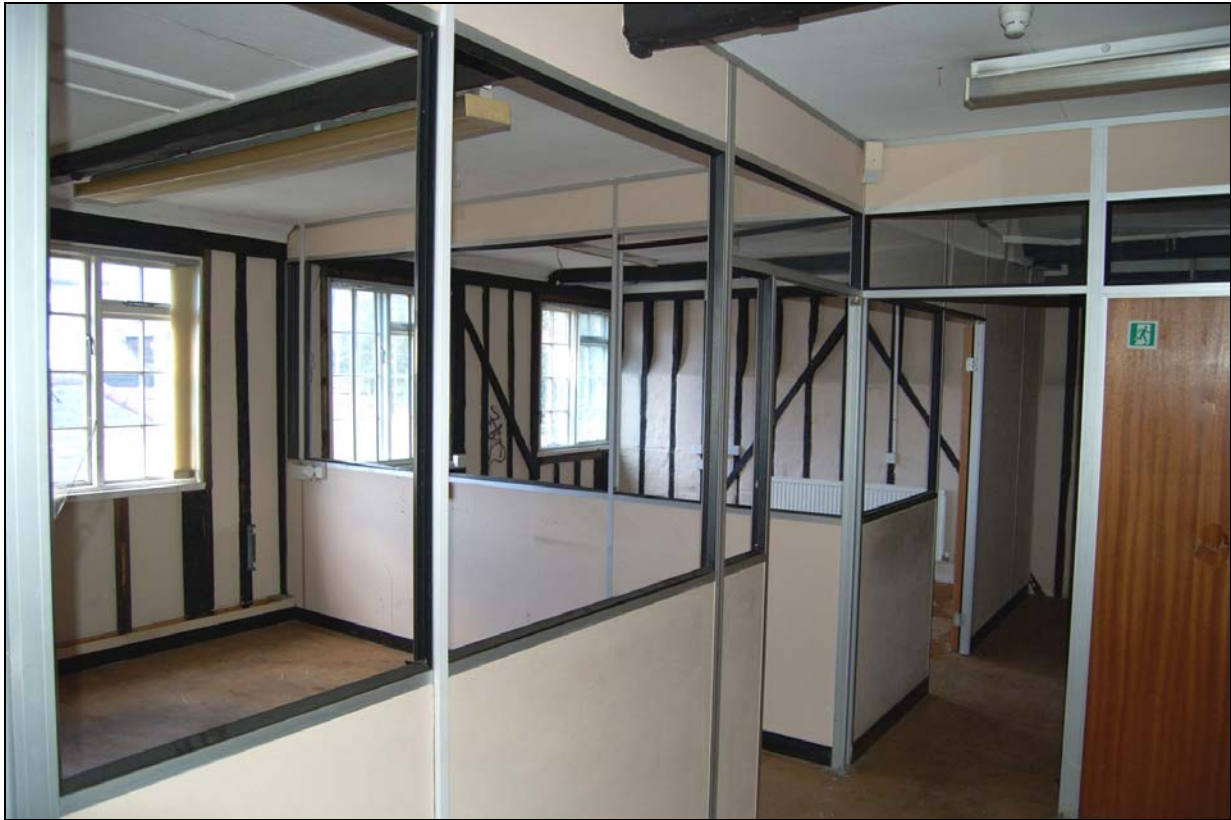
Plate 9 Timber framing and inserted partitions on first floor of barley store

The first floor is divided into offices and welfare facilities using modern partitions (plate 9). Part of the north end of the germinating floor is too. This floor adopts posts rather than columns in its construction, where the load-bearing is less. In contrast to the ground floor, the ceiling joists run the opposite way, across the width of the barley store, knitting-in the floors and adding to the overall strength of the structure. Some of the longitudinal primary joists are hidden by modern suspended ceilings and modern floor tiles may obscure any hatches or trapdoors associated with grain conveyance, especially to the steeps below.

On this level, the southern end exists as a partially weatherboarded wall, now embedded within an office partition in the former germinating floors area (plate 12). The wall aligns with a solitary post on the west side (fig.5), but any further walling or signs of structure are absent. Thin primary braced framing is evident on the other three walls (plate 9), although it is hidden

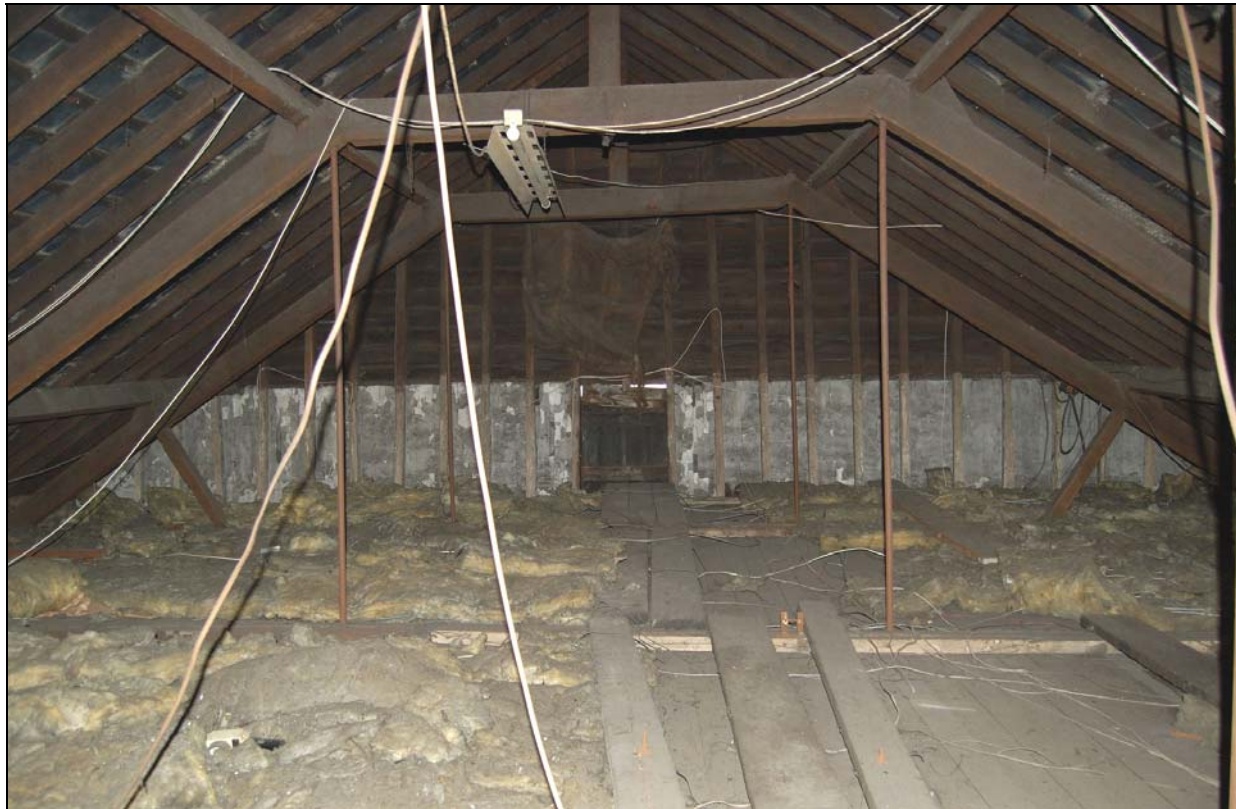
Plate 10 Small taking-in door at north end of barley store loft

The taking-in door on the north end (plates 10 & 11) opens inwards and is linked to the germinating floor barley loft by ramps and boards for barrowing the barley into the barley loft next door. 12cm-wide floorboards rest across the tie beams, now largely covered in insulating foam. Important floor hatches may be concealed here, for dropping barley down to the stores below for storage.

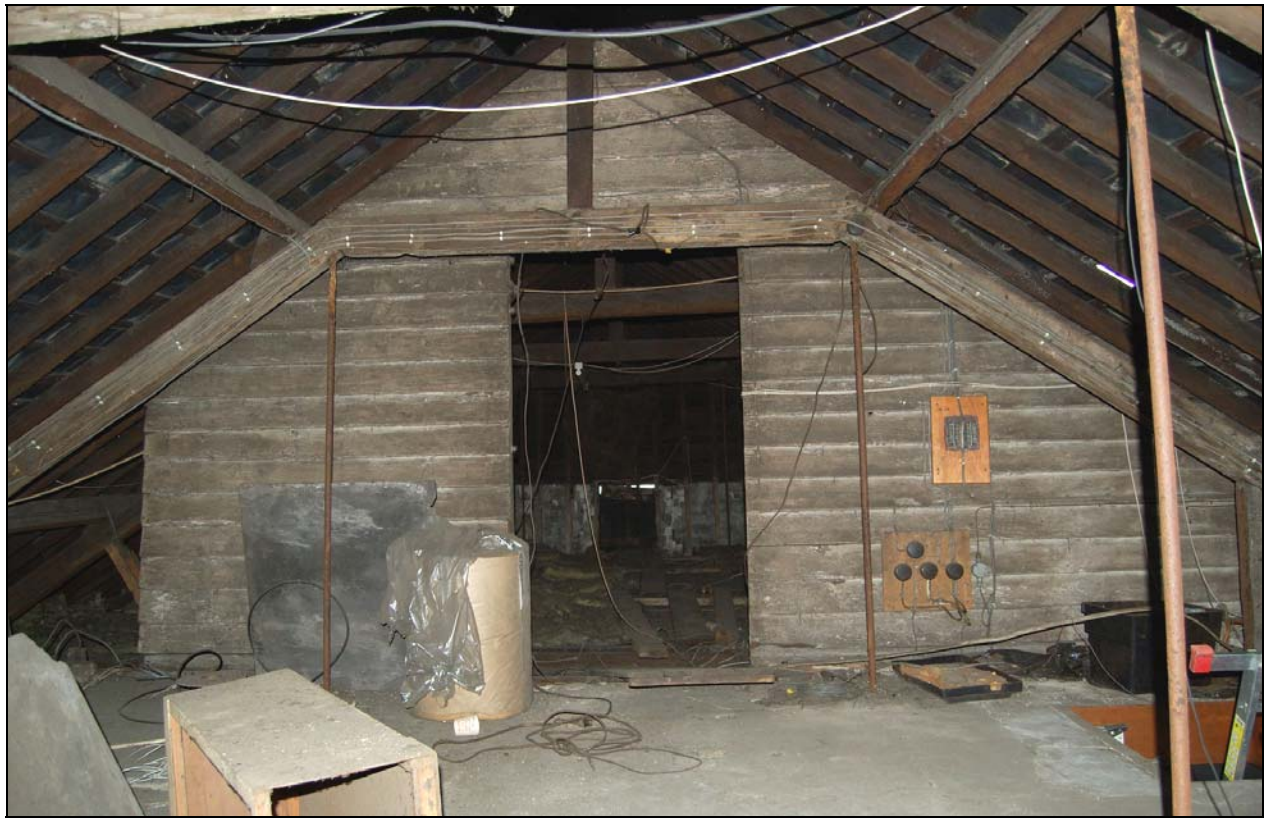
Plate 11 Southern wall of barley store from barley loft

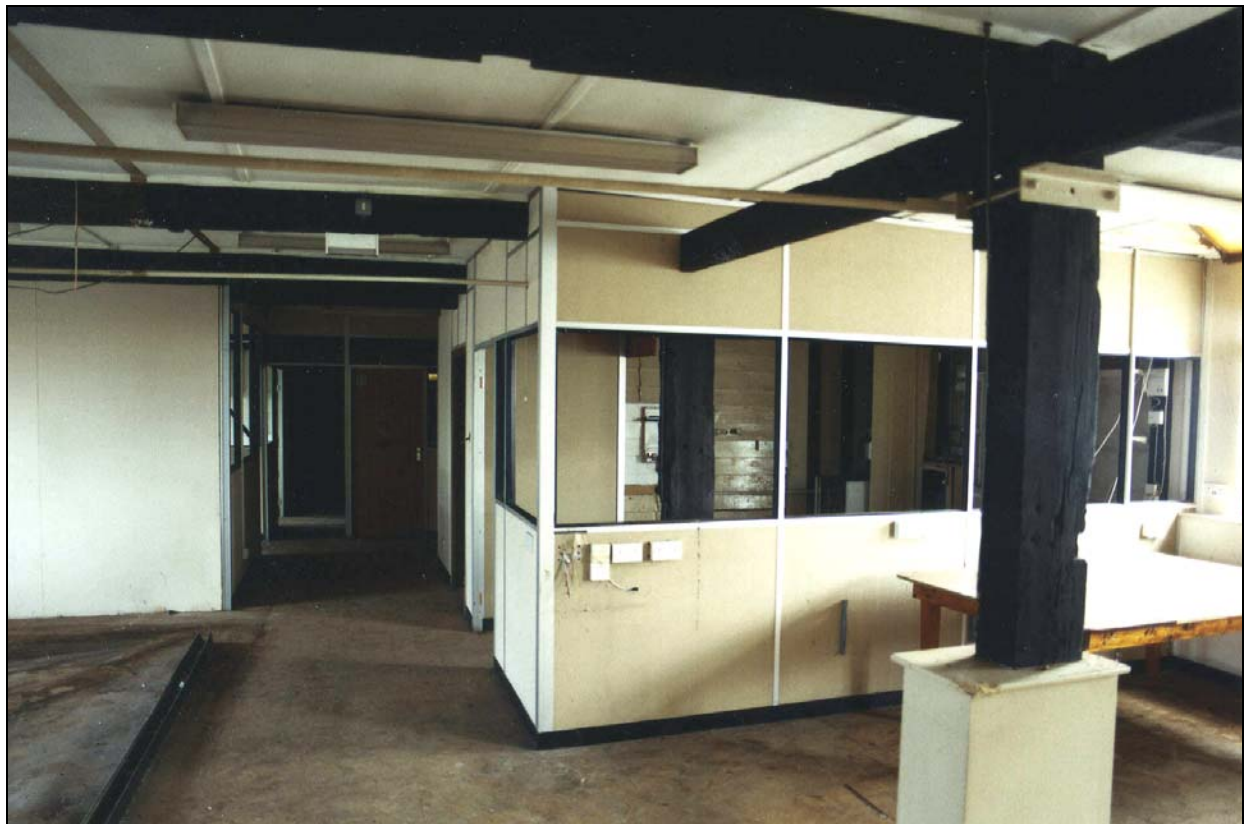
Plate 12 Remaining southern wall of barley store inside office partition (right)

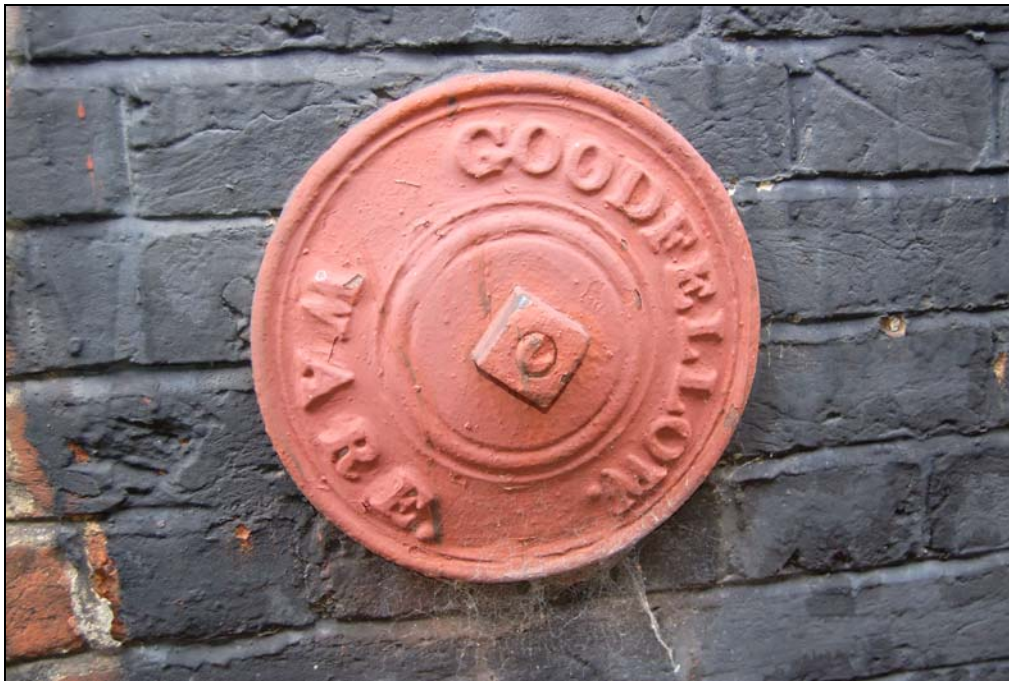
Plate 14 Cast tie rod plate with maker's name

The walls of the germinating floors are constructed entirely of brick, to support the weight of the steeped barley on the heavy wooden floors. Lateral force was countered on the walls by tie bars manufactured by 'Goodfellow Ware', whose pink-painted plates contrast with the black background of the western wall (plate 14).

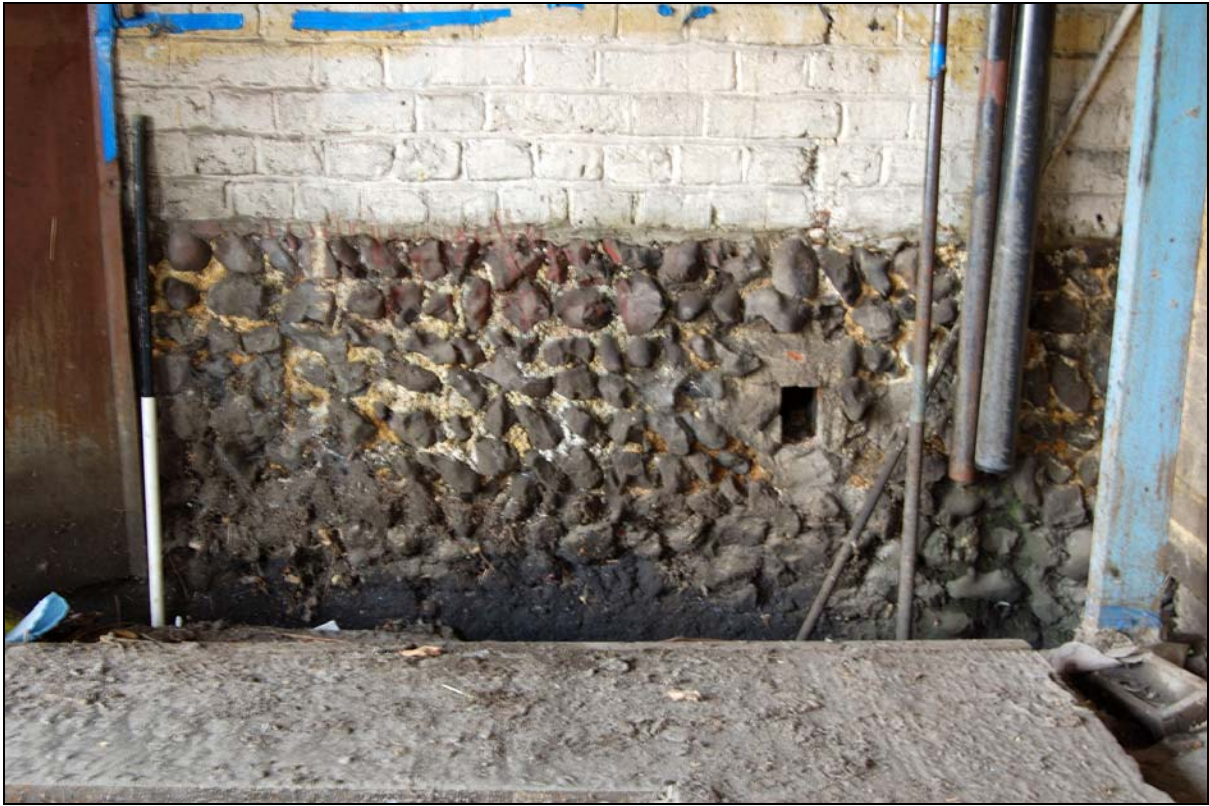
Plate 15 Flint wall to earlier construction, part of west wall of germinating floors

The main entry point into the germinating floors is a sliding wooden door at the south end, close to the kiln. It is modern, with a fan light over (plates 3 & 4), but may signify an earlier entrance, perhaps for carts. Much of the wall on the west elevation is built on a roughly-coursed flint wall bonded in lime mortar (plate 15) that pre-dates the malting.

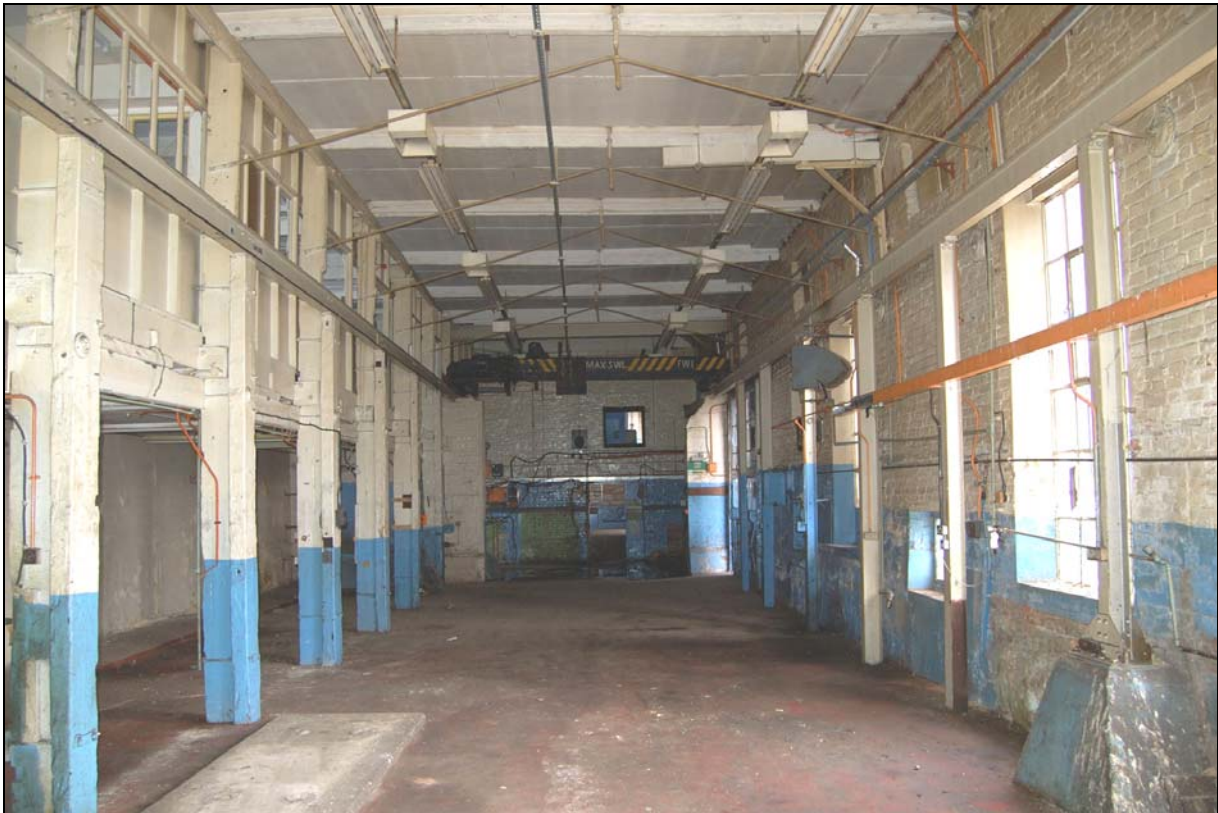
Plate 16 Interior of germinating floors viewed to south

The germinating floors were completely altered when Fyfe Wilson took over the site. The first and second floors were gutted to make one large working floor, providing room for a travelling crane (plates 16 & 17). The internal walls were lined-out to a height of c.4m in English-bonded brickwork to support the crane and outer walls, which, without assistance from the posts and joists were liable to collapse in on themselves. The floor was screed and a partial first floor linking the former kiln and barley stores was introduced around the new working area, built from fresh timber. Thus the existing floor layout has no resemblance to

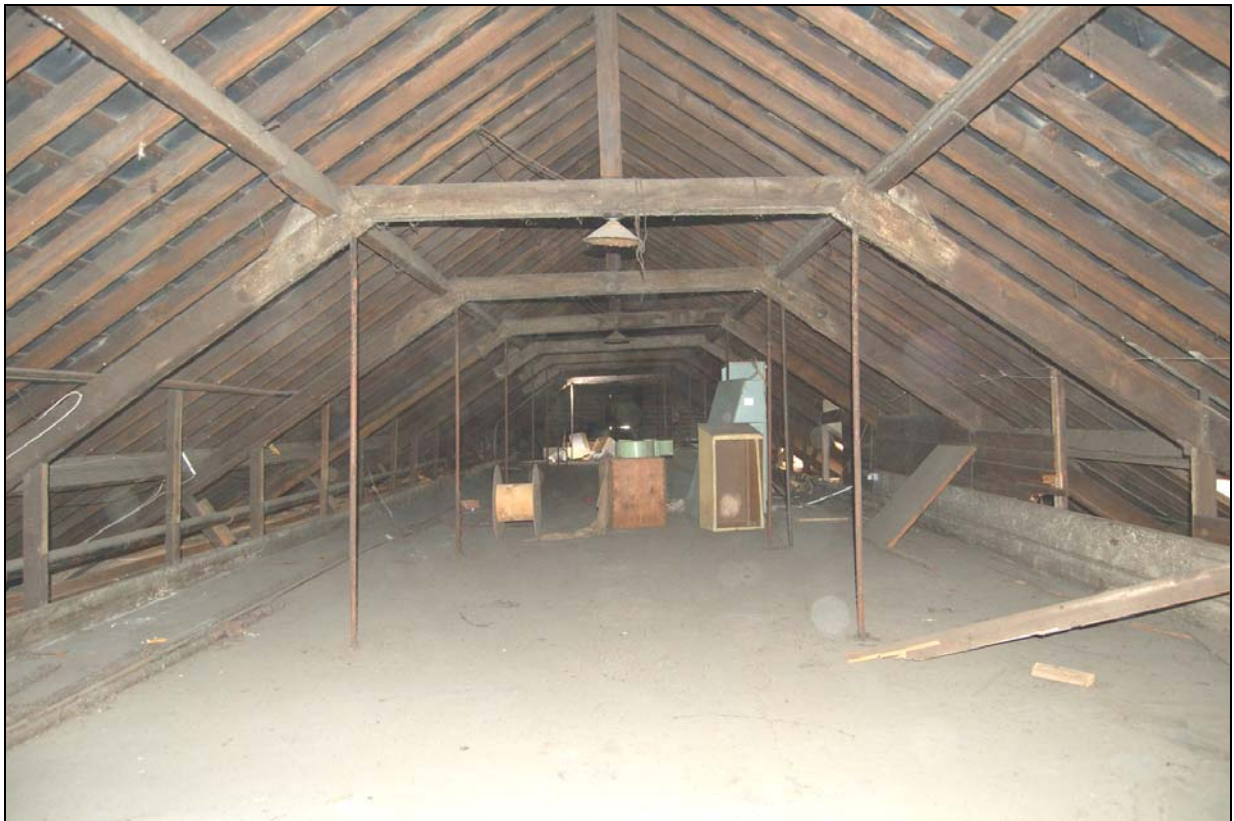
Plate 18 Barley loft viewed to north

Again, the only unaffected area is the barley loft in the attic space; a wide storage and walkway (plates 18 & 19) to transfer barley from store to kiln (for sweating) without interfering with the germination process. The barley loft was situated above the germinating floors with direct access to the kilns for sweating.

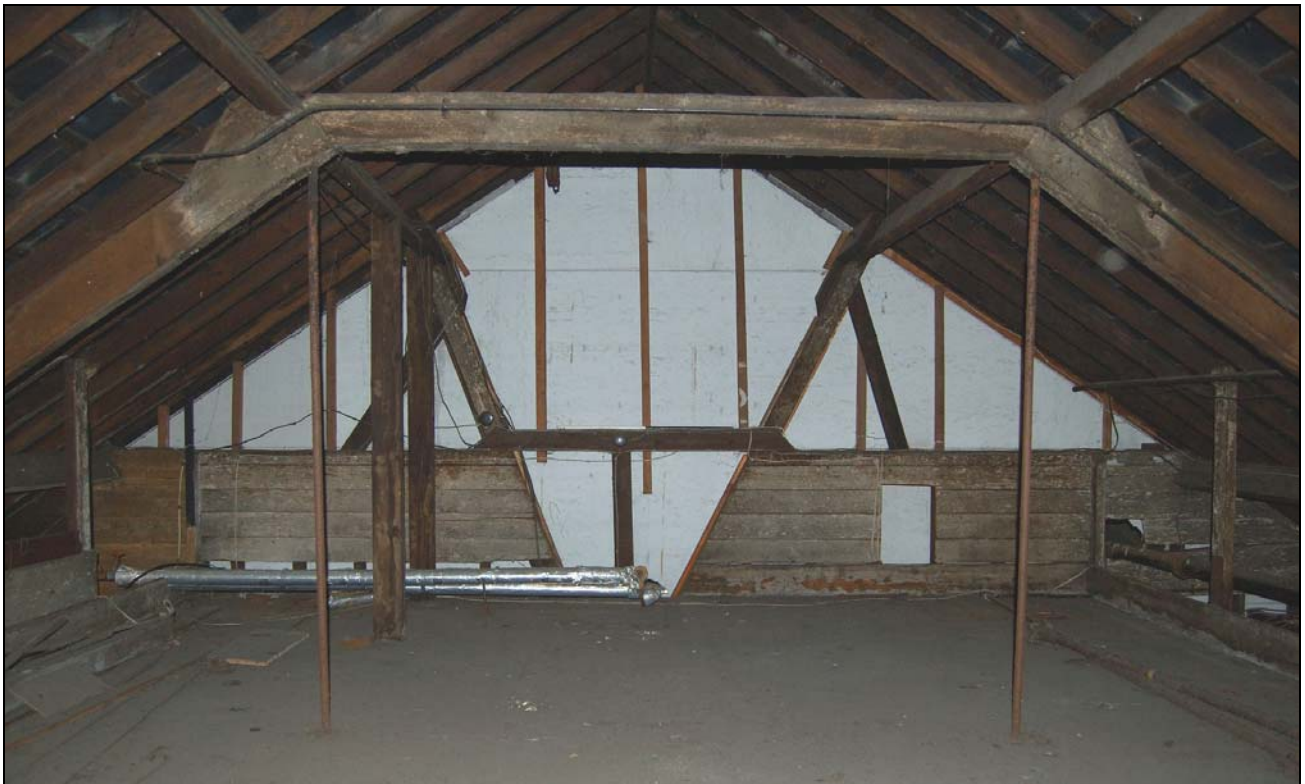
Plate 20 Rebuilt kiln wall and inspection hatch

When the welding shop was furnished in the former kiln next door, the partition wall was replaced with a fire-resistant asbestos screen fitted to a light timber frame (plate 20). However, important malting evidence has been preserved at the south end where the germinating floor formerly met the kiln roof above the roasting chamber. The end framing is different here, comprising two timber struts forming a V-shape, braced either side and connected to the roof purlins either side (plate 20). This supports a winch, set above collar/head height (plate 21). The winch fed baskets of barley grains through a central floor hatch to the floor below (fig. 6), where it could be placed in the kiln for sweating before storage. Grain could also be dropped through hatches set in the floor either side (fig. 6). A

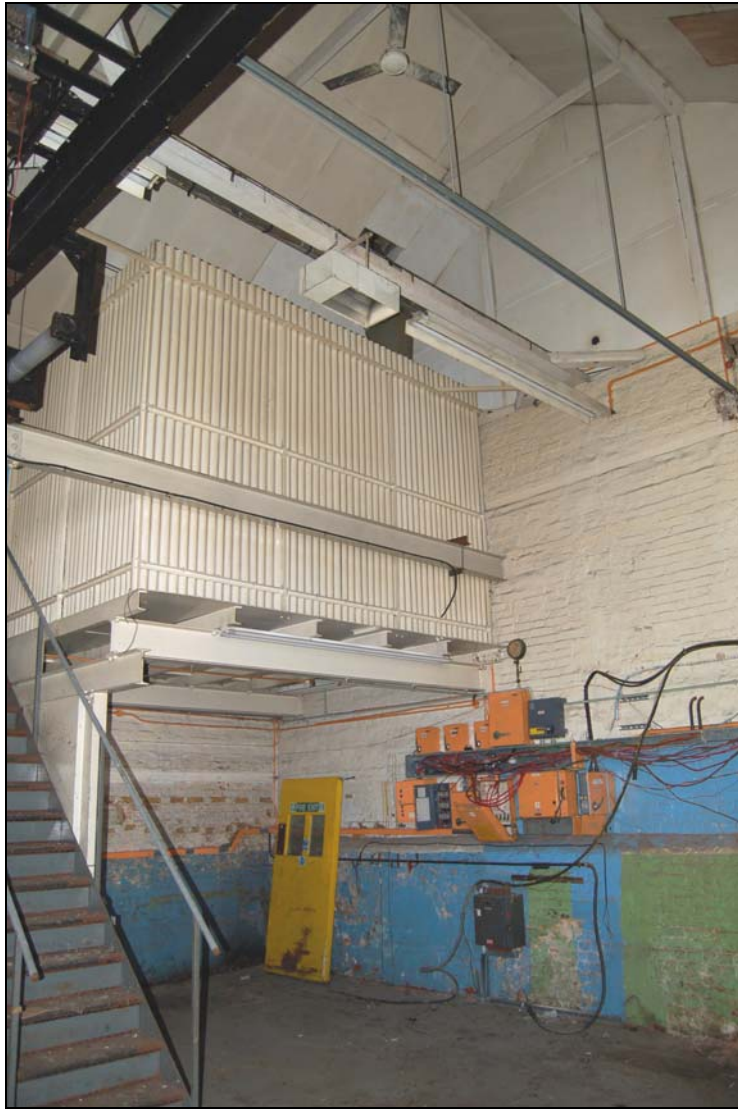
Plate 23 Stripped-out kiln interior

The interior has been completely stripped-out and a partial first floor has been built on the east side for an enclosed welding shop, accessed by a modern steel staircase (fig. 4, plate 23). Braced wall plates forming a figure '8' survive at eaves level that supported the two kiln roofs either side (fig. 5, plate 23), that could have been either conical or pyramidal. Given the remaining roofs was slated, the latter option is perhaps more likely. The present roof is rebuilt to bridge the structures either side. It is a light queen post collar purlin roof constructed from reused timber that is out of character to the rest of the structure. The roof and gables are clad in modern fire-proof asbestos panels. Sealed roof apertures are likely to be workshop roof lights or later flues.

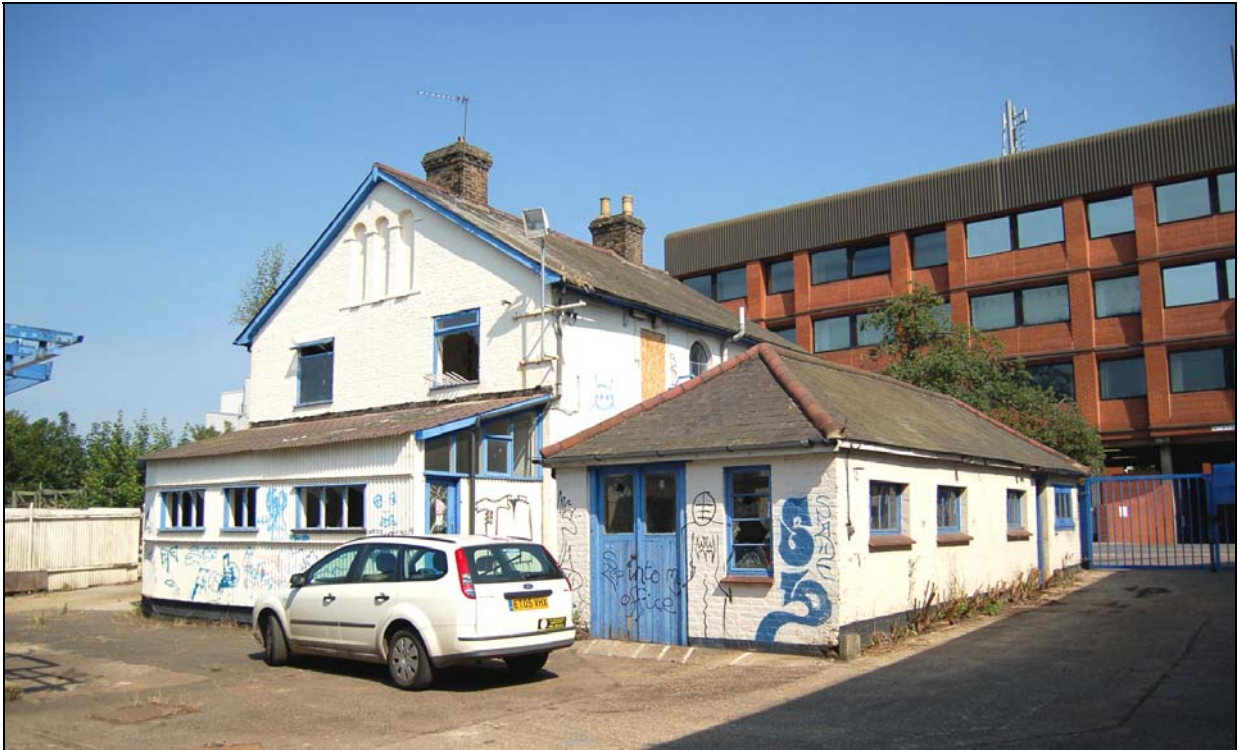
Plate 30 Maltster's house, (latterly offices), panel shop and canteen

The canteen and a half-hipped single storey brick structure (panel shop) have been added to the east and south sides the house (plate 30). The latter replaced two 19th-century buildings associated with the malting. The various other structures are single-storey flat-roofed workshops fabricated in a blend of brick, corrugated iron, asbestos and Perspex, fitted-out with wooden fixtures (plates 31 & 32).

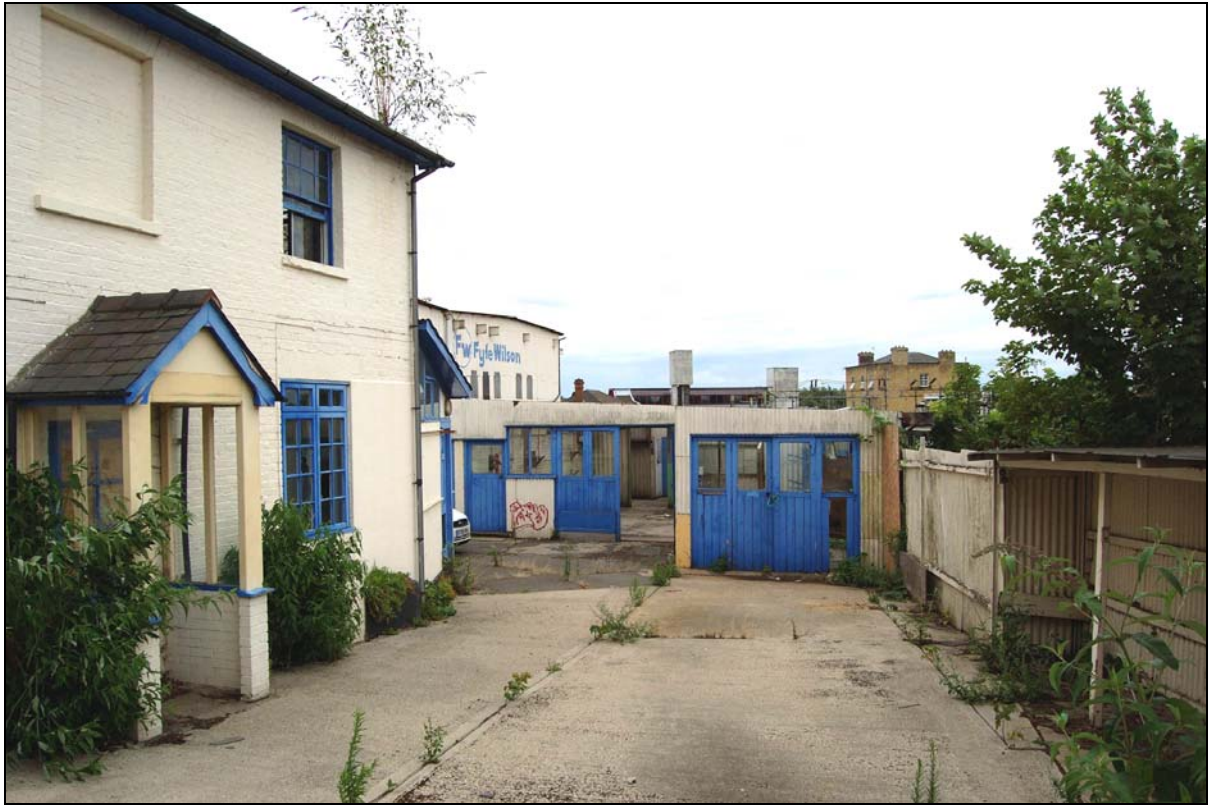
Plate 31 View toward 20th-century welding shop and loading bay

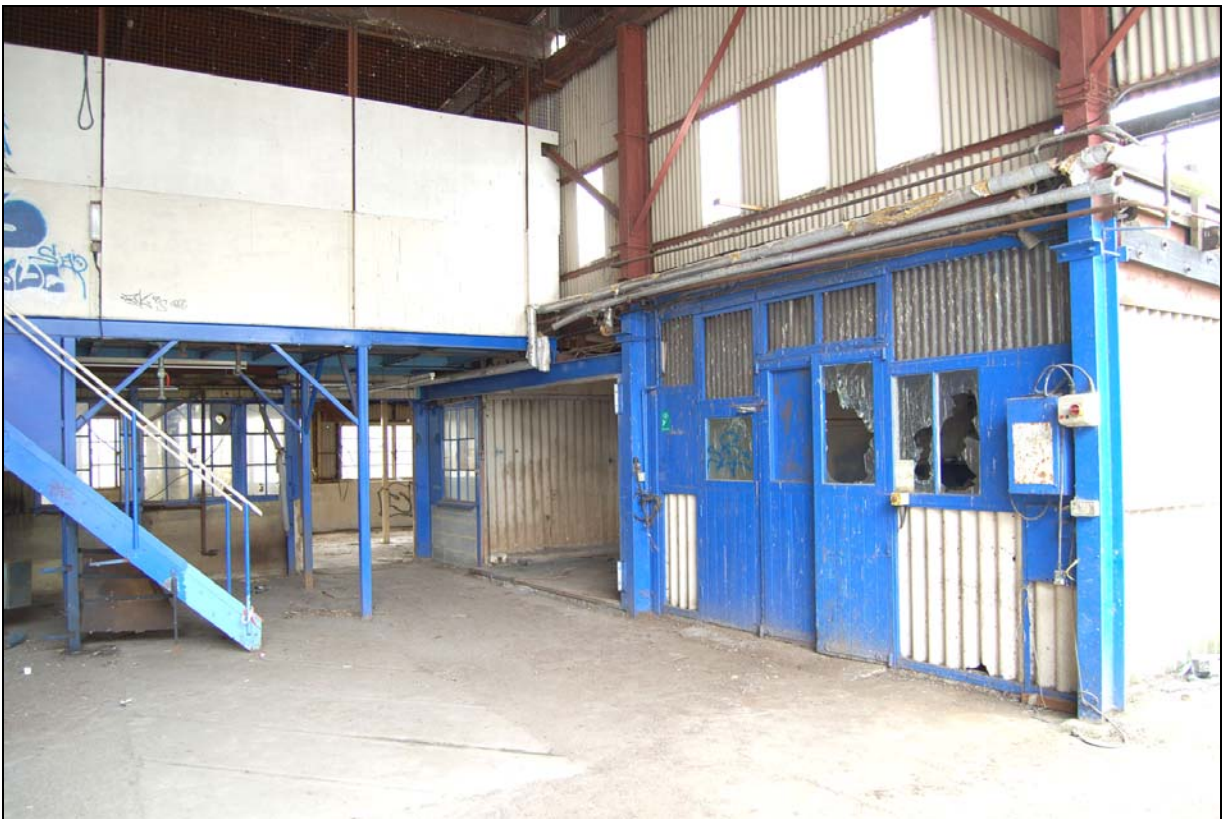
Plate 32 View inside loading bay
