**FISH-CURING SHED
TO THE REAR OF 170 MOULSHAM STREET
CHELMSFORD
ESSEX**

HISTORIC BUILDING RECORD

May 2007

Document Ref.	1755rep
Report Issue Date	15th May 2007
Circulation	ADH Ltd
	ECC Historic Environment Management
	Essex Historic Environment Record

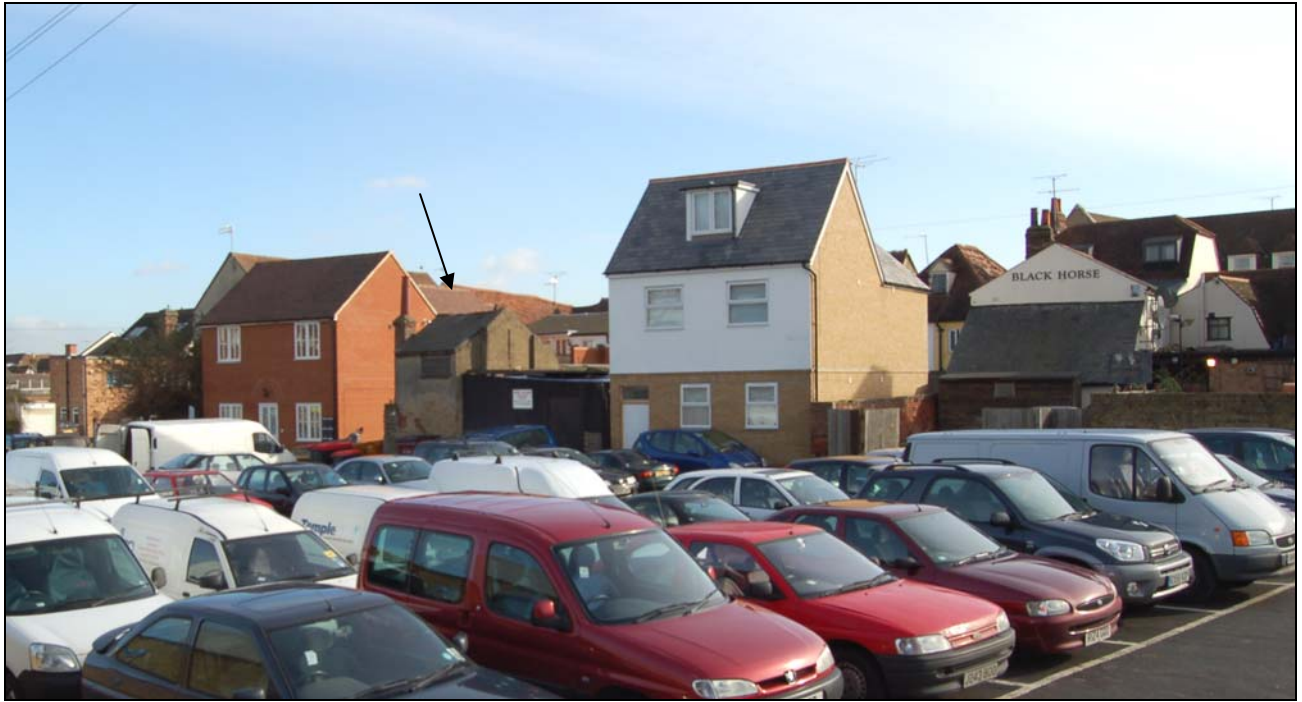
Plate 1 Curing shed (indicated) viewed from west across George Street car park

Chelmsford. The shed is positioned against the north-western boundary with the George Street car park and is walled-off from the Chinese take-away, occupying its own plot alongside recently-built houses at the backs of nos. 166-67 and 171-73. It now looks somewhat out of place in its new surroundings (plates 1 & 2). For many years the shed has been left to decay and is now in a poor state. The structure appears to be unsafe, with large cracks appearing in the shallow foundations.

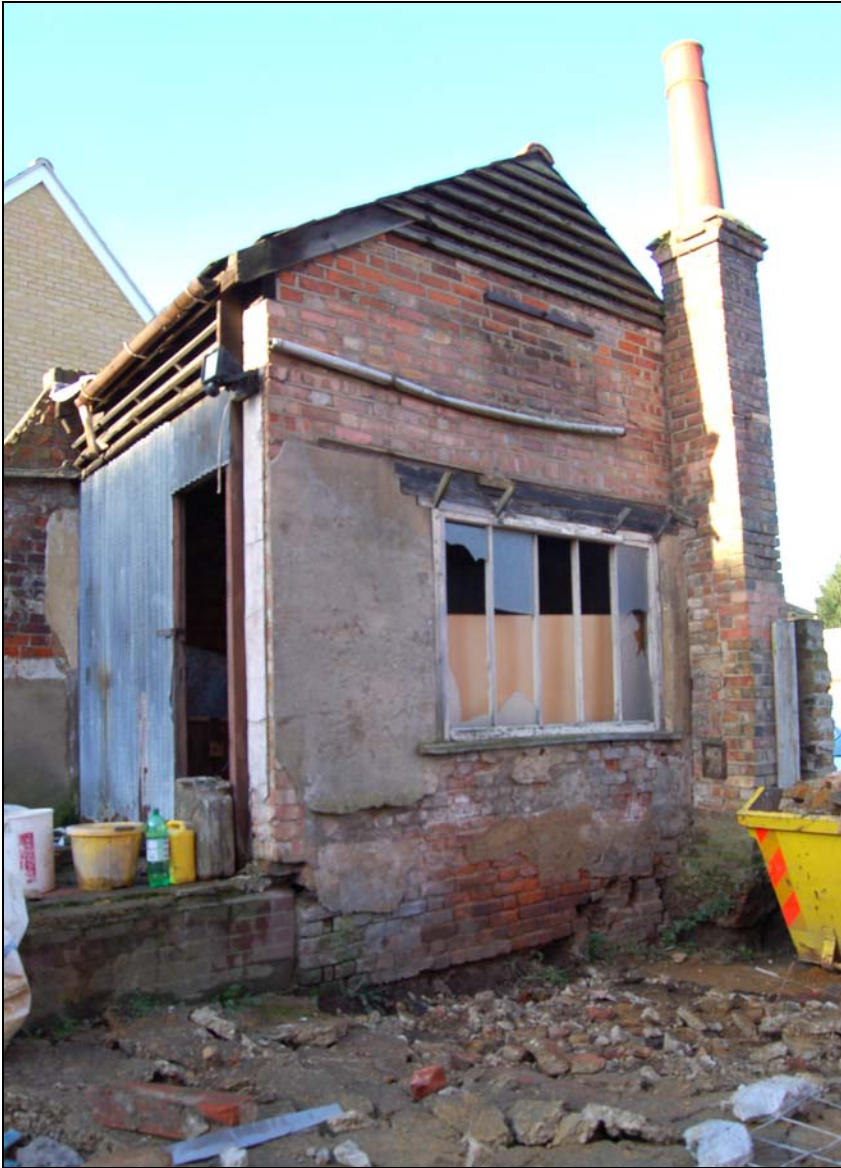
Plate 3 Shed viewed from east

corrugated tin front, beneath the main smoke vent (plate 3). The tin wall is unsuitable for a smokehouse and is clearly a later insertion contemporary with the concrete loading ramp (plate 4), perhaps representing a more recent but lesser-known commercial phase of use associated with No.170. Any scars for original brick walling on this side have been covered by the render.

Two wooden smoke vents appear to be the only original external features. They are positioned opposite one another on the two short sides (fig.2, plates 2-4 & cover) to regulate the temperature inside the shed. Any internal shutters have since been removed.

The roof is gabled both ends and pitched at 30°. It is slate-covered with a partly weatherboarded gable on the north-eastern side (plate 3).

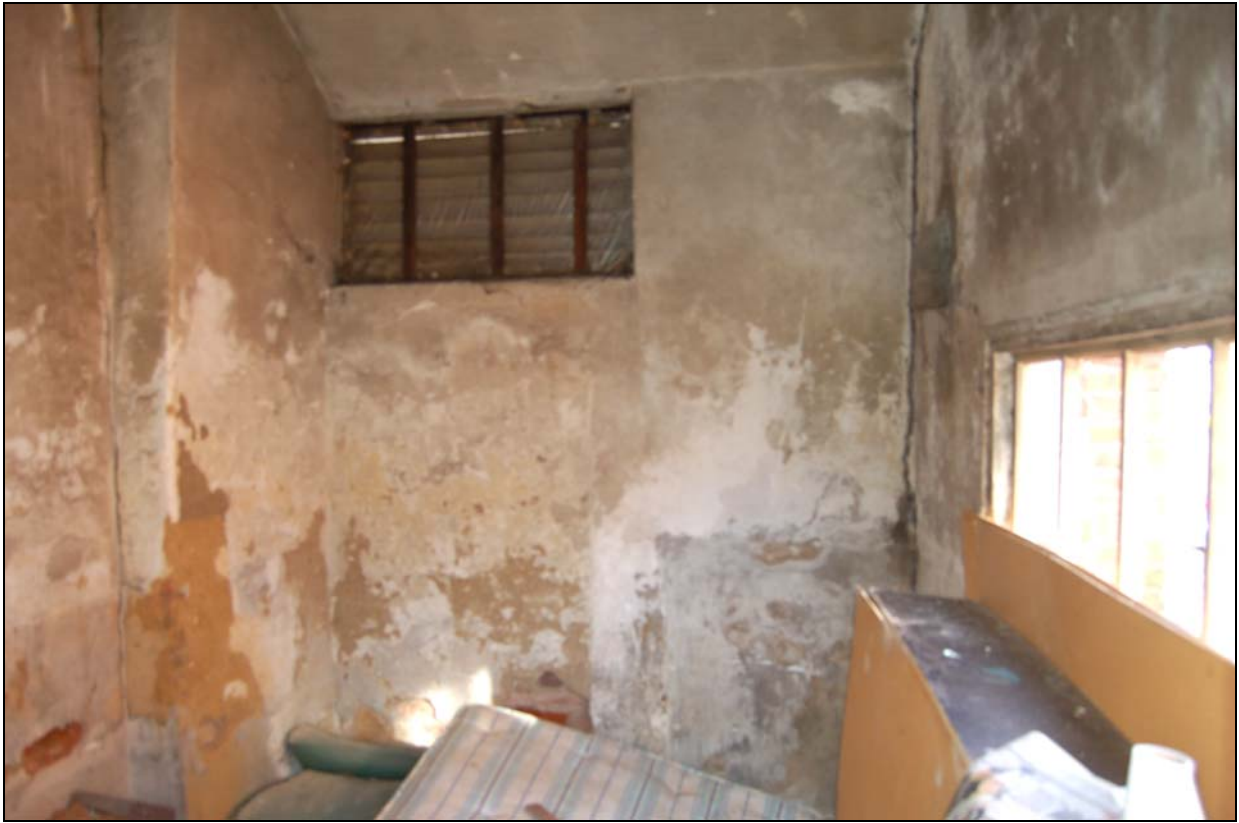
Plate 5 Interior viewed from entrance (south-east)

A single, collared, roof truss divides the interior into two bays. The interior is lath and plastered in lime, including the roof, a sensible fire precaution. However, none of the surfaces are fire-blackened (plates 5 & 7), suggesting the shed has been re-plastered since. A tie rod passes through the gables to prevent the walls distorting through the heat. Otherwise there are no additional fixtures or fittings of note. The concrete floor and lower parts of the walls are obscured by discarded furniture.
