**ASHEN HOUSE FARM
DOCTORS LANE
ASHEN
ESSEX**

ARCHAEOLOGICAL MONITORING

**Essex County Council
Field Archaeology Unit**

AUGUST 2007

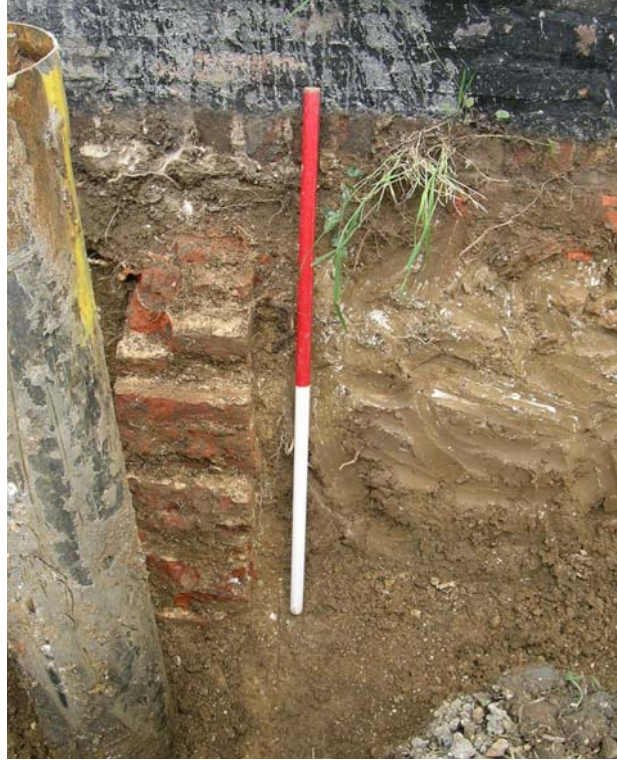
Plate 1. Brick wall 6 looking north, 1m scale

(Plates 1 and 2). The bricks were all unfrogged and measured 240 x 110 x 55mm. The foundation was trench-built and a construction cut was visible in section on its eastern side, cutting the subsoil and bottoming out at the top of the natural clay. Pat Ryan, the expert on bricks in Essex, suggests that the bricks and mortar used in the wall could be 16th-century in date. The foundation would originally have extended for 5m to the south, with its line represented by a vertical-sided robber trench (4) (Fig. 2, section 1). The eastern side and southern end of the robber trench were both visible in section, and it terminated just short of the southern limit of the sitting room. The backfill of the robber trench, visible along both sides of the western foundation trench, comprised mixed brown clay silt (5) with fragments of roof tile and mortar flecks, but contained no datable material. No equivalent foundation or robber trench was found extending from the south-east corner of the existing house. The south end of the wall line appears to have formed the south-eastern corner of a structure extending to the west.

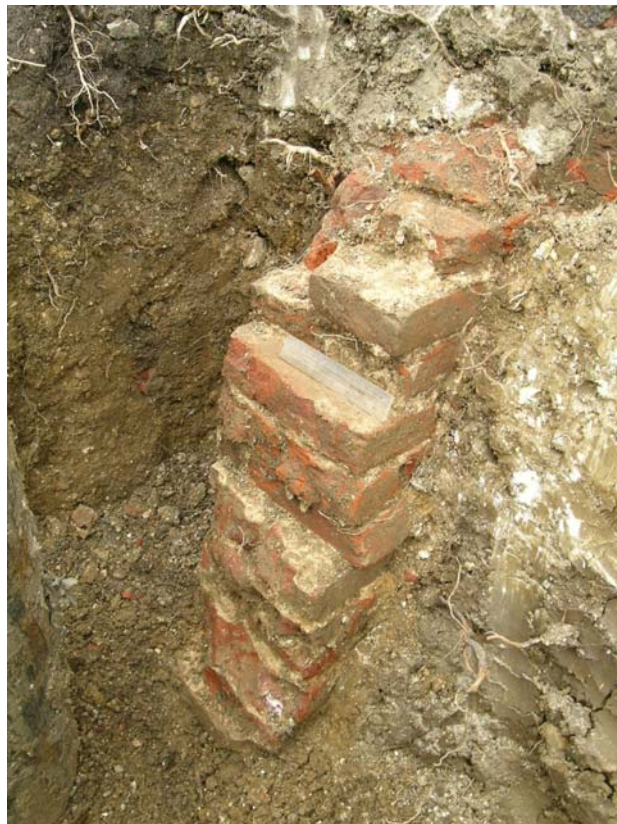
Plate 2. Brick wall 6, detail, 6" (150mm) ruler scale

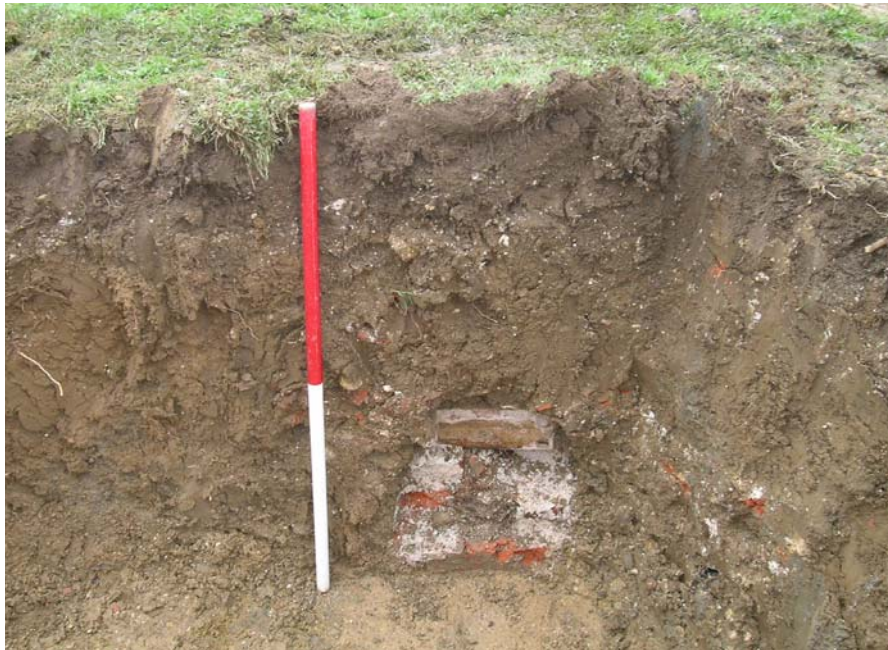
Plate 3. Brick drain 7, looking south, 1m scale

Remnants of a north-south brick drain (7), disturbed by the machine excavation, were recorded in the western corner of the bay foundation trench (Fig. 2, section 2; Plate 3). The drain was 0.34m wide and 0.34m high and may have originally extended some 0.8m into the trench. It comprised four courses of brick laid upon a bed of yellow-brown sand. The base of the drain comprised one brick laid across, with the walls formed of two courses of bricks laid lengthways, and the top of the drain formed by a one brick laid across on edge. The bricks were regular, appeared to be unfrogged and measured approximately 240 x 110 x 60mm. They were bonded with cream mortar containing small white and black inclusions. The sand and drain were laid in the bottom of a steep-sided construction cut (9) backfilled with mixed grey brown clay silt (8).
