**SITE OF THE BARLING WINDMILL
LAND ADJACENT TO 47 CHURCH ROAD
BARLING MAGNA
ESSEX**

ARCHAEOLOGICAL EXCAVATION

Field Archaeology Unit

February 2008

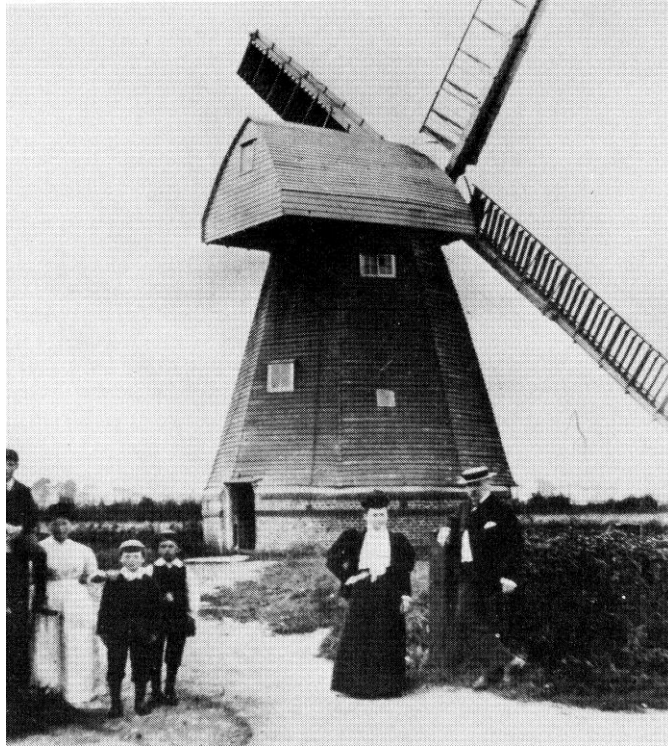
Plate 1. The Barling smock mill in c. 1898, looking south-west, with the sails turned to the west. The Mill House is off-picture to the left, and in the foreground are Herbert Manning, the last miller, and his family. (Kenneth Harries collection ©)

The windmill is clearly shown as a smock mill on Chapman and André's map of 1777. There are records of the windmill being leased throughout the late 18th and 19th centuries, and it continued to be worked until 1903. The latest state of the smock mill in working order is shown in a photograph taken in c. 1898 (Plate 1). The sails were removed in c. 1907 (Plate 2) and the mill was finally demolished in 1946.

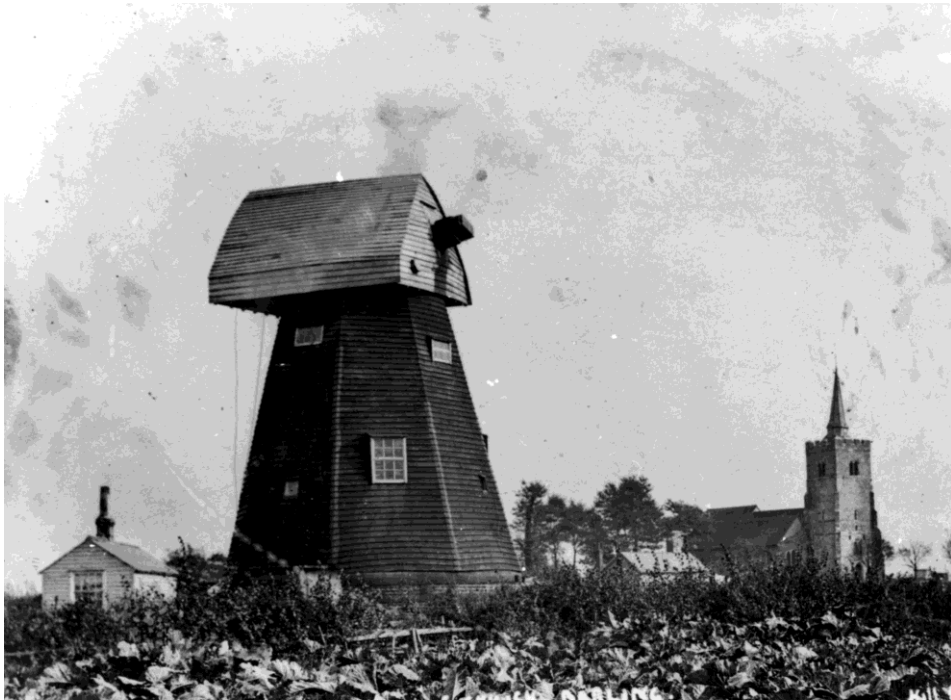
Plate 2. The Barling Mill in c. 1910, after the sails had been dismantled, looking east-south-east towards the church. (Essex CC Historic Environment Branch ©)

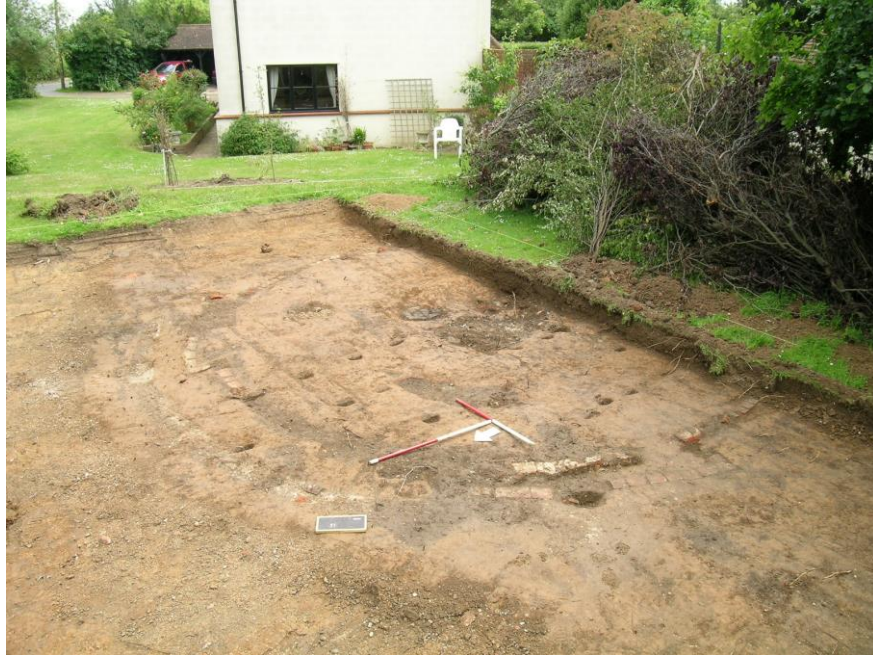
Plate 3. The truncated footings of the smock mill and the earlier post mill, with the Mill House in the background. The outer circle, showing as a mortar impression, represents the brick base of the smock mill. The inner circle, showing as bricks and a dark soil, formed the base of a brick roundhouse around the foot of the post mill. The square pit for the central post shows as a dark feature beyond the 1m scales, near the trench edge.

5.1 Introduction (Figs 3 and 4; Plates 3 and 4)

5.2 The Post Mill - before 1759/60 (Figs 3 and 4; Plates 3 and 4)

The brick footings of the roundhouse for the post mill survived patchily around most of the inner circle (Fig. 4), although the 1991 excavation plan (Fig. 3) recorded them as continuous around the whole circuit. The surviving footings were recorded but not excavated in 2007. They consisted of a single course, one brick wide, of half-bricks and occasional whole bricks laid end-to-end in chalky mortar (24) in a narrow foundation trench (23). The bricks were dark orange-red and unfrogged, and undoubtedly represent the same brickwork as was sampled in 1991 (see 6.0 below for details of the bricks). Areas where bricks had been removed in 1991 were visible as grey silt-clay soil marks (Plates 3 and 4).

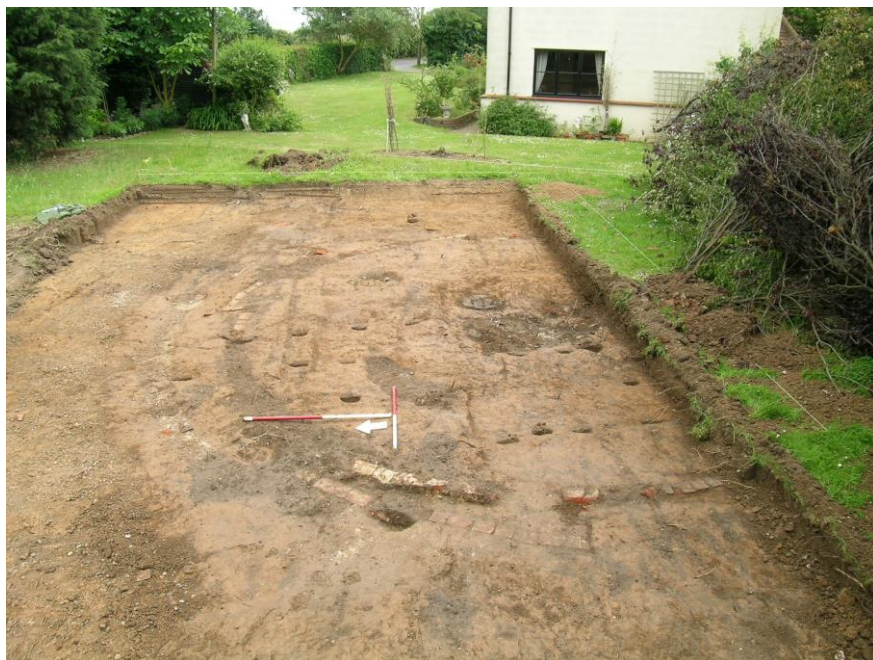
Plate 4. As Plate 3, showing detail of the two phases of brick footings (in front of scales). The dark soil marks in the foreground mainly represent trenches excavated in 1991.

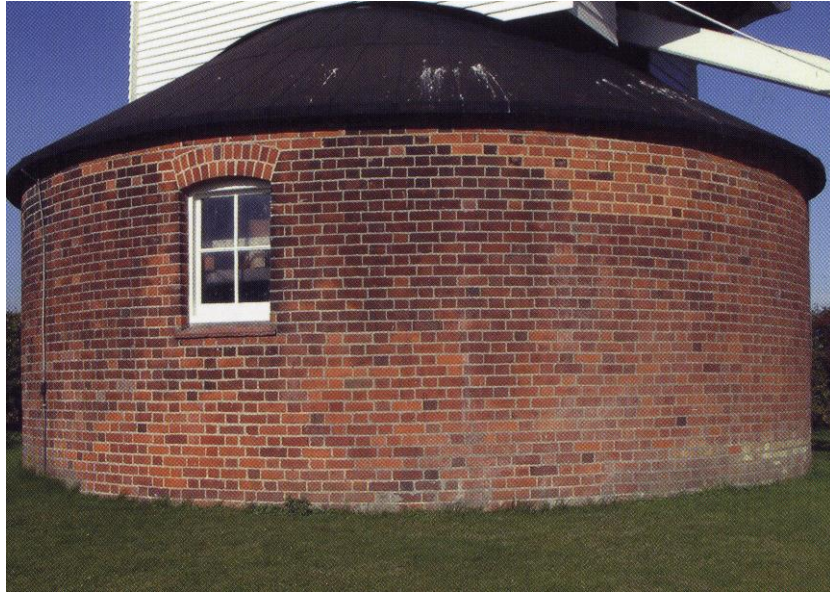
Plate 5. The roundhouse at the base of the post mill at Aythorpe Roding, Essex, built in 1779. (Essex CC Historic Environment Branch ©)

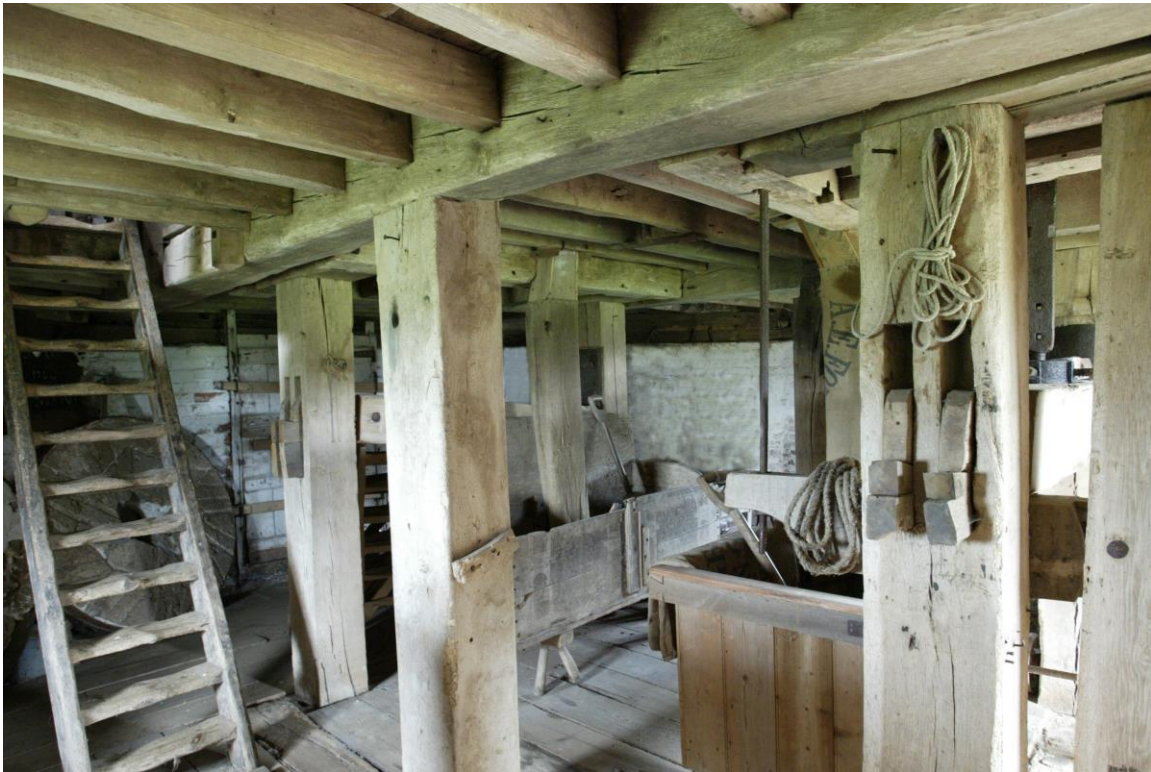
Plate 6. The substantial timber frame or 'hurst' supporting the millstones and machinery on the stone floor of the early 19th-century smock mill at Lacey Green, near Princes Risborough, Bucks. (Reproduced by permission of the Chiltern Society ©)

1. The base of the smock mill was formed by a brick roundhouse measuring 22ft 9in (6.93m) across externally;
2. The millstones were set in a grinding room (stone floor) above the roundhouse, supported by a “Hurst”, a substantial timber frame.
