**HISTORIC BUILDING RECORDING AT KING STREET FARM  
KING STREET, HIGH ONGAR  
ESSEX**

**November 2007**

**KING STREET FARM, HIGH ONGAR  
ESSEX**

**HISTORIC BUILDING RECORD**

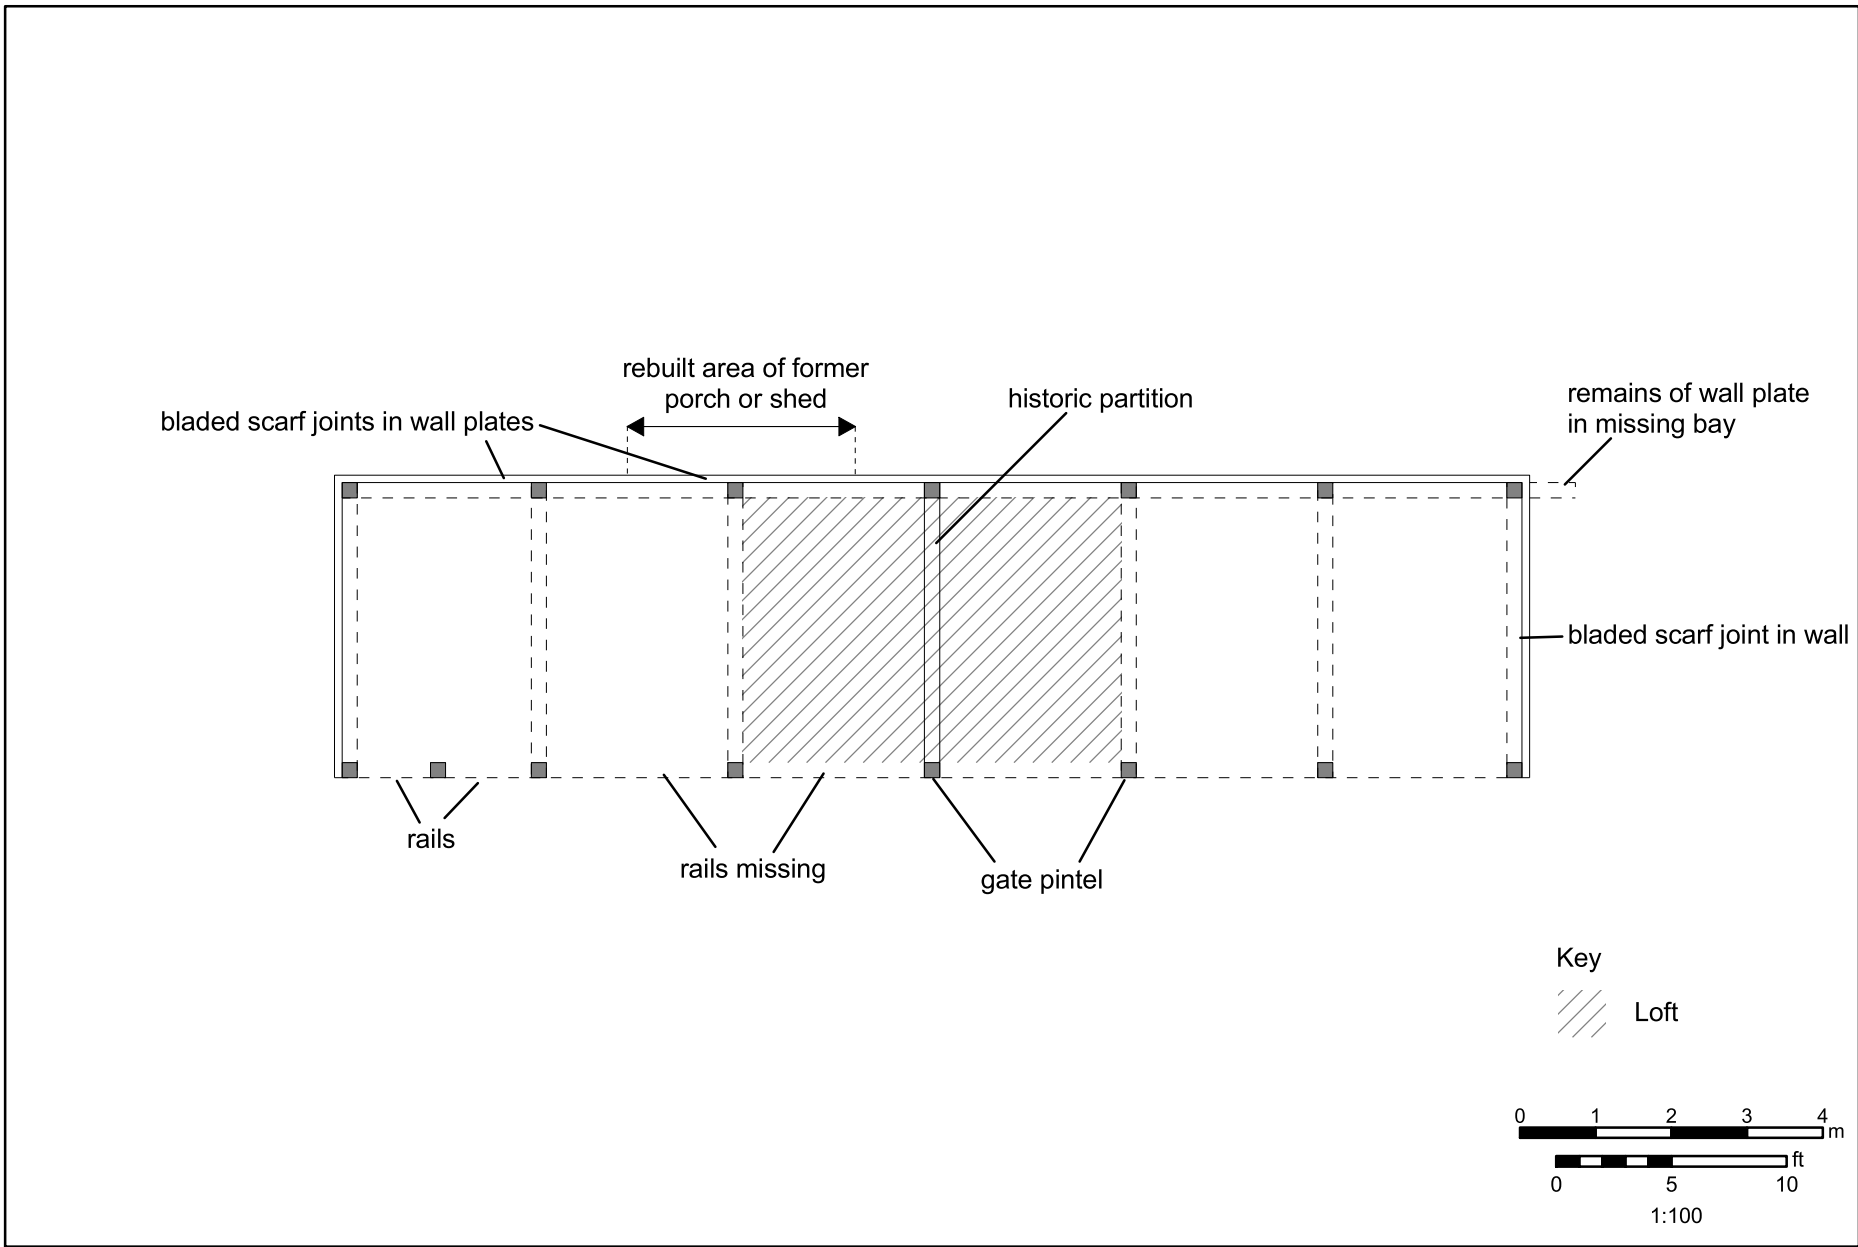
Fig.7. Plan of wagon lodge 8

indicates the missing bay (fig.7). The roof is gabled either side with a 45° pitch and would originally have been thatched. It is currently clad in pantiles apart from the rear of the eastern bay that has been replaced with corrugated iron sheeting. In contrast to the planked exterior, the gable ends are weather-boarded which, after all, would be easier to cut to size and fit in a small area.

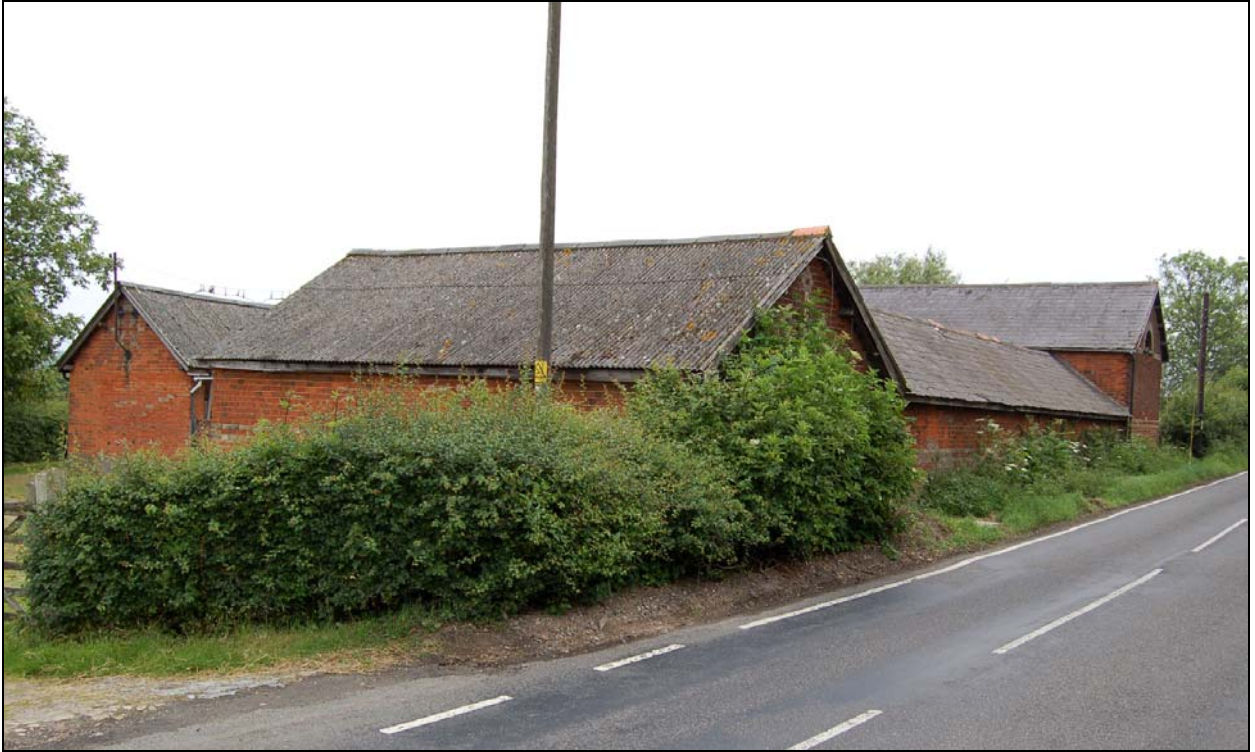
Plate 1 Planned farm viewed from south-west

The farm buildings are clearly seen from the road (plate 1), arranged in three connecting ranges around the yard, open to the west, facing the barn (plate 2). The southern range is sited along the roadside. All the structures within the main farm complex are brick-built. Some have slate roofs. Apart from the stable and wagon shed/byre, that have built-in hay lofts, they are all single-floored. The list description (LBS 118398) specifically cites the barn and roadside 'byre' as listed, though the whole complex is curtilage listed as one unit. On the north-east side of the main area, across a modern concrete yard, stands a timber-framed wagon lodge (plate 3) that may predate the planned farm and is curtilage listed with the barn and farmhouse.

The north range consists of a linear six-bay structure, gabled to the west and facing away from the entrance (fig.5). Upon the gable is a diamond pattern made from gault bricks largely obscured by an electricity mast (plates 1 and 26). The three western bays are open to the yard on its south elevation (fig.8a, plate 4). Two of the other bays have been filled-in with brickwork in the modern period. Basic softwood doors have been inserted and voids simply left in the brickwork for ventilation instead of windows or grills. The loose box (2) at the east end is unaffected externally and retains an original heavy ledged and battened cowdoor, with a hinged vent above (plate 4).

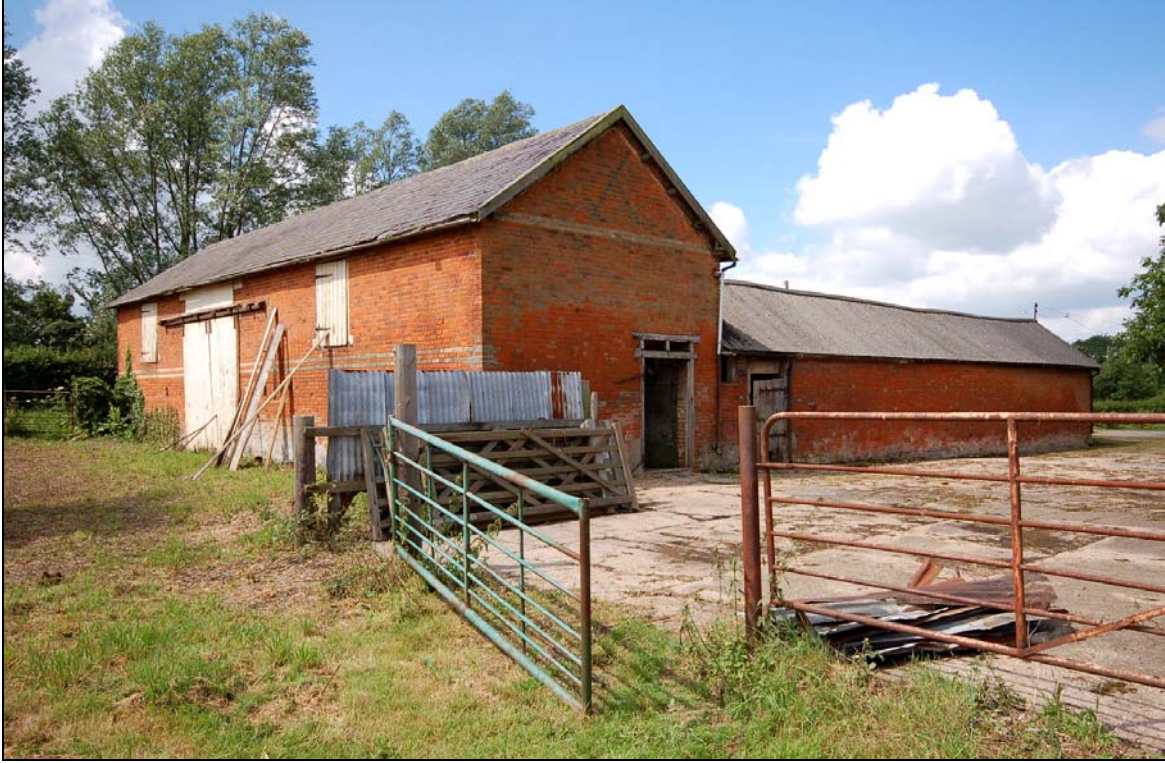
Plate 5 North and east ranges viewed from north-east

On the rear (north) elevation (plate 5) is another vented cattle door, from the loose box to the outer yard. Beside it is a small wooden-framed fixed square window. The rest of the elevation, i.e. the rear of the shelter shed, is plain brickwork.

Like the loose box, the stable also had entrances from the main yard and north yard. In the case of the latter, the doorway has a segmental arch head (plate 5). Both doorways have wooden slatted vents over the lintel, a common feature for enclosed animal areas on the

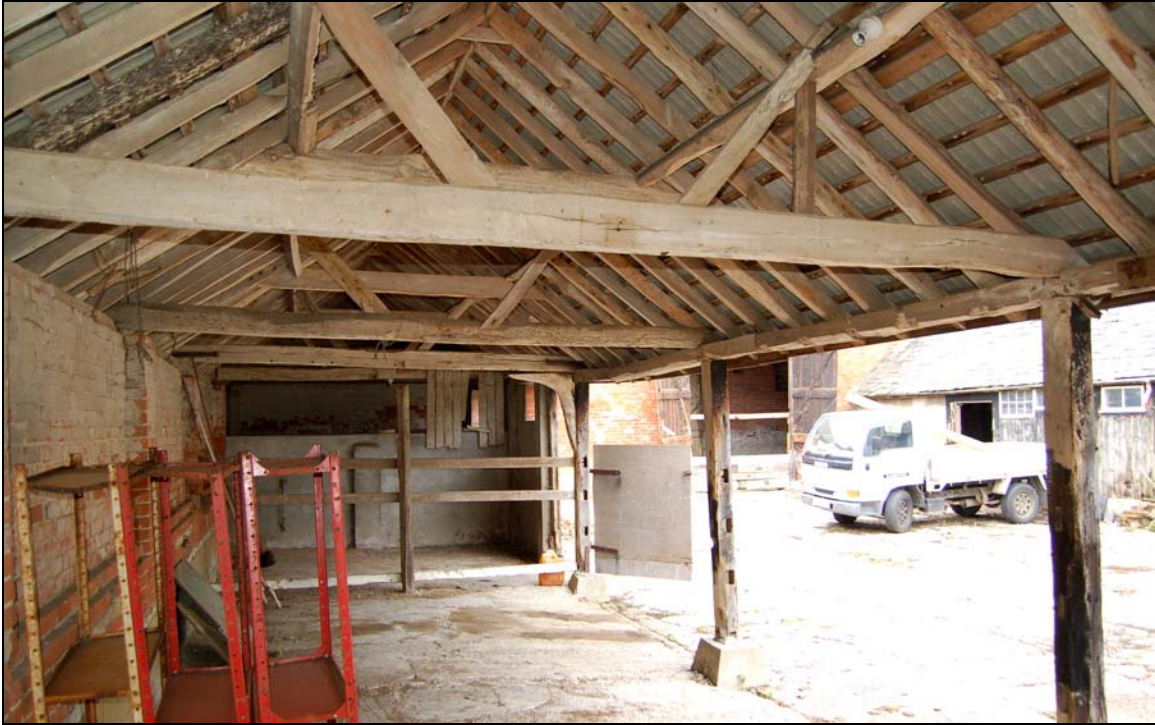
Plate 6 Interior of shelter shed 1 viewed to east

The roof frame comprises queen strut trusses nailed and lapped straight onto the purlins (plate 6, fig.6). The rafters are hand-sawn and mainly original, though some were replaced

when the battens were renewed for the corrugated asbestos roof. Otherwise the roof timbers are quite crudely cut and often have not been completely stripped of bark.

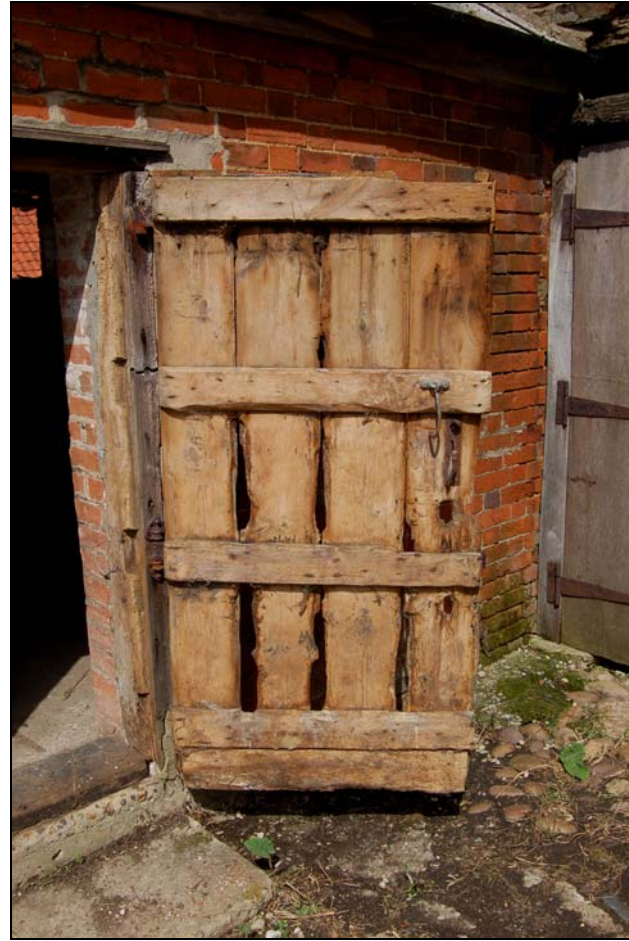
Plate 8 Original door into loose box 2

This is entered exclusively from the yards either side. The doors are original ledged and battened doors on pintel hinges (plate 8), as are all those that survive in the complex. The interior is white-washed and rendered to a height of 1.4m (plate 9). Although the dividing wall between loose box and shelter shed is built in English bond, it does not belong to a separate phase, as other areas of English bond were found inside the barn.

farm. In the corner between the stable and loose box is part of the original cobbled yard (plate 8), now mostly hidden beneath the existing concrete yard.

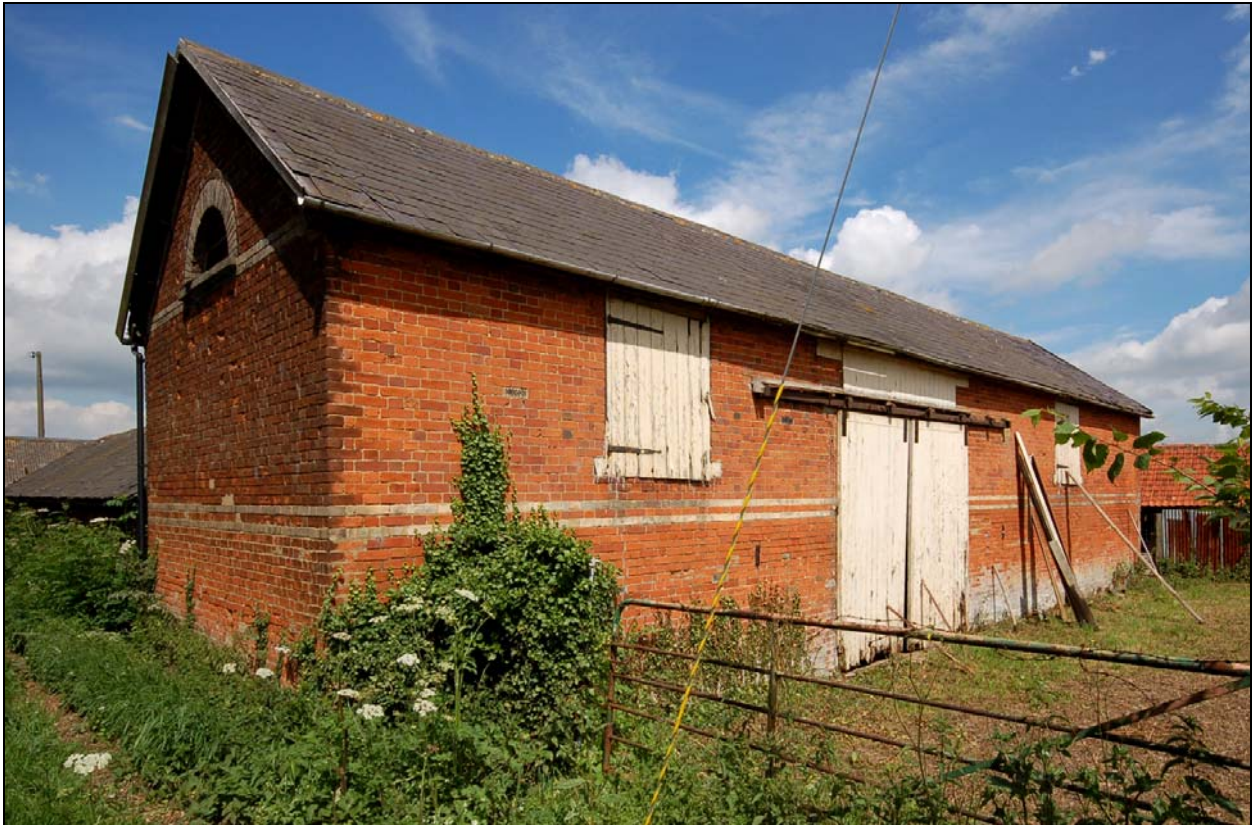
Plate 10 East range viewed from south-east

The range is brick-built and gabled either side. Double-coursed parallel white brick banding runs around the exposed east and south elevations (plate 10). The gables either end have a double row at eaves height and along the gable. In between is some nice brick detailing: a large 'X' on the north side in burnt brick headers (plate 5) and a semi-circular louvred wind-eye dressed in white brick headers (plate 10). Its appearance is very much like the Grade II Listed barn at 'Readings', in nearby Norton Heath that also has a wind-eye in the gable and white brick banding (Hudspith 2003).

The east side (plate 10) has an off-centre pair of sliding doors into the barn, hanging from a heavy cast iron rail, replacements for cart doors. The upper section above the doors is blocked. Either side are single pitching hatches neatly placed between the eaves and brick banding. There is a similar hatch on the first floor of the opposing west elevation, facing the yard, above the entrance into the stables (plate 11). Hay could be pitched up here or dropped down for the cattle in the yard. It is also possible that grain was kept here, out of the way of vermin.

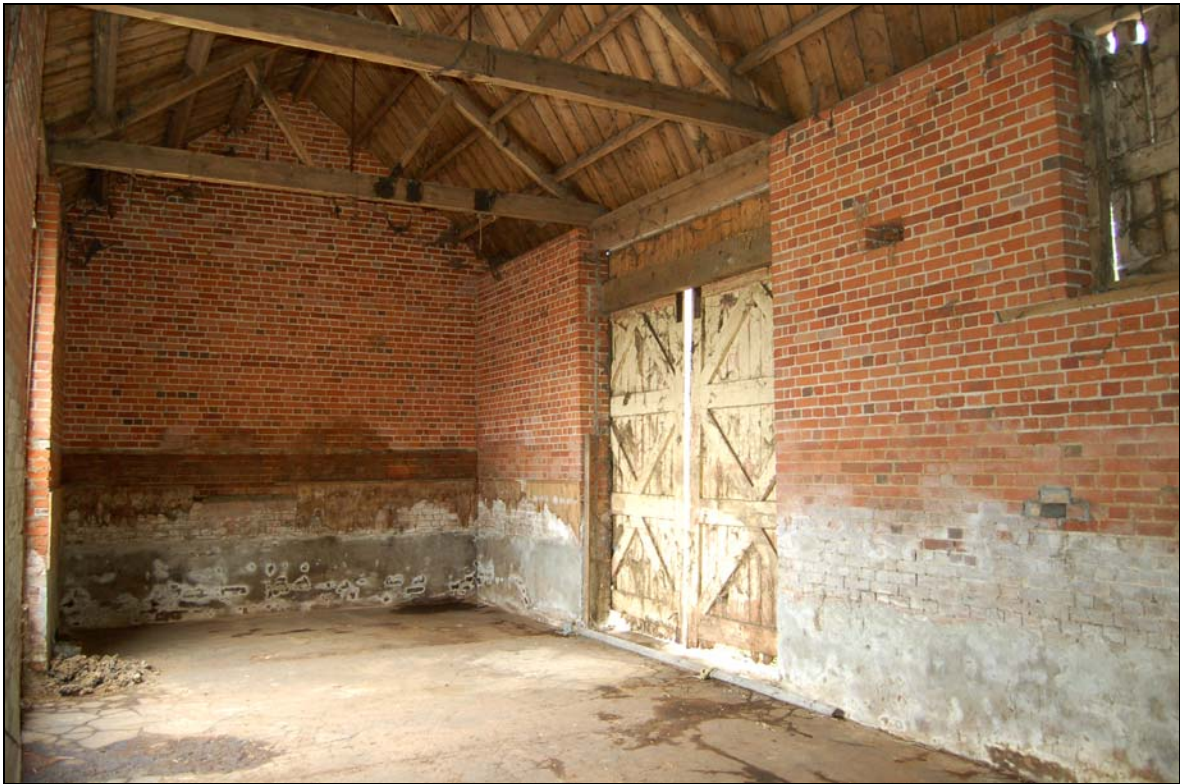
Plate 18 Interior of barn viewed to south

The original cart doors on the east side have been completely stripped and replaced with a pair of modern sliding doors with timber infill above. To the south there is a pitching hatch, identical to that in the feed store. The door is typical of all early doors, ledge and battened with wooden lintels. It is partly seen in plate 18.

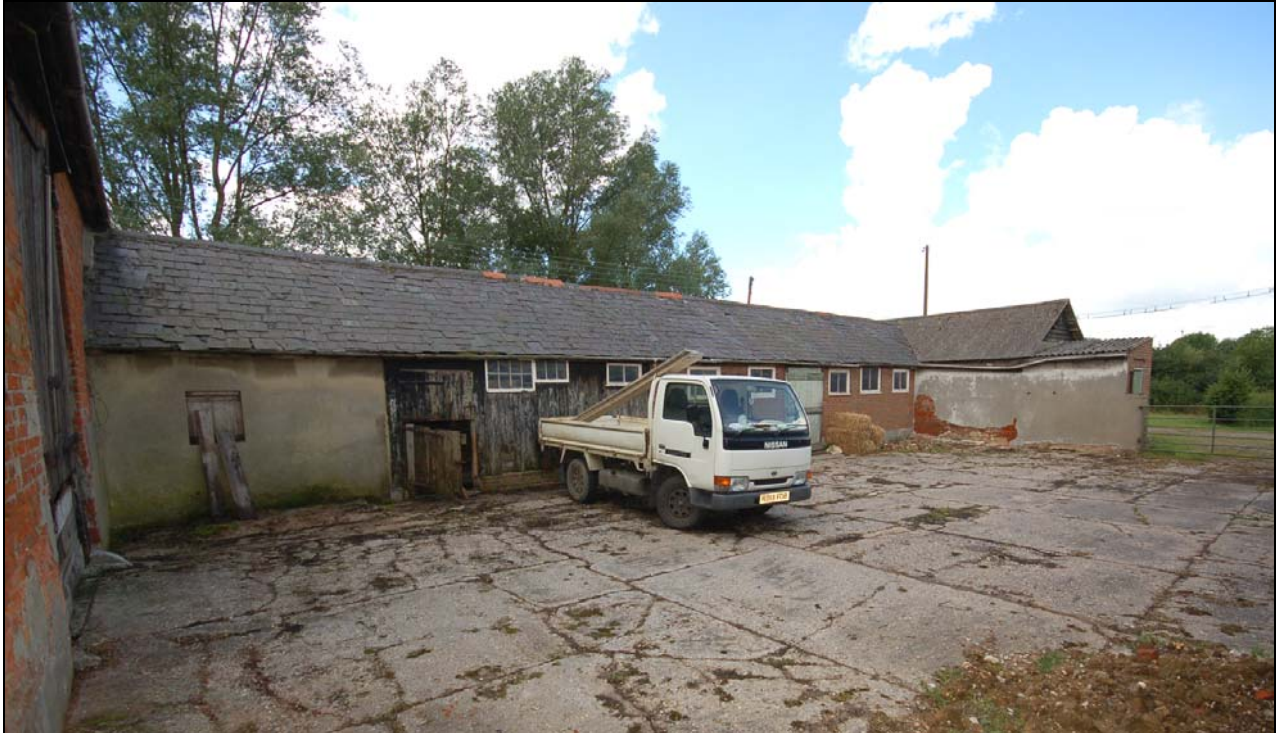
Plate 19 South range viewed from yard

Cowhouse 6 extends northwards from the shelter shed, finishing in a weather-boarded gabled end, somewhat spoilt with the addition of the modern farm office 7 (plate 26). A low quality timber cow door is a modern replacement. The east wall has been rendered over to mask the contrasting brickwork of the office (plate 19).

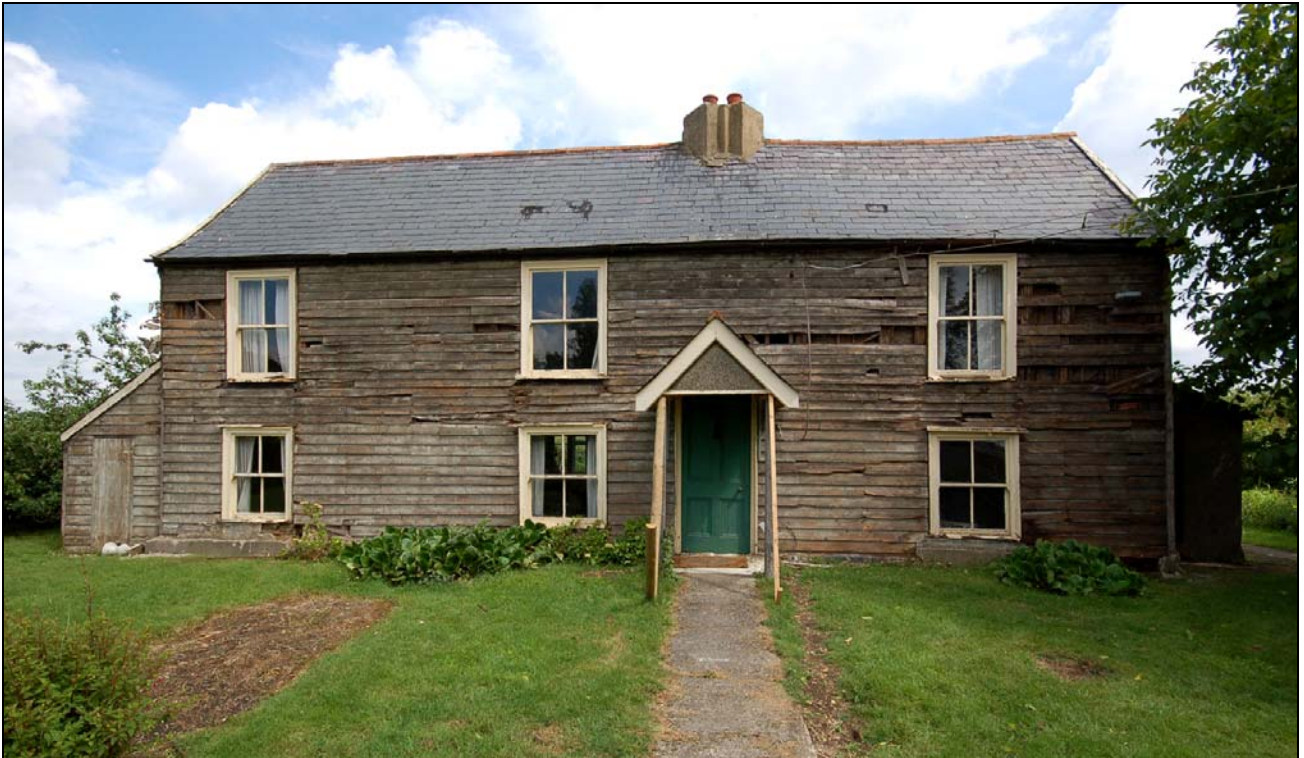
Plate 32 Front elevation of farmhouse

The structure had been covered in 20th-century cement render, which was removed to expose earlier weather-boarding and dry out the frame (plate 32). By viewing parts of the frame through missing boards, a better idea of the development of the house was established. The structure was built, as the listing states, in the 16th-century as a two storey cross-wing with a single storey range to the west. Heavy studwork was seen as well as external tension bracing (dated between the 14th to 17th-centuries) on the upper level of the crosswing. The chimney may be contemporary with the structure or inserted later. The original eaves were equivalent to the sills of the first floor sash windows and raised when the main range was heightened (in primary-bracing) in the 18th or 19th-century to create a first floor. Clapboard cladding was nailed to the frame and a new roof was built, extending across the crosswing and engulfing the chimney.
