**THE MALTING AT GOWERS FARM
TUMBLERS GREEN, STISTED
ESSEX**

HISTORIC BUILDING RECORD

Field Archaeology Unit

December 2007

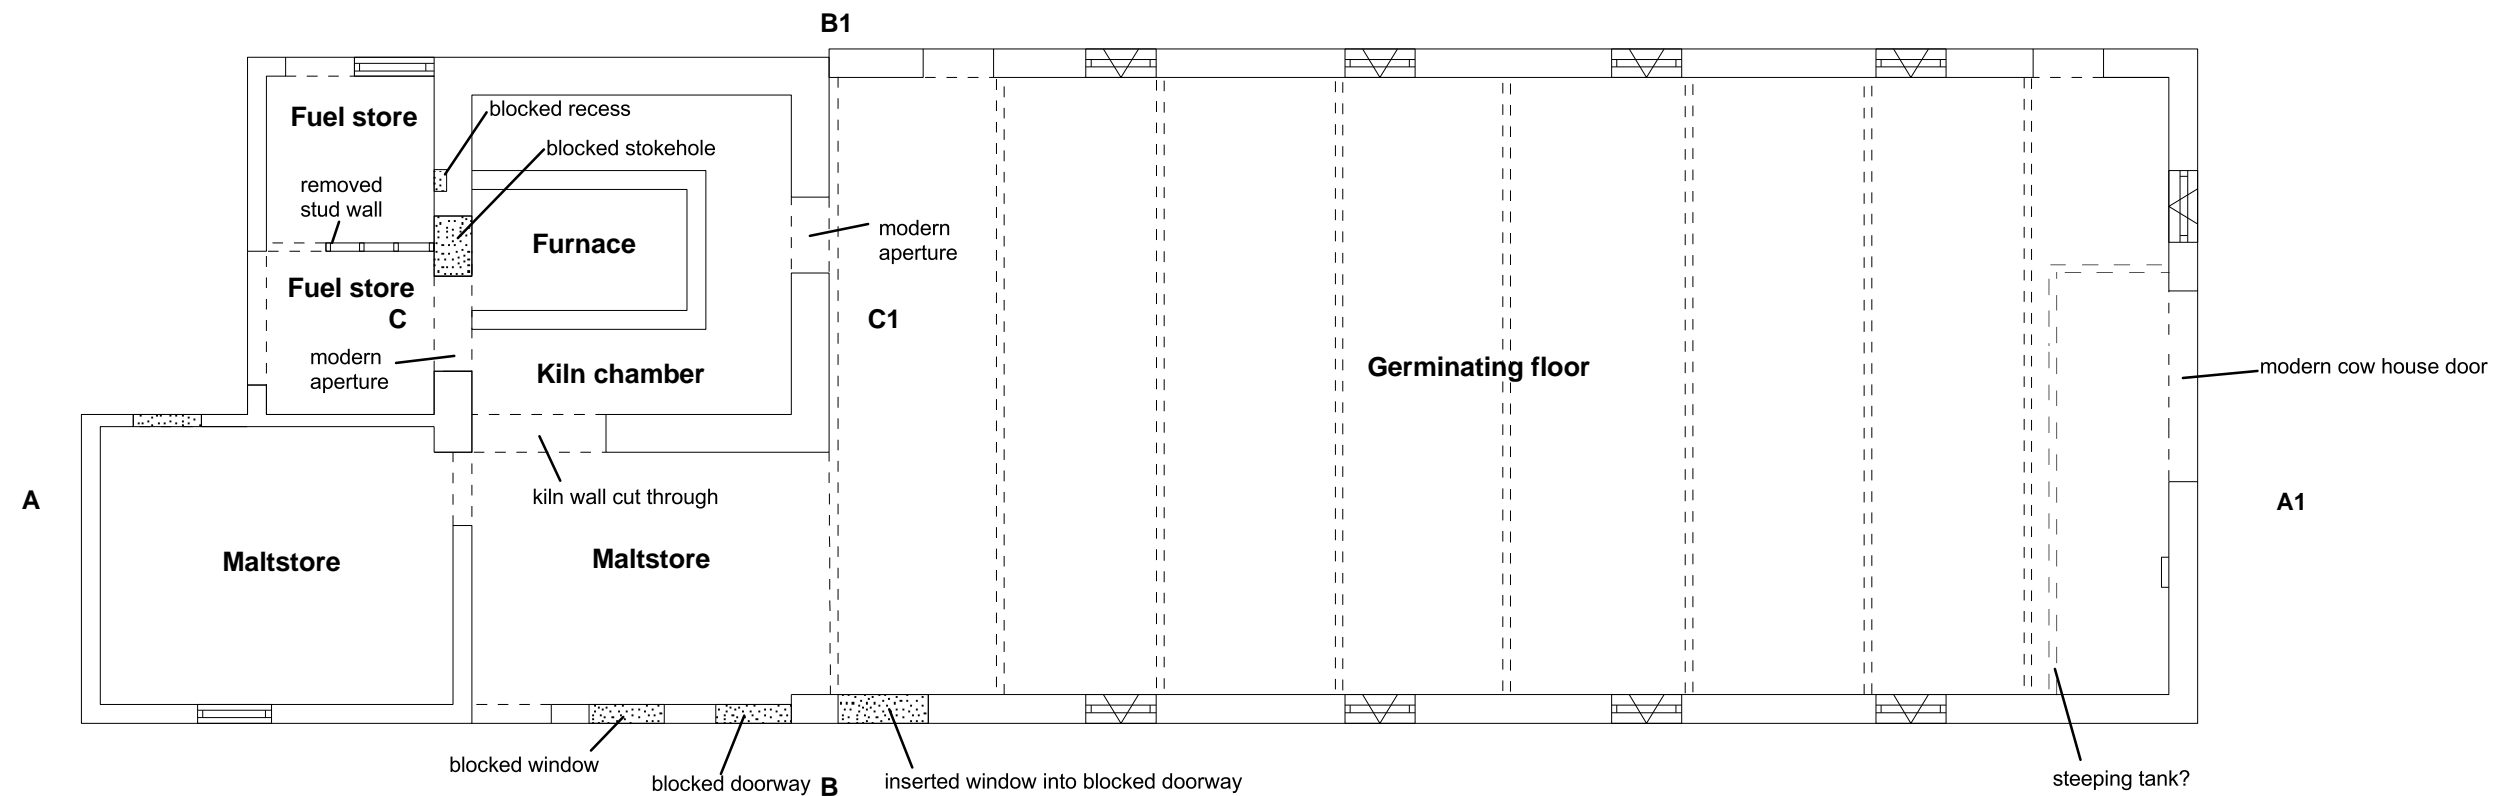
Fig.6. Ground floor plan of malting

At ground floor level, internal walls have been removed and openings inserted into the kiln during the recent works (fig.6, plate 7). Above the south-west aperture (plate 7) is a loading door aperture, used to transfer green malt from germinating floors into the kiln.

Evidence for the brick-built steeping tank was found in the eastern corner in the form of a wall scar 1.5m from the end wall (fig.6). From here it likely extended across the later cattle door and up to the window vent, providing enough room to enter through the door at the front. A narrow pipe at the base of the wall shows where the water was drained away (fig.6, plate 9). From the evidence, the steeping tank was 1.5m wide and 0.8m high. The thin lining of render at the bottom of the wall forms an unrelated damp course extending throughout the maltstore.

The major surviving internal feature is the remains of the kiln furnace that occupied much of the kiln chamber (fig.6). With so little remaining, it is difficult to make a reconstruction of it. The upper walls were removed to floor level in the 1920s and now only its floor and wall outline remain against the surrounding uneven mortar/clay floor (plate 13). The furnace measures 3.2 x 2.10m and was built against the south-west wall, though evidence for its attachment was likely removed during the recent stripping-out. The worn nature of the bricks show the upper parts of the furnace were dismantled a long time ago, presumably in the 1920s. The furnace was likely to be a simple affair, probably a grated fire basket set within a low wall. Fuel -most likely coke- was fed through the stoke hole from the fuel store (plate 13) onto the grate and the heat rose up from the furnace up to the wire mesh floor. Once finished, the ash could be raked out from below the grate. At ground floor level, the kiln would have been largely enclosed to keep the heat in. First floor shovelling hatches survive,

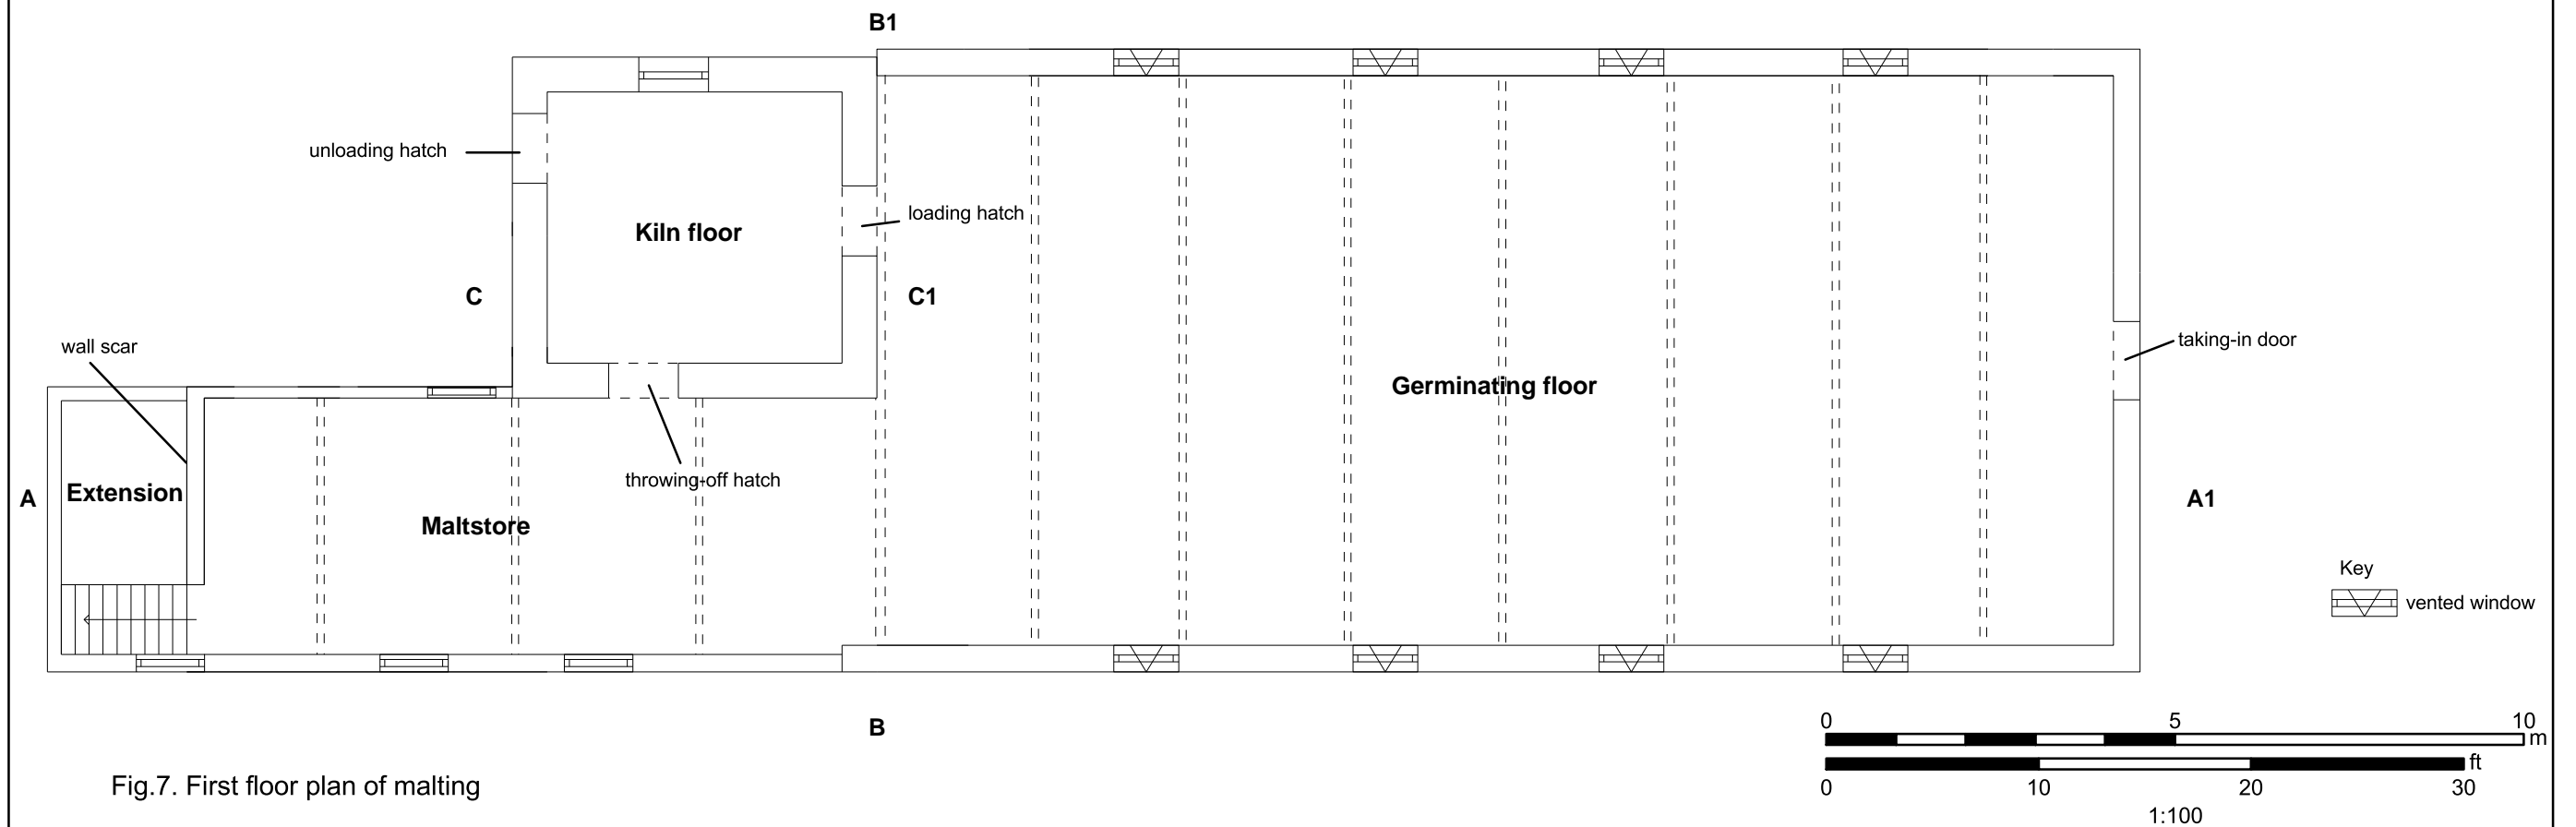
Fig.7. First floor plan of malting

The maltstore is brick-built up to first floor level and thereafter timber-framed and clad in weatherboarding, topped by a shallow pitched 35° slate roof, which may have been added with the extension. Only the south-east and north-west elevations are properly exposed, the other two mostly hidden by the kiln and malthouse. Part of the new-build shed wraps around the southern end on the ground floor. Beginning here and working to the north-east (plate 4), there is a plain empty window that appears to be inserted within a blocked doorway. Certainly the lower part has either been re-pointed or in-filled recently. This would originally have lead into the rear part of the maltstore (fig.6). A second off-centre entrance has been partly rebuilt. Further along is a possible blocked window (fig.6). Its ledge is formed by a row of on-edge headers that continue to a straight joint in the brickwork, another possible blocked entrance on this side. Above, in the weatherboarded part and just below the eaves, are a row of three-light wooden vents (plate 4), the third, with odd spacing, has been added to the secondary half-bay extension (fig.7).

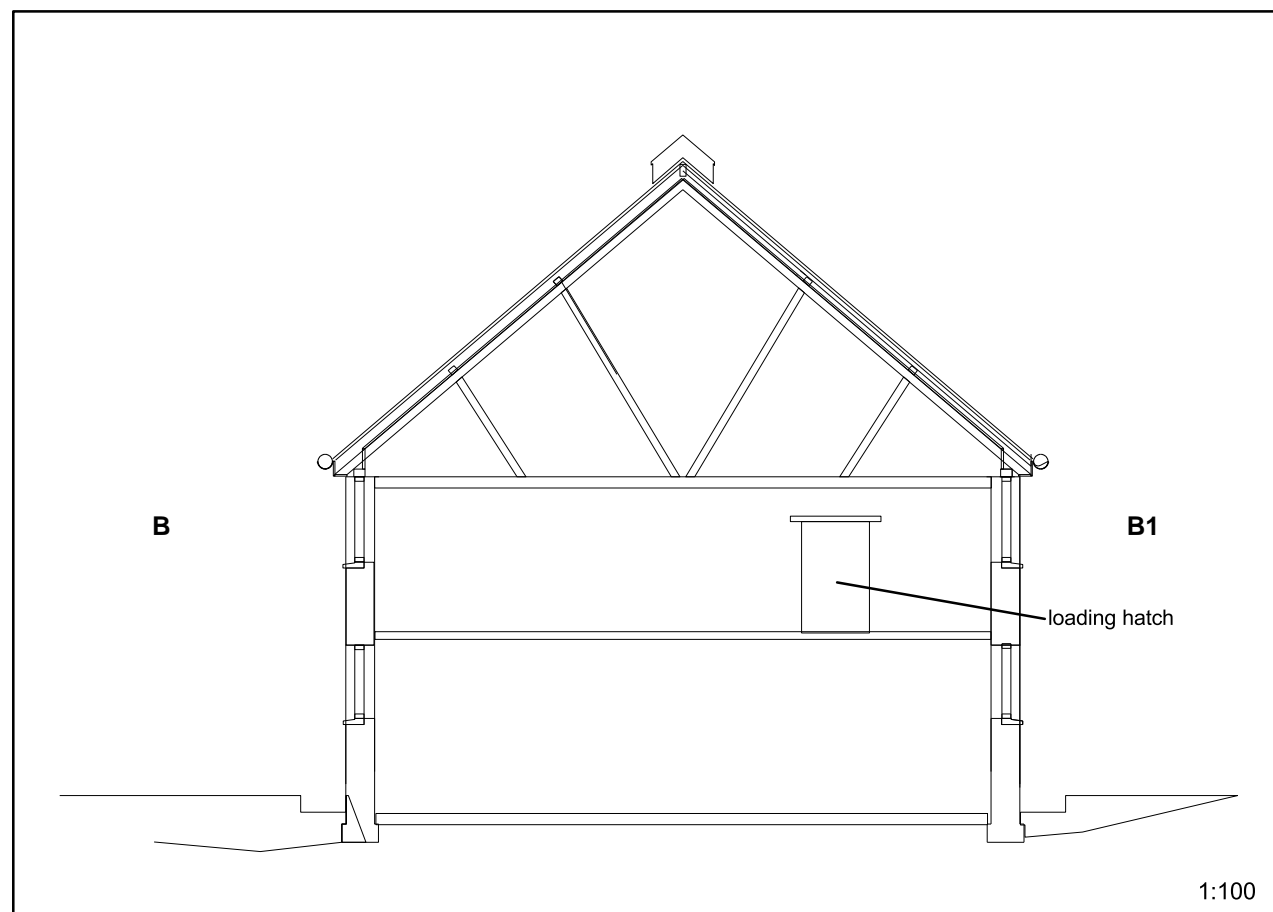
Fig.9. Section through malthouse (B - B1)

wooden plates beside the window heads that carried the main floor joists (fig. 9, plate 8), supported either on posts or cast iron columns, also not present.

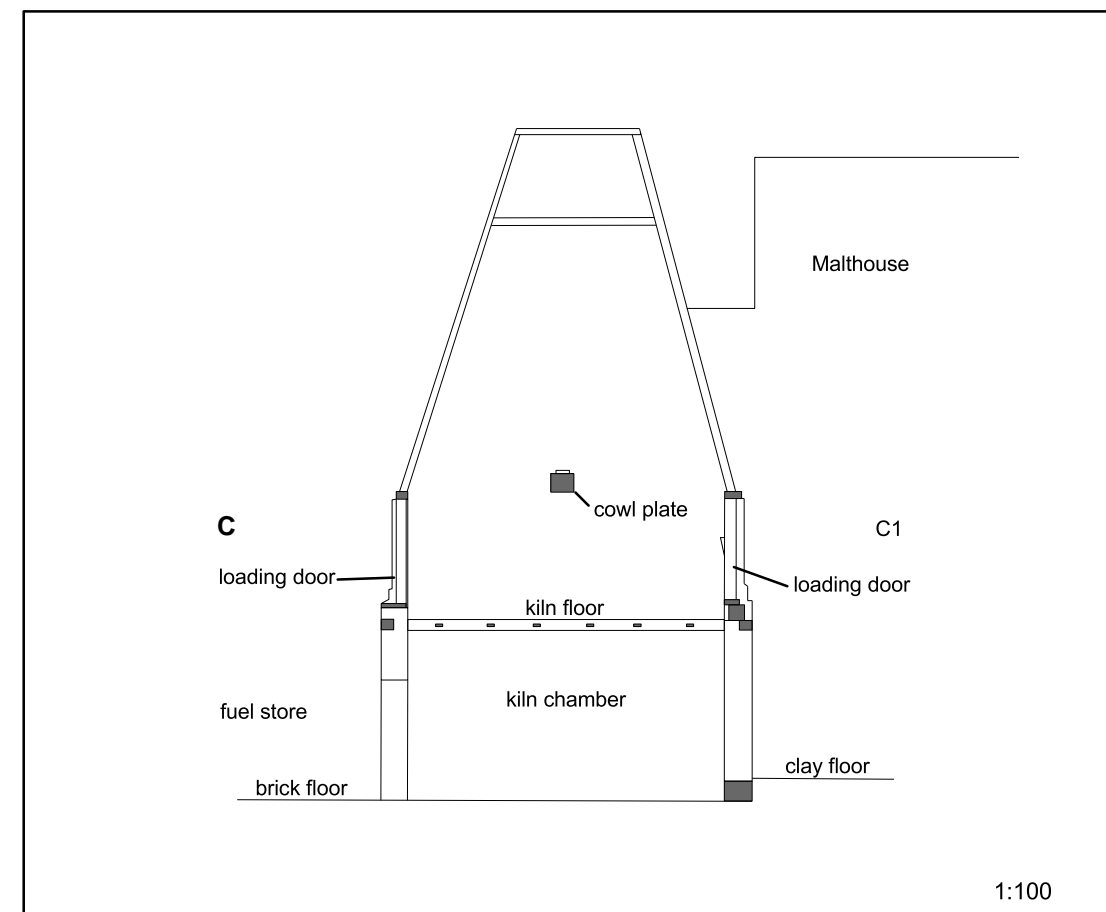
Fig.10. Section through kiln (C - C1)

Spanning the centre of the kiln at a height of 4m is a heavily soot-blackened oak beam containing the cowl shaft housing (fig. 10). It comprises a simple wooden block nailed to the plate with a 2 inch diameter recess (plate 15), enabling independent rotation of the cowl guided by the wind through its vane for effective smoke release. Shallow mortices on the beam soffit are unrelated to any other constructional features and indicate timber reuse. From the base plate, the kiln roof rises at a sharp 75° angle for some 4.8m to terminate in a circular wall plate (fig. 10, plate 14). The long rafters measure approximately 6 x 10cm and are trenched-into the collars. Some are replaced but most are hand-sawn and therefore original. Hipped rafters are attached to the bases of the south-west end rafters to create the hipped roof. No other fixtures or fittings are evident.

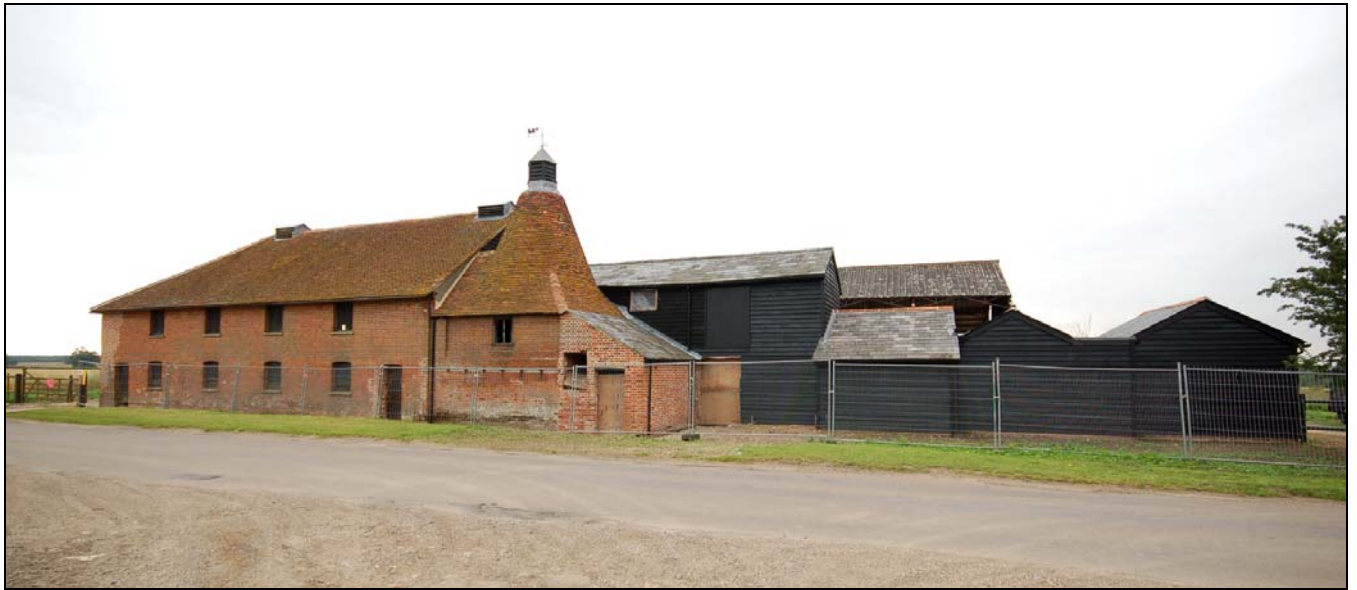
Plate 1 Malting with rebuilt outbuildings

Both of the long elevations have four pairs of equally-spaced wooden vents. Those on the front (north-west) elevation (plates 1-3) are in good order, while those to the rear (plate 4), exposed to the elements, have been replaced with empty four-light wooden frames. Ground floor vented windows have segmental arches while the heads of those on the first floor are set into the eaves. All have cement-rendered brick sills. Ventilation was controlled from inside by hanging shutters.

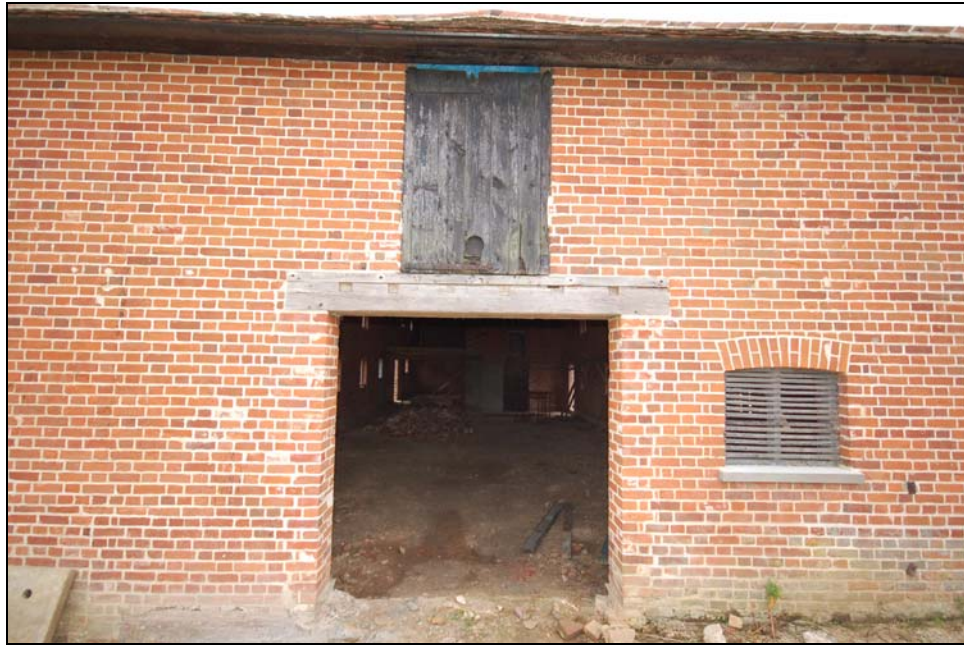
Plate 5 Loading door into malthouse above cattle doorway

The north-east gable elevation is dominated by a wide inserted cattle entrance (plate 5). A single vented window stands to the north-west. On the other side formerly stood the historic pump/well seen in 19th-century mapping, which supplied the steeping tank inside. On first floor level is a wooden loading door, hung on spear-headed strap hinges and iron pintels. At the base is a small opening (for cats?). There is a central wooden lock (plate 6); a reminder that grain was an expensive commodity. Any associated loading platform was removed when the heavy cattle door lintel was inserted in the 1920s, a reused bridging joist.

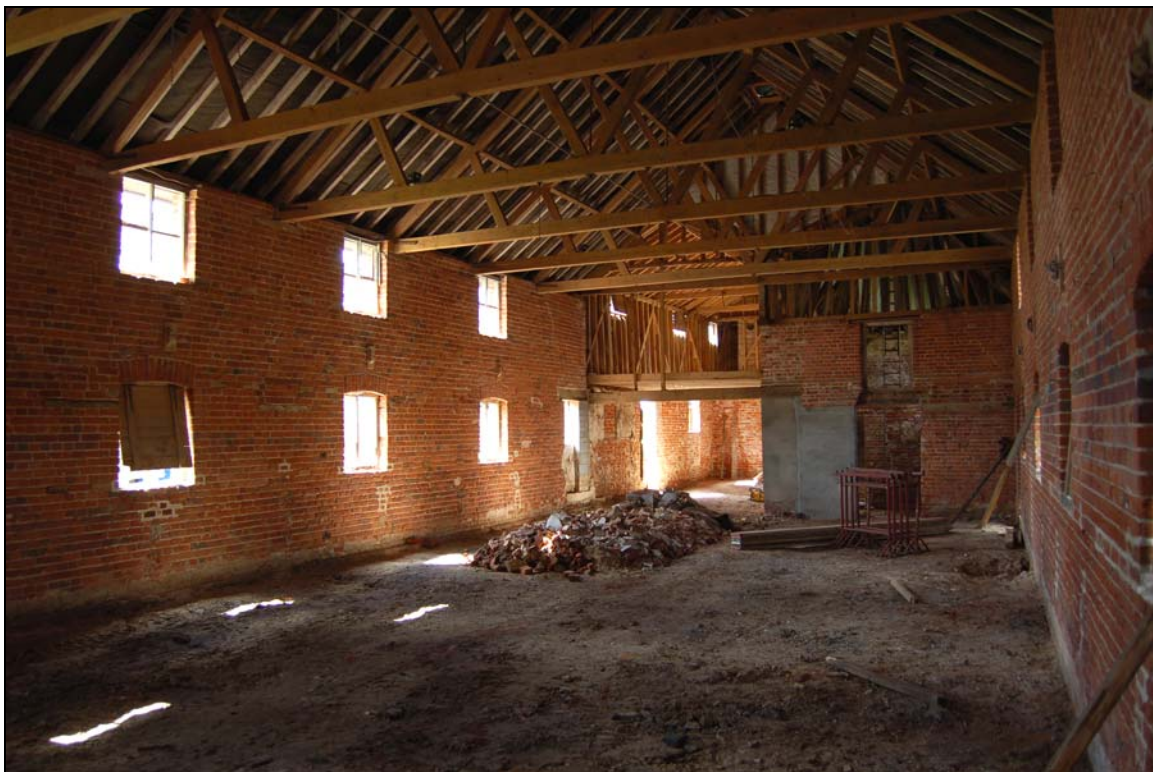
Plate 7 Interior of malthouse viewed to maltstore and kiln (south-west)

The ground floor (plate 7) has recently been completely stripped out to bare brickwork. New floor joists have been inserted into the upper floor, which at the time of the survey, had yet to be boarded. Therefore recording works were carried out from a ladder stood resting against the end joist. It is likely the maltstore and top germinating floor were originally partitioned, given the humid atmosphere of the malthouse, unless both were used for storage.

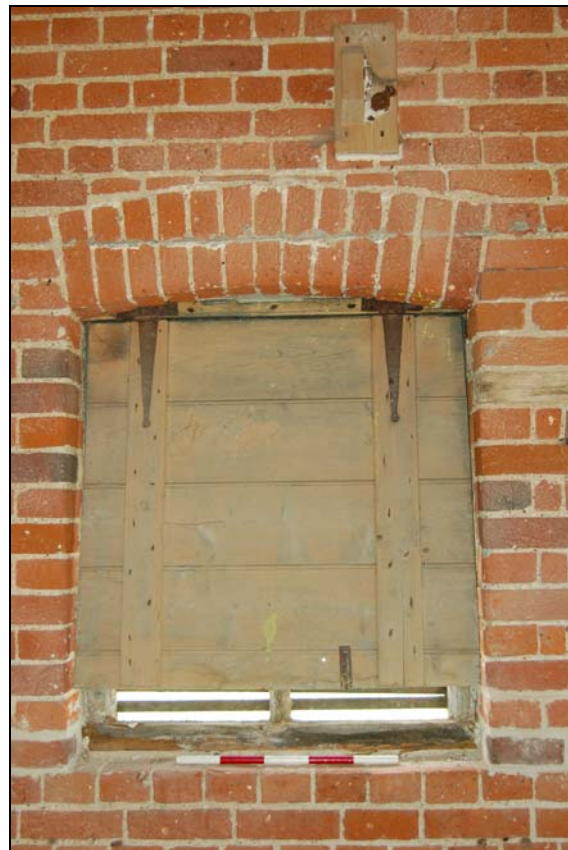
Plate 10 Shuttered malthouse window vent

The only intact fixtures to remain are the battened window shutters, primarily on the more sheltered north-west side. They were probably kept open with wooden hooks attached to the floor joists like those in the maltstore. However, these are gone and pairs of pulley wheels attached to wooden brackets during the life of the cowhouse (plate 10) whose function appears unrelated.

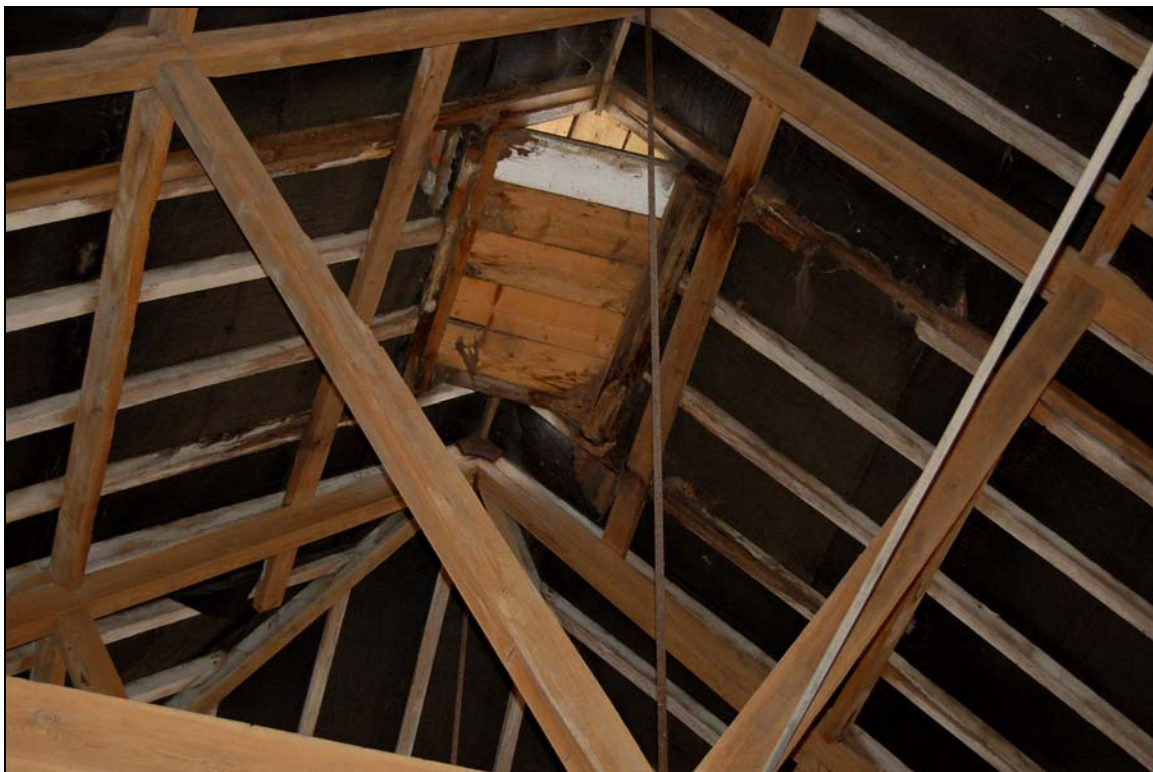
Plate 11 Roof truss and louver viewed from interior of malthouse

The bays are approximately 2m-wide and defined by 10-cm-wide beams. A telegraph pole has been inserted to carry later bracing and to divide the two north-eastern bays (fig.6). Above, the roof trusses are formed from pre-assembled machine-sawn queen strut frames with trenched purlins, kept in compression by vertical bolted iron rods (fig. 9). Such a form is common in later 19th-century farm buildings and indicates the roof is rebuilt (plate 11).

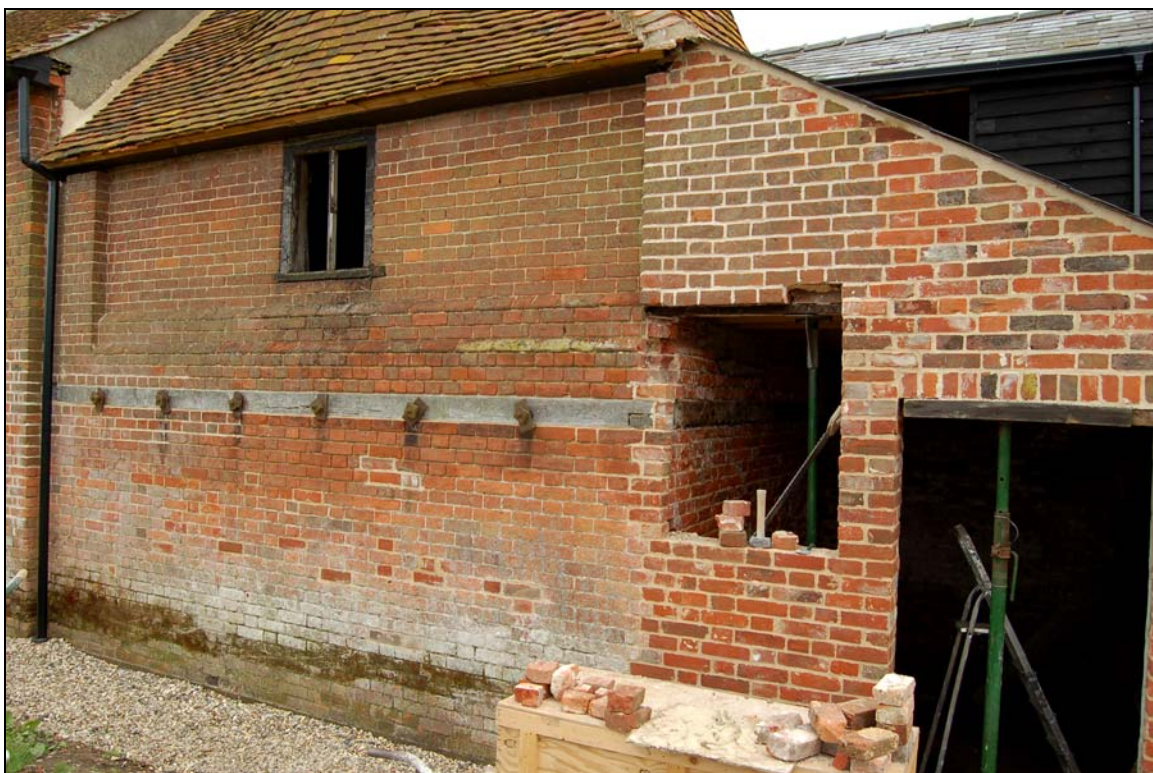
Plate 12 Tension bolts for wire mesh kiln floor and fuel store

The structure is built independently to the malthouse of bricks the same size and hue. Up to first floor level, indicated by the wire floor plate, the outer walls are the same thickness and duality of bonds, Flemish and English, as in the malthouse. Above, the walls step in on all sides in pier and panel construction in normal Flemish bond. The floor plate has 2½" headed tension bolts that held the wire mesh floor on 4" square iron backing plates to counteract the effects of heat on the wire. They are spaced approximately 26cm-apart (plate 12). The bolts are missing on the other sides.

Towards the fuel store, the eaves sweep down at 45°. A square two-light timber window faces the road, stripped of any other detail (plate 12). Existing apertures on the ground floor are modern in origin (either 1920s or more recent) but the first floor is relatively unaffected. This floor contains historic loading doors (or their openings) relating to traditional grain and malt transferral, essential in understanding the process flow of the complex.

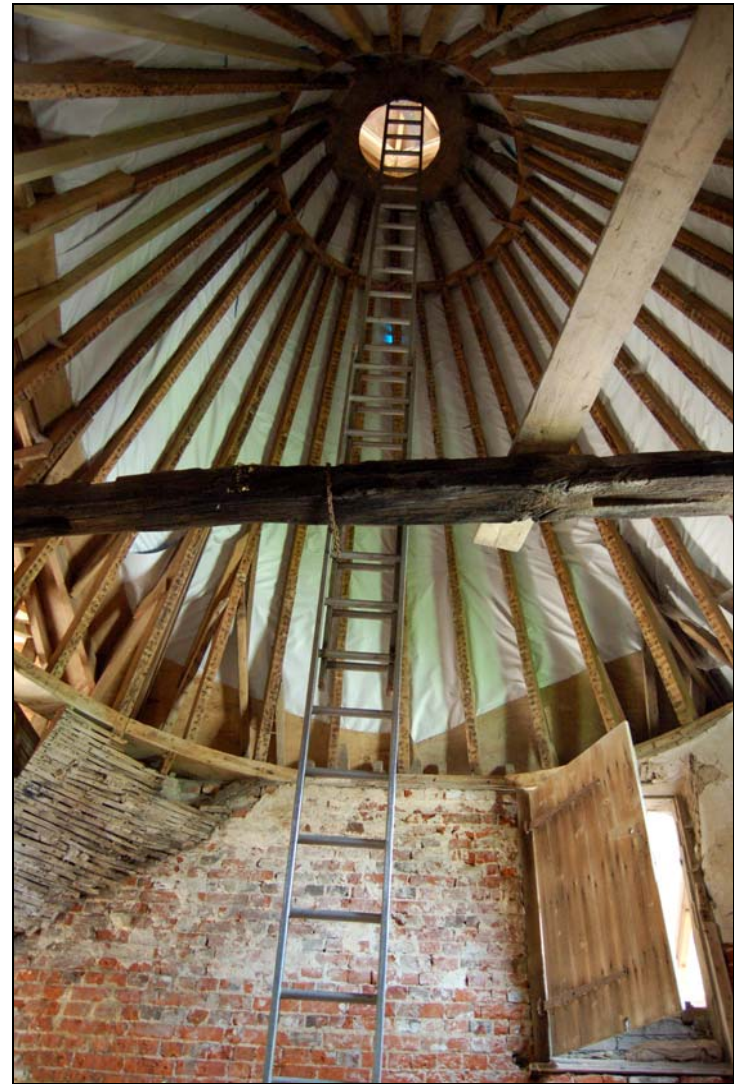
Plate 14 Kiln roof and cowl plate

linking to the malthouse, maltstore and fuel store (fig.6). The only remaining door is on the south-west wall (plate 14), leading to the fuel store, where the raw barley could be passed through for sweating upon arrival. The door is typical of those seen elsewhere in the survey, whether large or small; a simple ledge and batten style carried on round-ended strap hinges. Historic lath and plaster remains here to match the curve of the wall plate (plate 13) and other corners have been rebuilt or are in the process of rebuilding. Indeed, nails in the long rafters above show the whole interior was formerly plastered and limewashed (plate 14).

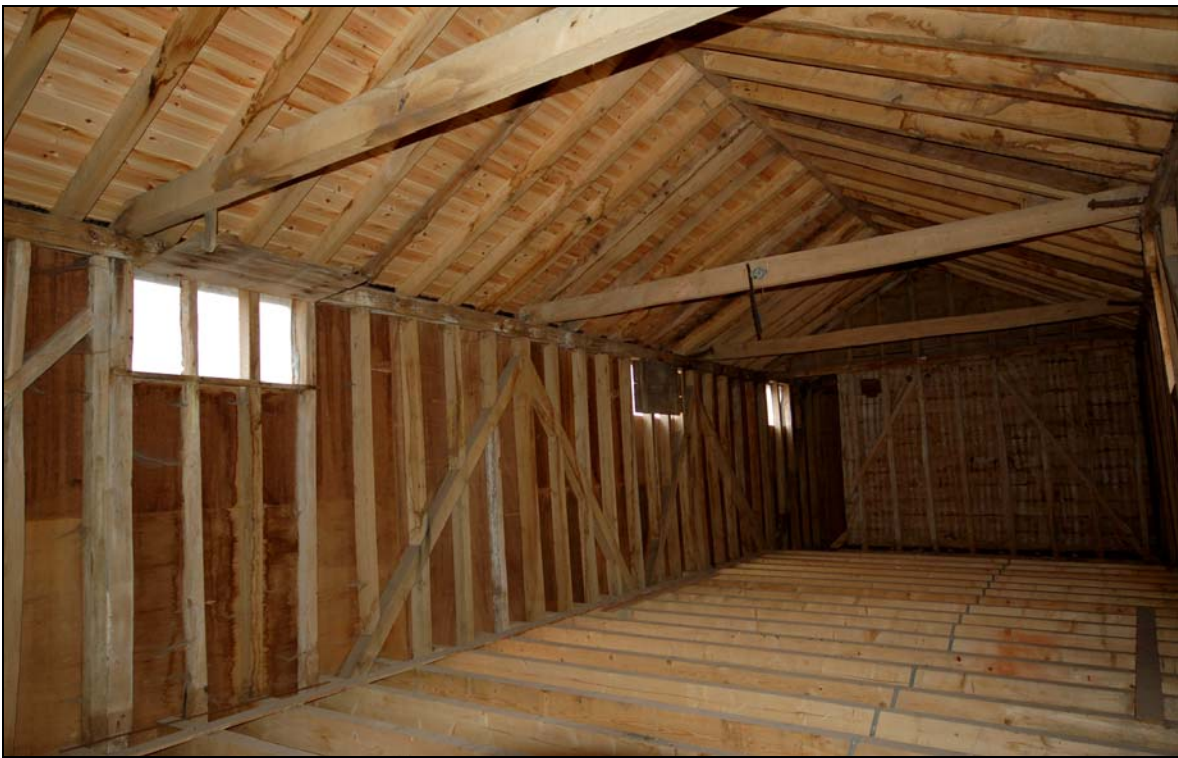
Plate 18 Maltstore first floor viewed to south

Each of the 3½ bays is defined by strapped tie beams. The walls are built in primary-braced timber-framing apart from the north-west wall that adjoins the kiln and is therefore partly bricked. An open loading hatch is set within the lower section for transferral from kiln to store and beyond the kiln is an external door for passing the grain down after sacking (plate 17) into carts beside the roadside. The south-western bay is shorter than the others and is built from more slender timber (plate 18).

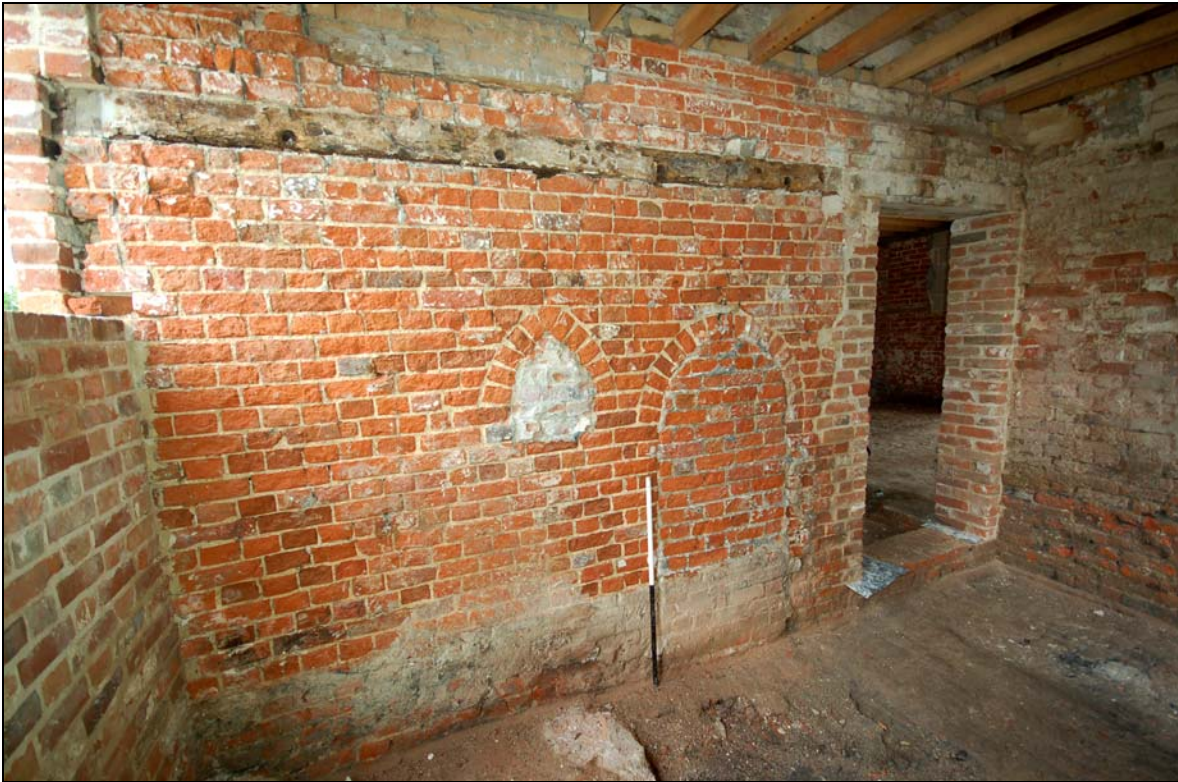
Plate 19 Blocked stoke hole and wall recess inside fuel store

Through the removal of cement render on the wall adjoining the kiln, a blocked stoke-hole and pointed-arched shelf recess in the wall beside it were revealed (plate 19). A hole nearby in the worn brick floor shows the blocking material used did not have far to travel. The stoke-hole is tall and stands 1.6m-high, with a semi-circular arched head. No fixtures are evident, but there are small areas of render on both sides that may represent positions of removed hinges and latch fittings to a cast iron kiln door. The existing entrance into the kiln is a later feature and uses the kiln floor plate as a lintel. During the conversion works, ceiling joists had been added, through which the loading door into the kiln for sweating was seen (plate 20).
