**FORMER ELECTRIC LIGHTING STATION
ANCHOR STREET
CHELMSFORD
ESSEX**

HISTORIC BUILDING RECORDING

January 2008

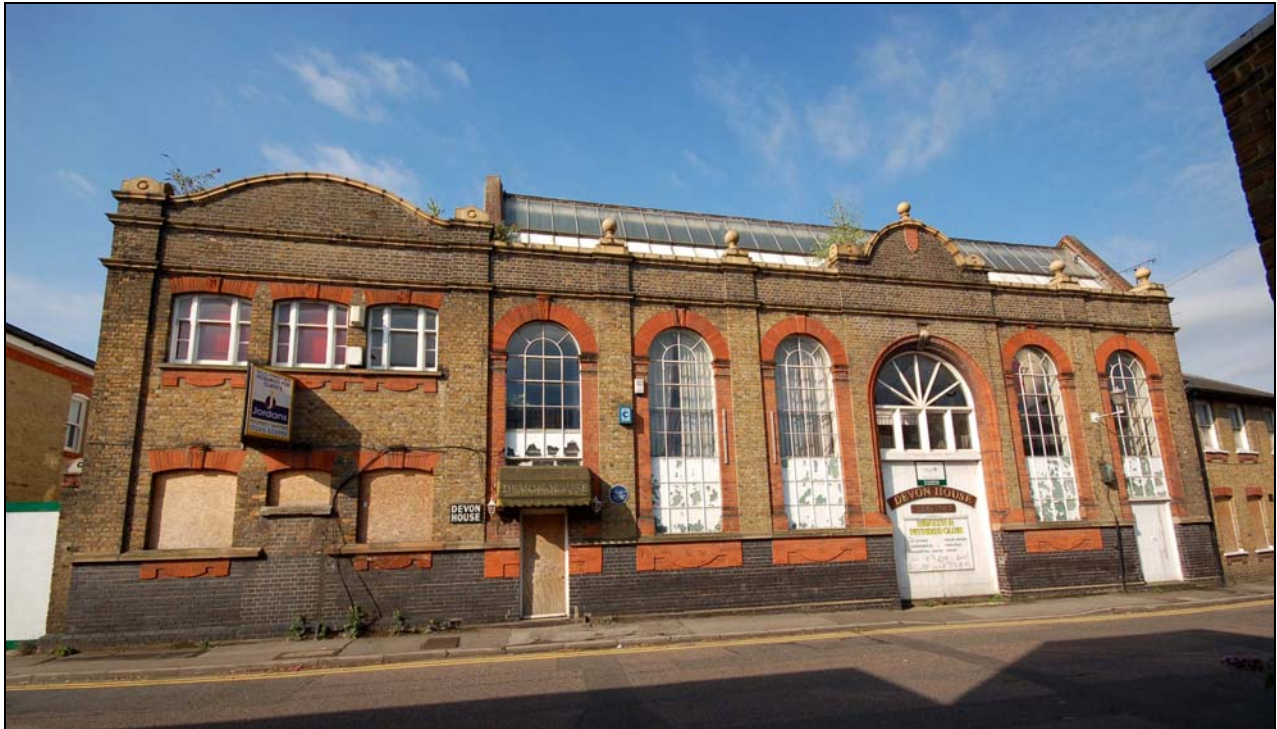
On the north elevation (plate 1), the structure stands on a high blue-brick plinth finishing in a sandstone sill band with pier and panel walling above to the engine house and plain walling to the office block. The main entrance is located on the fourth bay of the engine house as a pair of doors surmounted by a wooden glazed fanlight. A second, smaller doorway is located in the west bay. Tall iron-framed windows in each of the six bays light the large internal working area. Each has a terracotta semi-circular arched head, fluted keystone and red brick imposts and terracotta aprons. The lower panes of the windows were painted over when the gym first floor was added and the interiors boarded. The sill to the eastern bay of the engine house was raised when the gym was established to allow an additional entry point.

The two-storey office range (plate 1, left) has cambered-headed windows to each of the three bays. A central office door has been blocked in to form a small window. Twin projecting brick bands run along the top of the office and engine house. Above, in the engine house, sandstone ball finials top each of the piers, with another placed on the segmental arched pediment above the main entrance that also contains a brick keystone (plate 2). A swept pediment with sandstone copings completes the office range. The glazing of the north light can be seen on the roof of the engine house.

Plate 1 Listed Anchor Street frontage

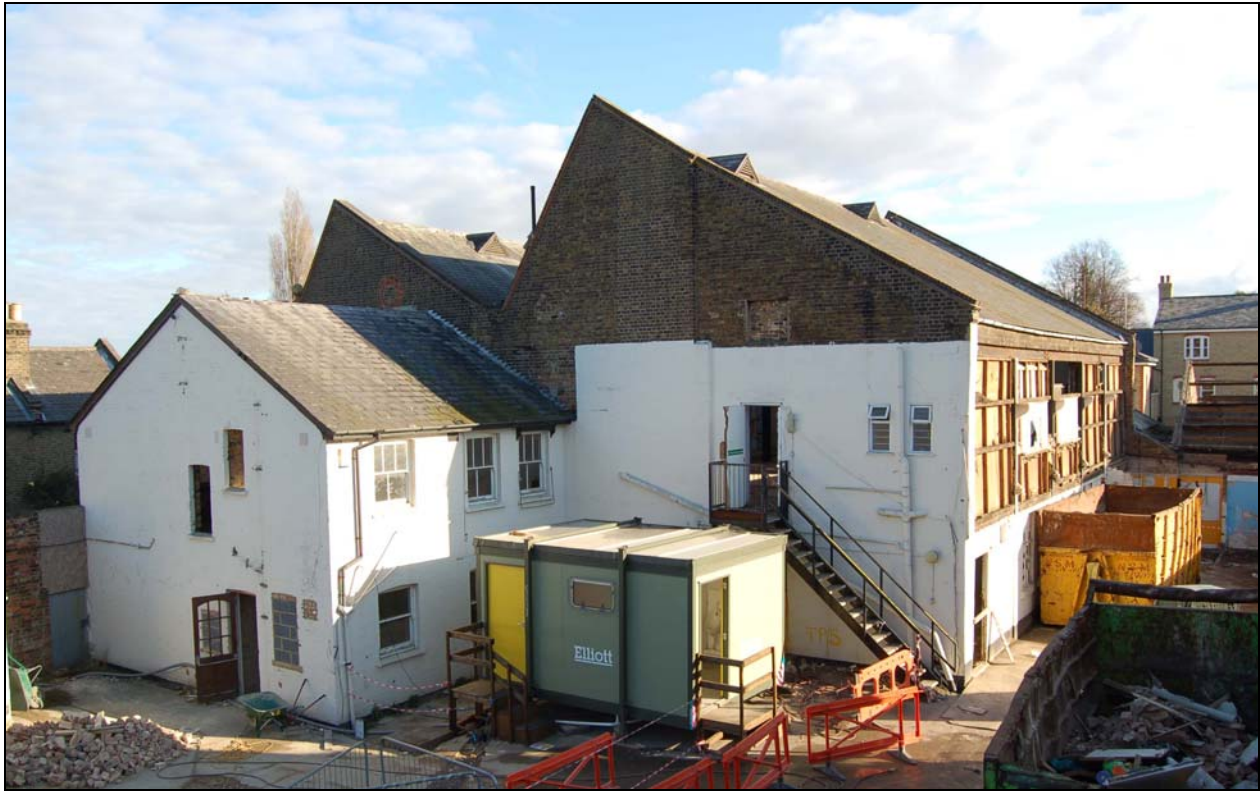
Much of the twin-gabled west elevation (plate 3) is either hidden by the later house, or painted over in white, perhaps showing the height of the demolished boiler house. A fire escape has been fitted to the south gable and modern windows for toilets. However, above the modern fire door is a blocked bearing box for line-shafting between the engine and boiler house. To the left of the door is a rebuilt area where the brick chimney stood. The pediment appears to have been rebuilt on the south gable, or else simply repointed. An oculus window in the shorter gable, to the north, is blocked.

Plate 3 West elevation of engine house and post-1924 house 6

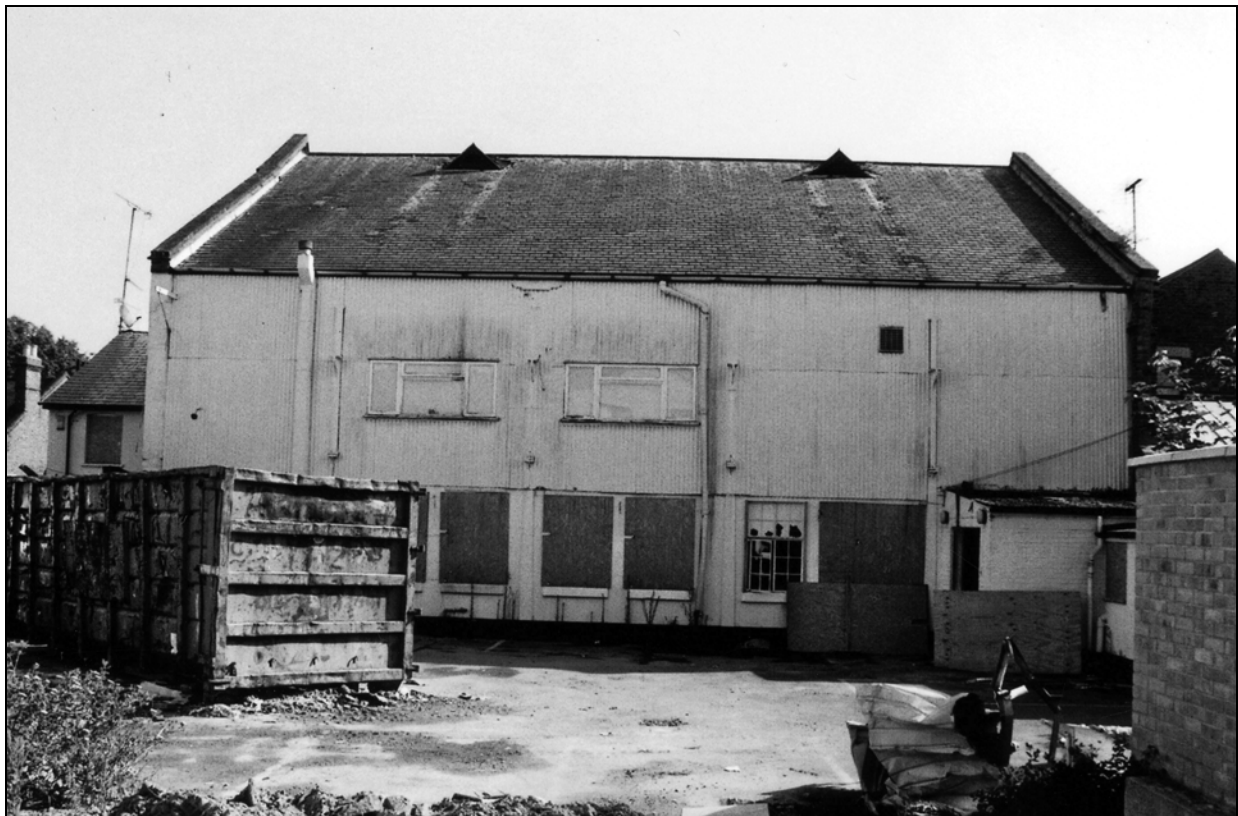
The rear (south) elevation (plate 4) is far less decorative and has been rebuilt, as part of the motor works, after the lighting station closed in the inter-war period. Tall steel uprights define five bays. The ground floor is built from a thin Fletton wall punctuated by wide iron casement windows. The upper level is covered in corrugated iron sheeting, fixed to an outer timber/board frame with breeze block inner wall, apparent on the second visit (plate 5). There are two modern wooden casements. The brickwork on the two pediments and walls facing the yard has been disturbed, probably when the extension/awning, apparent on the 1939 map (fig.6), was removed. The neatly-tiled roof is viewed without a pediment on this side and there are two wooden triangular ventilation louvres either side. Two others sited on the north roof were also observed from this side. Some small single storey structures of relatively late date extend from the east and form a block with workshop 4.

Plate 4 Re-built rear (south) elevation of engine house

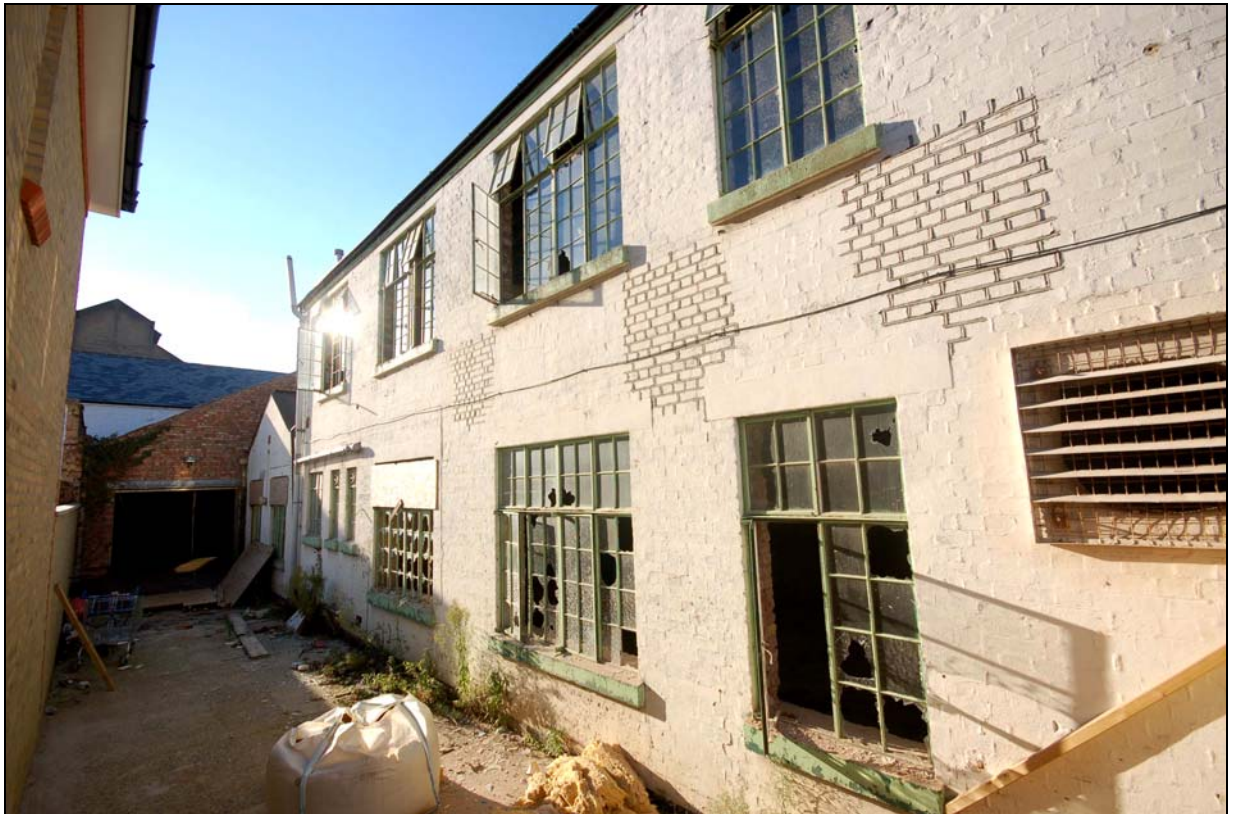
On the east side of office range 3 (plate 6), the wall contains later iron-framed Crittalls casement windows in each of the four bays. Sills and frames are painted a light green and there are some rebuilt parts under the sills but no architectural detail. The eastern gate post has the same moulded head as those on the pediment above. There is no opposite gate pier and the workshop that once stood on the other side of the entrance has been replaced by modern flats.

Plate 6 East office elevation

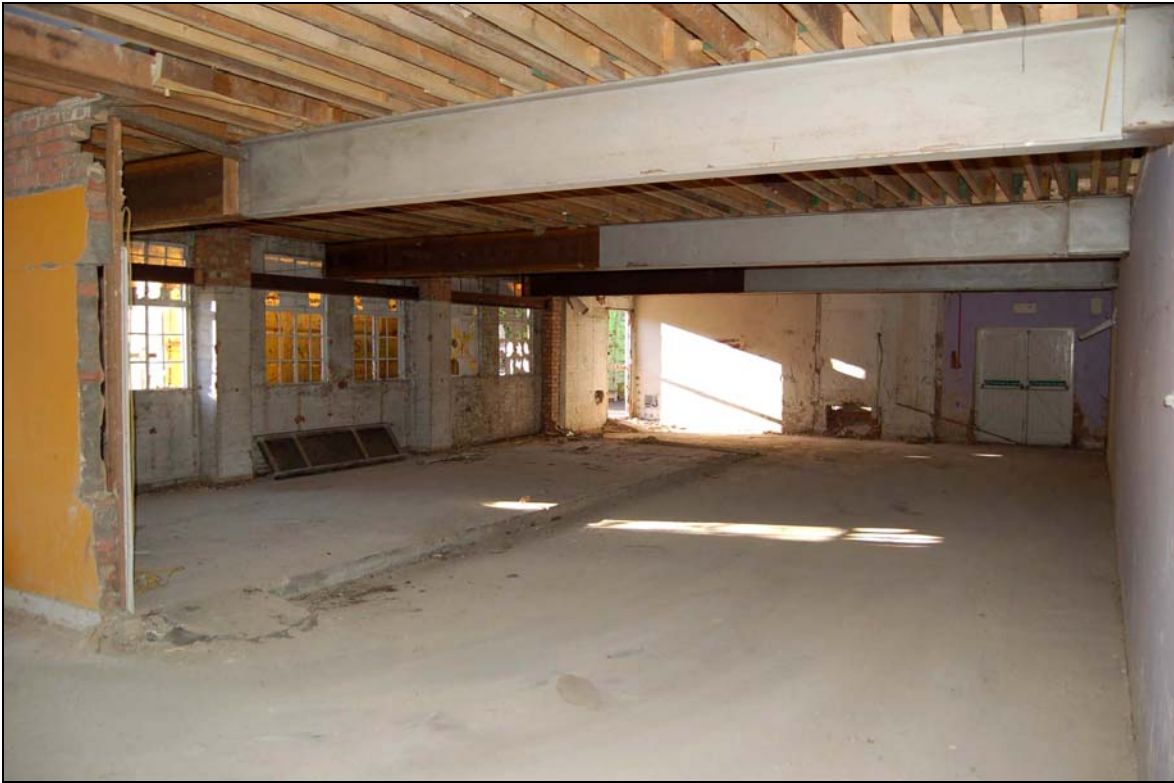
On the south (training room/bar) side (plate 9), most of the partition walls had been stripped out by the time of the second visit, giving a much better understanding of space. The south wall is constructed in 4 inch Fletton brickwork, with brick piers supporting the steel frame mentioned in section 5.2.1 and seen from the car park (plate 4). The inclusion of steel-framed windows confirms a likely 1920/30s date for the rebuilt south end, presumably around the existing steel frame. The windows are the same Crittalls type as those on the eastern side of the office building. There are several blocked apertures against the office building (fig.7) which were recorded on the office side (see section 5.2.3)

Plate 9 Ground floor (south) of engine house, viewed from east to rebuilt wall

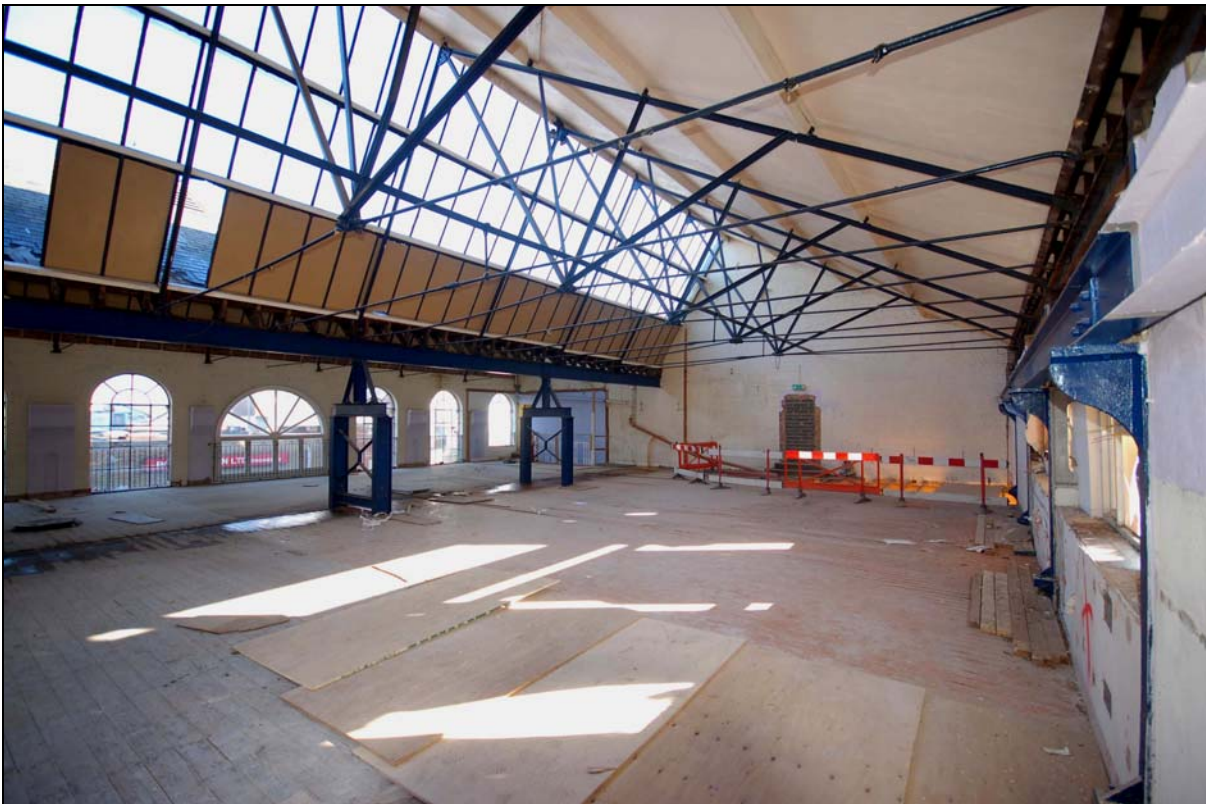
The north wall presents an attractive array of long iron-framed arch-headed windows, with a wider wooden-framed one over the main entrance forming a 'sunbeam' fanlight over the main

entrance (plate 12). This window is fixed and is a central showpiece. The iron-framed windows either side tilt open at the top (plate 15) through cord activation on the original working floor below. Either side of the windows, the bays are represented by relatively grand moulded pilasters (plate 11). Their flat heads would seem to have carried part of the structure, a horizontal steel girder perhaps to tie in the verticals. However, none is evidenced from the brickwork at either end and such a feature would also be an obvious visual impairment to the main façade,

Plate 12 Top floor of gym after strip, viewed from south-west

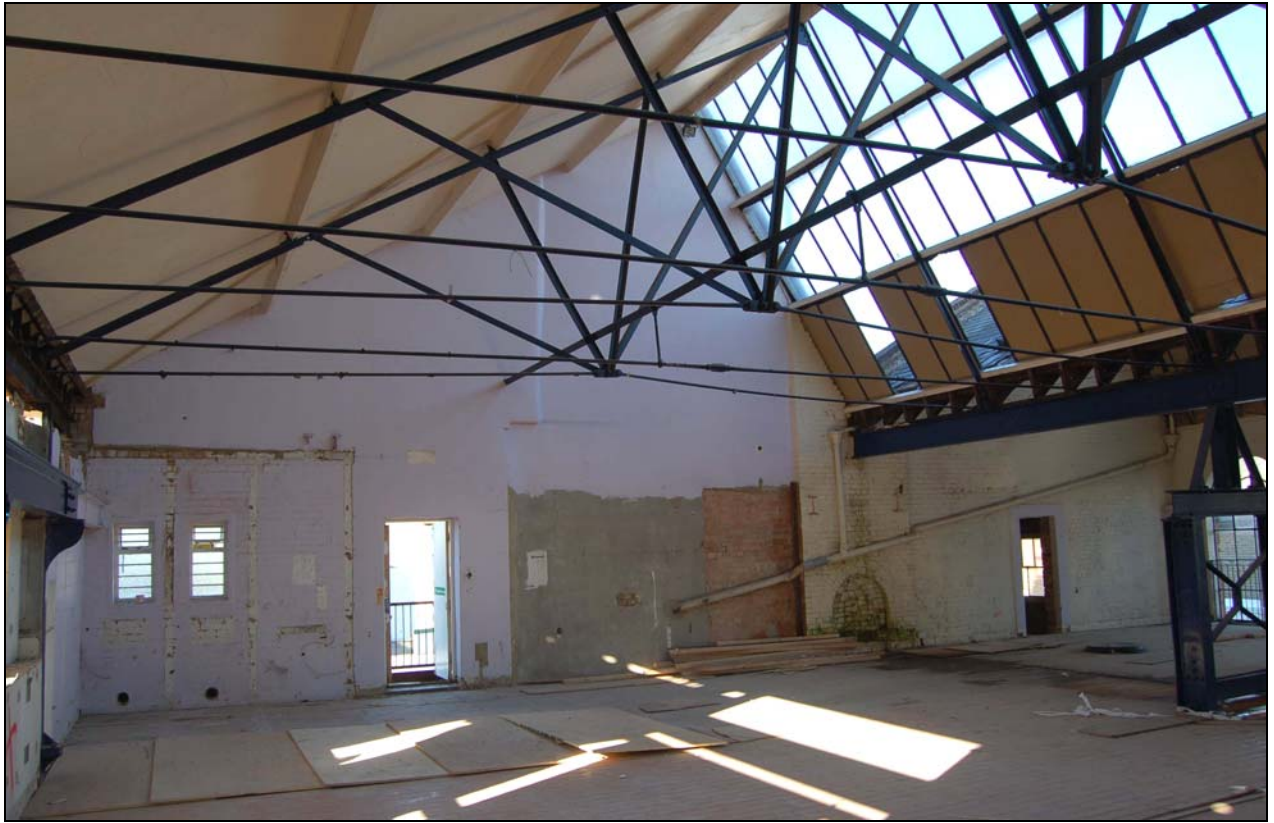
Plate 13 Removed chimney scar on west wall of engine house

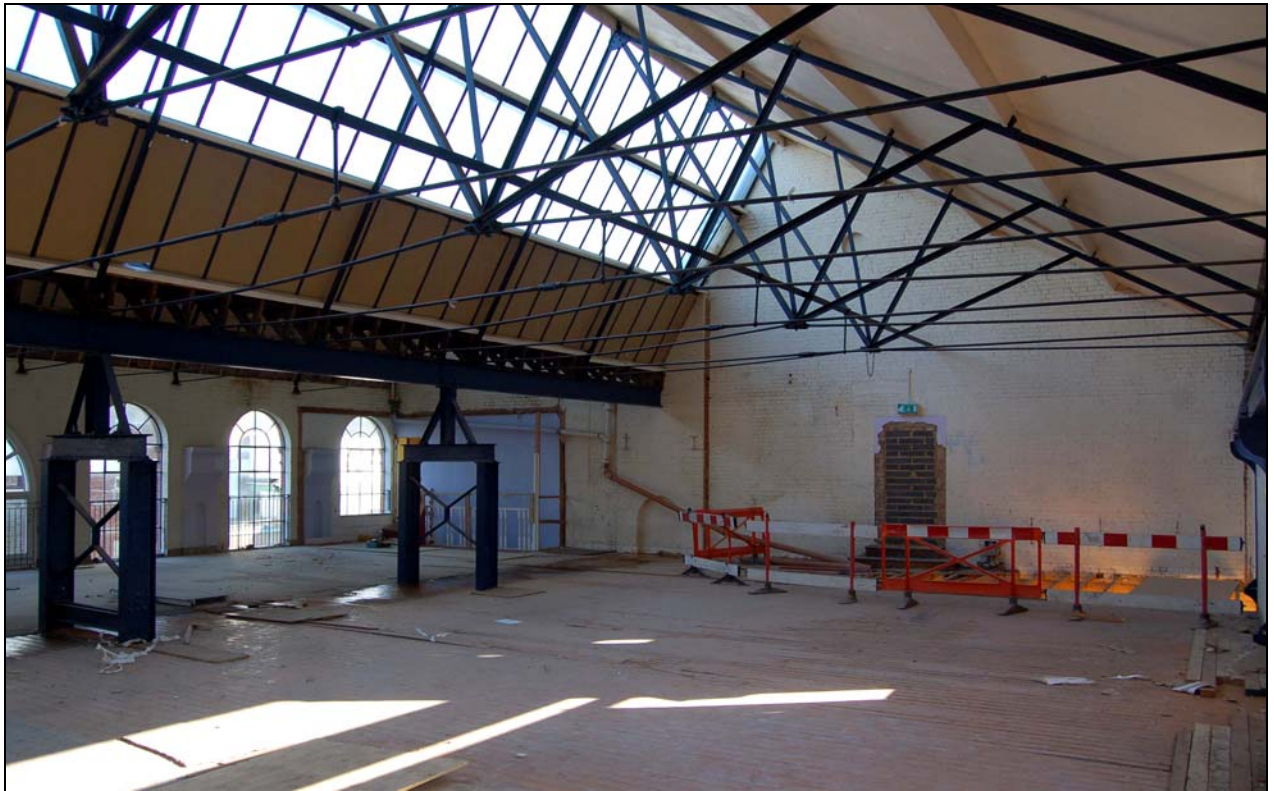
Plate 14 Blocked doorway cut through blocked window on east wall of engine house

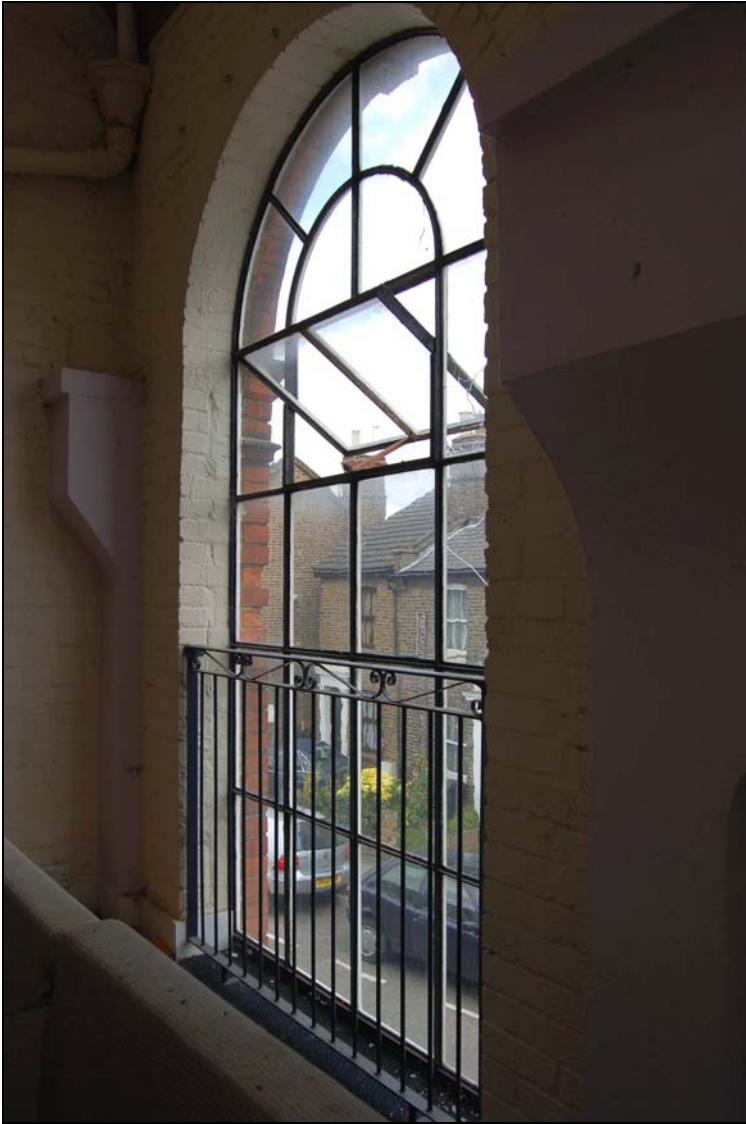
Plate 15 Detail of iron-framed window on north wall

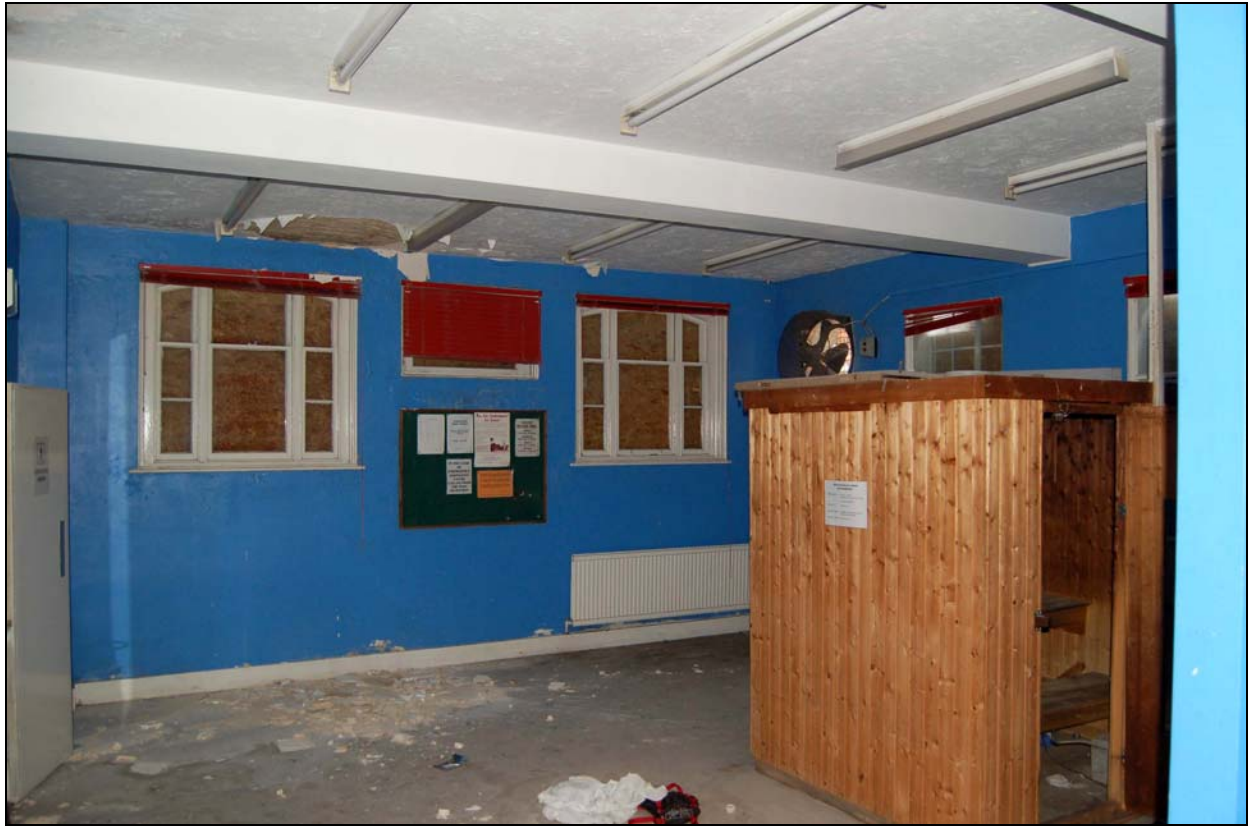
As part of the gym, the ground floor of the office range was divided into a sauna and exercise room at the front and showers and WCs at the back (fig.7). Modern fluorescent lighting, sauna room and plain door architraves and skirting boards are contemporary gym features. The original ceiling joists were boxed in (plate 17).

Plate 17 Ground floor office interior north wall before strip

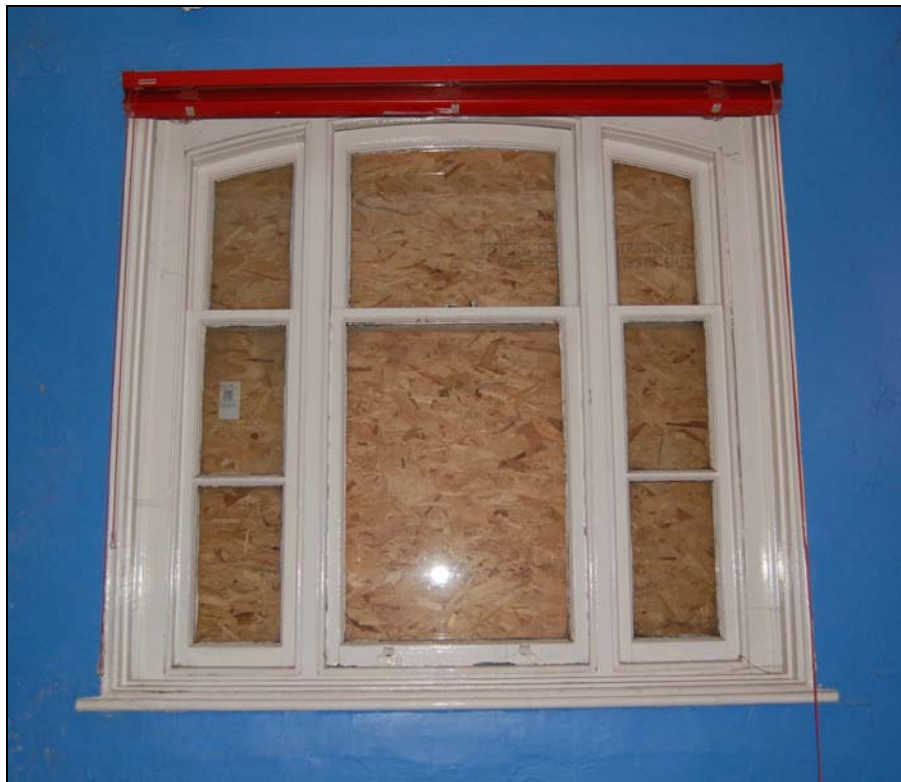
The original tripartite windows on the street frontage have a main central sash (with 'beehive' fixtures) and narrow side sashes (plate 18). Those on the east wall are steel-framed Crittalls casement windows (detail of window shown on plate 21) inserted in or after the mid-1920s, which would correlate with the closing of the lighting station and expansion of Clarkson's works. Concrete lintels and sills are sited above each of the windows on both floors. The sills are covered in 4 inch earthenware tiles, common to the period. The windows have flat frames curved latches and sliding handles to the casements (plate 21). Interestingly, the casements only open on the right side. There is no evidence of earlier windows.

Plate 18 Detail of front office window

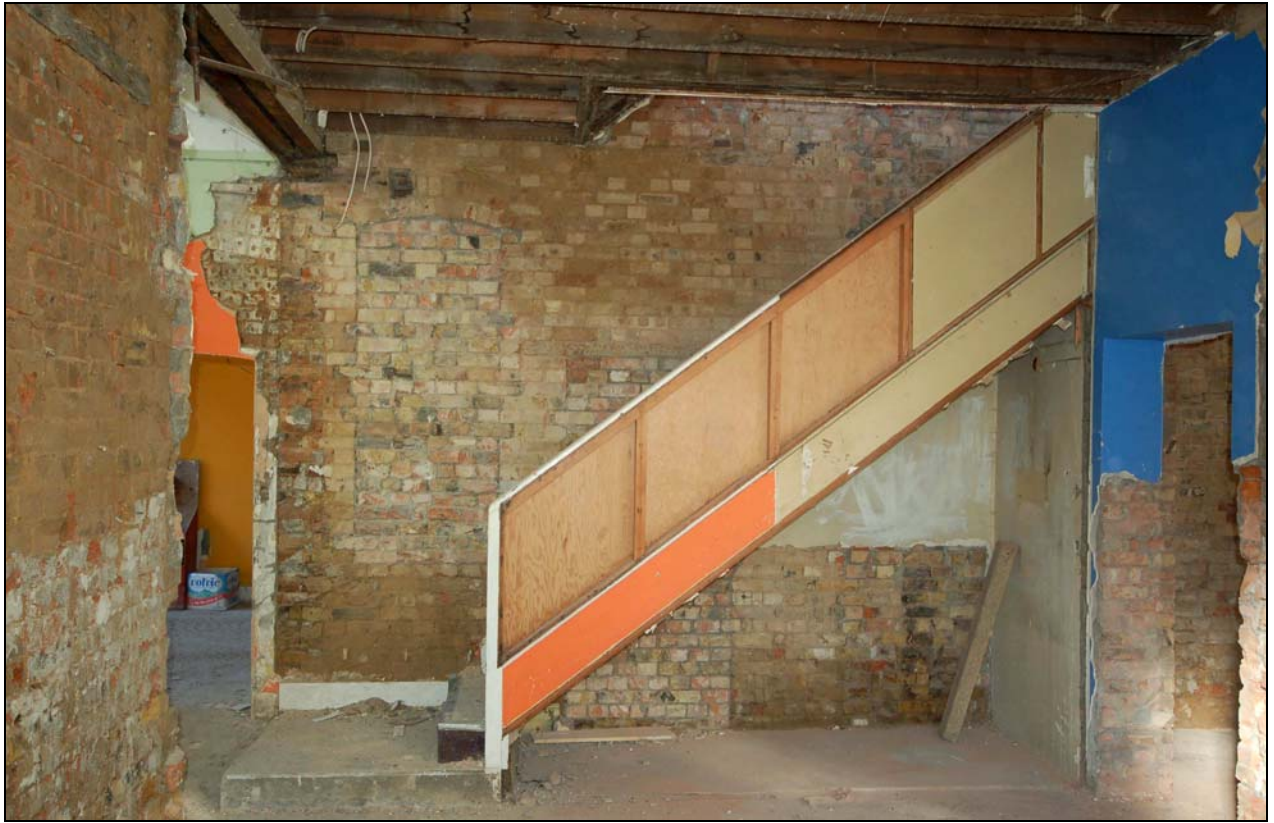
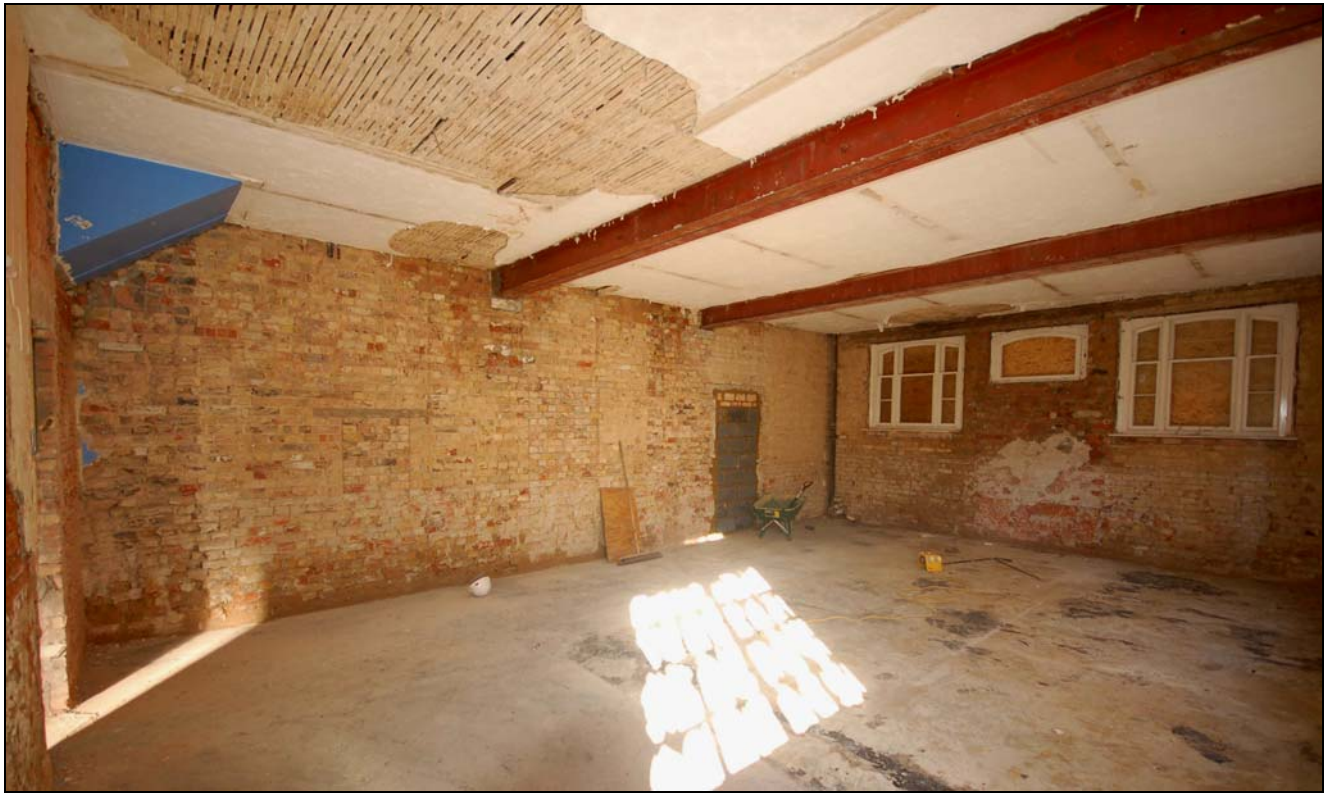
Below the stairs and continuing past the inserted red brick wall, is an area of rough brickwork (plates 19 & 20), perhaps where wall-mounted equipment or machinery has been removed and 'made good'. Moving further northwards, into the next room, a blocked portal and doorway were uncovered (fig.7, plate 20). The portal would have been used as a feed for cables or otherwise. A further, gym-era, doorway at the north end of the offices has been blocked in after the strip (plate 20). In the northernmost corner stands a rainwater down pipe, showing that water was collected and pumped back into the boilers to produce steam for the turbines.

Plate 19 Blocked areas in partition wall between engine house and south part of office range

Plate 20 Blocked areas in front (north) part of office after strip

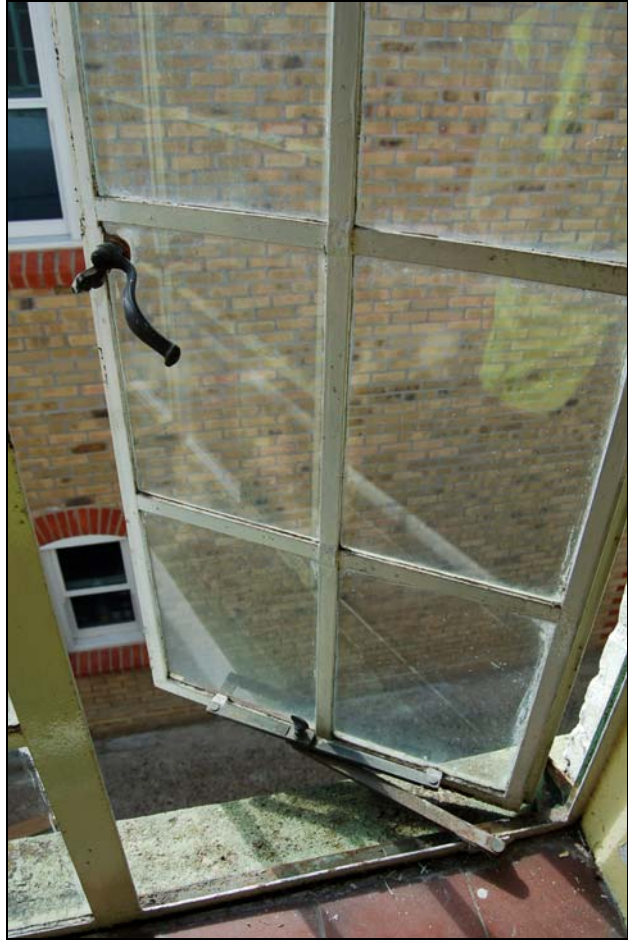
Plate 21 Inserted Crittall window on east office wall

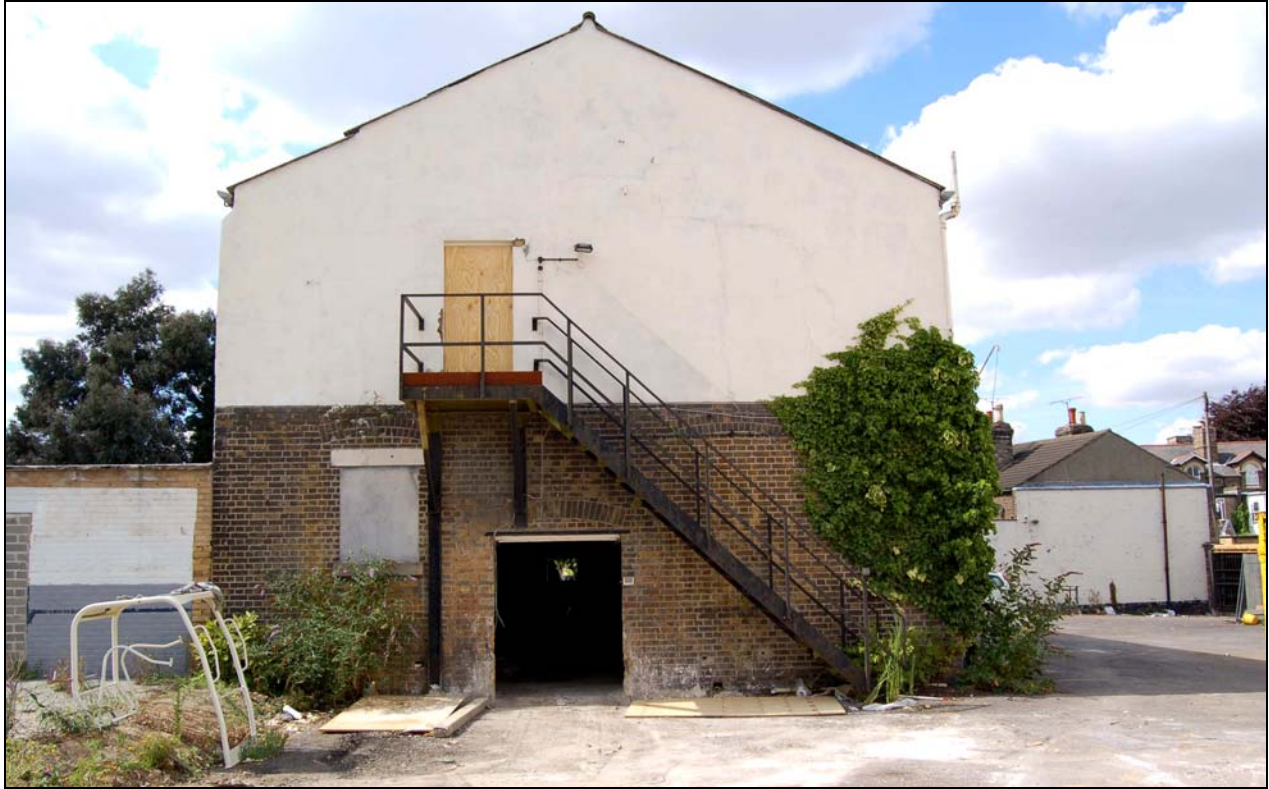
Plate 25 East wall of boiler house incorporated into warehouse 5 wall
