**PUMP HOUSE
CROMWELL HILL
MALDON
ESSEX**

ARCHAEOLOGICAL MONITORING AND RECORDING

**Essex County Council
Field Archaeology Unit**

APRIL 2008

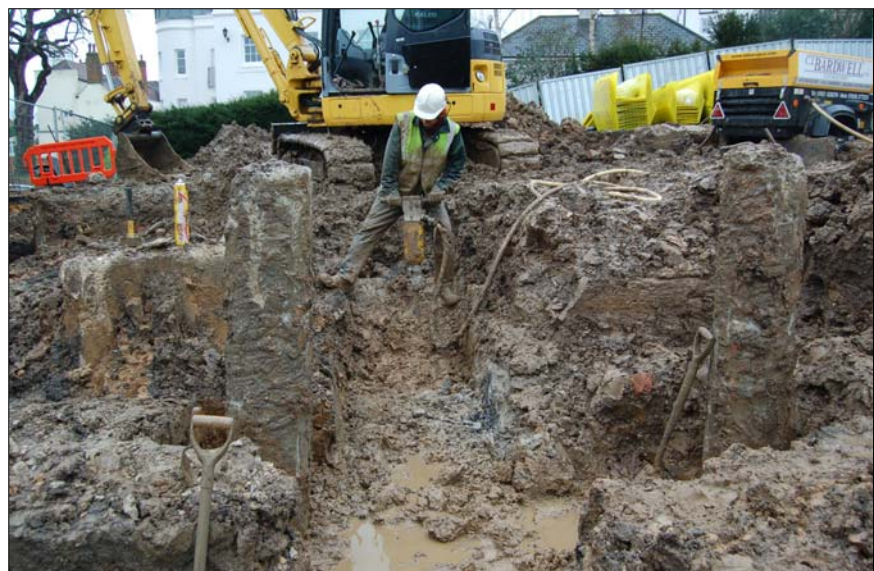
Plate 3 Removal of old concrete underpinning

though casual inspection showed that they were c.6m deep and inserted into London clay. In general, there was a fairly high level of disturbance, particularly in the centre of the site, which could be attributed to the construction of the former Pump House and its subsequent underpinning with concrete. Further disturbance occurred during demolition clearance, including the removal of the concrete underpinning, and during piling works. Work was also hampered by the wet weather conditions (Plate 3).

Pits 11 and 13 were both located to the rear of the property and could be accounted for as modern back-garden disturbance. The centre of the development area was heavily disturbed by the concrete underpinning (Plate 3) of the former Pump House and surface deposits of re-deposited clay and rubble were all the result of modern levelling.
