**PASSMORE HOUSE  
THIRD AVENUE, HARLOW  
ESSEX**

**ARCHAEOLOGICAL INVESTIGATION (PHASE 2)  
EVALUATION, EXCAVATION AND MONITORING**

**December 2010**

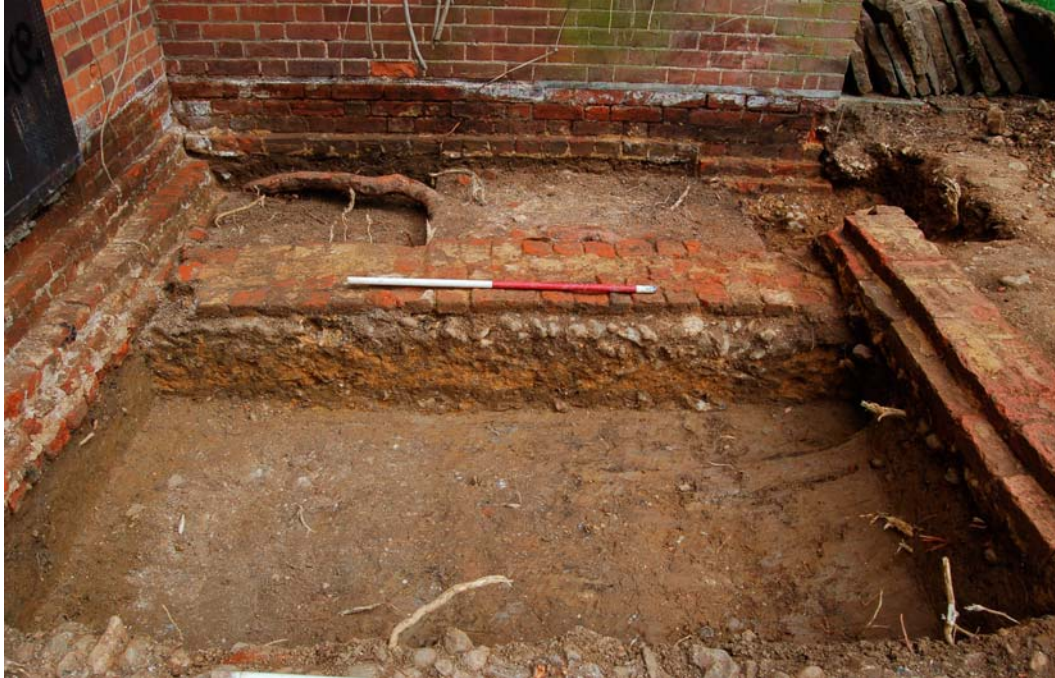
Plate 1. Trench 2 looking east, showing the west face of 16th-century flint wall 38, with 17th-century brick capping 37. The wall was constructed from the level of the natural clay in the foreground. Passmore House is to the left and in the background, with the Victorian conservatory wall to the right (1m scale)

In Trench 2 a Victorian conservatory measuring 6.7 x 2.8m was added at south-west corner of Passmore House, in the angle of its south wall and the projecting bay to the east (Plate 1). The conservatory was founded on sleeper walls built of three courses of London-type frogged stock bricks (14, 15 and 16), with a cobbled floor (12, 17, 23 and 24). A section through its west wall is illustrated (Fig. 8, section 3). A pair of under-floor heating pipes originally ran along the north side of the conservatory, along the south wall of Passmore House. An overlying layer of gravelly sand (11) formed the bedding layer for the modern patio which replaced the conservatory.

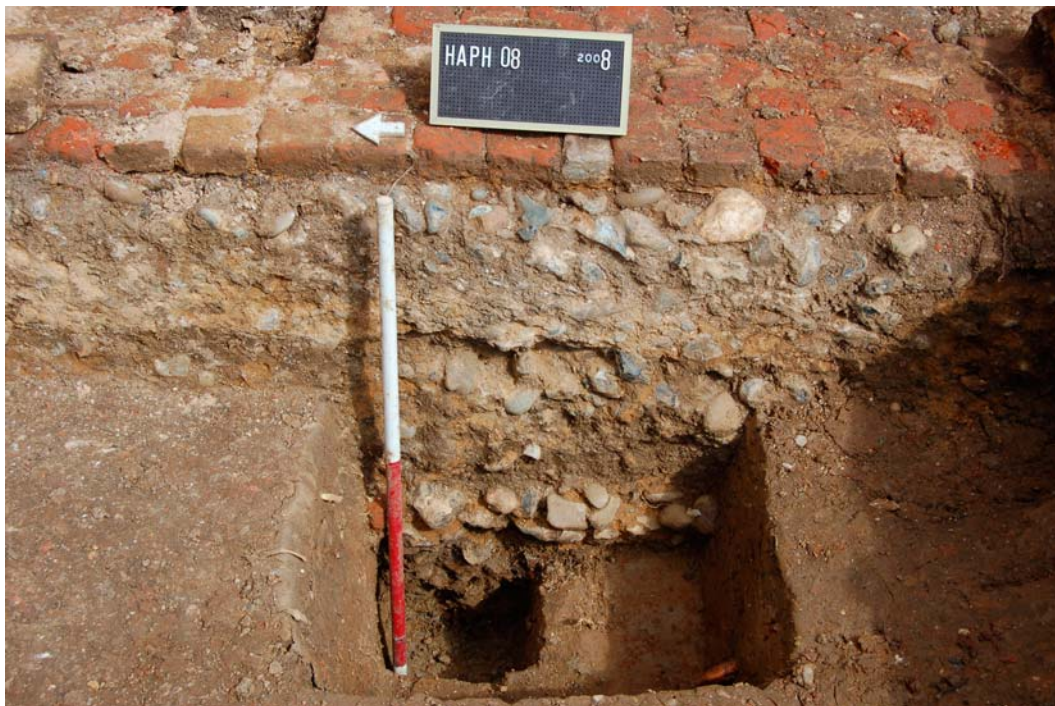
Plate 2. Trench 2 looking east, showing a detail of 16th-century flint wall 38, with regular facing above a roughly laid foundation 50 (1m scale)

The foundation of the eastern wall 38 was recorded in Trench 2, where a box-section was excavated against its western, inner face (Plate 2). It again consisted of roughly-laid flint with occasional fragments of 16th-century brick (50), forming an internal off-set, above which the upper wall, 0.55m wide, was constructed of regularly-coursed and well-faced flint in yellow sandy mortar (38). Foundation 50 was recorded to a depth of 0.8m (48.83m OD), the same level as the base of foundation 62 for the western wall 54 in Trench 3.

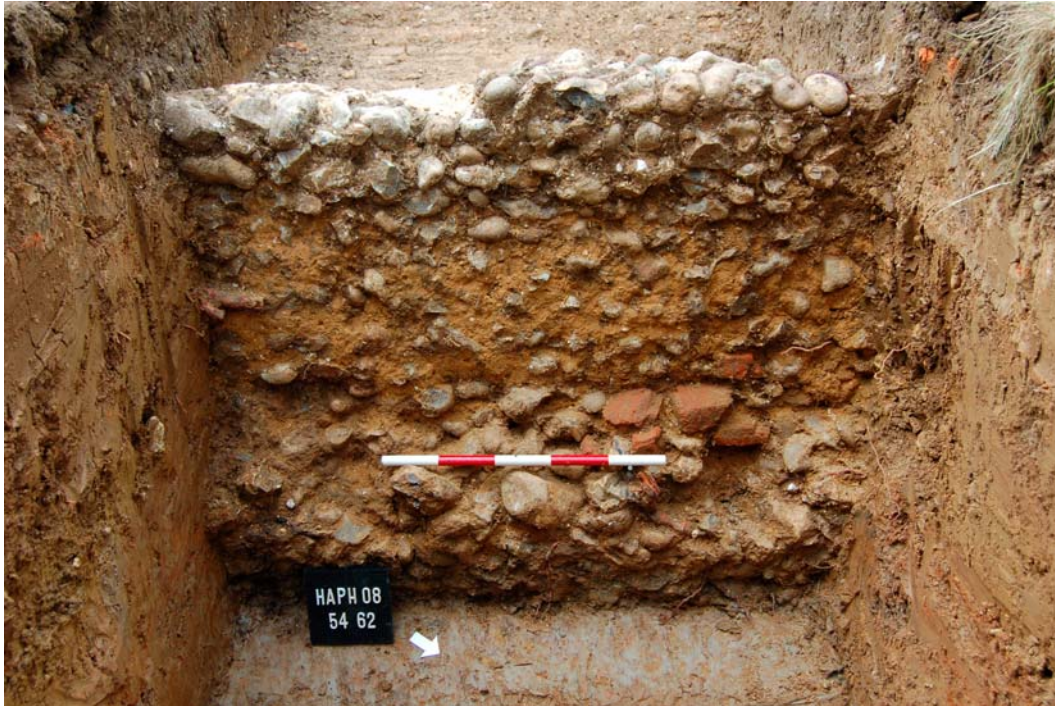
Plate 3. Trench 3 looking west, showing the inner face of 16th-century flint wall 54, with foundation 62 exposed showing bricks at the top of the foundation and regularly faced construction above (0.5m scale)

The full sequence of construction was recorded in Trench 3, where the foundation of the western wall 54 was exposed by machine-excavation (Fig. 8, section 1). It was substantial, 0.7m wide and 0.8m deep, and was constructed of roughly laid flint nodules in yellow sandy mortar with occasional 16th-century orange-red half-bricks (62), forming an off-set 0.15m wide on its eastern, inner face (Plate 3). Its western, outer face was capped by two courses of complete orange-red 16th-century bricks laid in stretcher bond to form a levelling for the construction of the upper wall 54 (Plate 4). Since the wall was left in situ these could not be sampled. Wall 54 was 0.55m wide and was built up from foundation 62 to 0.2m above the level of the natural clay, in regularly-laid, well-faced flint courses in yellow sandy mortar (Plates 3 and 4).

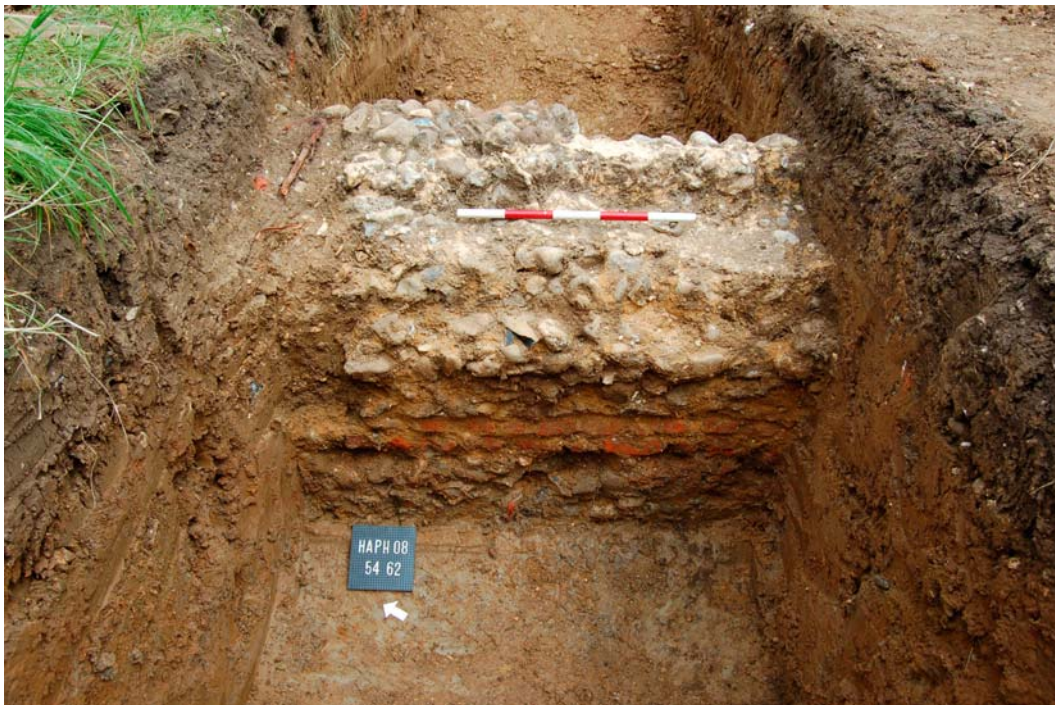
Plate 4. Trench 3 looking east, showing the outer face of 16th-century flint wall 54, and foundation 62 exposed with a double brick course at its top (0.5m scale)

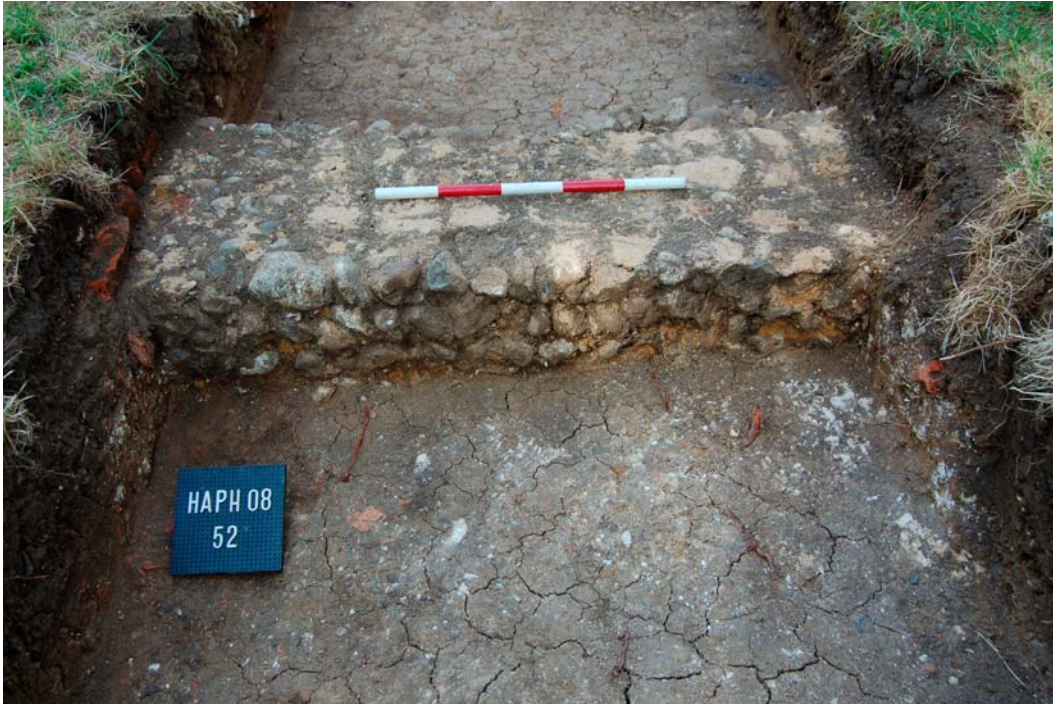
Plate 5. Trench 3 looking east, showing 16th-century flint wall 52. The top of the wall had an even surface interpreted as supporting a timber-framed superstructure (0.5m scale)

The foundations of wall 35 in the west of Trench 2 and wall 52 in the east of Trench 3 were not exposed, but the upper parts of these walls were identical in their construction to walls 54 and 38 (Plates 5 and 6). The walls all stood 0.2-0.3m above the surface of the natural clay, were faced both internally and externally, and had a well-finished surface consistently at a level of around 49.8m OD. This suggests that they were sleeper walls supporting a timber-framed superstructure rather than the upper walling being carried on up in flint. The substantial construction of the walls implies a major building.

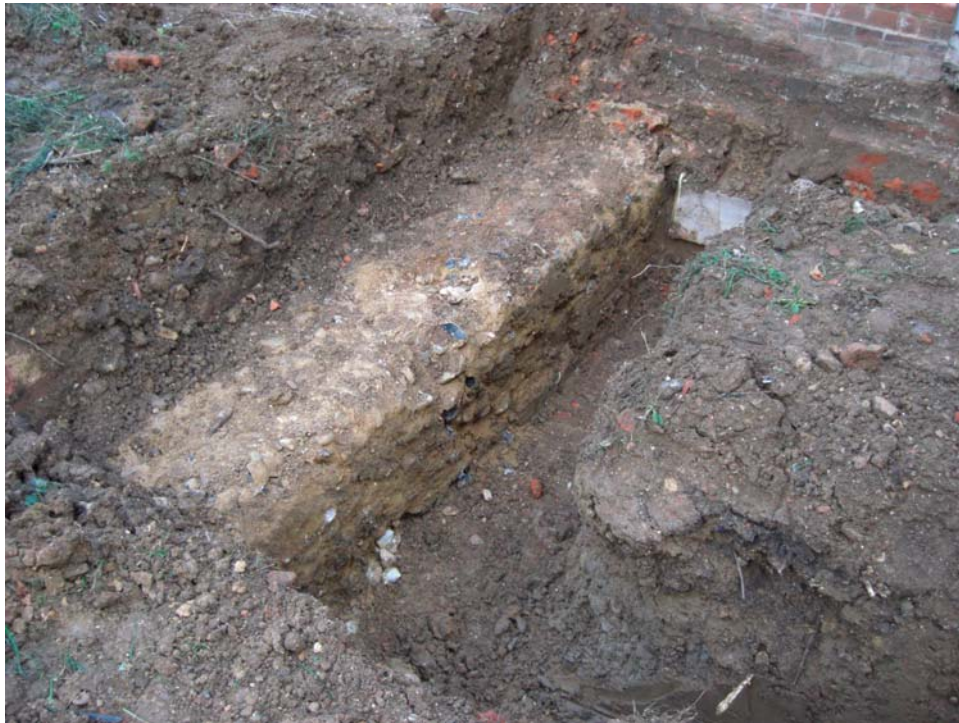
Plate 6. Trench 2 looking north-west, showing 16th-century flint wall 37 exposed during building works. As in Plate 5, the top of the wall had an even surface interpreted as supporting a timber-framed superstructure (the wall is 0.55m wide)

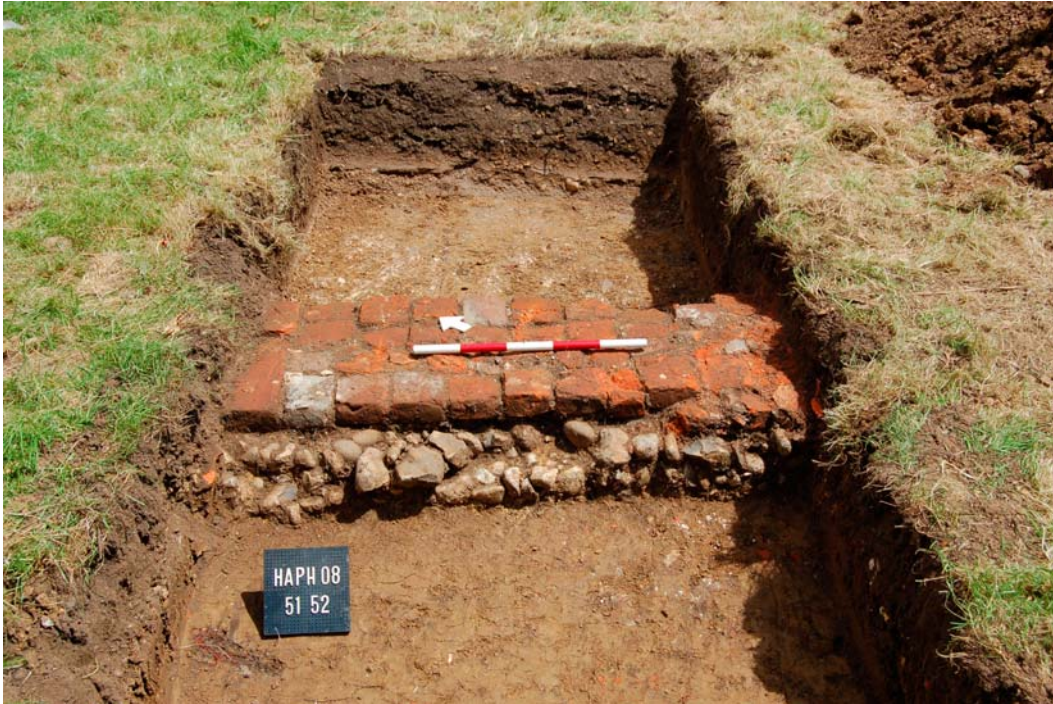
Plate 7. Trench 3 looking east, showing 16th-century wall 52, capped by brick course 51. The bricks are 16th-century but reused, and are interpreted as having been laid during replacement or repair of a timber superstructure in the 17th century (0.5m scale).

The brickwork capping both walls (37/51 and 34) consisted almost entirely of half-bats, with very few whole bricks (Plates 7-10). These were laid along the edges of the walls to form regular faces made up of headers, with brick rubble infill, in yellow and off-white chalky sandy mortar. This was distinct from the mortar used in the underlying flint walls, confirming that the brick capping represents a new phase of construction. The bricks all had worn surfaces and edges and had clearly been reused (see 6.3, Sample Bricks), so must have been laid some time after their 16th-century date of manufacture. The brickwork was consistently even and level at around 49.9m OD.

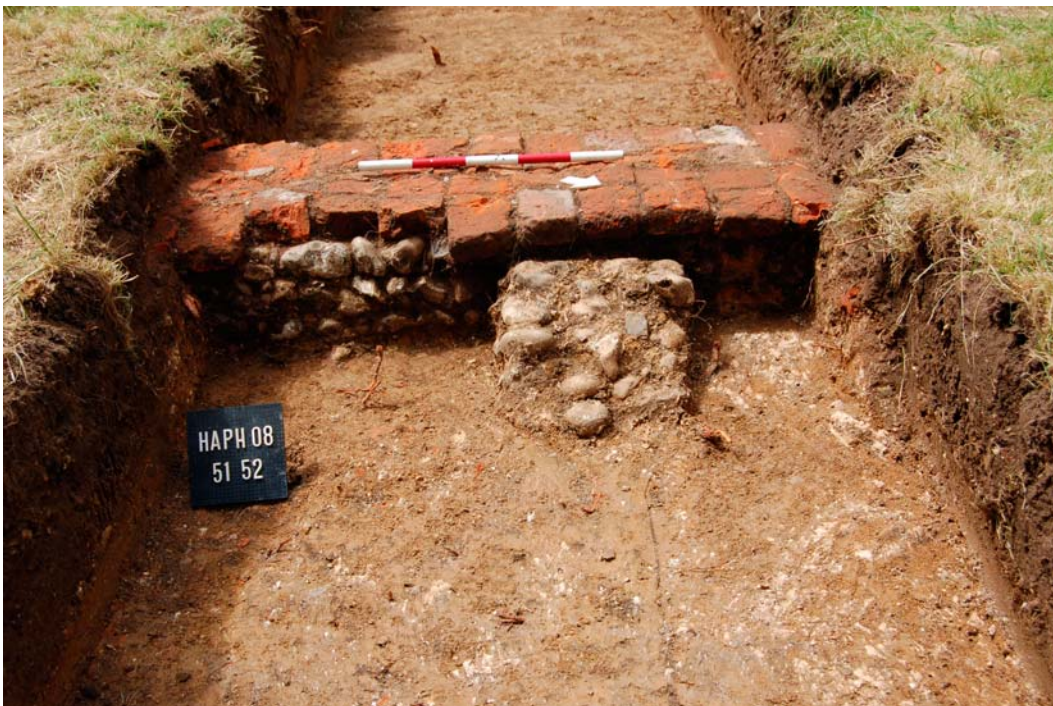
Plate 8. Trench 3 looking west, showing wall 52, with brick course 51. A small flint buttress 61 was added to reinforce the outer face of the wall (0.5m scale)

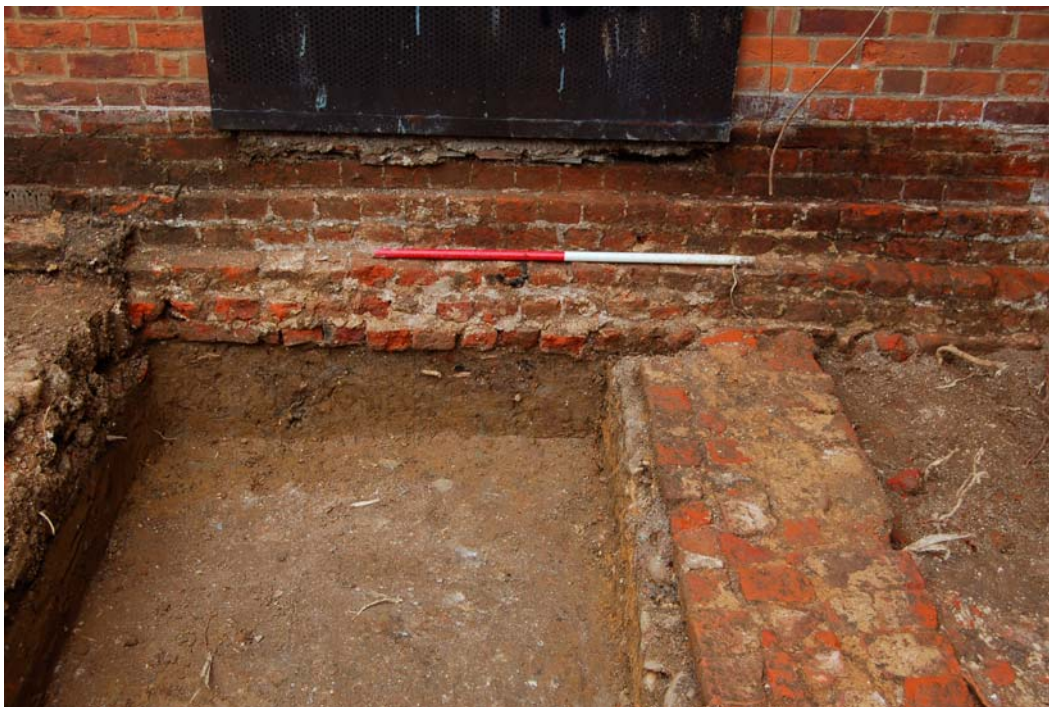
Plate 9. Trench 2 looking north, showing the south wall of Passmore House in the background, built on 17th-century brick wall 40 in off-white mortar (lowest two courses below scale). This was abutted by brick capping 37 of wall 38, on the right (1m scale)

Along the northern edge of Trench 2, brick courses 34 and 37 abutted the brick foundations of an earlier wall (40/43) beneath the south wall of the existing Passmore House (Plates 9 and 10). Wall 40 extended for 4.9m from the eastern end of Trench 2 and wall 43 1.1m from its western end, with a 0.8m-wide gap in between interpreted as a doorway.

Along the north side of Trench 2 the brick foundations of the south wall of Passmore House (39) were recorded up to the level of the slate damp-proof course and are visible on photographs as brickwork weathered darker red (Plates 9 and 10). The lowest foundation

course consists of headers and occasional stretchers laid on a bed of light brown mortar as a levelling over the earlier foundation 40/43, forming a foundational off-set one brick wide at 49.98m OD (Plates 9 and 10, below scale). Above this, four further courses of headers and occasional stretchers in light brown mortar carry the foundation up to the slate damp-proof course at 50.28m OD, above which the wall of the house is built of very regular orange-red bricks in light brown mortar, laid in Flemish bond. The different brick and mortar types and the high quality of the brickwork distinguish the 1727 build from the underlying foundation 40/43 of the previous phase.

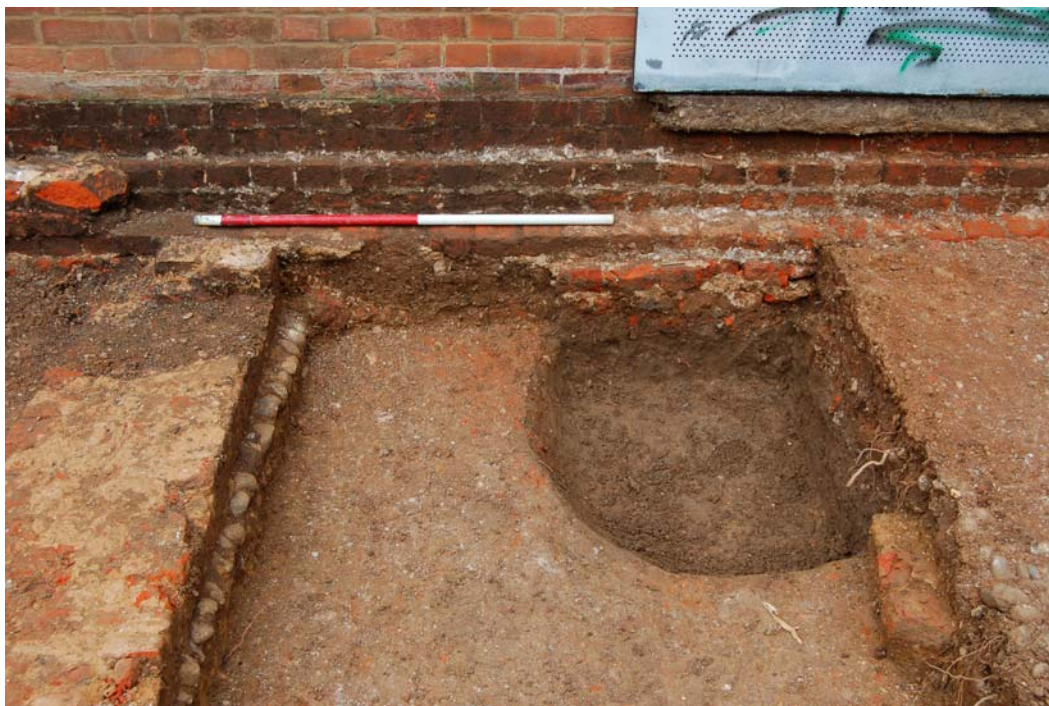
Plate 10. Trench 2 looking north, showing the south wall of Passmore House in the background, built on earlier brick walls 40/43 (lowest two courses below scale), abutted by brick capping 34 of flint wall 35, on the left (1m scale)

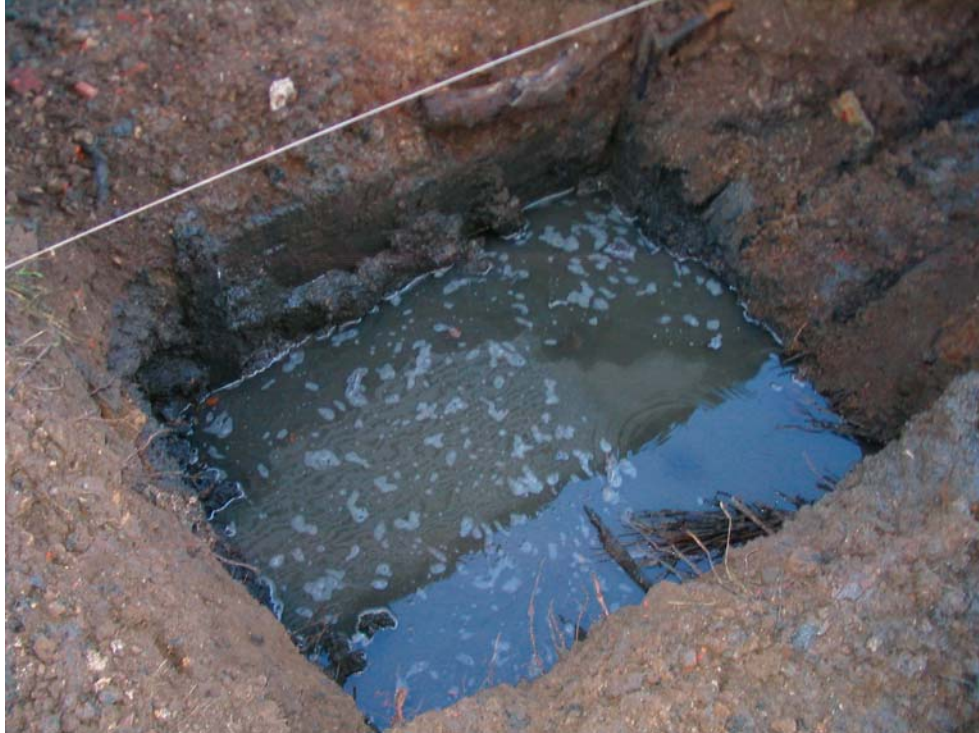
Plate 11. Trench 5, Manhole 5, looking north-east, showing plank lining 109 at the terminal of moat 115/119 (below string line) as originally exposed before the manhole was pumped out (manhole is 1.8m square)

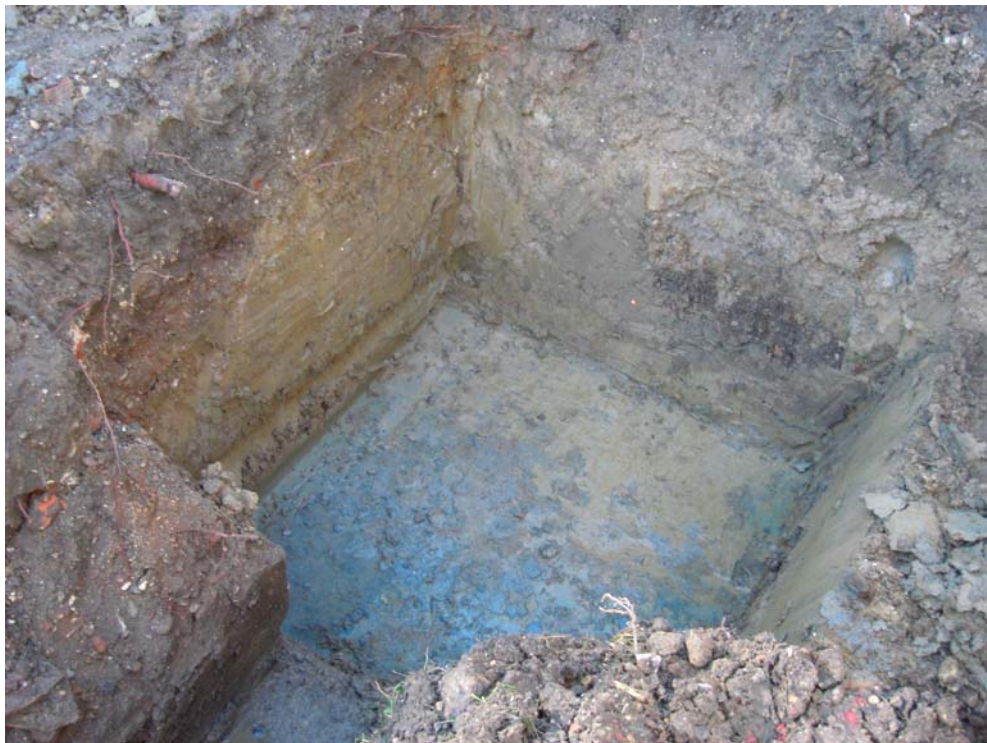
Plate 12. Trench 5, Manhole 5, looking north-east after it had been cleaned out, with the section in the top left showing natural clay at the terminal of the moat (119), while the other sections show waterlain moat fill 116/117/120 (manhole is 1.8m square)

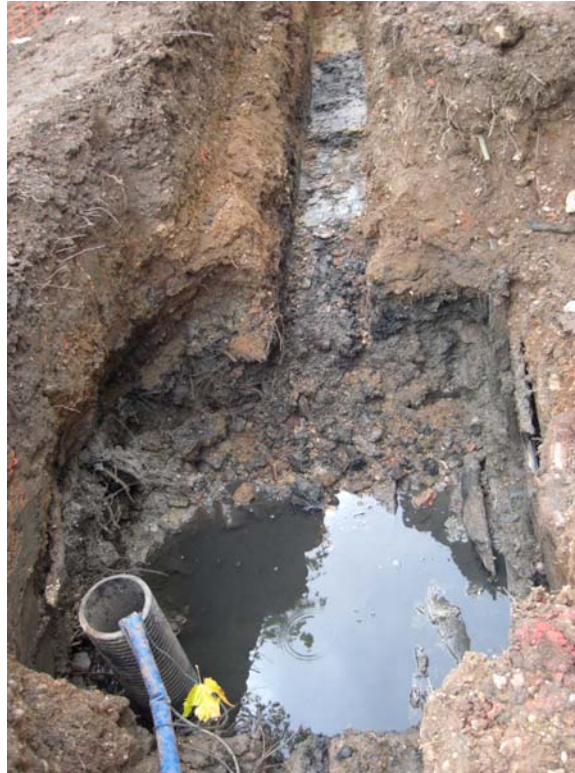
Plate 13. Trench 5 looking west from Manhole 5, showing organic fill 116 extending up to the western edge of moat 115 in the background, with natural clay visible beyond

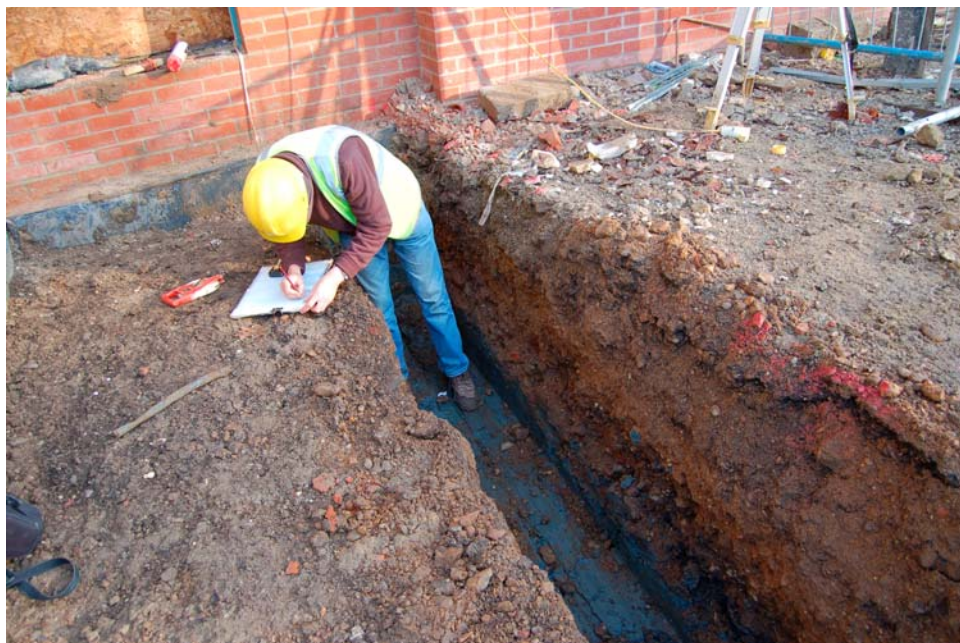
Plate 14. Trench 6 looking east, showing the section across moat 157, with the top of organic primary fill 154 visible in the base of the trench. The new residential block is in the background

Trench 6 recorded the moat as 13m wide and 1.6m deep (157), although it would in fact have been around 2m deep, as up to 0.5m of modern overburden had already been stripped off its top. Moat 157 occupied the entire area between the outbuildings of the main house and the new residential block to the east (Fig. 3 and Plate 14) and had a broad flat bottom on silt-stained natural sandy gravel (156). It was initially filled with organic blue-grey silt-clay, up to 0.6m thick, waterlogged and containing small twigs and wood fragments (154), sloping down from its eastern edge (Plate 14). This fill was at a similar level to the organic moat fill recorded in Trial Pit 6 immediately to the south (Fig. 3). Primary fill 154 was very thin in the west, where it was overlain by brown silt-clay (155) up to 0.6m thick. A depression in the top of the moat fill was filled by very dark grey sand-gravel containing brick and peg-tile fragments (153), 0.18m thick, and the entire moat was then filled with successive thick deposits of grey-brown and yellow-brown silty and clayey gravel (150, 151, 152), up to 0.9m thick overall. Very little dating evidence was recovered from this sequence of fills, but they represent a gradual silting of the moat over a period of time, with the upper fills representing a deliberate infilling in the post-medieval period.
