**HISTORIC BUILDING RECORDING AT
BRENTWOOD SCHOOL, INGRAVE ROAD
BRENTWOOD
ESSEX**

July 2008

FAU Project No.: 1874

Dates of Fieldwork: 26th-28th March 2008

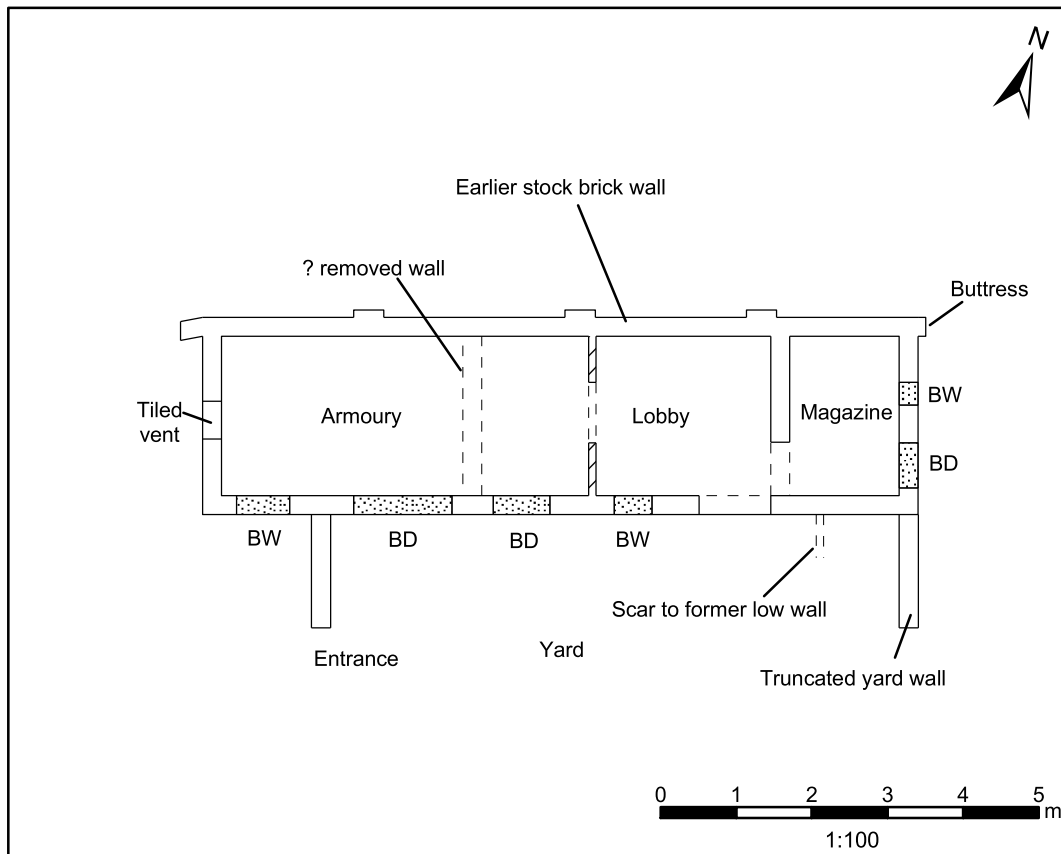
Fig.7. Plan of CCF Armoury

The wall onto which the armoury is built is made from yellow stock bricks in a mixed bond (plate 6). The four buttresses are related to the wall rather than to the building and are not seen on the opposite wall, facing the yard. The south-west yard side (plate 31) contains the only remaining entrance, now fitted with a heavy iron security door. Two other doorways, recently blocked, stand along this side, the larger of the two, at 1.3m, perhaps representing a small stables/wagon house (fig.7). Vents in the south-west gable corroborate this function.

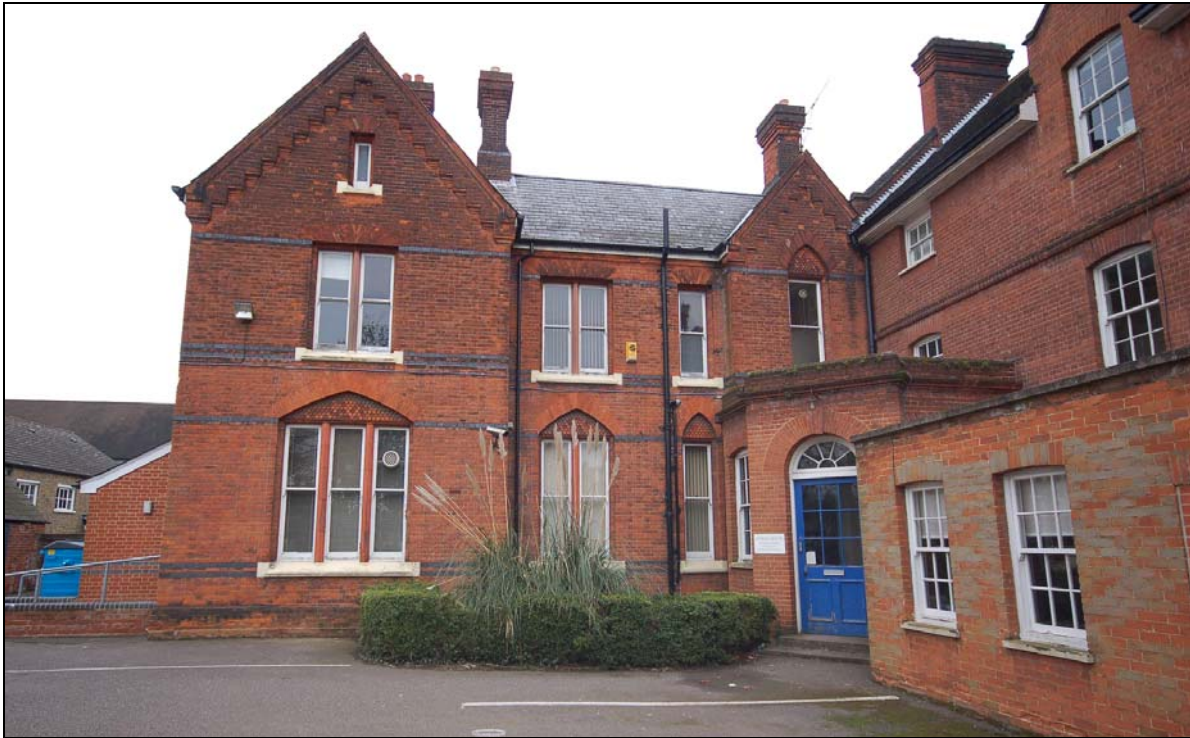
Plate 1 Former Otway House façade, with 1928 extension

Fenestration to all elevations comprises narrow horned sash windows arranged in rows of up to three lights, depending on the size of window. They are separated by ogee-moulded mullions and dressed in gauged brick heads with ashlar cast stone sills. Ground floor windows vary between single width gothic-style lancets and larger four-centred and perpendicular style, with recessed heads containing circular-patterned infill (plate 1). On the first floor, the window heads are mainly flat, but with a slightly-arched profile to the brickwork and pink-pigmented cast stone mullions (plate 1).

In the 19th-century, the **south-west** elevation was the main façade, reached by a formal driveway off Ingrave Road. The elevation (plate 1) may be discerned as dividing into four bays, with the fourth bay hidden by the 1928 extension. The slightly-projecting first bay forms the gable of the service range, which is set on three levels. The third level contains the loft, lit by a small attic light. The second bay is plain, with four windows. The third bay contains the narrow entrance gable, now enclosed at ground floor level by the 1928 porch. The gable projects 0.6m from the main building (fig.4), with a narrow arched window over the porch and a decorative cast iron cross attached to the roof (plate 2). Within the 1928 entrance porch is the former front doorway (plate 3). The front door has been removed to form a link and the outer walls plastered over to match the interior. Two stone steps lead up to the entrance, which is set within a tall lancet opening containing cast iron tracery above the door head in an Arts and Crafts style partly hidden by a suspended ceiling inside (plate 3). Flanking the entrance are two slender lancet sash windows.

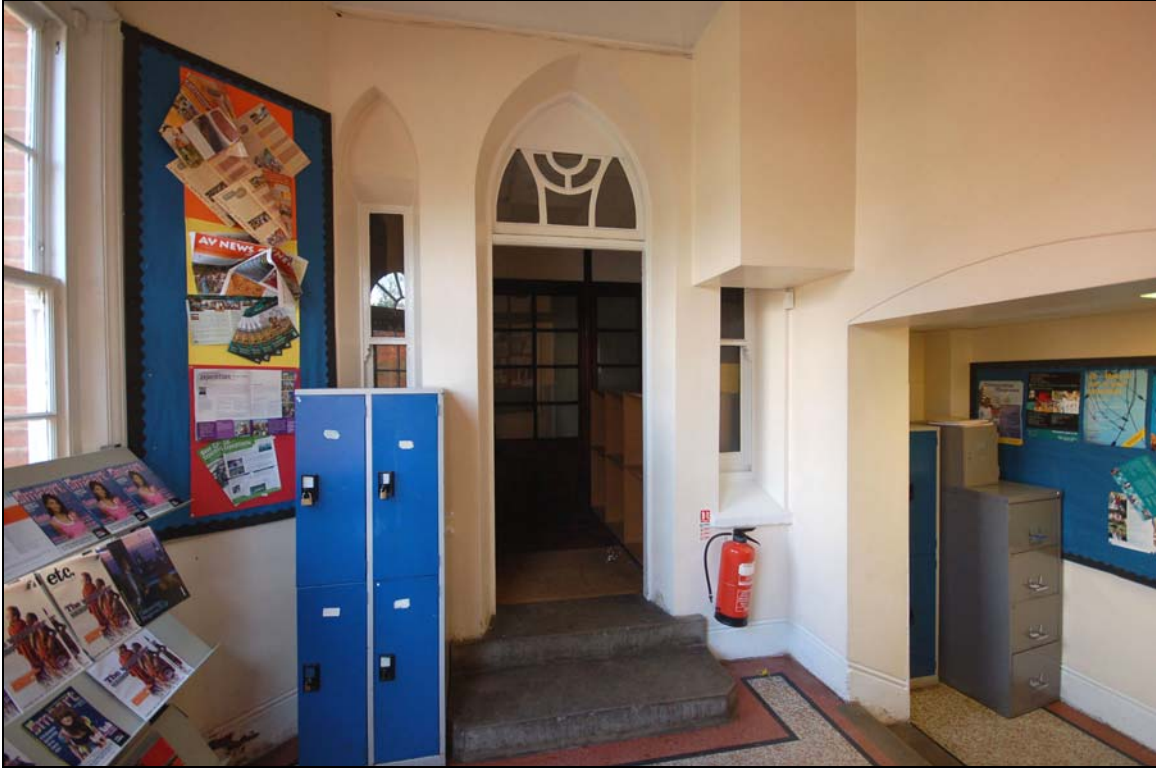
Plate 3 Former front entrance to Otway House

The original front door has been removed from the projecting **entrance porch 6**, leaving it open to the 1928 porch on the south-west side. The décor is rather sombre, with dark-stained doors and architraves (plate 3), a theme that continues into **hallway 1**. The old porch is now a redundant area, since the main sixth form entrance is currently on the garden side (the former back door). The fanlight over the door (previously described) is unfortunately now partly hidden by a modern suspended ceiling (plate 3). Two tall narrow (?shoe) cupboards are set either side of the front doorway. Large modern storage units situated in front of the cupboards prevented closer inspection. An original cloakrail is fitted to the north-west wall and on the opposite side is a doorway into common room 2a; an original, though now locked, feature. The porch floor is made-up of red and black 4 inch tiles laid in a diamond pattern with a zig-zag patterned border; a typical late Victorian style, also present in the hallway.

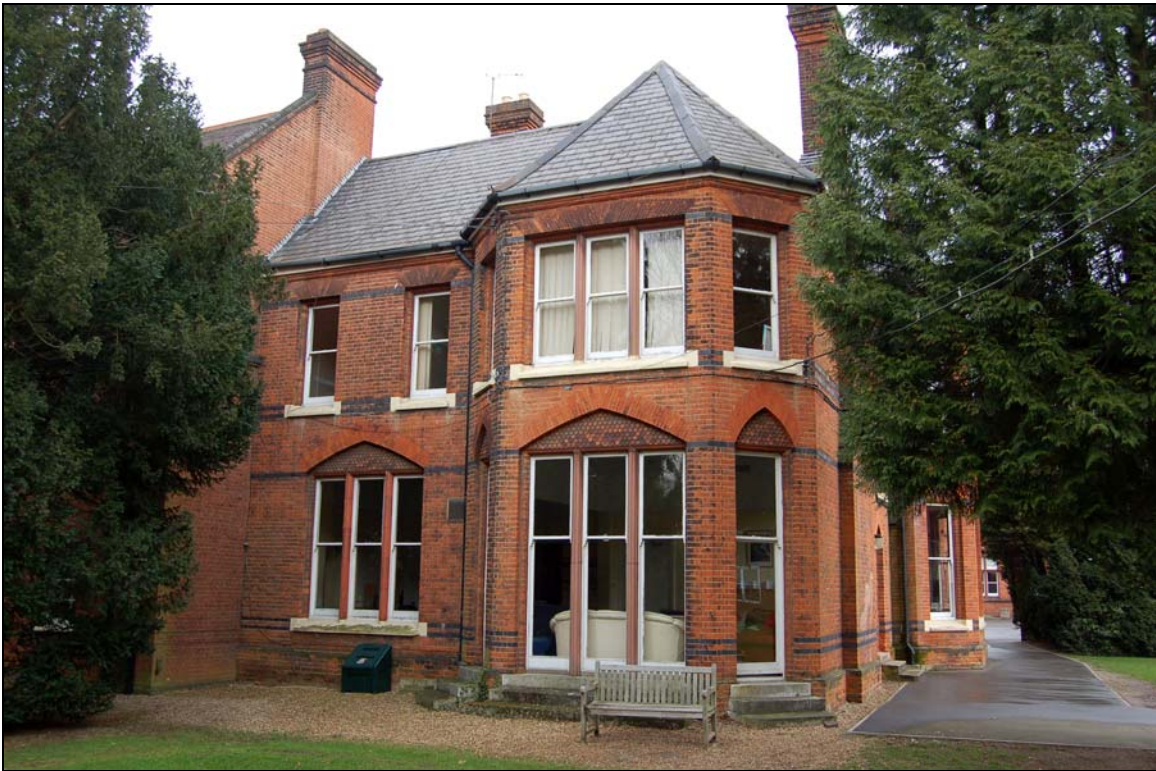
Plate 4 South-east elevation of Otway House

The first bay of the two-bay **south-east** elevation ends abruptly at the interface with the end gable and stack of the taller 1928 extension (plate 4) built onto the existing gable wall. A three-light window lights the downstairs and two single sashes light the two rooms upstairs. On the second bay, stone steps lead up to the bay window on all three sides. A full-length three-light window provides the main fenestration to the ground level bay, flanked by glazed doors incorporated into windows either side (fig.4), making good use of the garden aspect. The windows above adopt a similar form (plate 4). The yew trees in plate 4 that frame the picture either side are probably part of the original planting scheme.

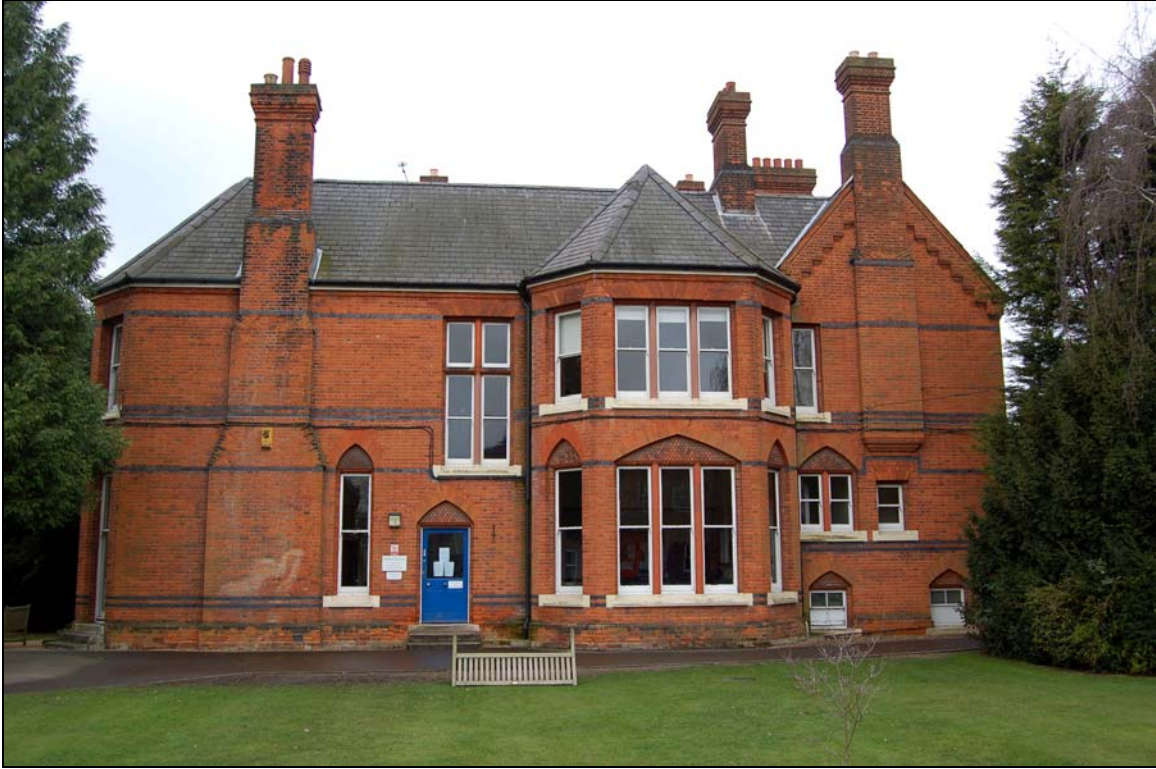
Plate 5 North-east elevation of Otway House

The rear elevation, facing the lawn on the **north-east** side, has a four-bay form comprising chimney stack, entrance hall and stairs, bay window and service end gable (plate 5). Apart from the bay window, looking out onto the gardens, it is the least decorative of the four sides.

This is largely down to its aspect facing away from the road rather than any service connotations. The first bay contains the chimney stack to one of the major rooms in the house. The garden entrance on the second bay is plain under an arched head. The door, approached by concrete steps, is possibly the original four-panel door, although the top two panels have been replaced by safety glass. The narrow window to the left (plate 5) lights the hall, and the casement style sash window above, the main stair. The bay window on the third bay has the same appearance as that on the south-east elevation, but without the doors. The fourth bay, representing the service end, has a stack beginning at first floor level and modest fenestration to the basement and ground floor. The narrow window to the left of the stack lights the service stair and that below, the stair and ground floor service corridor. Two partly-covered sash windows light the basement below (plate 5).

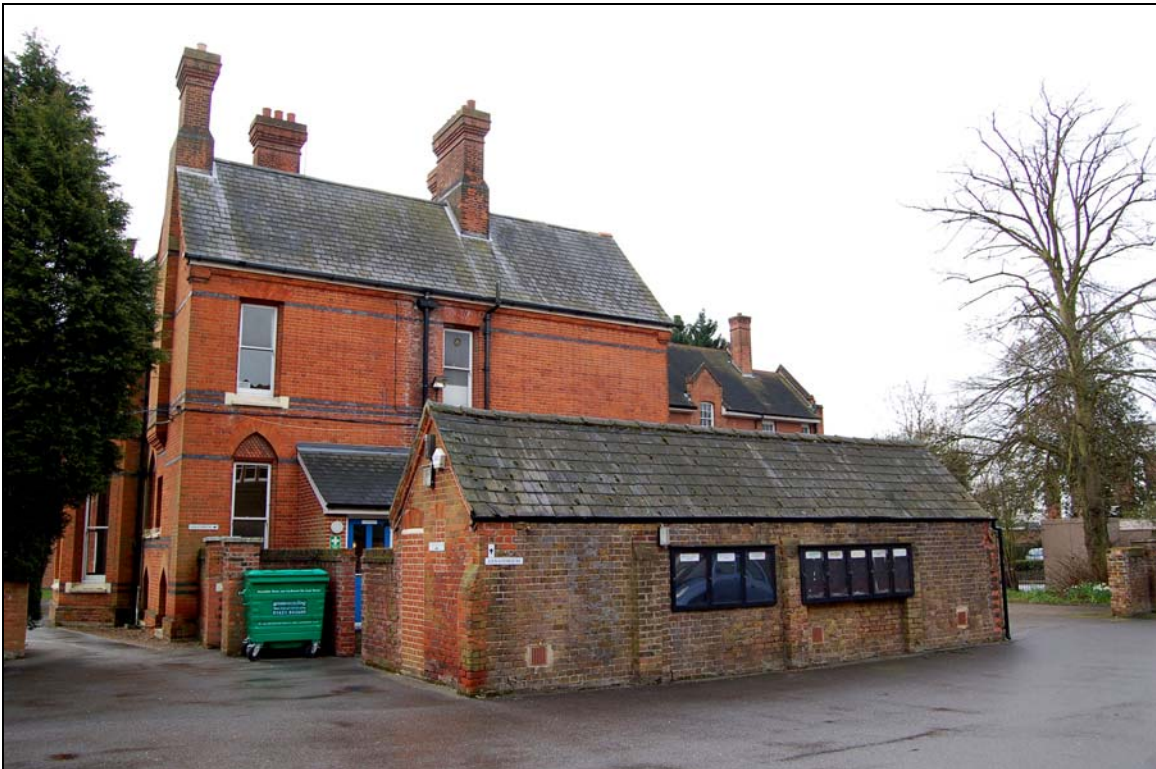
Plate 6 North-west elevation of Otway House with CCF armoury in foreground

The **north-west elevation** belongs exclusively to the service end of the house and faced the yard and outbuilding, the latter until recently functioning as the CCF armoury (plate 6). The original yard has been tarmaced over and part of the enclosing wall truncated, though one of the gate piers to the yard entrance remains (plate 31). This end of the building presently houses the school surgery. The two small lean-to extensions on this side are modern (1990) but have been built in the same brick bond and banding to match the original. The original doorway to the yard stands behind the western extension, leading directly to/from service corridor 7 (fig.4). The two bays are identical, with single sash windows on both floors, one above the other. A Tudor rose-emblem cast iron gutter head divides the two bays, connected to modern plastic down pipes.

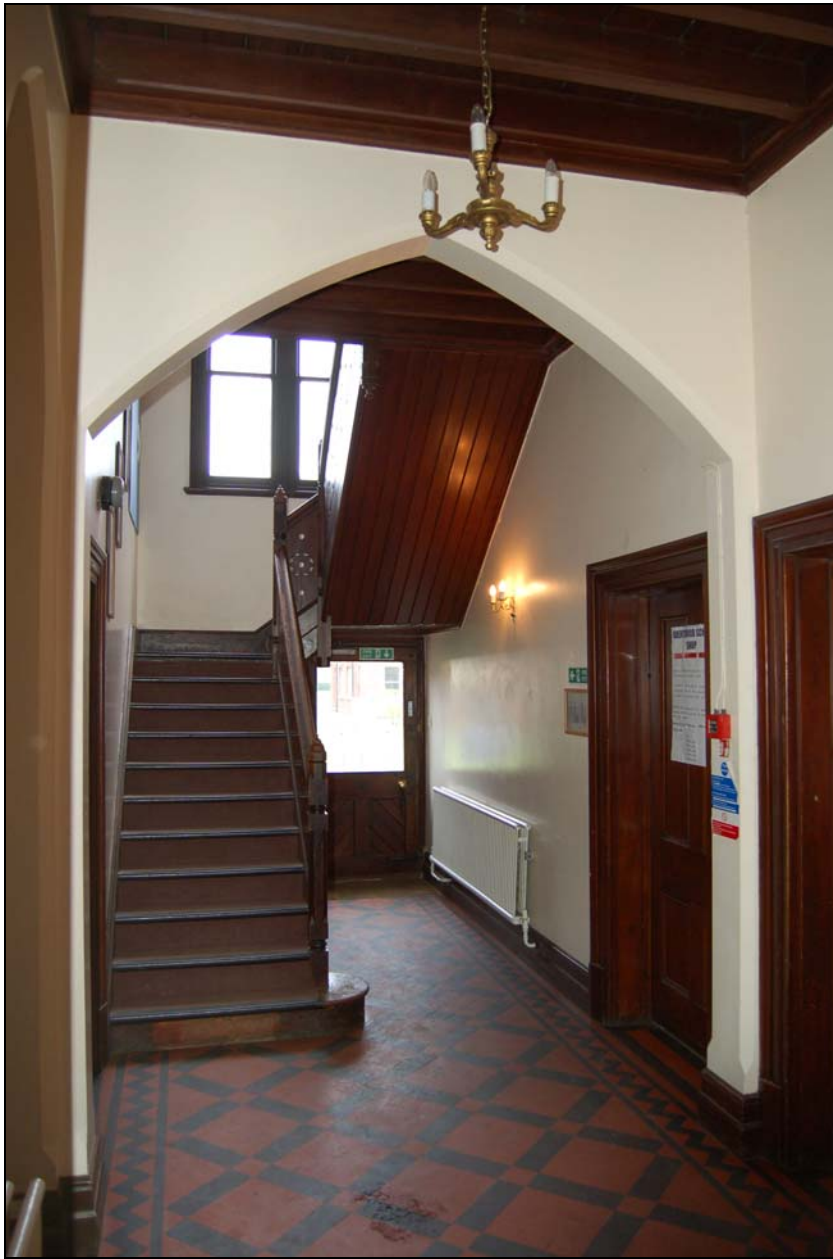
Plate 7 Entrance Hall 1

Like the porch, the décor in **hallway 1** is fairly sombre and formal and typically late Victorian. Viewed in its intended way from the entrance porch (plate 7) the stairs are framed by one of several gothic arches that probably conceal main joists spanning the load-bearing walls (fig.4, plate 7). This has a wide span, but others, often across corridors, are narrower. All are undecorated, with clean lines and chamfered edges. The almost baronial gothic feel is continued with exposed chamfered ceiling joists and stained floorboards (plate 7). As mentioned previously, the floor is tiled in a diamond pattern with zig-zag border. In addition, all the doorways leading off the hall have original dark-stained doors and architraves (plates 7 & 8).

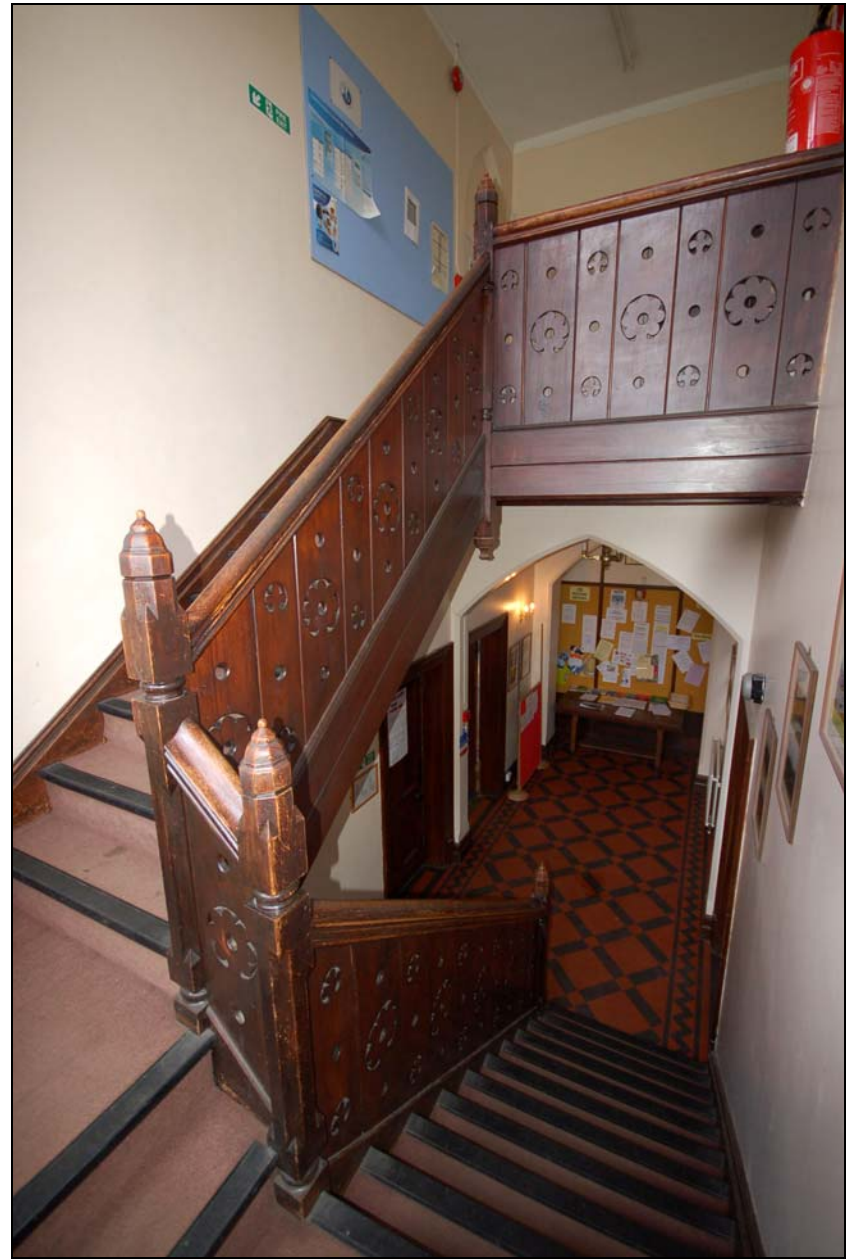
Plate 8 Main stairs 11

Stair landing 11 (plate 8) is lit by windows facing onto the former garden. It has an 8½" low beaded skirting board and thin cornice chamfered on one side. At the top of the stair are arched openings to corridors 13 and 21 either side, which now contain modern fire doors. Corridors on this level have a more basic beaded skirting. A third doorway on the landing leads into **male shower room 12**. The main area is now a large changing room with a Victorian fireplace and cupboard on one side and showers and (replaced) toilet along the other (fig.5). The showers are a later feature. The main part of the room was probably the bathroom of the vicarage, separate to the toilet that was accessed by a short passage off the main corridor, the same as on the ground floor below. The connecting doorway with **corridor 13** is now blocked (fig.5). A modern wash basin has been inserted below the former toilet door light which has the same patterned glazing as the corridor light downstairs in room 5 (plate 20). The wall in-between appears to have been rebuilt at the rear of the showers to make **deputy head of sixth form 15**, a former bedroom, slightly larger.

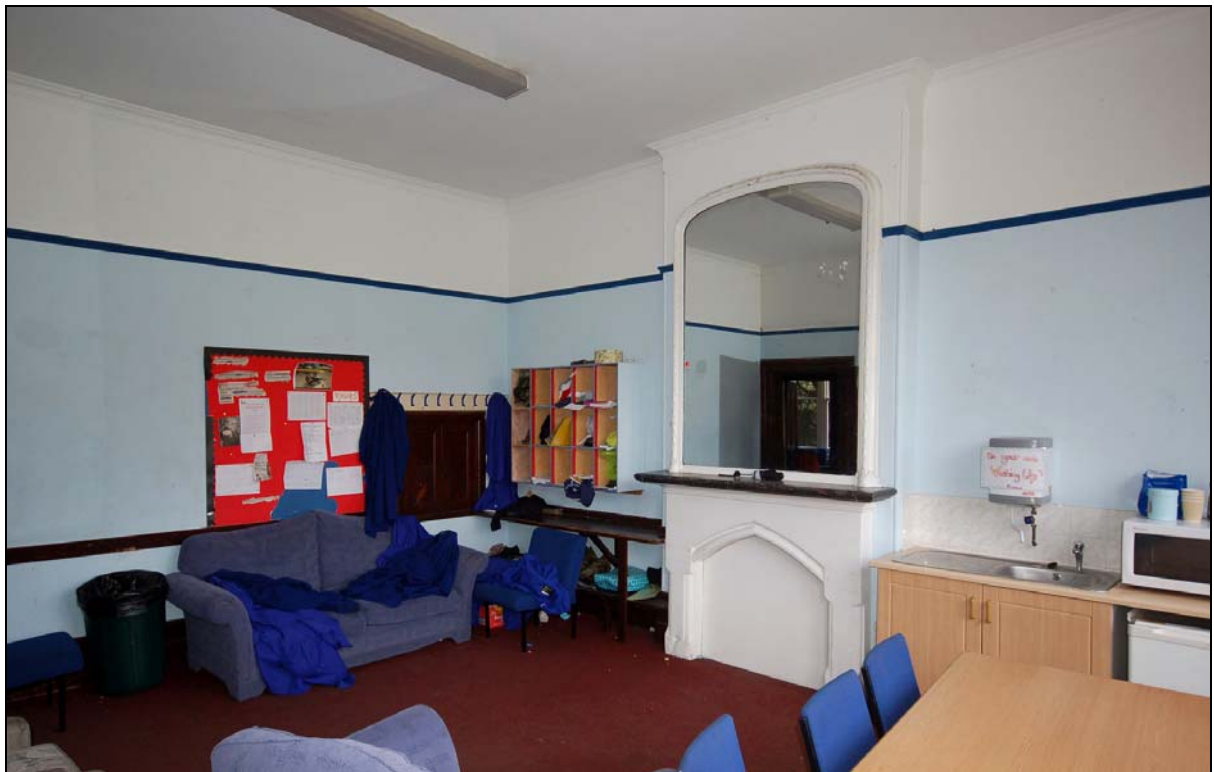
Plate 12 Preposter's room 3

Preposter's room 3 (plate 12) is located on the opposite side of hallway 1 to common room 2. The woodwork (windows and doors) is stained and varnished the same as the hallway and main porch and well-proportioned moulded skirting board, picture rail and cornice fixed to the walls. The windows contain fixtures for blinds and cords to the lower sashes. The presence of a wooden serving hatch linked to service corridor 4 indicates this was the Victorian dining room, as does the room's proximity to the service area. The hatch is hidden from view behind a school gown rail (plate 12). However, the main focus upon entry is the rather low, stout gothic fireplace and mirror on the north-eastern wall (fig.4). The fireplace (plate 13) is built in stone with a four-centred arch, bead-moulded sides and pillow heads topped by a short entablature and grey marble mantelpiece. At the base are impressions of the old fender. The chimney breast into which it is set, has the same beaded mouldings on the corner edges. The mirror above (plate 13) gives an indication of the quality and style of decorative fixtures no longer present elsewhere in the building. Its frame contains egg and dart moulding on the inside, leaf and berry garlands on the main border and small dentils on the outside. The fireplace is now blocked and it and the mirror have been painted. There are no other original fixtures and fittings apparent.

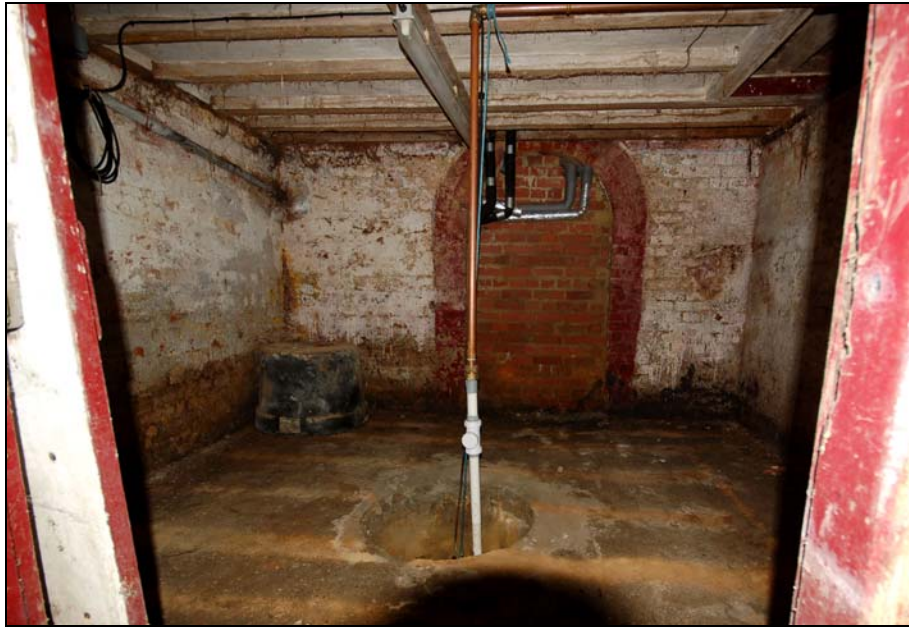
Plate 17 The basement

From corridor 7, a short stone dog-leg stair leads down to the **basement** (fig.6) under room 10. At the bottom are found two rooms, one containing stone shelves (a cold store) and the other with the filled remains of a well in its centre (plate 17). The two rooms are lit by the stair

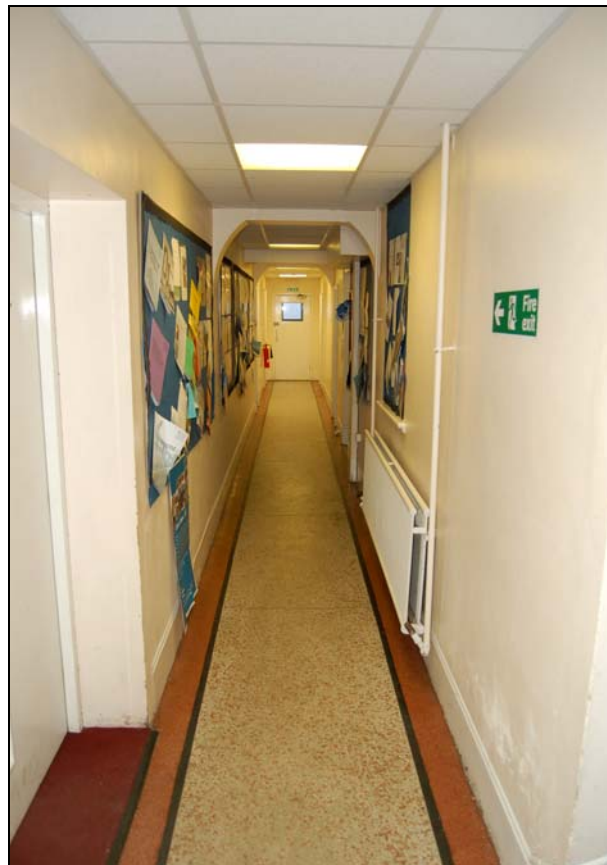
Plate 24 Corridor E1 viewed to south-west

The more recent porch (E2) has a terrazzo floor and a tall 9½" skirting board both of which are also features of the corridor. A notice board has clearly been inserted into the blocked sash window frame. Entry to the corridor is through a gothic arch that imitates those observed in Otway House and, from its position, served the same purpose: to hide steel joists on load-bearing walls. Further arches occur at regular intervals along the corridor (fig.4). Unfortunately their visual impact has been diluted by a modern suspended ceiling and associated infilling (plate 24).

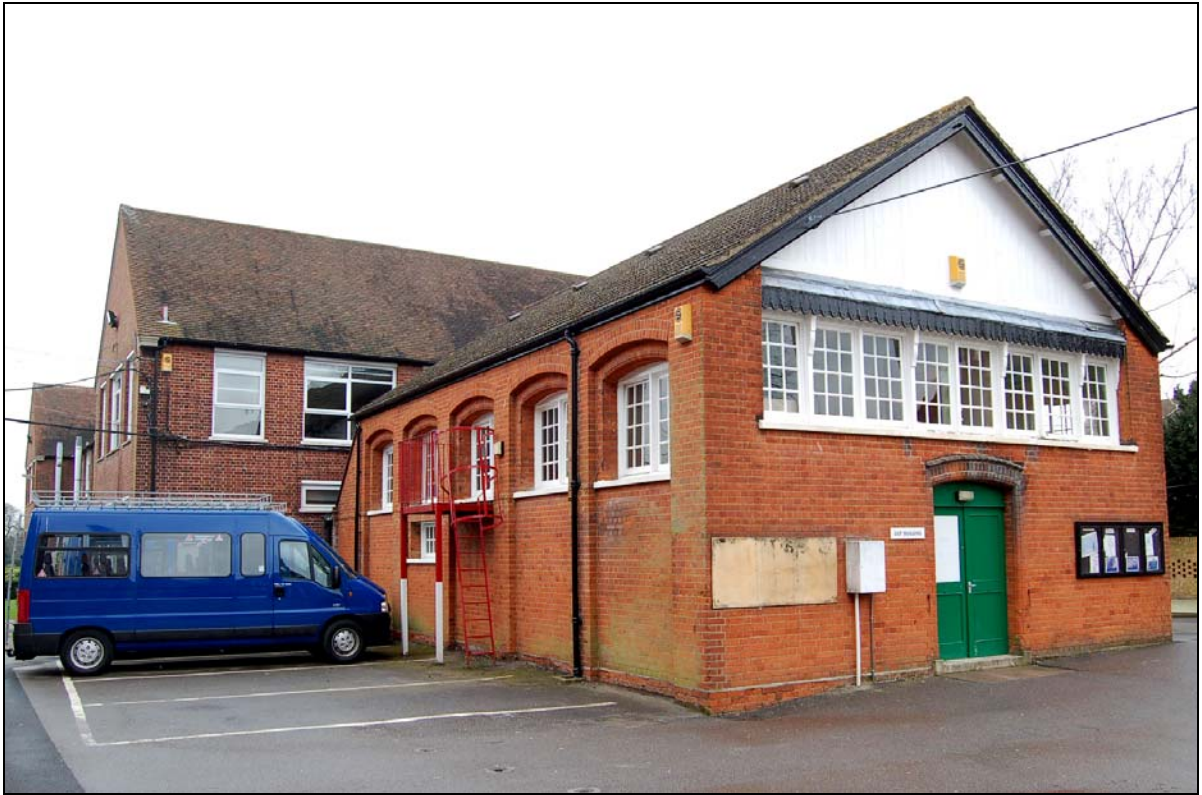
Plate 33 CCF Headquarters viewed from west

The gym follows the general north-east to south-west orientation of the other school buildings but is canted slightly to the north. It is divided into 6 bays, with a sloping roofed final bay at the eastern end (plate 33). The main build is constructed in English bonded red brick except for the south-east wall that is built in yellow stock bricks. Otherwise, except for obvious modern additions such as a fire escape and replaced grey tiled roof, the building remains largely unaltered externally. The front gable on the south-west side (plate 33) has a twin doored entry in modern, though unobtrusive, fire doors, set within a segmental arched, ogee-moulded head. Above the doorway is a prominent row of alternating fixed and tilting twelve-pane wooden-framed windows. The tilting windows were built for cord-operation from the ground floor, but are now fitted with metal handles since the upstairs offices were inserted. Carved brackets support a narrow wooden canopy above the windows ending in flat semi-circular pendants, preserved by lead flashing. Purlins extend out from the gable against the barge boards, framing vertical panelling (plate 33).
