**ST LEONARDS
BLACKMORE ROAD
FRYERNING
ESSEX**

ARCHAEOLOGICAL FIELDWORK

MARCH 2011

Document Ref.:	1976 Rep
Report Issue Date:	March 2011
Circulation:	Architectural Services
	ECC HEM team
	Essex Historic Environment Record

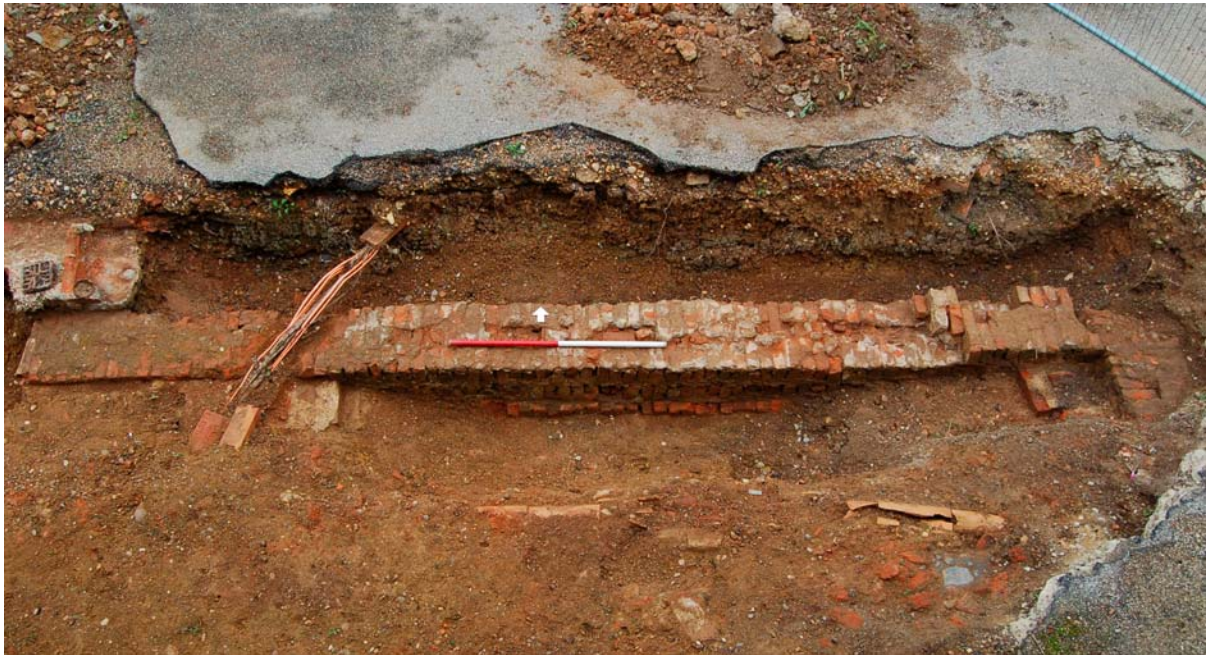
The exposed wall foundations ran either parallel to or at right angles to the existing house which is aligned north-east/south-west. Two differing types of wall foundation were present. The earliest type, represented by wall foundation 3, was located in the east of the area. This comprised a 5.4m length of north-east/south-west aligned foundation, 0.44m wide by 0.44m deep and constructed from three courses of brick laid on edge (Plate 1). The upper two courses were laid vertically whereas the lowest course protruded 0.04m on either side of the foundation. Each course of bricks was bonded by a layer of hard yellowy grey-brown mortar which was quite sandy in places. Virtually no mortar had been applied to the sides of the bricks and which were gappy and easy to prise out. Most of the bricks appeared to have been reused as many had traces of a different buff-coloured lime mortar adhering to them. Four sample bricks were recovered for examination, all were dated as Tudor or early 17th century in date.

Plate 1. Wall foundation 3 looking north (1m scale)

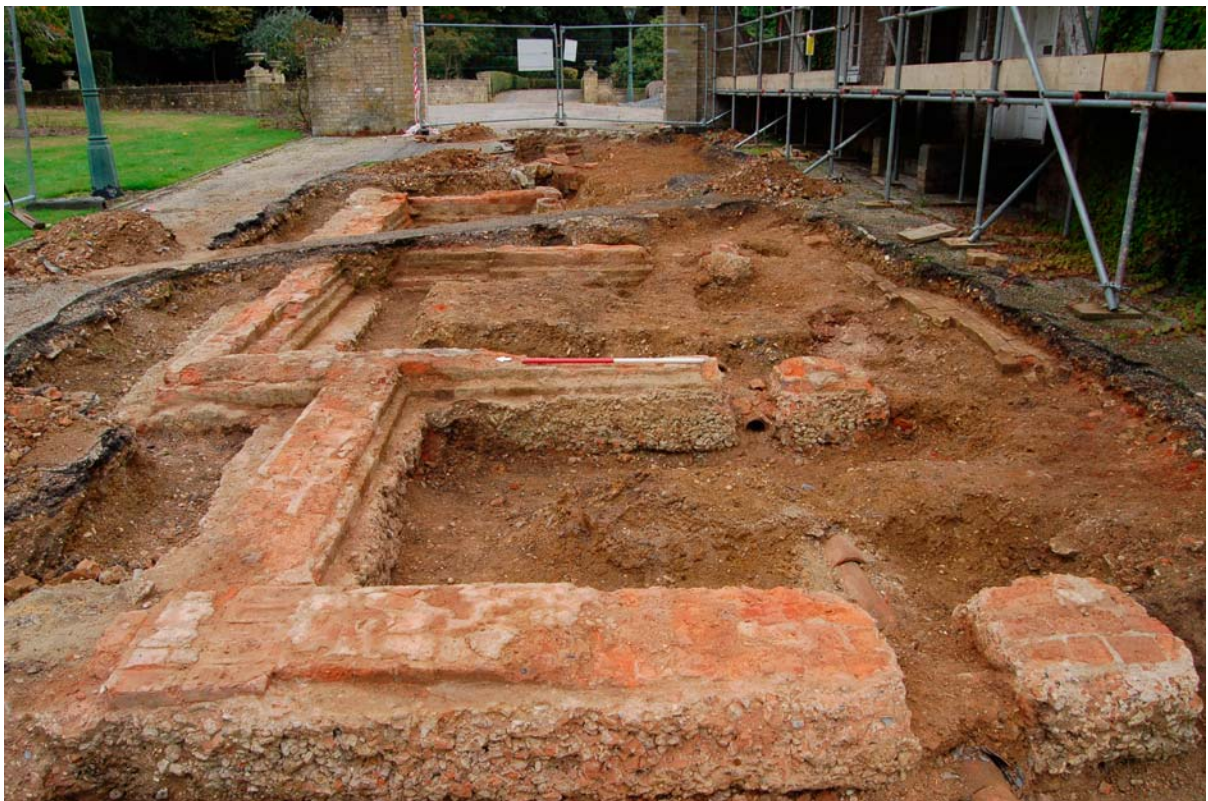
The second type of foundation (6), in the west of the area, consisted of up to four stepped courses of frogged bricks set on a thick layer of concrete (Plate 2). The foundations ran for

9.6m north-east/south-west (parallel to the existing house) and for at least 3.7m north-west/south-east (at right angles to the existing house). The external foundations were c. 0.5m wide and the two internal ones c. 0.4m wide. The bricks were bonded by hard light grey mortar containing flecks of flint, brick and lime. These foundations probably date to the later 19th or earlier 20th century and represent additions to the rear of the building.

Plate 2. Wall foundation 6 looking east (1m scale)

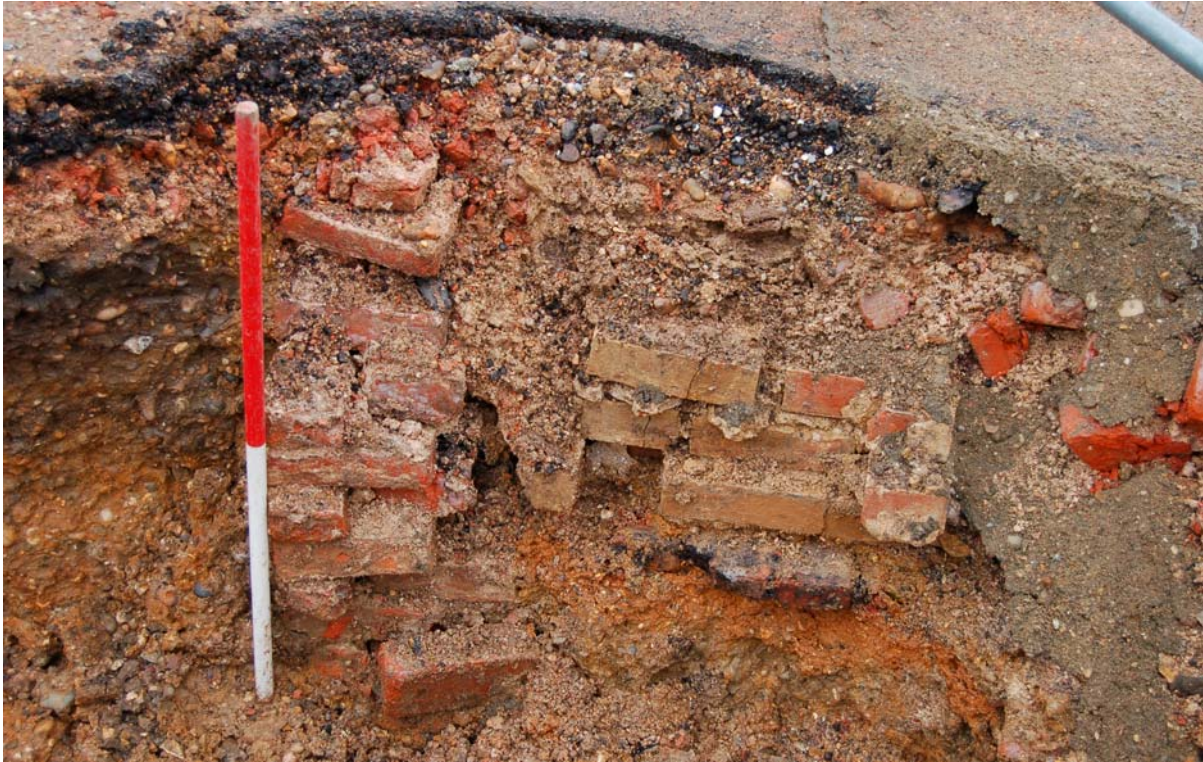
Limited monitoring was undertaken on the removal of the swimming pool and during part of the demolition of the modern lounge/conservatory/underground gym extension on the west of the house. No archaeological features were observed. However, a number of fragmentary pieces of walling were recorded in a new drainage trench to the north of the area. On the south side of the drainage trench was a jumbled piece of wall (33) c. 0.8m high constructed mainly from unfrogged red bricks of 18th or early 19th century date bonded with a buff-coloured lime mortar (Plate 3). In amongst the bricks were a couple of thinner examples of possible Tudor or early 17th century date. To the west of the wall were the remnants of a possible surface (34) constructed from flatter charcoal-covered flooring bricks. On top of this floor was a poorly-defined lump of masonry (35) constructed from unfrogged cream-coloured bricks, similar to those in surface 5, and pinkish bricks bonded with a buff-coloured mortar.

Plate 3. Wall 33 et al looking south (1m scale)

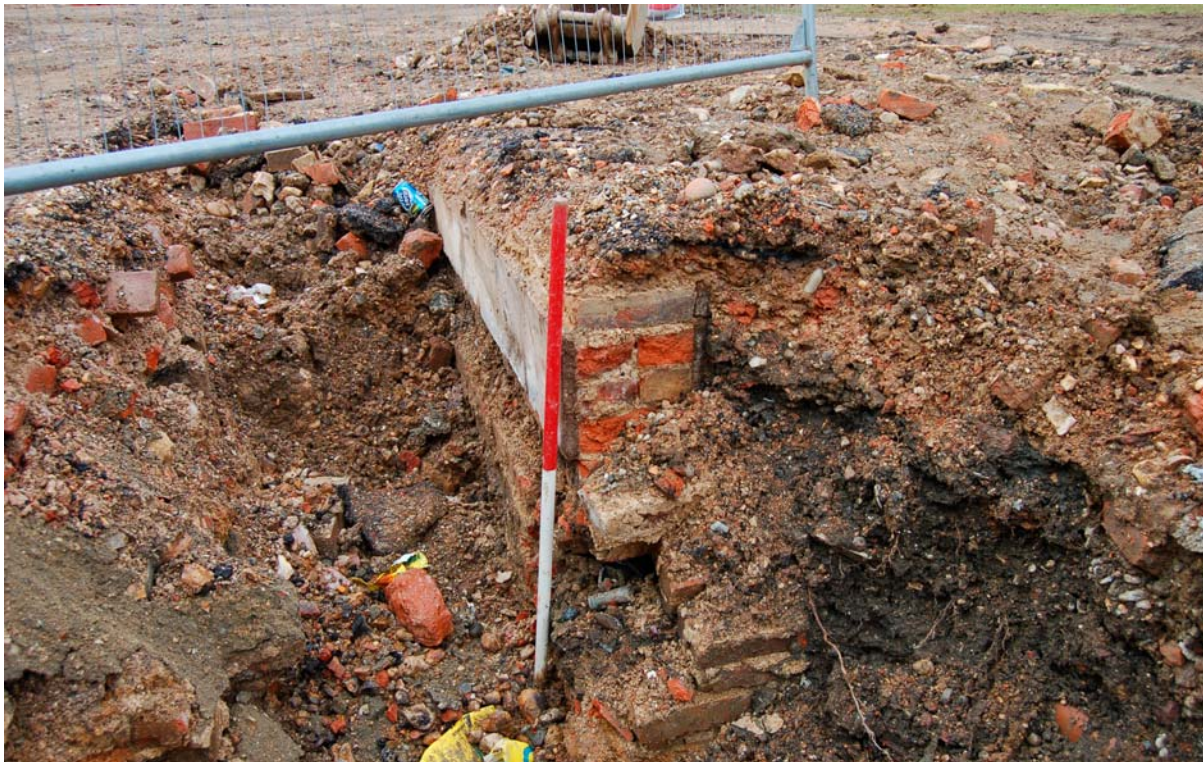
In the east of the trench was a more substantial, east-west aligned wall (36) constructed from red bricks again bonded with buff-coloured mortar (Plate 4). The entire wall was some 0.8m high, consisting of c. 0.4m of rendered wall sitting on a further c. 0.4m of slightly projecting foundation. Traces of a truncated fragment of possible southern return wall were noted at its eastern end. The ground on both sides of wall 36 had been disturbed. To the north of the wall part of a modern drainage pipe was visible beneath a thick deposit of dark grey backfill. The drainage pipe aligned with a series of manholes located to the rear of the house.

Plate 4. Wall 36 looking west (1m scale)

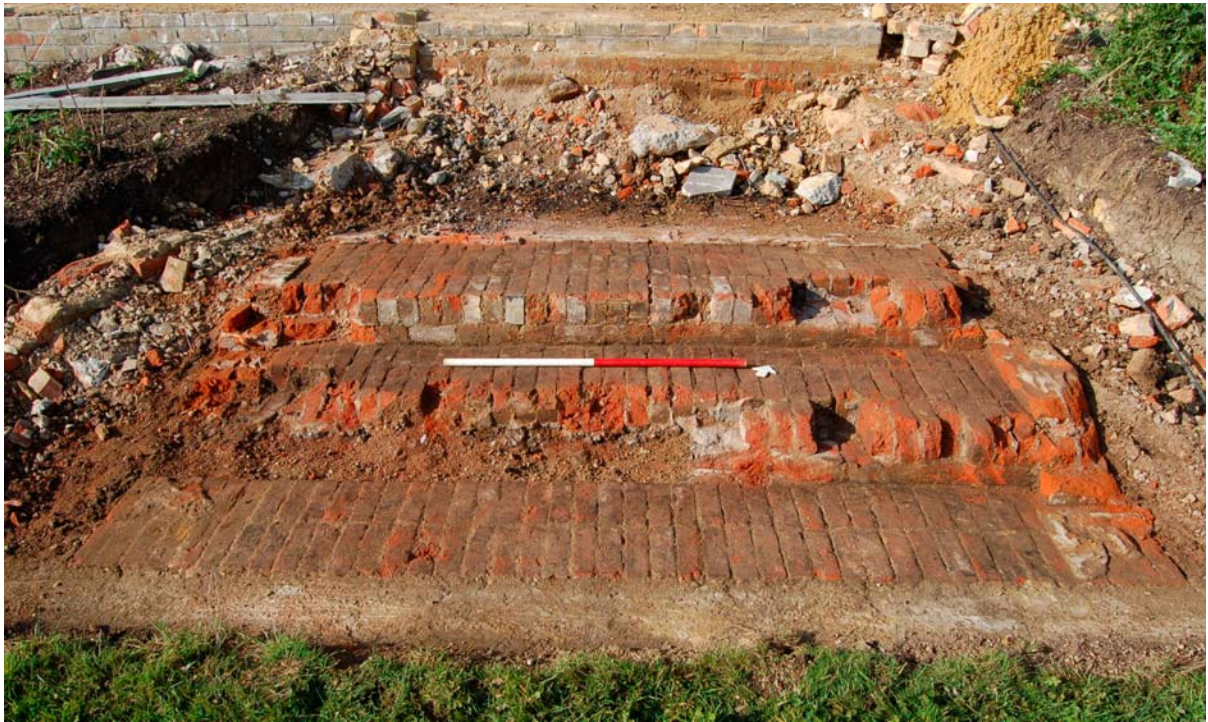
The work commenced with the demolition of the modern splayed steps, beneath which the partly surviving remains of an earlier set of brick steps (31) were revealed (Plate 5). The set of steps was 3m wide and c. 1.8m long and consisted of three steps – the bottom step (at lower ground level), steps one and two, and traces of side walls. The steps were composed of rows of 34 header bricks laid on their sides and bonded with light grey mortar. An additional four header bricks to either side had traces of the very truncated mortar and brick remains of the side walls upon them. The bottom step consisted of two rows of header bricks whilst steps one and two, which were both damaged, consisted of three rows apiece. Steps one and two were each approximately 0.18m high and consisted of two courses – the upper of the header bricks on their sides and the lower mostly consisting of header bricks and the occasional stretcher brick laid flat. All bricks were red in colour, unfrosted where visible and measured 220-230 mm by 65-67 mm by 100 mm, suggesting that they most likely date to the early 19th century.

Plate 5. Brick steps 31 looking north-west (1m scale)

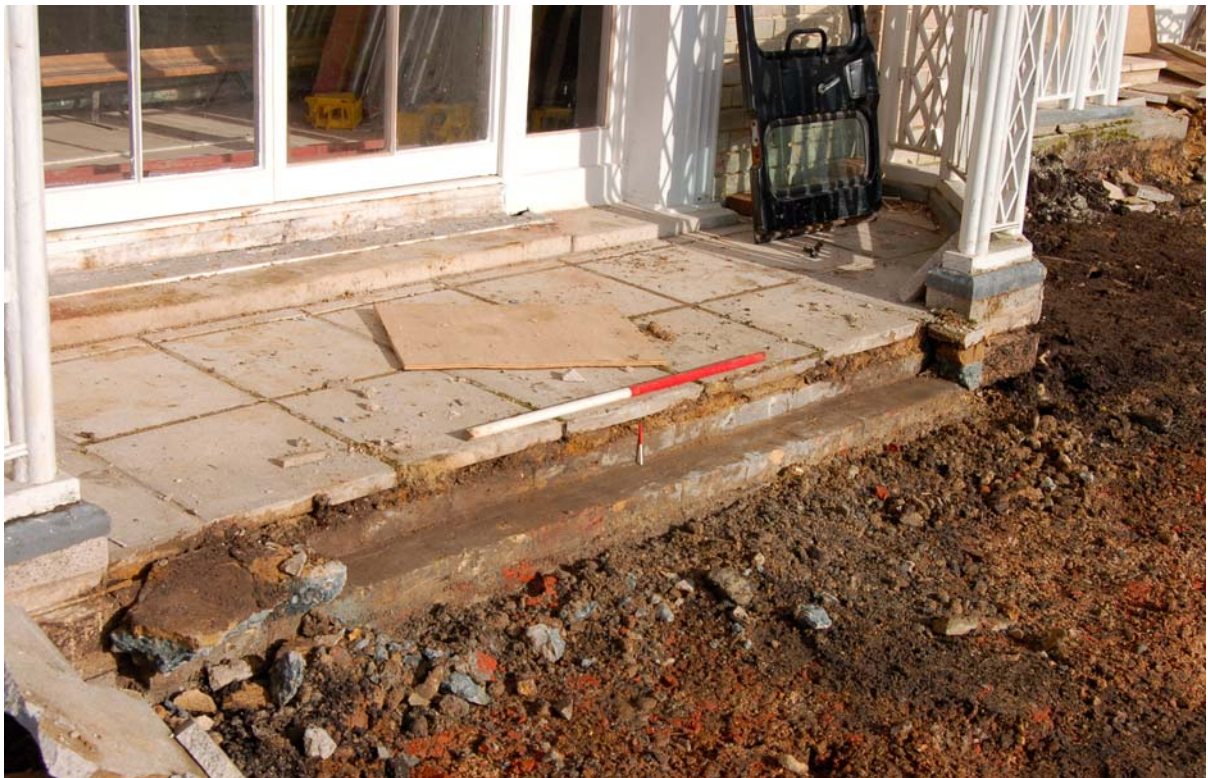
observed. The top of a possible 19th century brick step constructed mainly from yellow unfrosted bricks was exposed in front of the western French windows in south front of the house (Plate 6). An east/west drainage trench was noted crossing the terrace with a square modern brick inspection chamber. The demolished terrace retaining wall was constructed from yellow and red frosted bricks and occasional re-used unfrosted examples on a wider concrete foundation. Natural gravel was exposed to the south of the wall and appeared to be root disturbed in places. No other archaeological features were observed.

Plate 6. Brick step in front of west window looking north (0.10m & 1m scales)

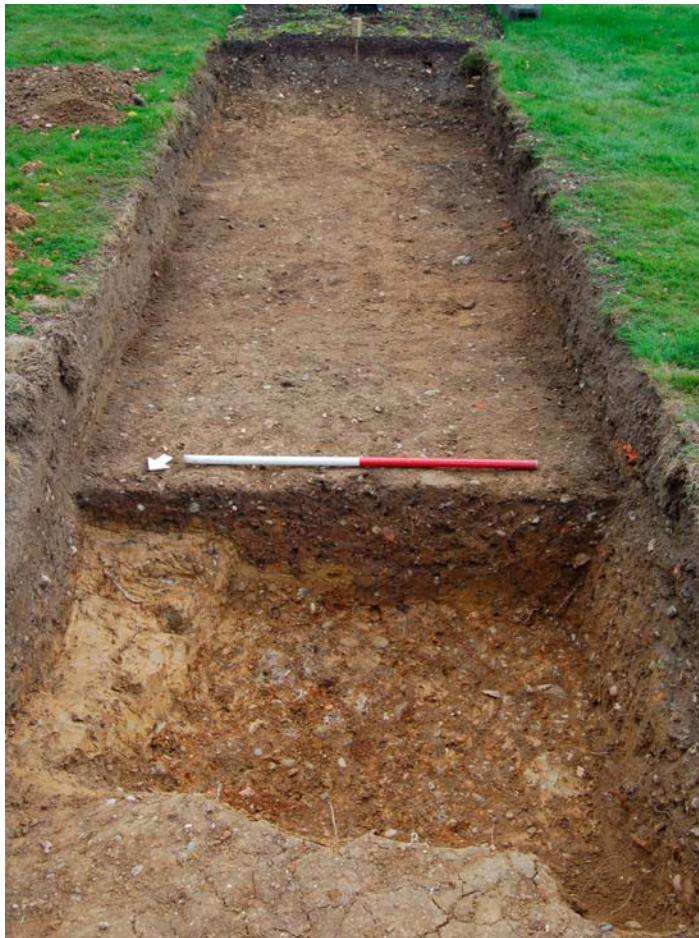
The earliest feature in the trench was a large pit (20), over 6m in length and 0.42m deep (Fig. 7, Section 2). It was filled with greyish brown silty clay that contained 17th/18th century pottery, post-medieval brick and roof tile and a residual worked-flint scraper. The pit had a vertical northern side, a stepped eastern side and a flat bottom (Plate 8). It is possible that the pit was dug for clay extraction as it cut through a layer of natural clay and bottomed out onto underlying gravel.

Plate 8. Pit 20 looking south-east (1m scale)
