**LITTLE NUNTY'S FARM, NUNTY'S LANE
COGGESHALL
ESSEX**

HISTORIC BUILDING RECORD

**Essex County Council
Field Archaeology Unit**

January 2009

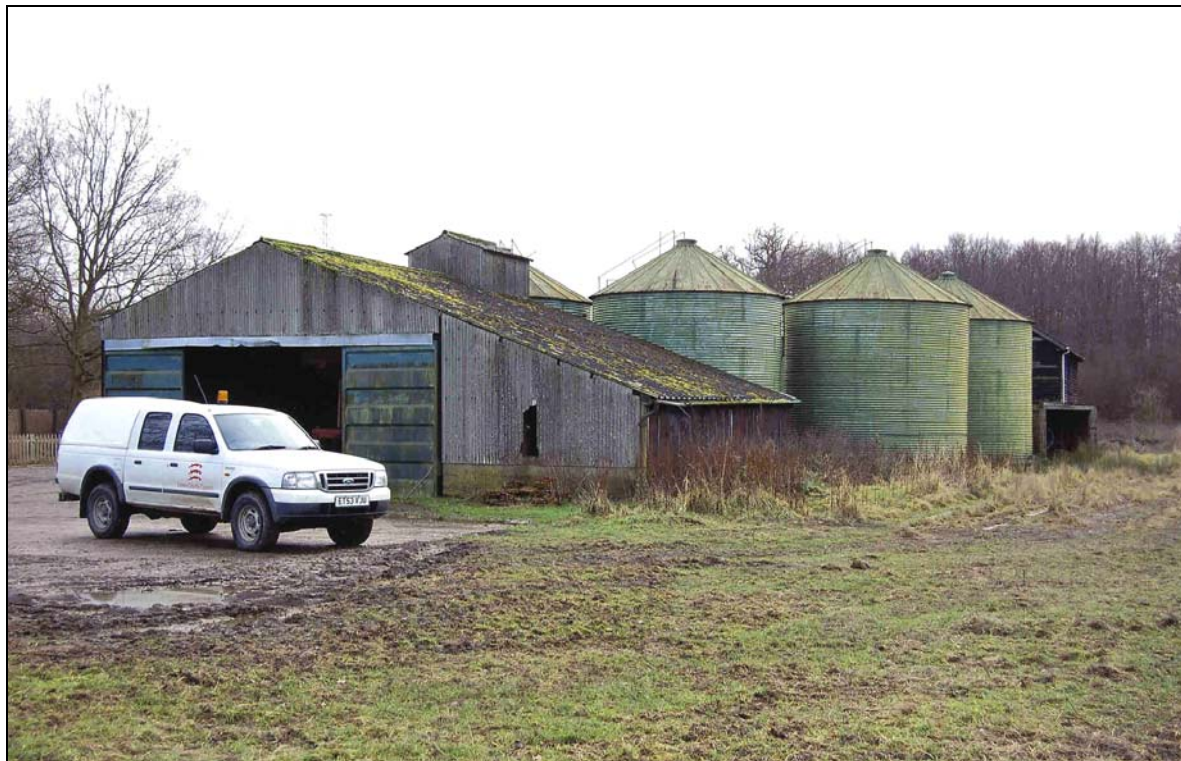
These two structures stand either side of the traditional farm core, built from corrugated asbestos sheets on angle iron and timber frames (plates 1, 2 & 9). They are large prefabricated structures built to house modern farm machinery or straw bales, most likely a

Plate 2 View of farm from north

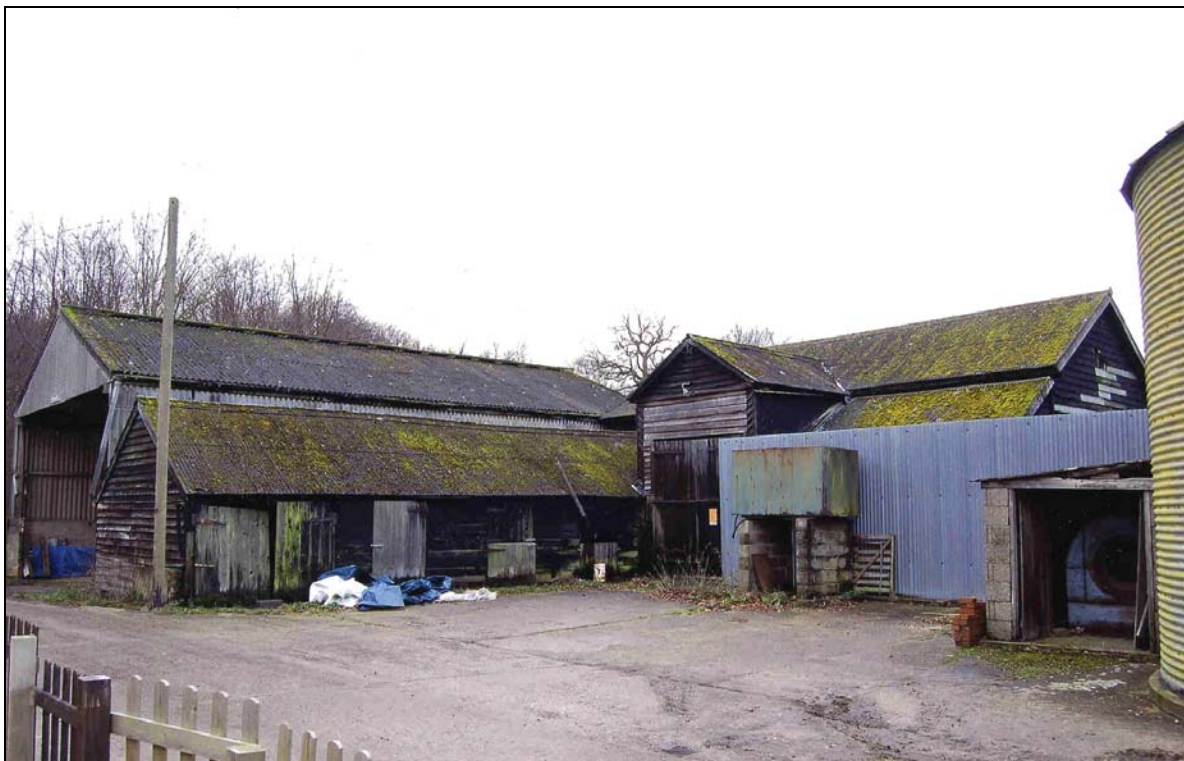
The main elevation contains a porch facing east across the yard to the farmhouse (fig. 1), much of which is hidden from view by the proximity of the stables and shed 4, as well as a corrugated tin screen built around the northern lean-to (plate 3). The large cartdoors to the porch are original, with cast iron pintel hinges, but the low threshold 'leap' has been removed to gain easy entry. Beyond the corrugated iron fence is the later northern outshot, which houses grain processing machinery (plate 4). Most of the fixtures here (T-hinged doors, windows, etc) are relatively modern and it is likely to have been refurbished comparatively recently. The outshot lacks a proper plinth and the front wall has an unusual 'toothed' profile, which clearly identifies it as a later building phase.

Plate 3 Barn and stables around former stock yard

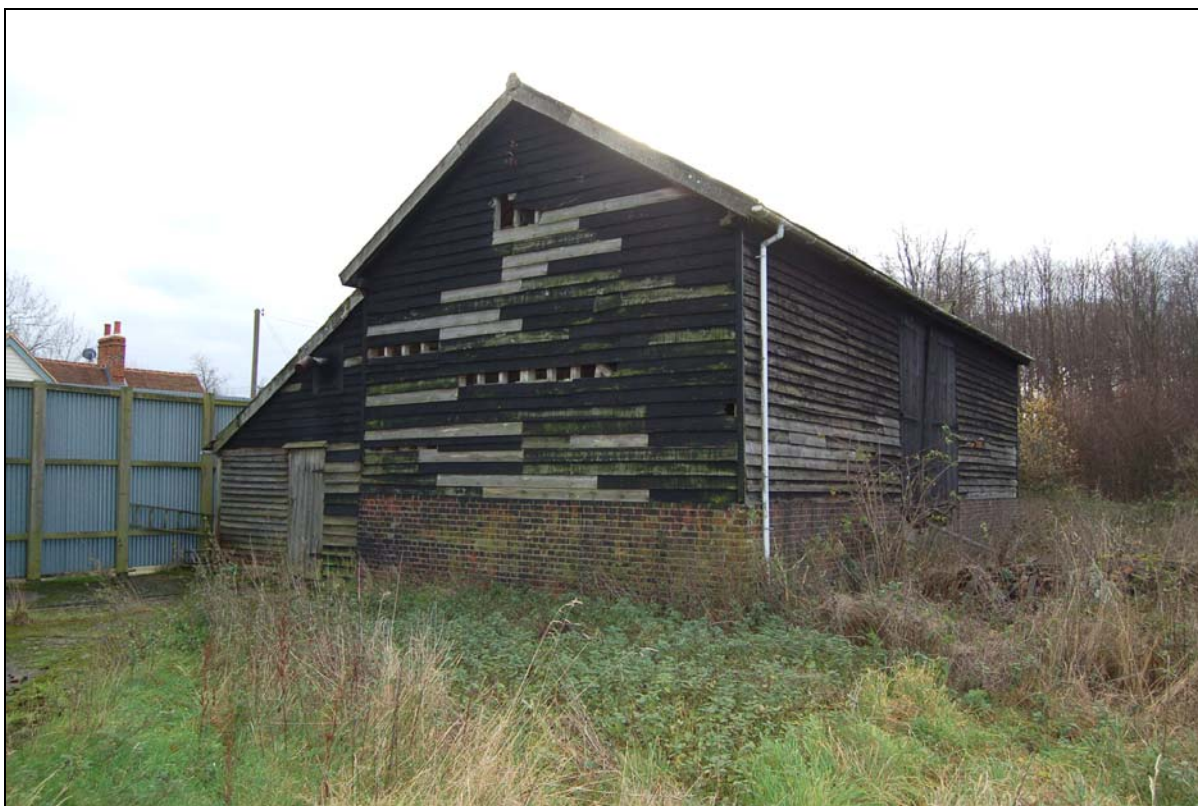
The rear elevation, facing onto the fields to the west (plates 4 & 5), is largely intact, containing a pair of cart doors onto the fields, with three of the four leap boards surviving below. The two gable ends are featureless, apart from the conveyor feed on the north end (plate 4). The proximity of modern shed 3 to the southern gable has caused damp to be trapped and the boards to rot on this side.

Plate 4 Barn viewed from north-east

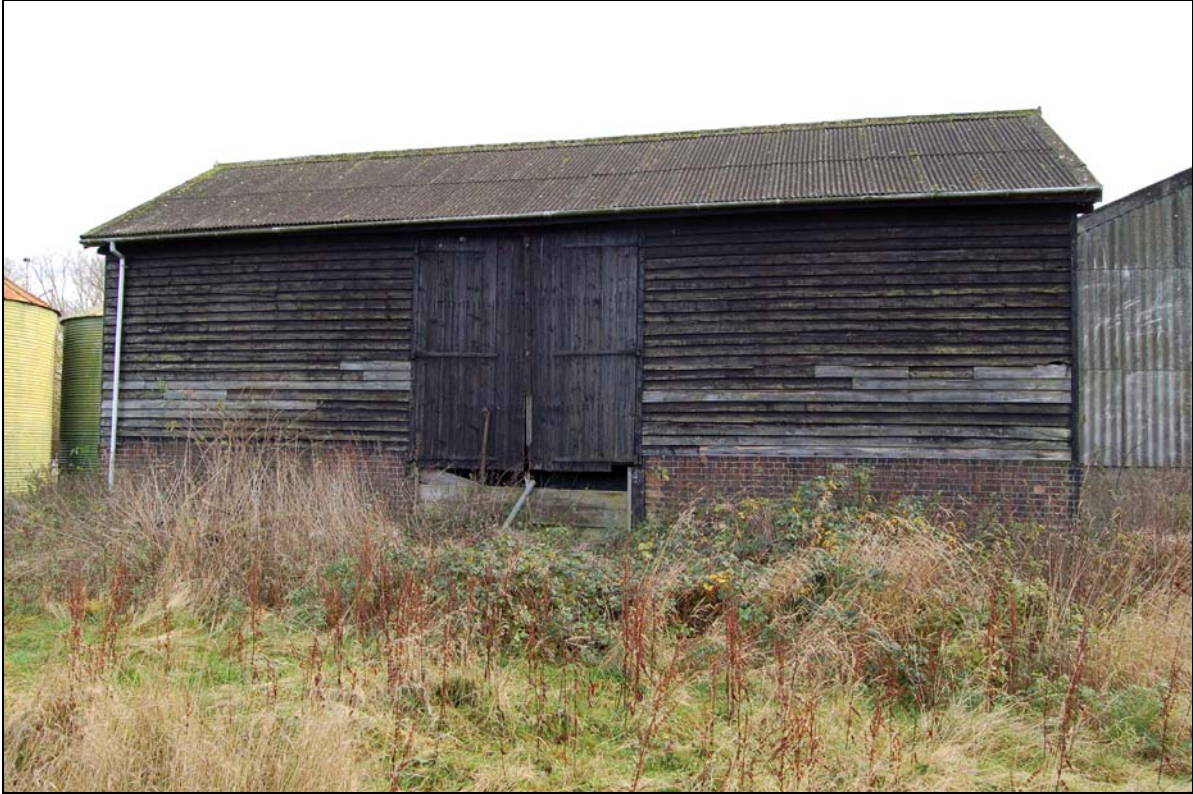
Plate 5 Western cartdoors facing onto fields

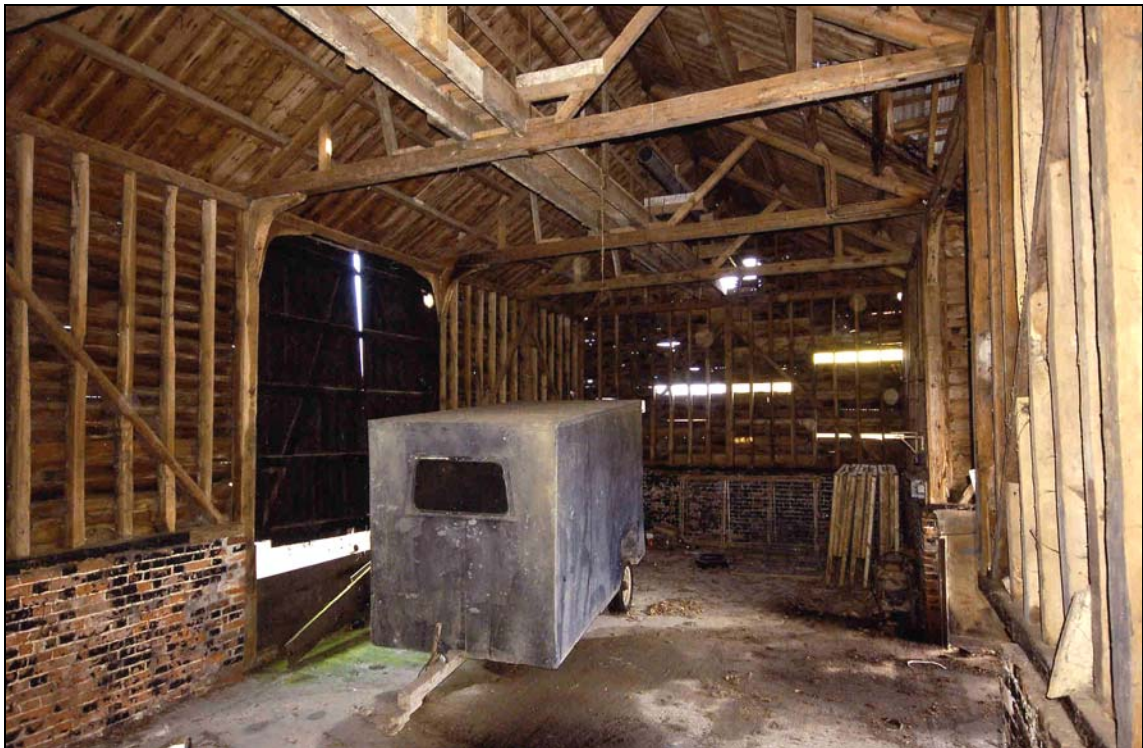
Internally the barn is divided into four short 2.5m wide bays either side of the central midstray which is 1m wider, traditionally to admit loaded wagons during harvest time. The barn contains various pieces of equipment, such as a feeding trough, wire cage panels and most obviously the mobile 'crew trailer' in the centre of the floor. There are scars in the concrete floor for removed modern fittings, the most obvious being the grain silo at the south end (fig. 4) which was supplied by an overhead conveyor travelling between the roof trusses (plate 6).

Roof trusses are built in stout pre-fabricated units altered latterly to carry the grain conveyor. A central bolted iron rod keeps the truss in tension and raking struts either side provide further strength, aided by vertical struts to the ends (plate 6). Those struts on the western side were removed when the conveyor was fitted. The trusses are supported by bolted knee braces to the midstrey but are otherwise un-braced, the bays being narrow and the frame relatively light, yet well-constructed. The underside of the roof is finished in pine sarking boards (plate 6).

Plate 6 Interior of barn viewed to north

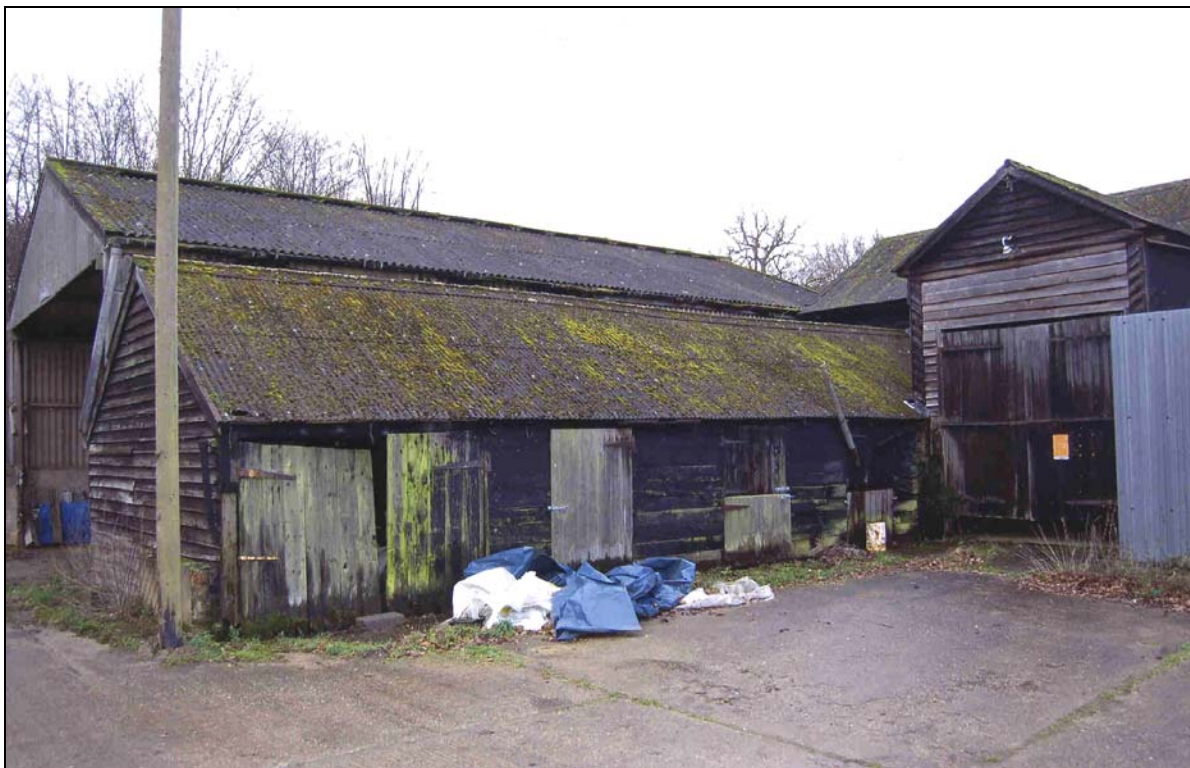
The main elevation faces onto the yard to the north and is built on a light frame of halved, vertical timbers punctuated by half-heck stable doors (plates 3 & 8). Most of these are in a poor state and one of the doors is a modern replacement. Most of the original iron strap hinges to the others have been replaced by modern T-hinges. The eastern bay was used as a wagon bay and the doorway into it is wider, to allow access for carts (fig. 4, plate 8).

Plate 8 Barn porch and stables

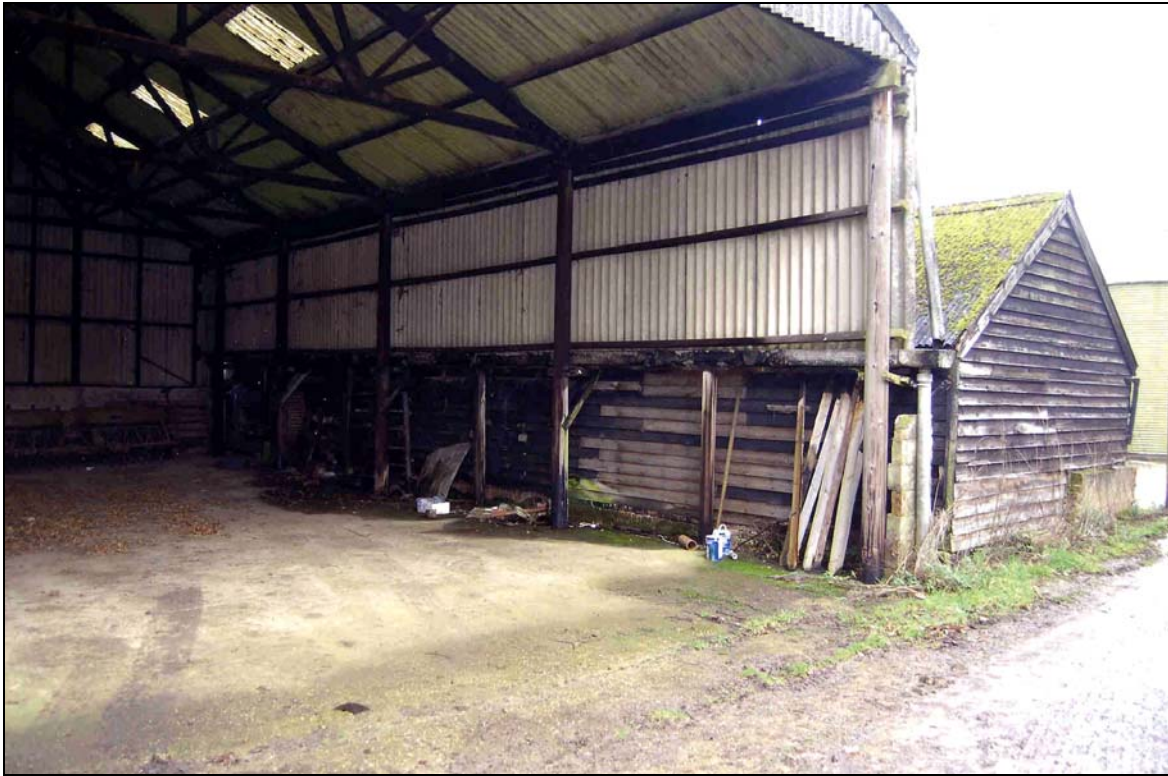
The rear wall of the stables is now incorporated within modern shed 3 (plate 9) and displays no features of historical interest.

Plate 9 Rear of stables viewed from south through building 3

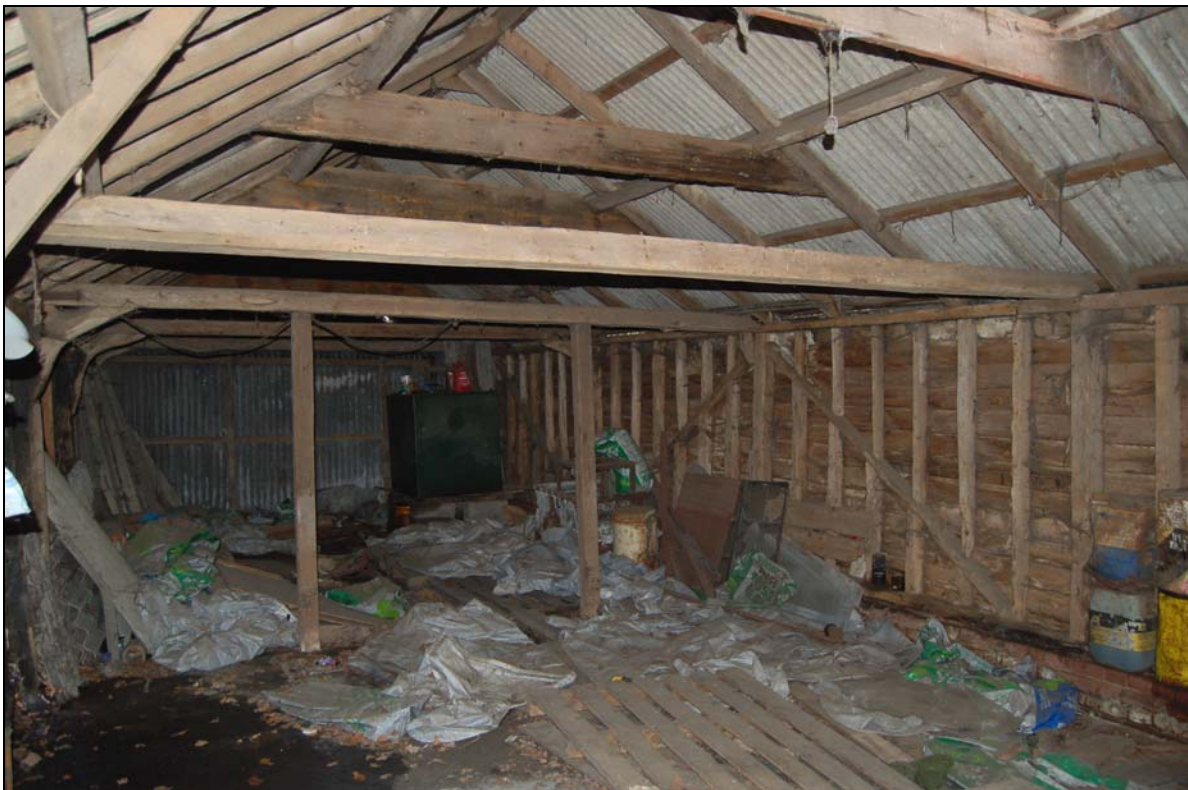
Wall-framing consists of thin primary-braced softwood timbers, some machine-sawn, stood on a low three-course brick plinth (plate 10). Wall plates are in shorter, approximately one-bay lengths joined by single-pegged edge faced and bladed scarf joints. The north wall is clearly inserted between the bay posts as the framing here is in crude, widely-spaced halved studs, many with their bark still on and there are no stud sockets in the wall plate. The stable wall plate on this side is bolted onto a nailed fish plate from the porch plate and there are clear indications of damp in the valley between the stables and porch (plate 11).

Roof-framing is basic, consisting of tie beams and wide planked collars set within the bays and nailed to the rafters (plate 10). Knee braces are bolted between tie beam and bay post on the formerly open front to lend greater support.

Plate 10 Interior of stable viewed to partition at east end

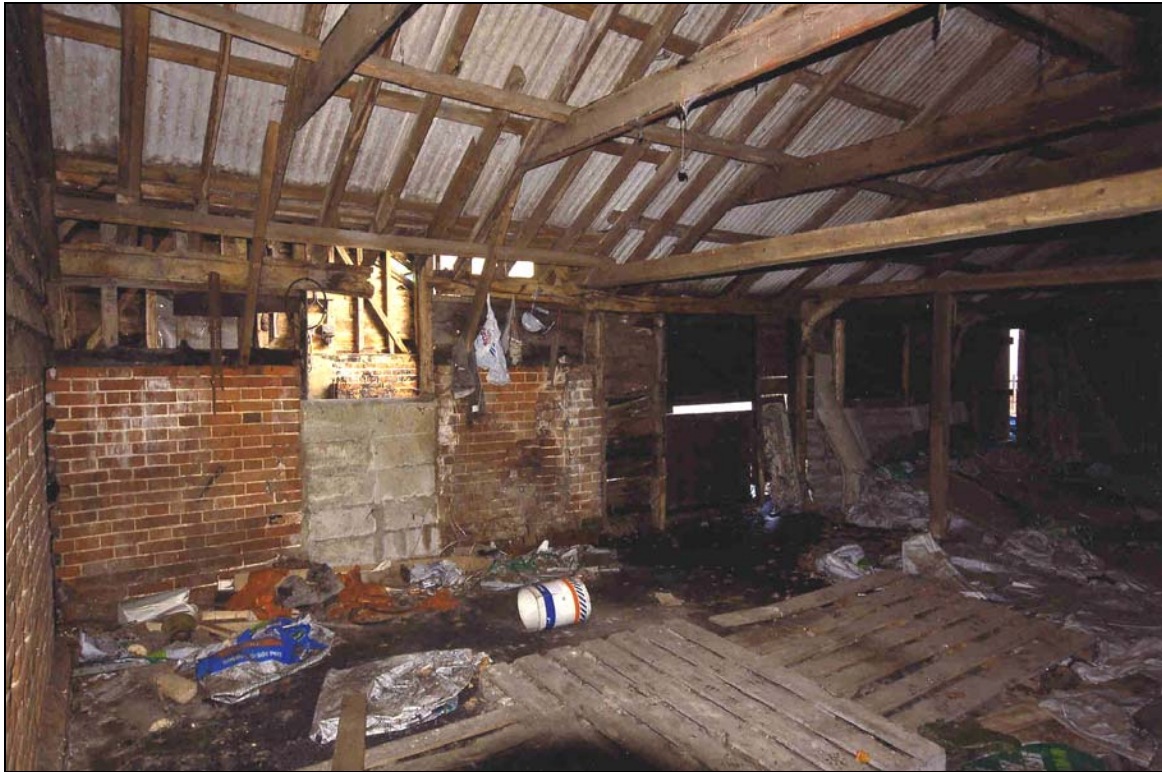
Plate 11 Interior of stables showing construction around porch and later infilling at front

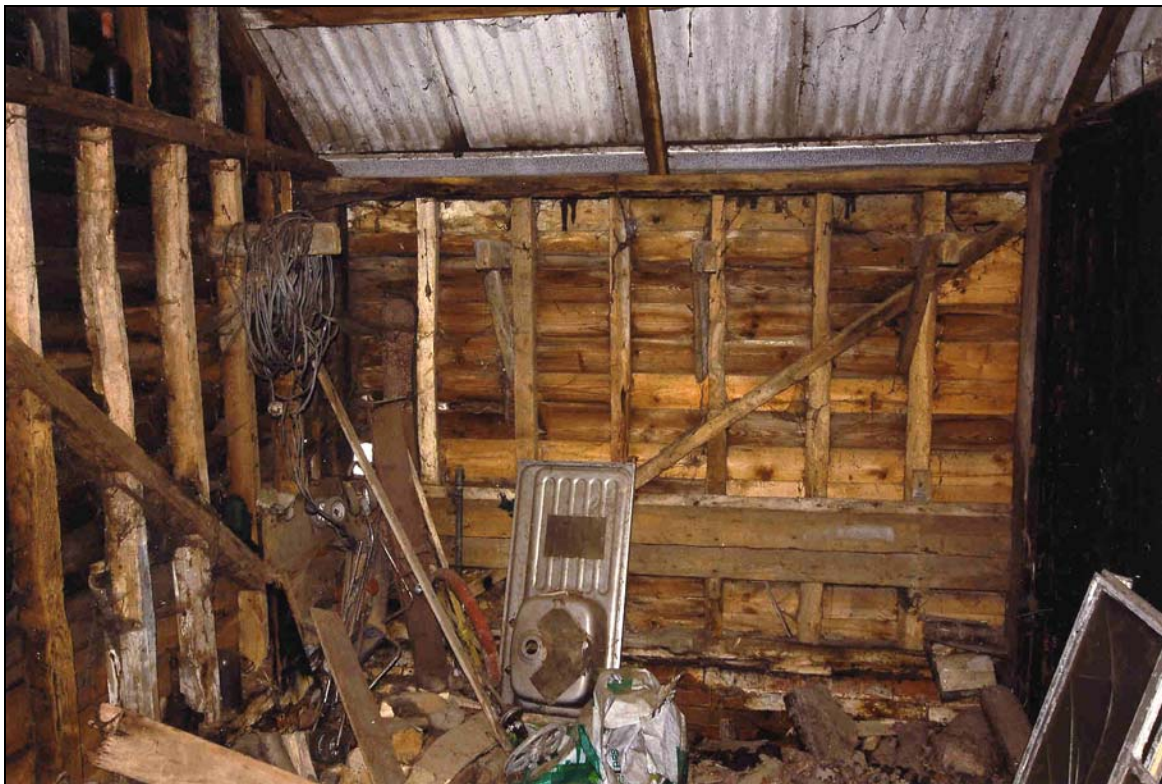
The interior comprises four open bays (plates 10 & 11), with a fifth bay partitioned off to form a wagon bay (fig. 4, plate 12). Although this is a modern partition, formed from light timbers and corrugated tin, it may represent an earlier feature, perhaps removed along with any horse stalls when the concrete floor was laid. The wagon bay displays the only historic fixtures recorded in the stables, namely boards from the rear of a cattle feeding trough relating to the earlier use of the building, and four harness racks set about the southern wall (fig. 4, plate 12).

Plate 12 End wagon bay with remains of feeding trough and harness racks
