**ESSEX AND SUFFOLK WATER OFFICES  
HALL STREET  
CHELMSFORD  
ESSEX**

**ARCHAEOLOGICAL TRIAL PIT  
EVALUATION**

**April 2009**

**ECC FAU Project Number:** 1867

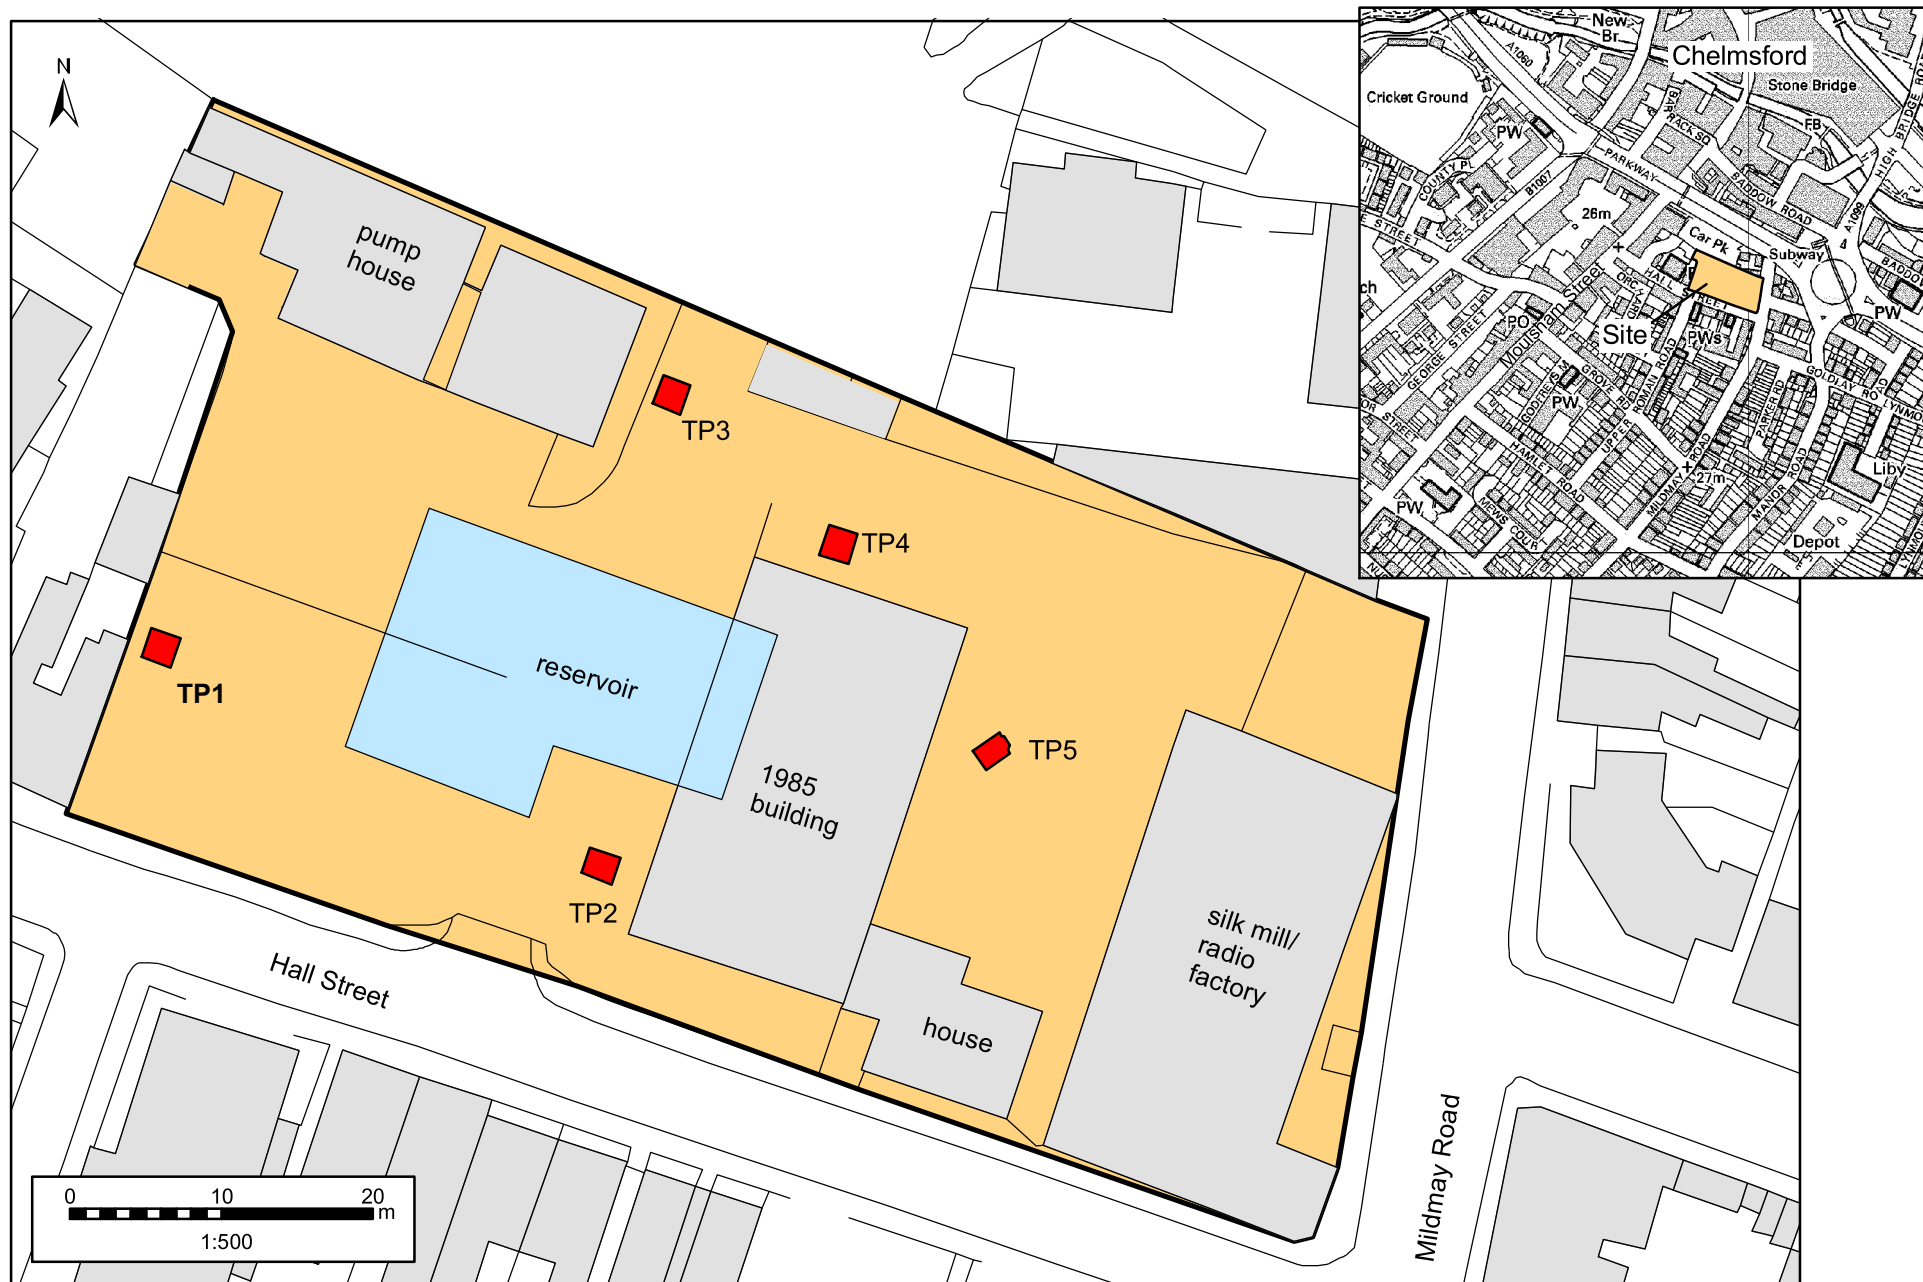
Fig.1. Location of trial pits (1-5)

The site (Fig. 1) is rectangular, measuring 82m east-west by 45m north-south, and occupies a corner site, bounded by Hall Street to the south and Mildmay Road to the east. Most of the offices have been converted from former 19th-century industrial buildings. Along the east side of the site a former silk mill/radio factory range, with a small office block attached, fronts onto Hall Street and extends back parallel with Mildmay Road. There is a house to its west, on Hall Street, and the pump house of the original water works survives in the site's north-west corner. A modern computer block was constructed immediately to the west of the house on Hall Street in 1985. Most of the western half of the site is a staff car park surfaced in tarmac, which overlies an underground reservoir, now infilled. A survey carried out in April 2007 has detected a dense network of underground services across the site, especially along its northern edge.

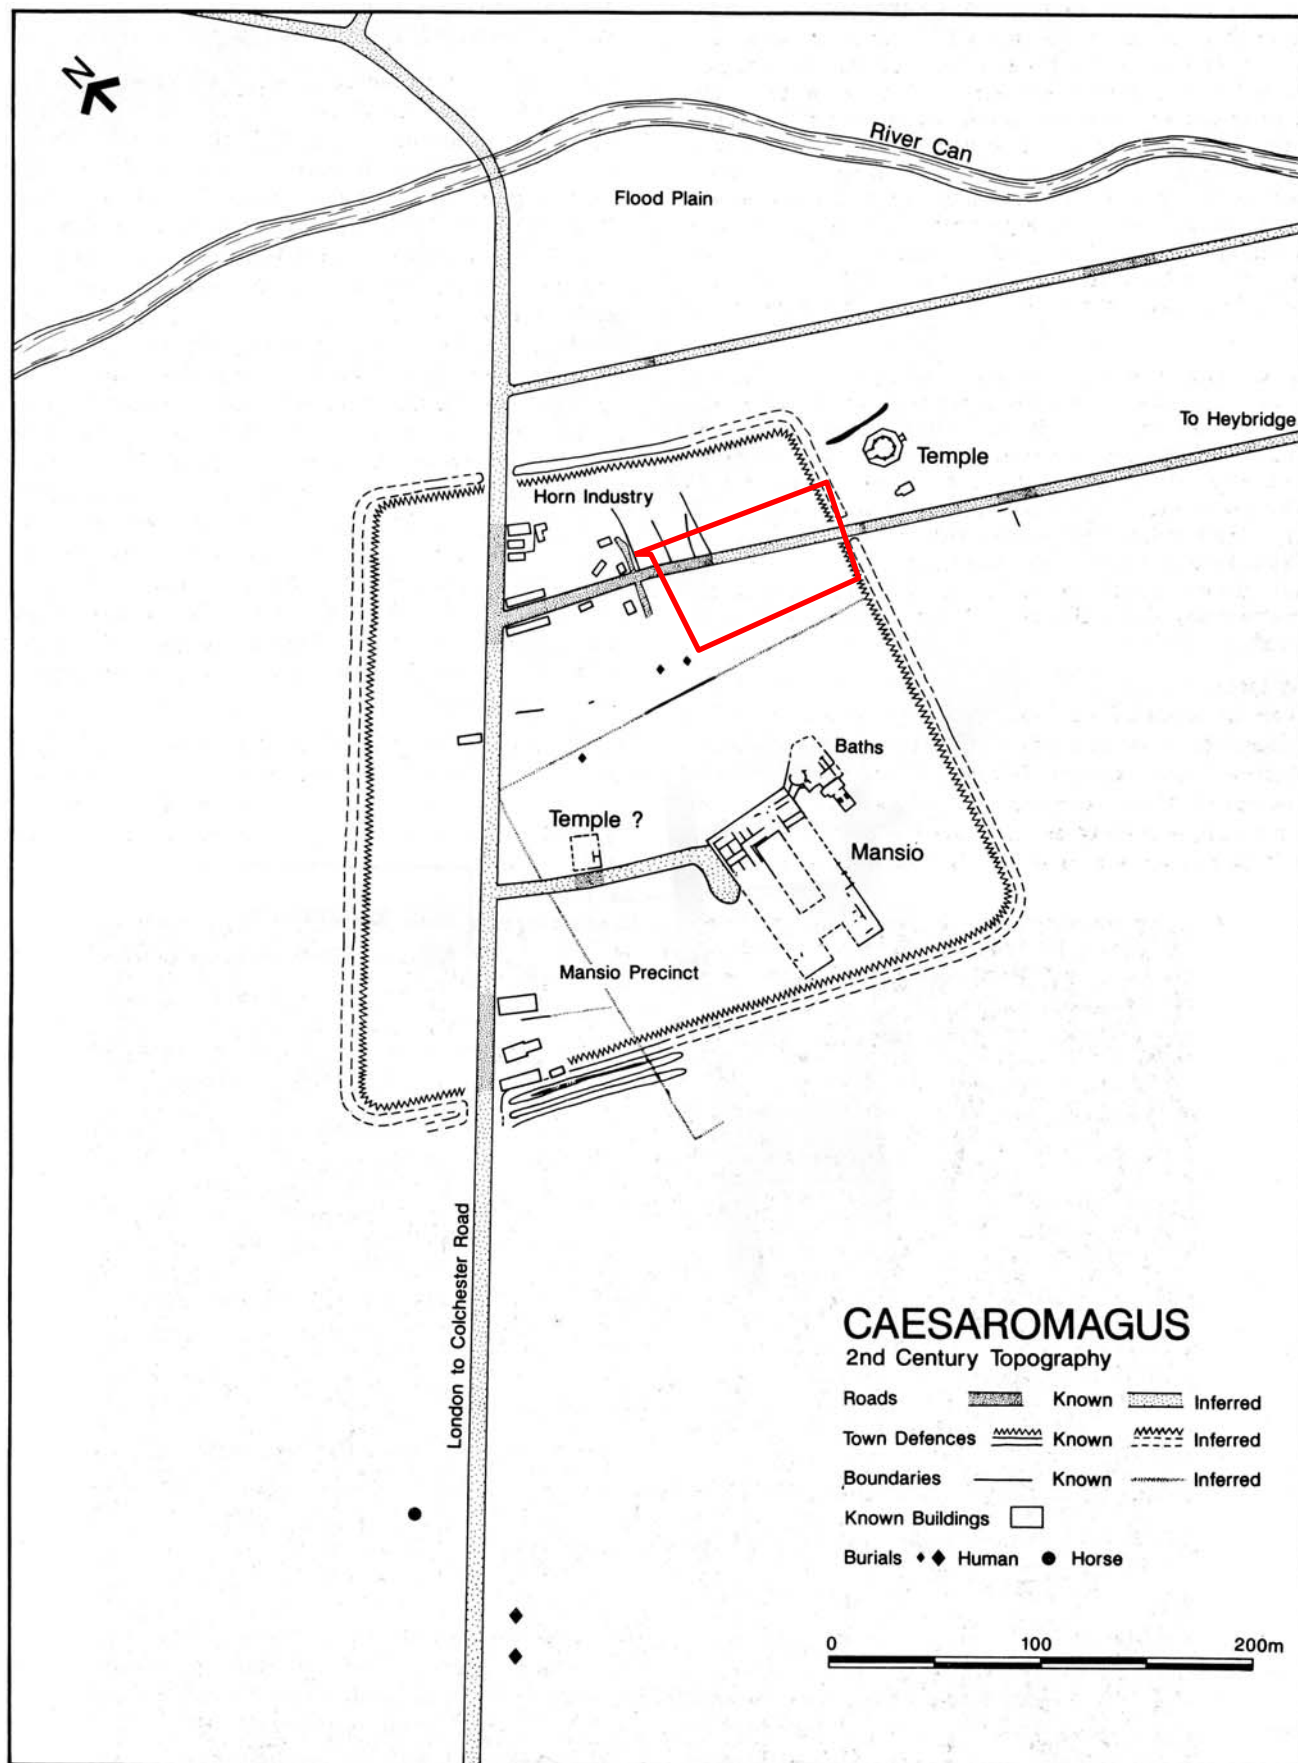
Fig.2. Roman Chelmsford, 2nd century topography, with the octagonal temple added in the 4th century (from Wickenden 1996)

The Roman town underwent a major re-organisation in the early 2nd century and assumed its final plan form, with few changes until its abandonment in the early 5th century (Fig. 2). The side-road projected as running through the Hall Street site appears to have been extended eastwards in the early 2nd century, following a new alignment south of the temple precinct. The area to the south of Hall Street was occupied by the *mansio* (posting station), which had been rebuilt as large courtyard building with a bath house, within a much-enlarged official precinct. The town grew to its greatest extent in the 2nd and 3rd centuries, with timber houses/shops/workshops extending along the main London-Colchester road, and along the side-road as far east as the site area.

In the later 2nd century the town was provided with earthwork town defences, which are projected as running along the eastern boundary of the Hall Street site, separating it from the temple precinct to the east (Fig. 2). The temple precinct was provided with a new stone-built octagonal shrine in the early 4th century. Timber buildings along the main roads continued to be replaced in the 3rd and 4th centuries, although by the mid-late 4th century there is evidence of decline, with roads falling into disrepair and some building plots being left vacant.

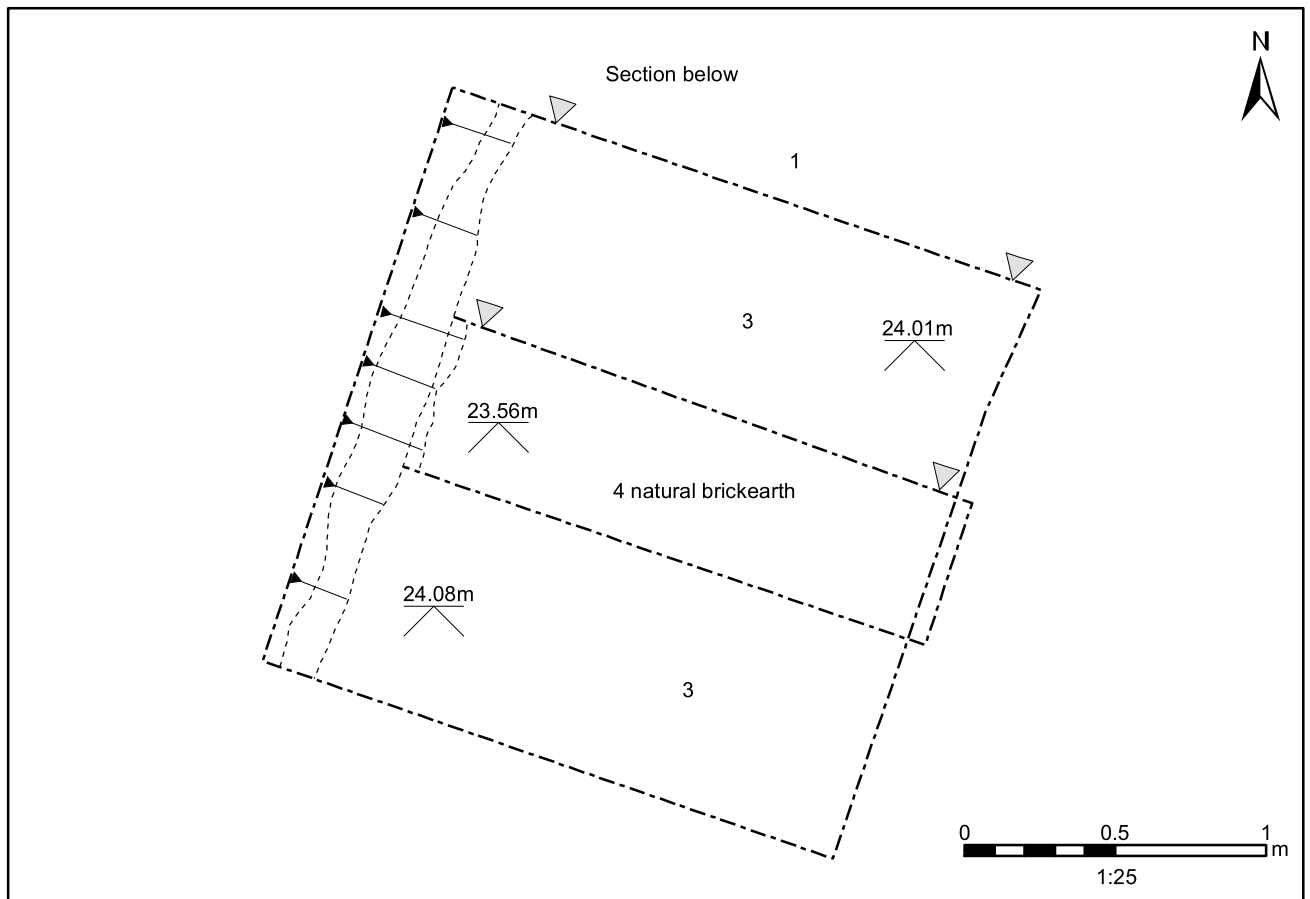
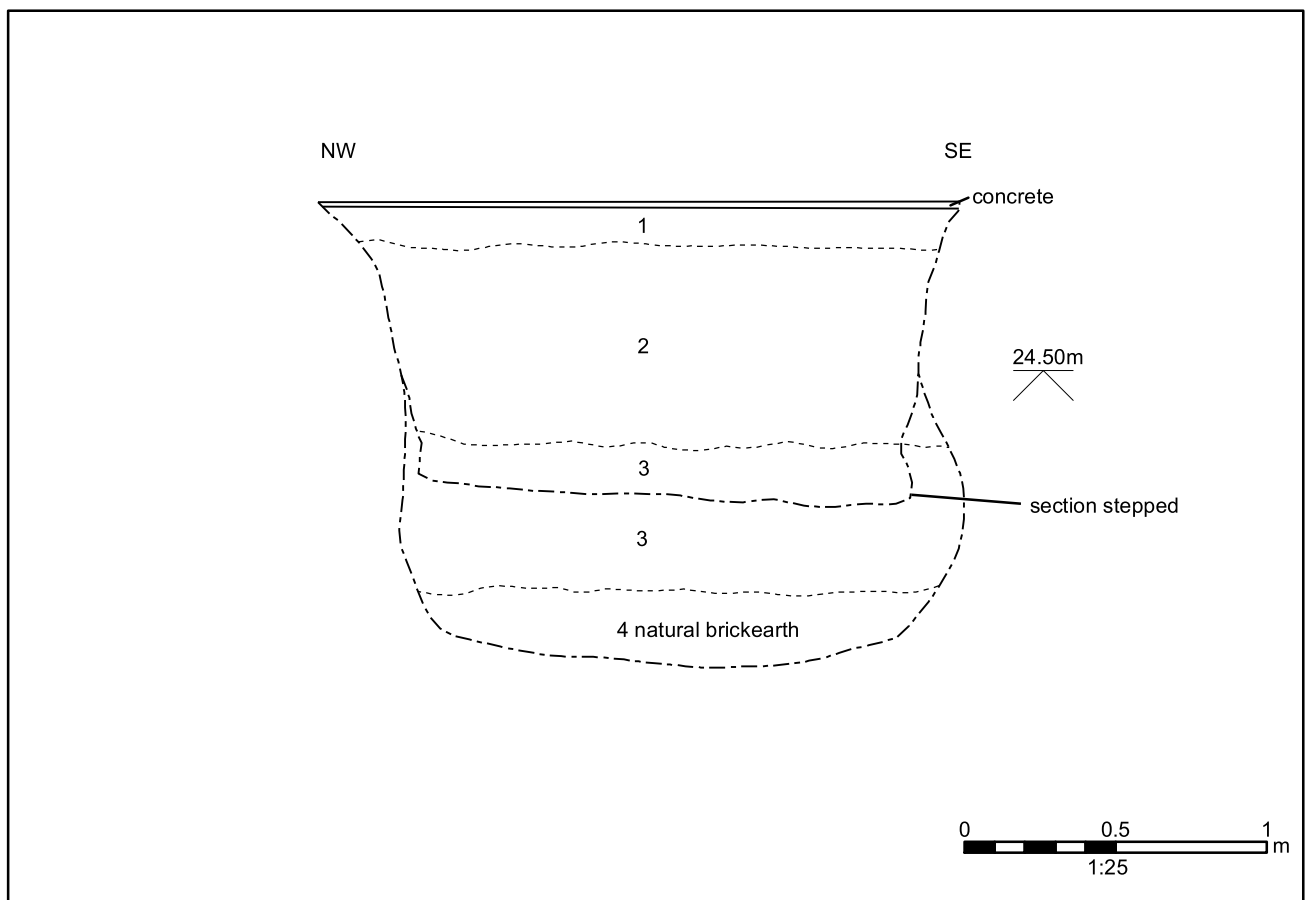
Fig.3. Trial pit 1, plan and section

Trial Pit 1 measured 2.0 x 2.0m and was located in the south-west of the site, against its western boundary.

Natural brickearth (4) was recorded at 23.56m OD, 1.25m below modern ground level. It was overlain by a 0.5m-thick layer of dark yellowish brown clayey silt with occasional pebbles, stone fragments and charcoal flecks (3). This contained 31 sherds of Roman pottery, including diagnostic sherds datable to the 3rd century or later, as well as Roman tile fragments. A single post-medieval pottery sherd is considered to be intrusive, especially as the boundary between layer 3 and the overlying layer was not well defined. Layer 3 is interpreted as a Roman buried soil.

The Roman soil was overlain by a 0.6m-thick layer of dark grey-brown clayey silt with few inclusions (2), the cultivated soil previously recorded in the 1985 trial pits. Soil layer 2 contained a few sherds of post-medieval roof tile and bottle glass, small pieces of coal, and two sherds of modern pottery. It was directly sealed by the modern car park surface.

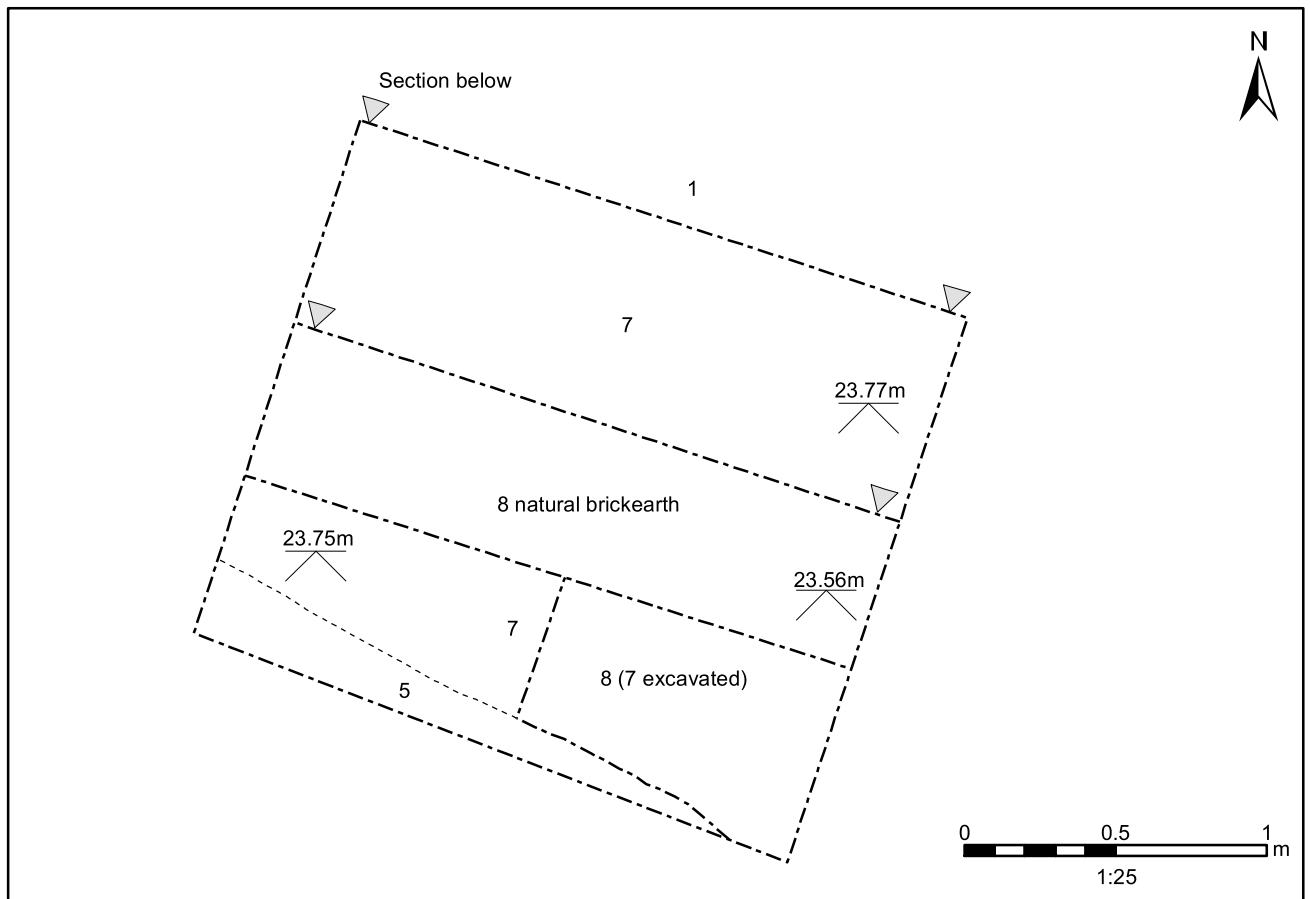
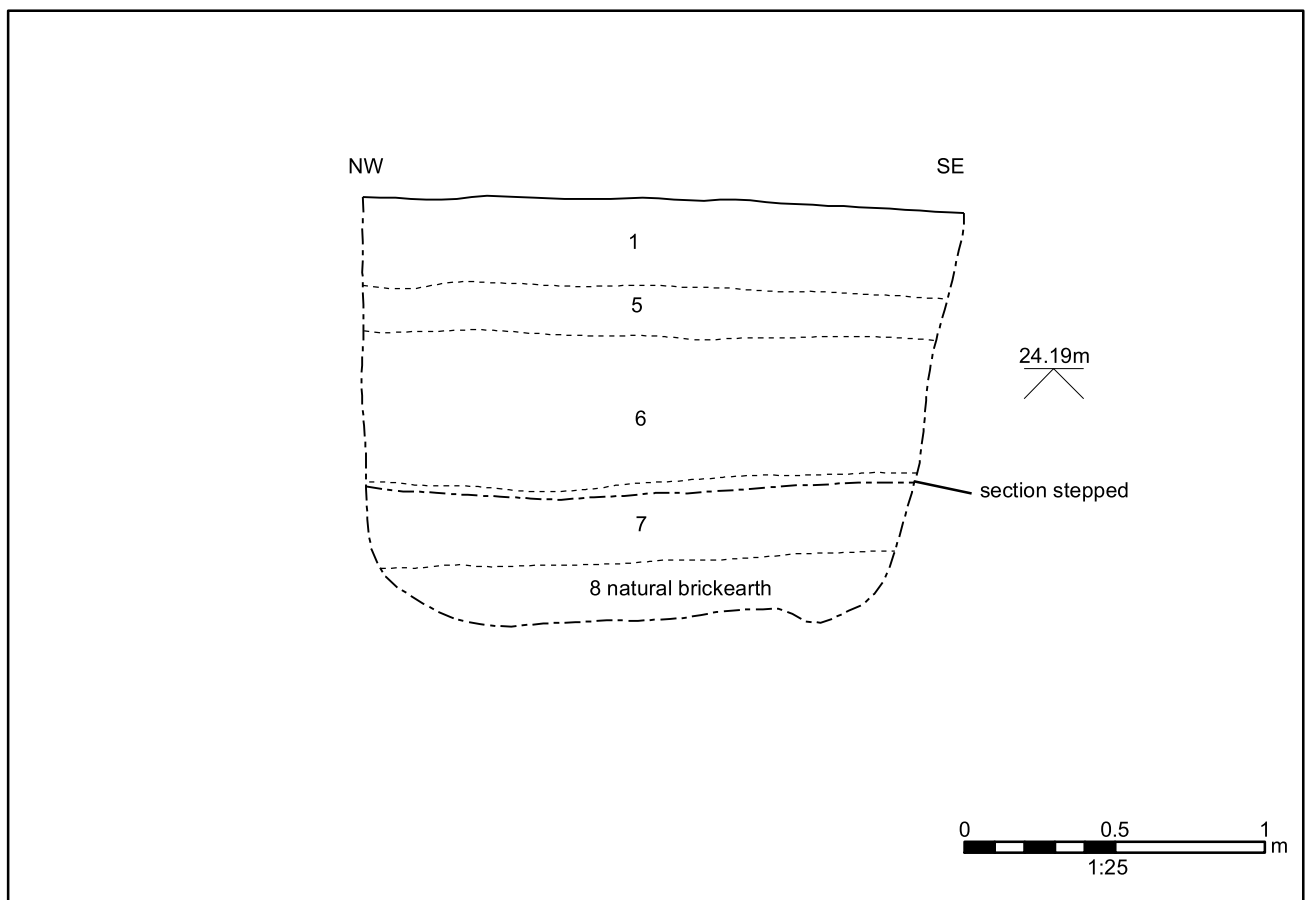
Fig.4. Trial pit 2, plan and section

Trial Pit 2 measured 1.9 x 2.1m and was located in the centre-south of the site, against the west wall of the new computer building constructed in 1985. It was located close to the 1985 Trial Pit 2, which recorded a Roman external surface (see 2.3.2 above, p.6).

Natural brickearth (8) was recorded at 23.56m OD, 1.2m below modern ground level. It was overlain by a 0.25m-thick layer of dark yellowish brown clayey silt with moderate stones and a lens of red burnt daub or mudbrick (7). This material was excavated in the south-east of the trial pit as well as in the slot up its centre, but appears to represent no more than a spread of hardcore deposited to provide a rough surfacing (Plate 1). Layer 7 contained 10 sherds of Roman pottery, including diagnostic sherds datable to the 3rd century or later, and Roman tile and glass fragments. As with the similar layer in Trial Pit 1, it is interpreted as a Roman buried soil, although with some evidence of patchy surfacing.

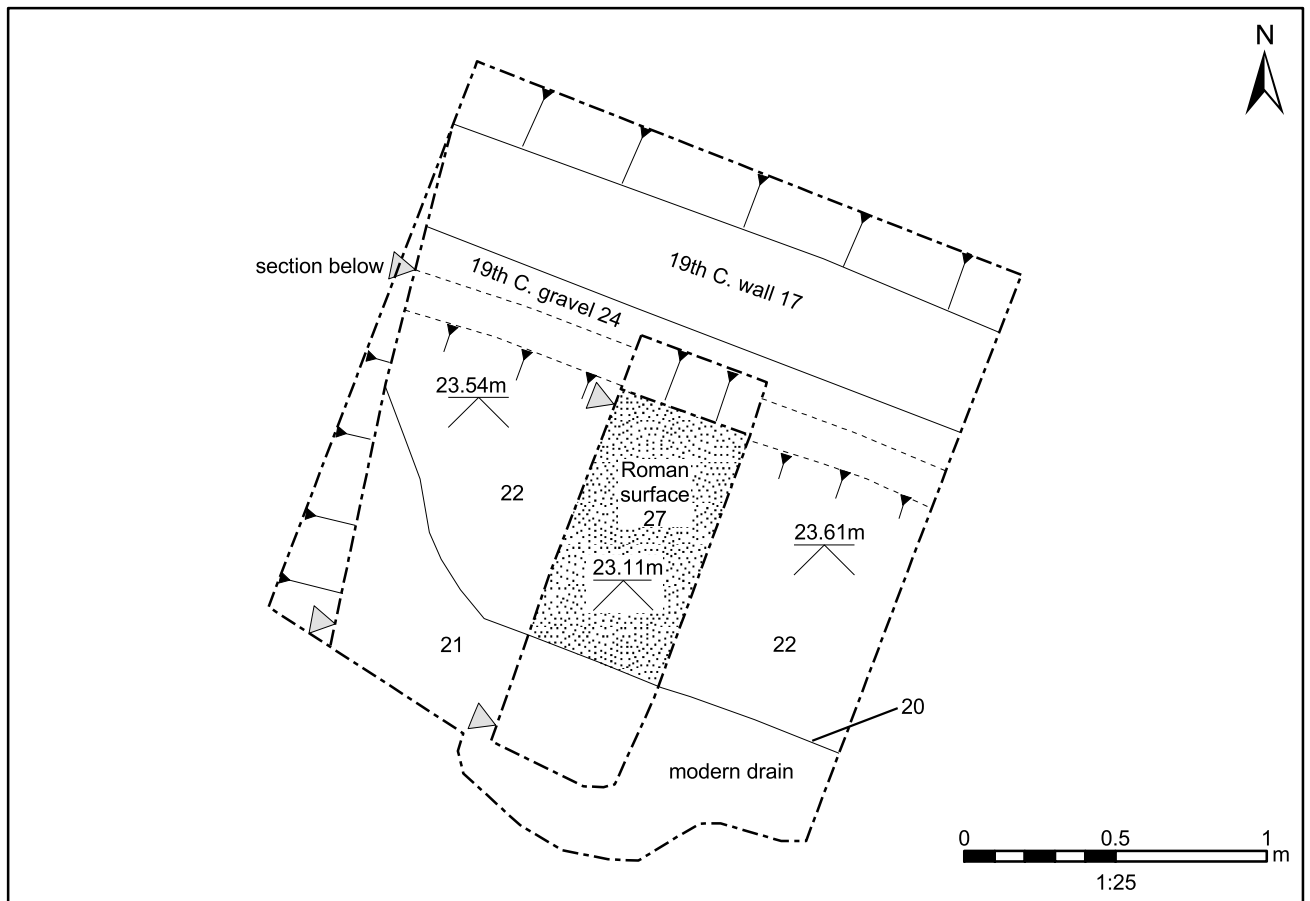
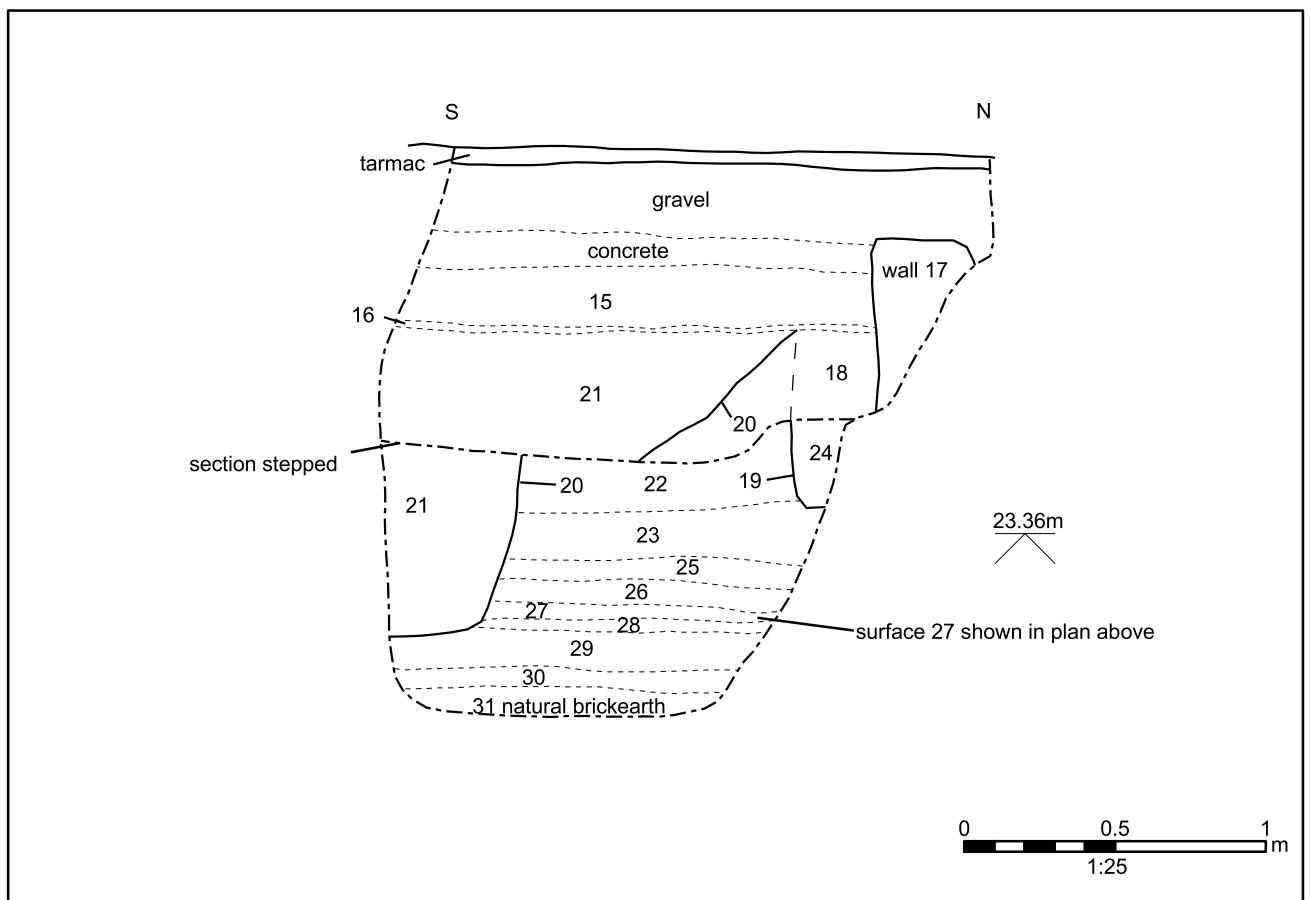
Fig.5. Trial pit 3, plan and section

The Roman strata were sealed by a 0.6m-thick layer of greyish brown clayey silt (22), the cultivated soil previously recorded in the 1985 trial pits. To the north, soil 22 was cut by a wall aligned east-west, made up of stock and red bricks bonded in a creamy brown mortar. The wall was constructed on a foundation of compacted yellow-brown sandy gravel (24) within a broad foundation trench (19) that cut down to the top of the Roman strata. The foundation was offset 0.25m from the south face of the wall, and the upper part of the foundation trench was backfilled with mixed silt and brick rubble (18). Cut from the same level as foundation trench 19 was a large trench for a drain (020), 1.0m deep, which truncated almost all earlier strata along the southern edge of the trial pit. It was backfilled with mixed brick rubble and disturbed soil (21). Wall 18 is dated by its brickwork to the 19th century, no doubt to the period after the 1850s when the site was developed as a water works and a silk mill. A thin dark grey-black ash layer (16) sealed the backfill of the drain and ran up to the south face of wall 18. Layer 16 was sealed by a thick layer of rubble incorporating stock and red bricks (15) from the demolition of wall 18 and any related structure. This formed the base for the modern concrete surface for the car park. Above this a thick layer of gravel capped by tarmac raised the level of the car park locally, almost certainly part of the works carried out when the new building was constructed in 1985.

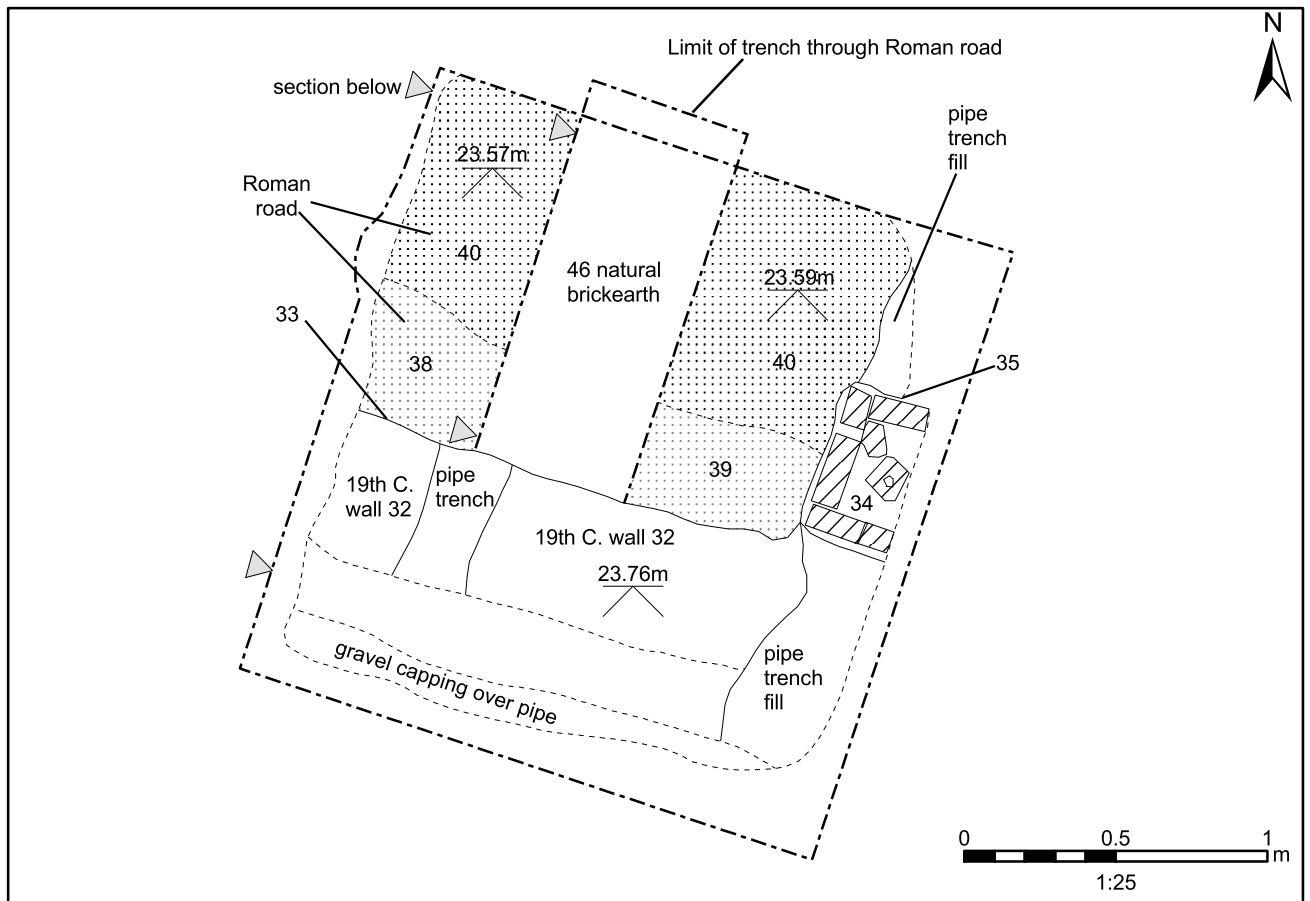
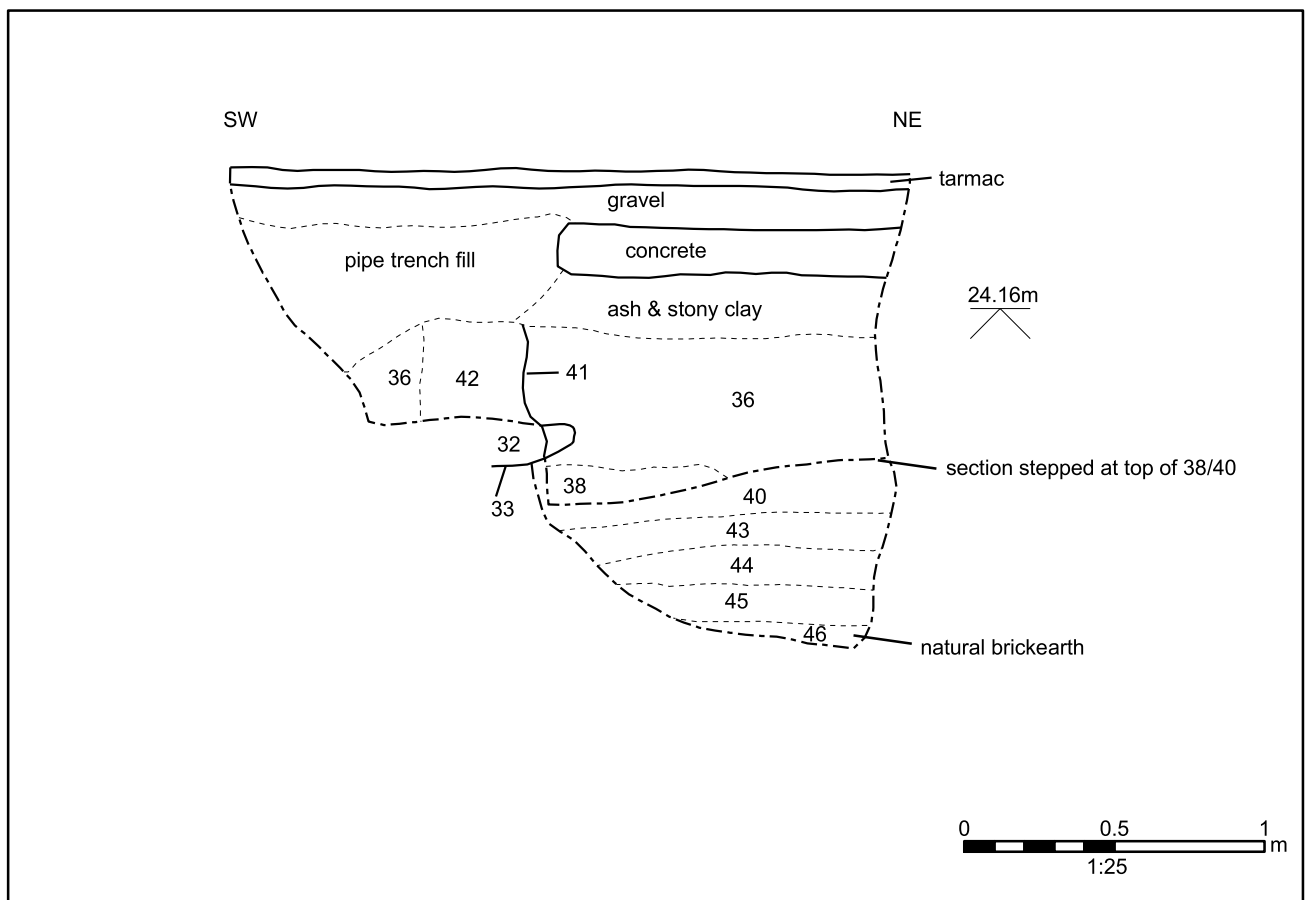
Fig.6. Trial pit 4, plan and section

The Roman road was sealed by a 0.45m-thick layer of grey-brown clayey sandy silt (36), the cultivated soil previously recorded in the 1985 trial pits. This was cut to the south by the foundation of a wall aligned east-west, 0.50m wide and 0.15m deep, trench-built (33) and consisting of a base of hard pale yellow-brown pebbly mortar (32) (Plate 3). The base of the foundation rested on the top of the uppermost Roman strata. The upper part of the foundation had been robbed (41), with the robber trench infilled with dark grey-brown sandy silt mixed with fragments of yellow-brown mortar and red brick (42). This foundation is likely to have been Victorian, as its mortar is similar to that of known Victorian structures on the site. The robber trench and cultivated soil were truncated by a modern layer of ash and stony clay, forming a levelling for a concrete slab. This was cut in its turn by several modern pipe trenches, now disused, before the entire area of the trial pit was sealed by a gravel levelling and tarmac surface for the modern car park.

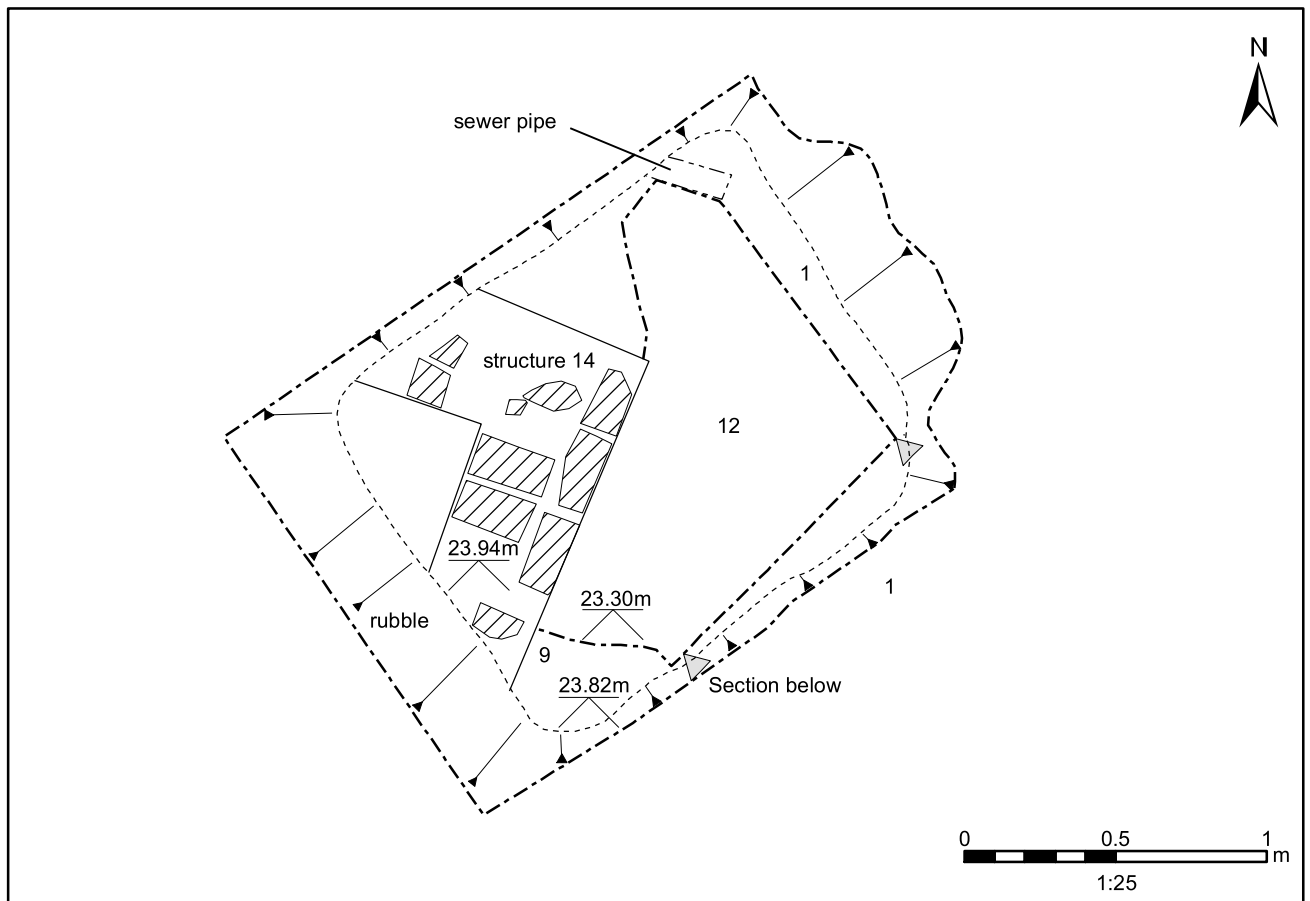
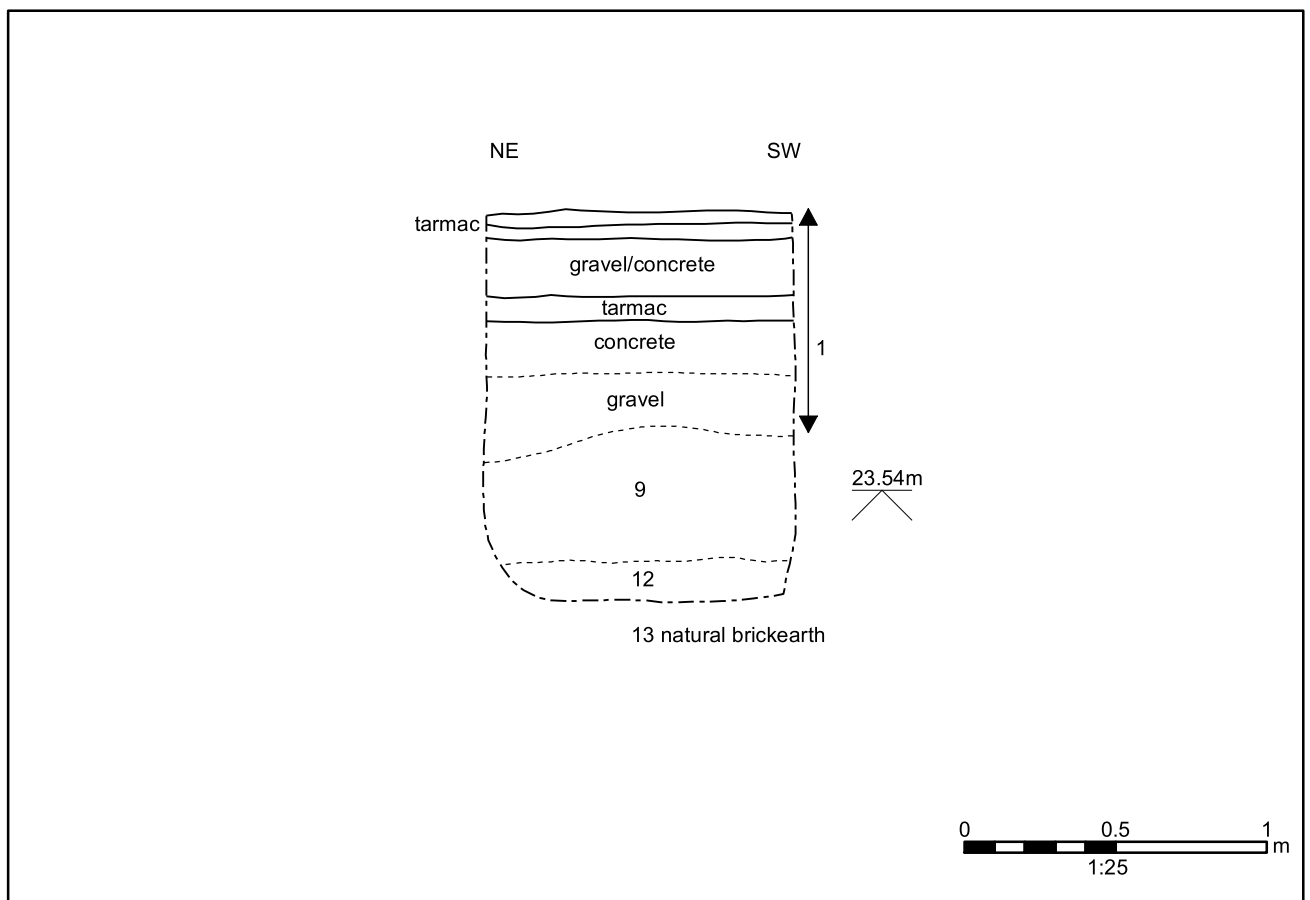
Fig.7. Trial pit 5, plan and section

Natural brickearth (13) was recorded at 23.22m OD, 1.33m below modern ground level. It was overlain by a 0.11m-thick layer of yellowish brown clayey silt (12), which contained a few sherds of Roman pottery, and represents a Roman buried soil layer. Trial Pit 5 failed to locate the northern edge of the projected second Roman road, although given the small size of the trial pit the lack of evidence is not conclusive.

The Roman soil was overlain by a 0.5m-thick layer of dark greyish brown clayey silt (9), the cultivated soil previously recorded in the 1985 trial pits. Cultivated soil layer 9 was cut by the north-eastern corner of a brick structure (14), represented by two short lengths of brick foundation (10 and 11) comprising stock and red bricks laid in English bond. The foundation cut to below the natural brickearth, while its top was 0.4m below modern ground level. The

materials used in the foundation are typically Victorian and it is probably significant that the structure shares the alignment of the 1858 silk mill to its east and the related house to its south. The foundation and cultivated soil were overlain by two successive tarmac surfaces on thick beds of gravel and concrete, forming the modern car park surface.

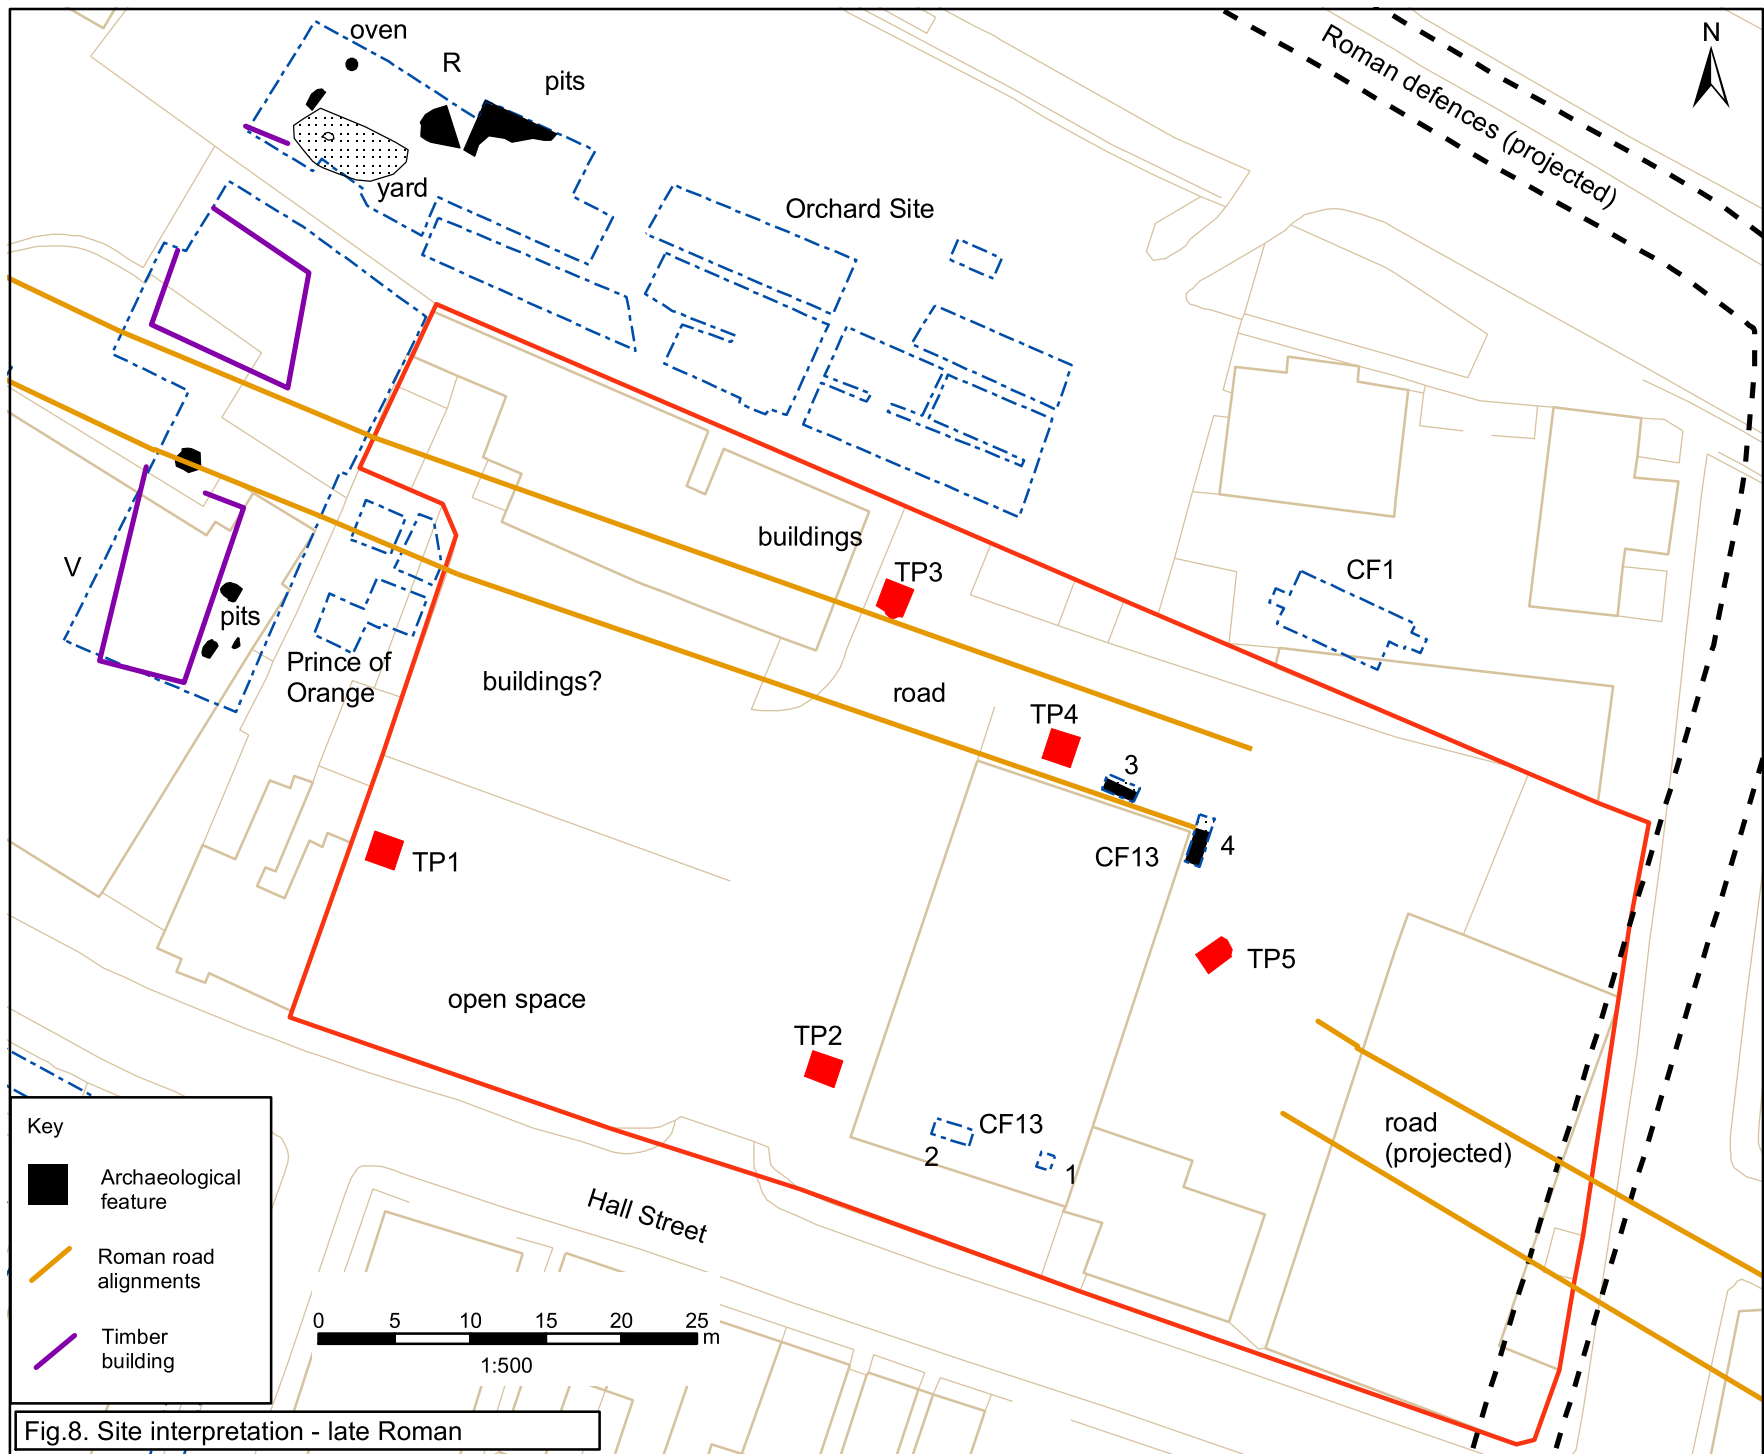
Fig.8. Site interpretation - late Roman

The trial pit evaluation failed to locate the suggested second Roman road, projected as extending south-eastwards from the first (Fig. 8). The second road line is unlikely to survive in the west of the site, near its projected junction with the original road, as this area has been extensively disturbed by the infilled underground reservoir in the west of the site (Fig. 9). There is, however, still a high probability that it exists in the yard area to the east, between the 1985 computer building and the former silk mill/radio factory.

Although the trial pit evaluation failed to locate the projected second Roman road (Fig. 8), the potential presence of this road on the site is highly significant for understanding the topographical development of this part of the Roman settlement. Recording and dating the second Roman road would enable the suggested change in road alignments at Hall Street to be fully understood in relation to the development of the Roman temple precinct immediately to the east of the site, as well as the settlement's eastern suburb (Allen 2007, 18 and fig. 7).
