**ESSEX AND SUFFOLK WATER OFFICES  
HALL STREET  
CHELMSFORD  
ESSEX**

**ARCHAEOLOGICAL TRIAL PIT  
EVALUATION**

**April 2009**

**ECC FAU Project Number:** 1867

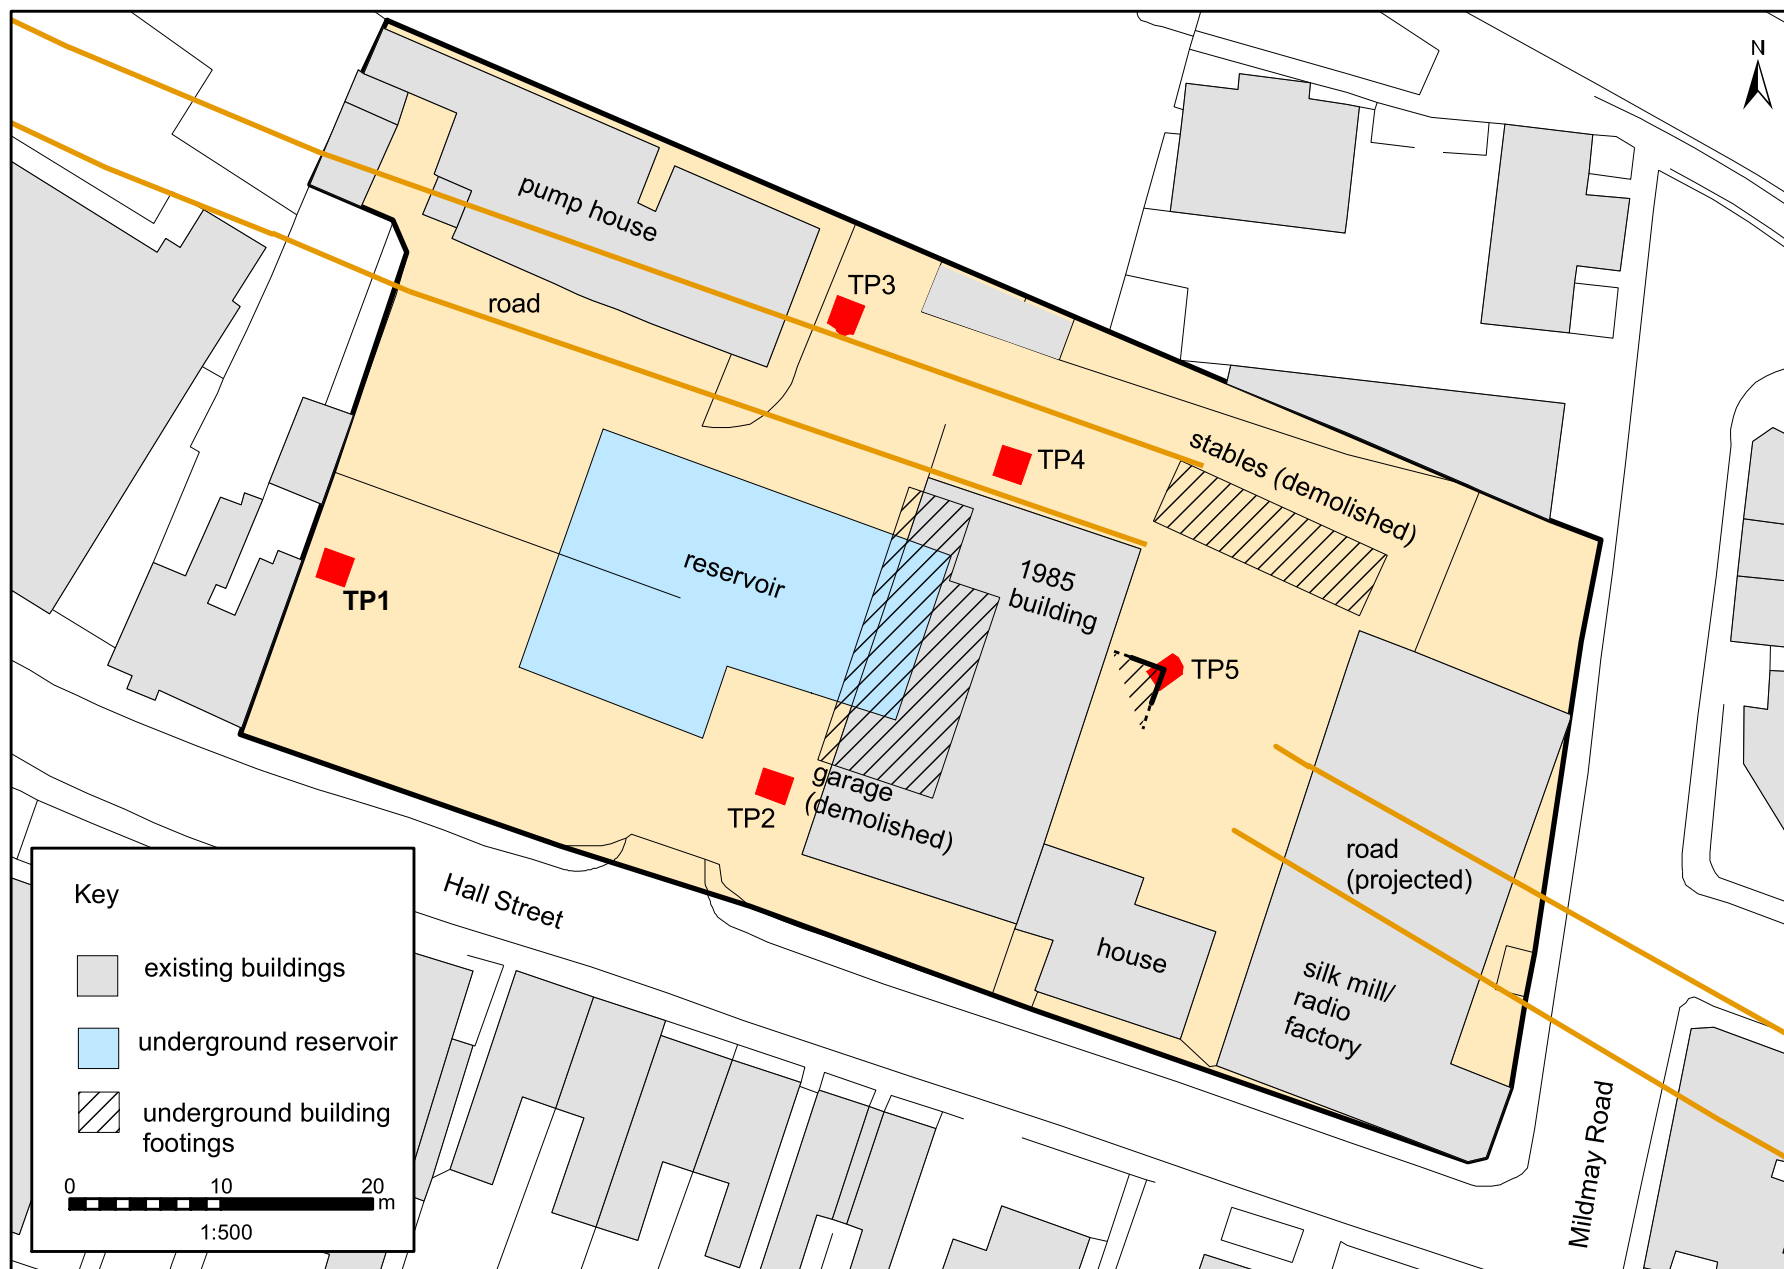
Fig.9. Site plan showing constraints, trial pit locations and Roman roads

The cultivated soil was cut by several Victorian foundations related to the development of the site from the 1850s onwards as a water works and silk mill, as well as modern foundations and service trenches, all of which were sealed by modern car park surfaces. Trial Pit 5 in particular recorded the north-eastern corner of a brick structure that appears to have extended northwards from the existing 19th-century house on Hall Street. Early Ordnance Survey maps show a building range in this location, presumably an outbuilding on the west side of a courtyard bounded by the house to the south and the former silk mill/radio factory to the east (Fig. 9; and Allen 2007, fig. 12). Other Victorian walls were recorded in Trial Pits 3 and 4. As these walls were on the western side of the site, they presumably represent outbuildings related to the original water works of 1854 and its subsequent expansion in 1860-8 (Fig. 9; and Allen 2007, 19, and fig 12).

The archaeological desk-based assessment has recommended that the site's three historic buildings, the pump house, the silk mill/radio factory and the house on Hall Street (Fig. 9) should be retained in any redevelopment (Allen 2007, 20). It is assumed that preservation of the historic buildings will be a central part of the development design, involving no major groundworks and with no requirement for below-ground archaeological investigation.

The areas of archaeological significance across site that may require mitigation measures are limited to the car parks and access routes, excluding the area of the infilled underground reservoir beneath the main car park in the west (Fig. 9). There will be some disturbance in the north of these areas from the foundations of demolished 19th- and 20th-century buildings, but the trial pits have shown that this disturbance is not extensive and that Roman stratigraphy will survive between the later intrusions. The area of the 1985 computer building may also need to be considered if the development plans include its demolition to allow new construction. While the open spaces have been evaluated by the trial pits, this has not been possible for the 1985 building, and if demolition and new build is planned then further evaluation by trial pits would be necessary to assess the survival of archaeological deposits within its footprint.

To summarise, Roman deposits of high significance are known to survive with relatively little disturbance in most open areas of the site, sealed by a post-medieval cultivated soil, which is cut by the foundations of 19th-century industrial buildings. The main areas of archaeological significance, which should be further assessed for construction impacts to formulate mitigation measures, are as follows (Fig. 9):

4. The footprint of the 1985 computer building should be evaluated by trial pits to assess deposit survival if it is decided to demolish and build new in this part of the site.
5. It is recommended that the existing historic buildings on site be retained in any scheme of redevelopment, and that the Chelmsford Borough Council's historic buildings advisor be consulted over any proposed new works to be carried out on them.

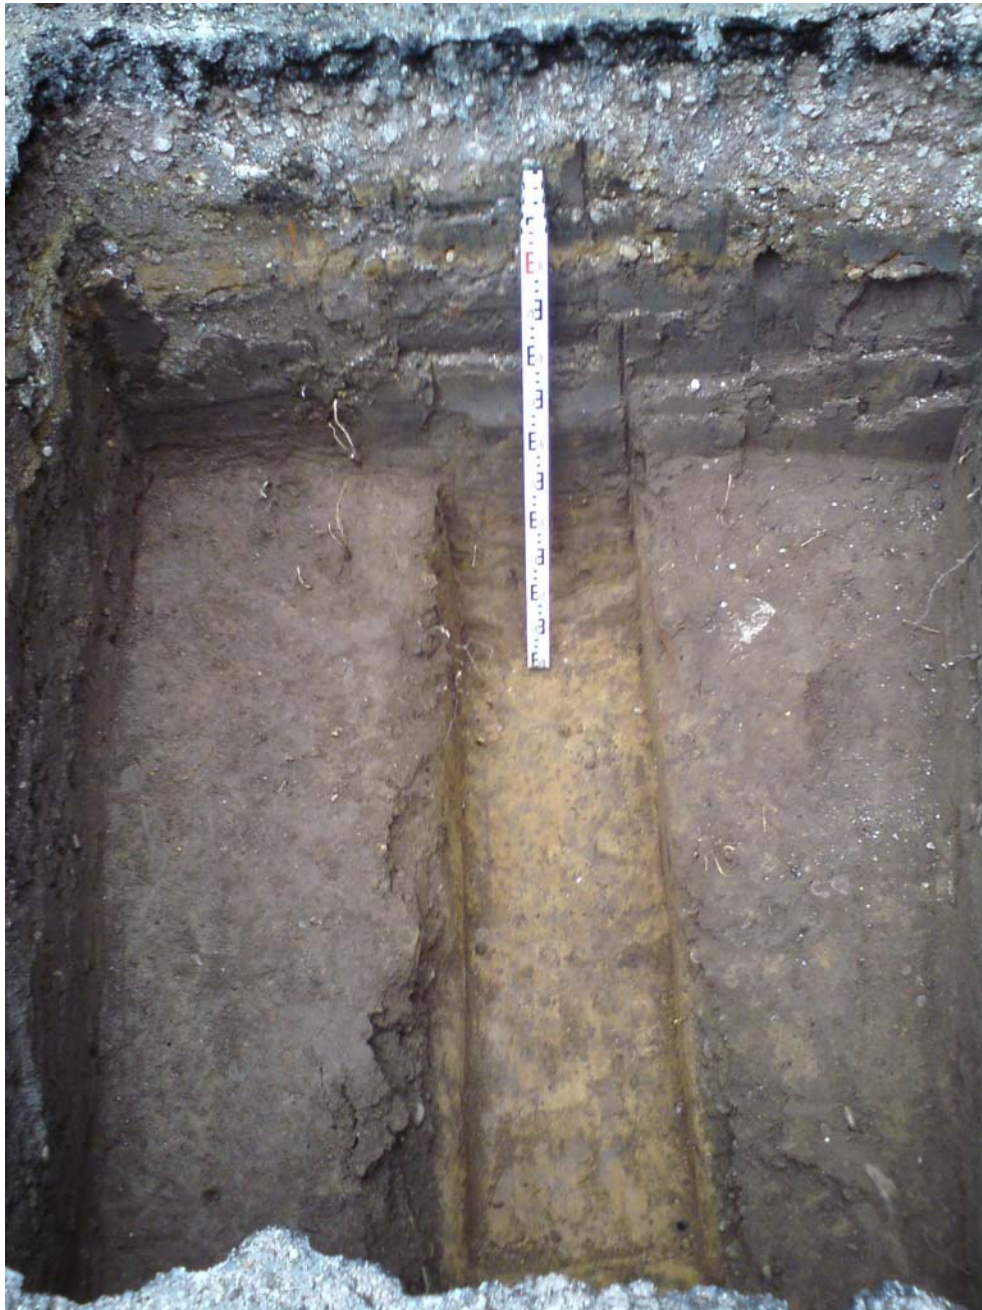
Plate 1. Trial Pit 2 looking east, showing Roman buried soil 7 (in plan), overlying natural brickearth (base of slit trench) and sealed by post-medieval cultivated soil (in section). Scale 1.2m

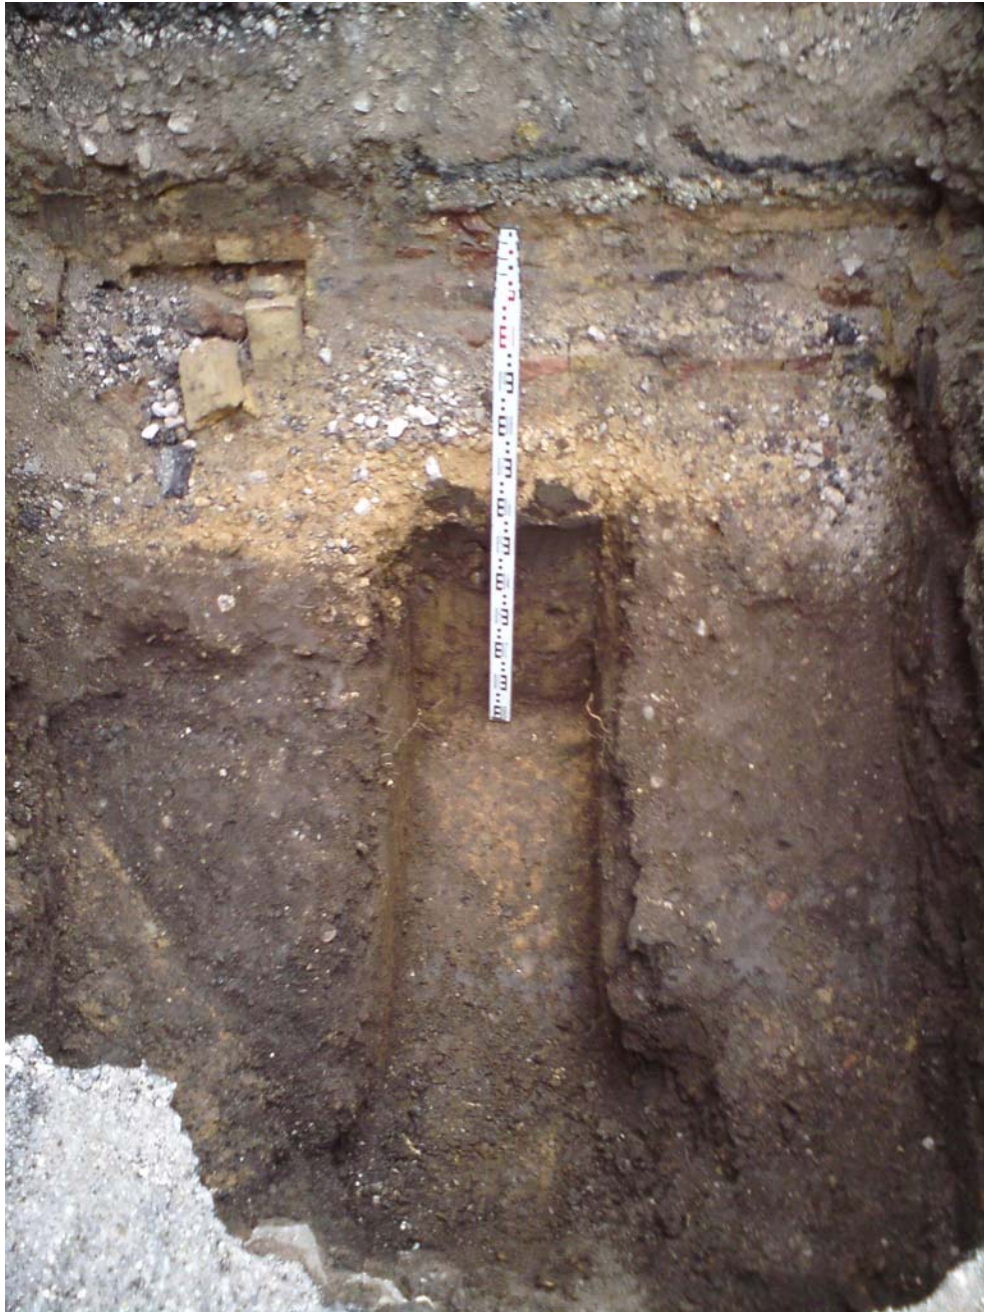
Plate 2. Trial Pit 3 looking north, showing Roman brickearth surface 27 (base of slit trench), probably forming the floor of a timber building to the north of the Roman road. This was the second of a sequence of three Roman surfaces alongside the road, sealed by post-medieval cultivated soil (in plan). The Roman sequence survives at a depth of between 1.2 and 1.8m below modern ground level. The gravel in the background is the base of a Victorian brick wall. Scale 1.2m

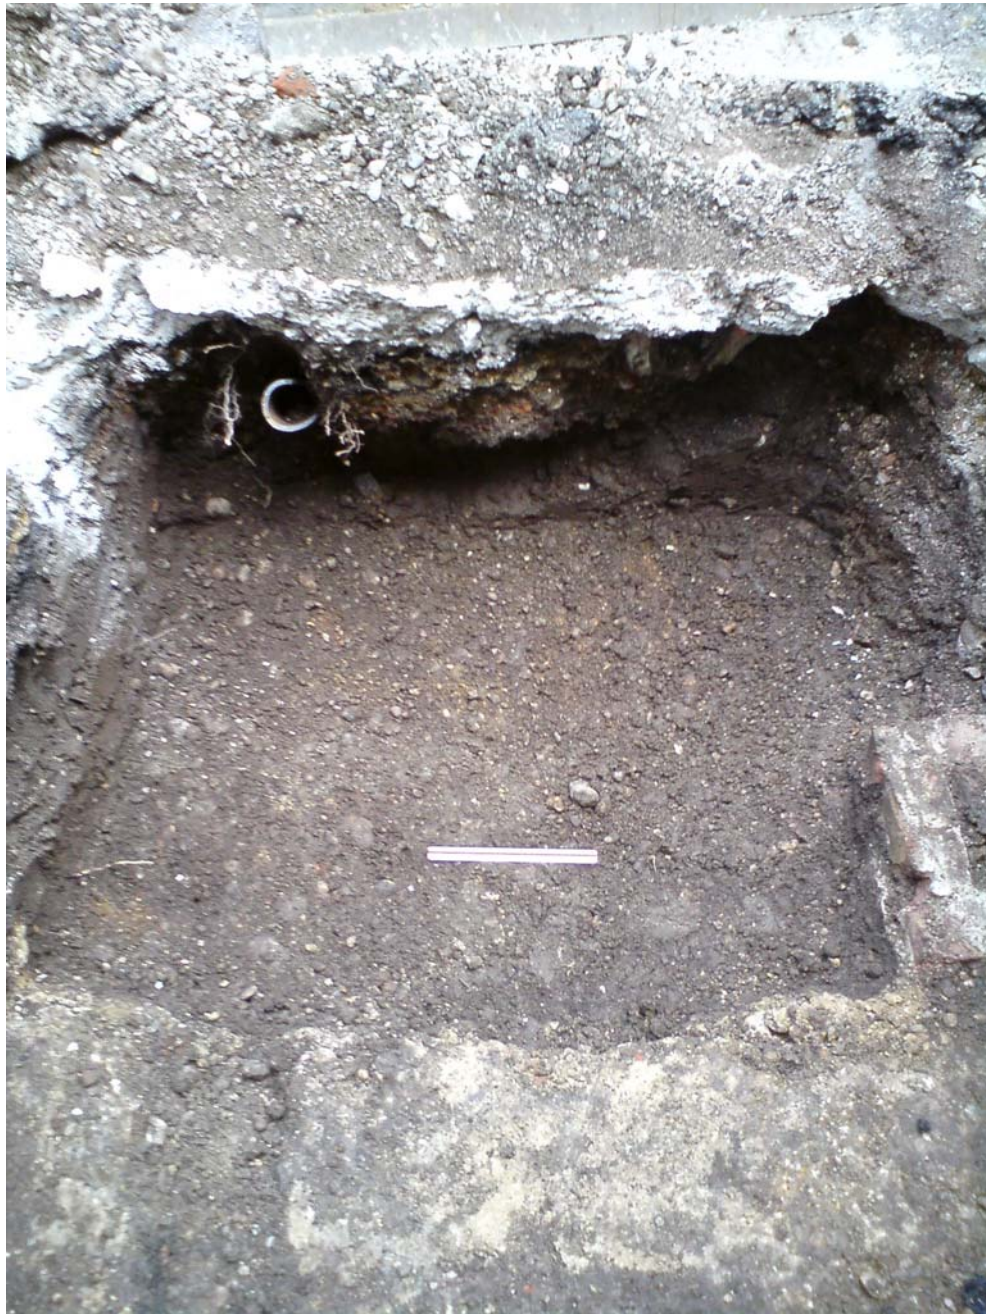
Plate 3. Trial Pit 4 looking north, showing the latest surface of the Roman road that ran east-west across the north of the site. The orange gravel road metalling 40 is visible in the background, with trampled gravelly silt wash 38/39 along the road's southern edge in the centre. In the foreground is Victorian wall 32. Scale 0.3m

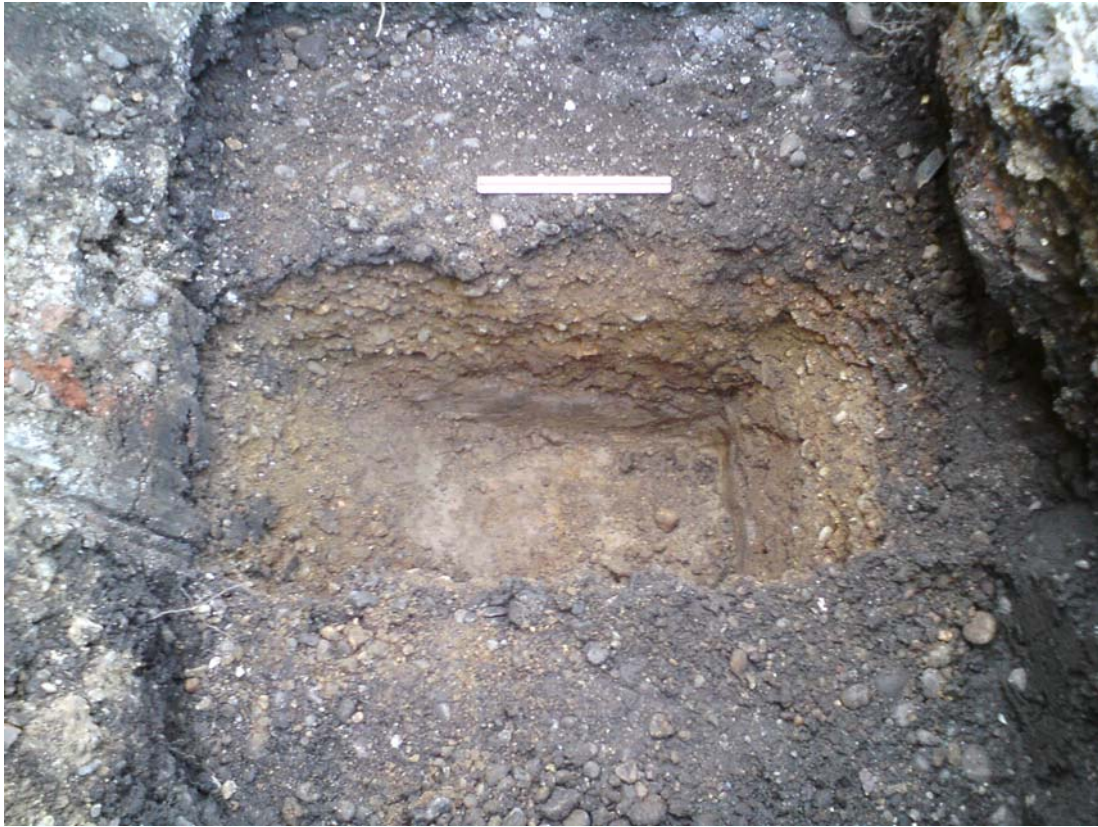
Plate 4. Trial Pit 4 looking west, showing a section through the Roman road, with a camber down to its southern edge visible to the left. The latest road surface 40 overlies two earlier road surfaces 43 and 44 (in section), above a grey subsoil at the top of the natural brickearth (base of slit trench). Scale 0.3m

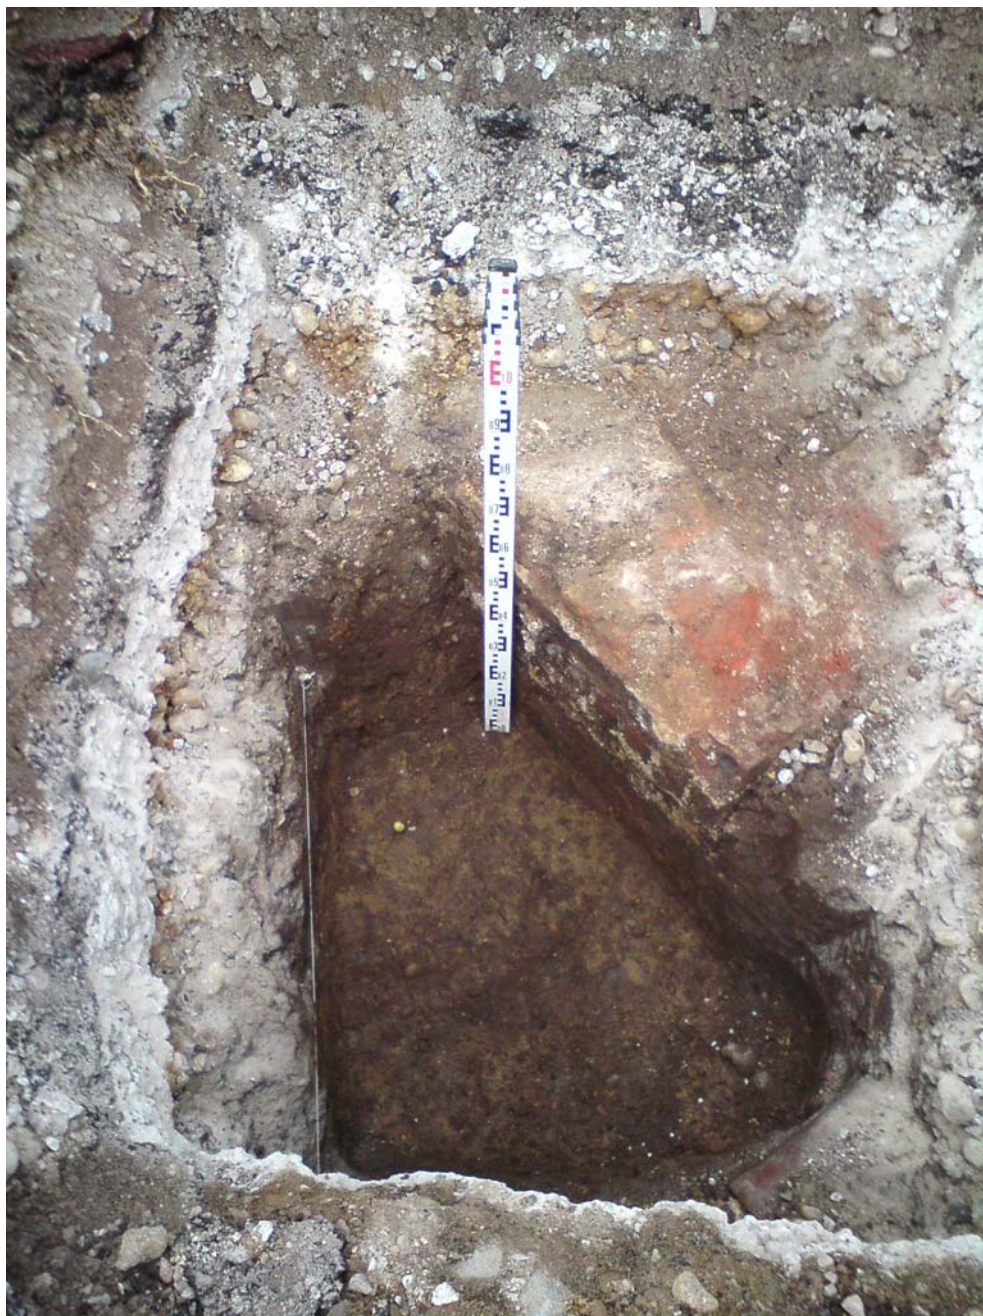
Plate 5. Trial pit 5 looking south-west, showing Victorian wall 14, part of an outbuilding on the west side of the yard bounded by the 1858 silk mill to the east and the manager's house to the south. Trial Pit 5 failed to locate the projected second Roman road, but a Roman buried soil 12, overlying natural brickearth, was recorded in the base of the trial pit. Scale 1.2m
