**CHALK END FARM, FARMBRIDGE END ROAD
ROXWELL, CHELMSFORD
ESSEX**

LEVEL II HISTORIC BUILDING RECORD

Essex County Council
Field Archaeology Unit

July 2009

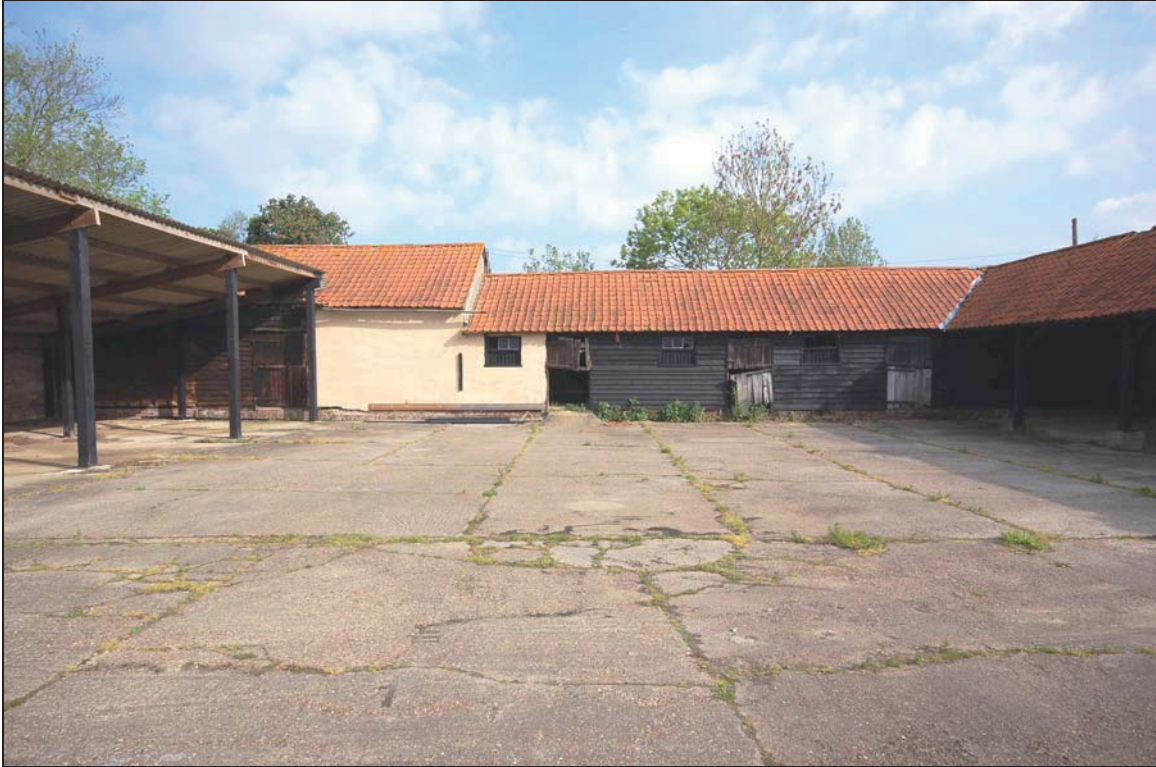
Plate 1 Farmyard viewed to north

On the south (yard) elevation (plate 1) the exterior is weatherboarded up to the main entrance, a wide ledged braced and battened half-heck door that leads onto the yard. The outline of the former brick wall and roof of the old western range can be seen to the west of the yard door, inside the modern shed 6 (plate 2). Beyond the south door, heading east, the walls are rendered in cement over the existing weatherboarding, and this is also true of the gables and rear (north) wall where the whole of the north range has been re-covered (plates 3 & 4). Access out of the north side is by a second half-heck door, identical to that on the south side that leads out onto the fields (plate 3).

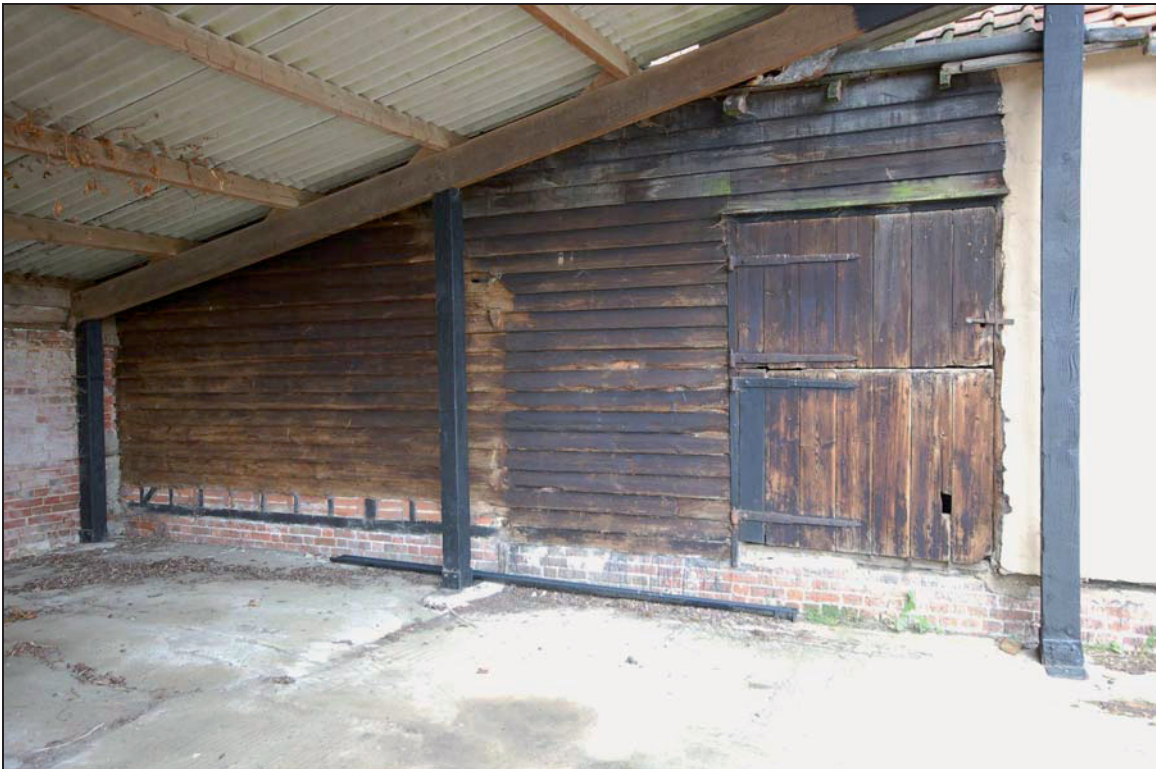
Plate 2 Wall scar of former West Range on Barn 1

The external main elevation facing onto the yard is weatherboarded except for part of the most westerly bay, which is rendered over (plate 2). Half-heck stable doors are arranged at roughly regular intervals along the elevation, with windows between, providing entry to each section (fig. 6). The doors have wooden ventilation grills above the lintel and the windows are unusual in having a vented lower part and glazed upper part (plate 8) that could be slid open horizontally from the interior (plate 11) to bring in fresh air.

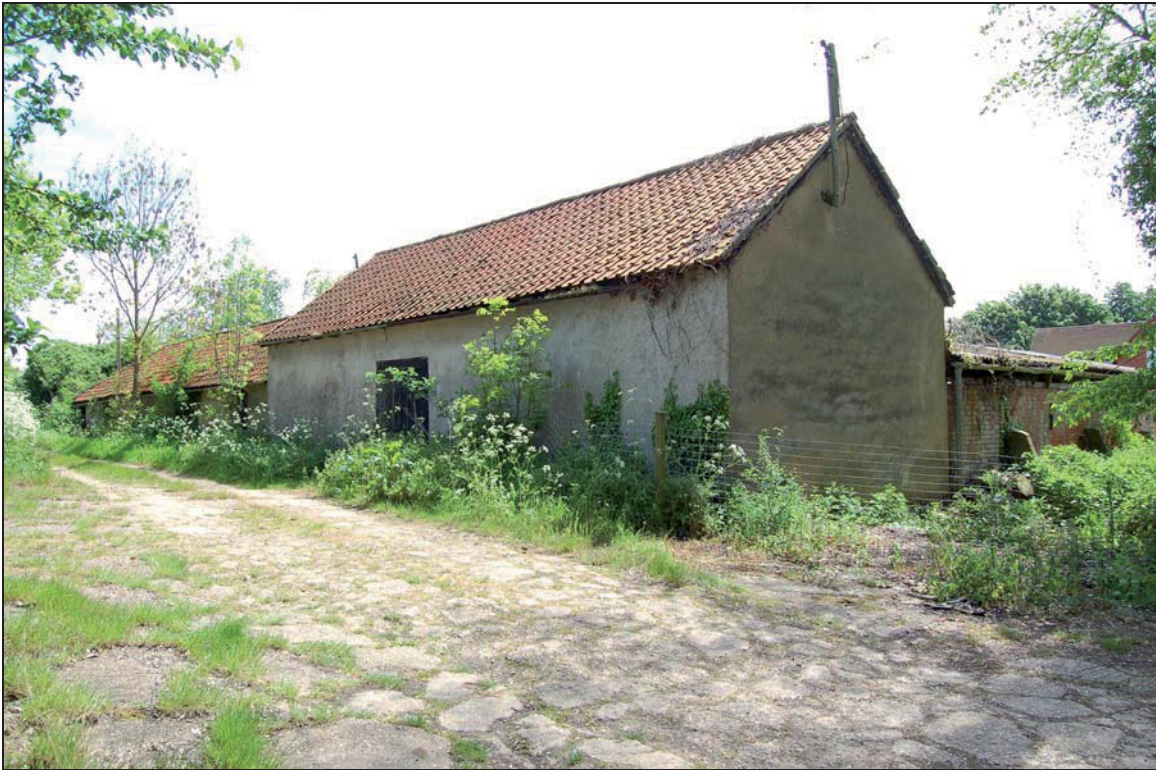
Plate 3 Barn 1 and North Range viewed towards south-east

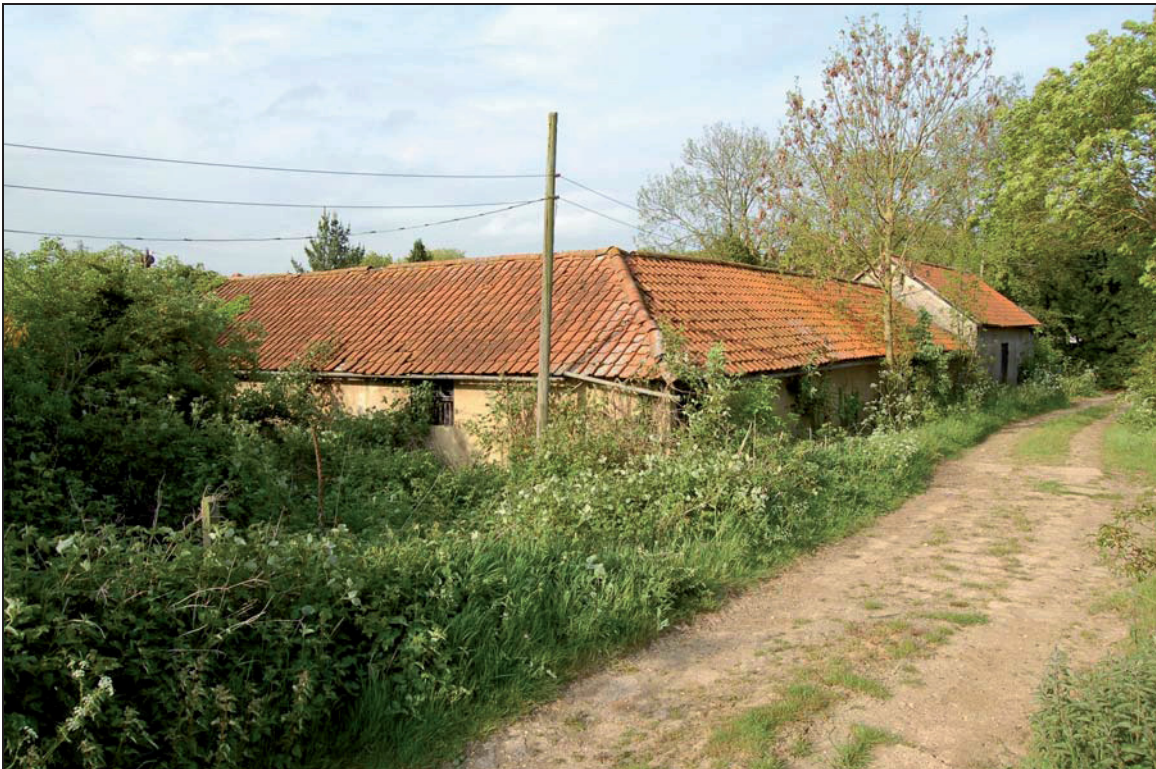
Plate 4 North and East Ranges viewed towards south-west

Render has been applied to the rear elevation and continues onto the east range. The roof between the two ranges is hipped (plate 4).

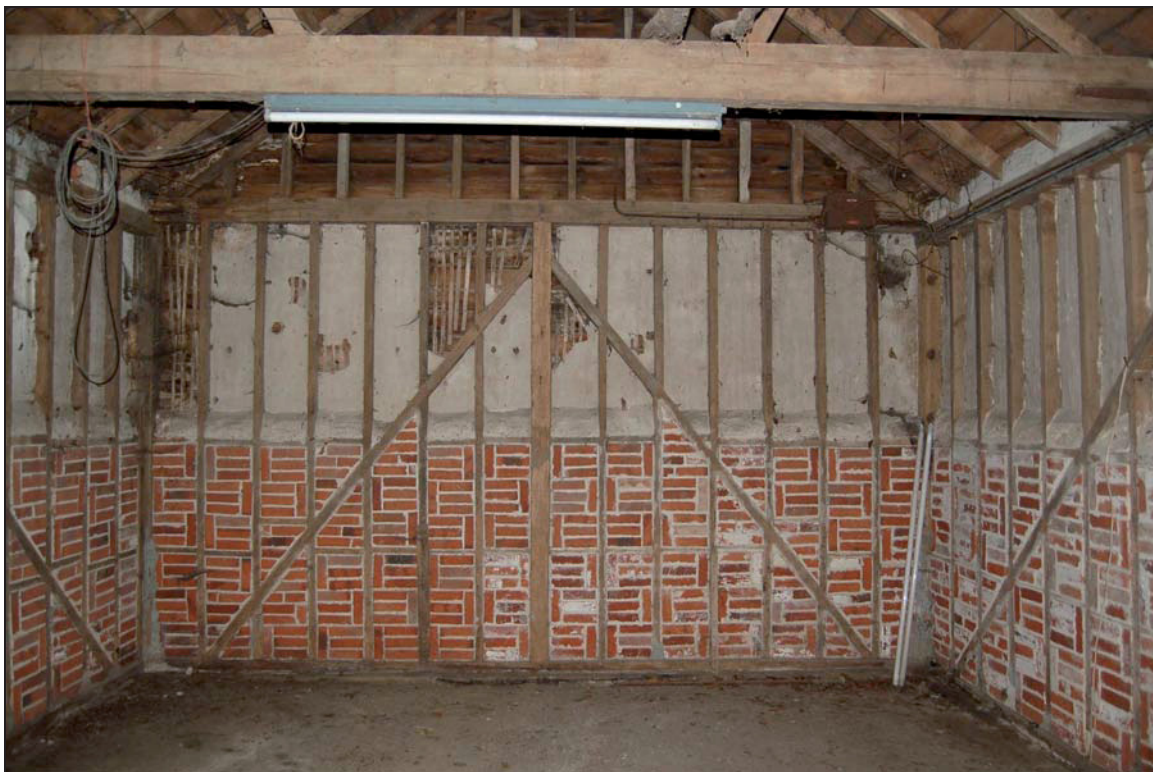
Plate 5 Brick noggin inside Barn 1 (west wall)

Internally the barn is divided into five roughly-equal short bays between 2 and 2.5m wide. A regular, nailed, primary-braced timber frame rests on a wooden sill and the spaces in-between the timbers have been infilled with (frogged) brick noggin up to 1.5m high in an alternating four-brick pattern (plate 5), which is rather unusual. Above, the panels are lath and plastered. A floor scar between bays 3 and 4 shows where a partition stood, which is likely to be freestanding and modern as there are no historic fixing points on the walls or truss above.

Following the fire, the north range was completely rebuilt in new machine-sawn timbers. Inside, the barn was lined-out in a decorative pattern of brick noggin and plaster that would have provided a form of insulation more typical of a building meant for stock. Indeed, were it not for its lack of light and ventilation, this would be the likely function. After all, there is no familiar porch and large cart doors more typical of barns. Given the size of the barn it would only be suitable to store small harvests or animal feedstuffs, though cartographic sources show it to be comparable in size to the former barn.

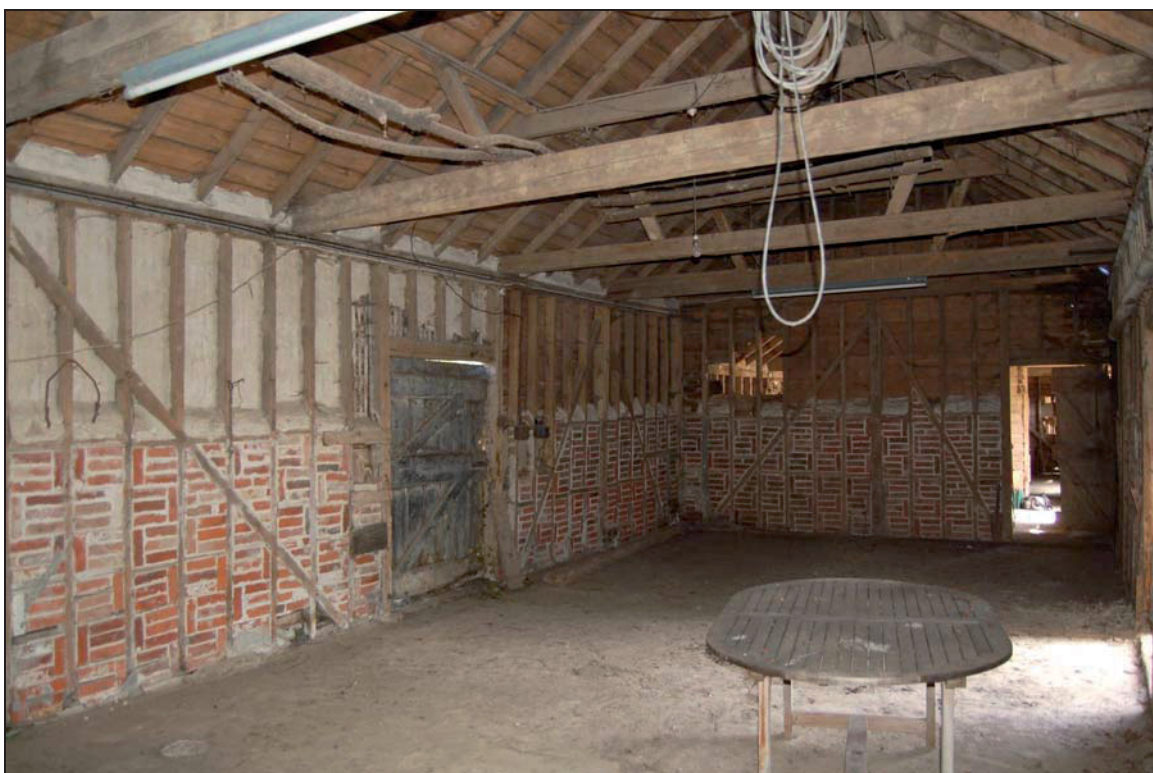
Plate 6 Interior of Barn 1 viewed towards Stables 2 (east)

The narrow 8 x 3 inch tie beams are fixed by iron straps at either end, while the roof trusses consist of widely-spaced raking queen struts and intermediate collars to purlins (plate 6).

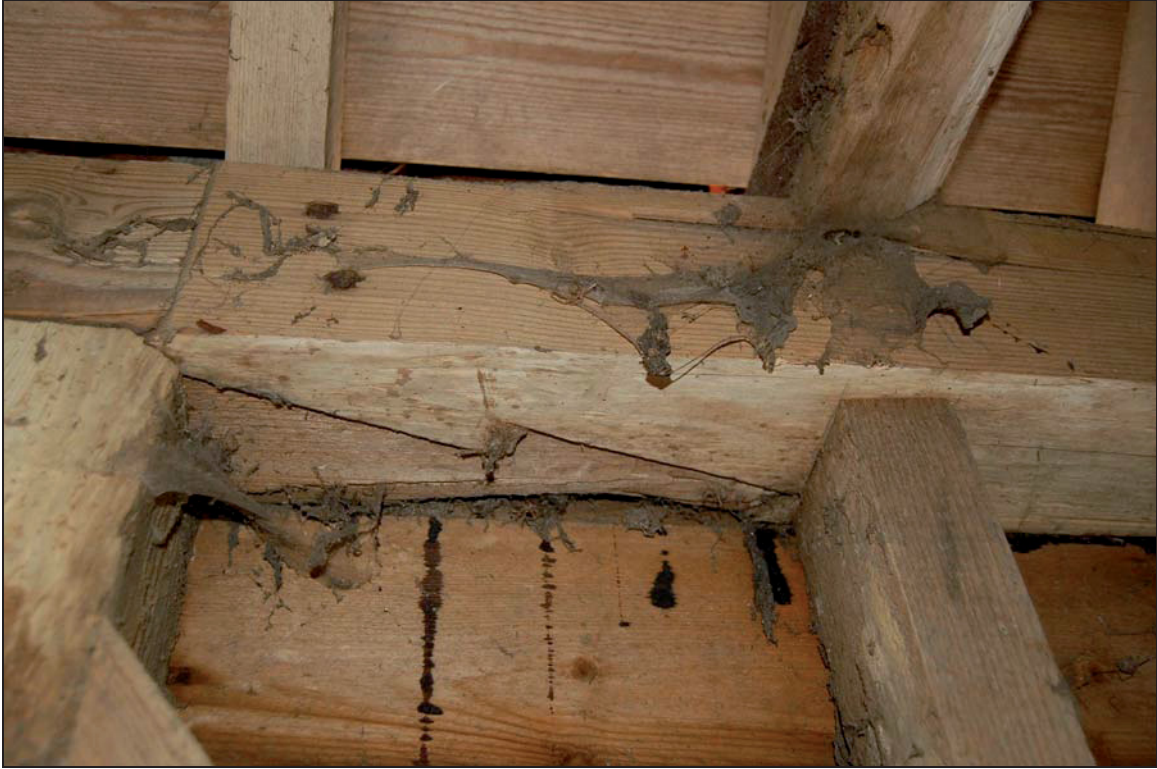
Plate 7 *Trait de Jupiter* scarf joint

The wall framing has long wall plates held together by nailed and pegged through-splayed and tabled scarf joints (*trait de Jupiter*- plate 7), initially a medieval form but revived during the late 19th century in use across the whole of the north range. The studs are narrow and straight, with 2 by 4 inch scantling.

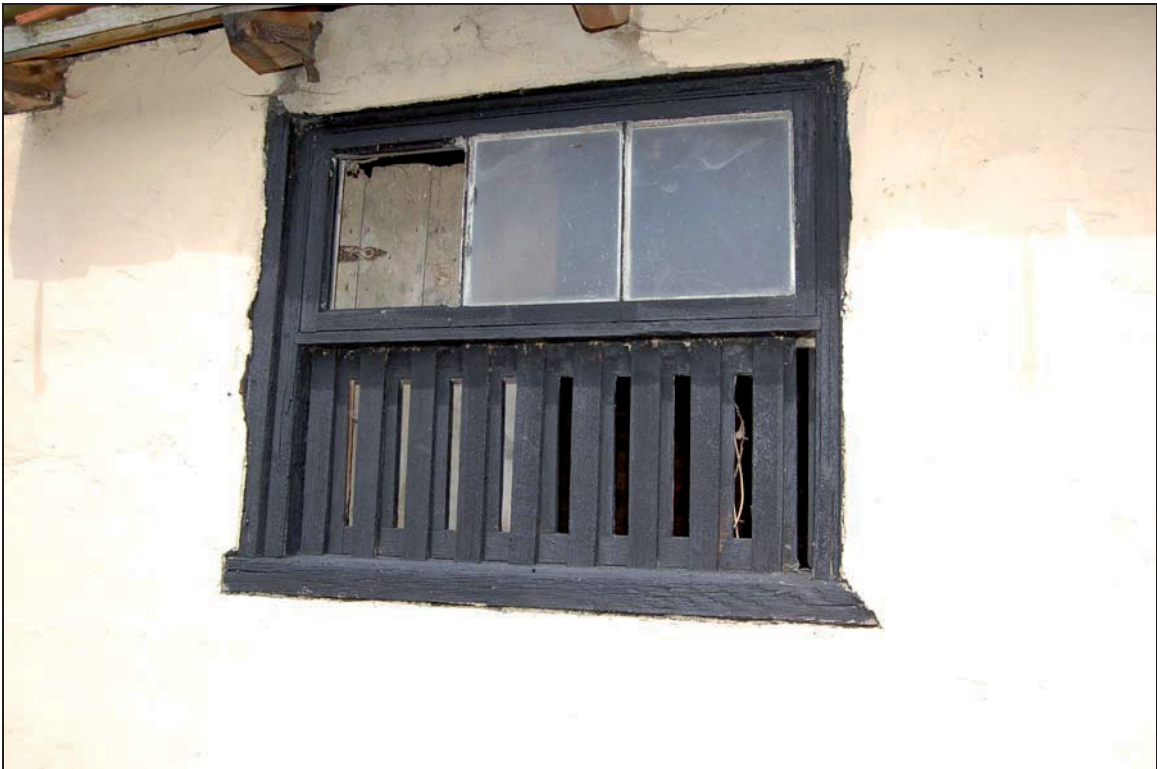
Plate 8 Vented window on stable block

for three horses, but there were probably more. The stable windows with their sliding air vents are notable features.

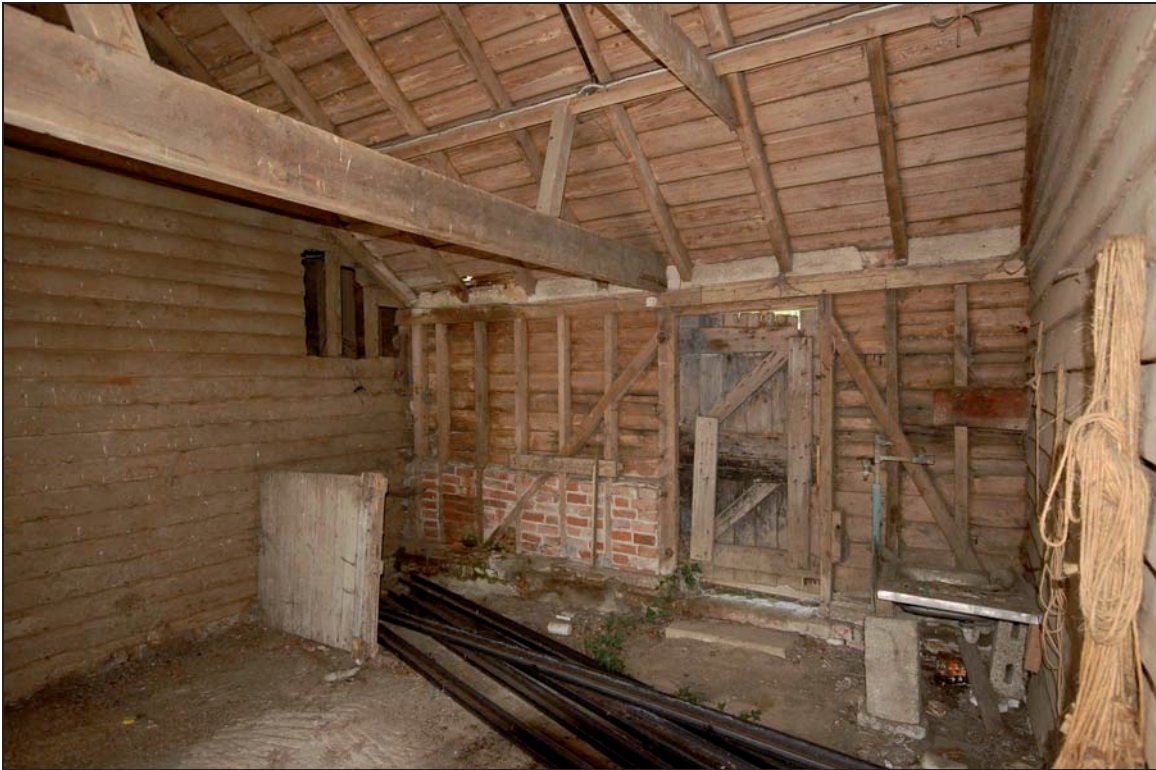
Plate 9 Interior of feed store in Stables 2 (view to north-west)

A two bay feed store is located between the barn and stalls, identified by the remains of a wooden grain bin by the barn wall (fig. 6, plate 9). A tap has been fitted on the other side which, although later in date, again points to a utility function. Part of the rear wall has brick infill but this is absent elsewhere. A half-heck door leads out through the north wall to the back (plate 9).

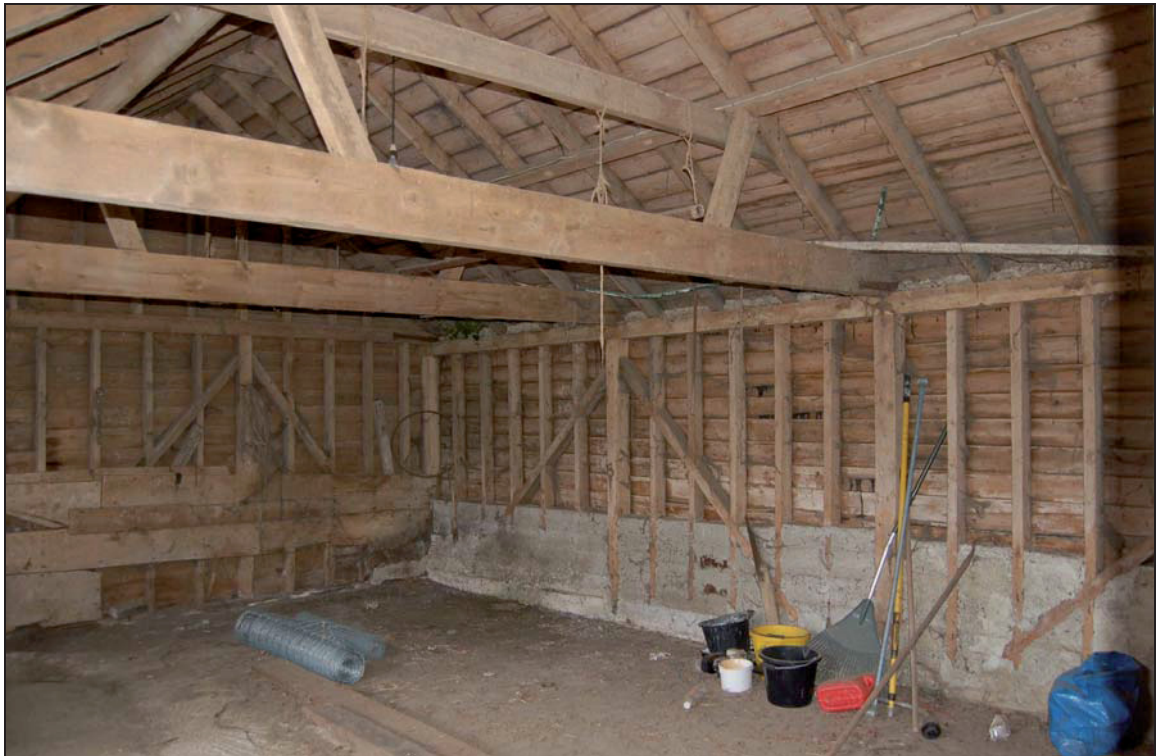
Plate 10 Interior of stalls in Stables 2 (viewed to north-west)

The stalls occupy the three bays east of the feed store. The two end walls are partially boarded to protect the horses and the back wall has concrete infill around the lower parts of the studs (plate 10) where the old feeding trough and hay feeder would have been located.

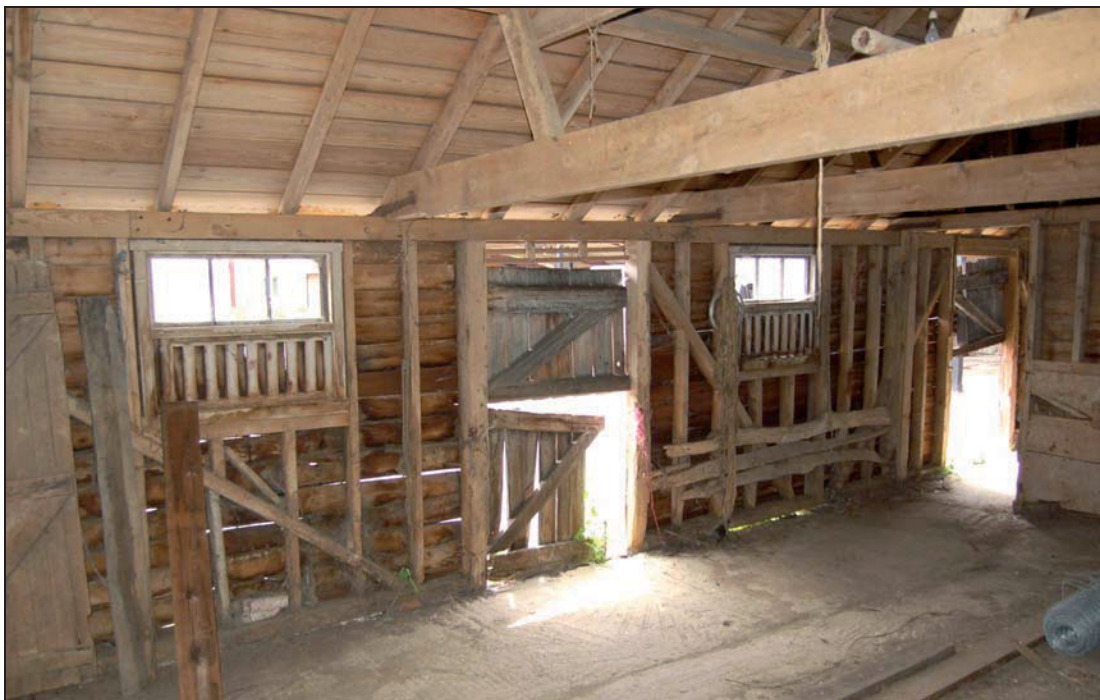
Plate 11 Stalls in Stables 2 viewed towards yard (south)

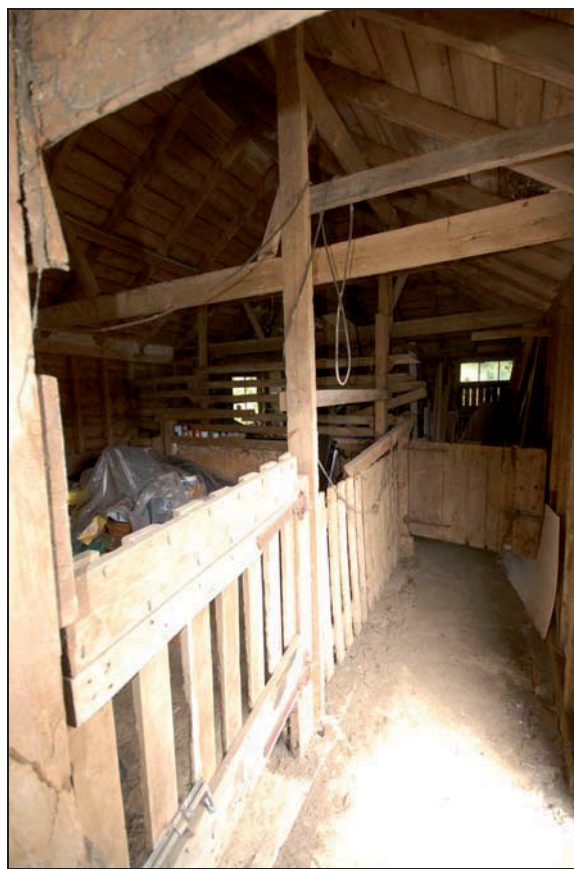
Plate 12 Interior of Loose Box viewed to east

The two loose boxes differ in their construction, the western one being slatted and the eastern one boarded (plates 12 & 13), though the holding fixtures are the same to each and identical to the doors out onto the yard. The outer walls are half-boarded, with three harness racks attached to the south wall (fig. 6). A plank of wood nailed to the same wall contains an inscription reading 'March 1886 TR' and alludes to the rebuilding of the range after the fire (plate 14). The initials probably belong to either the landowner, farmer or the builder who carried out the work. There are other less conspicuous inscriptions, most notably 'WH 1900' to the right-hand side (plate 14), possibly referring to some long-forgotten phase of improvement or maintenance work. Other inscriptions are indistinct and impossible to decipher.

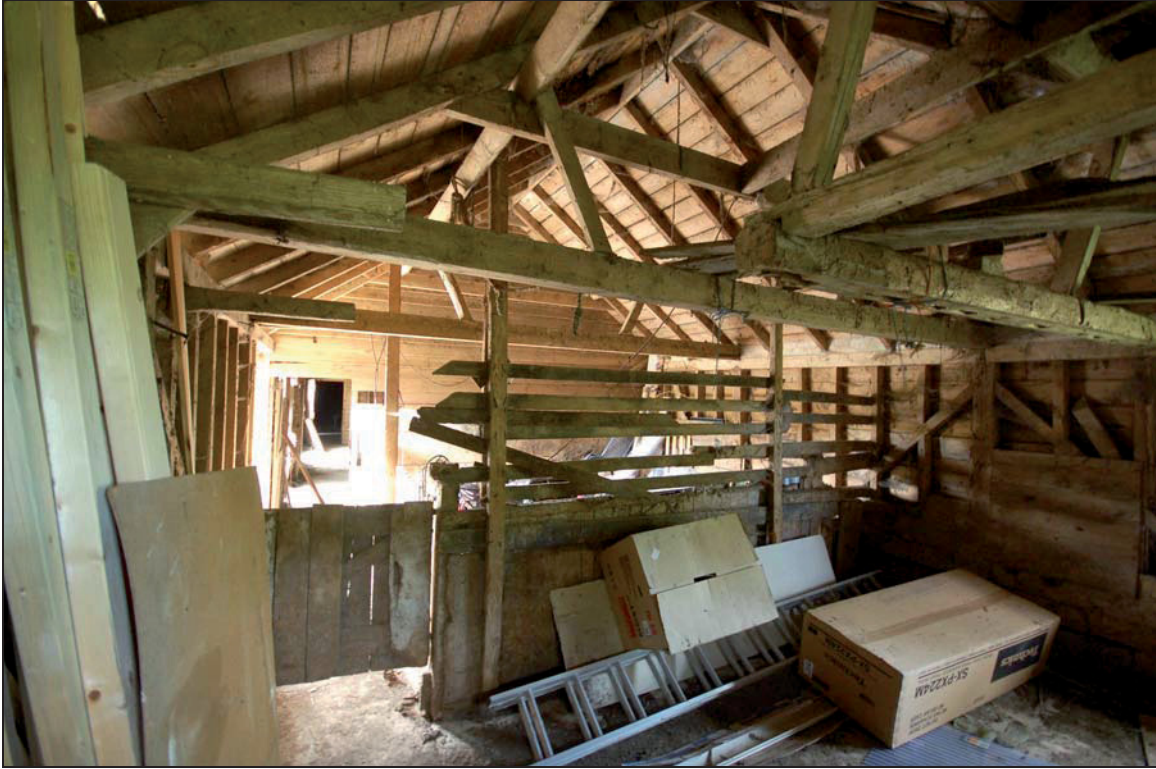
Plate 13 Interior of Loose Box viewed to west

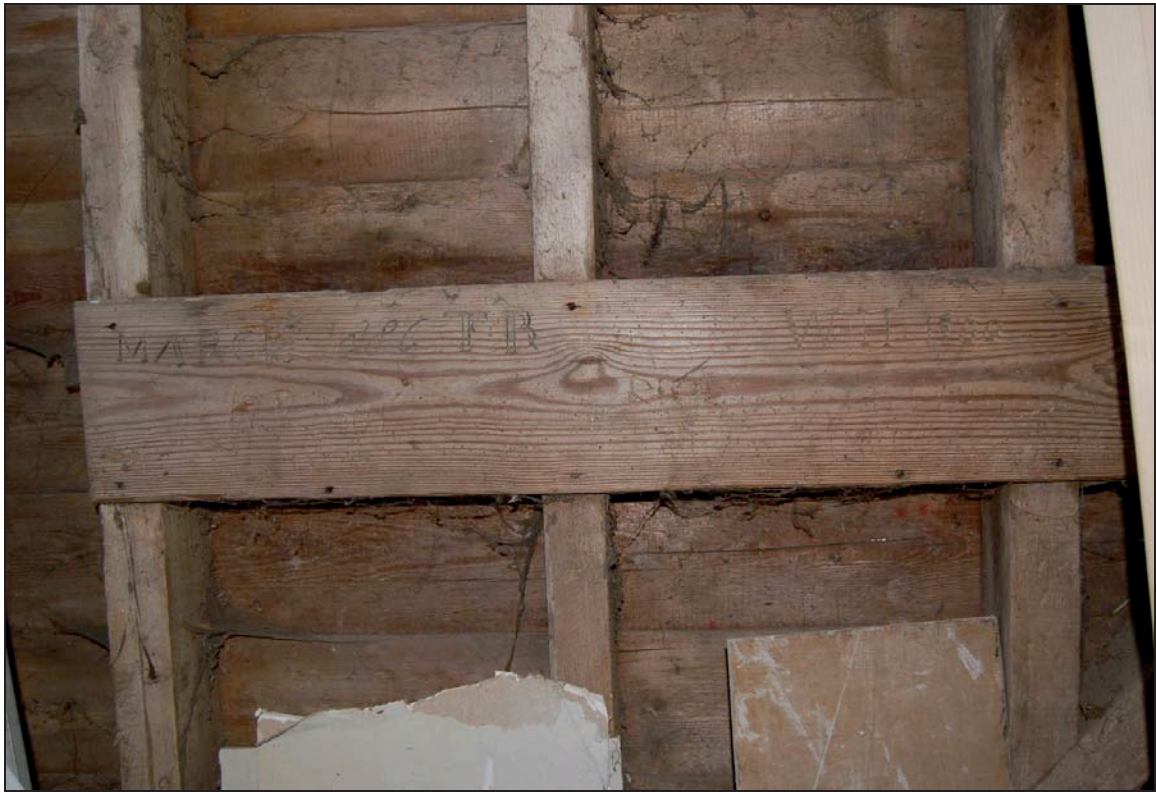
Plate 14 Dated inscription inside Loose Box

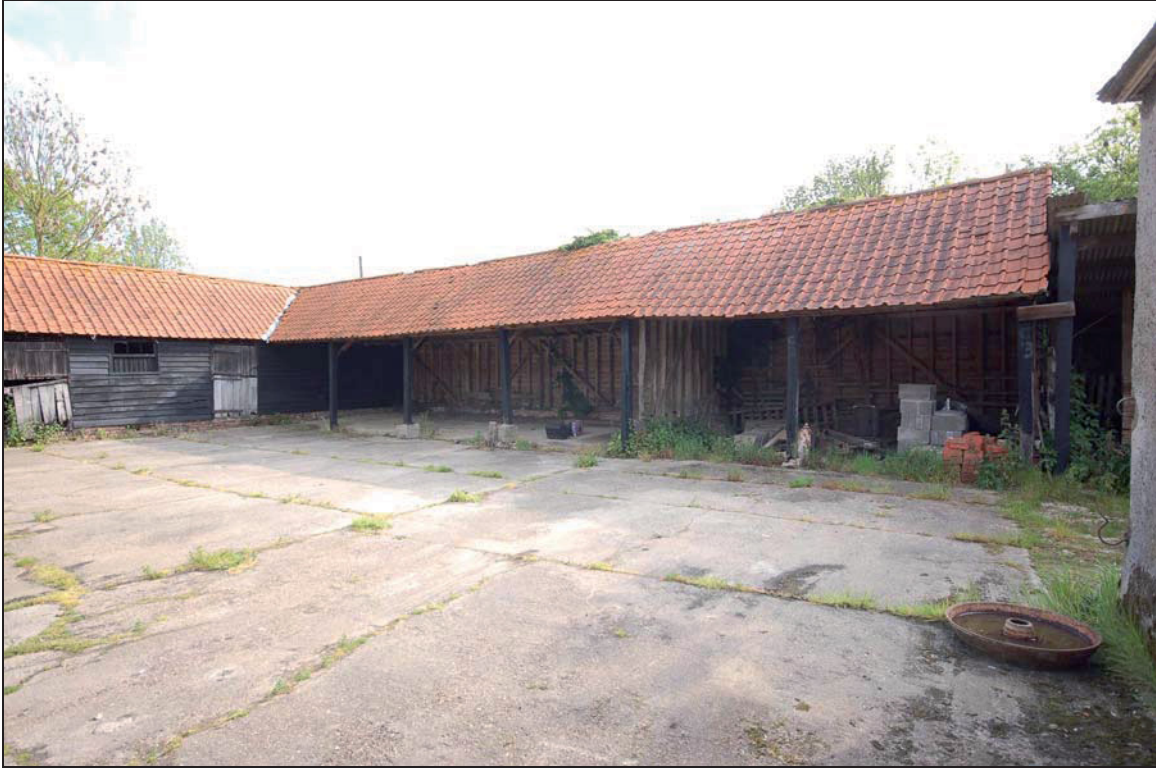
Plate 15 East Range viewed towards north-east

Two cattle sheds face onto the eastern side of the yard (plate 15), which were rebuilt in the 1880s using mainly reused timbers from the earlier farm and farmhouse. Much of the main framing (bay posts, sills and braces) is heavier than the rest, with a high percentage hand-cut and re-used. Also, some of the studs are heavier (up to 4 by 4 inches) and have a waney appearance often seen in structures dating to the 18th and early 19th-century (plates 16 & 17), though there are many machine-sawn studs included in the build, particularly in shed 4.

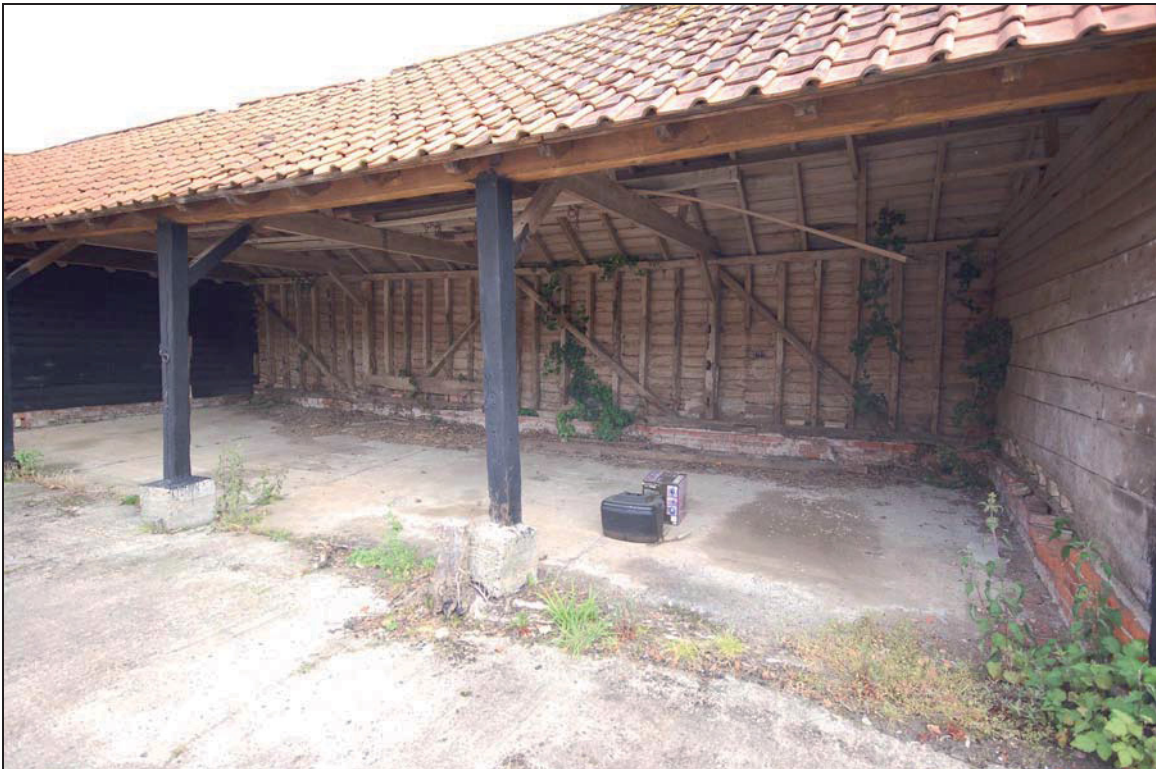
Plate 16 Cattle Shed 3

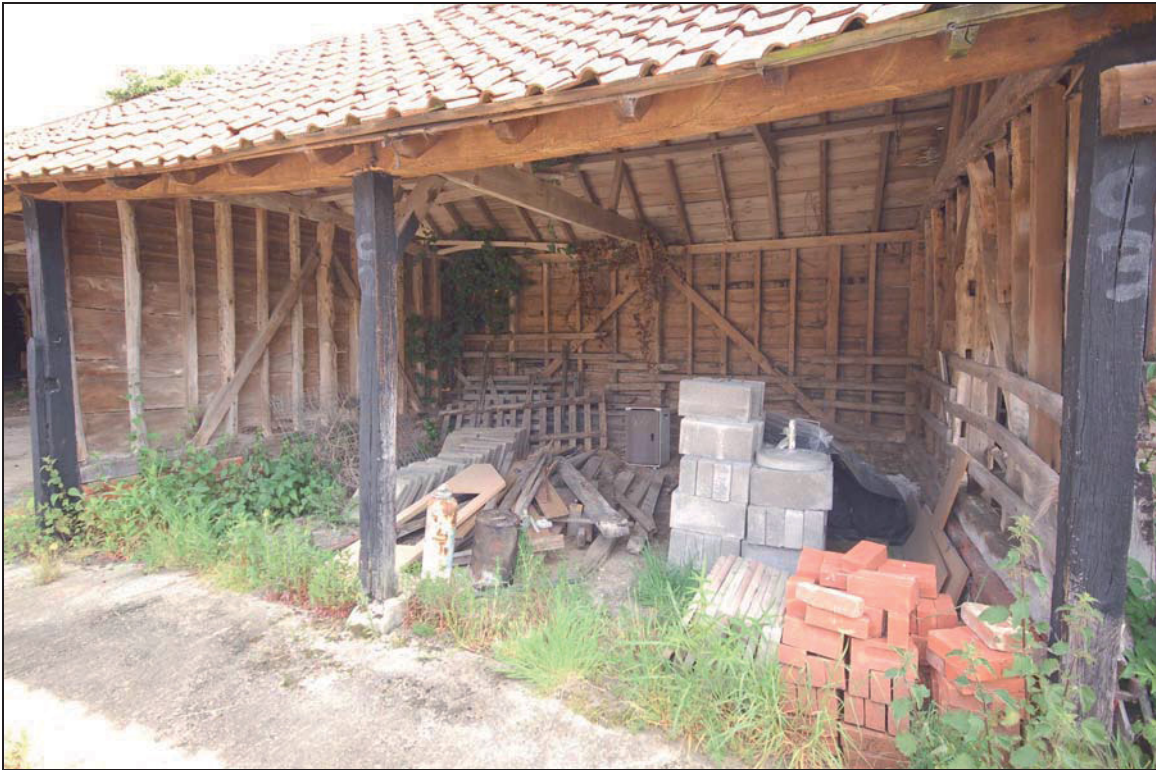
Plate 17 Cattle Shed 4

The two sheds are raised on low brick plinths that also support a stout dividing wall incorporating a reused plate and sill (plate 17).

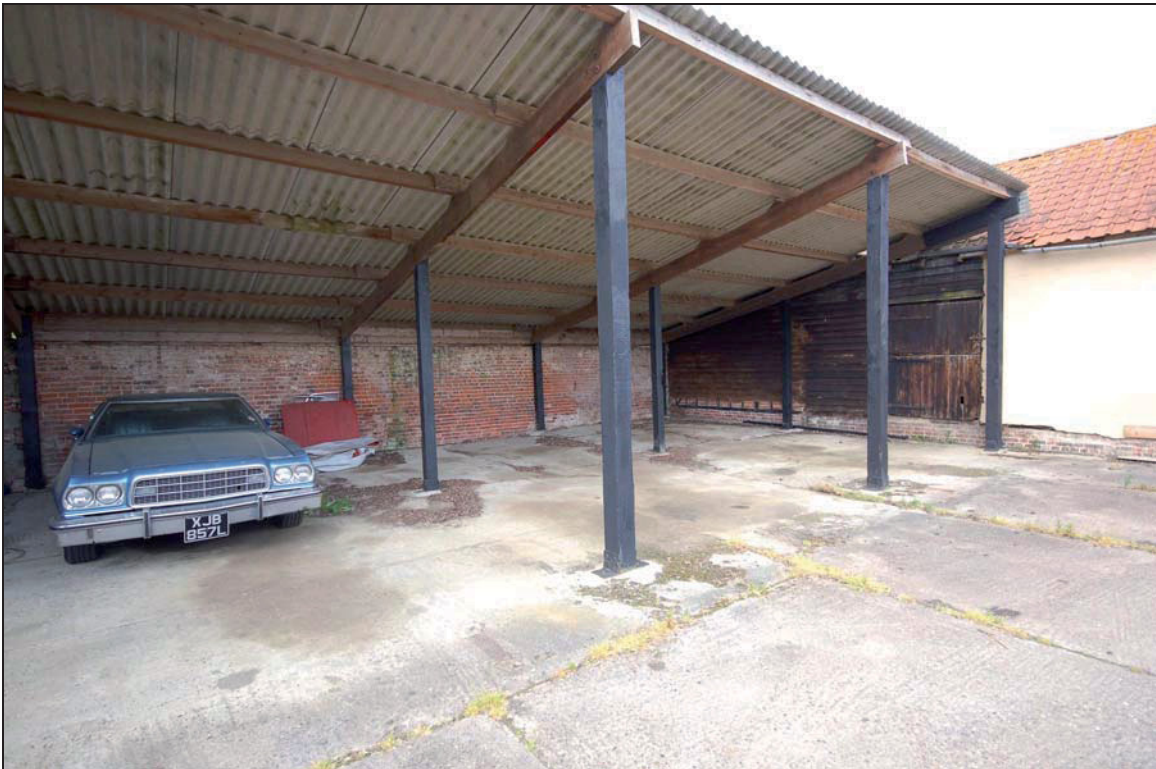
Plate 18 Remains of West Range within Modern Shed 6

Two tall modern sheds, built from timber and corrugated sheeting, were built at the end stages of farm. The largest is shed 6, which is built onto the former rear wall of the western shelter shed range (plate 18). This wall is constructed in monk bond from 9 inch soft red bricks typical of those manufactured in the 19th and 20th centuries (Ryan 1996) and thus fits in well with the rebuilding of the farm in the 1880s.

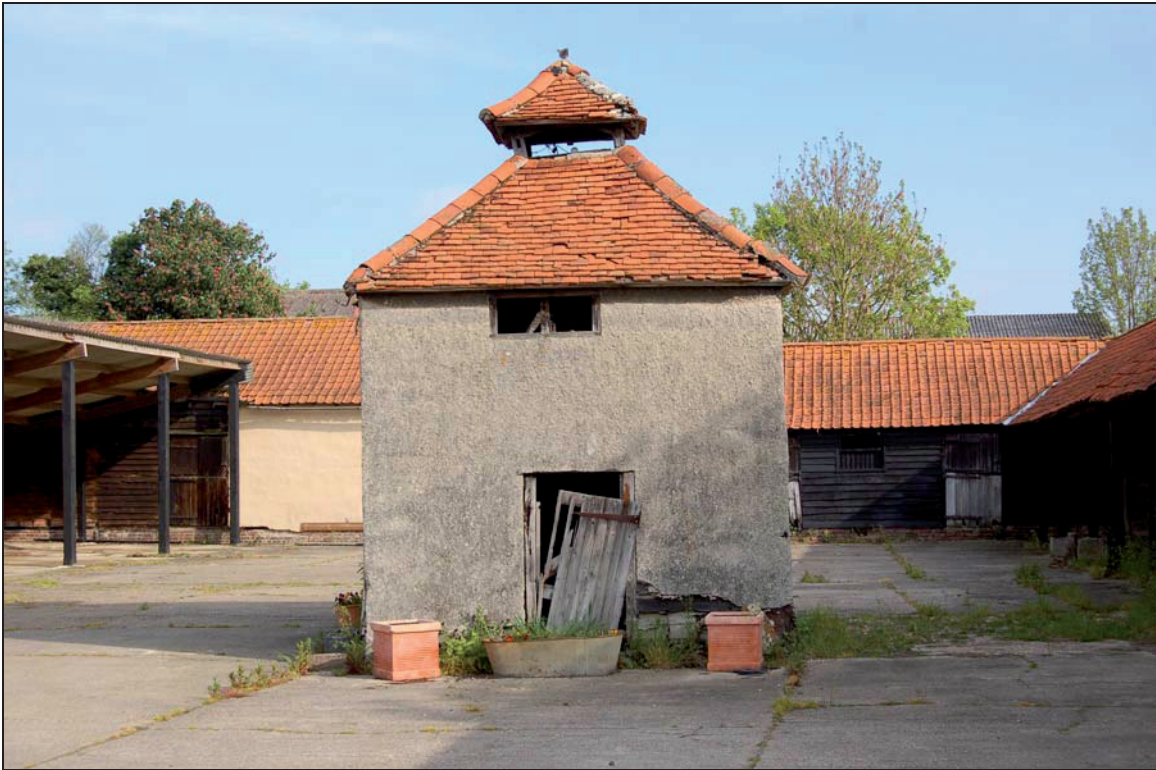
Plate 19 The Dovecote

The dovecote is a timber-framed and weatherboarded structure encased in a modern cement render skin. The sole entrance is on the south side and there is a later inserted window above (plate 19). The roof is plain-tiled and pyramidal in form with a canopy at the top for bird egress. The interior is primary-braced in quite heavy timbers (plate 20), some of which are pegged. Most of the main timbers are reused, some containing sockets for down bracing. All fresh studs are irregular, hand-cut in an 18th century form.

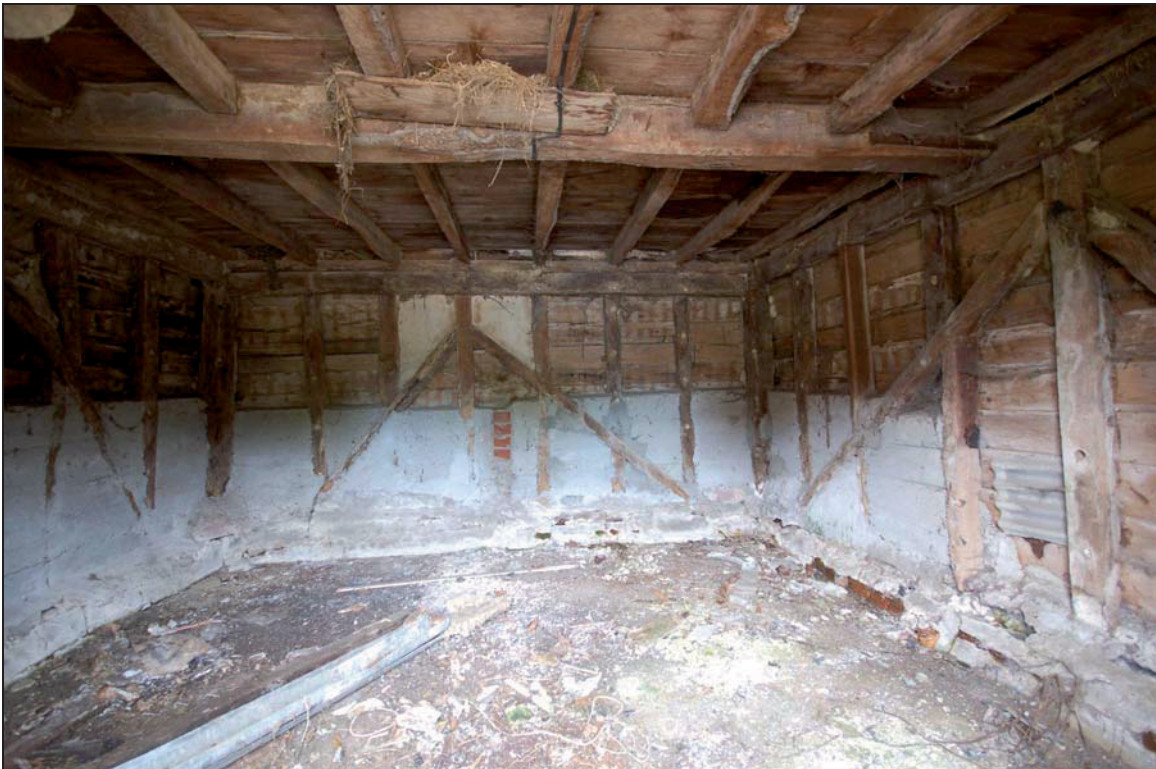
Plate 20 Dovecote interior (ground floor)

The first floor is inserted. Around the walls are empty pegholes for 'columbaria' or nesting boxes (plates 20 & 21), one of which lays amidst the rubbish on the first floor (plate 22), reached by a trapdoor at the south end. The roof has been re-felted and some new rafters inserted. Further photographs and a measured sketch plan of the building are included in the archive.

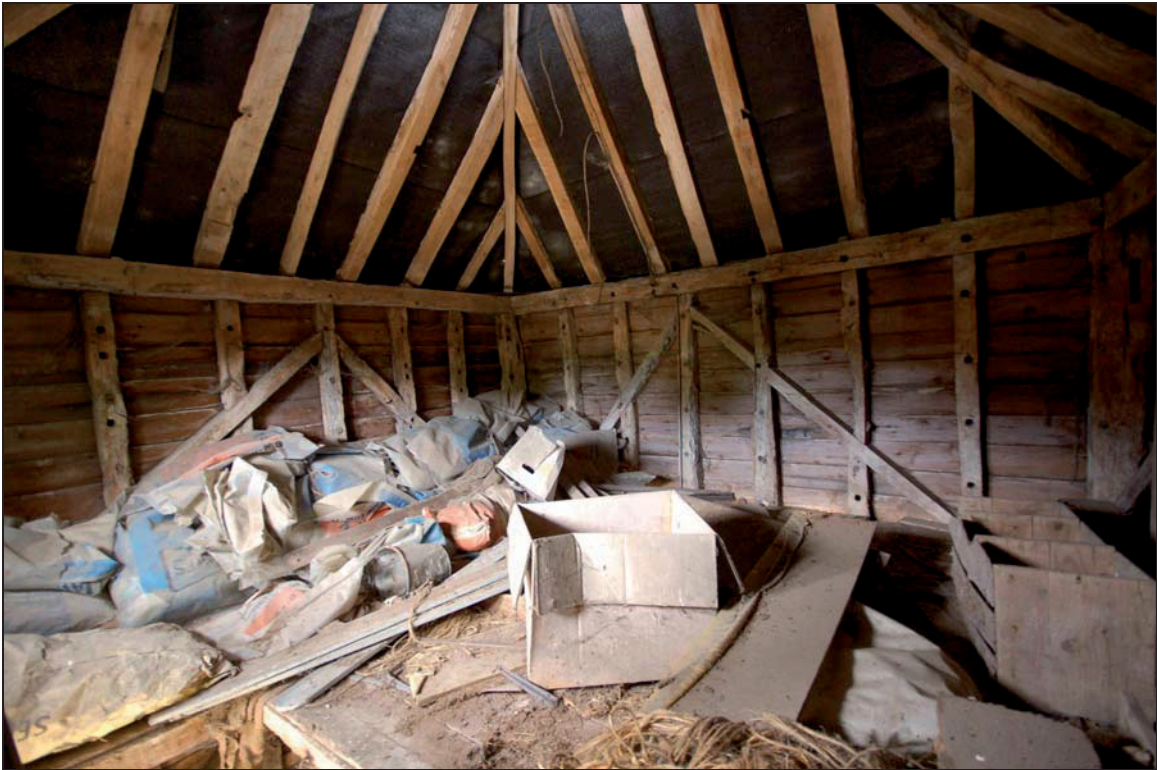
Plate 21 First floor of Dovecote

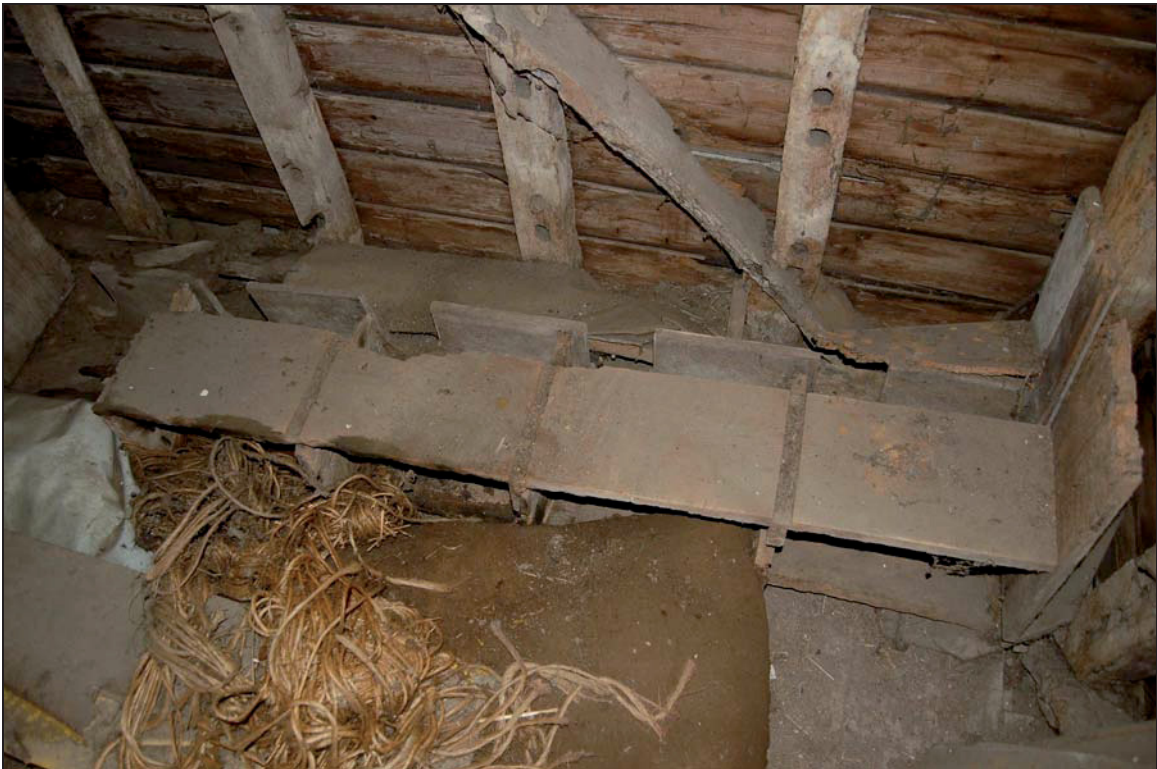
Plate 22 Nesting box (upside-down)
