**SALTBOX SQUARE, THE DOWNS
GREAT DUNMOW
ESSEX**

ARCHAEOLOGICAL EXCAVATION

Essex County Council
Field Archaeology Unit

January 2005

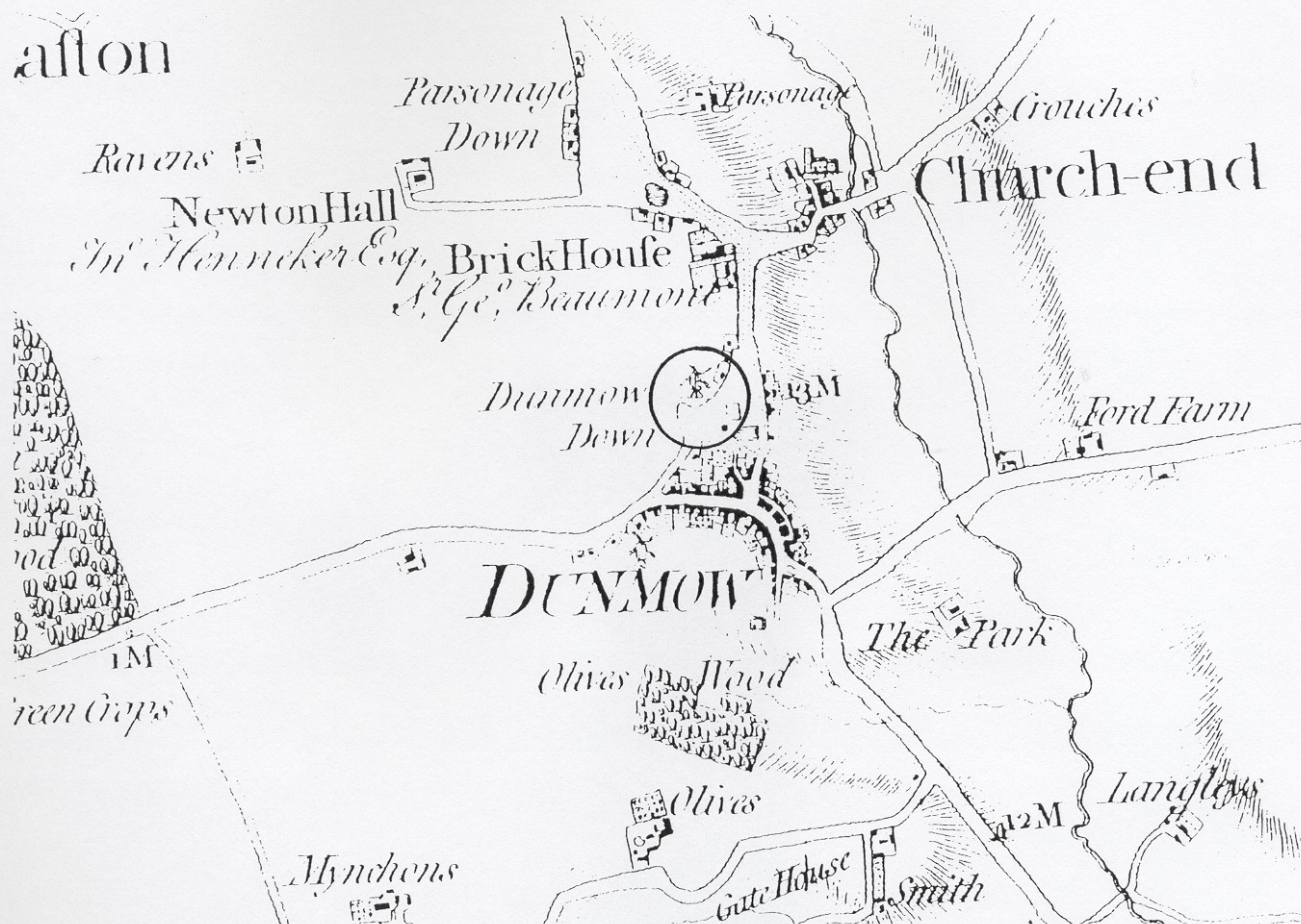
Fig. 2 Extract from Chapman and Andre map, 1777

Cartographic evidence (fig. 2, Chapman and Andre 1777) shows a possible medieval windmill in the proximity of the development area in the 18th century (HER 1316). This had disappeared by the mid-19th century (Tithe map 1840, not shown). However, an area to the rear of Saltbox Square is still known as 'Mill Field'.

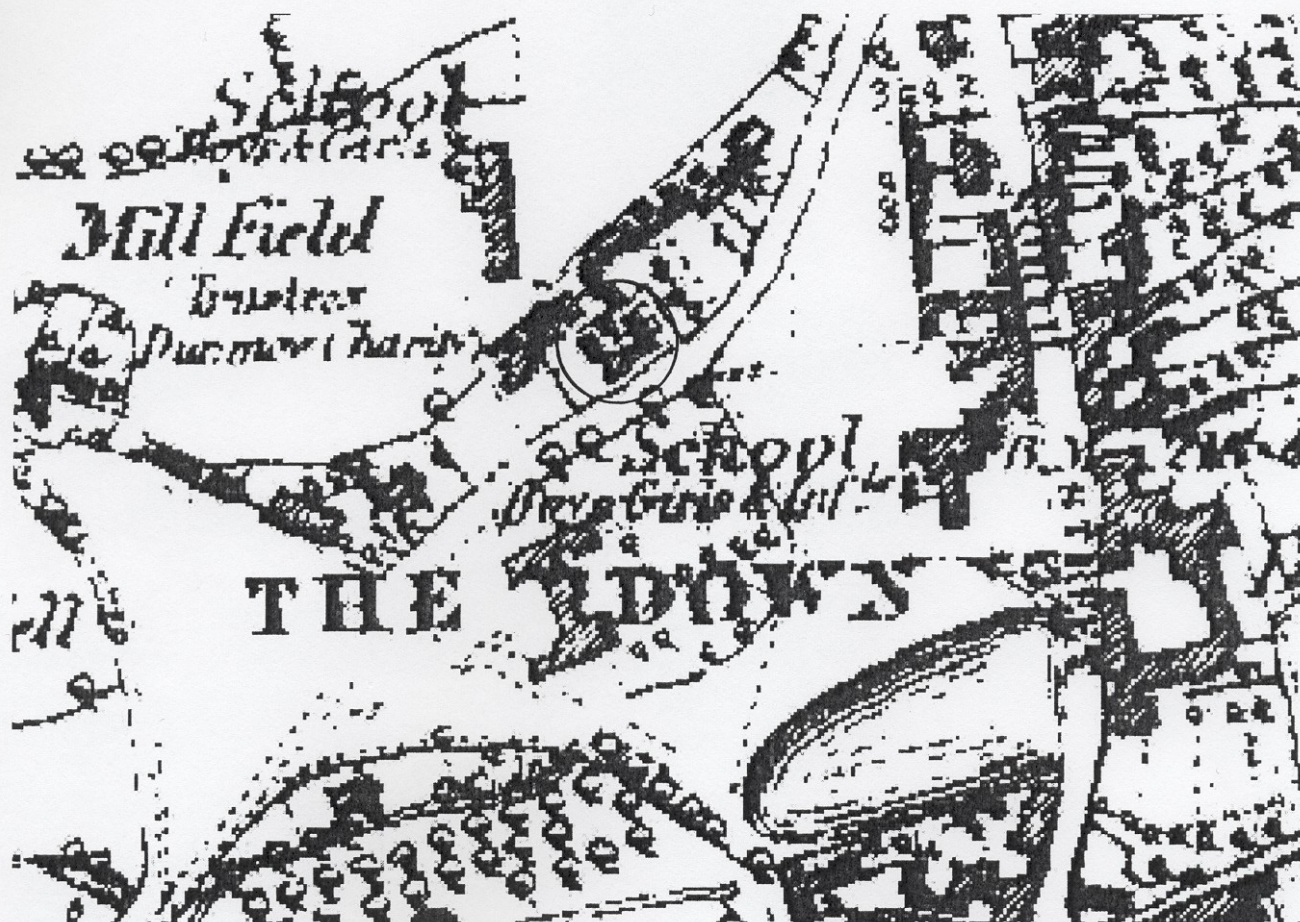
Fig. 3 Extract from First Edition OS map, 1881

Late 19th century mapping (fig. 3, OS First Edition, 1881) although not clear, appears to show a small block of houses on the site, likely to be Saltbox Square. According to the brief these were small one-up-one-down worker's houses, possibly forming an artisan quarter (Havis 2004). The New Series OS map, c. 1925, shows Saltbox Square in detail (fig.4). A slightly oblong block of eight houses on three sides can be seen, formed around a central yard open to the north. A separate block to the rear of the yard, also shown, contained a washroom and WC (S. Radland pers comm.). Most houses are of equal size and have front gardens. However, the two on the south-western arm and a third in the eastern corner, appear smaller. Those to the south-west also lack gardens (fig. 4).

The structure is apparently of one phase, partly built from red bricks of late 18th or early 19th character. A more exact date may be the middle of the 19th century: between the publication of the 1840 Tithe map and the 1881 OS First Edition. It is likely to be contemporary with surviving Victorian buildings located nearby, which exhibit similar characteristics in appearance and build.
