**THE TERRACE
WITHAM ROAD, HATFIELD PEVEREL
BRAINTREE
ESSEX**

LEVEL II HISTORIC BUILDING RECORD

September 2009

Prepared By: Andrew Letch Position: Project Officer	Signature: Date: 15th September 2009
Approved By: Mark Atkinson Position: Project Manager	Signature: Date: 15th September 2009

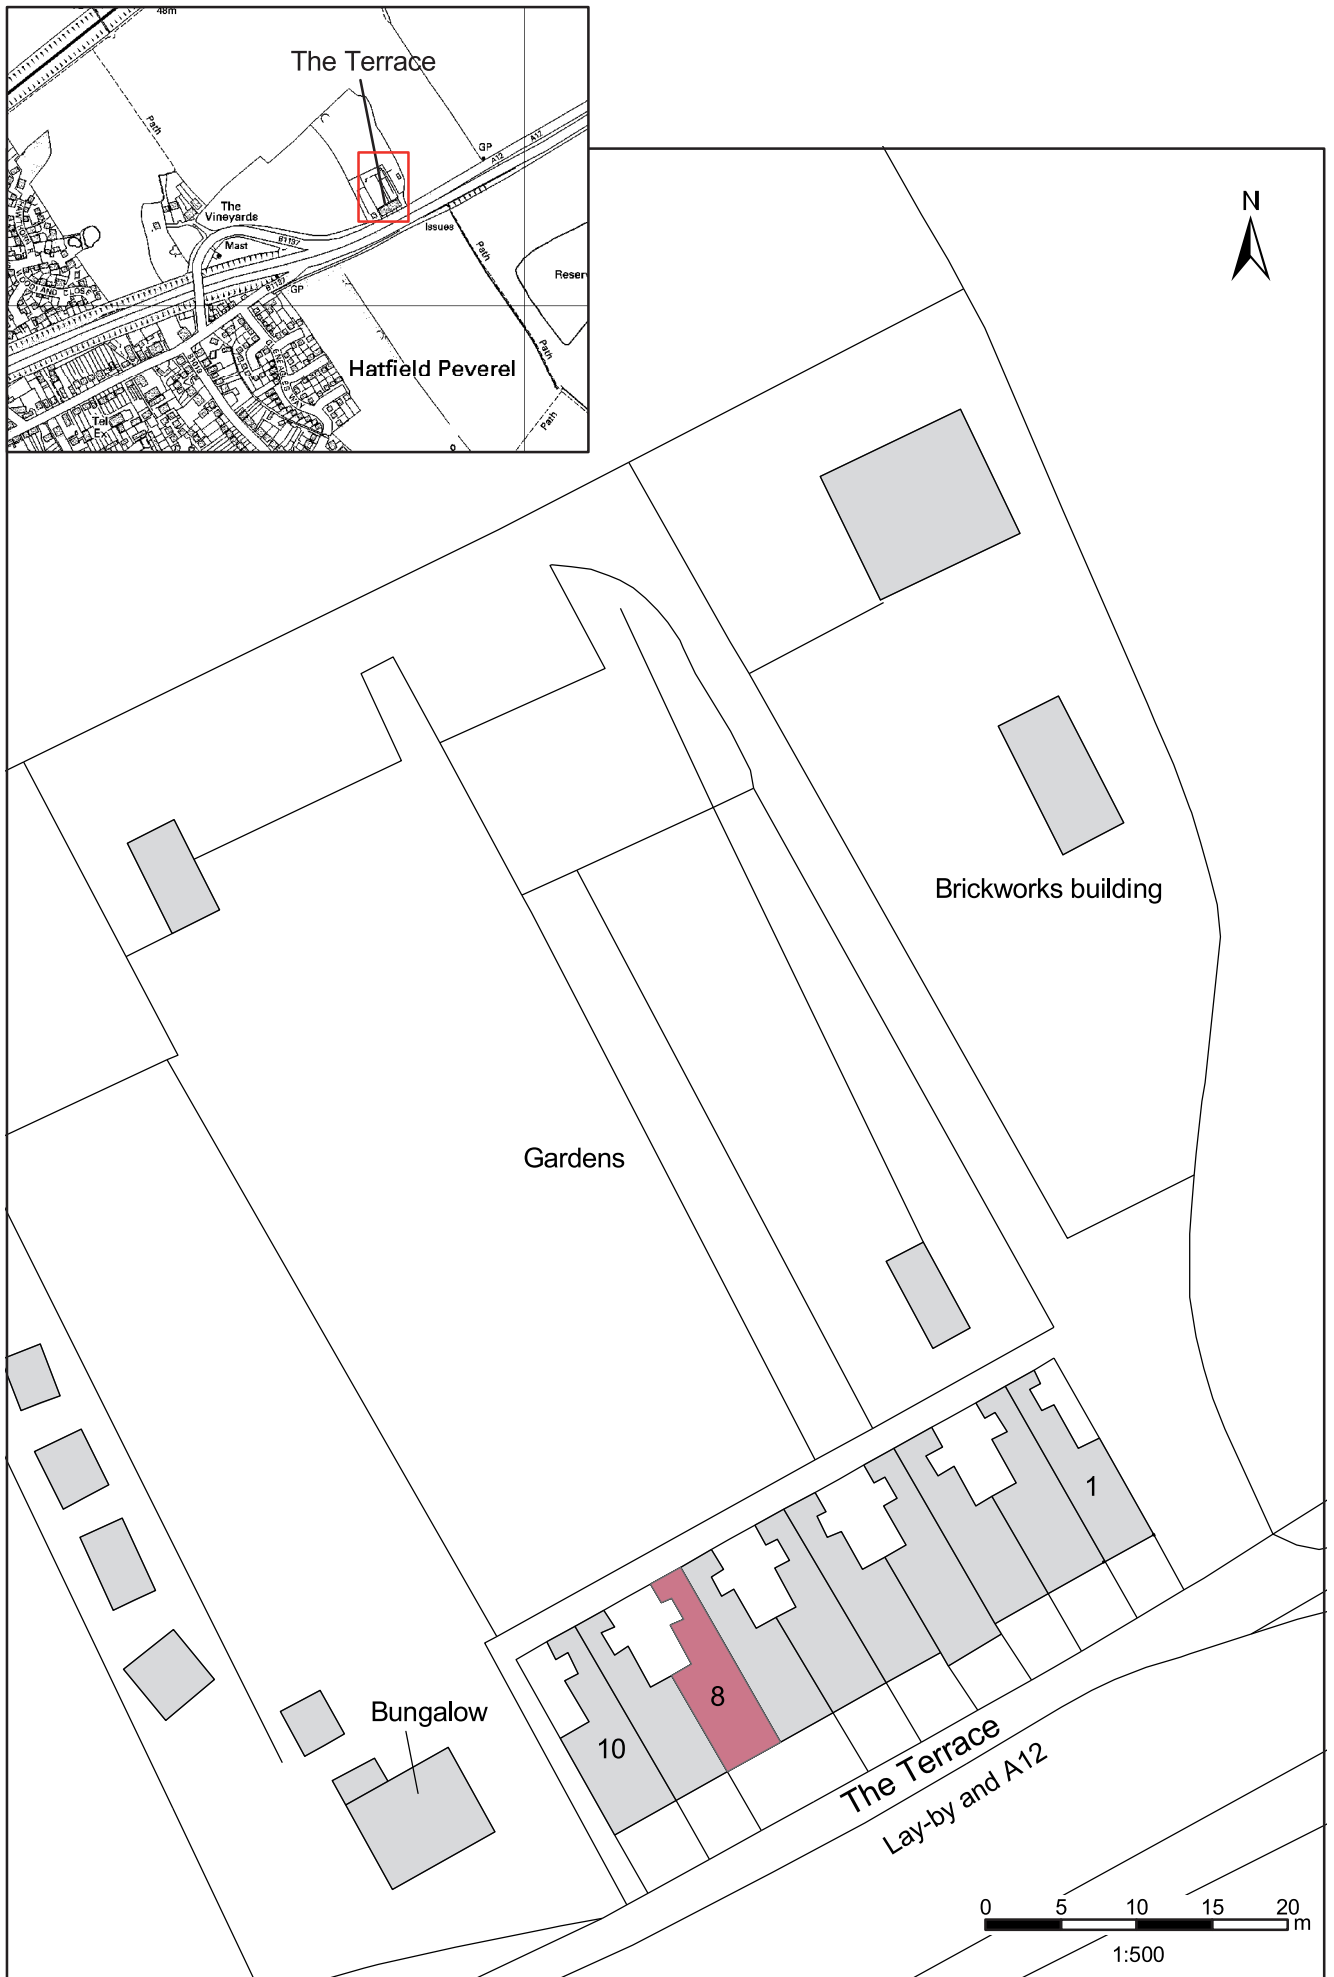
Fig.1. Site location

The Terrace lies to the east of the village of Hatfield Peverel along the busy A12 dual carriageway. It is an isolated group of buildings accessed by a lay-by just east of the Hatfield slip road at NGR TL 7975 1219. There are 10 cottages in all, each one until recently in private occupation. A modern bungalow stands on the west side ('Elmhurst'), which is not subject to survey.

The cottages are built from yellow stock bricks with red brick detailing forming a long range facing the south-east and the road. The properties are bounded at the front by rough brick walls and cast iron gates. To the rear are yards and long gardens within the earthworks of the old brickworking field, with garages and hard standings for cars at the bottom (fig. 1). The only other above-ground remnant of the brickworks is a small disused building to the north-east which is outside the development area (fig. 1, photos in archive).

A location/block plan was produced to show the context of The Terrace within its surrounding landscape (fig.1) and documentary and cartographic research undertaken to investigate the origins and development of the brickworks and houses (section 2.3).

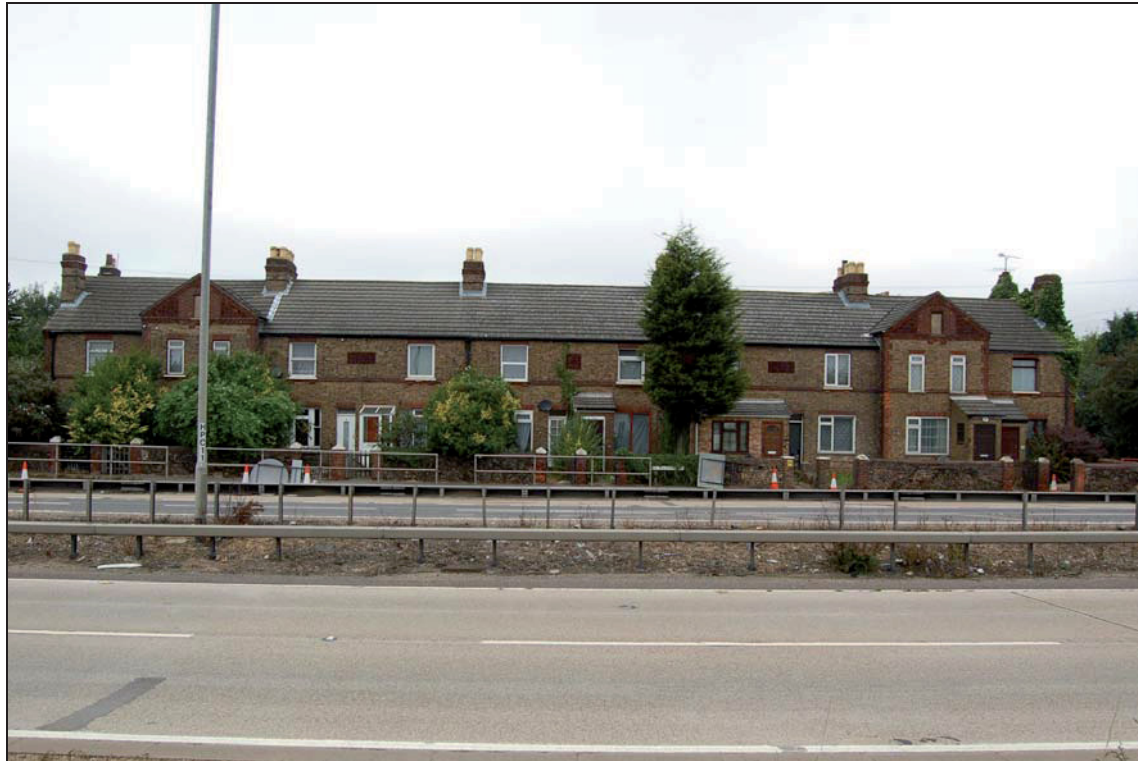
The main façade faces onto the road and comprises a single range with projecting gables in the penultimate bays either end (plates 1 & 2). All the windows and doors on the ground floor have been replaced and most windows on the upper floor, except possibly for the sash window on no. 8 (plate 3), though it is fitted with large single panes rather than double panes like those on the back. Ground floor windows are larger and probably had side sashes as well, similar to the window in no. 8 though this is a replacement. Windows and doors have flat red brick heads and red brick bands connect the windows at sill level on both floors (plates 2 & 3). Decorative features are provided in red brick.

Rectangular decorative panels are found between cottages 3 and 4 and 7 and 8 (plates 1 and 2) made from leaf and bud and leaf and berry tiles (plate 6). The best panel is in the middle of the terrace (cottage 5, plate 7); a square panel featuring a large sunflower at the centre, formed from four tiles, and bordered by bud and leaf tiles (plate 8).

Plate 1 The Terrace viewed to north-west

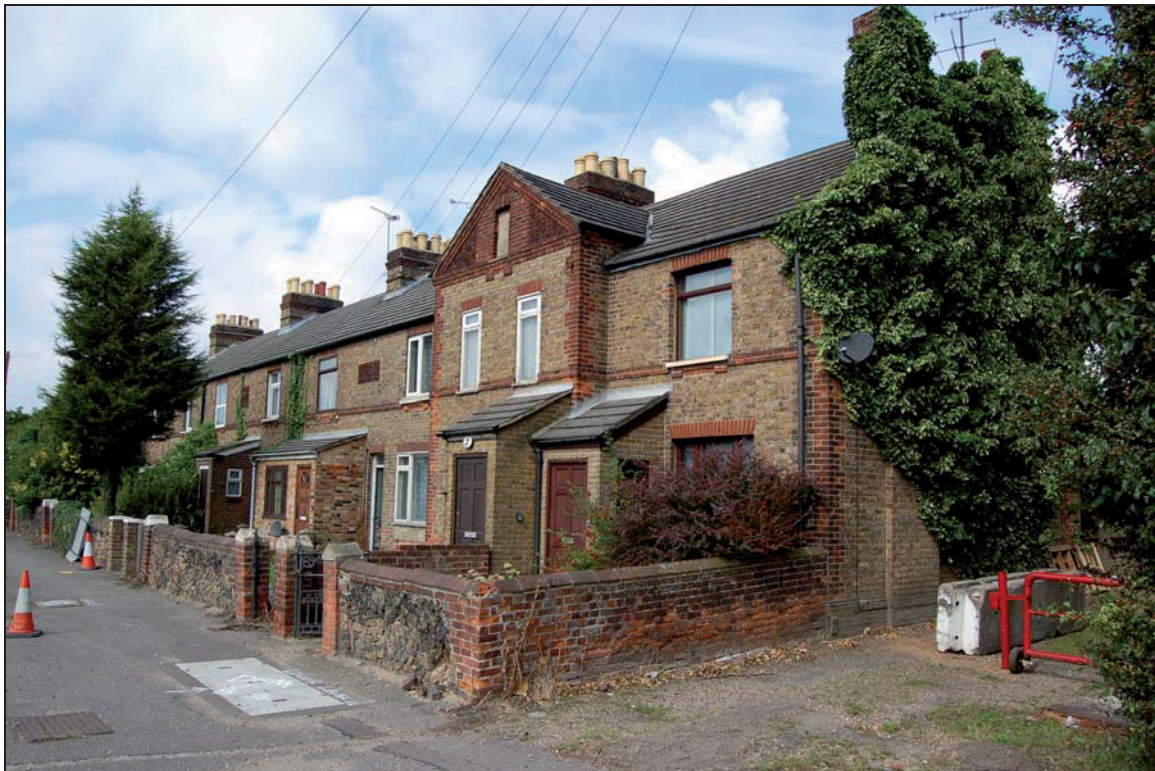
Plate 2 Cottages 1-7 viewed to west

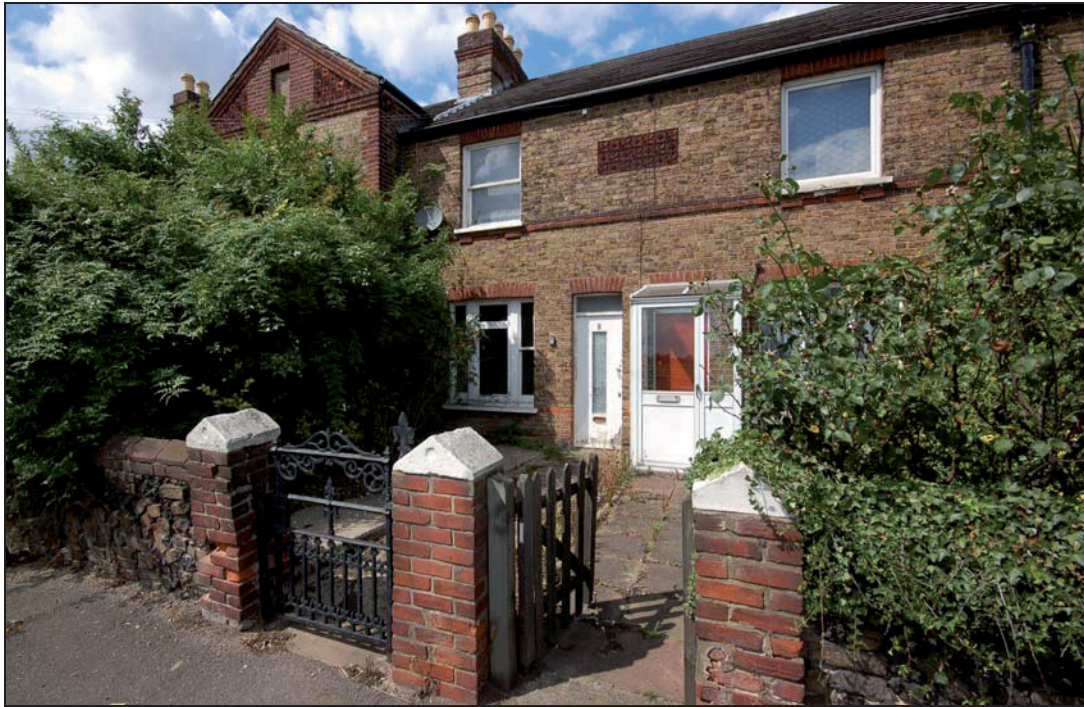
Plate 3 Cottages 7-10 viewed to north-west

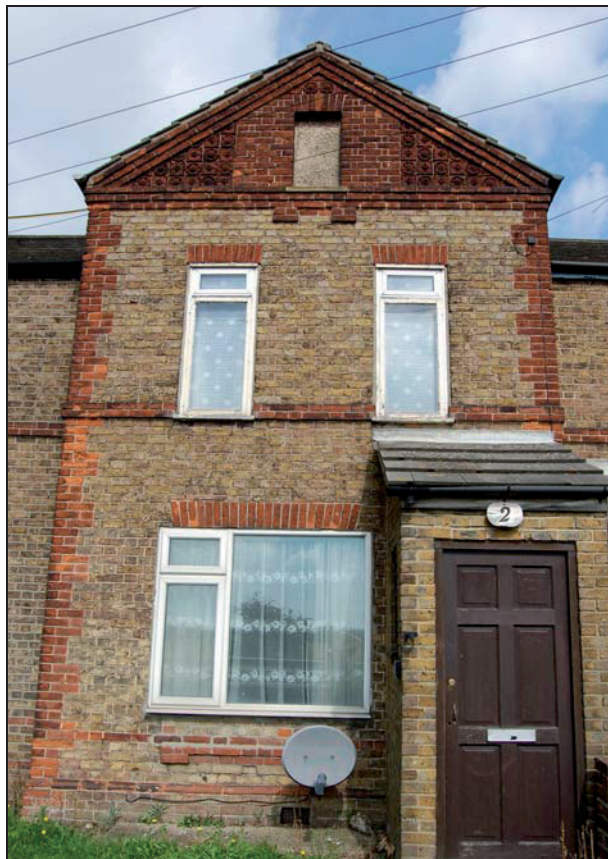
The gables are identical and hold pairs of narrow windows on the first floor, all of which are replaced. They are an unusual feature to a terraced house and have a red brick tympanum made from three courses of stepped brickwork around a blind central window (plate 4). On three sides of the window are borders created from decorative tiles employing alternating flower and leaf/bud designs (plates 4 & 5), typical of the late 19th century.

Plate 4 Gable of cottage 2

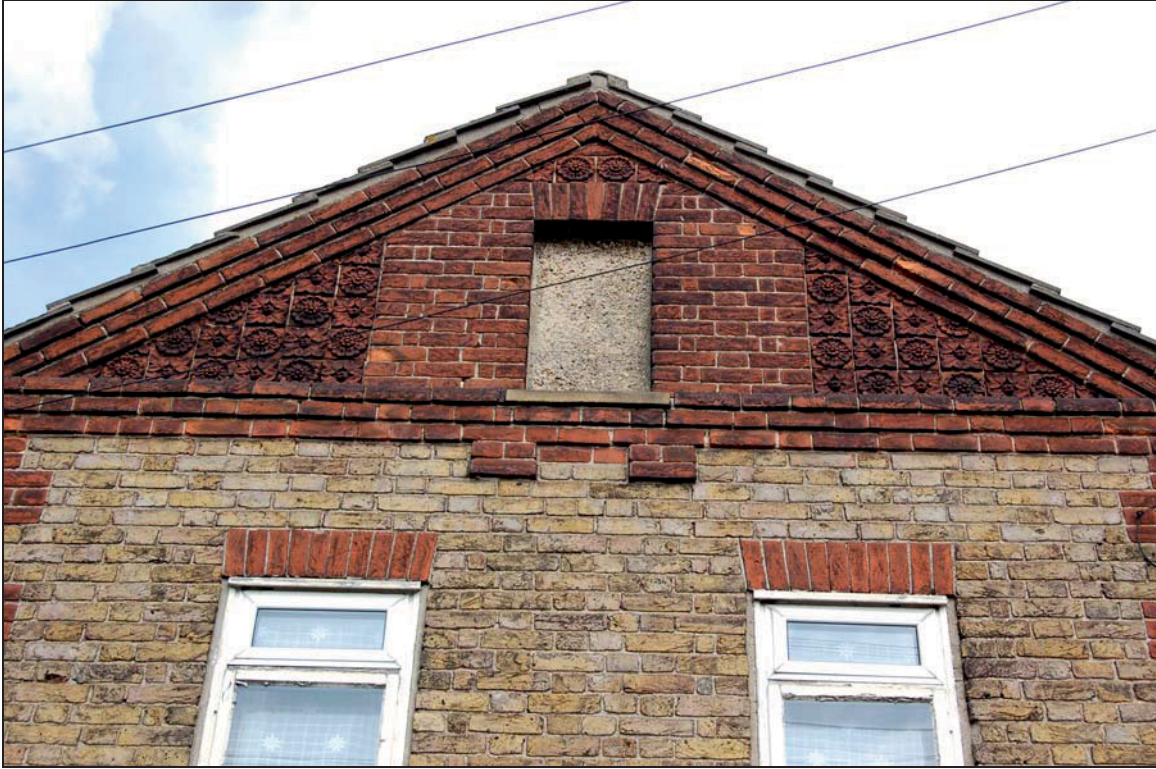
Plate 5 Decorative tiling on gable (cottage 2)

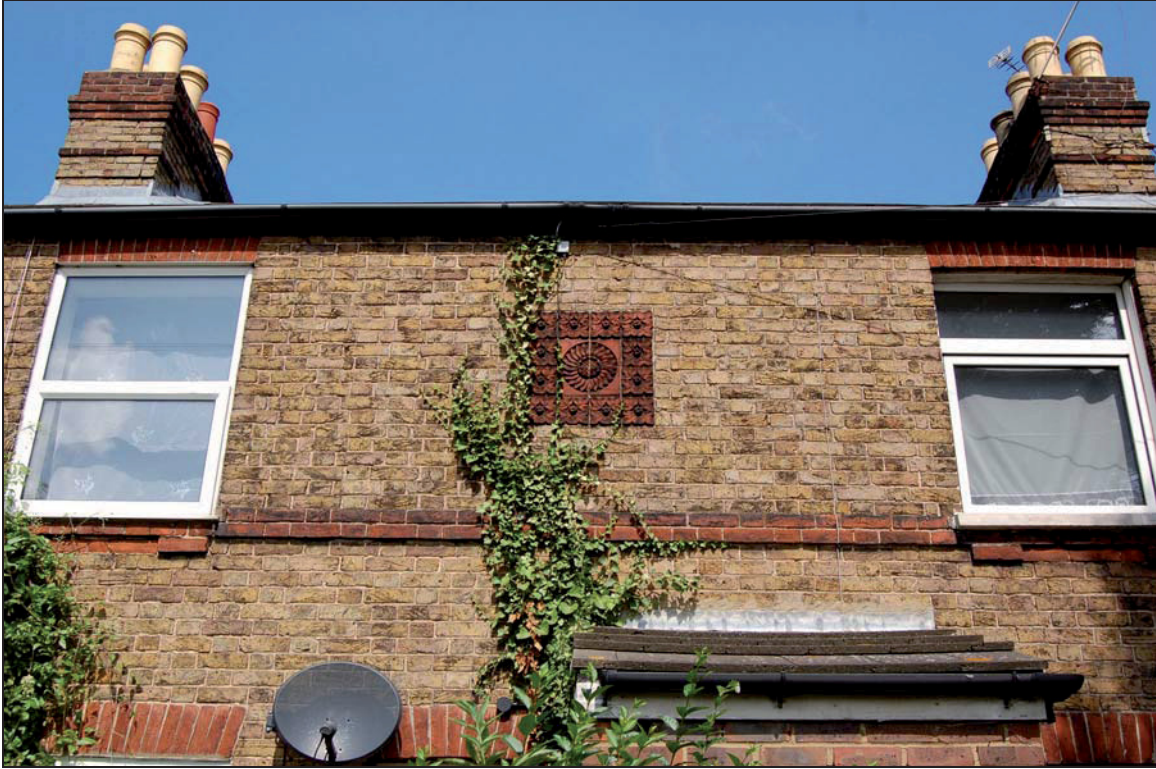
Plate 7 Location of square tiled panel on cottage 5

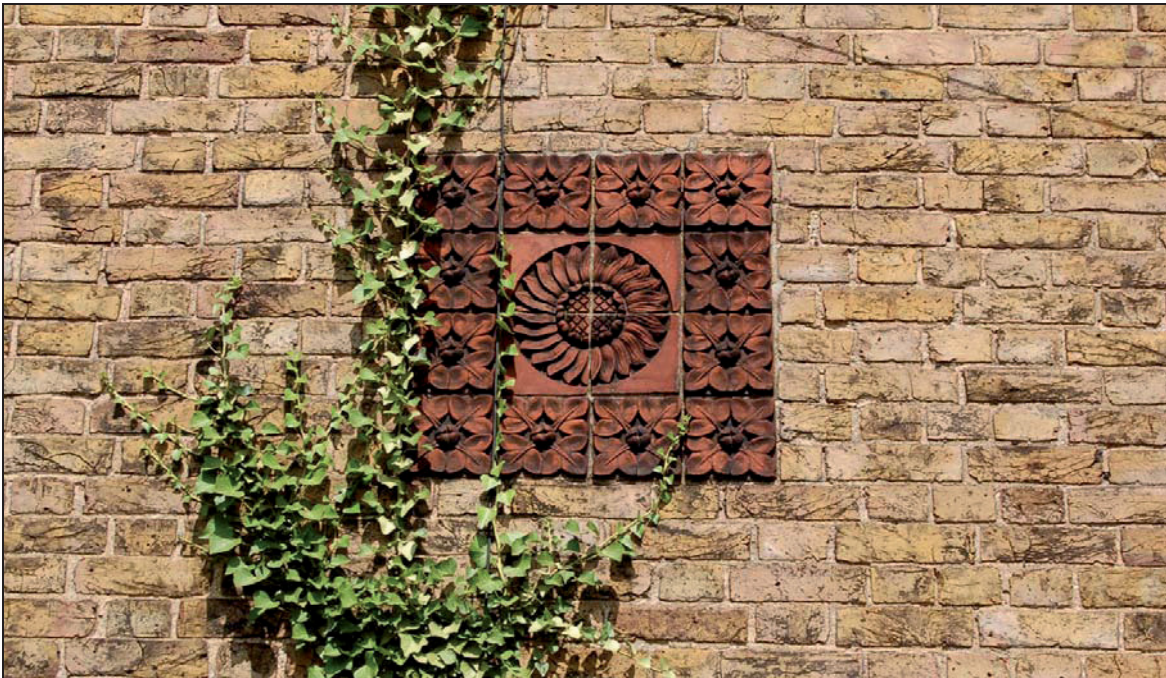
Plate 8 Detail of square tiled panel

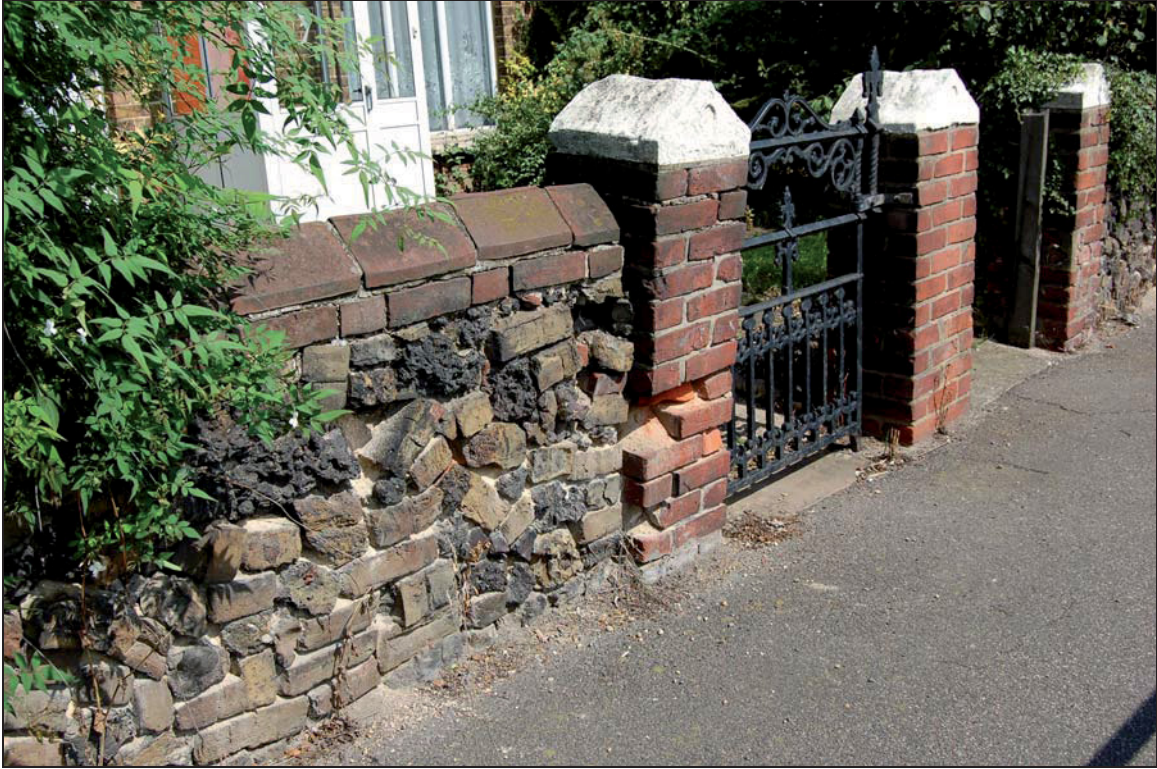
Despite the obvious attention to detail to the terrace, the front of the building is bounded by a crude wall built from brick kiln waste, consisting of un-coursed half and whole yellow bricks and large lumps of clinker/badly burnt bricks (plate 9). The walls are tied-in by an upper course of red brick and saddleback coping that suits the brick gate piers. Rather decorative heavy cast iron gates survive to most of the cottages (plates 9 and 10).

Plate 9 Boundary wall and gate (cottage 8)

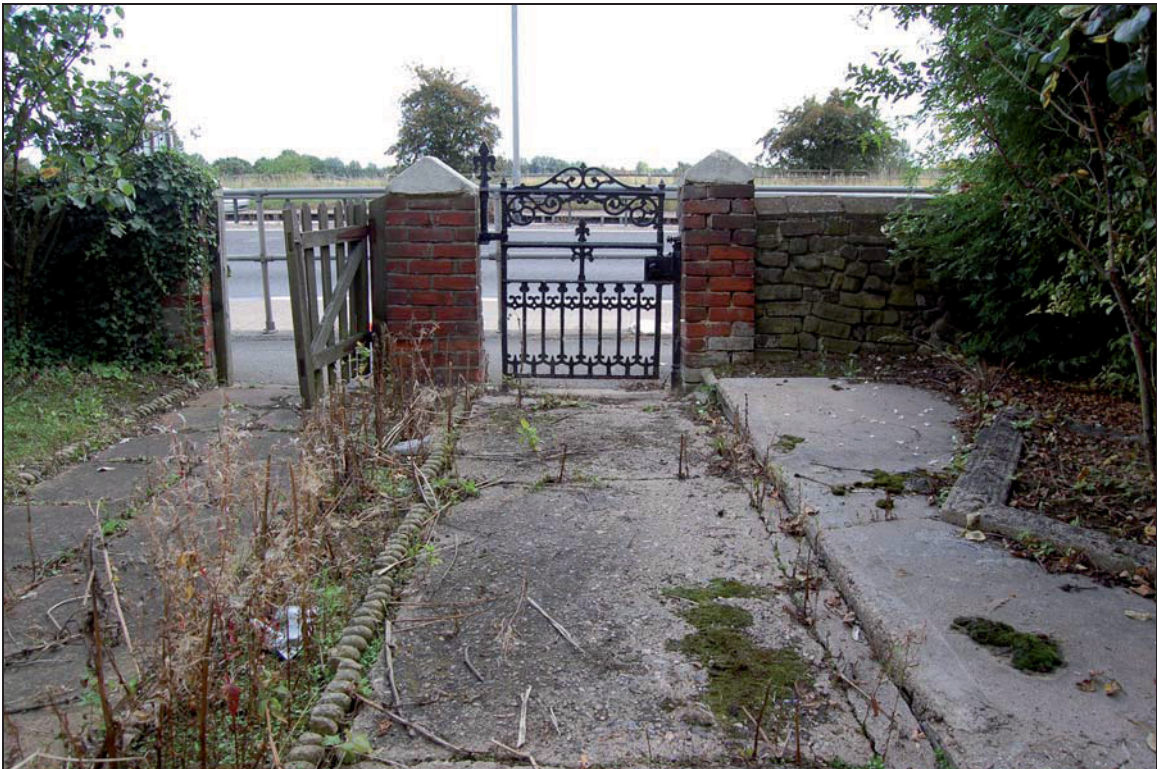
Cottage 8 is the only property to retain something of the original front garden layout. The gardens were small, approximately 4 by 4½ m and the pathway between gate and front door lined either side with ceramic ropework borders (plate 10), also probably made by Clover. There are no vestiges of original fences or railings separating individual gardens.

Plate 10 Front garden to cottage 8

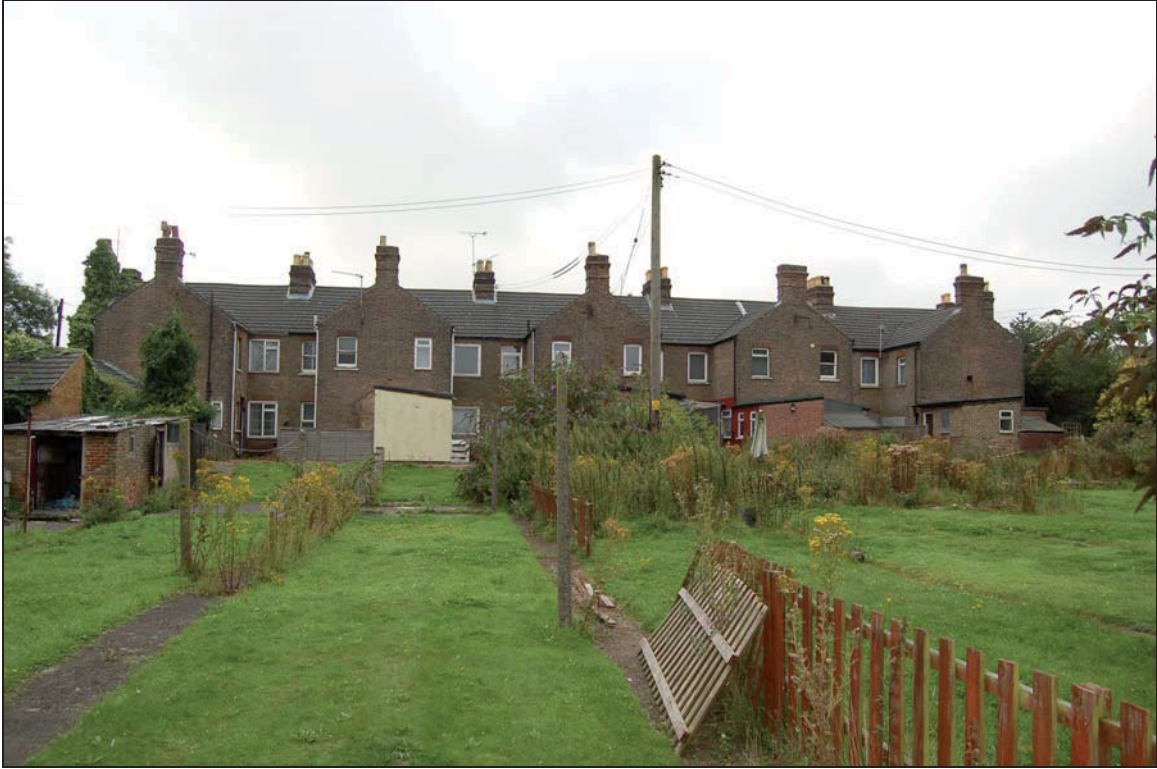
The rear elevation is fairly uniform and plain, without the decorative panels or banding seen on the front (plate 11). The bricks are more of a mix of quite rough, creased yellow, pink and red stocks. Most of the cottages this side have been re-pointed in cement. Windows on the back on both floors have cambered rather than plain heads and originally housed double-pane sashes, but now tend to have replacement casement types, sometimes too large for the original aperture (plate 12). Cottage 8 is notable for retaining all its sash windows at the back (plate 13). Heavy cast iron Victorian rain goods survive in some places.

Kitchen/box room blocks extend out from the back. A large proportion of kitchen windows have been replaced and all of the side doors. Some doorways were blocked when new extensions were added. Many of the old box rooms have been converted to upstairs bathrooms and new windows fitted. For some reason, the box room windows on the end cottages are located on the side, while the others face out to the gardens (plate 11).

Plate 11 Terrace viewed from rear (north-east)

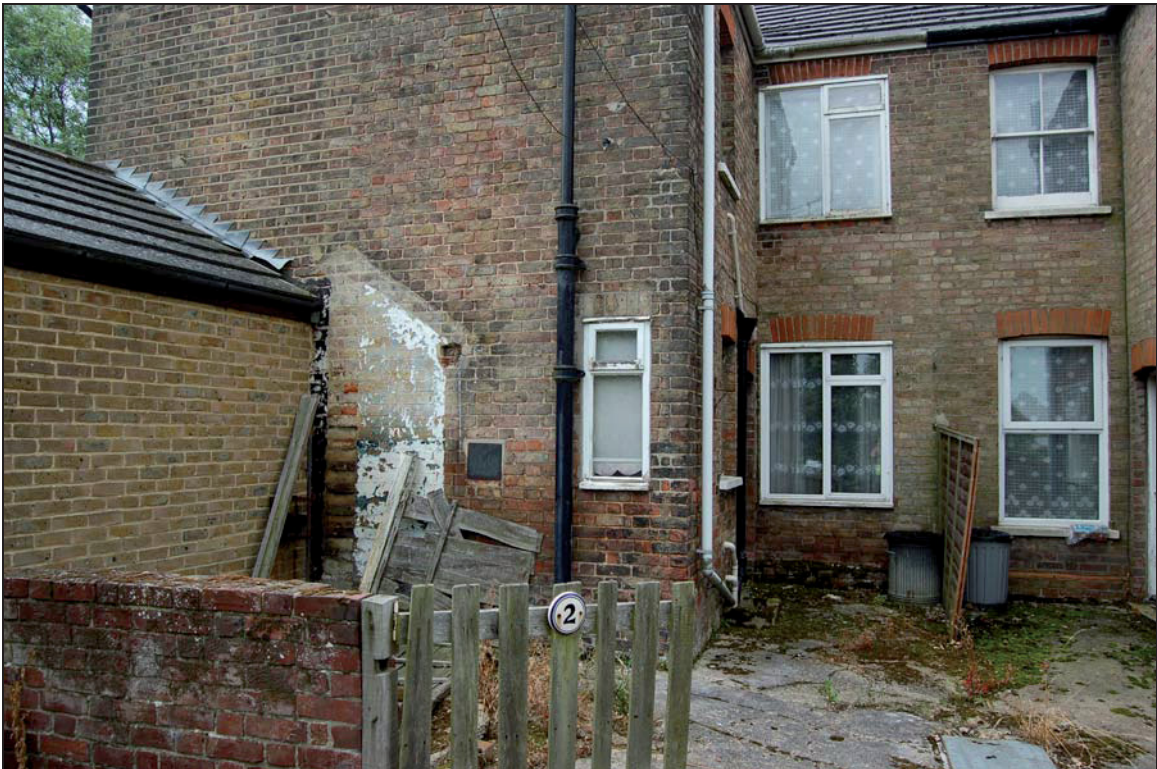
The old Victorian toilet and coal house structures have mostly been replaced by modern shallow-pitched extensions. Cottages 2 and 3 show the wall scars where they have been removed (plate 12) but they have been retained in cottages 8 and 10, roofed over to become one modern unit (plates 13 & 14). It is perhaps odd that these outbuildings are built in red rather than the yellow brick of the cottages, but they do match the rear boundary wall that survives to the rear of cottage 10, along with its simple wooden gate (plate 14).

Plate 12 Outline of removed outbuilding on cottage 2

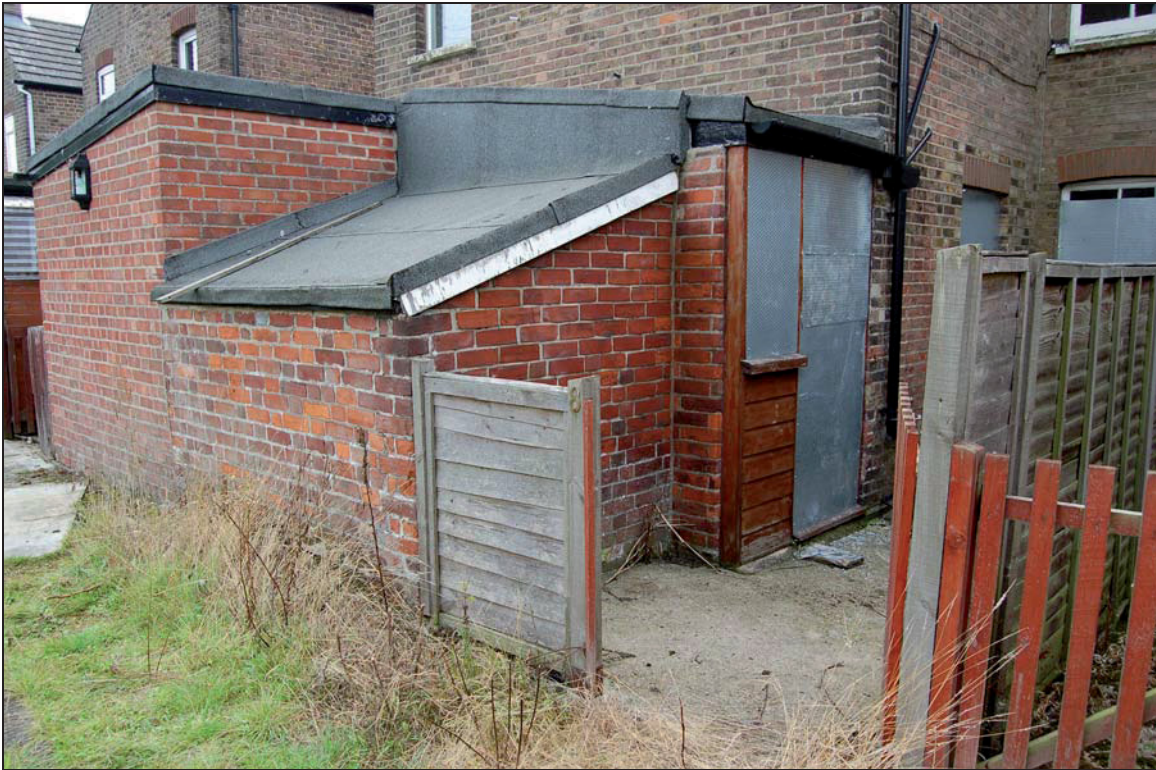
Plate 13 Surviving outbuildings enclosed under modern roof (cottage 8)

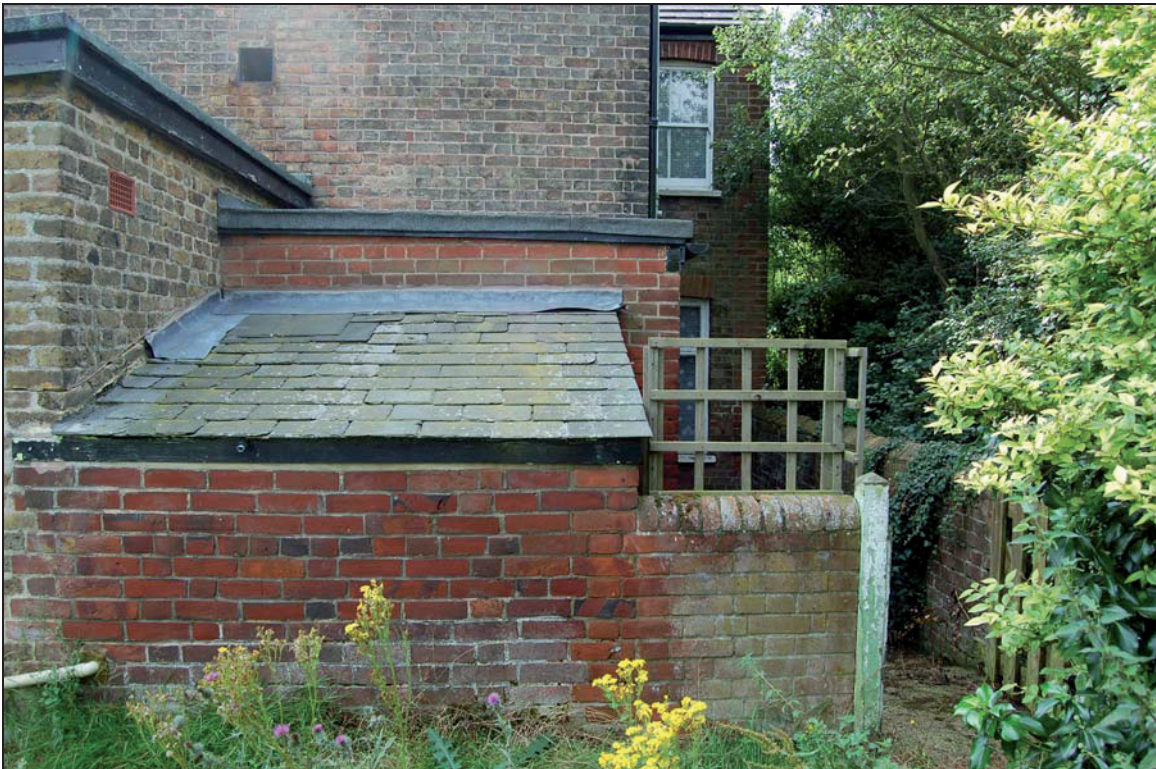
Plate 14 Rear wall and enclosed outbuildings (cottage 10)

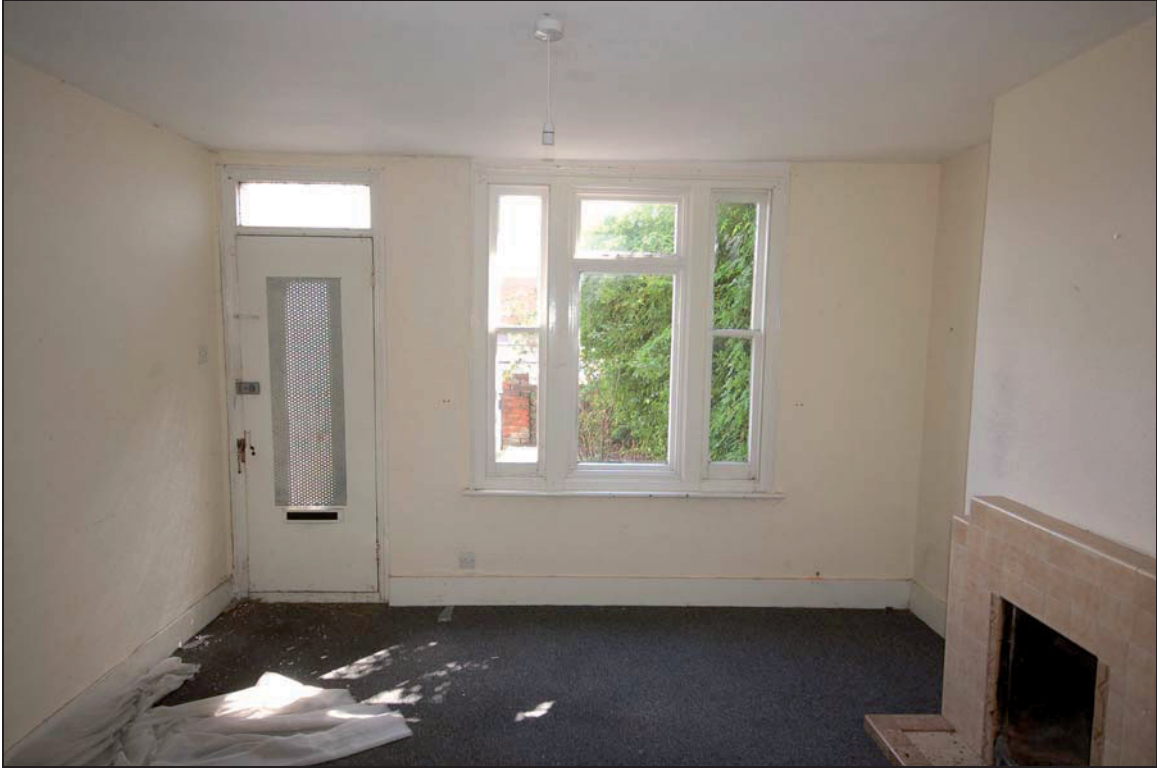
As there is no hallway, the front door leads directly into the **living room** (plate 15). The front doors are no later than the 1950s or 60s but the plain fanlights above may be original. All the front windows have been replaced on this level, though the one seen in cottage 8 would appear to be one of the earliest, a vented window with side sashes likely to date from the 1920s or 30s (plate 15). The walls have no picture rails or cornices, only a plain 4½ inch skirting board at the base; a familiar feature of all living, dining and bedrooms throughout the terrace. In similar vein, there is no ceiling decoration, such as ceiling roses. The fireplace is a replacement and probably dates to the mid 20th century.

Plate 15 Living room

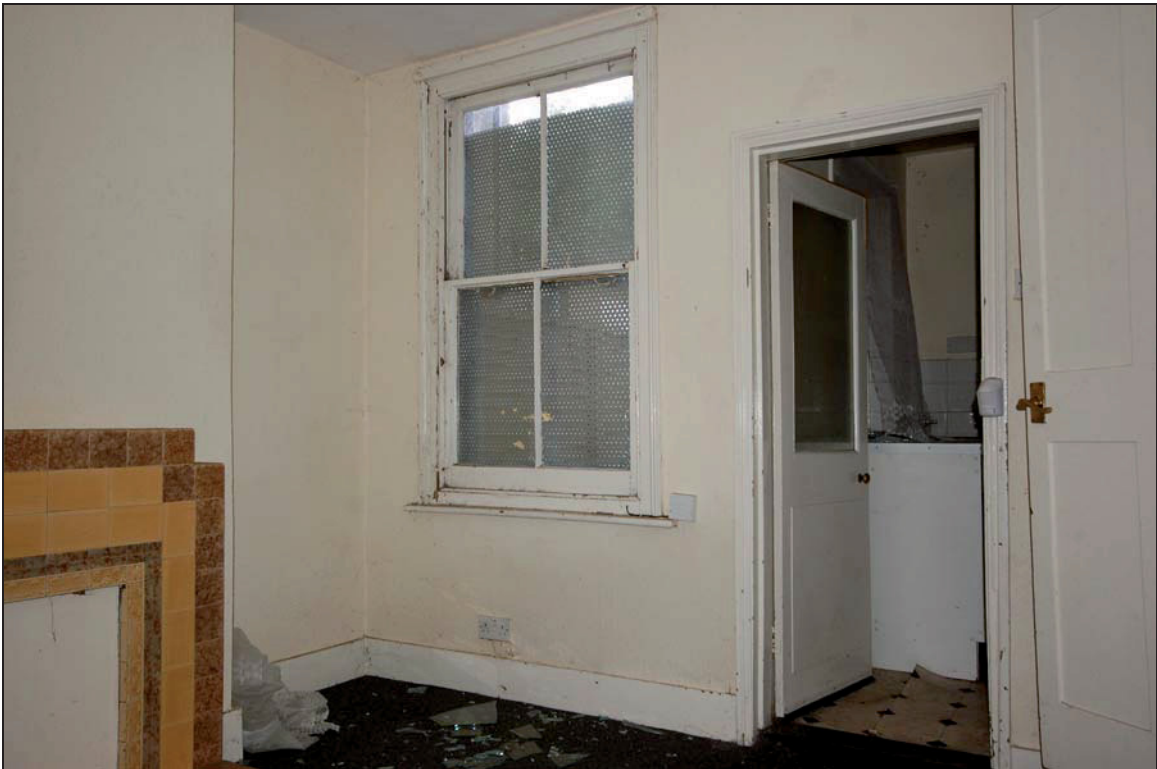
Entry into the **dining room** (plate 16) is through a central doorway. The stairs are on the right hand side upon entry, hidden from view by a matchboard screen (plate 17). A ledged and boarded utility door leads into the stair cupboard that is fitted with two shelves on iron

brackets (plate 18). Access to the stairs is by a more regular four panel door. The fireplace is replaced but the sash window facing the back yard is the original two-pane type and has cast iron handles on the upper section (plate 16).

Plate 16 Dining room

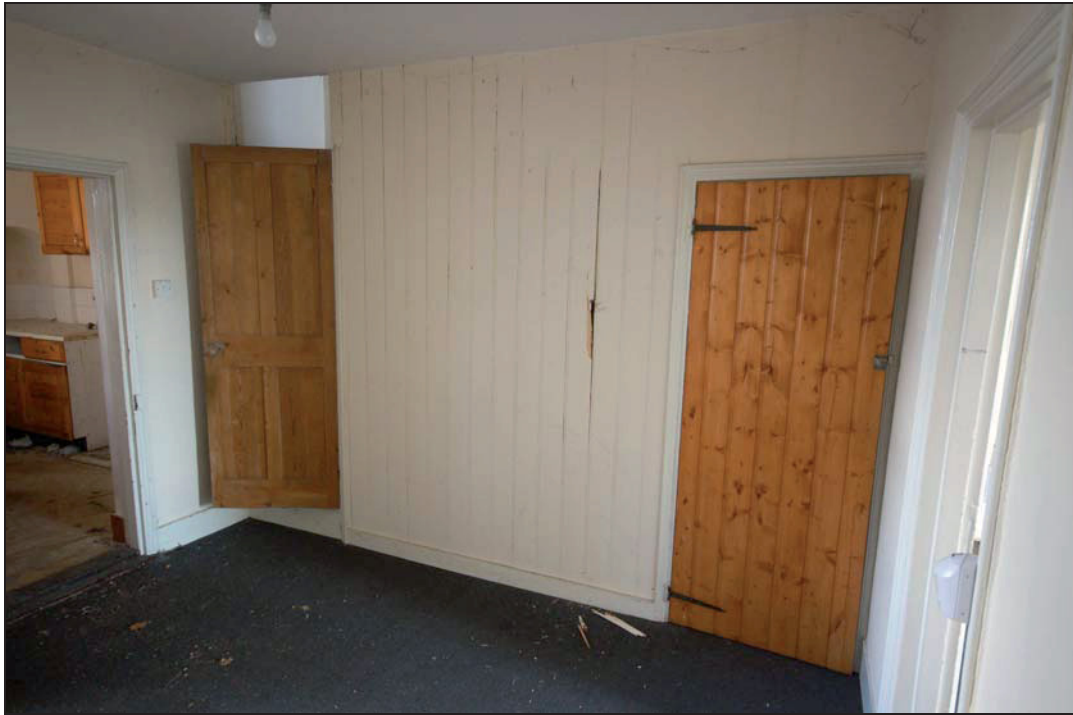
Plate 17 Dining room stair partition (cottage 2)

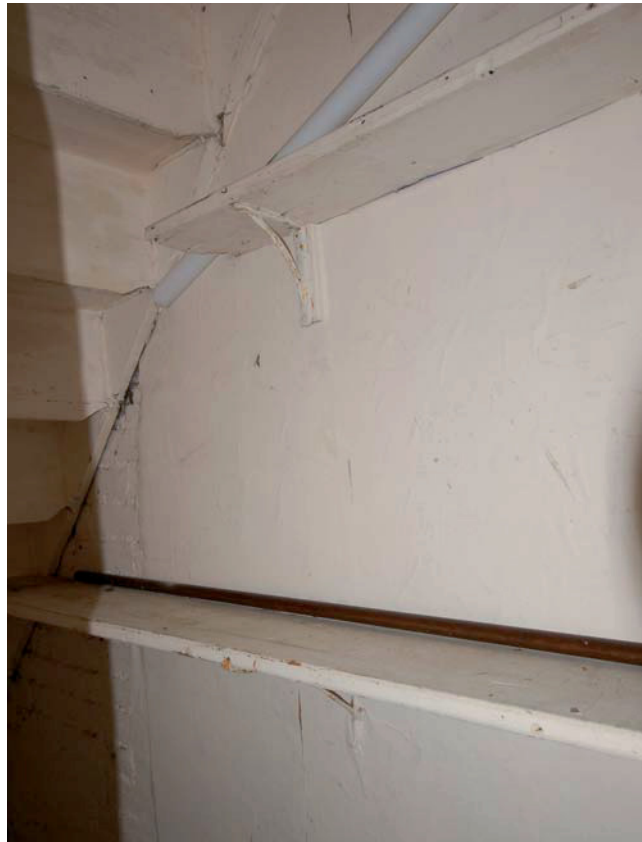
Plate 18 Shelves inside stair cupboard

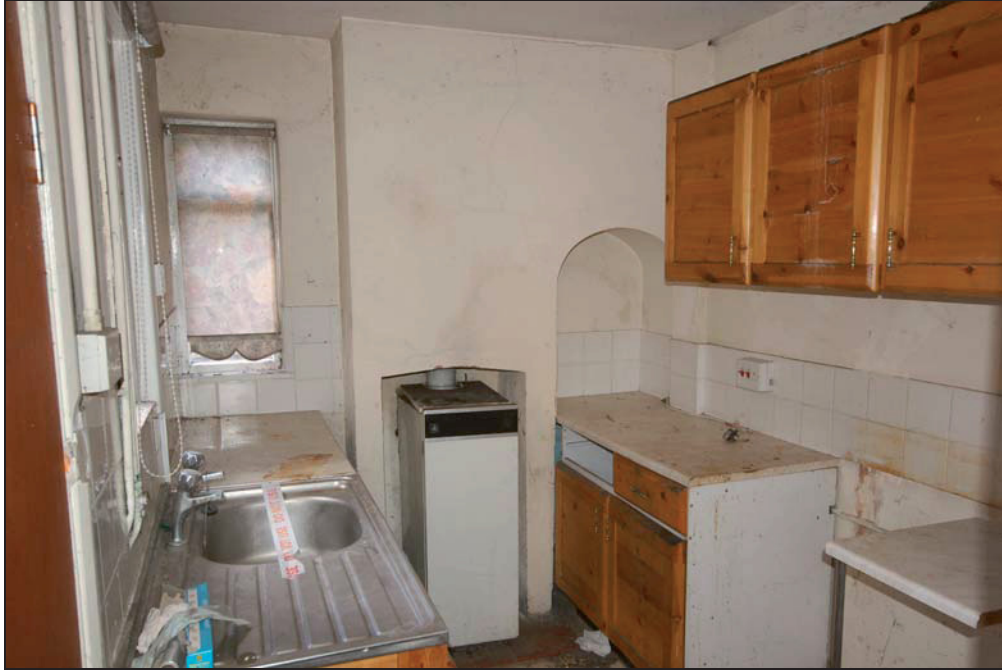
Kitchens are one of the first rooms to be updated and improved in a house and only cottage 2 retains its original form (plate 19). Most of the other cottages have had the lower parts of the chimney removed to create access into rear extensions, but here the chimney breast and alcove for the old range, remains. Originally the kitchens only had side doors out to the yards and any other doors are modern additions.

Plate 19 Kitchen (cottage 2)

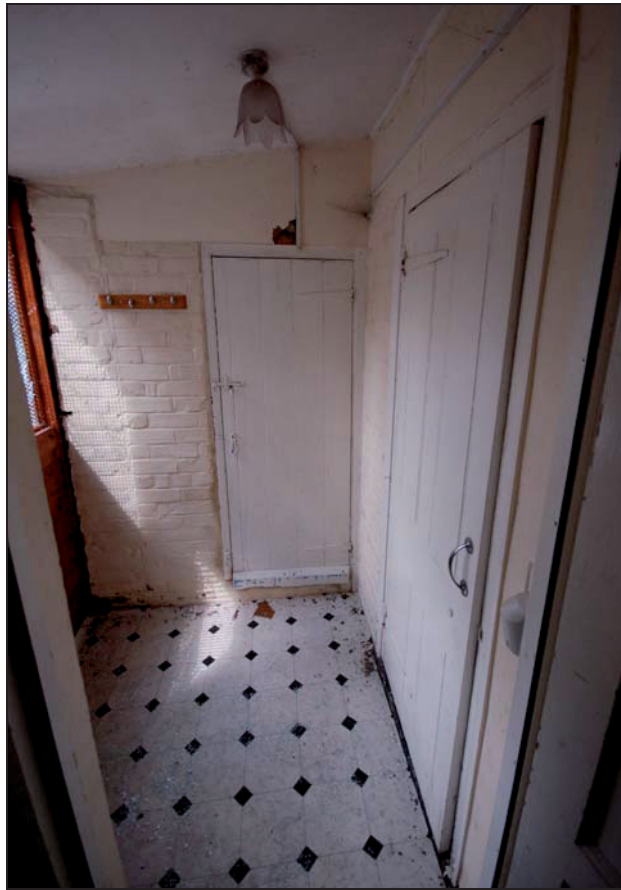
Outbuildings at the back were necessary to accommodate the **outside toilet and coal house** (plate 20). With each room having a fireplace (though seldom used upstairs) and the kitchen range going most of the time, a plentiful supply of coal was necessary. The idea of having a toilet inside the house was seen as unsanitary, but over time attitudes changed and the old blocks were either incorporated into the house (like 8 and 10) or rebuilt new. Only those of cottages 2 and 3 were not replaced, and their toilets are now with bathrooms in the box rooms upstairs. Since he also manufactured drainage goods (ERO D/DGS E113 1901), William Clover would presumably have built the toilets with their own plumbing, rather than 'earth closets'. Figure 4a shows how the outbuildings were arranged before the area was enclosed. Although now enclosed, the appearance of the outbuildings to cottage 8 has hardly changed. Original doors remain (a framed toilet door and utility ledged and battened door to the coal store) and the brickwork is unplastered (plate 20).

Plate 20 Enclosed toilet/coal house range

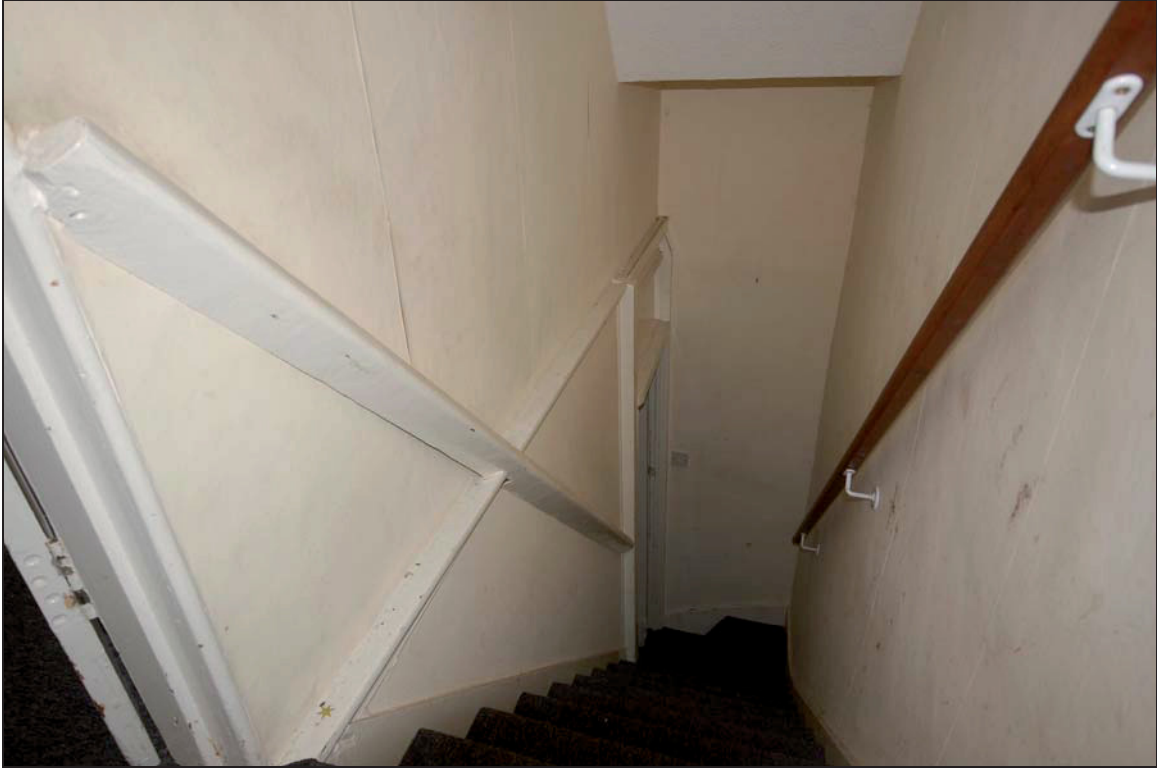
A single flight of stairs leads to the bedrooms on the first floor (fig. 4b). Going up, the handrail was on the right hand side, against the wooden screen, but later rails have been placed on the wall the other side (plate 21). The stairs lead directly into the front bedroom (**bedroom 1**) that had a boarded wardrobe in the alcove with a tri-central door (plate 22), plus a cast iron fireplace of the type found in cottage 3 (plate 23). Inspection of the loft space via the hatch located in this room reveals a simple trenched purlin roof made from machine-sawn timbers.

Plate 21 Stairs

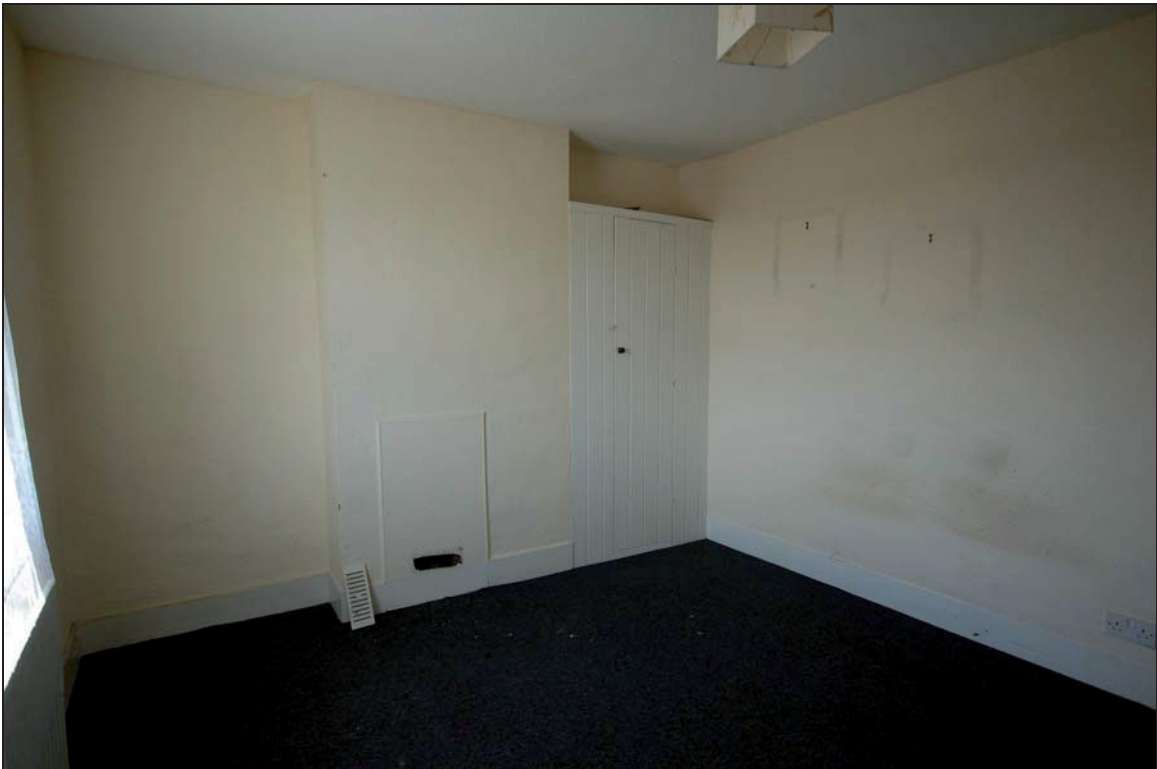
Plate 22 Front bedroom
