**THE TERRACE
WITHAM ROAD, HATFIELD PEVEREL
BRAINTREE
ESSEX**

LEVEL II HISTORIC BUILDING RECORD

September 2009

Prepared By: Andrew Letch Position: Project Officer	Signature: Date: 15th September 2009
Approved By: Mark Atkinson Position: Project Manager	Signature: Date: 15th September 2009

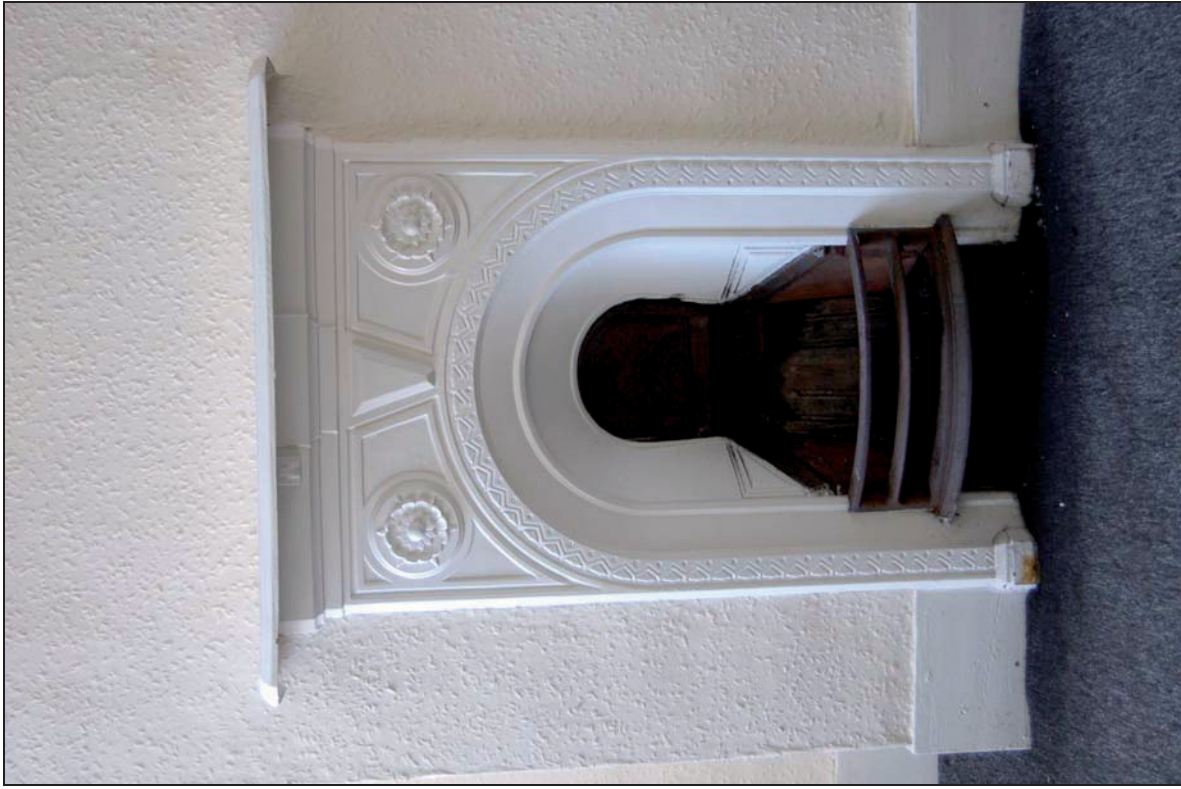
Bedroom 2 is also located off the stair, but is smaller in size. It contained the same style of fireplace (though there may have been variation between cottages) and probably a four-panelled door cupboard like that recorded in cottage 7, though with more subdued paintwork (plate 24). Some of the doors are fitted with locks and some are not, and there are two varieties of door furniture; the standard sort with lock and hold and an earlier sprung latch type. There are only a few of this earlier type, and all were located upstairs where they were

Plate 23 Typical bedroom fireplace (cottage 9)

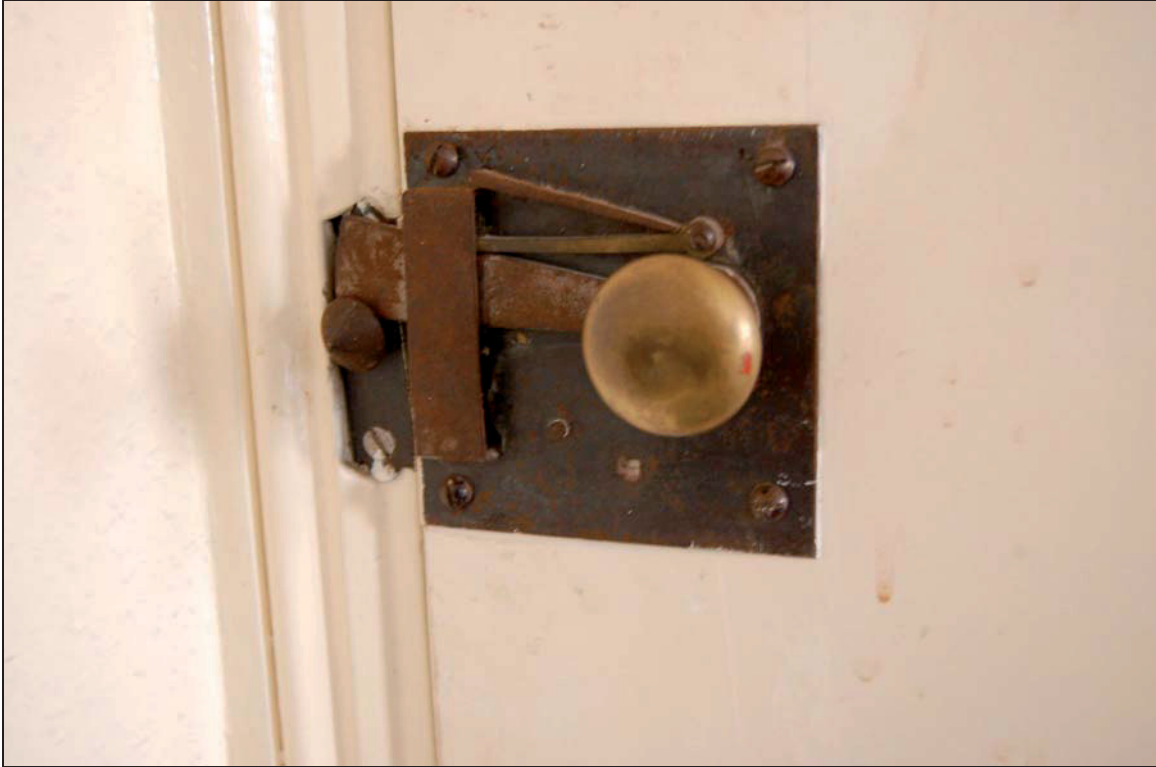
not 'on show'. An example of the latter is in the door to bedroom 2 in cottage 3, where the lock case is missing, thus exposing the spring latch mechanism, which is a simple device where a metal calliper spring activates on the inside of the case and top of the latch to lift the end of the latch on and off a pointed stud (plate 25).

Plate 25 Sprung latch mechanism (cottage 3)

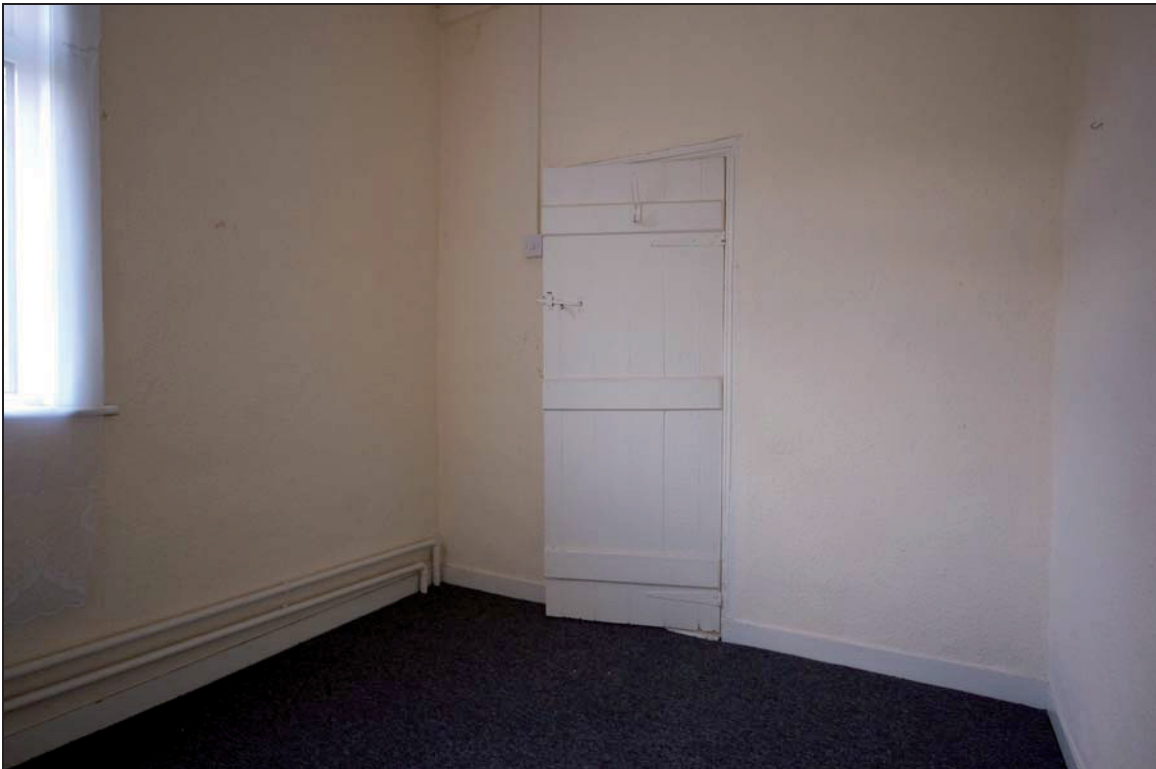
Similarly there is little pretence to the finishing of the **box room**, which in its original form has a ledged and boarded door and regular 'shed door' type latches, like that seen to the coal house downstairs. A good example is found in cottage 9 (plate 26), whose box room is less altered. It is interesting to note that the doorway is much lower here, at 1.65m rather than the standard 1.9m recorded in the other rooms. With Victorian families being larger than today, and children sharing rooms, the box room presumably provided accommodation for the very youngest members of the family.

Plate 26 Box room (cottage 9)
