**ELM COTTAGE
NEWMARKET ROAD
GREAT CHESTERFORD
ESSEX**

ARCHAEOLOGICAL EVALUATION

**Essex County Council
FIELD ARCHAEOLOGY UNIT
November 2009**

Client: Mrs. P. Maurice
FAU Project No: 2125
NGR: TL 5041 4320
Planning Application No.: UTT/1045/09/FUL
Site Code: GC49
OASIS No: essexcou1-66048
Date of Fieldwork: 22/10/09 – 26/10/09

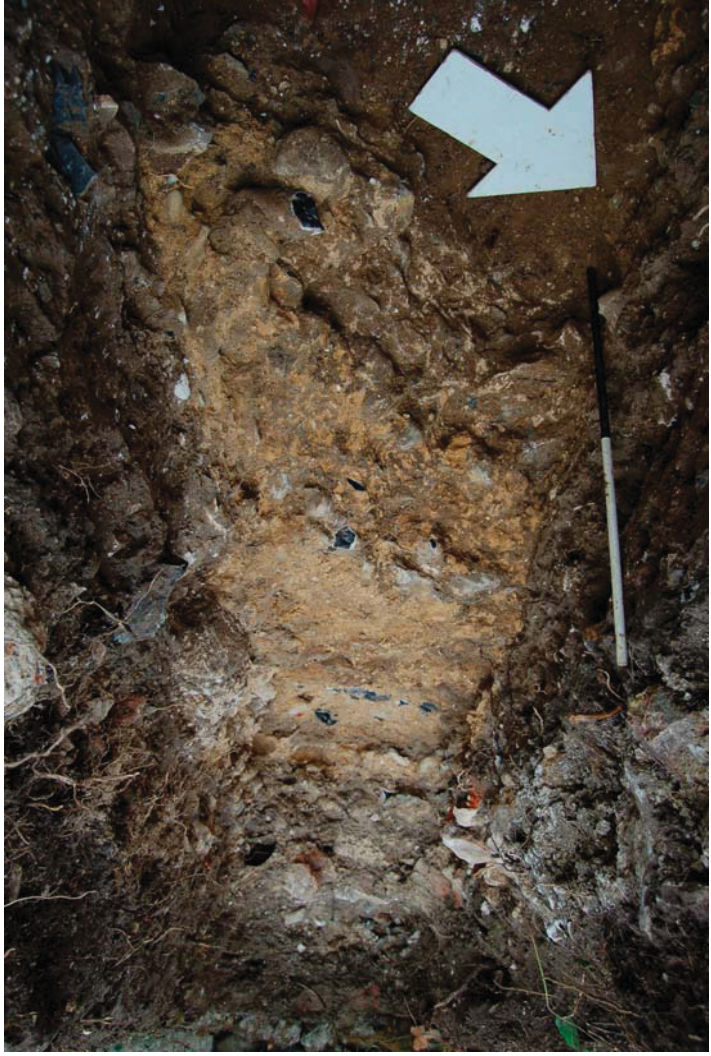
A section of the remaining Roman town wall foundation (Plates 1 and 2) was revealed in the north-eastern end of the music room trench (Fig.2). The wall is aligned north-north-west to south-south-east and is present 0.51m below modern ground level to a depth of at least 0.91m. It must be noted here that excavation was halted at 0.91m below ground level in the north-eastern end of the trench and 0.99m in the south-western trench. It is therefore likely to extend to a significantly greater depth. The surviving foundation (17) measures over 1.3m wide, extending beyond the north-eastern edge of the trench. The fabric of the wall comprises large flint nodules with the occasional small chalk block, bonded with sand mortar and matches that discovered just a little further south along Newmarket Road (Brooks and Wallis 1991).

The apparent NNE-SSW alignment is likely to be slightly misleading, as the eastern side of the wall foundation was not revealed. The wall is thought to follow more of a north-west to south-east alignment at this point in order to line up with other known and excavated sections (e.g. Brooks and Wallis 1991). It is probable that the south-western edge of the foundation was disturbed, possibly by root action (all of the deposits within the music room trench were heavily disturbed). Layer 19 (see below) varied in appearance and consistence at its point of contact with the foundation, whereupon it became considerably sandier and took on a lighter colouring, perhaps indicating that this area of the deposit was mixed with the truncated remains of the wall foundation.

Plate 2. Wall 17, looking north-east (0.5m scale)

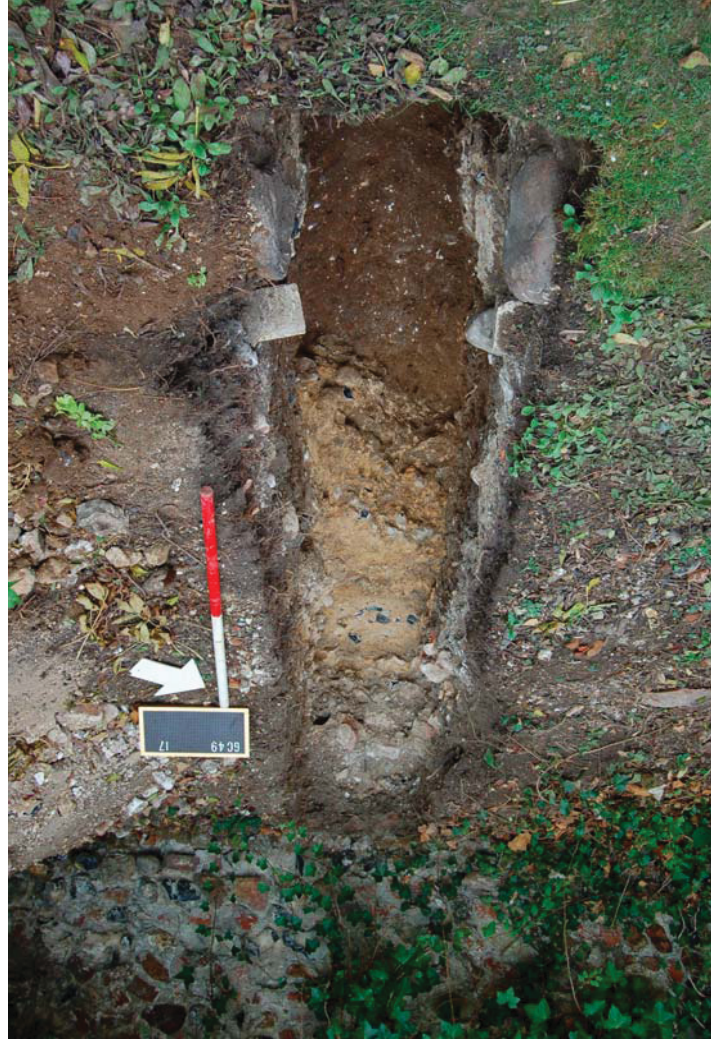
Plate 1. Wall 17, looking north-east (1m scale)

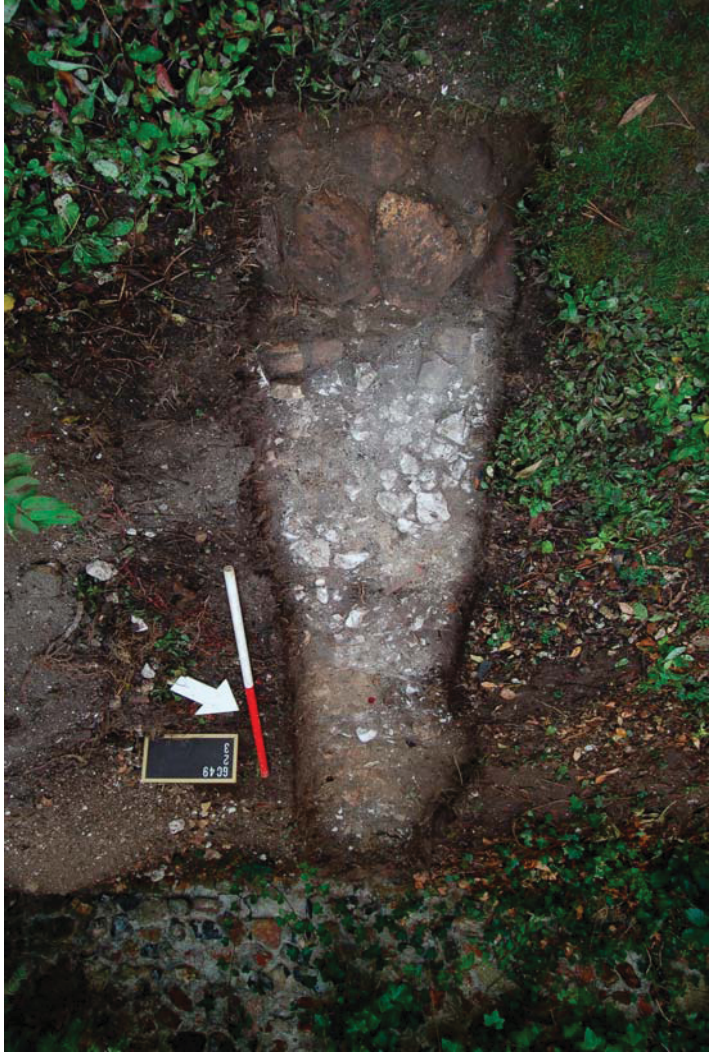
Wall 3 (Plates 3 and 4) was present in the south-western end of the trench, parallel to wall 9. Comprising large flint nodules bonded with limestone mortar, the wall footing (deposit 7) was present beneath a layer of large stones and disturbed bricks, which probably formed the above ground section of the wall. The construction cut (6) had vertical sides and a flat base. This may represent the south-western wall of a small structure abutting the extant garden wall, as depicted in the First Edition Ordnance Survey map. An uneven chalk surface (deposit 2) on a bedding layer of sandy mortar, brick and ceramic tile (deposit 4) was present to the north-east of Wall 3. The uneven nature of the surface may have been the result of root disturbance, as this area of the garden was recently used as a shrubbery and plant bed. It is likely that this was the part of the floor within the structure. Deposit 22 was situated in the south-western end of the trench against the exterior face of Wall 3. It contained a large

amount of chalk, brick and tile fragments, perhaps indicating that it was a dump of excess material used in the creation of the chalk surface (deposit 2) on the other side of the wall.

Plate 4. Chalk surface 2 and wall 3, looking north-east (1m scale)

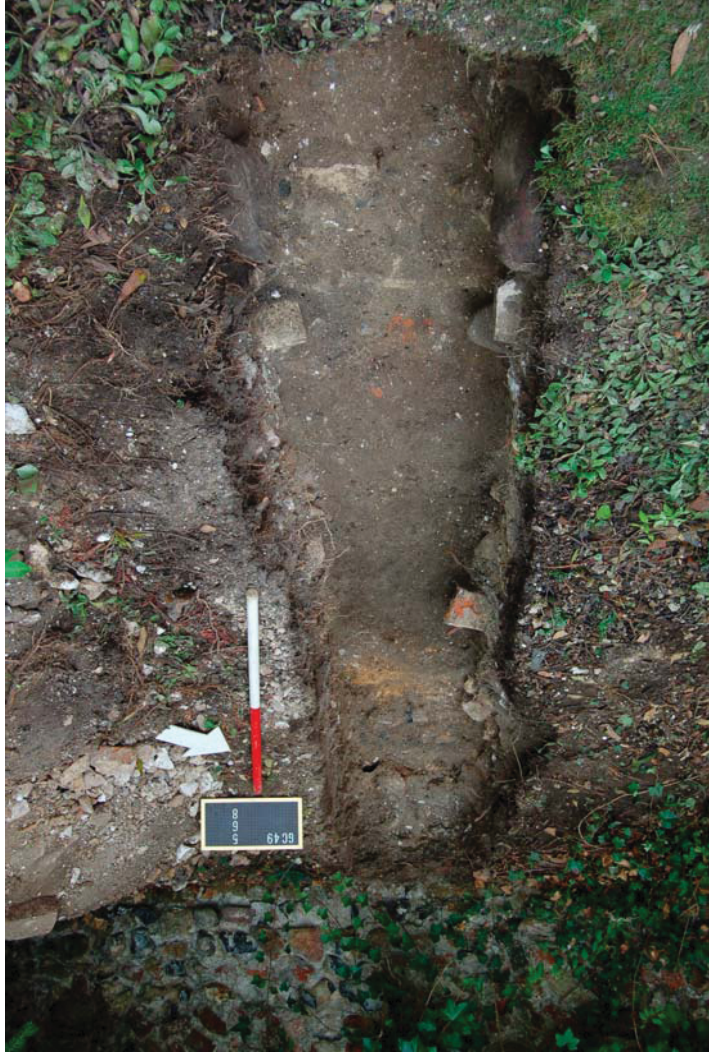
The majority of the archaeological activity present within the music room trench can be ascribed to the post-medieval period. The earliest feature is likely to have been Cut 8 (Plate 3). This may have represented the original robber cut of the Roman wall or it may indicate modification of the earlier structure in order to create a new wall directly above (Wall 9). A thin layer (deposit 21) formed above/within the cut to a depth of 0.02m indicating that the cut was left open for a short period. Wall 9 was subsequently constructed on top and survived as a truncated remnant comprising flint nodules, chalk and ceramic tile bonded within a sandy mortar. This was overlain by the former topsoil (deposit 5) suggesting that the wall stood for only a short period, being created and demolished during the 19th century.

Plate 3. Layer 5 and walls 6 & 8, looking north-east (1m scale)

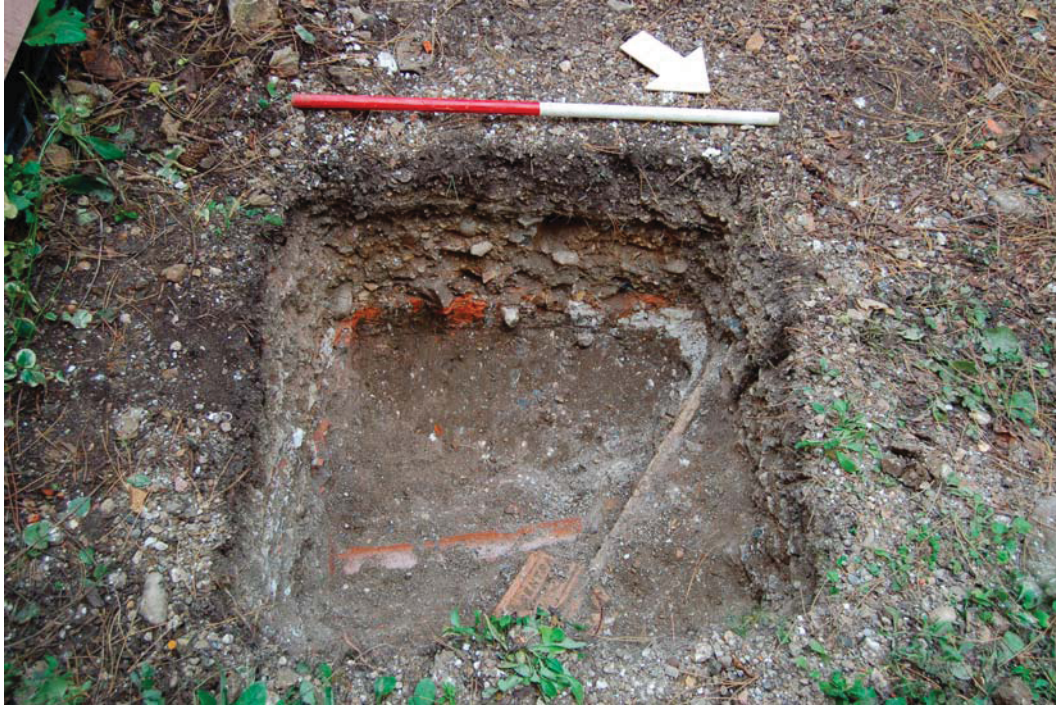
The excavation of the test pit in the area of the kitchen/bedroom extension, to the rear of the house and north-west of the music room trench (Plate 5) revealed two disused services which may have been associated with the possible former outside lavatory to the north-west. These lay below two modern surfacing layers (deposits 11 and 14), the lower of which was cut by the services. The services also cut through a post-medieval chalk, brick and ceramic tile layer (deposit 15), possibly a surface, which overlay a brown soil (deposit 16). Layer 16 contained modern and Roman ceramic building material. Excavation was halted at a depth of 0.46m, with the agreement of the ECC HEM officer, due to the presence of the modern services.

Plate 5. Test pit, looking south-west (1m scale)
