**240-242 ST MARY'S LANE  
UPMINSTER  
LONDON BOROUGH OF HAVERING**

**ARCHAEOLOGICAL EXCAVATION AND MONITORING**

**JULY 2010**

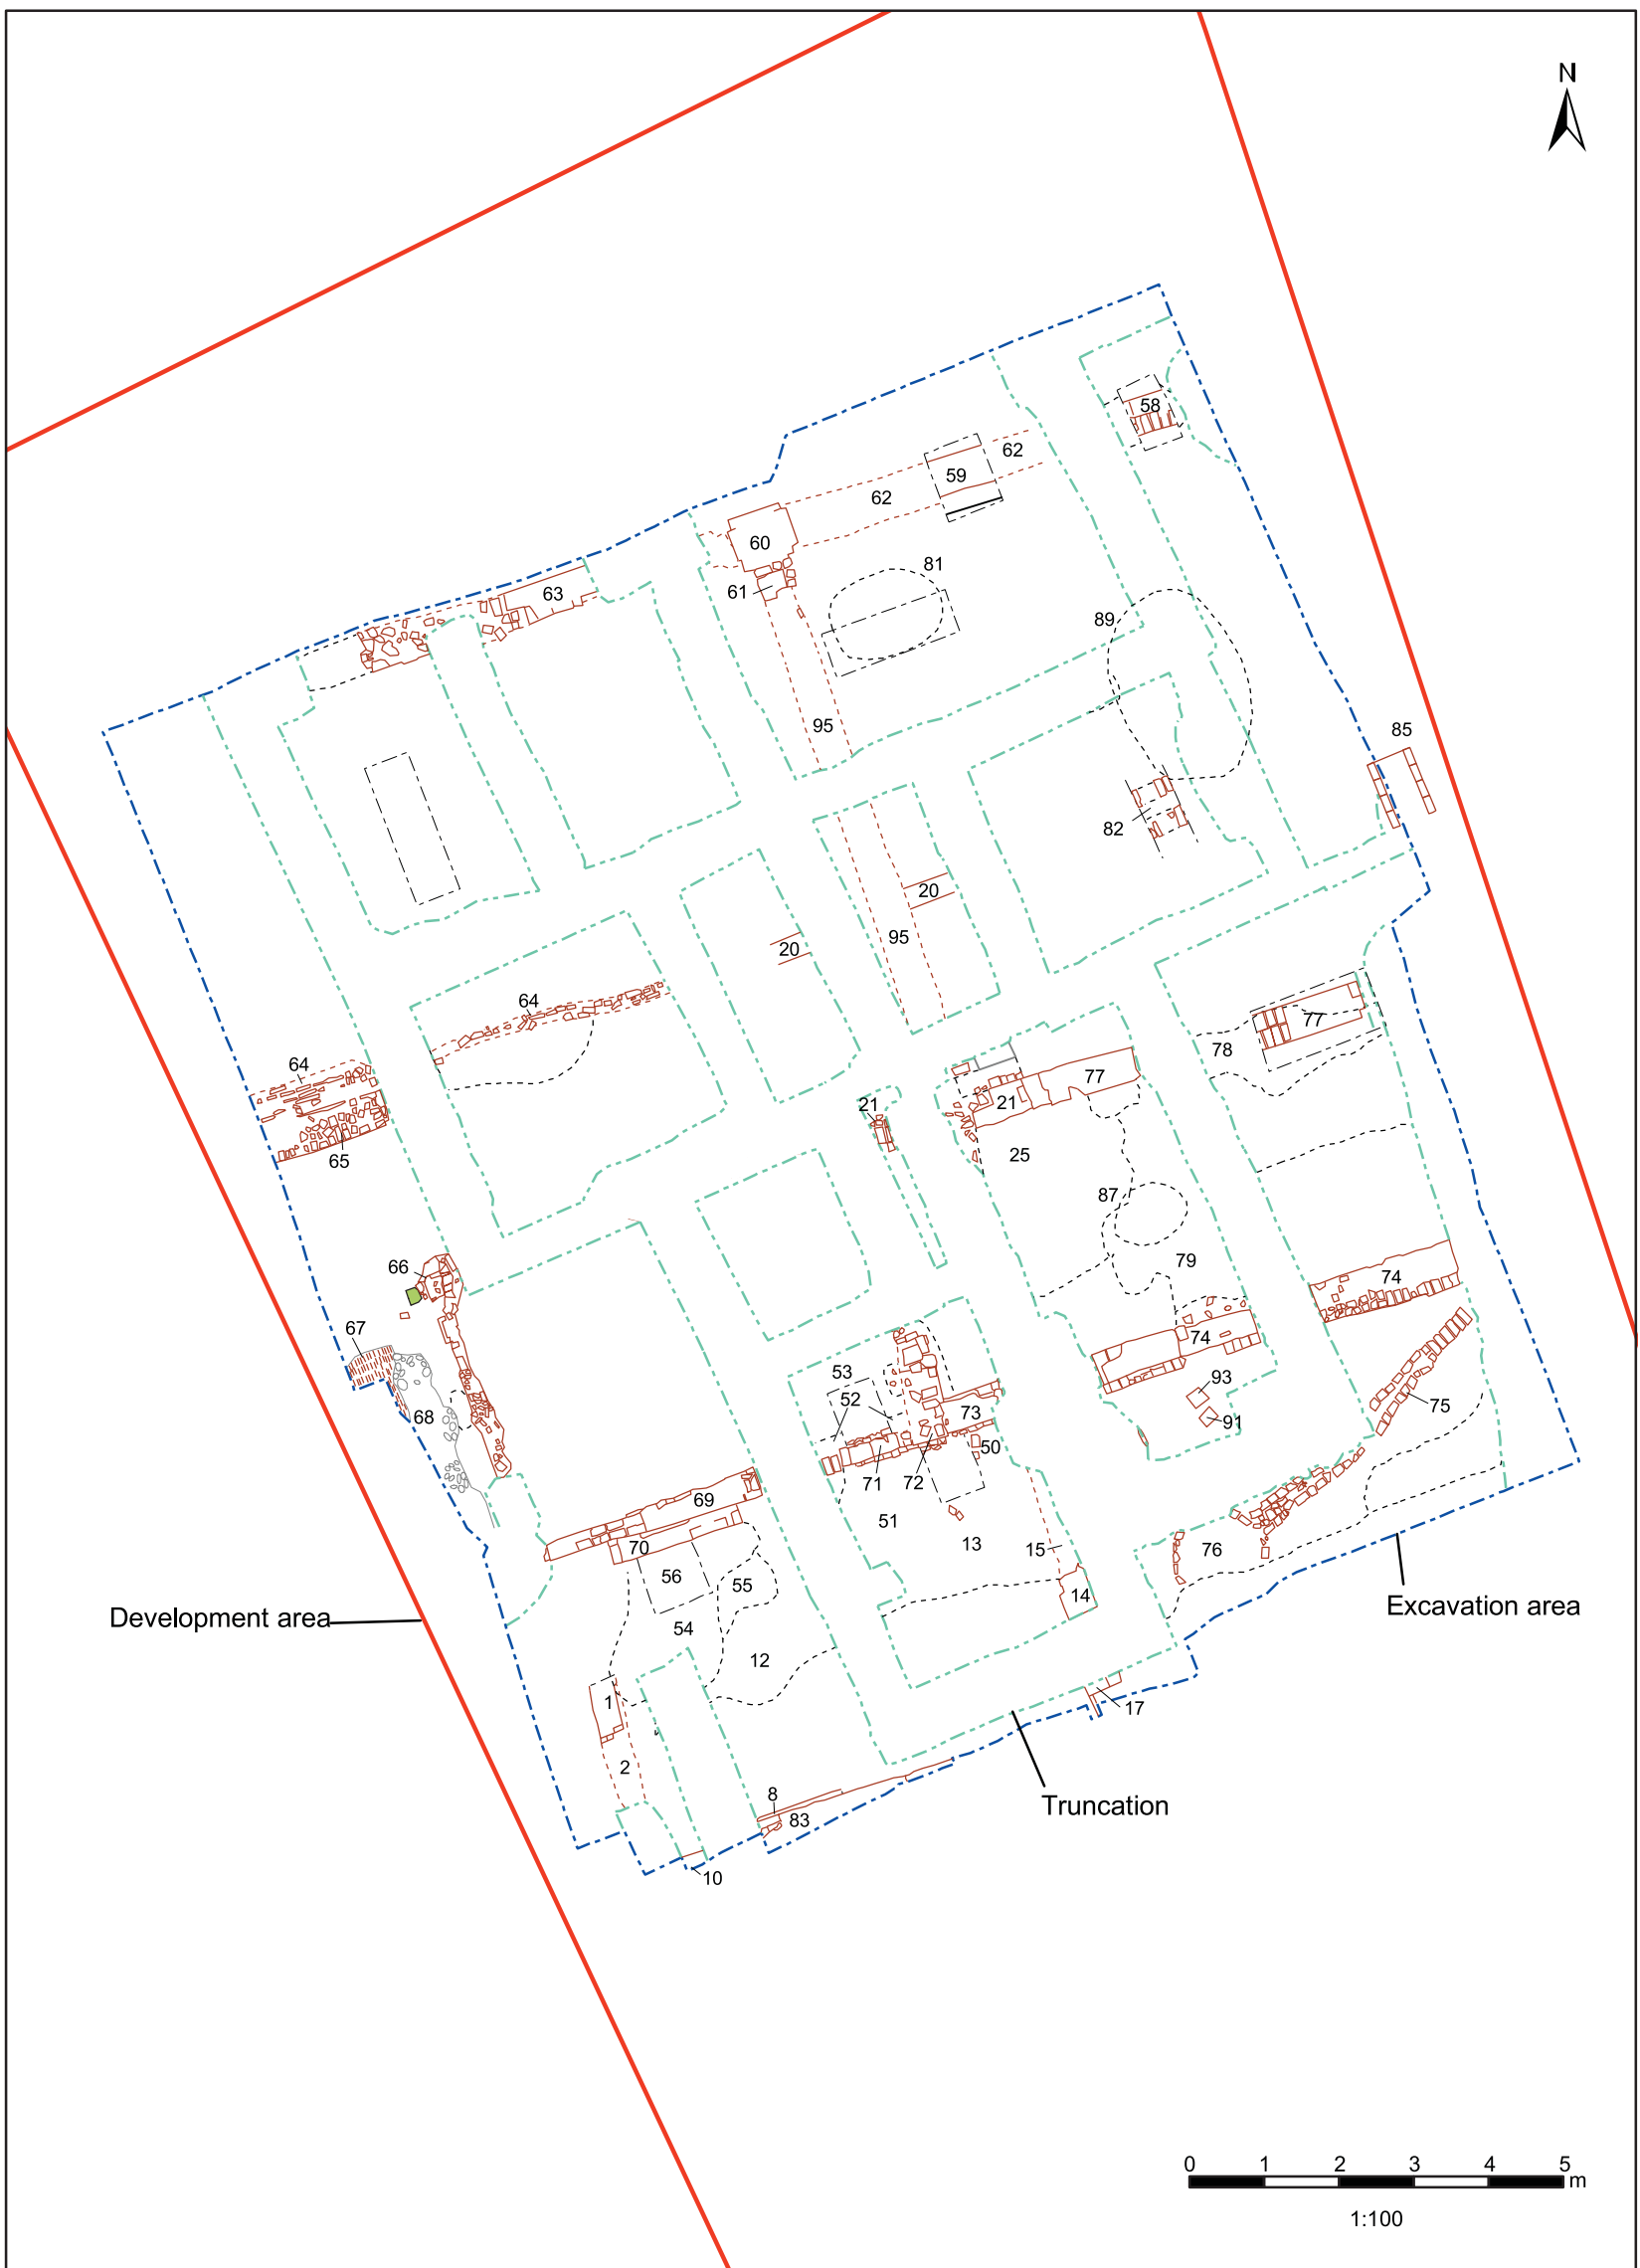
Fig.4. Archaeological features and areas of truncation

Pit 89 was the largest of the three pits, measuring 2.0m long by 1.7m wide. It was filled with dark grey clay, frequent charcoal and pebbles, a fragment of re-used and discarded post-medieval brick and a large piece of timber post. This pit was located directly below the junction of three 20th century walls and probably represents an area of disturbance of comparatively modern date (Fig. 4).

Post-medieval walls and deposits were recorded within the excavated area of the new building (Fig. 3). Although modern overburden had been removed by machine, the post-medieval remains were truncated at frequent intervals by a network of 20th-century concrete and brick foundations, which were planned but not recorded in detail. The post-medieval remains are described in chronological order in sections 5.1 to 5.5 below, and are illustrated both as planned on site, excluding areas of later truncation (Fig. 4), and as an interpretative phase plan (Fig. 5). Detailed context information for both the evaluation and excavation phases is presented in Appendix 1.

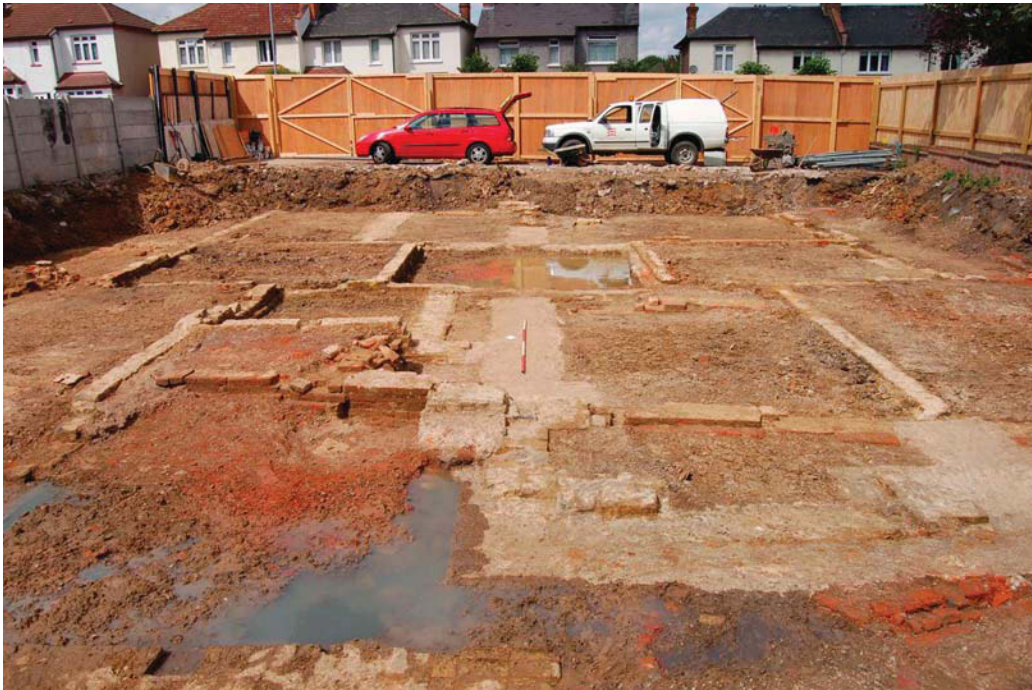
Plate 1. The site looking north, with remains of the late 16th/17th-century house overlain by modern foundations (2m scale)

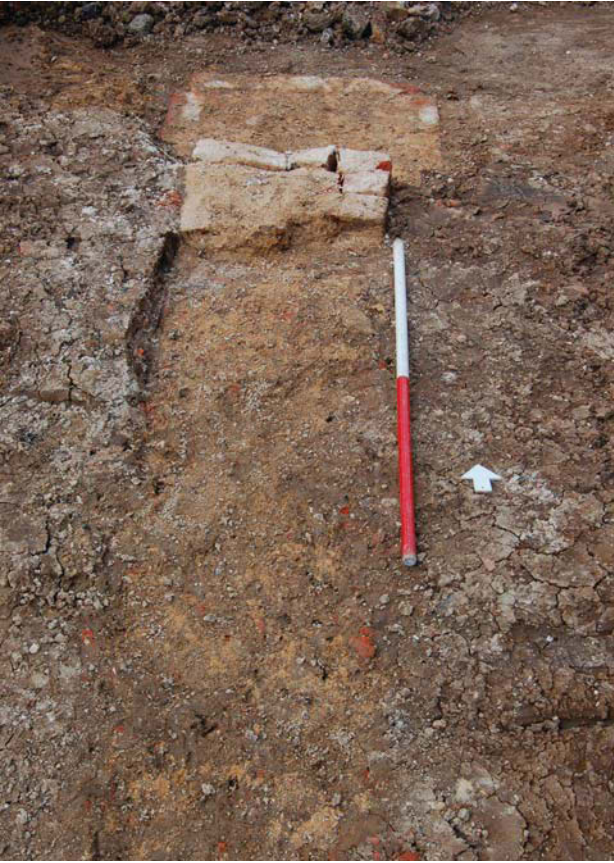
Plate 2. Pier base 60 (top), wall 61 and robber trench fill 95, dividing Rooms 1 and 3 (1m scale)

West of brick pier 60 the northern wall (63) survived as a single course of bricks heavily obscured by mortar, but probably consisting of two rows of bricks laid as headers. The western end of the wall consisted of broken bricks, beyond which there was only a yellow mortar mark. An area of mortar robber-trench fill also ran up to pier 60 to the east, while the eastern wall 61/95 (described under Room 1) had also been extensively robbed.

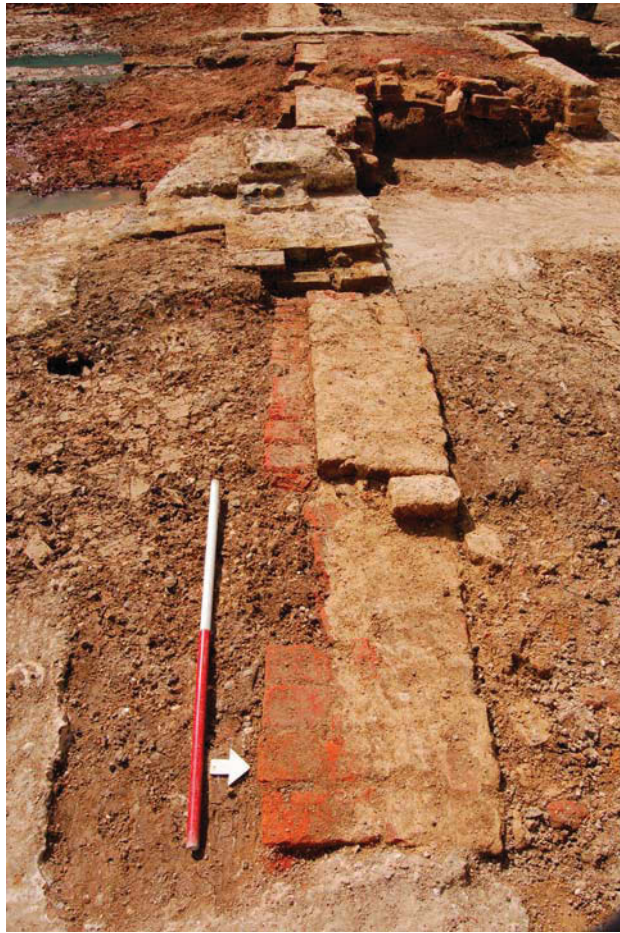
Plate 3. Wall 74, the southern wall of Room 2, with external foundational off-set (1m scale)

Room 2 was located to the south of Room 1, measuring at least 5.5m east-west by 3.2m north-south. The southern wall (74) was at least two courses deep and was of similar build to the northern wall 77 (described above under Room 1), again built in English bond. The brickwork was mainly obscured by mortar, but the uppermost course was constructed of bricks laid as stretchers along the southern face of the wall and headers along its northern face. An external foundational off-set of 0.10m extended along the wall's southern edge, consisting of bricks laid as headers (Plate 3).

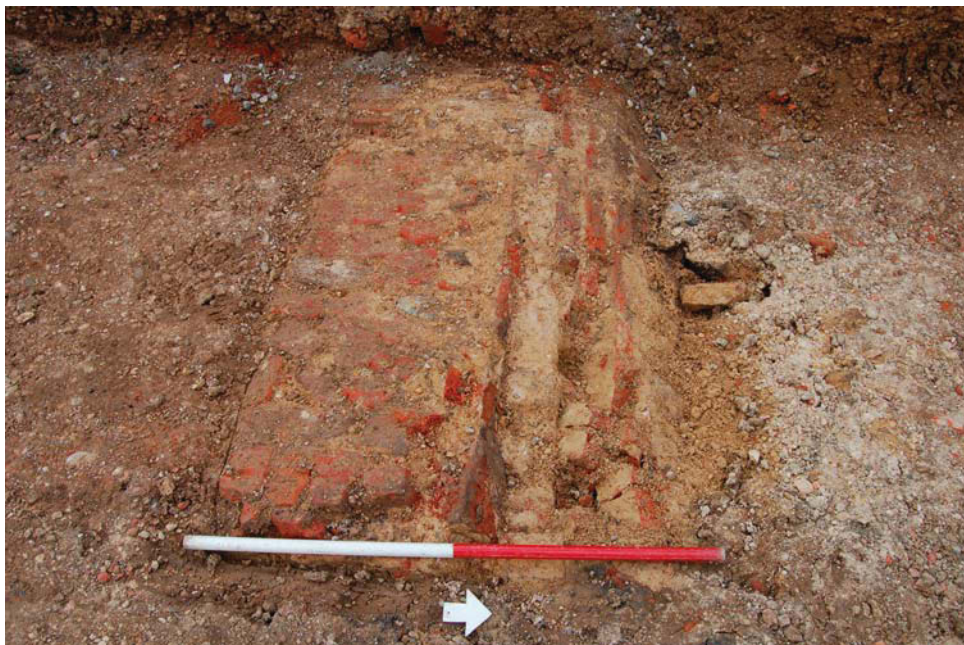
Plate 4. Wall 65, the southern wall of Room 3, with culvert 64 on its north side (1m scale)

channel (83), and the remnants of a truncated second course were also visible on either side. The culvert was filled with dark grey clay, beneath which probing suggested that there were no further bricks. The culvert was clearly below contemporary ground level as its roof was at the level of the irregularly laid foundation of wall 65.

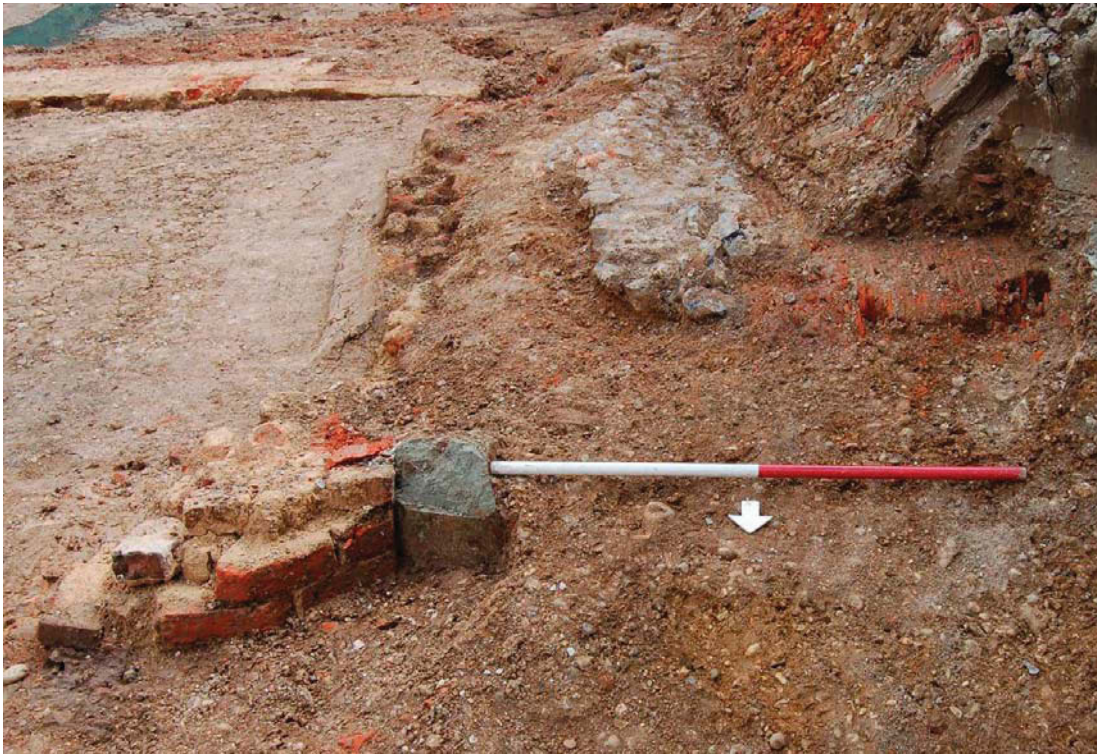
Plate 5. Wall 66 (left), with a greensand moulding for a doorway in the south of Room 4, with cobble and tile courtyard surface 67/68 in background (1m scale)

To the west of the of wall 66, the western wall of Room 5, was a scattering of pebbles and tile fragments upon which was laid a compact surface comprised of flint cobbles (68) and broken roof tiles set on edge (67). The surface was between 0.10m and 0.12m thick and bonded by brown clay with traces of yellow and off-white mortar. There was no evidence of heat distortion, as would be expected of a hearth or oven, and the cobble and tile surfacing is more likely to be external to the building, probably as part of a decorative path or courtyard surface. Significantly, the external surfacing lies opposite the doorway in the south wall of Room 4 (Plate 5), which appears to have provided access to a courtyard in the angle of Rooms 4 and 5. This external surfacing survived to a higher level than the adjacent walls, all of which were truncated, and gives an indication of contemporary ground level.

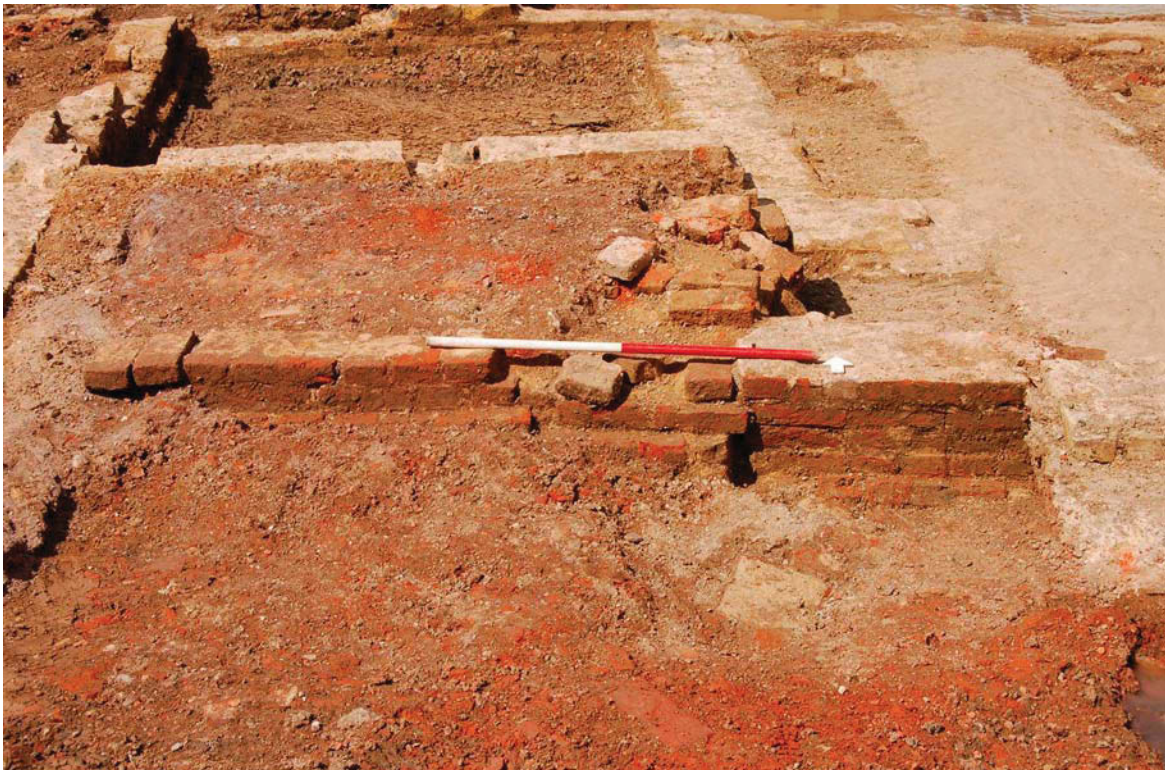
Plate 6. Wall 73 (right) of the original building phase, abutted by walls 71 and 72 related to the rebuilding of Room 5, with brick rubble levelling 13/51 in the foreground (1m scale)

Wall 73, forming the original southern wall of Room 5, was abutted to the west by a wall of different construction (72) that extended 1.0m to the north before being truncated by a modern foundation (Plate 6). Wall 72 was 0.50m wide and over 0.45m deep. At its abutment with the earlier wall, wall 72 consisted of four to five courses of brick laid in English bond, on mortar and brick rubble. Where it extended to the north the wall was less substantial, seemingly only consisting of two courses laid directly on the initial clay levelling. Beyond the northern end of wall 72 were several chunks of mortared brick that looked to have been dislodged from its top, most probably during the 20th-century building works.

The rebuilt wall continued westwards of wall 72, forming a new southern wall of Room 5. This wall (71) was narrower and consisted of two courses of bricks laid as headers, overlying an external foundational off-set (Plate 6). On the south side the projecting foundation consisted of a neat row of headers but on the north side the foundation was more irregular and roughly mortared. On top of the wall was a linear yellow mortar mark approximately 0.20m wide. The wall continued to the west (69) beyond a modern truncation. This length of wall was slightly irregular in construction and varied in width, with the eastern half being 0.40m wide and the western half only 0.22m wide. On top of wall 69 was a linear

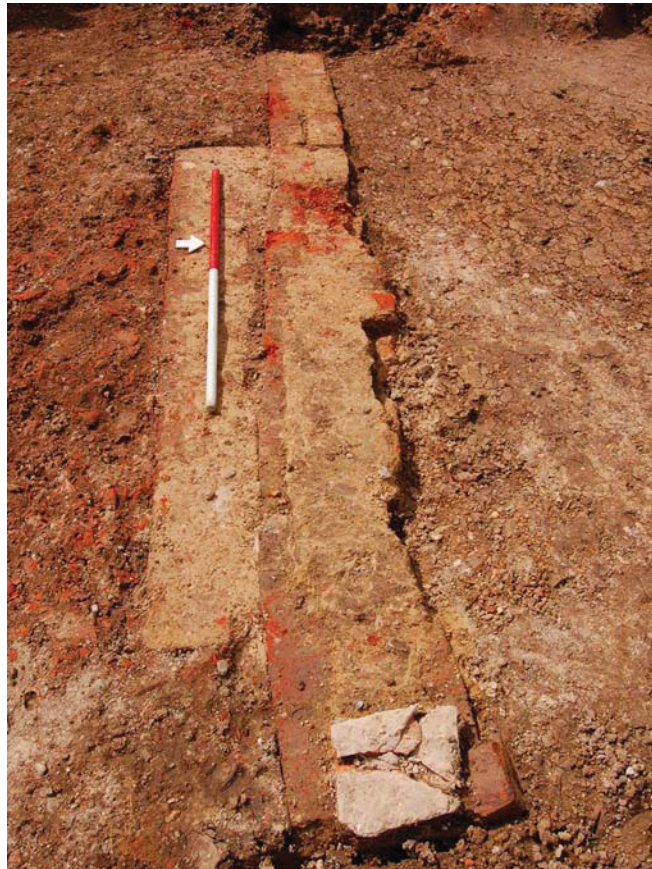
Plate 7. Wall 69 (right), the rebuilt southern wall of Room 5, with foundation 70 added to its south (1m scale).

yellow mortar mark, 0.20m wide, aligned with that on top of wall 71 (Plate 7). The wall was at least two courses deep, and although its construction was not clear the upper course in the western half consisted of two rows of bricks laid lengthways. At the east end of the wall a single cracked roof-tile adhered to the linear mortar mark (Plate 7), suggesting the presence of a tile course. Interestingly, walls 66, 69 and 72 all showed traces of paler whiter mortar on their upper surfaces which perhaps indicates uniformity in build. Whiter mortar was also apparent on top of the earlier wall 73 but perhaps resulting from alteration or repair at the same time.

A 1.8m-long section of wall (70) was added to the external, southern face of wall 69, with the two walls separated by a thin seam of greyish brown clay (Plate 7). These walls are shown on Fig. 5 as structural phases 2 and 3 of the late 16th/17th-century house. Wall 70 was 0.30m wide and 0.13m deep and consisted of a single course of bricks, mainly headers with occasional stretchers and half bricks, overlying two courses of flat roof-tile, overlying gravel external surface 55 (Plate 8). Wall 70 was most likely added to strengthen the foundations of the earlier wall 69. It may be significant that wall 69 bowed outwards, while wall 70 added to it was very regular (Plate 7).

A further explanation of the rebuilding of Room 5 may lie in the wet ground conditions in this part of site. The southern wall 69 of the rebuilt Room 5 had to be strengthened by the addition of foundation 70 against its outer face as a result of bowing of the original wall. It is possible that earlier wall lines may also have suffered structural problems due to the wet ground. The extensive spreads of crushed brick that accompanied the rebuilding of Room 5 were presumably a result of demolition and construction work, but may also have been deposited as a levelling specifically to make good a wet area. The mixture of earlier bricks and pottery amongst those contemporary with the house would be consistent with material being brought in as hardcore. Given the ground conditions it is not surprising that a well or

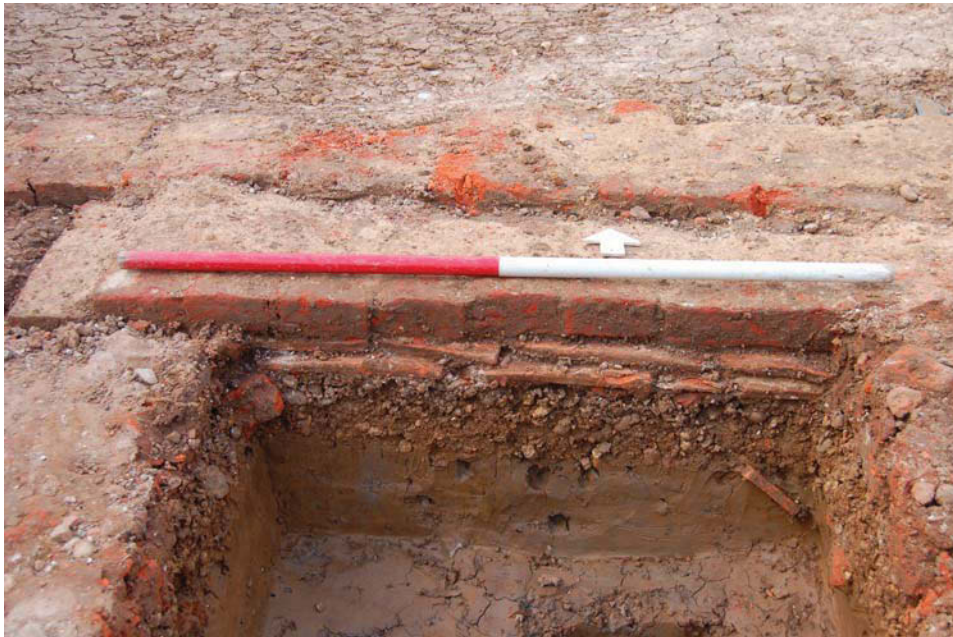
Plate 8. Foundation 70 overlying external gravel surface 55, above clay levelling 56, and natural clay at the base of the trench (scale 1m)

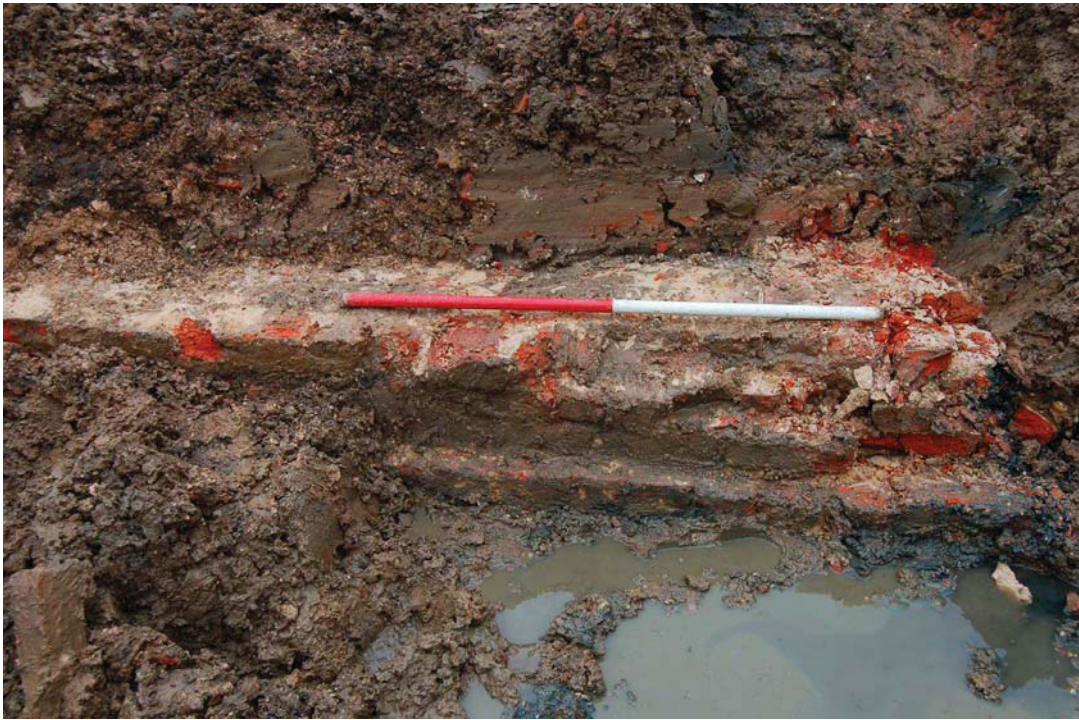
Plate 9. Wall 83, the front wall of the 1775 house, with external foundational off-set, looking south (1m scale)

The wall (8/83) was 0.50m wide and four courses were recorded, with the lowest forming an external foundational off-set (Plate 9). It was constructed of Late Tudor/17th-century place bricks and at least one 17th-century stock brick, with the bottom two courses laid as headers. The bonding arrangement of the upper two courses is unclear. Some of the bricks had mortar covering broken faces confirming that they were re-used. The mortar itself was sandy brownish-yellow (Munsell 1975, 10YR 6/6) where sampled, although appeared greyer in situ, with generally frequent inclusions of lime, some of which were large, and smaller and rarer chips of brick, pellets of brown clay and two of possible soot. The wall was exposed for a length of 2.75m and was truncated to the west by a modern service trench, beyond which it continued as a fragment of wall (10) only 0.30m long, truncated to east and west. The lengths of wall exposed survived only at foundation level.

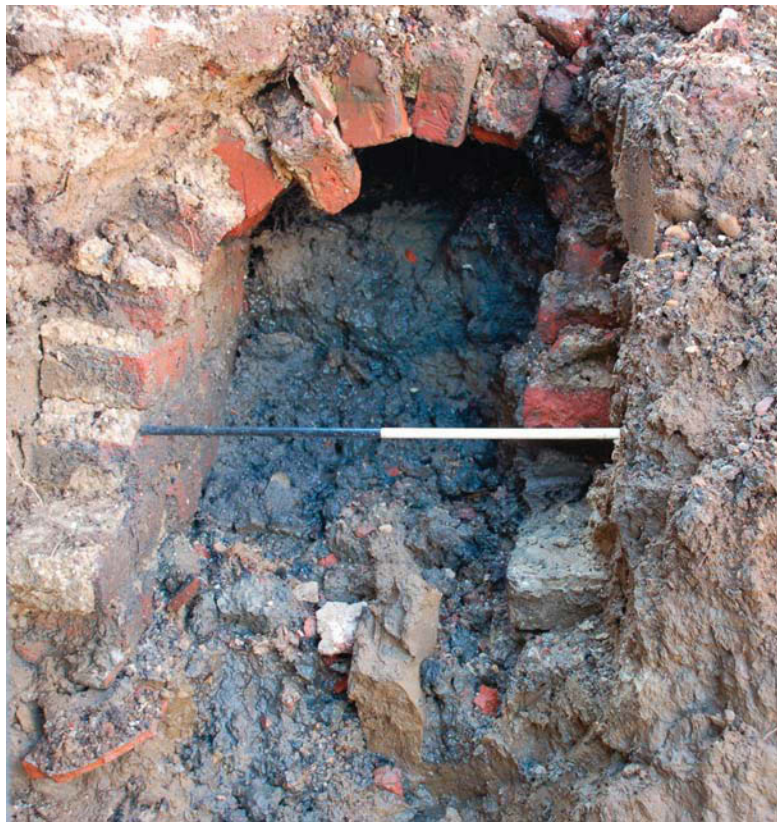
Plate 10. Brick culvert 85, related to the 1775 house, looking north (0.5m scale)

<b>Context</b>	<b>Type</b>	<b>Description</b>	<b>Period</b>
84	Found. trench	Linear cut containing culvert 85	18th century
85	Culvert	Arched brick structure, 0.63m wide by 0.68m high, sandy yellow lime mortar.	18th century
86	Fill of 85	Mid grey brown silty clay (within culvert)	18th century
87	Pit	Irregular oval, 1m x 0.80m	18th century
88	Fill of 87	Dark grey clay, frequent charcoal	18th century
89	Pit	Irregular oval 2m x 1.7m wide	Modern
90	Fill of 89	Dark grey clay	Modern
91	Post-hole	Square, 0.17m x 0.17m	Post-med.
92	Fill of 91	Black charcoally clay	Post-med.
93	Post-hole	Square, 0.17m x 0.17m	Post-med.
94	Fill of 93	Black clay	Post-med.
95	Fill of robber trench	In Evaluation Trench 2 (previously numbered 17) Greyish brown silty clay, mortar and brick & tile fragments	18th century
96	Found trench	Linear cut, N side of wall 71, 1.2m x 0.2m x 0.17m deep	17th century
