**DAIRY OUTBUILDINGS AT ASHDOWN HOUSE  
HARE STREET, GREAT HORMEAD  
HERTFORDSHIRE**

**HISTORIC BUILDING RECORDING & ARCHAEOLOGICAL  
MONITORING**

May 2010

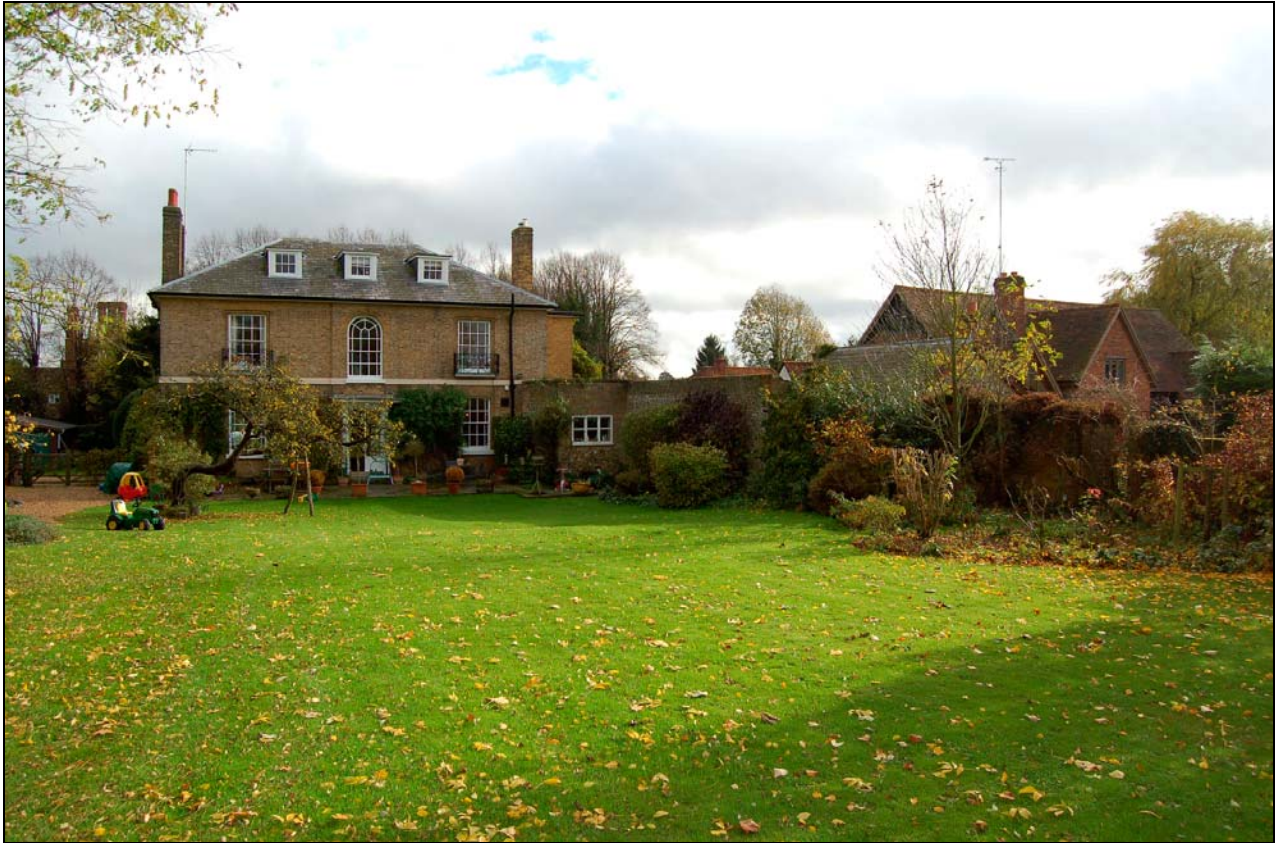
Plate 1 Ashdown house with outbuilding range to right

The study area forms a single-storied slightly staggered range of service buildings built onto the rear of the house (plate 1) along the boundary/trackway into the farmyard (fig. 1). The house and farmyard were formerly linked by access routes from the house (a side door and steps onto the yard, fig. 5) and via the outbuildings. Many of these doorways were blocked-in or sealed when the farm was sold.

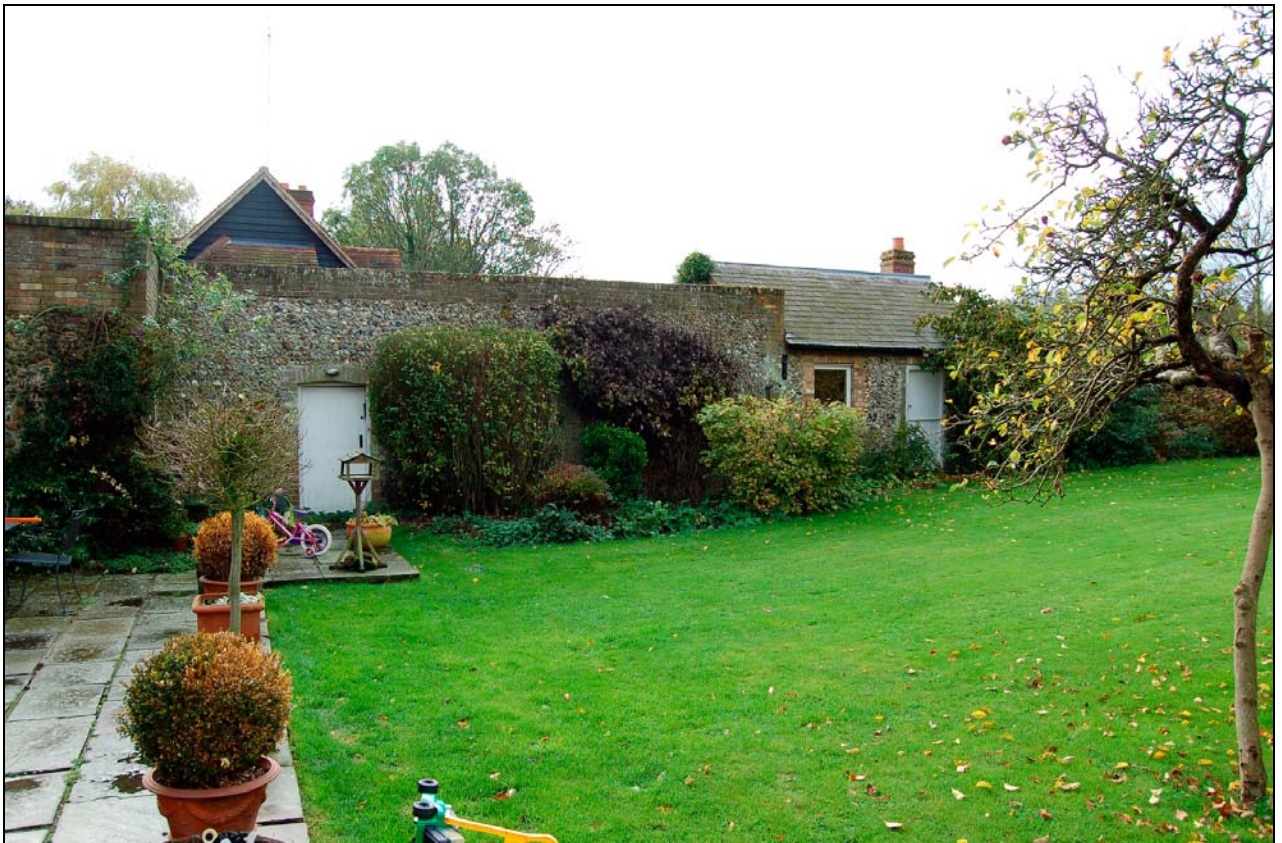
Plate 2 Outbuilding range and schoolroom from garden

Apart from building 4, which is only partly standing, the character of the buildings has changed very little apart from recent replacement windows and blocked doorways on the farm side. They are largely built of flint, kept in place by iron tie rods, with red brick dressings

to the doors and windows (plate 2). The roof over storage area 1 has been partially raised in recent times to conform to the general roof line and much of the garden elevation is screened by shrubs.

Much of the garden elevation is hidden behind shrubs (plate 2). Access is by a heavy framed door, panelled on the inside. The window beside it is replaced like the others but is set into an earlier aperture. There are no openings into area 2 on this side.

The main door into the room from the garden side is likely to be the original and is stout and half-heck in form with a central ledge (plate 2). Another stood centrally on the farmyard side (plate 9), but is now blocked (fig. 5). Modern windows are positioned at either side of the blocked door, fitted with curled handles imitating an earlier style (plate 11).

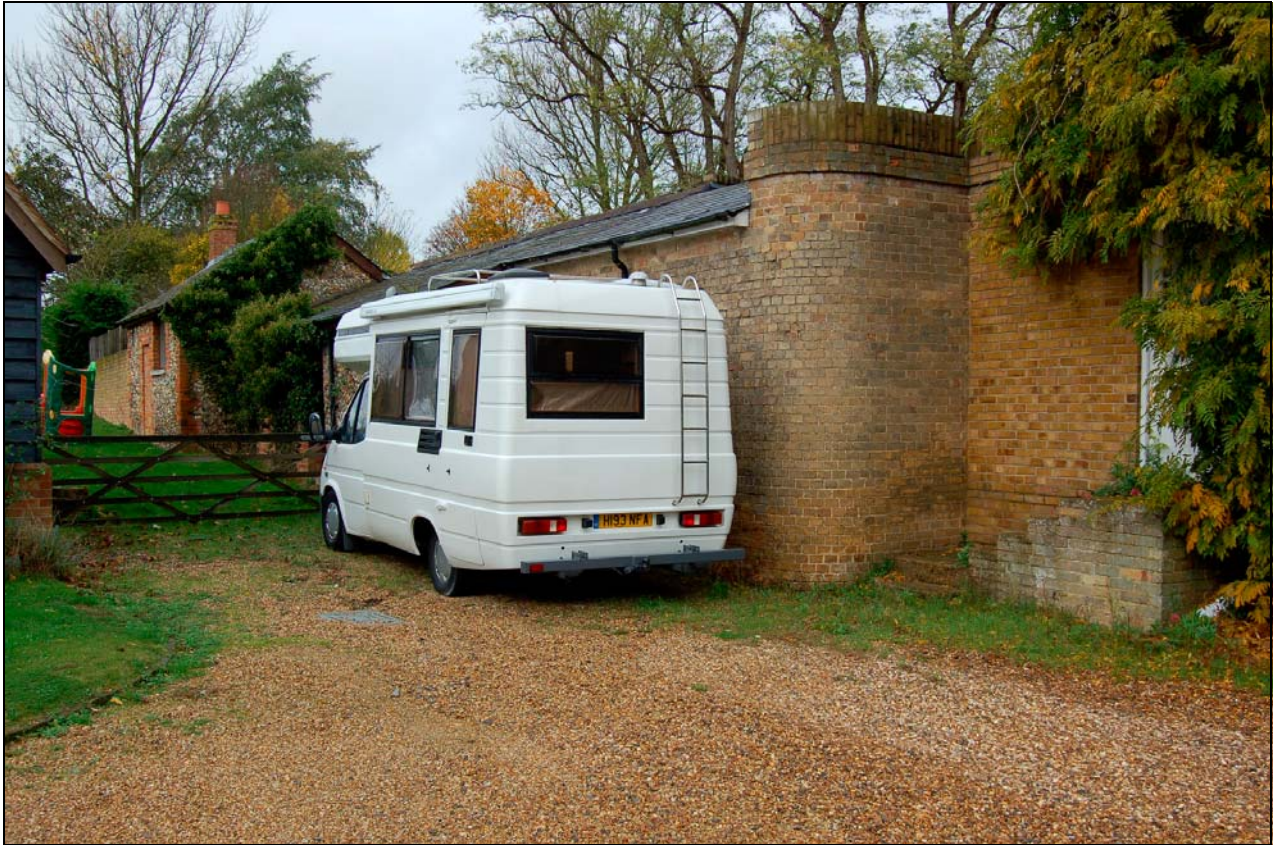
Plate 3 Utility room and outbuilding range viewed to west, along former farm track

The roof has been raised on the southern side with the addition of two extra brick courses, thus presenting a continuous pitch from the utility room (plate 3). It is a simple rafter purlin roof supported on a rough, reused, wooden strut nailed onto a rafter and cemented into the wall (fig. 6) and likely to be post-1910 in date. The roof in room 2 is hidden behind a hardboard ceiling (plate 8).

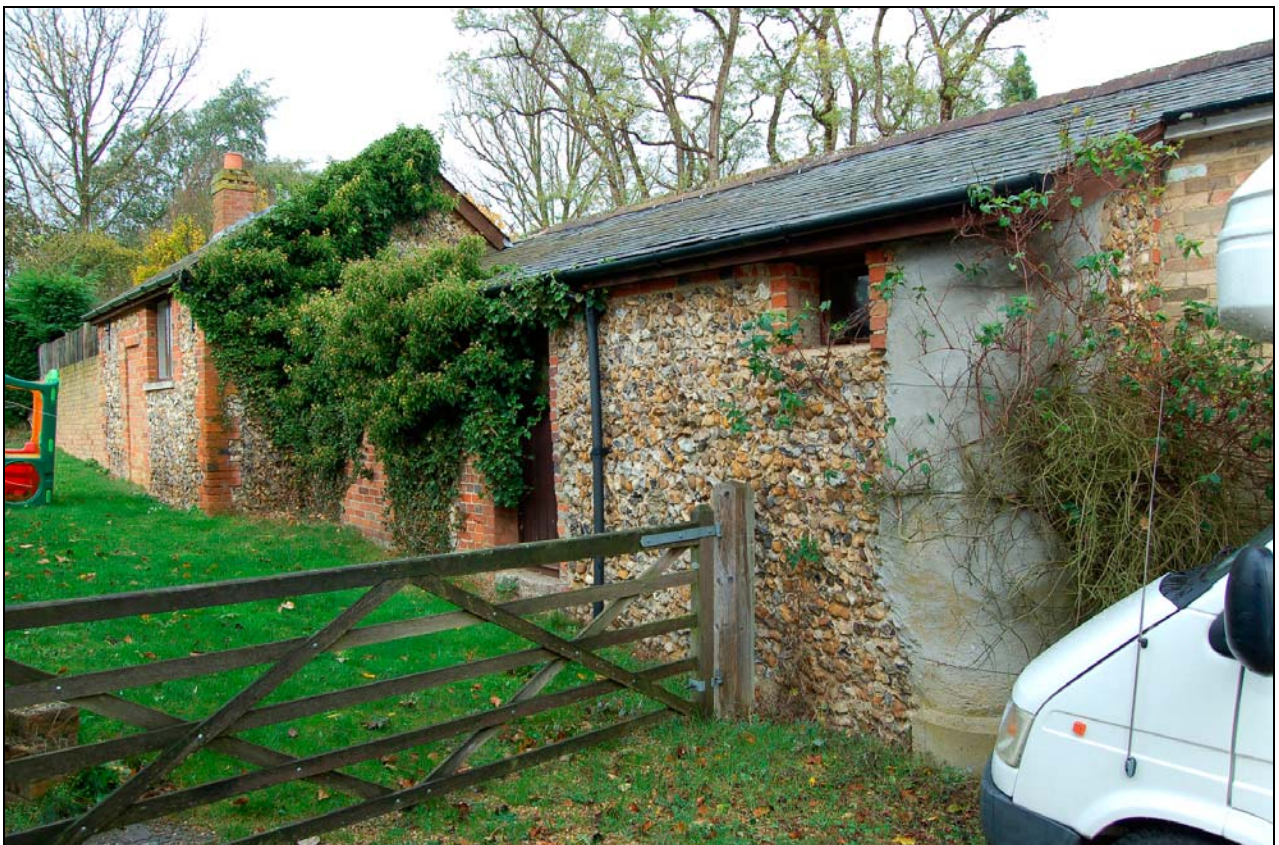
Plate 4 Former dairy, harness room and schoolroom viewed to west

A large ivy bush covers half of the farmyard side. The dairy unit steps out from the utility room on this side and some damage has occurred to the rounded corner, indicated where the flintwork has been repaired in cement (plate 4). Access points into the two rooms can still be recognised as a sealed doorway into room 1 and a bricked-up doorway into room 2 (fig. 5). The latter now holds a casement window, providing the only natural light. A second, small

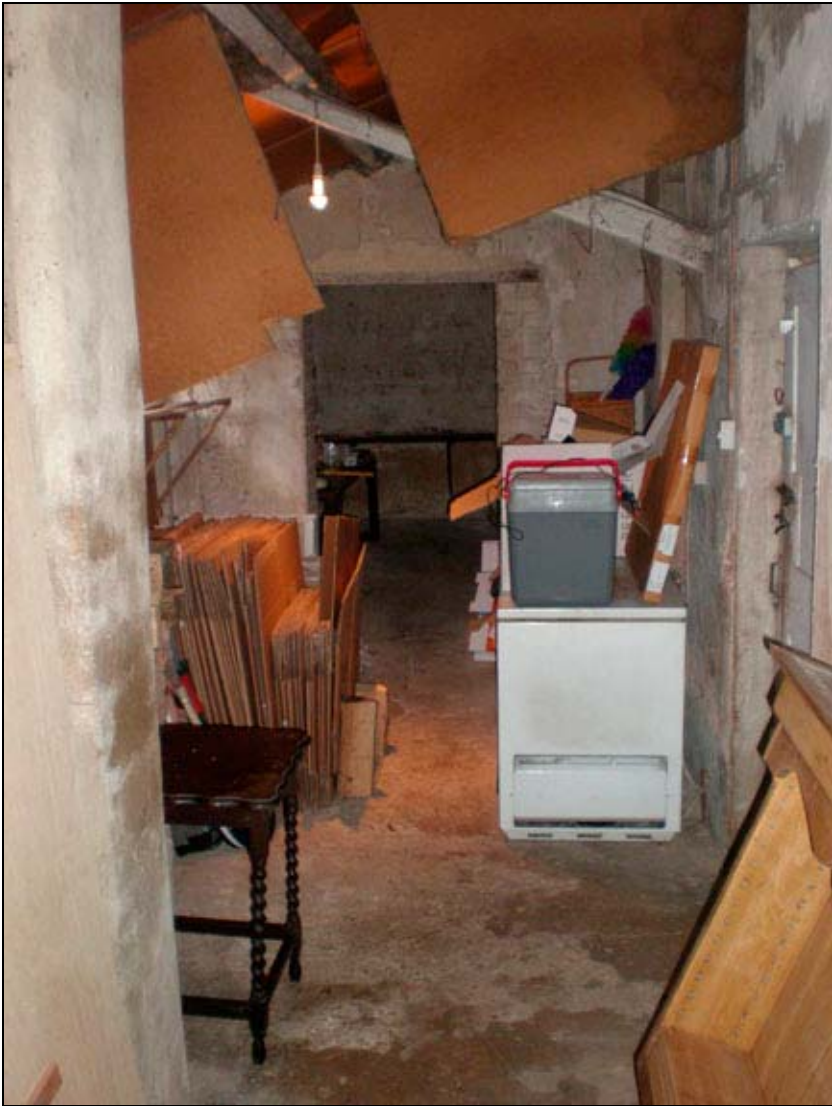
Plate 5 Interior of dairy 1, viewed to west

Rooms 1 and 2 have hard mortar floors and plaster over the thick flint walls (plate 5 & 6). There is a slight ramp down from room 2 at the threshold. The main features inside room 1 are the heavy slate table in the south-east corner (fig. 5, plate 7, bottom left), formerly used as a 'cold table' for the dairy products. In the opposing corner is a partly-exposed brick feature that probably held a copper, though it was only partially exposed. The bricks and bonding material (lime mortar) appear contemporary with the building.

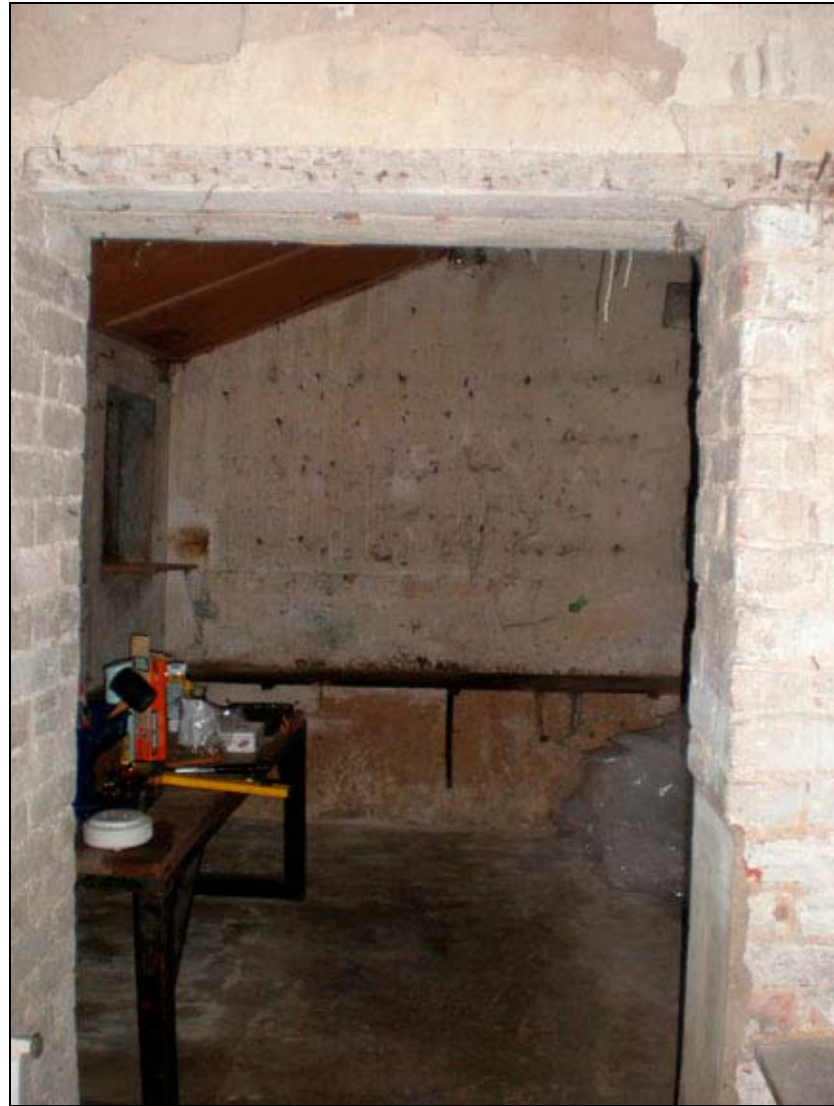
Plate 6 Interior of harness room 2, viewed to west

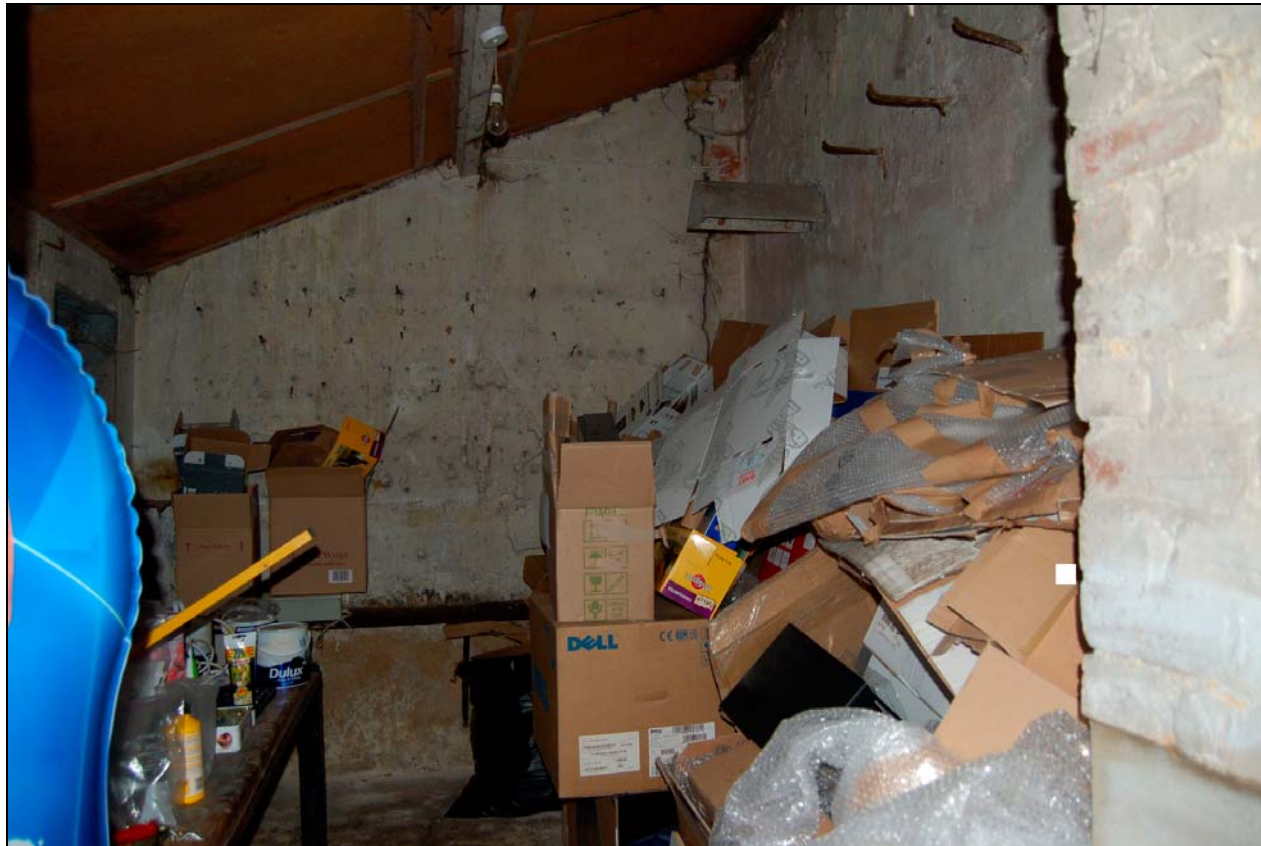
Plate 8 Interior of harness room 2 viewed to west

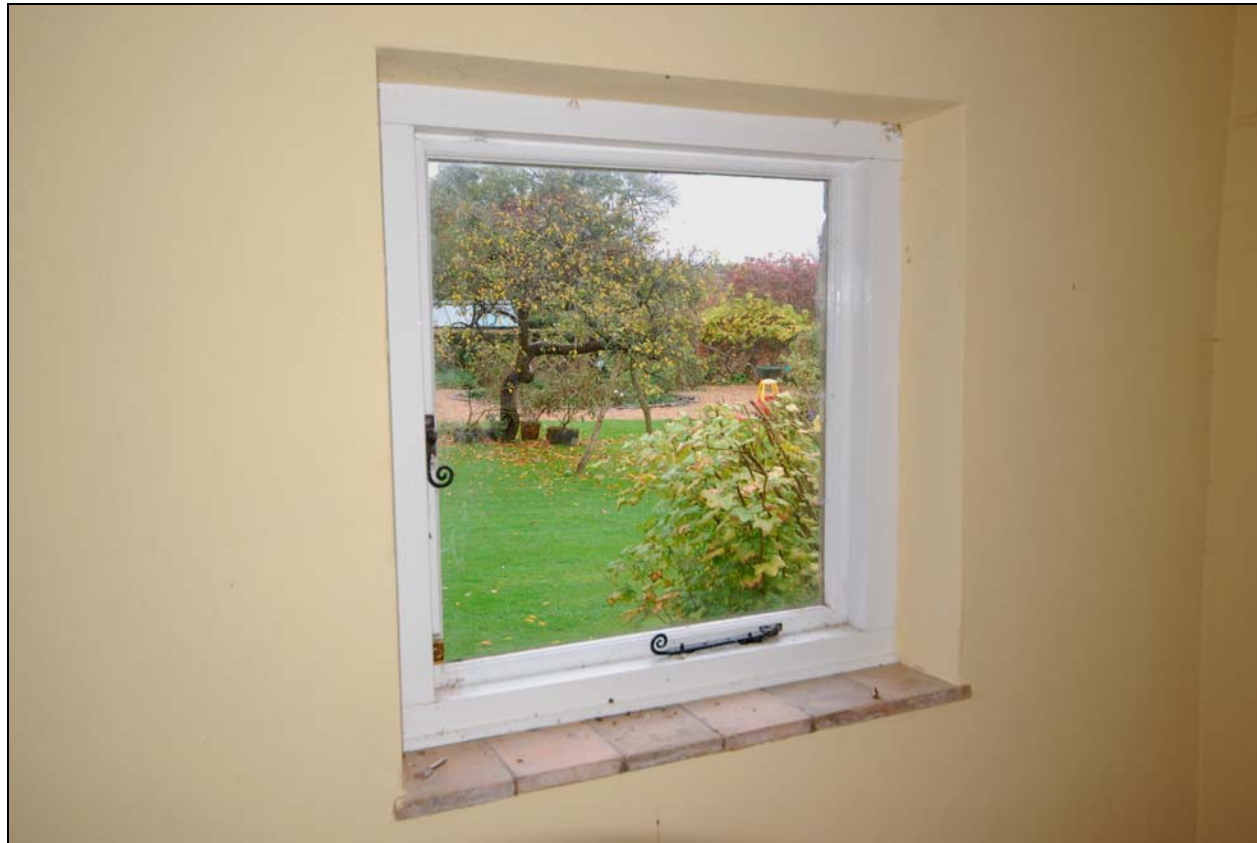
Plate 11 Typical replacement window (in schoolroom)

A single 2 x 7½ inch pine beam divides the room into two bays. Above it are collars nailed to each of the rafters that are exposed in the ceiling (plate 11).

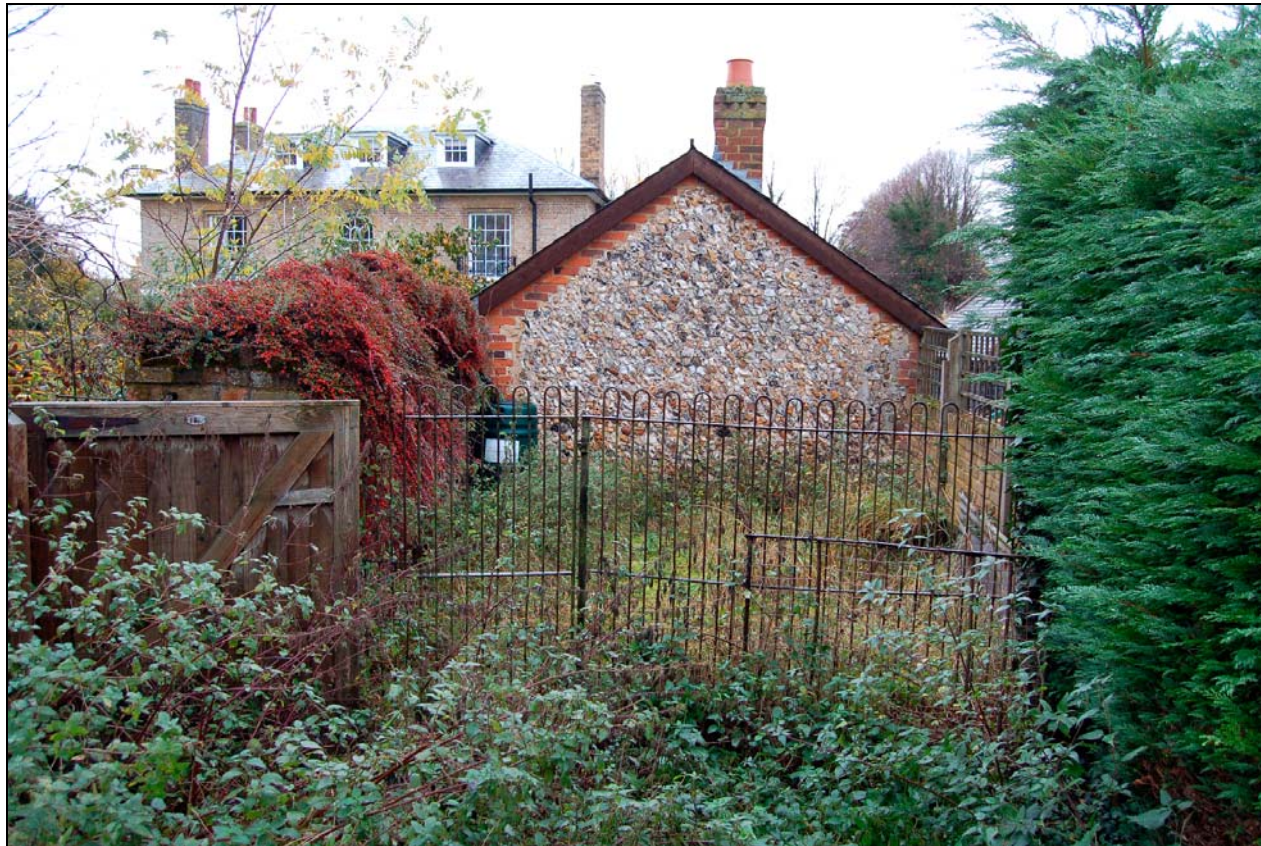
Plate 12 Location of demolished chaise house 4 (garden area)

The former interior has a concrete or compacted mortar floor hidden by vegetation. Iron gates have been inserted along the old west end (plate 12) and the strip of land continues to the end of the plot, with occasional stray pieces of brick wall and timber posts suggesting more-temporary timber structures continued on the line of the range at some stage.

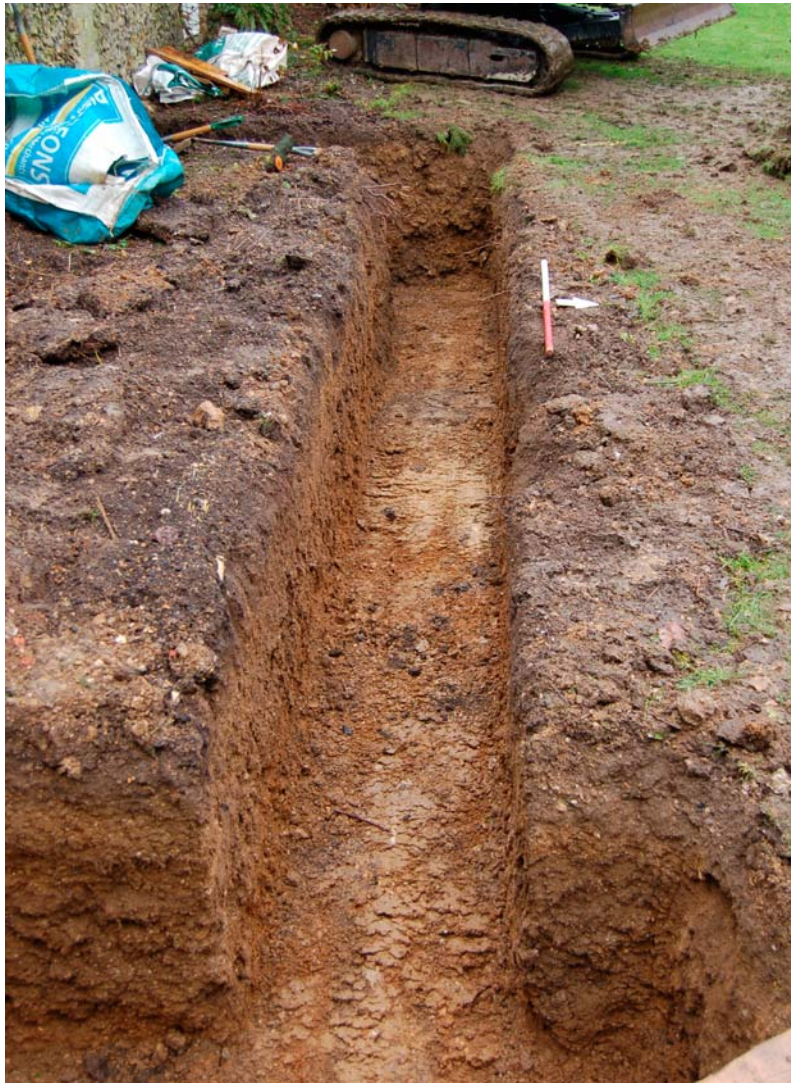
Plate 13 Main foundation trench, viewed to west (1m scale)

Natural brown clay and gravel was exposed in the base of the external foundation trenches (plate 13). Above the natural was an undisturbed mid greyish brown silty clay subsoil which varied in thickness from 0.38m to 0.50m and contained occasional small flints. In the east of the trench this subsoil was sealed by a 0.12m thick layer of re-deposited chalk with a 0.25m thick mixed layer of greyish brown clay with chalk and brick flecks above that. In the western parts of the trench the subsoil was overlain by a thin (0.10m thick) seam of fine yellow gravel with 0.15m of dark grey organic topsoil at the top of the sequence. Internally and leading out northwards below the former dairy wall the sequence was noticeably different. Above the natural was a deposit of greyish brown silty clay that was similar to the subsoil in thickness and composition but which appeared more disturbed, particularly near the north wall of the former dairy, and contained occasional small fragments of brick and tile, with flecks and lumps of mortar. Above this layer was 0.30m of compacted brick rubble upon which the 0.08m thick compacted mortar floor of the building had been laid. The rubble and mortar floor butted up to the flint foundation of the northern wall of the former dairy building which extended to a depth of 0.5m below ground level (plate 14). A sherd of possible early 19th century flower pot rim (pers. comm. Helen Walker) was retrieved from the top of the disturbed clay layer directly beneath the wall foundation. The disturbed clay continued externally for 1m or so beyond the dairy wall, though its interface with cleaner subsoil to the north was obscured by dark grey organic rooty material that marked the former position of a large shrub (plate 2).

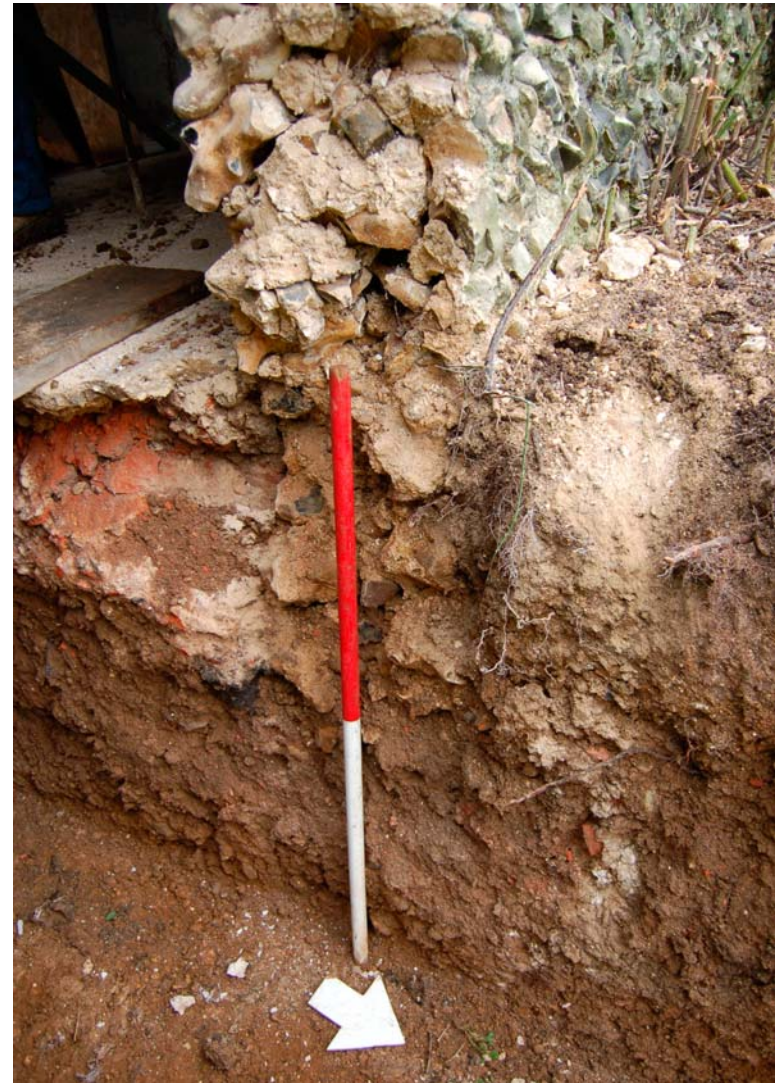
Plate 14 Northern wall of former dairy building (1m scale)

No remains of medieval or earlier date were identified. The deposits exposed in the foundation trench were all of a comparatively modern date. The earliest was the clay beneath the floor and northern wall of the former dairy building which was probably disturbed during the construction of the outbuildings in the early 1830s. The fragment of possible early 19th century flower pot recovered from the disturbed clay fits with this interpretation.
