**LUCKING FARMHOUSE,  
LUCKING STREET,  
GREAT MAPLESTEAD,  
ESSEX**

**ARCHAEOLOGICAL MONITORING AND EXCAVATION**

**Essex County Council**  
**Field Archaeology Unit**

**March 2010**

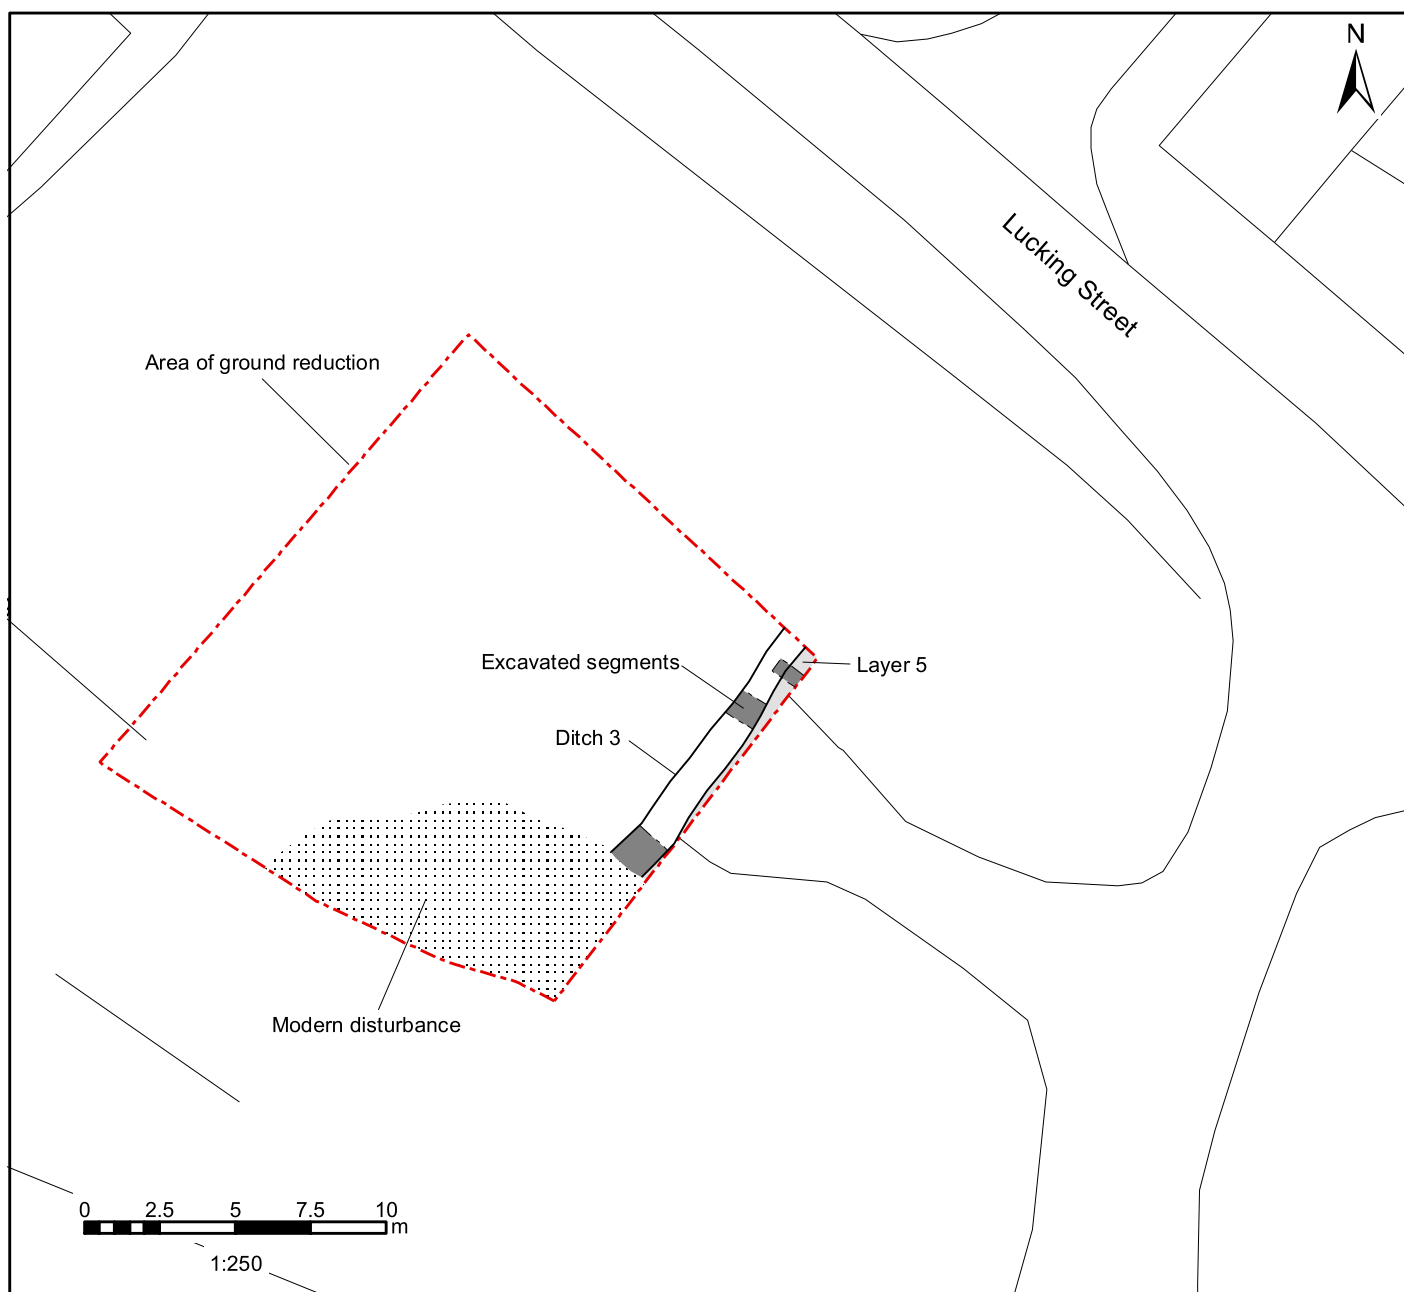
Fig.2. Area of ground reduction and excavated features

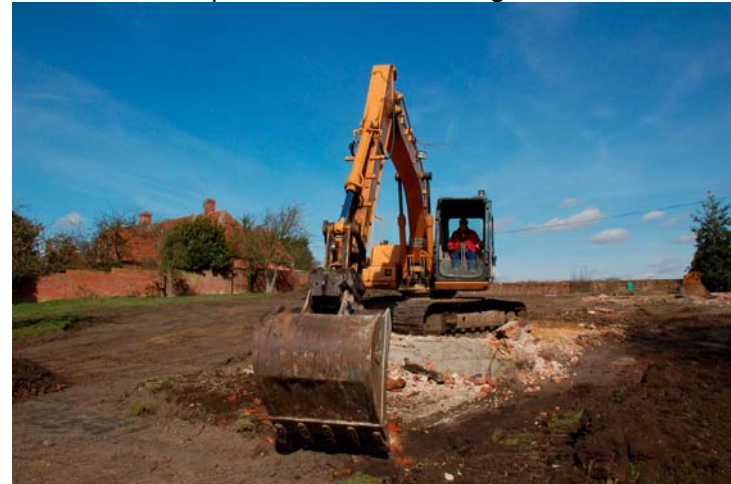
Plate 4. Demolition of stable. Looking north.

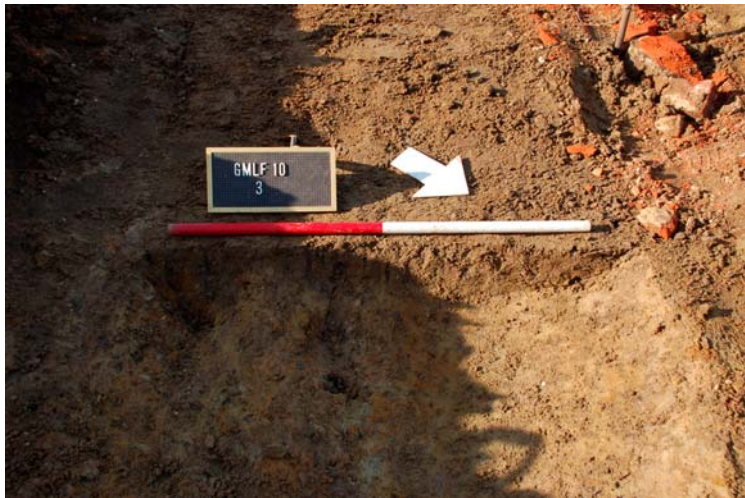
Plate 5. Ditch 3, looking south-west. 1m scale.

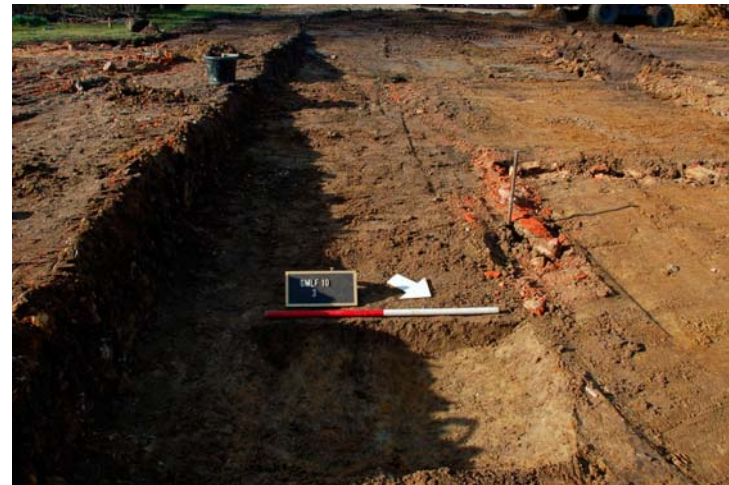
Plate 6. Ditch 3, looking south-west. 1m scale.

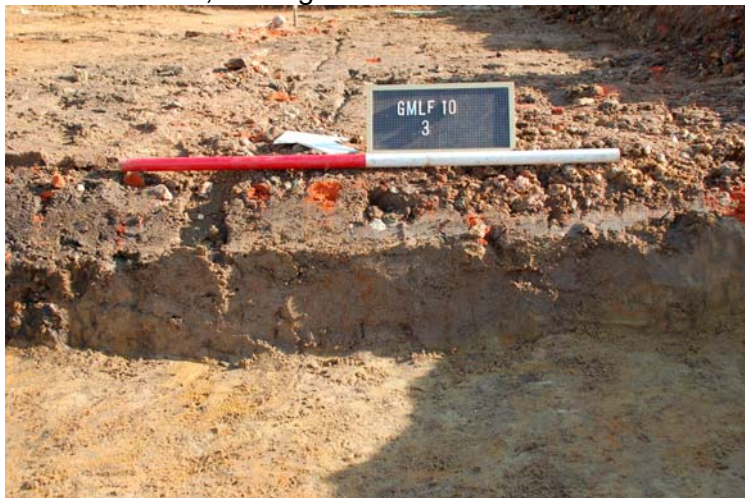
Plate 7. Ditch 3, looking north-east. 1m scale

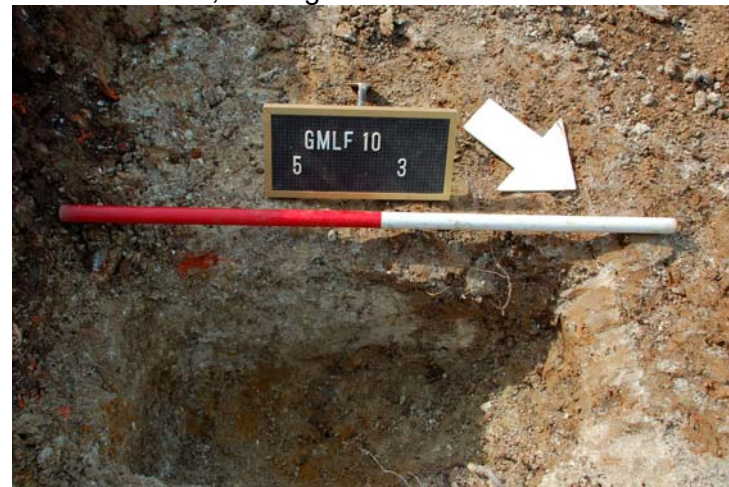
Plate 8. Ditch 3 and layer 5, looking south-west. 1m scale
