**ONGAR WAR MEMORIAL HOSPITAL
FYFIELD ROAD
CHIPPING ONGAR
ESSEX**

HISTORIC BUILDING SURVEY

**Essex County Council
Field Archaeology Unit**

June 2010

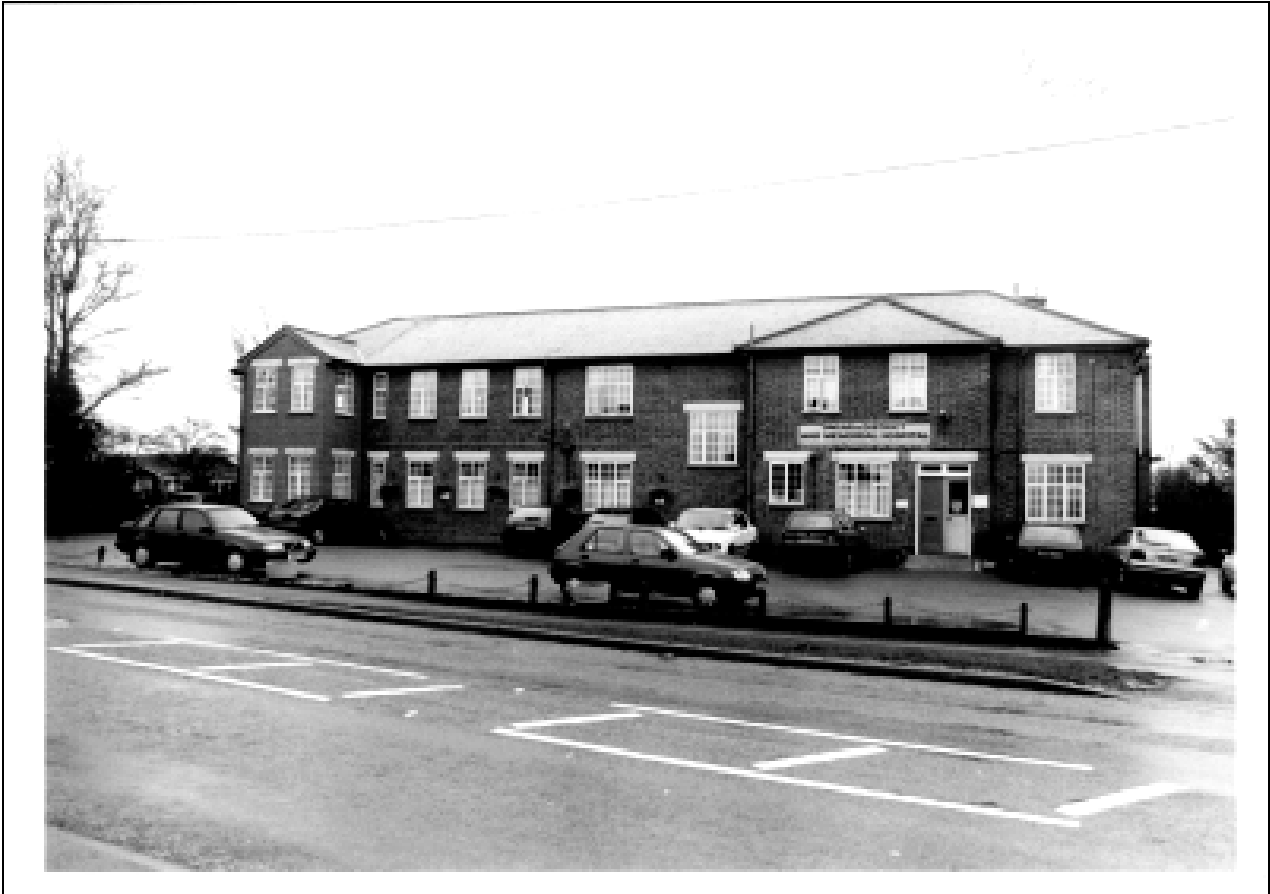
Plate 1 View from Fyfield Road in 1999

In 1971/72 the hospital was taken over by the County Council for use as elderly and mentally infirm accommodation. Funded by the League of Friends, a day room and lift were added in 1979, which was followed by a rear extension in 1988, together with the addition in 1995 of a three bay physiotherapy department onto the southern end in 1995, also constructed by the original builders, Nobles. Plate 1 was taken in 1999, before the lift was replaced.

The main entrance was, and still is, on the east side of the administration block. A covered porch was added in the modern period, but the former entrance may be viewed in plate 1. The entrance leads into the hall, latterly linked to a corridor into the 1939 extension at the west end of the building (plate 11), and southwards as a long corridor to the ward and latterly the physio dept. (fig. 3). Chamfered beams pass along the ceiling (fig. 3), providing some

Much of the equipment in the **operating theatre** has been removed and replaced by filing cabinets, but the old theatre light remains (plate 13). Opposite is the **stretcher** store (figs. 2 & 3). The current **motor room** was formerly the dispensary but now provides power to the modern (post 1999) **lift**. It is possible the former lift was located in the corridor leading to the current lift, although the earlier façade photograph (plate 1) shows a single mid-height window more suggestive of a stair light.

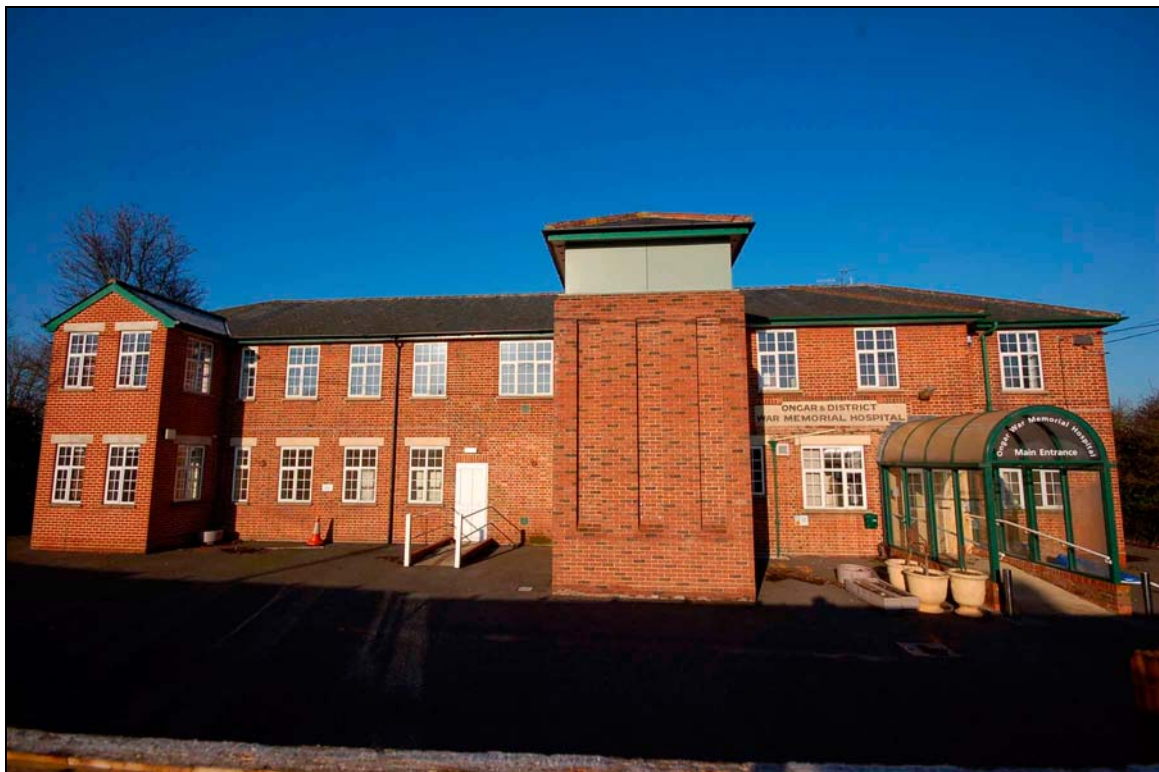
Plate 2 View from Fyfield Road in 2010

Extensions to the back of the main building are largely brick-built except for the day care block, which is pre-fabricated. More modern additions have been made to the front in the form of a two-bayed gabled projection at the south end (1996) and the lift building protruding from bays four and five (c.1999) (plates 1 and 2).

The main façade is the **east elevation**, facing onto the road, with the former car park at the front. It is of a consistent build, in Flemish bond, except for modern additions comprising the lift housing and 1996 extension, which that are in stretcher bond but in a similar tone of brick. Ground floor windows in the main part have stone sills and concrete lintels, whilst those on the first floor are built into the eaves (plate 2).

in 1996, with gable end and matching windows and green fascia boards that are the same colour as the cast iron rainwater pipes (plate 2).

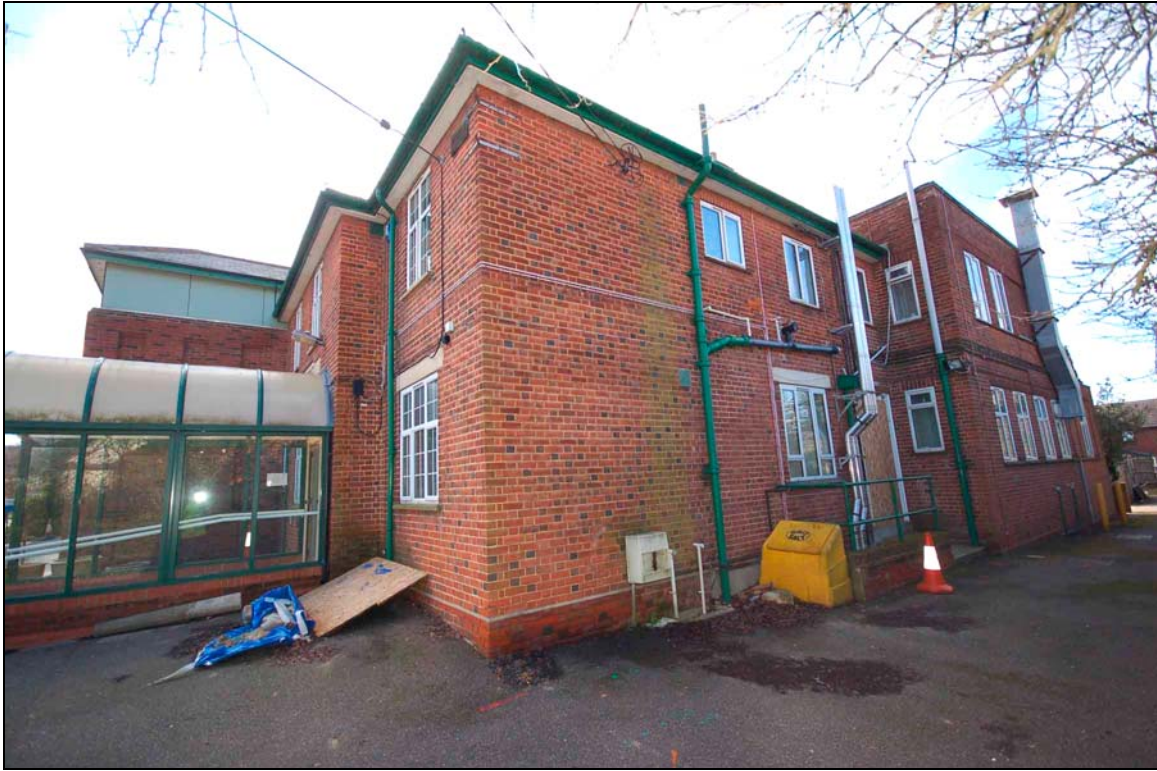
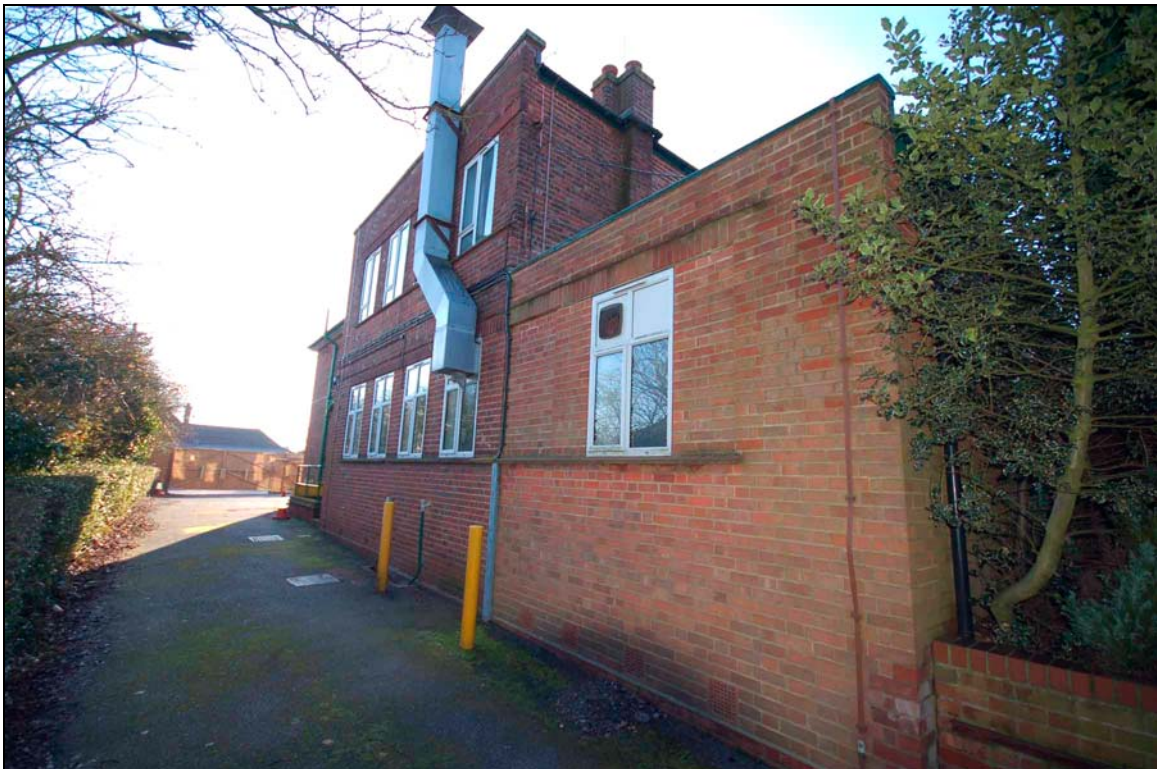
Plate 3 North elevation viewed to south-west

Plate 4 North elevation viewed to south-east

The **north elevation** (plates 3 & 4) stands alongside a tarmac drive leading to the rear, close to the boundary hedge (fig. 1). This represents the north end of the original hospital plus the 1939 kitchen extension (fig. 2). There are few features to the 1933 building part from a sole window on the ground floor located above the steps to the (now flooded) basement, which is identical to those on the front. Those above it are more plainly presented, with utilitarian tile sills and soldier heads, as with the extension. The extension begins at the side (tradesman's) entrance whose doorway has 'modernist' design influences unusual in this building, with definite geometric themes to the door surround: glazed and unglazed oblong panels and a column of three circular vents in the top left corner (plate 4). Echoes of modernist design are also reflected in the four-bayed 1939 flat-roofed kitchen extension, whose windows are in two horizontal recessed panels, with continuous soldier heads and tile sills to the top and bottom (plate 4). The bottom panel continues into the single storey mortuary room that is lit by a single window.

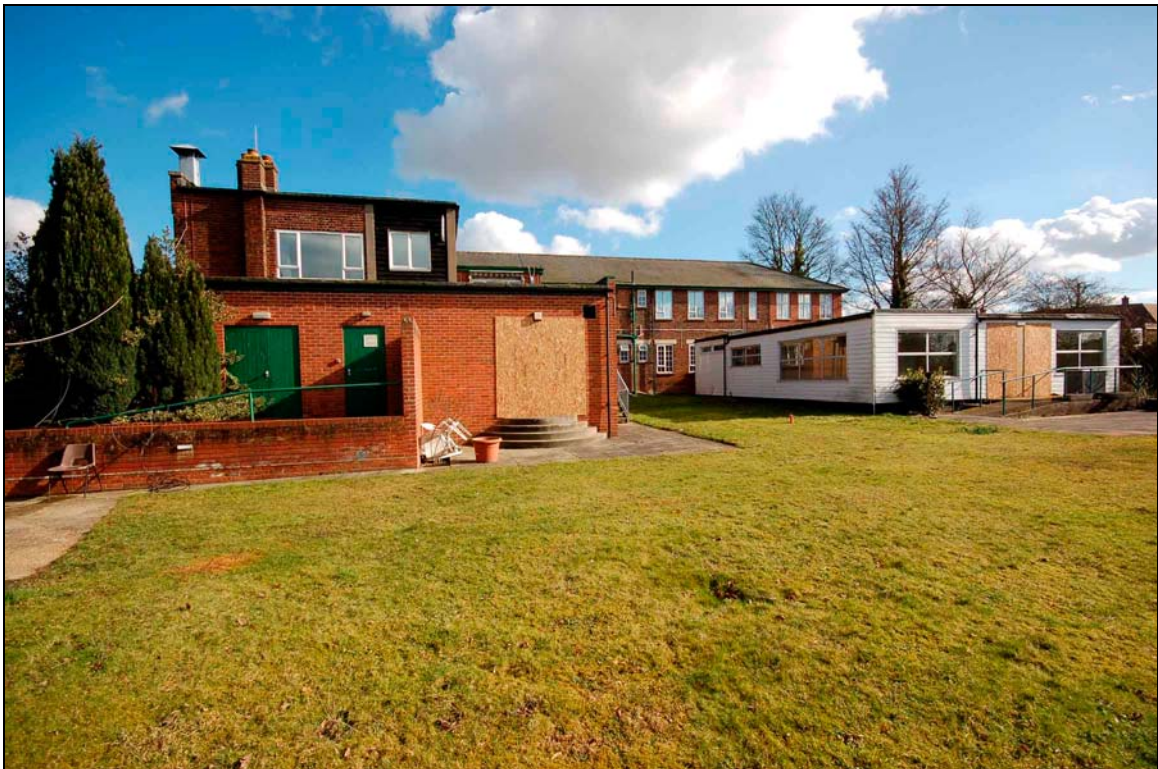
Plate 6 West elevation

The larder is long gone. The present **corridor** was formerly two connecting rooms: a sewing room and bulk store. The current corridor retains a utilitarian aspect with its bare painted brick walls, chains for gas bottles on one side and modern shelf fixtures on the other (plate 20). According to the plans of the 1939 extension, the **mortuary, sterilising room and store** at the far end were only accessible from the outside (fig. 2). However, this seems unlikely as there is no evidence for doorways where they should be and it is uncertain whether the plans were fully-adopted. Certainly an internal route to the mortuary would seem a good idea, as well as the discrete rear exit that still exists (fig. 3), with a utilitarian pair of ledged braced and battened doors (plate 6). All three rooms are stripped-out and display no features relating to function.

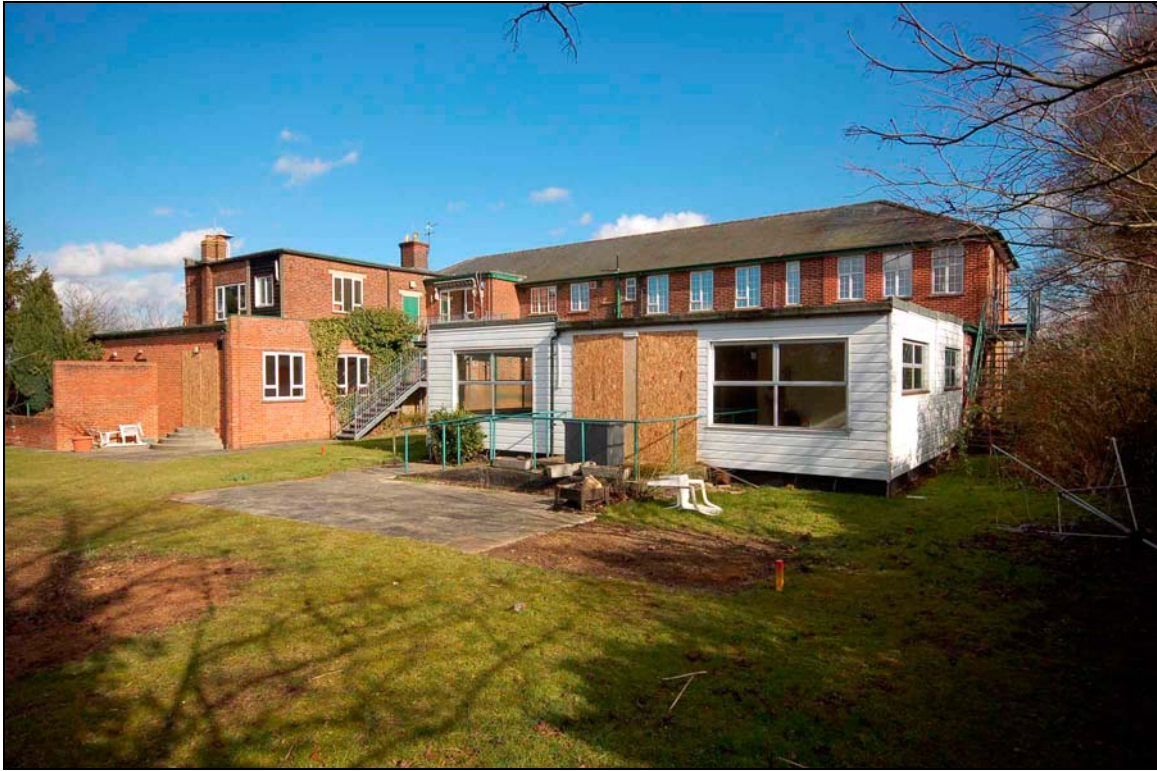
Plate 9 West elevation viewed to north-east

Viewed from the grounds at the back of the hospital, the most visual aspects of the **west elevation** are the 1939 and 1979 extensions that project outwards from the main core (fig. 1, plate 6). A small south-facing patio area stands at the back of the 1939 extension, connecting to the staff room, which is a later addition (1988?) built onto the earlier part in stretcher bond along with the screening wall in front of the mortuary which appears to be contemporary. Semi-circular concrete steps lead down to the patio from modern French doors. Closer to the main part of the hospital is the presumed 1944-45 operating theatre extension, which is now staff changing rooms (figs. 1 and 2). Construction is in the same Flemish bond and a scar marks the position of the original west wall (fig. 2). One of the windows was blocked when the changing rooms were introduced (plate 7). Over the extension, the first floor is stepped back from the ground floor and contains no features of note, with its flat roof, plain chimneys and metal air vent leading off from the kitchen below (plate 4). Between the extensions part of the main hospital is visible, showing window ranges to service rooms on the left of the smaller toilet windows and the wards to right (plate 8). All of the original cast iron vents, rainwater goods and waste pipes (painted green) are still present. The flat-roofed single storey 1979 day room extension protrudes from the south end of the elevation. Typically it has a boarded exterior and large aluminium windows to maximise light levels (plate 9). Above it, the change in build between the 1933 hospital and three-bay 1995 south wing can be clearly seen (plate 9).

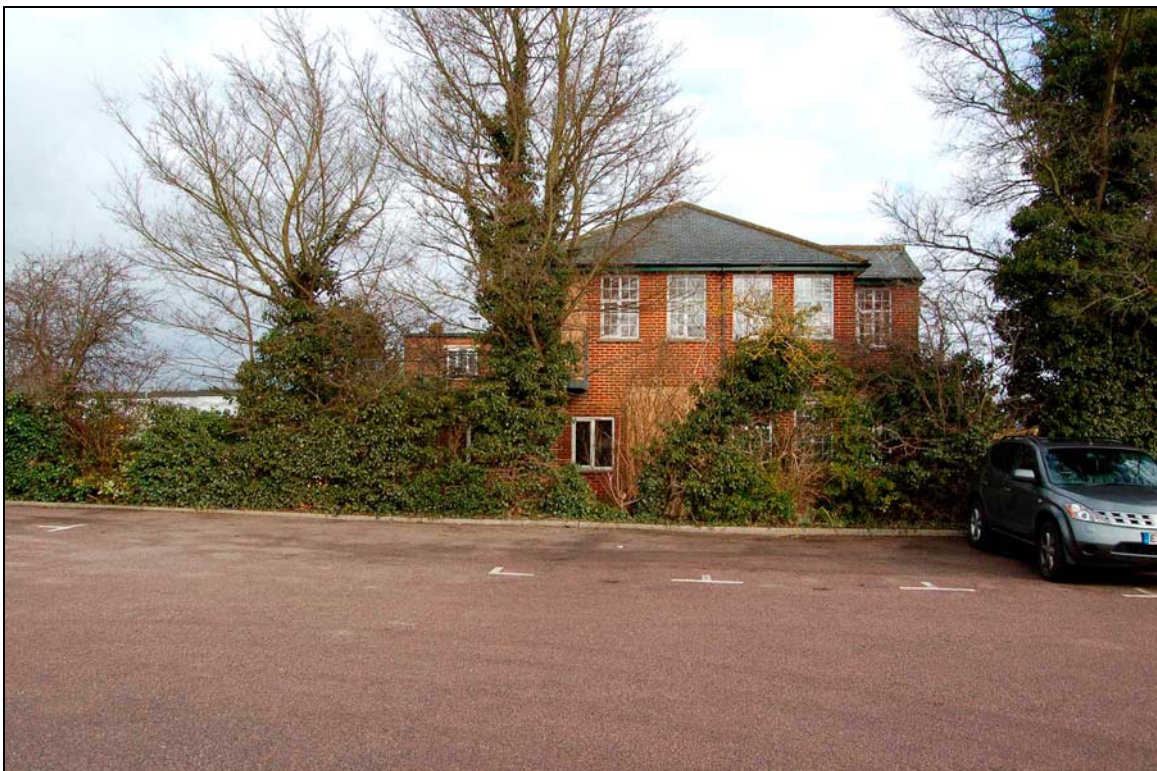
Plate 10 South elevation from adjacent car park

Viewing the **south elevation** (plate 10) was difficult because of the overgrown hedge between the building and the tarmac car park to the south that perhaps once was used by the hospital. This side consists of later extensions, principally the 1979 day room and 1995 physio block, which have been sympathetically constructed and blend in well with the main structure.

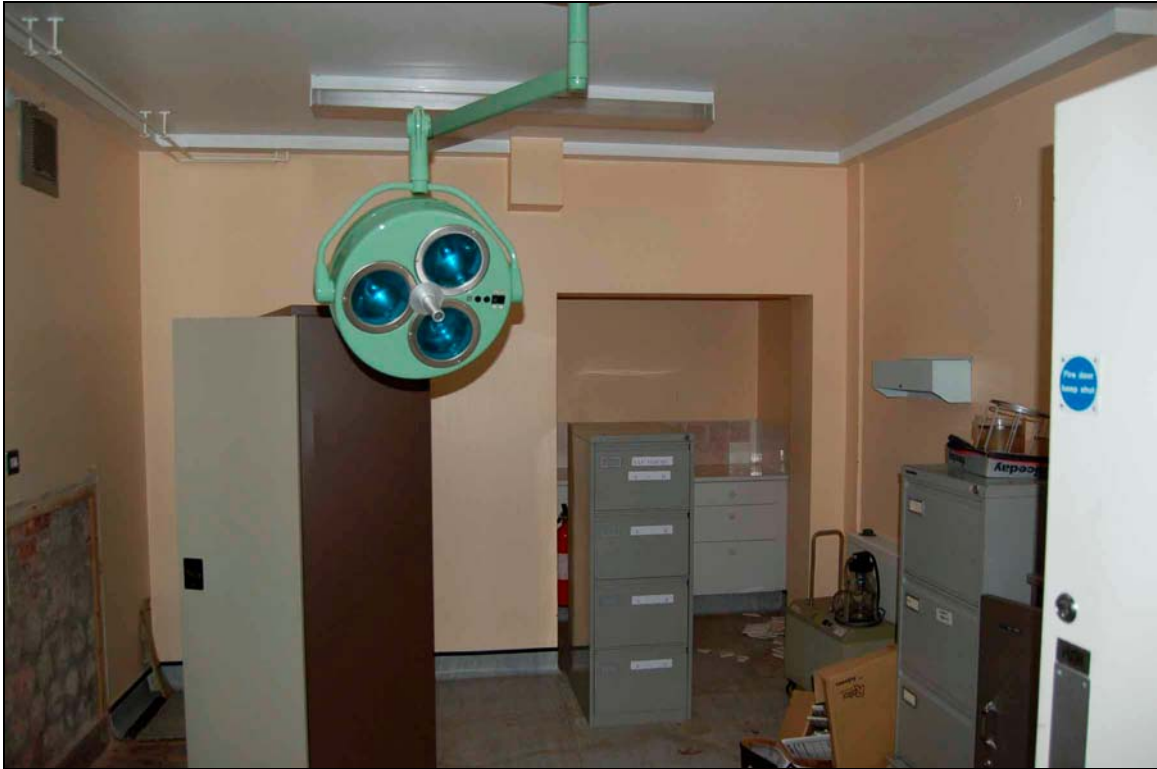
Plate 13 Operating theatre

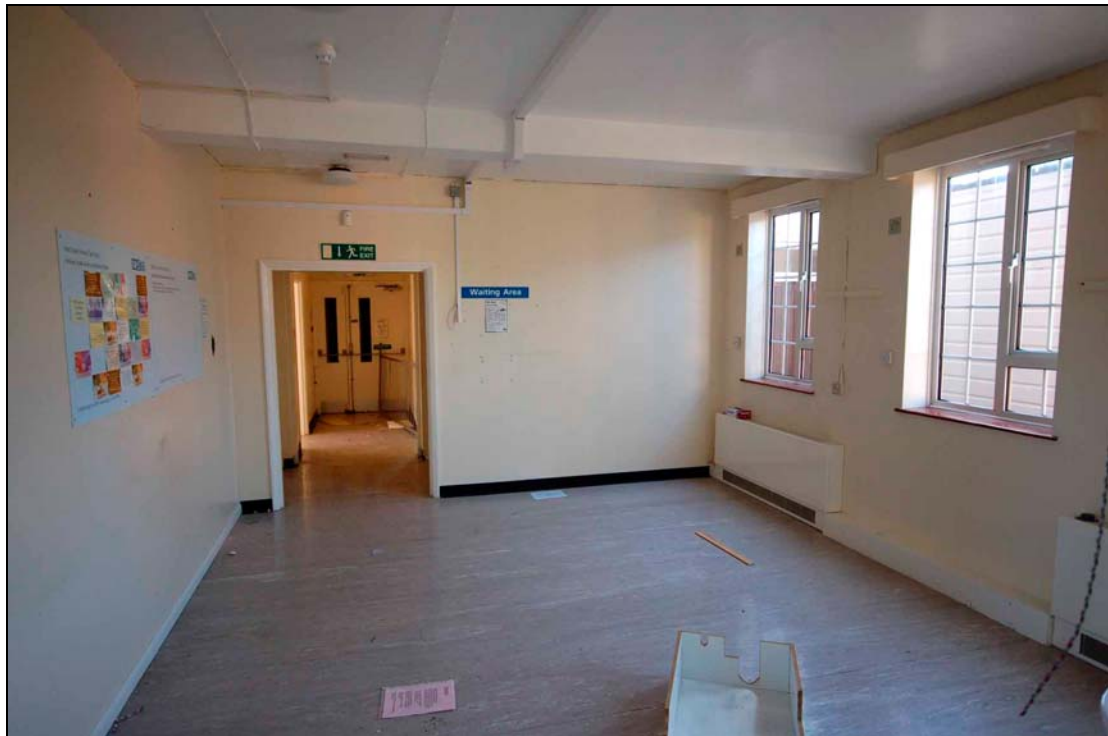
Plate 17 Waiting room viewed to south (physio. Dept.)

The former 6-bed ward at the south end is now a waiting room (plate 17) and treatment room for the physio dept, augmented by a 4-bay physio ward for in patients and an office in the **1995 extension** (fig. 3). All fixtures in the **waiting room** and **treatment room** are modern (vinyl floors, etc) and much has been cleared out, although the ward windows, set opposite each other, retain their 1930s window pelmets and metal curtain tracks.

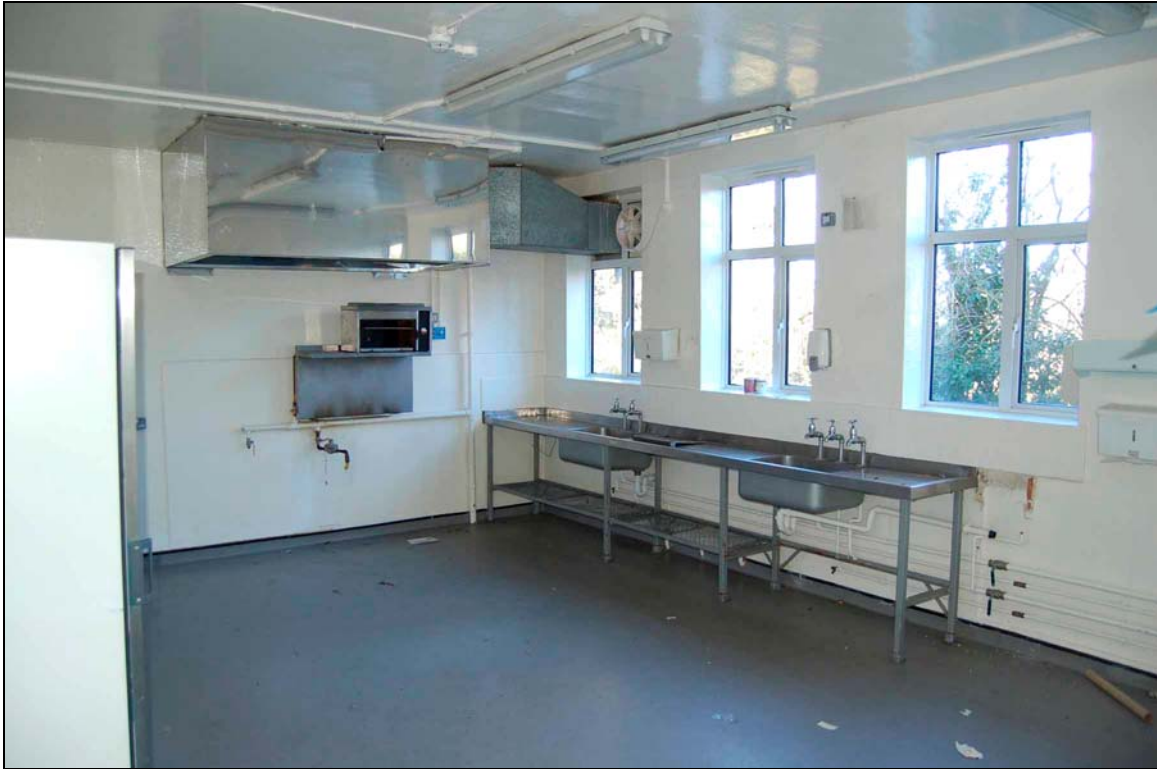
Plate 19 Kitchen

A side entrance (labelled as tradesman's entrance in figures 2 and 3) links to a corridor from the 1933 entrance hall that extends the length of the west extension (fig. 2). It has a red quarry tile floor. The side door, hidden from view from the outside, is split into two glazed panels at the top and a single board panel below and is fitted with a Yale lock. The glazed door surround can be seen on the left of plate 18 but the other parts are hidden by a modern electricity cupboard that carries conduits and relays to power the lift. Leading from this is the **kitchen**, partly stripped-out but still containing freezers and other modern features (plate 19).

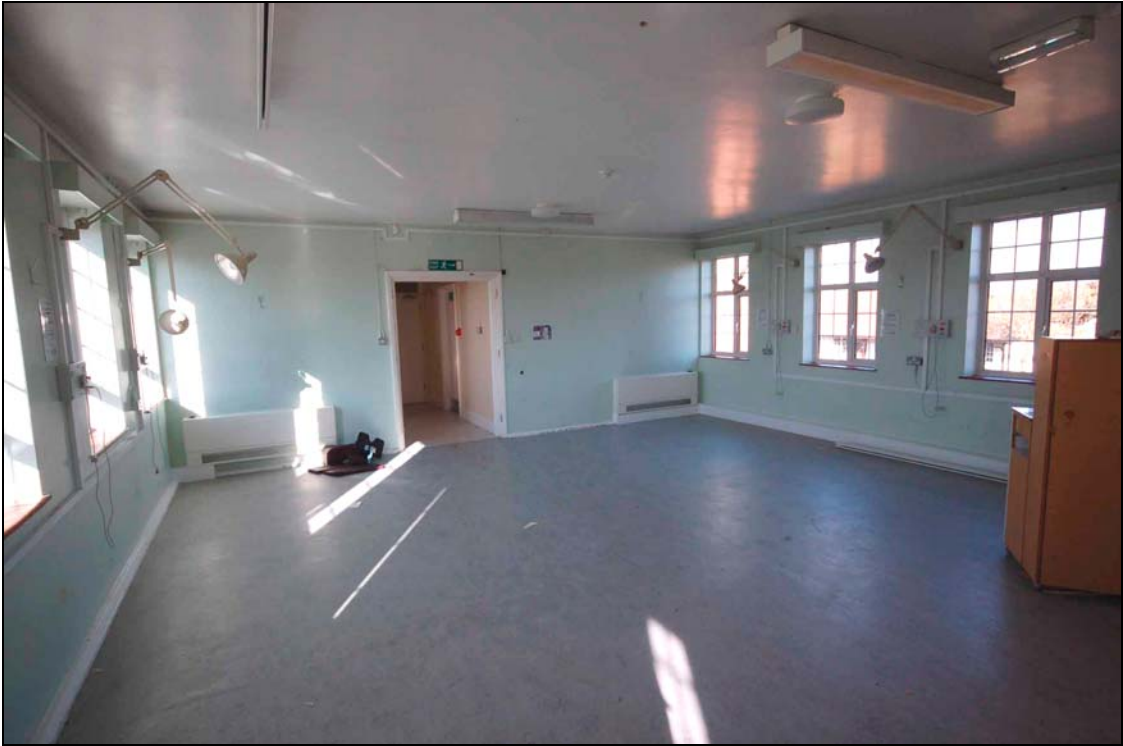
Plate 21 Female ward viewed to north

The stairs open onto the broadly central utility area, including a bathroom and small kitchen, etc. A **corridor** leads between the main ward to the south and separate wards to the north, accompanied by their own day rooms. The **ward** to the south ((fig. 3, plate 21), the main ward on this level, shares the same design and features as the one below, namely fixtures around the windows: pelmets, metal curtain fixings and tile sills. The floor is modern vinyl against 2 inch-wide skirting boards, both later additions and the furniture is modern. The doors have been removed but there are rebates for the large roller hinges. A **single bed ward**, located at the southern end within the 1995 extension, was screened-off from the main part for privacy. On the other side, the recess of the former south window now functions as a shelf in the modern day room (fig. 4).

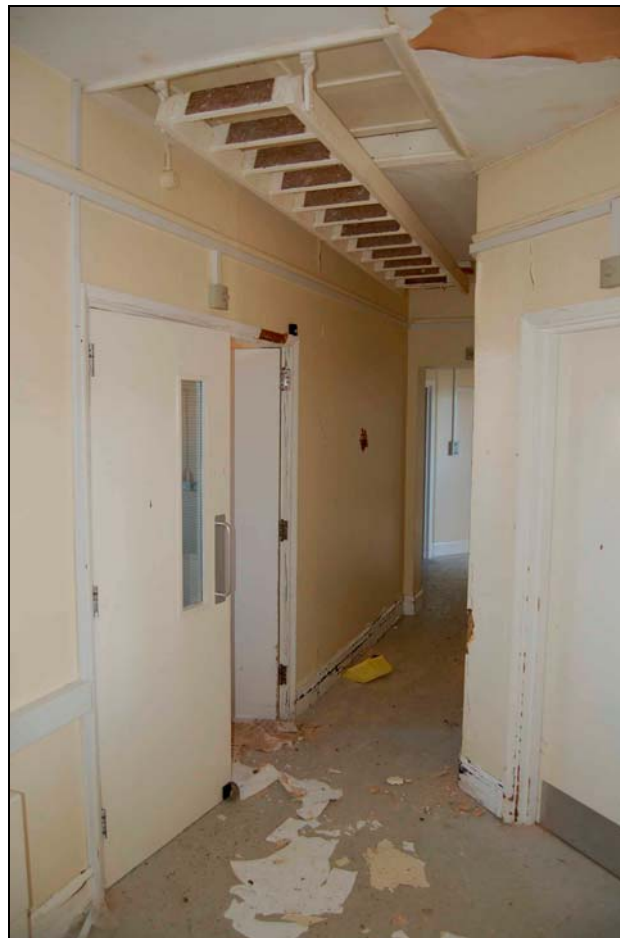
Plate 22 1933 corridor and loft hatch

Along the corridor between the wards is the **loft hatch** (fig. 4), which is accessed by a wooden stair ladder fastened to the ceiling by a hook (plate 22). The loft door has four panels. Up in the loft is the usual array of water tanks, insulation and wiring. The roof structure comprises purlins supported by wide collars and lapped raking struts over some of the bays (plate 23), though the original drawings show a more basic form (fig. 2b). At the south end is a doorway into the loft over the 1995 extension (plate 23).

The **male ward** was originally built as a three bed maternity ward (fig. 4). The room retains its skirting board and a 2" picture rail, a less common decorative feature found only on this level (plate 24). Of particular interest are the triangular shelves fitted to each of the four corners (fig. 4, plate 24), surviving in this room only. On the opposite side of the corridor is the former **one-bed ward** whose size was doubled during the 1944-45 extension to hold two beds. It is lit by a large canvas canopied window that gives a good view to the rear. It is interesting to note that the doorways into the rooms off the corridor at this end are situated in the corners of the rooms in order to maximise available room for trolleys and hospital beds in the busy corridors (fig. 4, plate 22), a likely design feature of many hospital interiors.

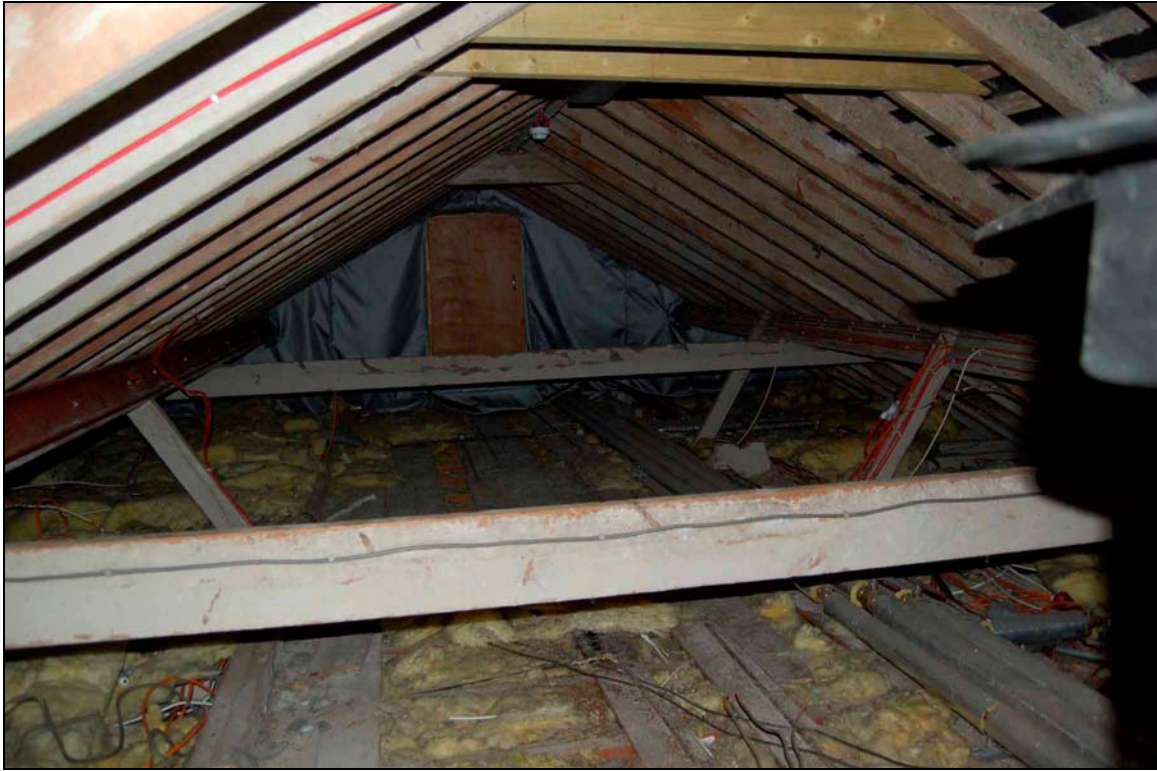
Plate 23 Roofspace viewed to south

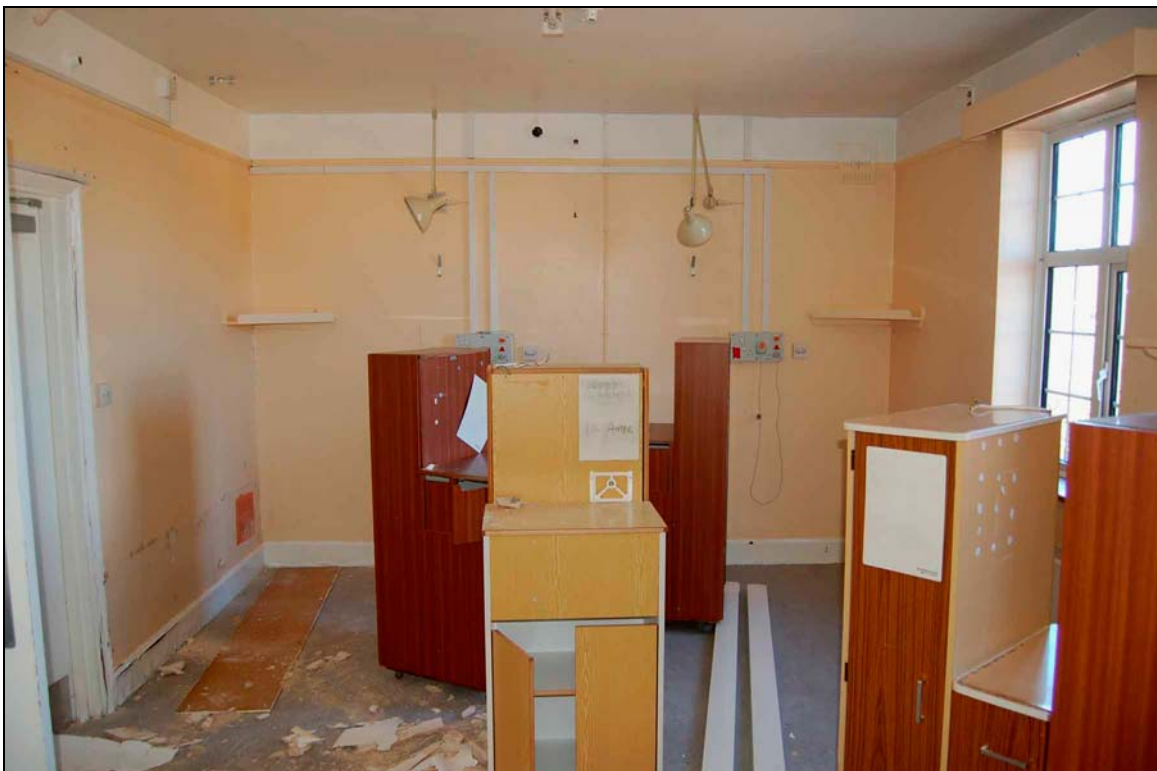
Plate 24 Male ward

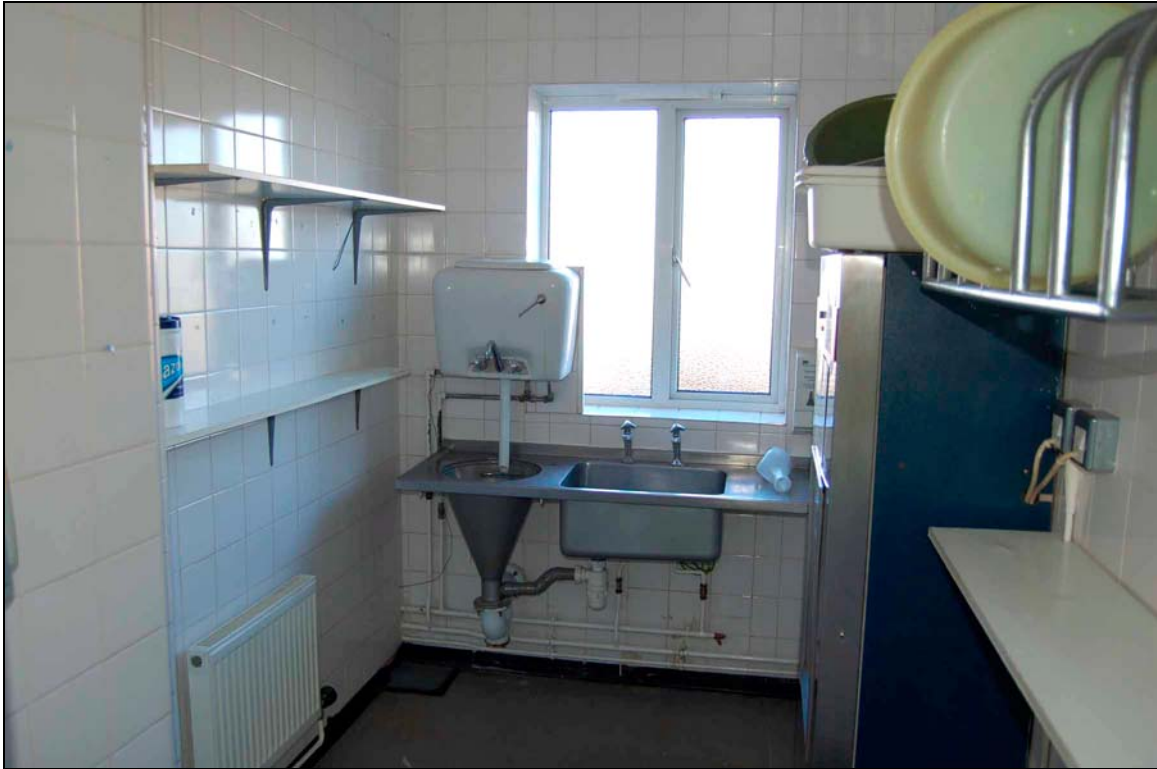
Plate 25 Sink room

Along the north wall of the original hospital are three rooms. The first is presumably a single room for palliative care that was formerly the labour room (figs. 2 & 4). Next door is the male WC, formerly the sink room for cleaning bed pans, etc, and a bathroom, formerly with separate baths for mother and baby (fig. 2). The fixtures and fittings in these rooms are largely modern and the only historic features to remain are the picture rail in the **single room** and the old cistern in the **sink room** (plate 25).

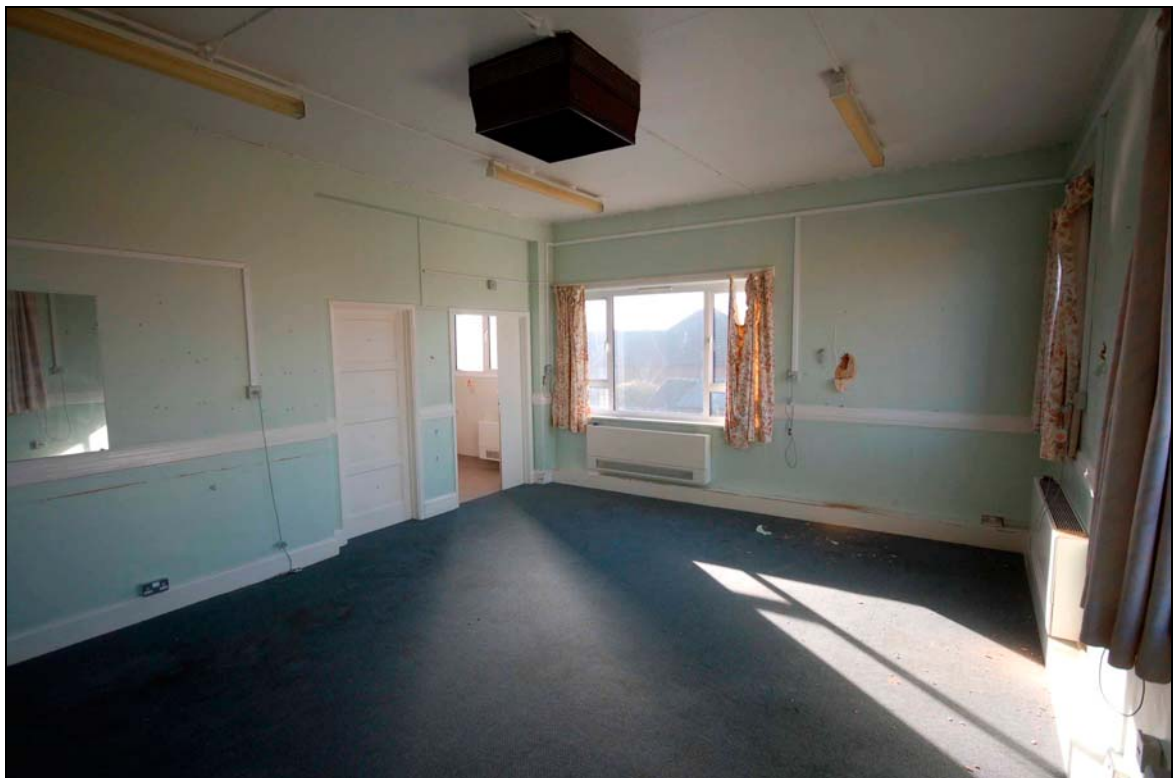
Plate 26 Day room viewed to south-west

the day room through a four-panelled 1930s style door (plate 25), though the doorway is now sealed and does not feature in the 1930s plans. The **day room** is quite spacious and receives plenty of afternoon sun. The wall to the bathroom has been roughly inserted at an angle to the door (fig. 4), with a chamfered skirting board and ovolo-moulded dado rail fitted around the edges. The windows have tiled sills and fixtures for blind cords (plate 27) but are currently fitted with curtains

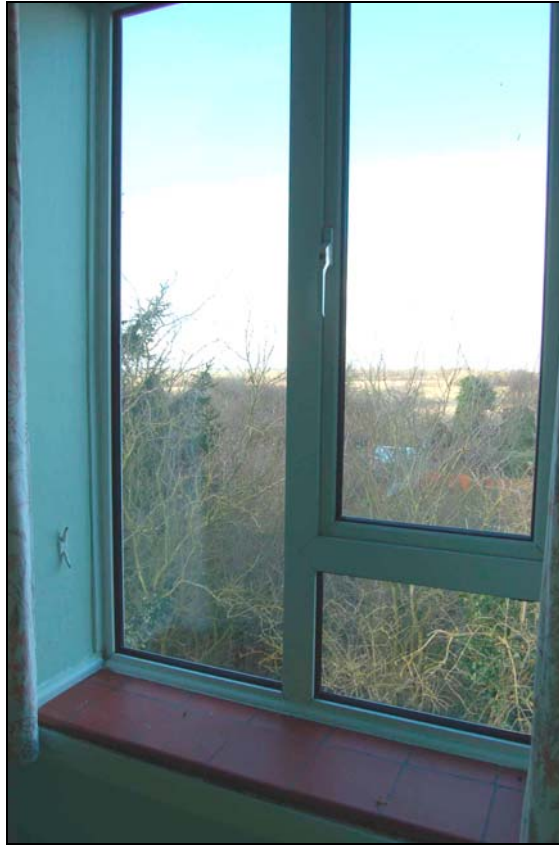
Plate 27 Window in day room

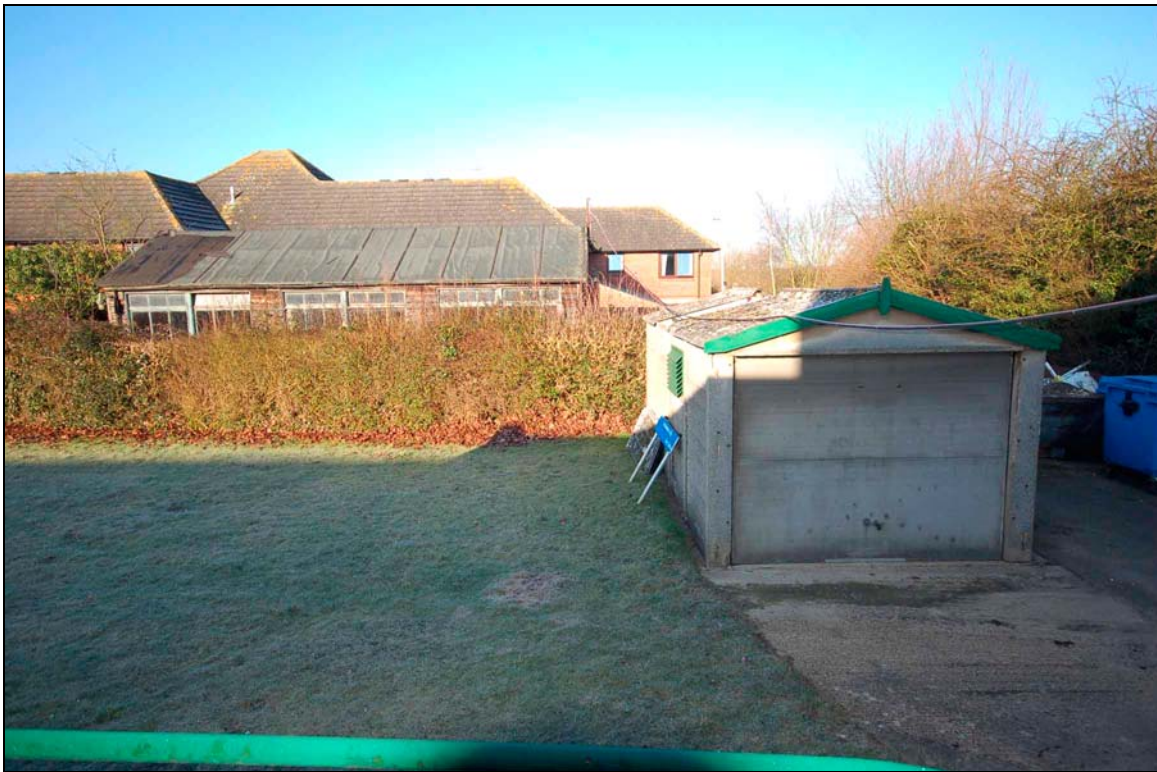
Plate 28 Garage and shed in remains of grounds to west

Two outbuildings remain on the western side of the hospital, a garage and shed (fig.1). The **garage** is a modern pre-fabricated concrete type with a corrugated asbestos roof (plate 28). Grills on the sides and vacant pipe fixtures inside show it held an engine of some sorts, probably a generator in the event of power cuts.

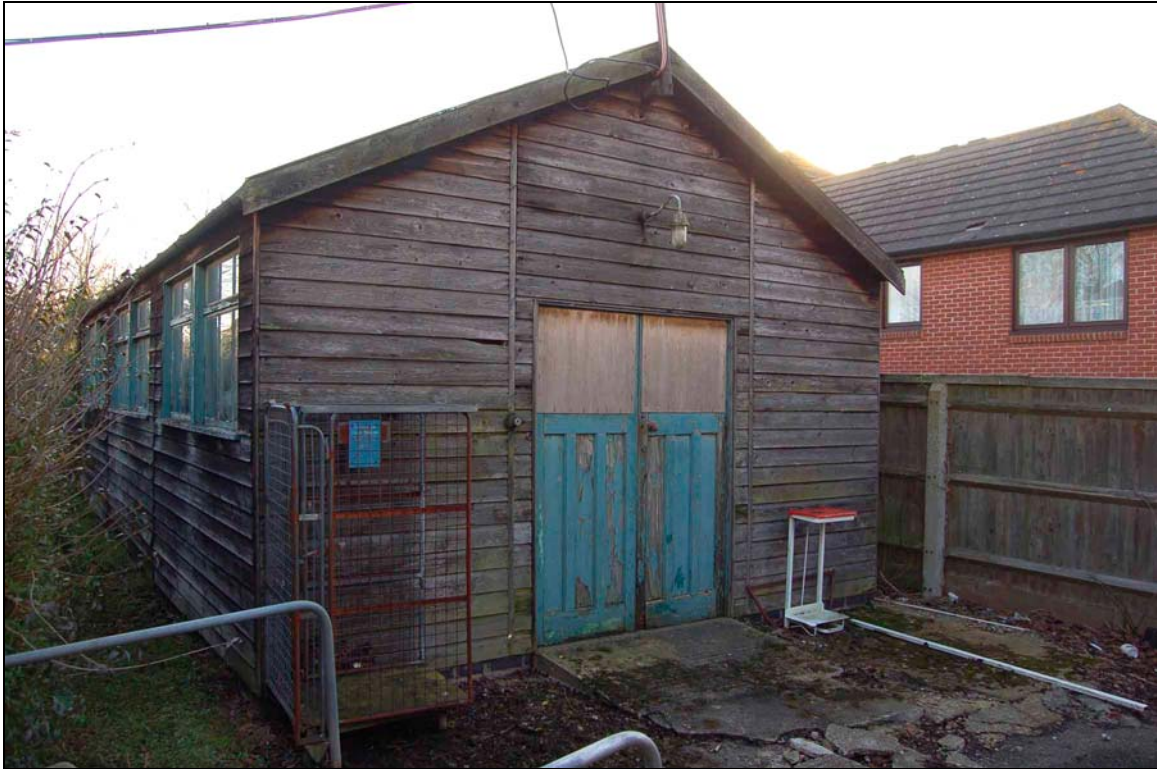
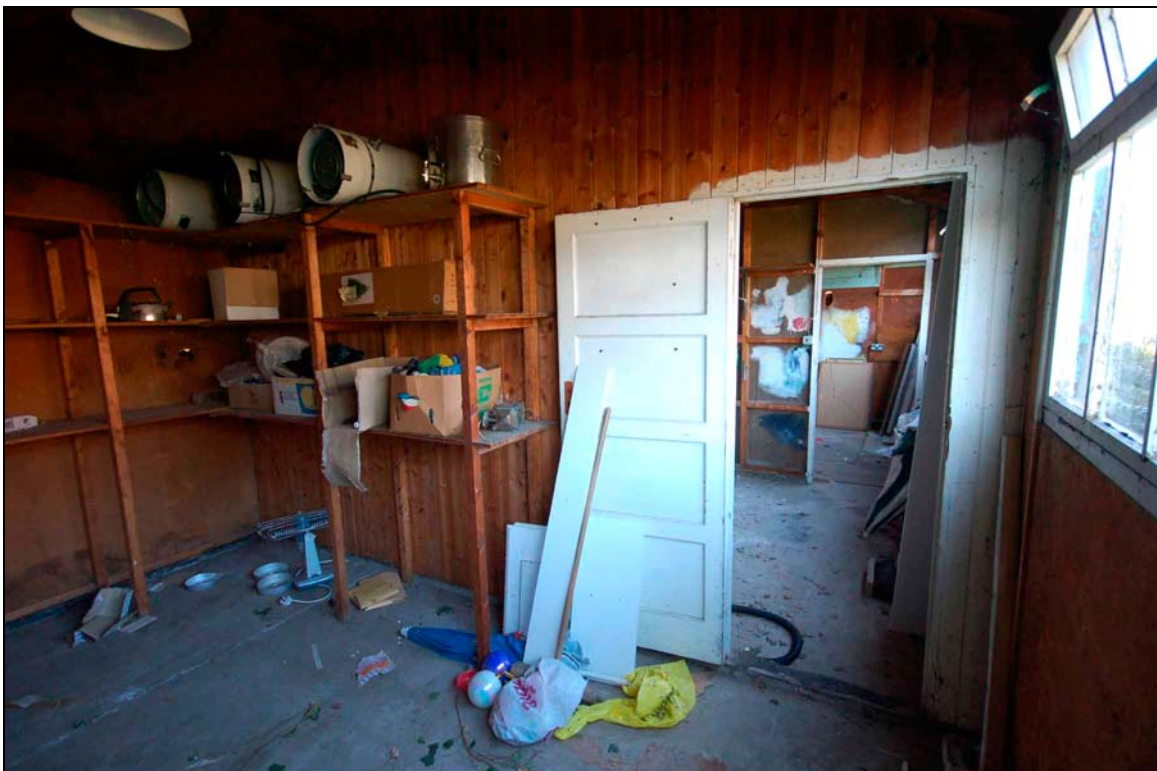
Plate 29 Shed viewed to south-west

Plate 30 Interior of shed viewed to north from southern bay

The **shed** is more interesting and probably dates to the 1930s or 40s. It has a timber-clad exterior, gabled ends and three bays laid south to north. The north end has panelled garage doors (plate 29) and there is a single semi-glazed door at the opposite end. A long timber vented window range occupies the eastern side, facing the hospital (plate 28). The interior is lined-out in hardboard, partitioned into three rooms along the lines of the three bays, each connecting to the other along the length of the building. Some 1930s/40s shelving and doors remain (plate 30), and there is an interesting *ad hoc* list of some of the vegetable and flowers grown in the 1960s when hospitals grew their own food and the patient's natural environment was considered part of the treatment.
