**PRIOR'S HALL
WIDDINGTON
ESSEX**

ARCHAEOLOGICAL MONITORING

JULY 2007

Document Ref.:	1472 Rep
Report Issue Date:	July 2007
Circulation:	Mr D. Webb
	ECC Historic Environment Management
	Essex Historic Environment Record

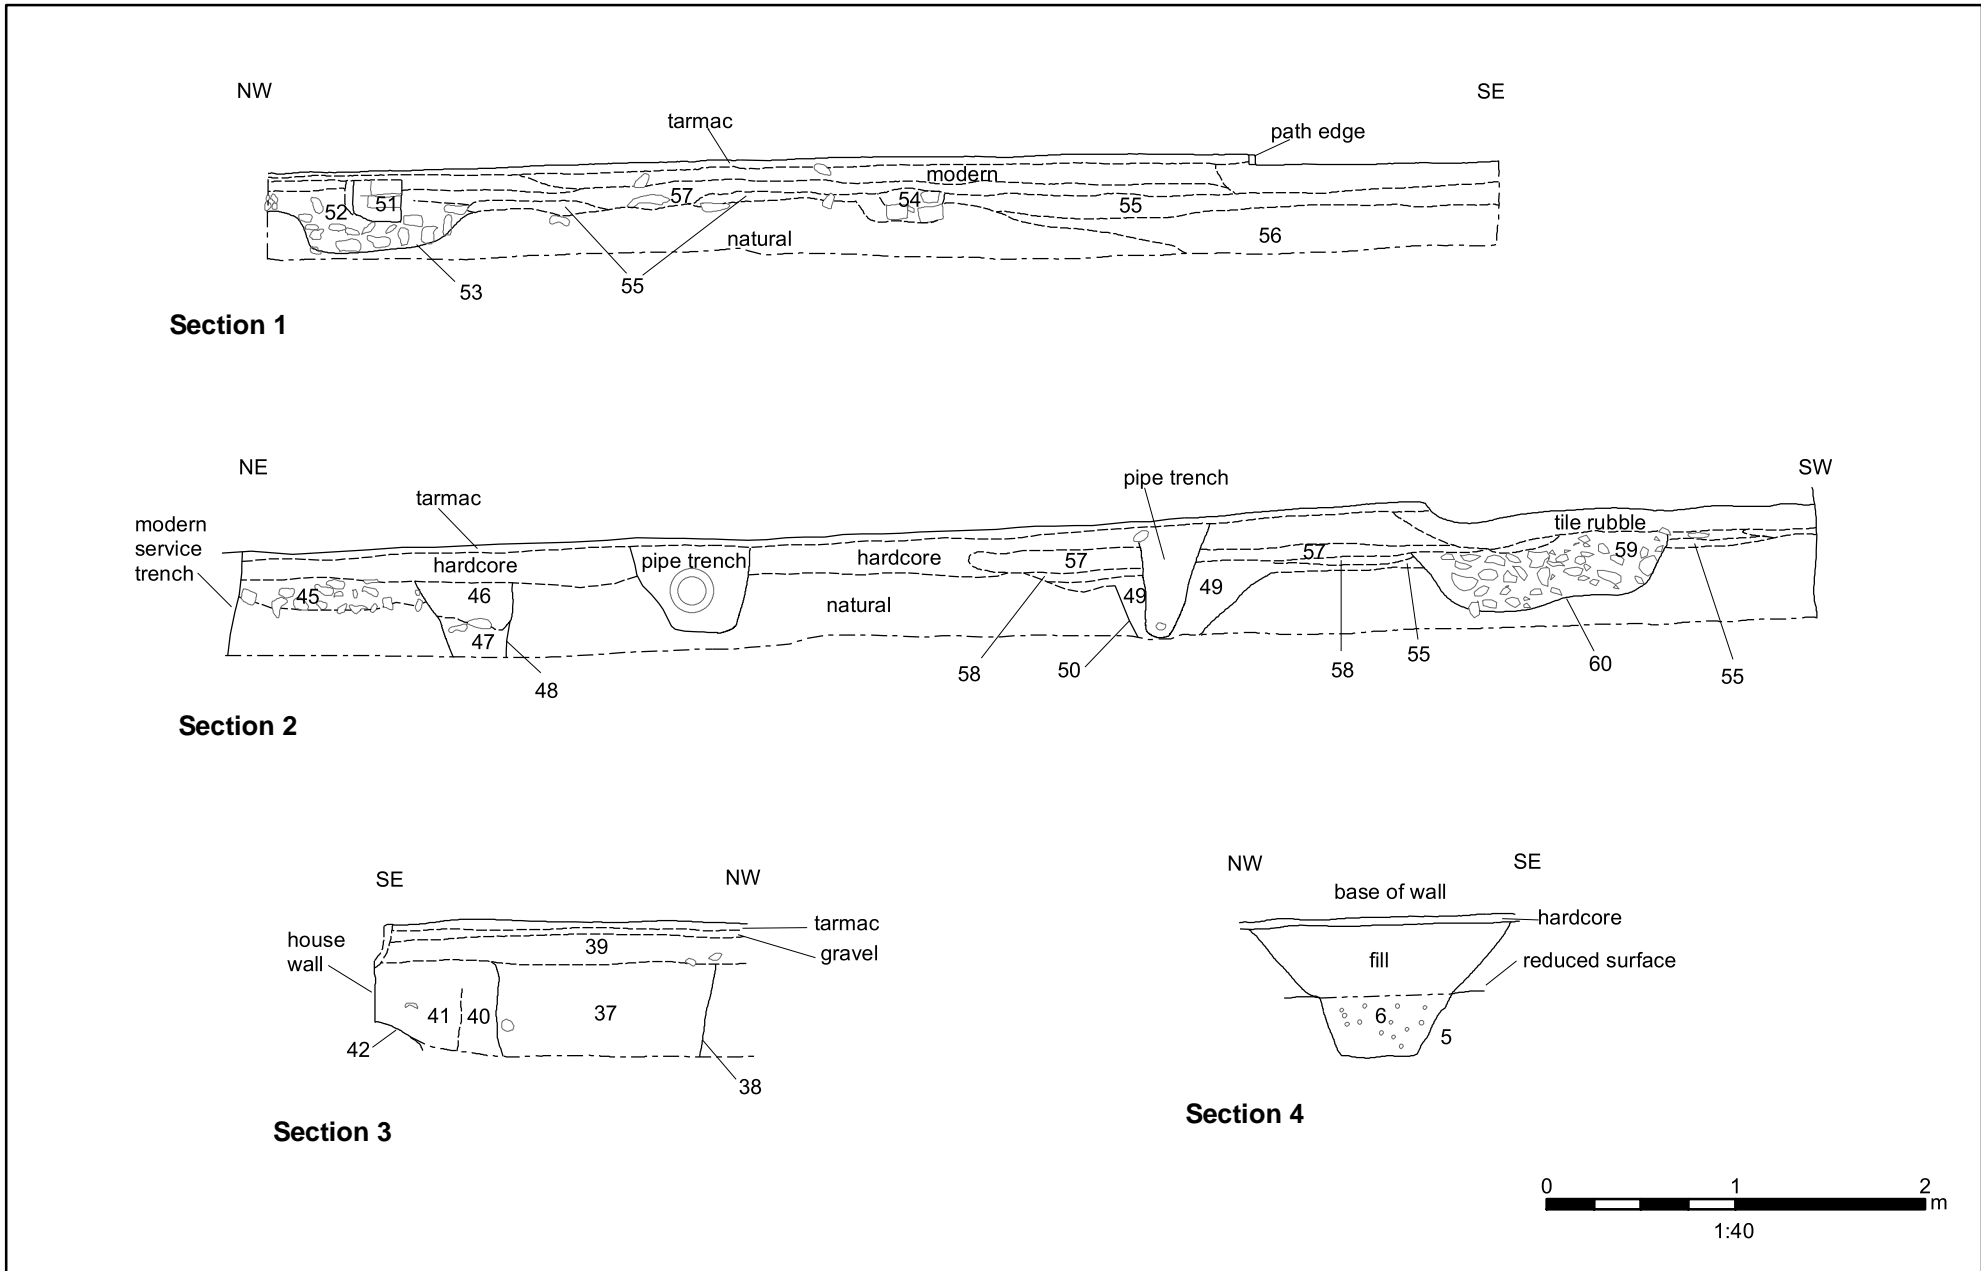
Fig.6. Sections

Several archaeological deposits and features were recorded in section (Fig. 6, Section 1) in the southern half of the trench. At the base of the sequence, the natural deposit comprised clean light brown clay with chalk flecks. At the south end of the trench the clay appeared greyer and more disturbed and was issued its own context number (56), although it was not distinctive enough to positively identify as fill. Above the natural (and sealing 56) was a layer

of dark grey clay (55), up to 0.12m thick, probably the remnants of buried topsoil. At the north-west end of the section the natural was cut by an east-west aligned linear feature (53) filled with medium to large flints and occasional fragments of chalk and stone (52) in a grey clay matrix. No direct dating evidence was recovered from this feature which may be a path or foundation.

Several archaeological deposits and features were recorded in section (Fig. 6, Section 2). The underlying natural clay was light yellow brown in colour with grey streaks and flecks of chalk. Overlying the natural at the north-east end of the section was a compact deposit of flints with chalk flecks in a light grey clay matrix (45). This deposit was similar to, and on the same east/west alignment as, the probable path (53) in Trench 1 and was almost certainly a continuation of this feature. Cutting the edge of the path was a poorly defined feature, possibly a pit or post-hole (48) containing two fills. The feature appeared to continue below the limit of excavation and is likely to be of later date if its stratigraphic relationship is correct. Some 3.2m to the south-west was a better defined pit (50) whose grey clay fill (49) contained fragments of animal bone and two sherds of 13th century pottery. On either side of pit 50, but with an unclear relationship, were further traces of charcoal flecked grey (55) believed to be a continuation of the buried topsoil from Trench 1. Cutting through this layer and the underlying natural was another linear pathway feature (60) composed of compacted flint in a matrix of grey clay (59). The deposit also contained traces of yellow mortar, although none

of the flints appeared to be bonded. It was visible in both trench sections and appeared aligned with a near-by door to the outbuilding. Overlying the fill of pit 50 were traces of orange clay and gravel (58) which were sealed, along with fill 59, by chalk layer 57 (also evident in Trench 1). At the top of the sequence were mixed make-up deposits of gravel and brick/tile hardcore, which were cut by two modern pipe trenches and sealed by tarmac.

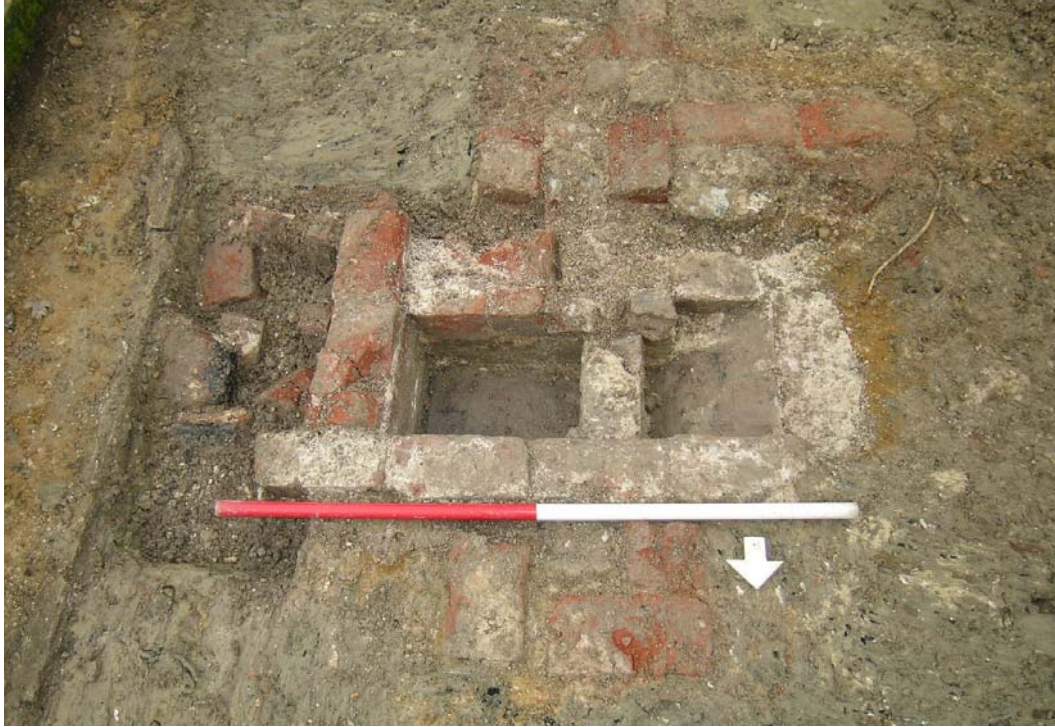
Plate 1 Brick ash pit 18 (1m scale)

In the room to the north of the partition was a well-defined rectangular brick lined ash-pit (18) with a sloping west side and a flat bottom (Plate 1). The pit was constructed from unfrogged bricks bonded with creamy mortar with rare white and black flecks. A sample brick was dated as 18th century. At some point this structure had been altered with the insertion of a north-south brick at the foot of the slope and a thicker lining along the south side.

in Chalton, Hampshire. In this complete example, an iron grate for the base of the fire sat above the pit with the copper supported on brickwork above. Elsewhere within the brewhouse were patches of heated clay that are presumably contemporary with its use.

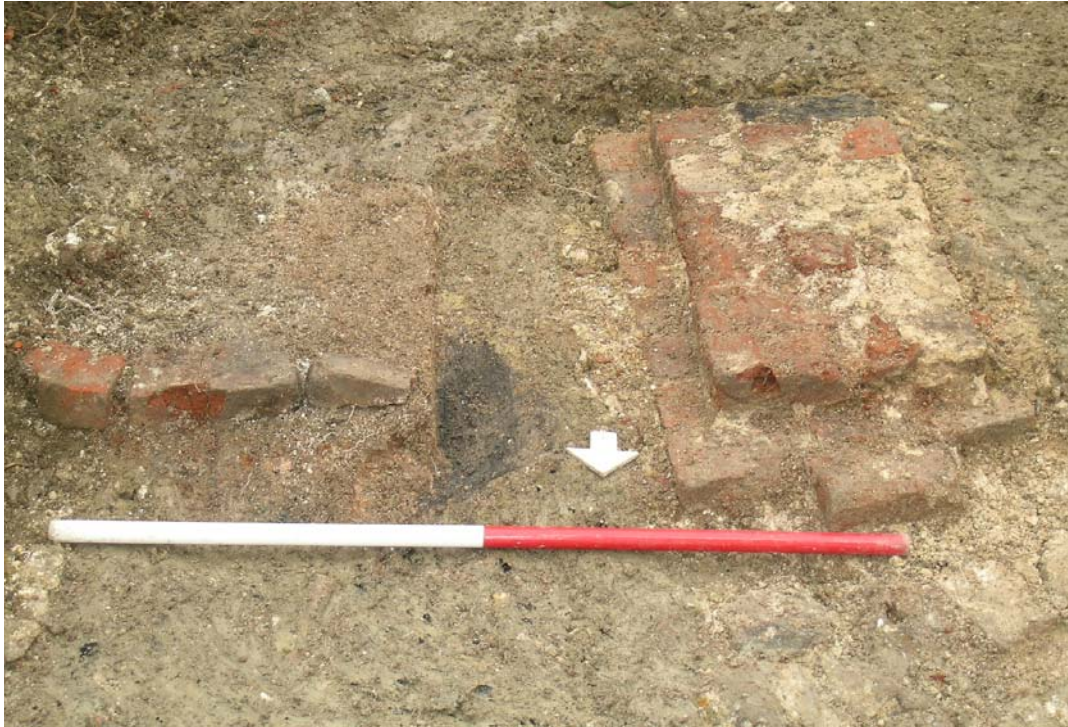
Plate 2 Brick structures 15 and 36 (1m scale)

To the south of the partition was another foundation deposit (16) comprised of buff/white mortar over brick and flint. One brick from this deposit was dated as late 17th/early 18th century though it is possible that this brick was reused. Built upon 16 was a substantial rectangular brick structure (15) (Plate 2), perhaps the base of an oven or chimney. Two courses of brick were visible; a protruding lower course (foundation?) and a narrower upper course (superstructure?), both constructed by part bricks (dated as 18th century) in a light buff to cream mortar matrix with white inclusions. To the east of structure 15 was a slight hollow in the clay (20) covered in a thin smear of charcoal (Plate 2). The hollow and adjacent area was infilled and overlain by a 0.1m thick deposit of pink silty ash (31). Above the ash was a line of three bricks laid end to end (36) and truncated to north and east.

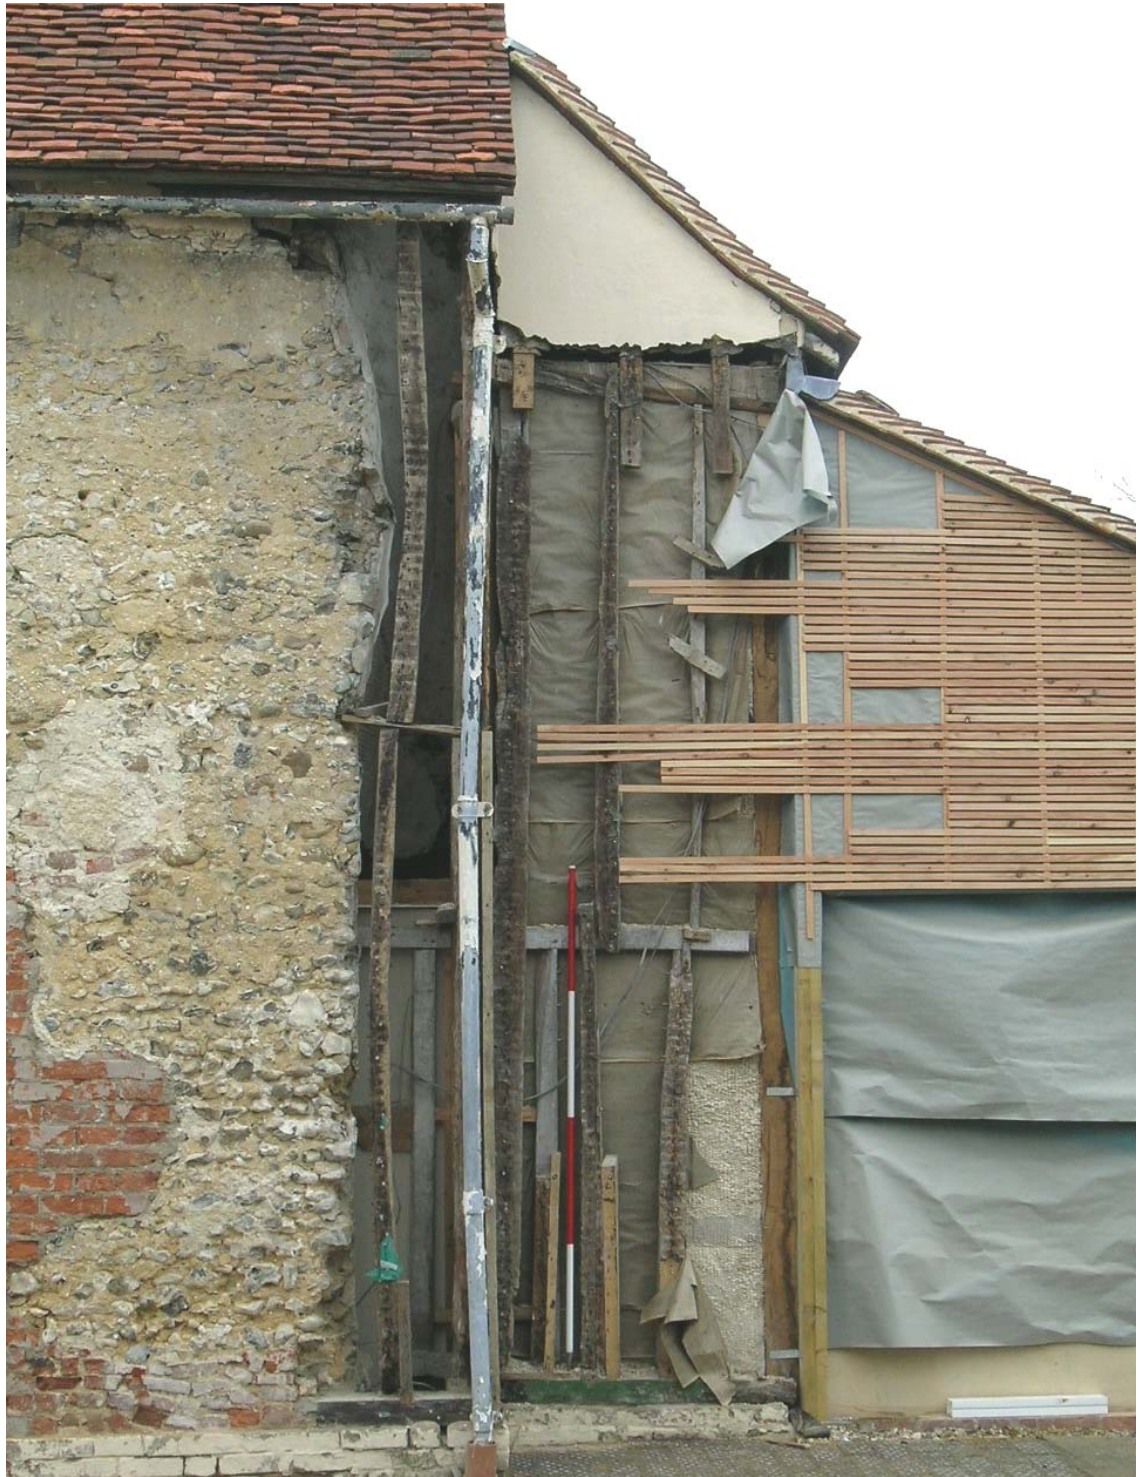
Plate 5 South-east corner of building (2m scale)

At the request of English Heritage an archive photographic record was made of the timber frame exposed during renovation work to the south-east corner of the Late Saxon building (Fig. 3). The original south-east corner of the building had been truncated by about 0.5m and all trace of the long and short quoin stonework, as recorded on both northern corners of the building, had been removed. The stonework had been replaced by a timber frame believed to be part of an 18th century stair extension, the east end of which was recorded by

the Central Archaeology Service in 1997. Whether the stonework was removed to facilitate the construction of the stair extension is unclear.

A variety of timbers were noted during the photographic survey (Plate 5). Some were shaped and clearly re-used, one timber post had bark adhering, a few timbers showed traces of paint and others were clearly recent repairs. It is therefore reasonable to assume that this corner of the building has been subject to regular repair over a considerable number of years.
