**ST PETER'S CHURCH  
SOUTH WEALD  
ESSEX**

**ARCHAEOLOGICAL MONITORING AND RECORDING**

**MARCH 2011**

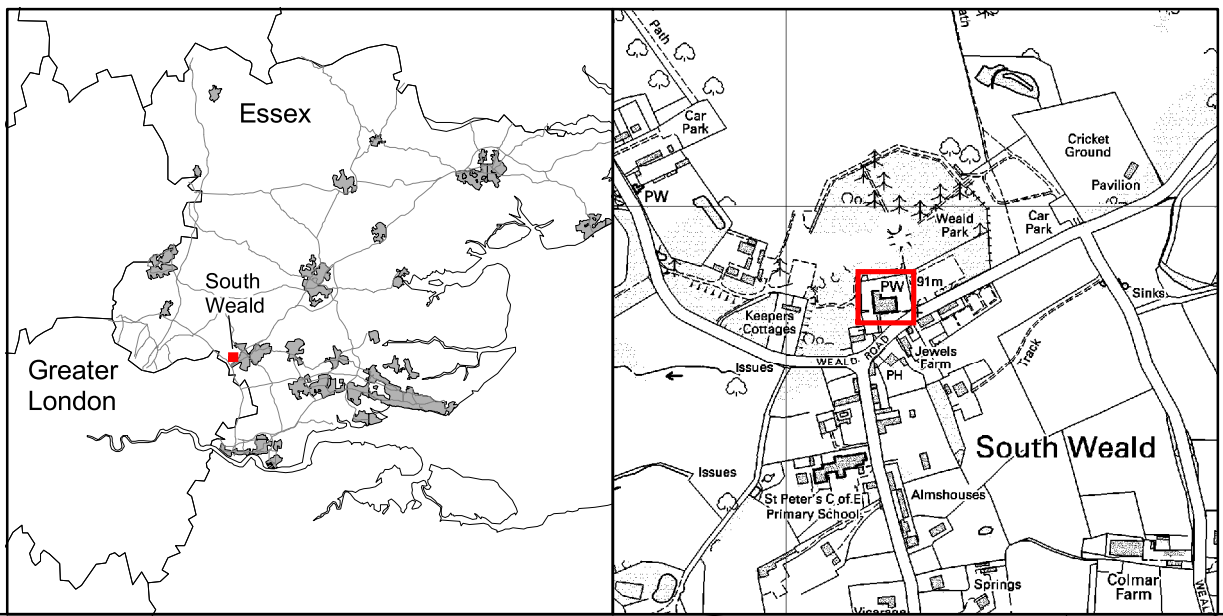
Fig.1. Location of areas of archaeological monitoring

St Peter's church and its churchyard are situated to the north of South Weald village centre, two miles to the west of Brentwood (TQ 57130 93869) (Fig. 1). The site is located on the southern border of Weald Country Park and is bounded to the south by Weald Road. A car park is situated to the east while the western boundary comprises a residential property. The surface geology is glacial clay overlain by mixed silty sandy clay subsoil.

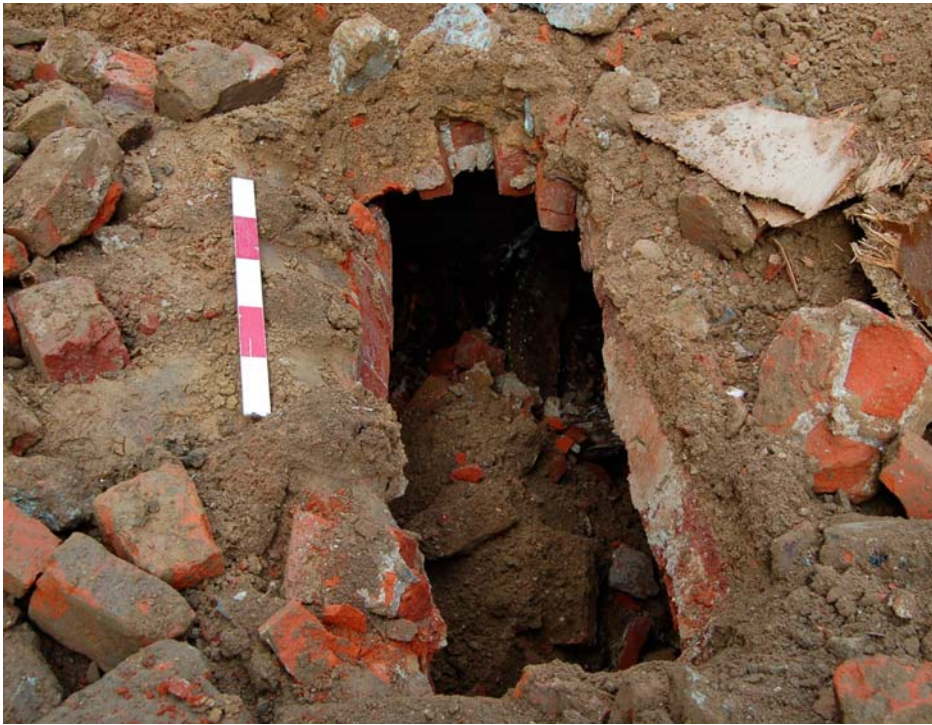
Tomb B was 2.5m long by 1.5m wide and c. 1.5m deep. Its walls were two bricks wide and constructed from orange-red un-frogged bricks bonded with lime-based mortar. Additional cement bonding suggested that the tomb had been repaired in modern times. Although the contents were partly covered by builders spoil pieces of a studded wooden coffin were visible

(Plate 1) along with a small stack of bones in the south-west corner that implied later disturbance.. Overlying the vault was a large piece of folded-up lead sheet, presumably either from a lead coffin or the roof of the church. Also recovered unstratified from the initial groundworks was a large piece of architectural stone from a former window mullion (Plate 2) .

Plate 1. Tomb B looking west (0.5m scale)

The studded timber fragment was probably part of an additional disturbed burial of possible late 18th or early 19th century date. Similar studding was noted on pieces of coffin timber observed within Tomb B. This tomb was constructed from unfrogged bricks of similar later 18th or early 19th century date. The internally painted Tomb A was most likely of Victorian date as it was constructed from frogged bricks which date from the mid-19th century onwards. Both tombs were located within the footprint of the 1981 extension, presumably sealed beneath the floor.

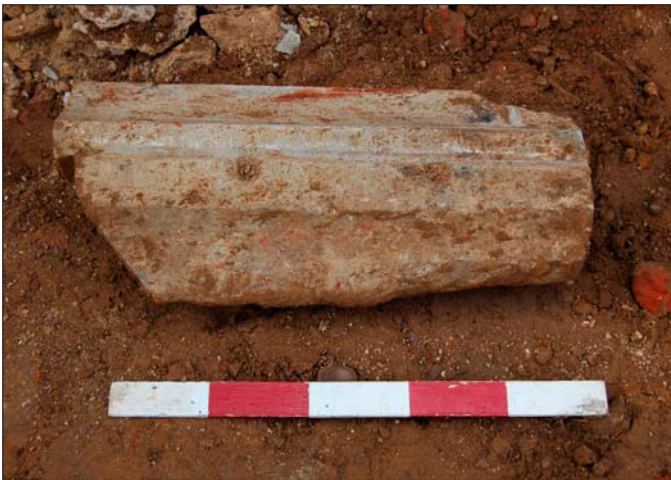
Five pieces of worked stone (probably all limestone) were recovered. A 0.55m long fragment of limestone window mullion with small square holes for glazing bars on both sides (Plate 2) was recovered from the initial ground clearance. Three further fragments of worked stone were recovered from the excavation of the footings and a fourth from the excavation of the gas service trench. The first fragment was of unknown function. It was roughly rectangular in shape, 0.42m long by 0.24m wide, with a square cut-out on one side (Plate 5). The second fragment, possibly part of a grave kerbstone, measured 0.44m long by 0.12m wide and 0.15m high. It had flat surfaces, other than where broken, and a single beaded edge (Plate 6). The third fragment was 0.67m long by 0.26m wide and 0.33m high and appeared to be part of a broken gravestone (Plate 7). The fourth fragment was a cylindrical piece of architectural stone approximately 0.75m wide by 0.5m in diameter. The fragment had a notch at one end (Plate 8) and was probably one section from a column, perhaps formerly part of a monument or tomb.

Plate 2. Window mullion (0.5m scale)

All of the worked stone fragments were recovered from unstratified contexts. The stone window mullion may have come from a demolished part of the church and some of the other stone fragments from destroyed or broken grave-related features. None of the worked stone was dated. However, it is reasonable to assume that the fragment of window mullion is likely to be of medieval date, particularly as other fragments of stone mullion of 14th or 15th century date are known to have been incorporated into the church yard wall (HER 634).

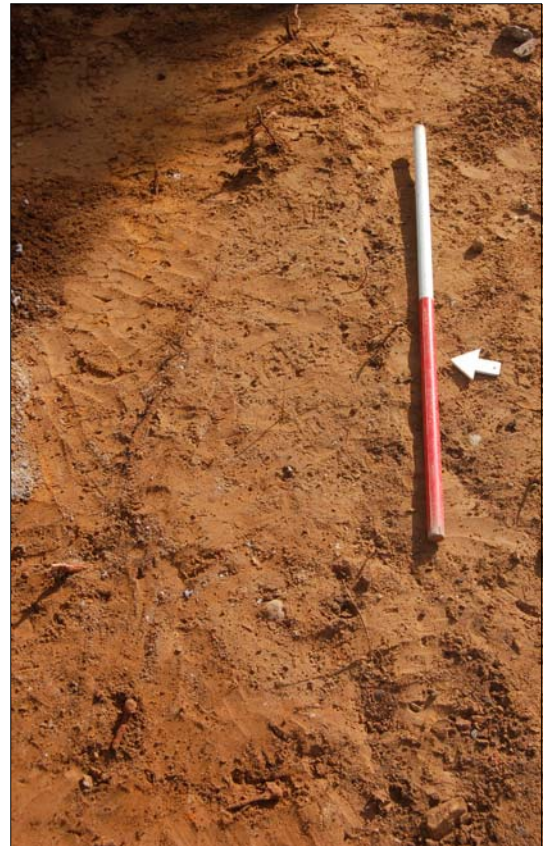
The outlines of four graves were observed in the base of the trench. Loose on the surface of Grave 1 in the north-east of the development area were a number of encrusted iron objects and nails which were retained for analysis (Plate 3). After cleaning the objects were revealed as a complete coffin handle, attached to its escutcheon and a fragment from a second handle both probably dating to the first half of the 19th century. Two fragments of post-medieval brick were recovered from the backfill of Grave 2.

Plate 3. Grave 1 with coffin nails in foreground (1m scale)

A complete coffin handle, attached to its escutcheon, and a handle fragment were recovered, from Grave 1. Both are encrusted with corrosion products, but mechanical removal of these has revealed some details. The handles are roughly semi-circular in plan with a flat back and a swollen grip, in the manner of drawer-handles. The grips of both examples carry simple decoration in the form of three moulded ribs rising from each side of a plain central point. There is a step which narrows the handle to one side of the main decoration, but the ribs appear to continue around the curve of the handle. The escutcheon has a prominent boss, presumably with suitably similar decoration although, unfortunately, corrosion products still obscure the detail. The robust style of the handles suggests a Victorian date, perhaps first half of the 19th century.

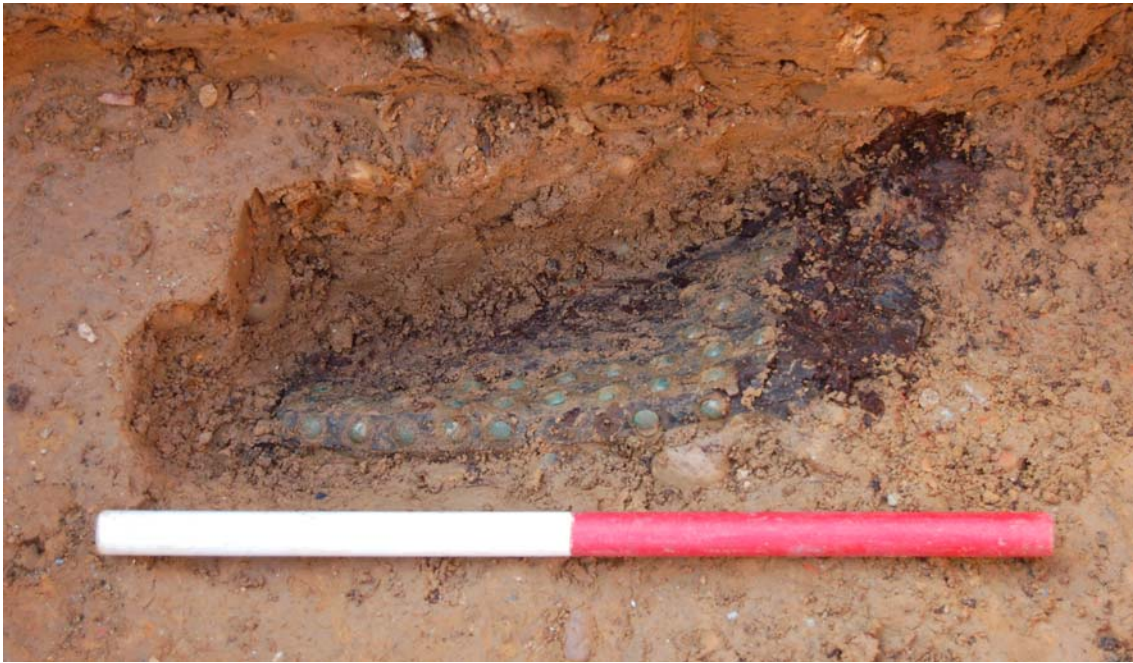
In the west of the footprint was a partially exposed fragment of soft and decomposing timber, 0.37m long and 0.03m thick, covered in copper alloy studs (Plate 4) some of which were retained for analysis. Although clearly originally part of a coffin the timber did not appear to be *in situ*.

Plate 4. Studded timber fragment looking south (0.25m scale)

A number of copper alloy studs, still fixed onto pieces of wood from the coffin, were collected from a fragmentary timber in the west of the site. These studs, in either copper alloy or iron, were mostly used to attach fabric to the outside of the coffin, but were also used to form decorative patterns. The South Weald studs have evidently been used for fixing cloth, since remains of a plain-weave fabric are trapped beneath the heads. A loose stud also retains a piece of fabric, pierced by the shaft. The nature and colour of the fabric cannot now be

determined, due to decay and staining from the surrounding clay soil. Fabric remains are also attached to the underside of one piece of coffin wood, which has studs on the upper surface and on one contiguous side; the piece is probably the remains of a coffin lid. The studs also have traces of gilding. Studs were very often painted black, especially if used with black fabric. A coffin from St Luke's, Old Street (Boyle *et al* 2005), has double borders of studs, very similar in form and size to those from South Weald. This cemetery was in use from the late 18th to early 19th centuries, and the South Weald studs are likely to be of the same date.

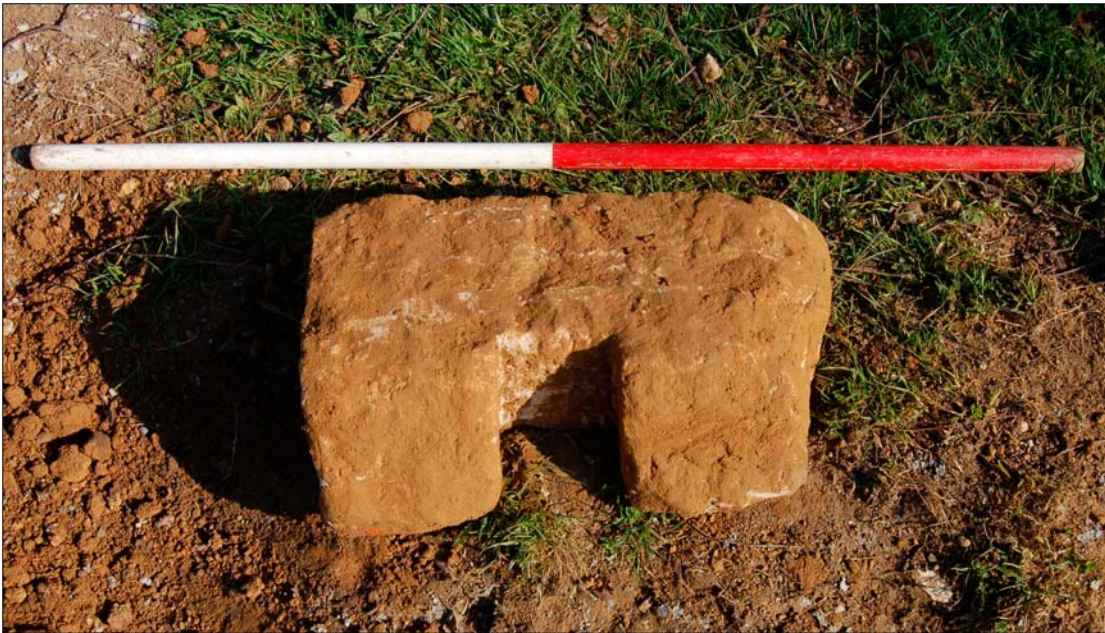
Three fragments of unstratified worked stone were recovered by the builder's during the excavation of the new footings. One of the fragments was possibly part of a grave kerbstone and another part of a gravestone. All three were photographed (Plates 5, 6 and 7) and sketched (in archive) but not retained.

Plate 5. Worked stone (1m scale)

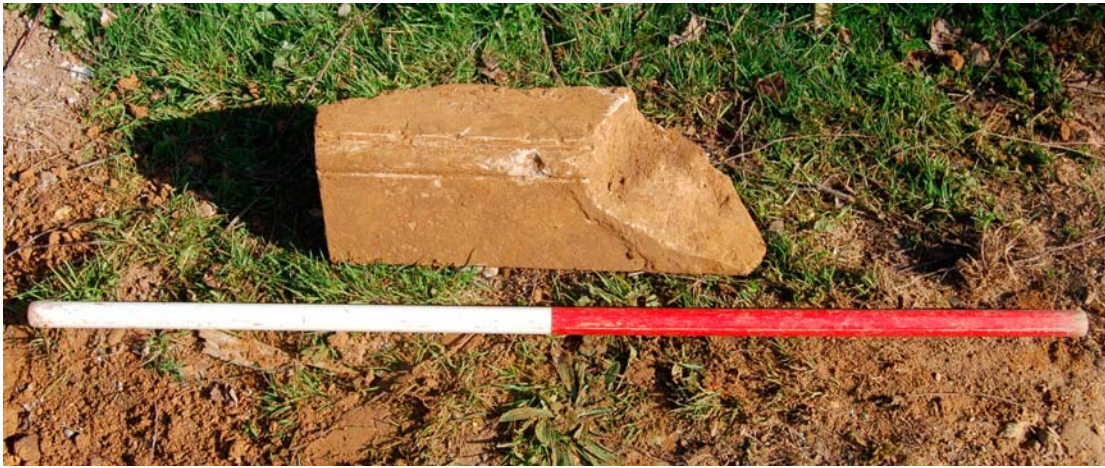
Plate 6. Possible grave kerbstone (1m scale)

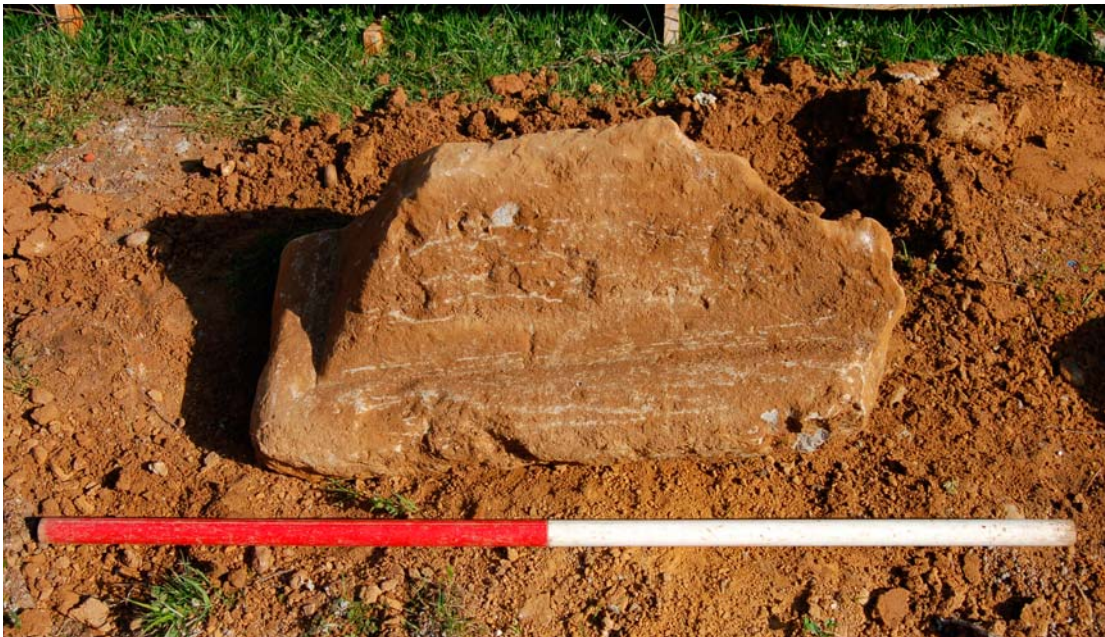
Plate 7. Possible gravestone (1m scale)

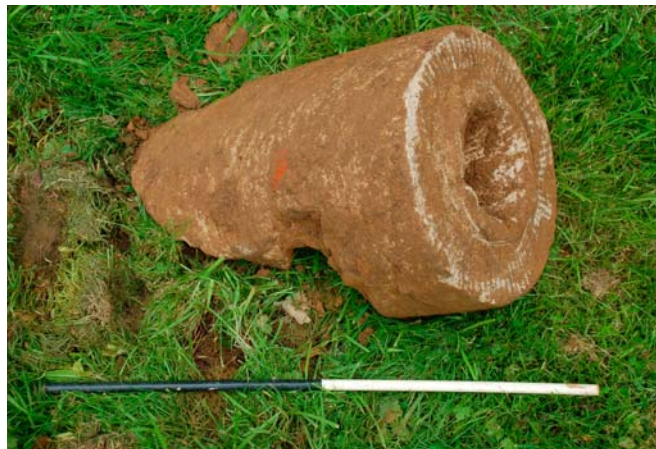
A cylindrical piece of worked stone was uncovered within the topsoil during the excavation of the gas service trench (Plate 8). A notch at one end indicates that this was designed to adjoin to another piece of worked stone and probably originally part of a column.

Plate 8. Cylindrical fragment  
(0.5m scale)
