**DUNMOW INFANTS SCHOOL  
ROSEMARY LANE  
GREAT DUNMOW  
ESSEX**

**HISTORIC BUILDING SURVEY**

**November 2010**

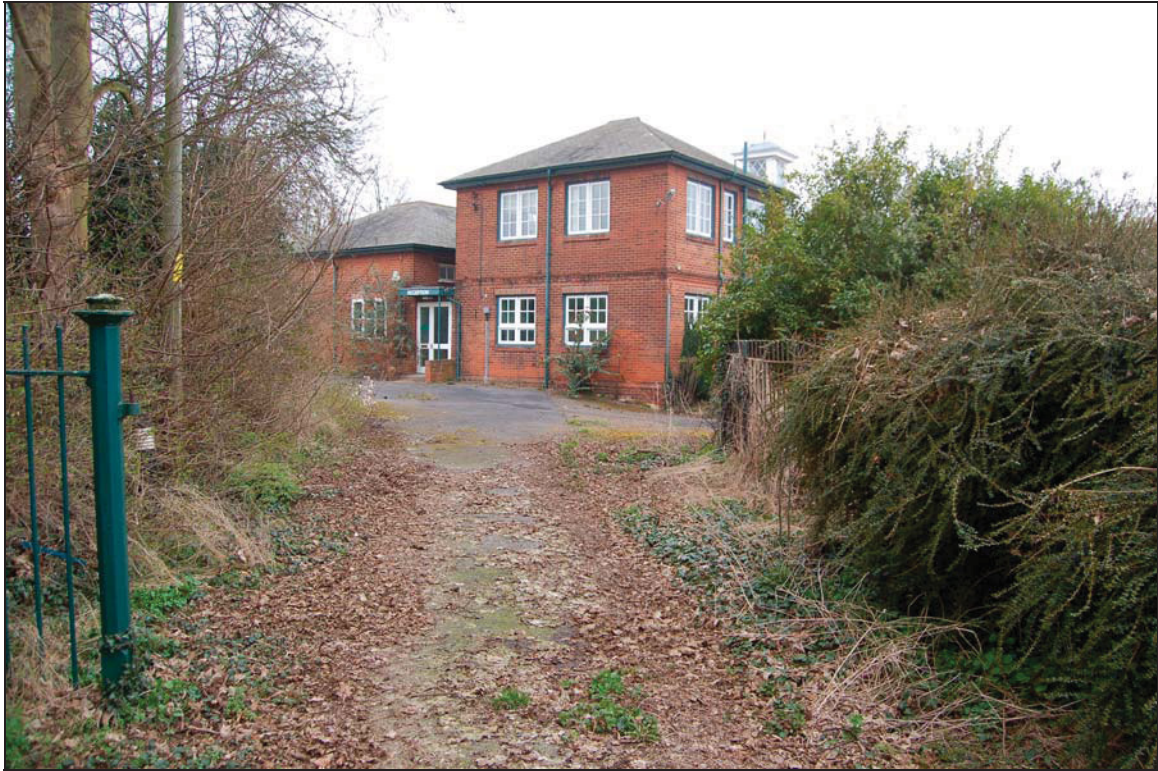
cast iron fences and gate posts presumably contemporary with the construction of the 1958 school (plate 1).

Plate 1 View of school from Rosemary Lane entrance (south-east)

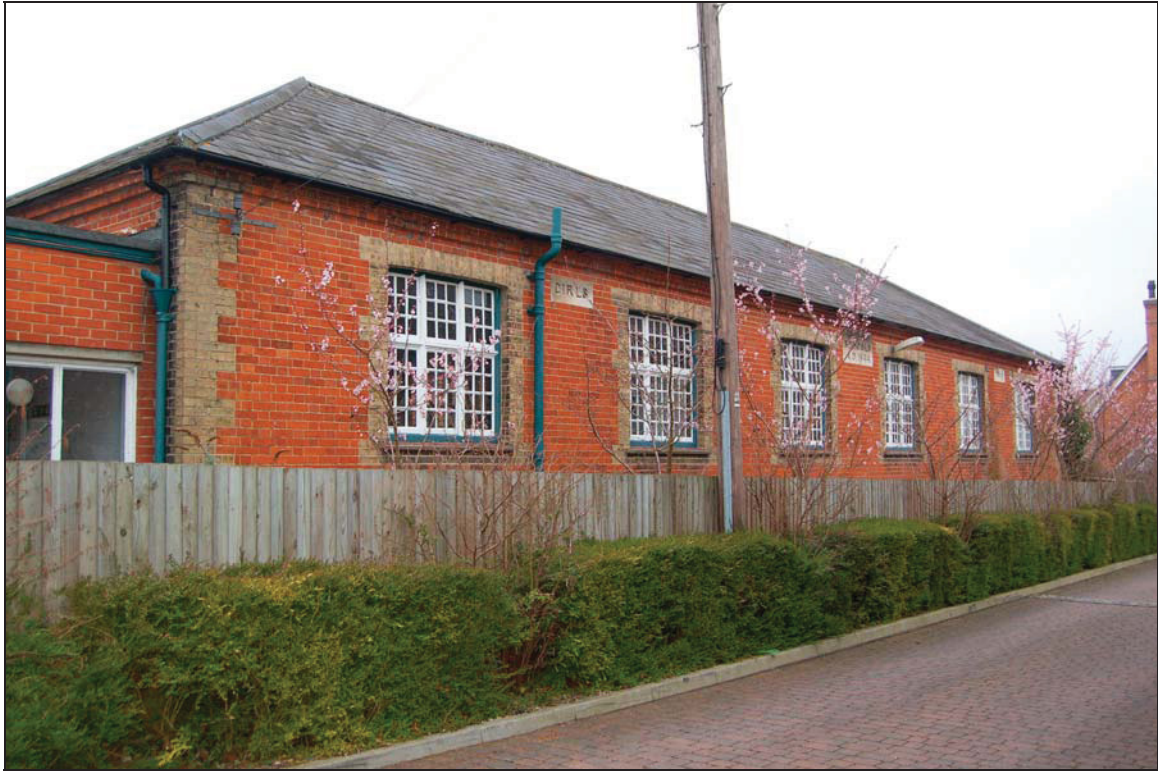
The main façade is the **east elevation** (plates 3-5), bordering Pondfields and partially screened by young trees contemporary with the new houses. Photographs taken on the preliminary visit in 2009 are included as plates 3 and 5, which show the trees earlier on in their growth. The character at the front is essentially unchanged. The bricks are fairly typical of 18th and early 19th century forms (Ryan 1996), varying in colour from orange to red and commonly measuring 215 x 107 x 65mm. They are also quite soft and gritty with frequent crease marks. Cream-coloured gault bricks are used for the quoins and dressings around the windows (plates 3-5) producing a polychrome affect. The outshot to the north (boys entrance lobby) is of the same basic construction but has no detailing around the entrance, which is a wide (1.1m) four-panel door, now shrouded in ivy (plate 5).

Between the windows, just below eaves level, are stone plaques indicating the separate entrances for boys and girls (plates 3 & 5 to north and south), who were each taught in their own half of the building (fig. 4). Another plaque in the middle reads 'British School 1844' (plate 4).

Plate 3 1844 School viewed to north-west

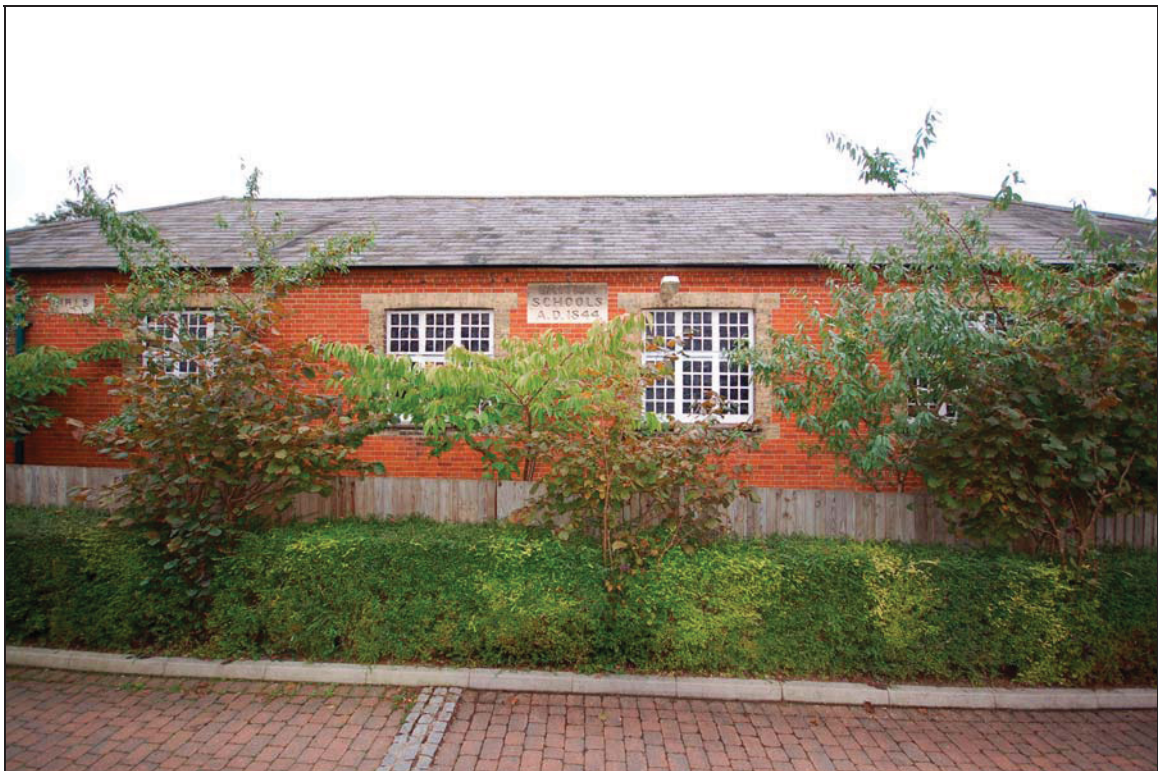
Although currently boarded-up at the front, the windows on this side have been painted to look realistic (plate 4). These windows, which are common to both long elevations, are divided by thick wooden frames into six multi-pane lights, arranged in two rows of three, with those on the bottom row being three panes larger, at twelve rather than nine panes apiece.

Plate 4 1844 School viewed to west

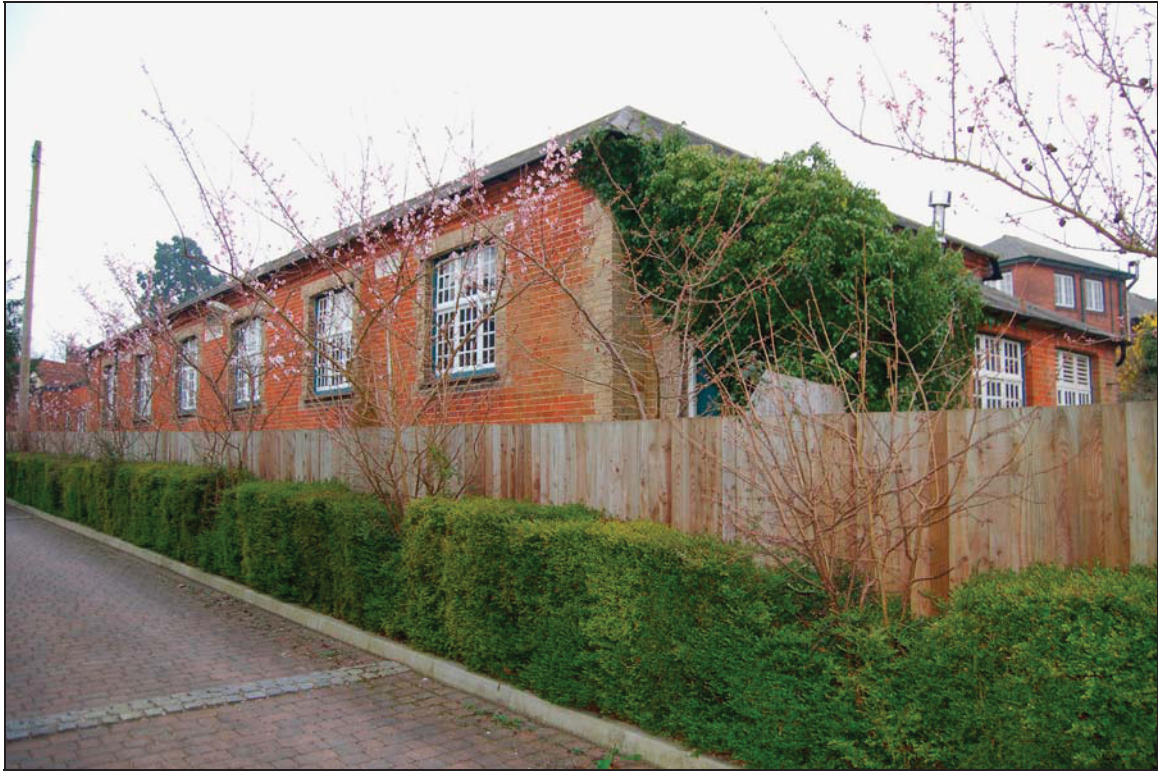
Plate 5 1844 School viewed to south-west

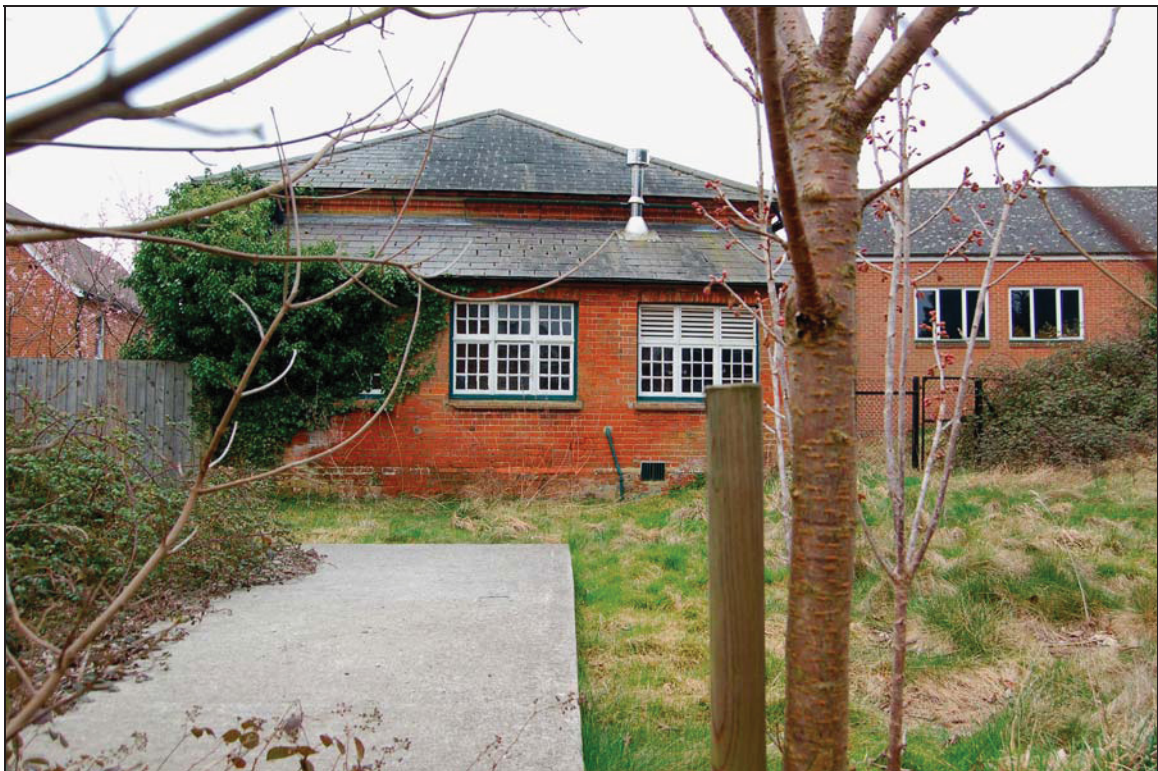
The **north elevation** (plate 6) contains the single pitch lean-to of the boys entrance lobby into the school. Again this retains much of its Victorian character, with the exception of modern wooden window vents on the western window, and stainless steel chimney added to the western bay for the boiler. The elevation contains windows similar to those on the main façade but slightly smaller at six panes over nine (plate 6). Those on the bottom row are casements and those on the top have a middle vent, except for the partially-replaced western window, as discussed.

Plate 6 Former boys entrance lobby viewed to south

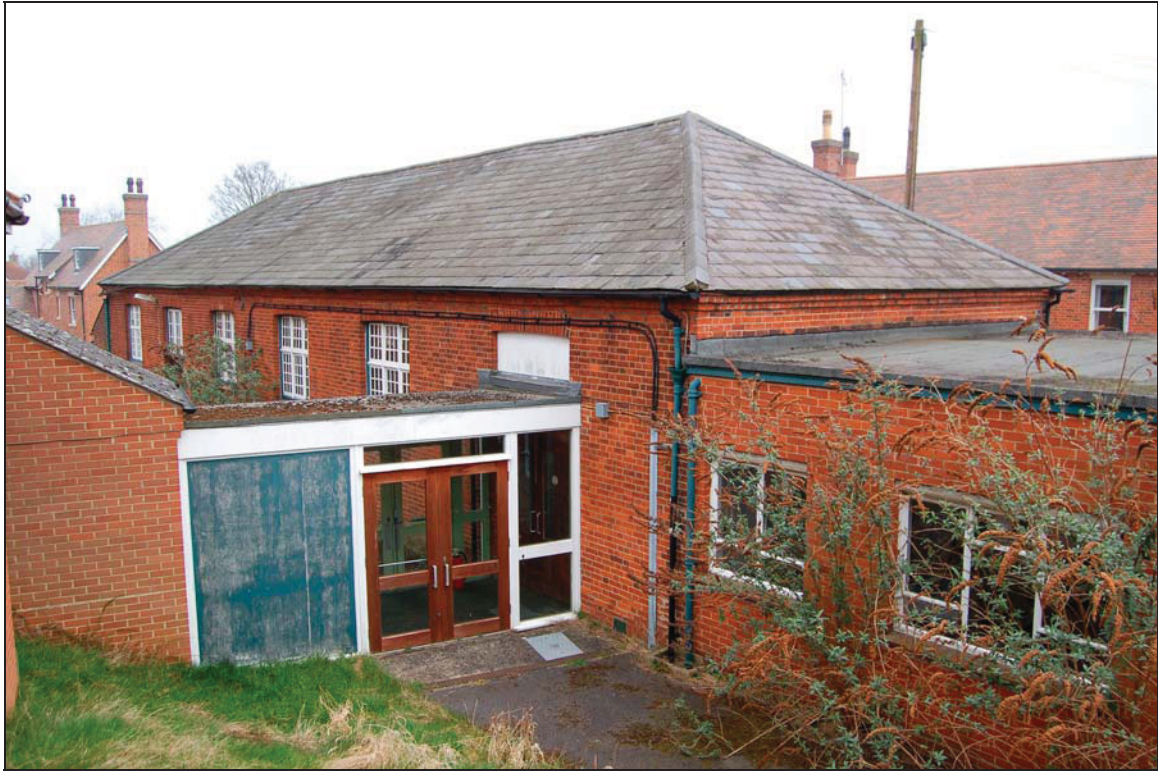
Being at the back of the building, the **west elevation** (plates 7 & 8) features a lower level of detail than the façade. However, with the addition of the later school complex, this side effectively became the frontage. Changes have been made to the fabric through the insertion or remodelling of doorways and the addition of a flat-roofed glass linking corridor to the main school. The doorway towards the southern that connects to the corridor (plate 7) has been built into a former window (the upper part of which is now rendered over) but is likely to represent the original girls exit to the playground and toilets (fig. 4). At the north end, a second doorway has been added in the penultimate window, the top part of which has been replaced (plate 7). Just to the side, between the door and the second window, appears to be the original, now blocked-in, boys exit (fig. 4 & plate 8).

Plate 7 1844 School viewed to north-east with modern kitchen and link

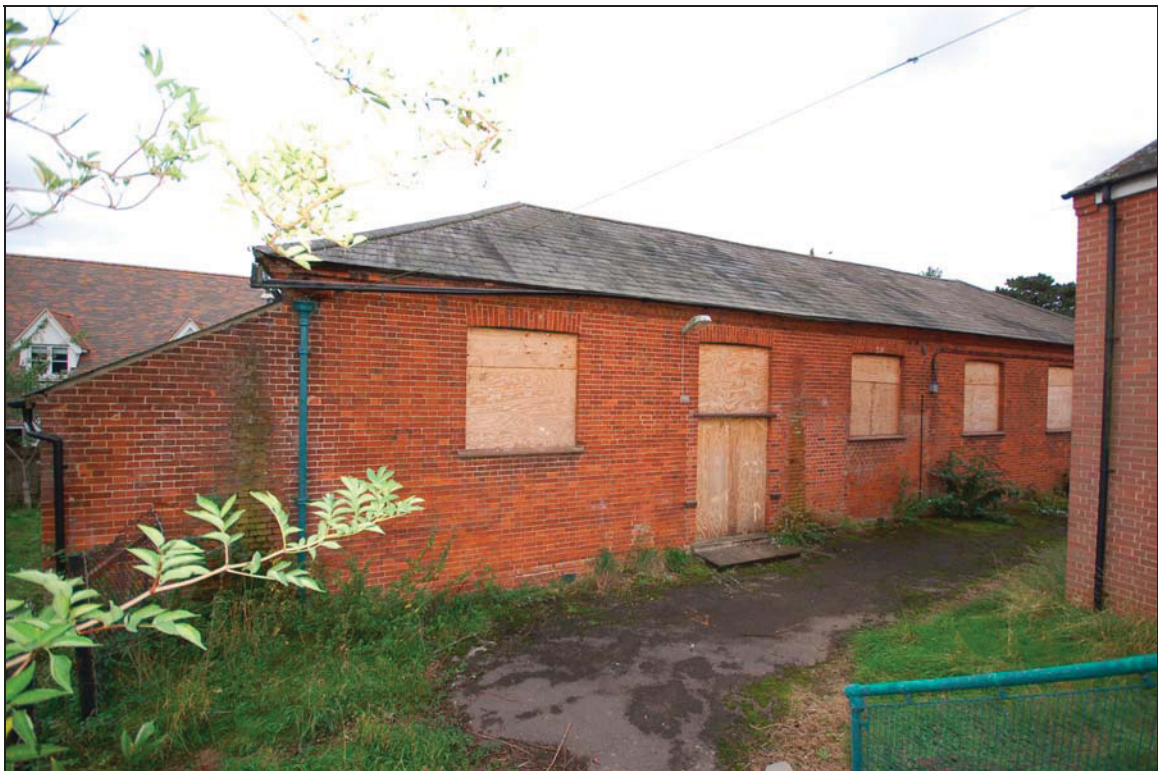
Plate 8 Part of western elevation of 1844 school

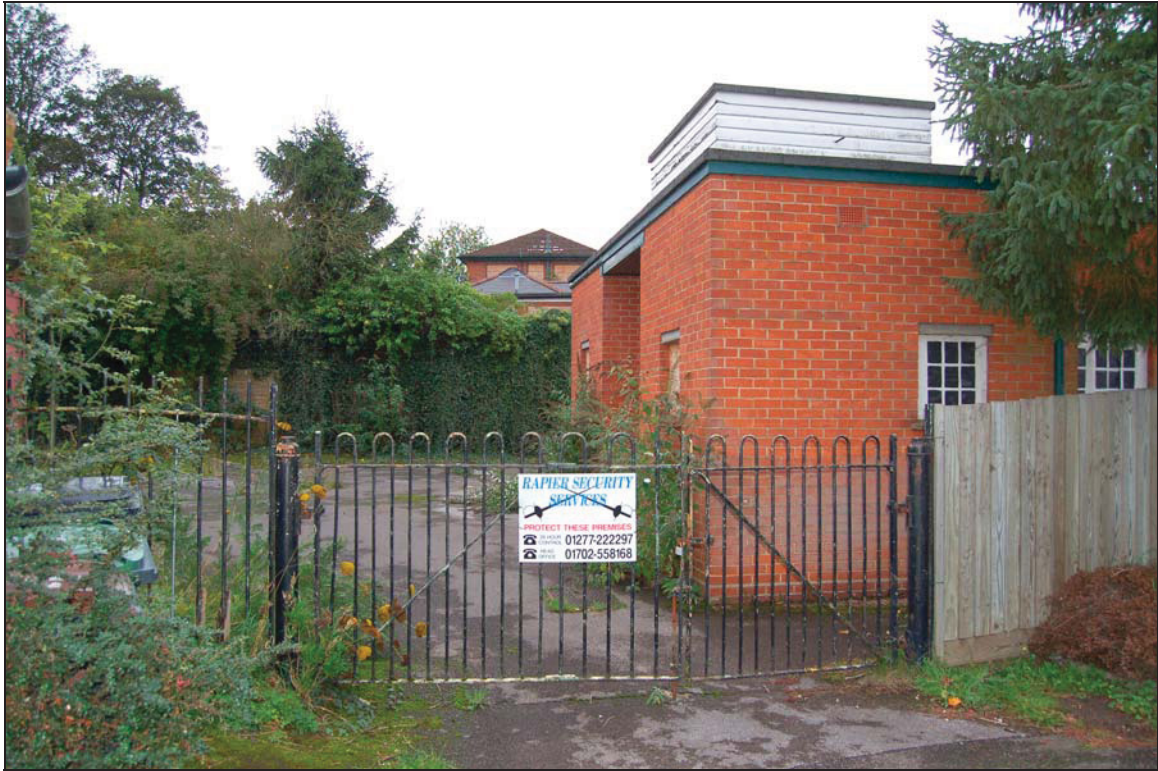
The kitchen attached to the Victorian schoolhouse (plate 9) is also modern, but pre-dates the modern school block.

Plate 9 Kitchen extension next to side entrance

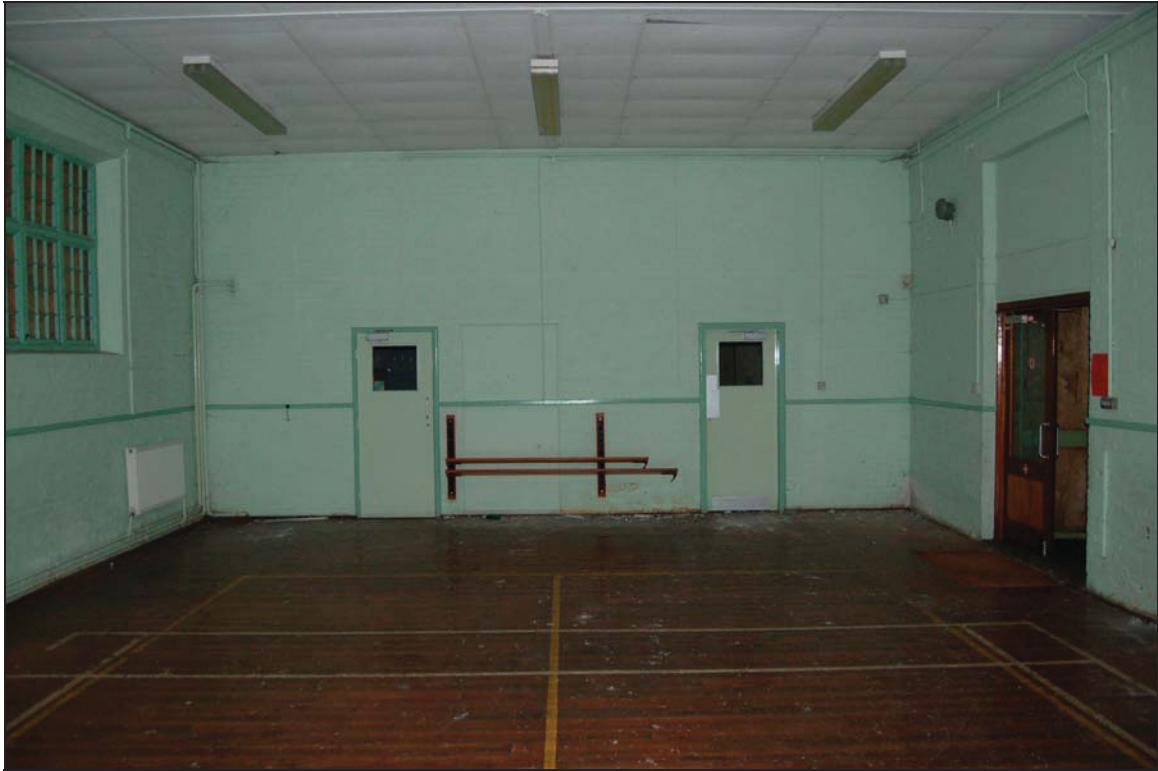
The south wall shows evidence for blocked doorways leading into the former girls entrance lobby (fig. 4, plate 11). Each has slightly cambered heads like those above the windows outside. The north wall retains its original doorways, both plain four panelled doors typical of the Victorian period. The moulded architraves of the doors are missing on the inner side suggesting an earlier fixture, perhaps the blackboard or panelling was removed (plate 12). The rest of the wall is boarded over. In the north-east corner are a row of mid-20th century wire coat hooks (plate 13), probably associated with a seating area.

Plate 11 Interior of gym viewed to south

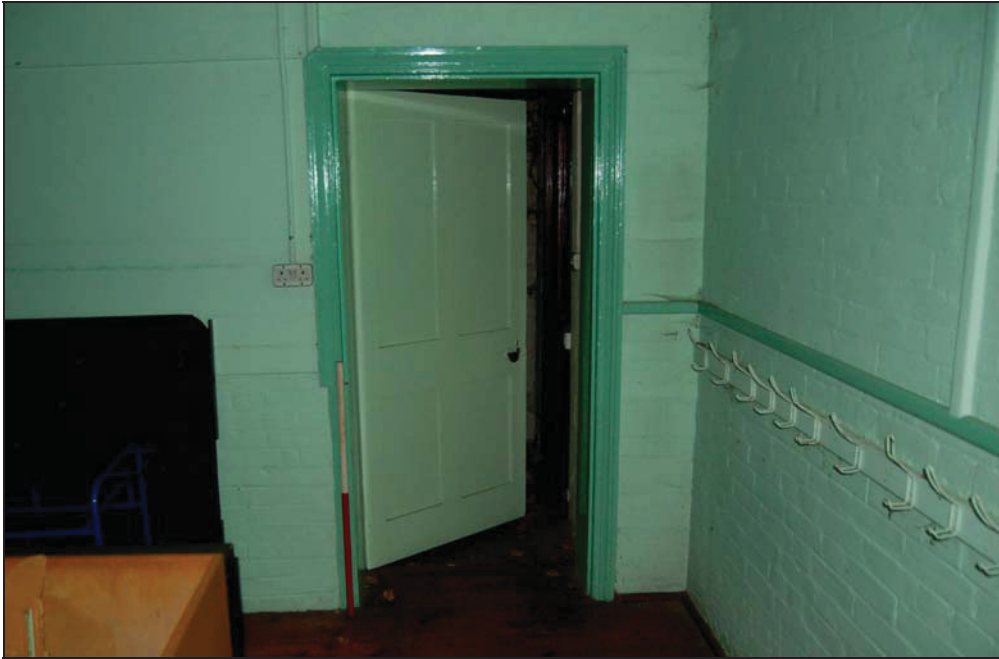
Plate 13 Doorway into boys lobby

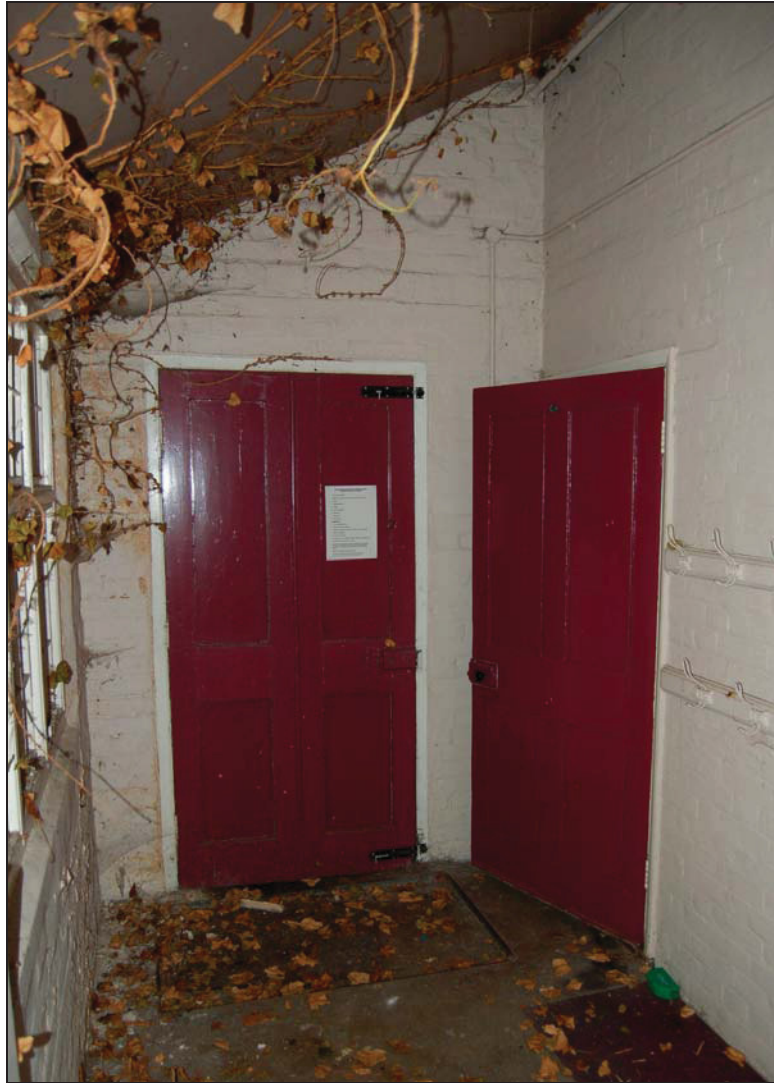
The former entrance lobby is divided into three irregular-sized bays by narrow beams (fig. 4). The walls show bare painted brickwork and the floor is made of concrete (plate 15). There are few original fixtures remaining. Currently the former lobby is divided by a modern internal partition into two areas, a boiler room and a cloakroom/changing room. A narrow door, locked at the time of the survey, connects the two. The partition was inserted to create two changing rooms; the western side was converted into the boiler room in a later phase, but this function continued on the eastern side.

Plate 15 Entrance into boys lobby

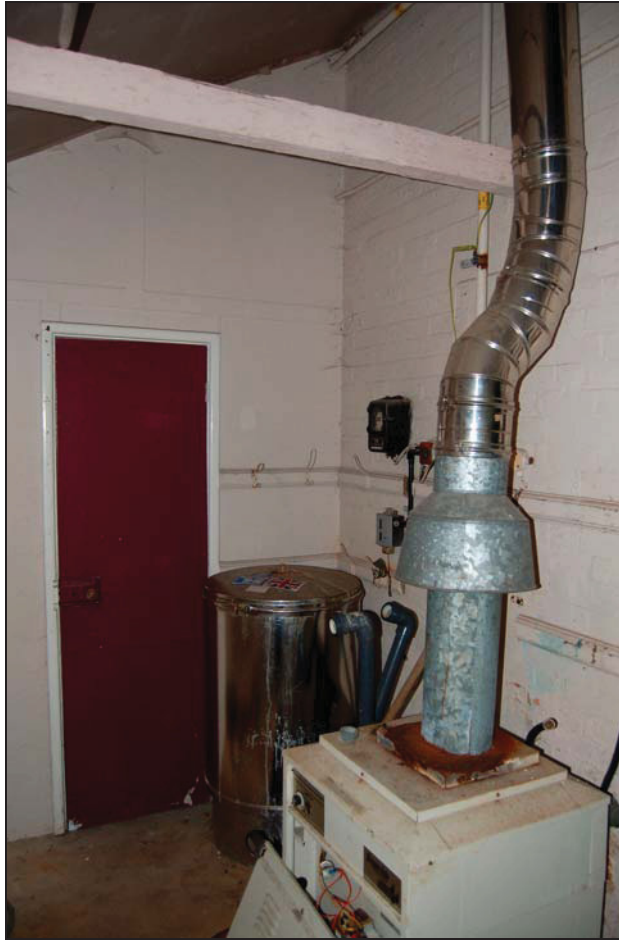
Entry into the boiler room (plate 17) was from the gym or a narrow plain doorway within the later partition. A modern gas boiler and swimming pool filter drum stand against the back (south) wall. Around the walls are two rows of cloak pegs, except for the outer (north) wall, which alludes to the room's use prior to being a boiler room. None of these are numbered. Modern wooden vents have replaced the top windows on the only complete window on this side (fig. 4 & plate 18). According to a plate on the 'Venner' boiler timer, it was installed in 1963. High up on the west wall is a modern wooden rack/shelf.

Plate 17 Interior of boiler room viewed to east

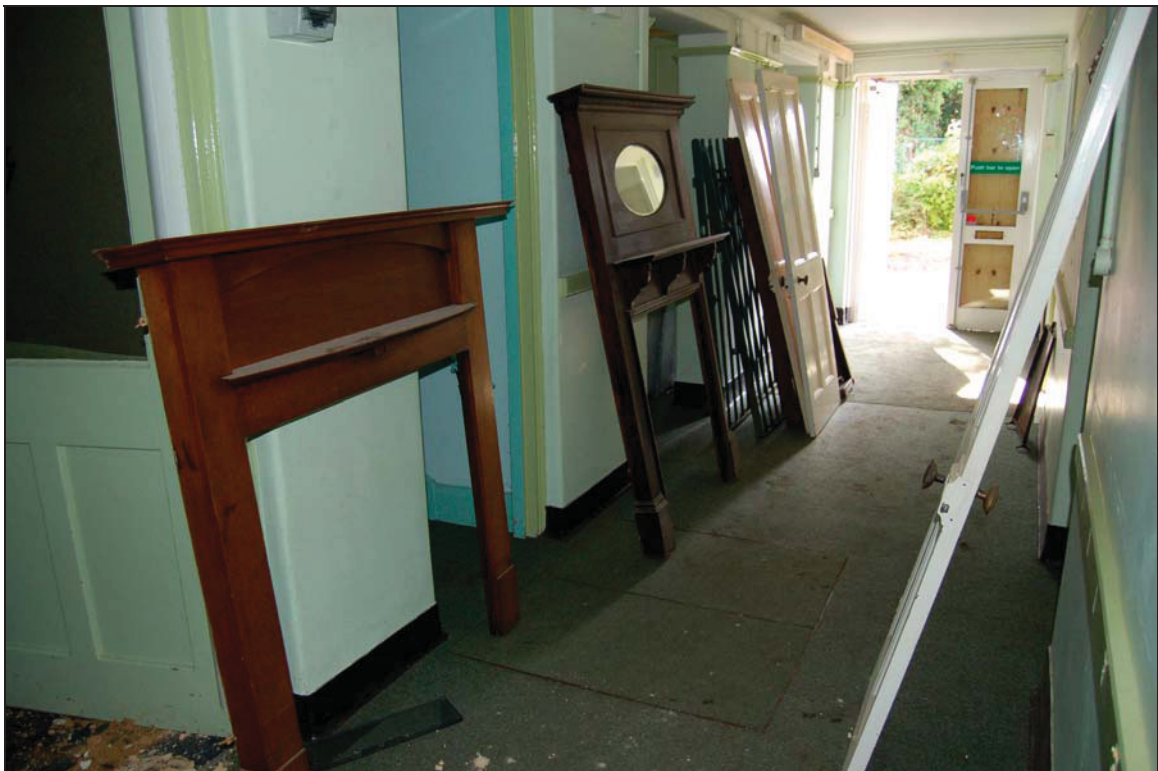
The **corridor** has plastered walls and a moulded picture rail and is heated by large cast iron radiators, of the type often found in institutional buildings of this date. It is lit by a central skylight, though was dark at the time of the survey, when it was being used to store various fixtures for later use such as doors, mantle pieces and the school gates (plate 24).

Plate 24 Corridor interior viewed to reception area (north)

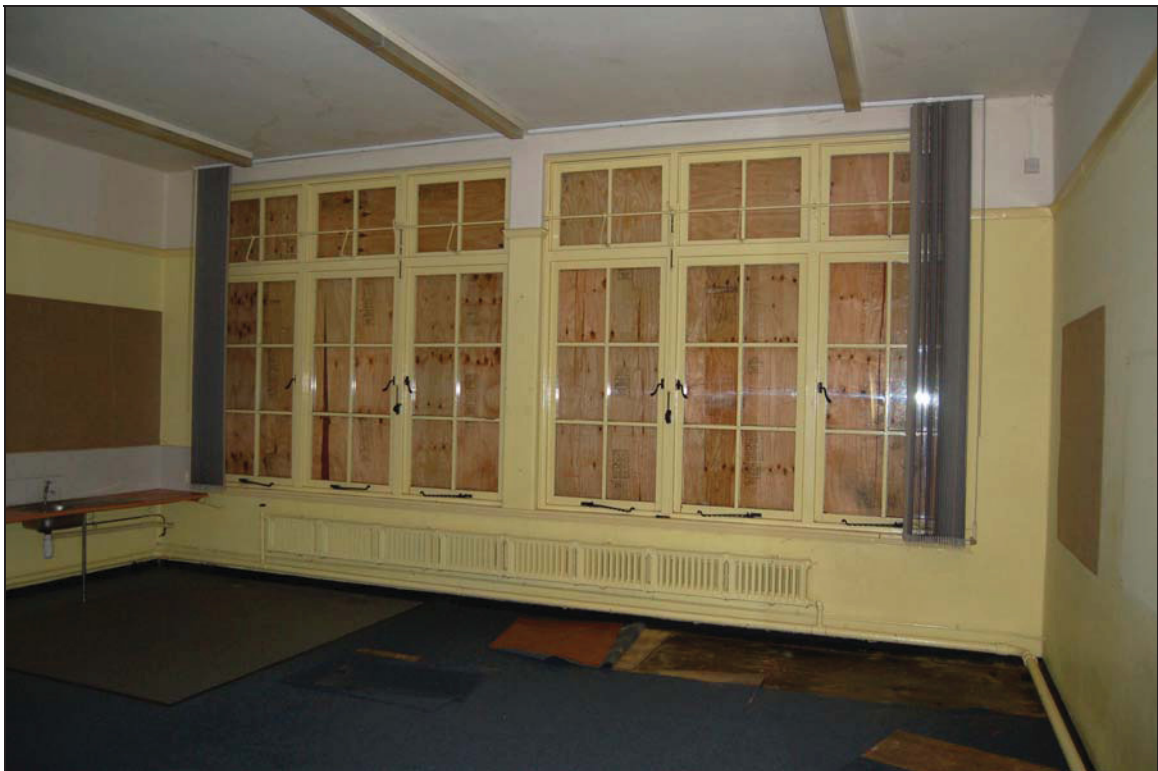
All extant **classrooms** retain fixtures and fittings dating from the 1950s, though, as may be expected, the electrical and light fittings are modern. Classroom 5 was recorded as a typical example, but all were investigated apart from classrooms 3 and 6, which were locked and no keys available. The classrooms are entered from the corridor through semi-glazed doors. Most, though not all, have windows onto the corridor that bring outside light into the corridor and also facilitate a level of general control and supervision. Above the picture rail are set two four-pane skylights (plate 25) that take light from above the flat-roof of the central corridor. Large windows, two in each classroom, occupy most of the exterior walls. The bottom windows are casements and the top ones tilt open, thanks to a handle-operated screw/iron rod mechanism (plate 26).

Plate 26 Windows in classroom 4

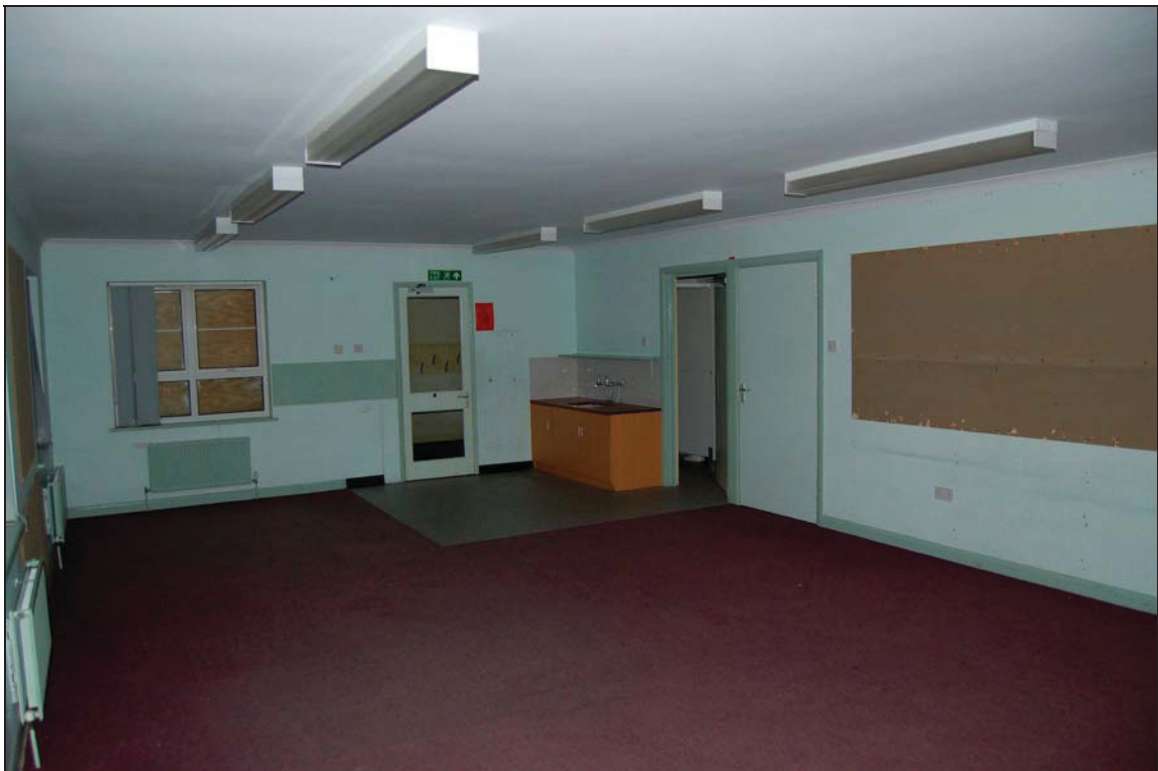
The modern school comprises two large brick blocks of little architectural interest either side of a flat-roofed corridor that forms a link between the 1844 schoolhouse and 1958 block (fig. 1). From observation, it was probably built within the last 20 years, the main part of which, if not all, was probably built in one phase. That part on the north side of the link (plate 6, right) is a large and very plain building containing two large modern classrooms. The southern part appears more bungalowoid in aspect, with slate-covered gabled roofs and an external covered walkway leading between the southern end to the linking corridor (plate 29). Inside are two large classrooms (plate 30) and a cloakroom.

Plate 30 Typical modern classroom
