**CASTLE HILL TENNIS CLUB
SAFFRON WALDEN
ESSEX**

ARCHAEOLOGICAL MONITORING

**Essex County Council
Field Archaeology Unit**

JANUARY 2011

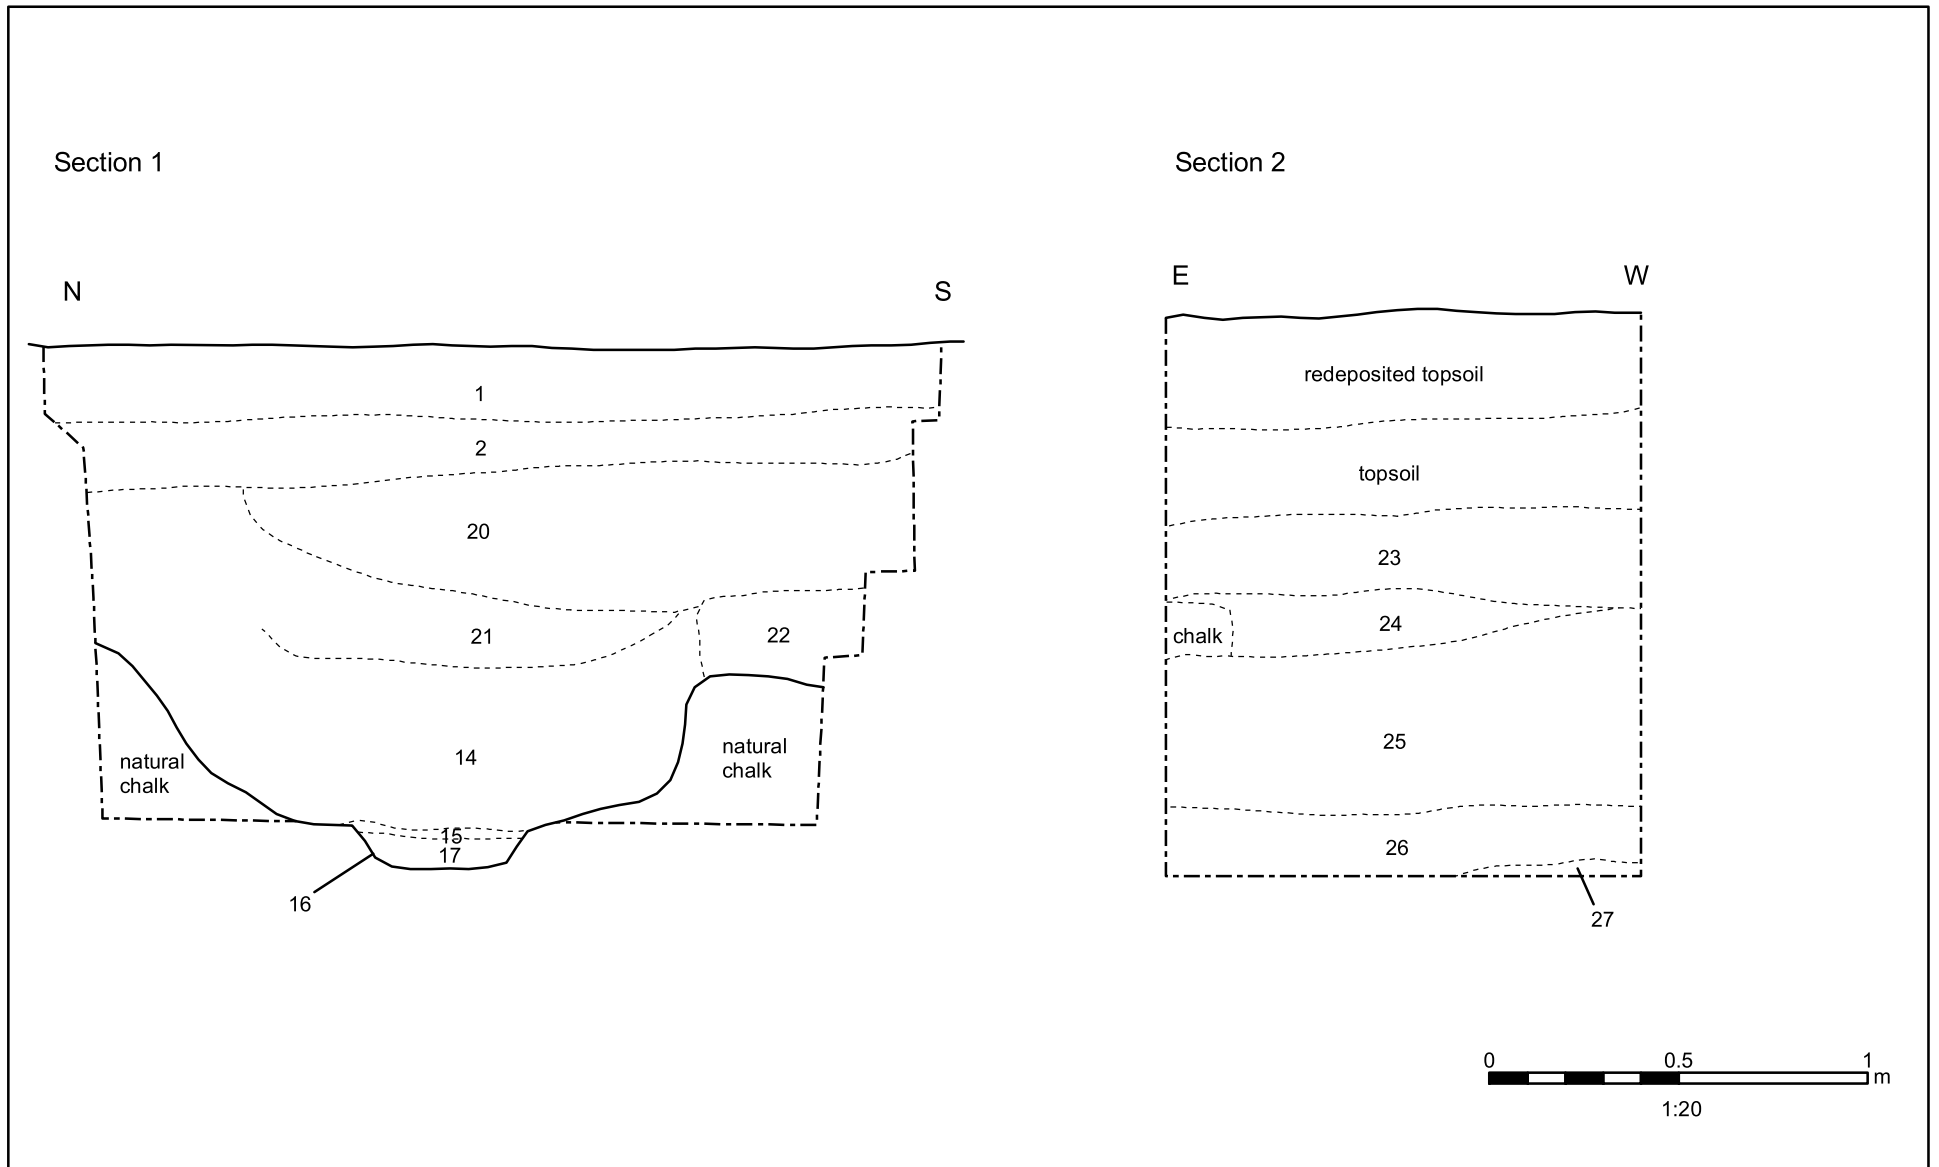
Fig.3. Sections

Sealing the silt was a thick deposit of mixed greyish light brown clay silt containing common flecks of chalk and flint (14). Finds included fragments of roof tile and a fragment of (architectural) worked stone. Above layer 14 and filling a large irregular depression (13) in its top was a very loose deposit of brown and greyish brown silt (12) containing common flints and occasional chalk flecks and fragments of yellowish/buff mortar (Plate 3). Numerous fragments of roof tile dated to the late 13th to 15th century were present (of which only a sample was retained) along with a few fragments of animal bone and a further fragment of worked architectural stone. The edge of a similar but physically separate tile-rich deposit was recorded as context 21 in Section 1 (Fig. 3, Section 1).

The soakaway was approximately 1.5m deep (Fig. 3, Section 2; Plate 4). Exposed at the required limit of excavation in the base of the trench was a layer of mid greyish brown chalk-flecked silt (28) which had the appearance of buried topsoil. In the south-west corner of the trench this was overlain by a localised thin layer of small flints embedded in chalk (27). Sealing the flints were two fairly dry deposits (25 and 26) of unusual character (Plate 4). Deposit 26 was pale pinkish yellow in colour, 0.18m thick, and appeared to consist of mixed crushed Limestone, some fine and some coarser with small pieces. Deposit 25 was up to 0.5m thick and consisted of compacted predominately fine-grained material which was light grey in colour with a slight greenish tinge and a consistency best described as plaster-like. Above was a more readily identifiable layer of grey silt and chalk rubble (24), which appeared to become more chalkier to the east, in turn overlain by a layer of mid grey clay silt (23). At the top of the sequence was 0.5m of dark greyish brown, root disturbed, organic topsoil the lower half of which was *in situ* and the upper part built-up from recent groundworks. No dating evidence was recovered from any of these deposits.

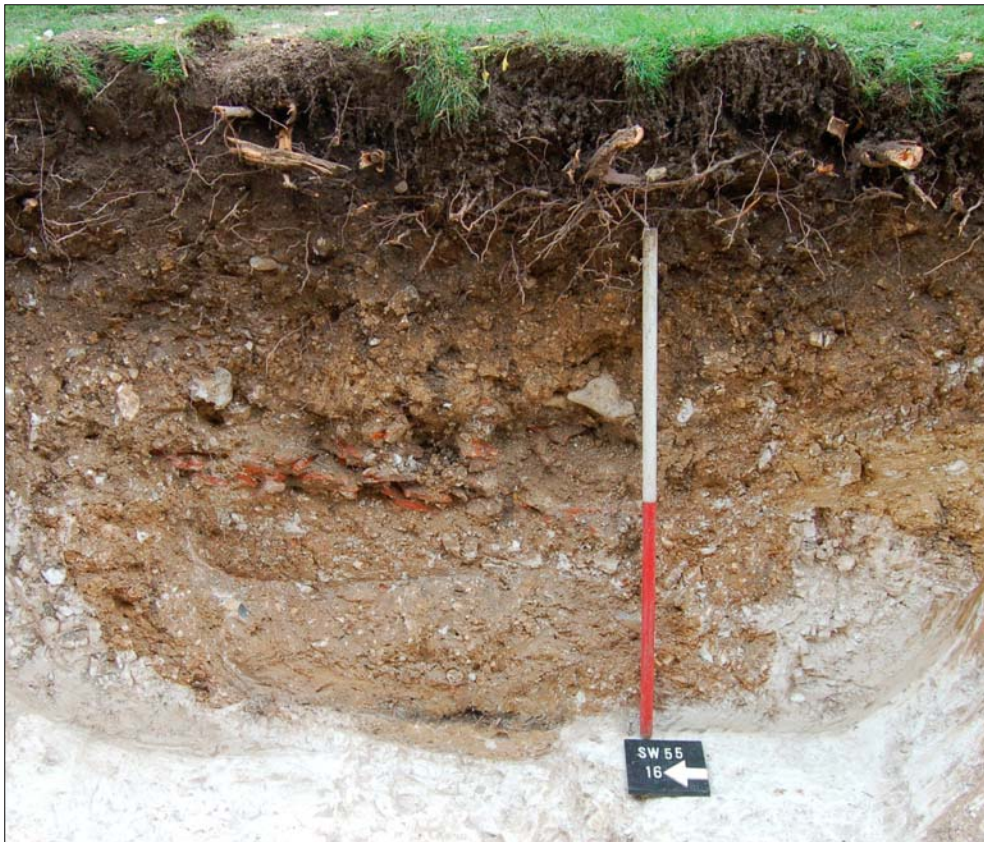
Plate 1. Section 1 (1m scale)

At the base of the excavated sequence was natural chalk. This was exposed at a depth of 0.8m below the surface in the northern side of the trench, but elsewhere, particularly to the south and west, had been truncated to a depth of c. 1.2m. In the eastern section (Fig. 3, Section 1; Plate 1) a small patch of solid, chalk-flecked, yellowish buff clay silt (22) may have been the only surviving remnant of undisturbed subsoil.

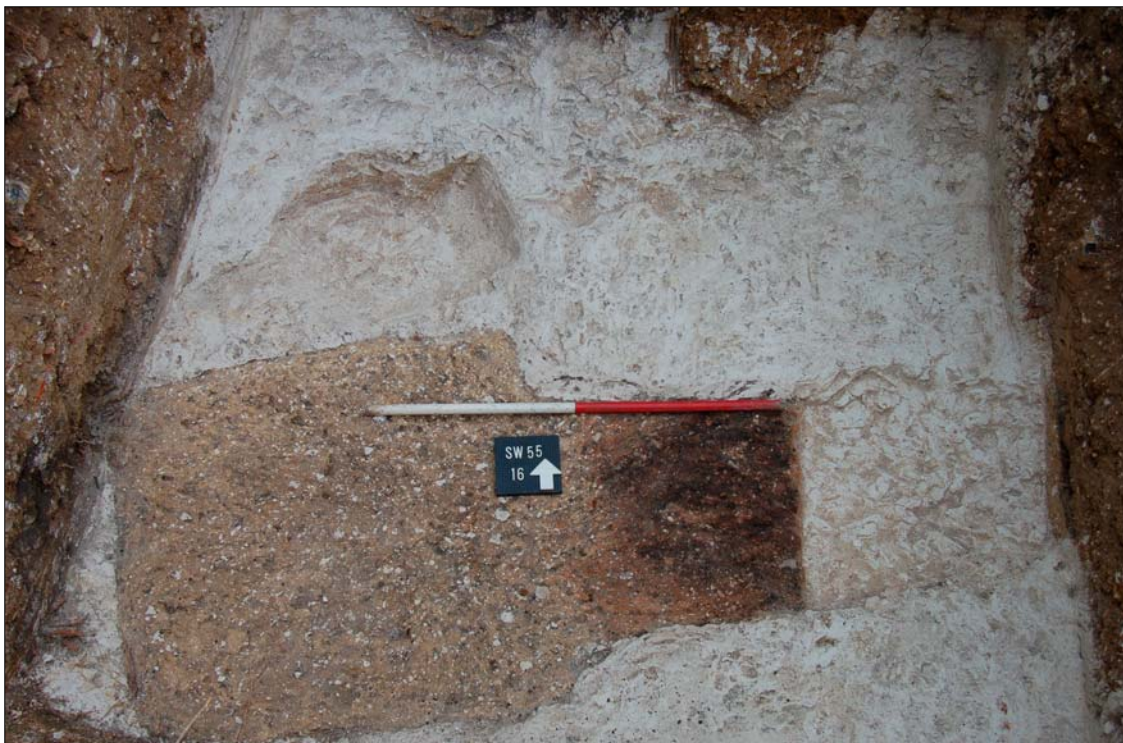
Plate 2. Feature 16 (1m scale)

Cutting the truncated chalk in the base of the trench were two features (16 and 18). Feature 16 consisted of a north-east/south-west aligned flat-bottomed slot over 1.16m long by 0.55m wide. To the west, the slot widened-out to form a square end approximately 1.04m long by 0.95m wide (Plate 2). Both elements were about 0.08m deep and filled with compacted

yellow clay containing frequent flecks and lumps of chalk and rarer small lenses of yellow sand (17). The fill in the narrower part of the feature had been subjected to intense heat visible as an oval patch 1.08m long. The centre of this oval was very dark brown in colour and had a slightly shiny/glassy appearance whilst around the edges it was a lighter orangey red.

The archaeological monitoring has recorded several deposits and features of archaeological interest, the most significant of which is the linear foundation and square pier base revealed in the base of the septic tank trench. This appears to be part of a major structure that has been severely robbed. The original foundation had been cut into the chalk bedrock and consisted of compact chalky clay which had been burnt *in situ* presumably when the structure was demolished and robbed. The grey silt overlying the foundation may indicate that the trench was open for short while between robbing and backfilling. The date and function of the structure is hard to determine from a comparatively small investigation and the lack of dating evidence. Although it is possible that the structure is of post-medieval date the natural assumption is that it dates to the medieval period and is part of an outbuilding within the western half of the inner bailey. Bassett (1982, 18) intriguingly makes reference to a masonry hall situated in this part of the inner bailey but it is not certain if this is that same building. The recovery of two pieces of architectural stone and several larger than usual pieces of broken roof tile from the backfill do however point to the existence of a major medieval building in the vicinity.
