**FORMER OFFICERS MESS SITE
MESS ROAD
SHOEBURYNESSE GARRISON
ESSEX
ARCHAEOLOGICAL MONITORING**

FORMER OFFICERS MESS SITE
MESS ROAD, SHOEBURYNESSE GARRISON, ESSEX:
ARCHAEOLOGICAL MONITORING

Site code: SHOM 10

FAU Project No: 2422

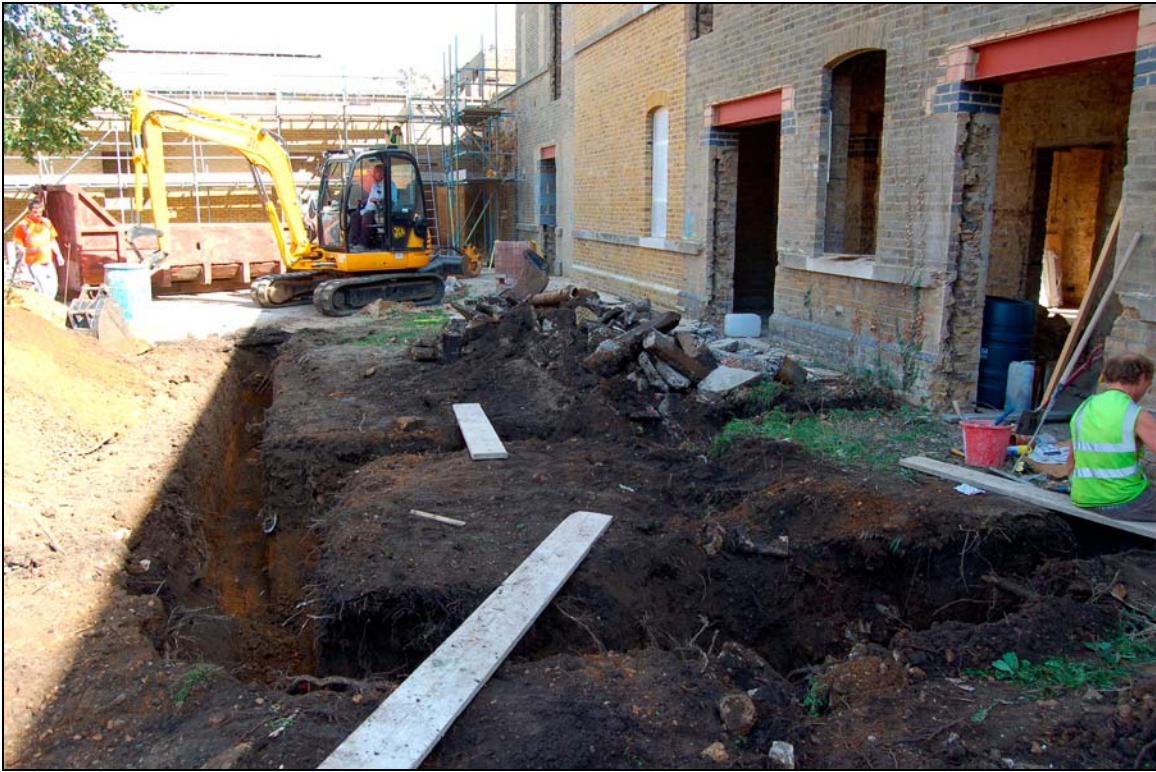
Plate 1. Plot 5 extension post-excitation, viewed to north-east

Those in **Plots 4-6 and 10** were machine-excavated to a depth of 1.2m through ground generally heavily-disturbed by modern service pipes, concrete bases, tanks and previous excavations. Where undisturbed, a brown subsoil survived at 0.4m below ground level and natural sand and gravel survived at a depth of 0.7m. The Plot 4, extension, previously investigated in test-pit 2, was disturbed by modern pipes. Plot 5, previously investigated in test-pit 3, contained a concrete base and general modern disturbance (plate 1). Plot 6 (test-pit 4) was disturbed by conifer roots, modern pipes, a brick-lined diesel tank and another concrete base. Plot 10 (plate 2) contained modern service pipes, though was found to be relatively undisturbed in test-pit 5.

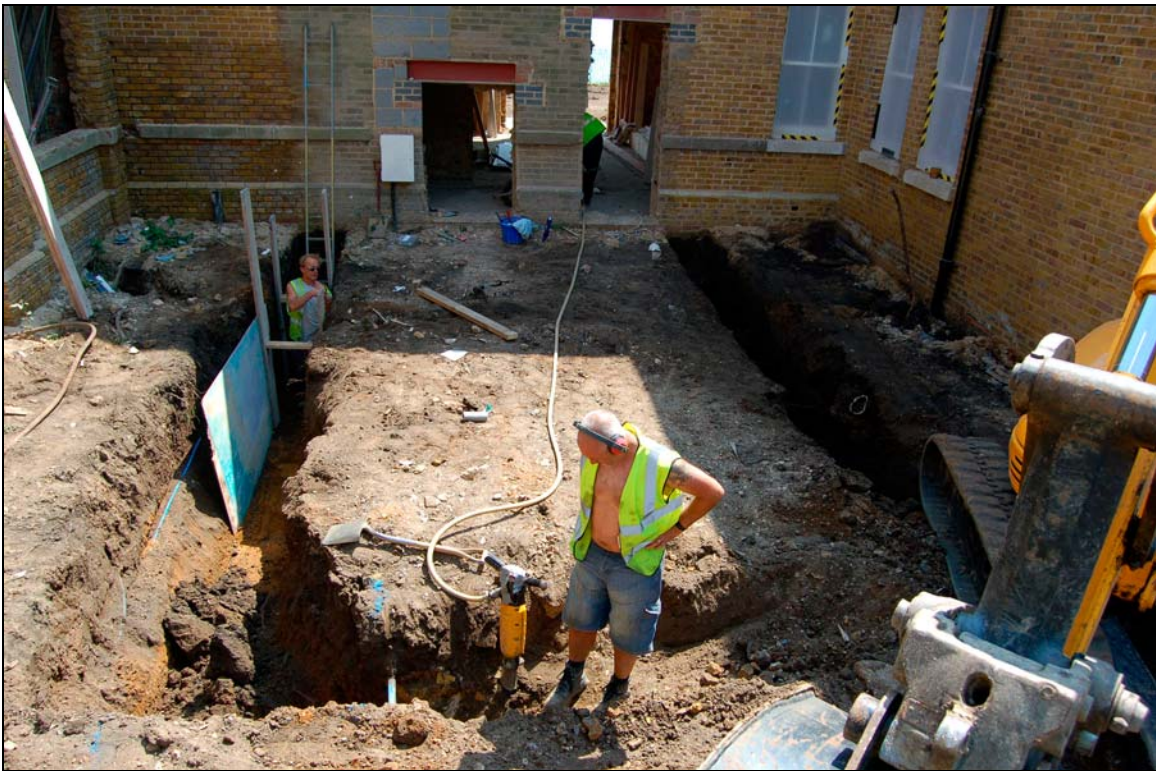
Plate 2. Excavation of plot 10 extension, viewed to south-east

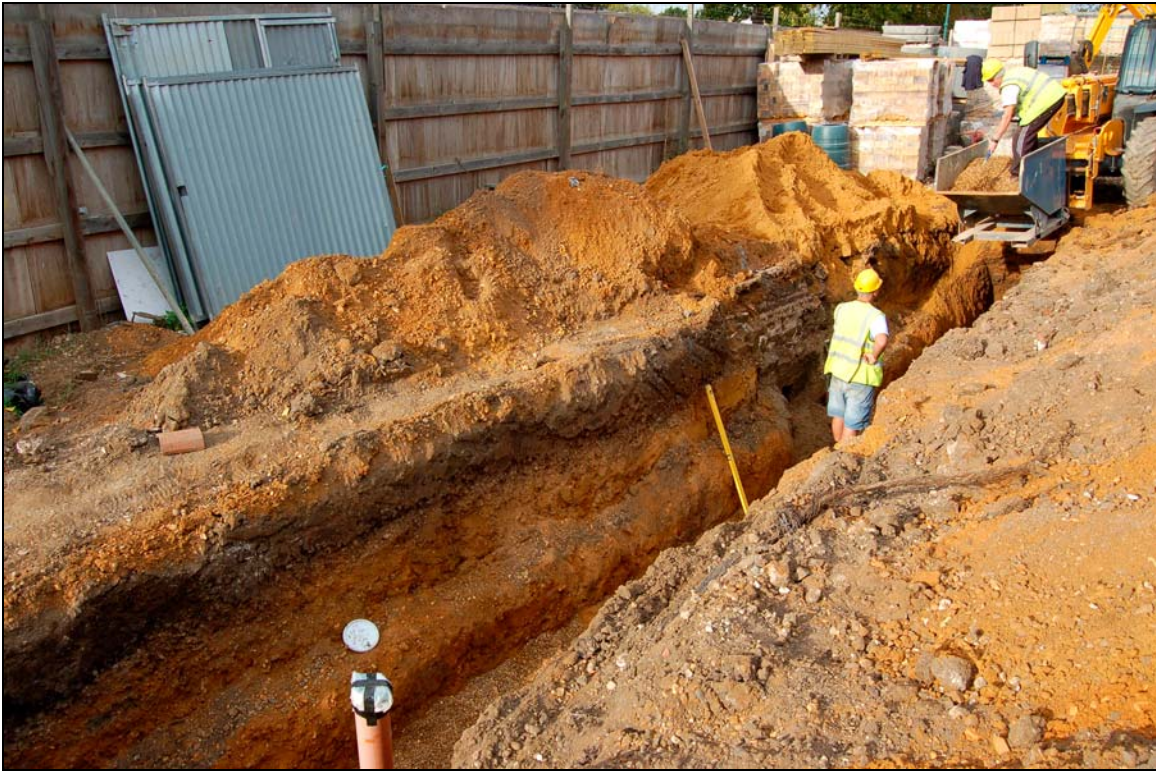
Excavation of the substantial **storm drain** that ran between plots 3 and 8 provided a 48m-long and 1.9m-deep section through deposits in the middle of the site (plate 3). The south-west ends of three small underground structures of 19th/20th century date, indicated as 'bunkers' in fig. 2, were exposed. The bunkers formed a row of three small underground structures constructed from single-skin yellow London stock brick walls aligned with the road frontage. The features, all of which had been backfilled, lay beneath a mixed layer of modern material. The largest of these lay towards the western end of the trench and was almost 5m wide (plate 4). The other two, located midway and towards the north-east end of the trench were each 2m wide (fig. 2). The south-east walls of each feature lay along the line of the storm drain and were therefore removed during machining. The full extents of these features is unknown and their depths vary from 1.4m to over the limit of excavation at 1.7m. Large

There was a similar level and type of modern disturbance to that observed in the Plot 4-6 building extension trenches, plus some large modern pitting. Topsoil and brown subsoil were disturbed to a depth of between 0.4 and 0.9m, down to where the undisturbed natural deposit was encountered.

Plate 3. Excavation of storm drain trench, viewed to north-east

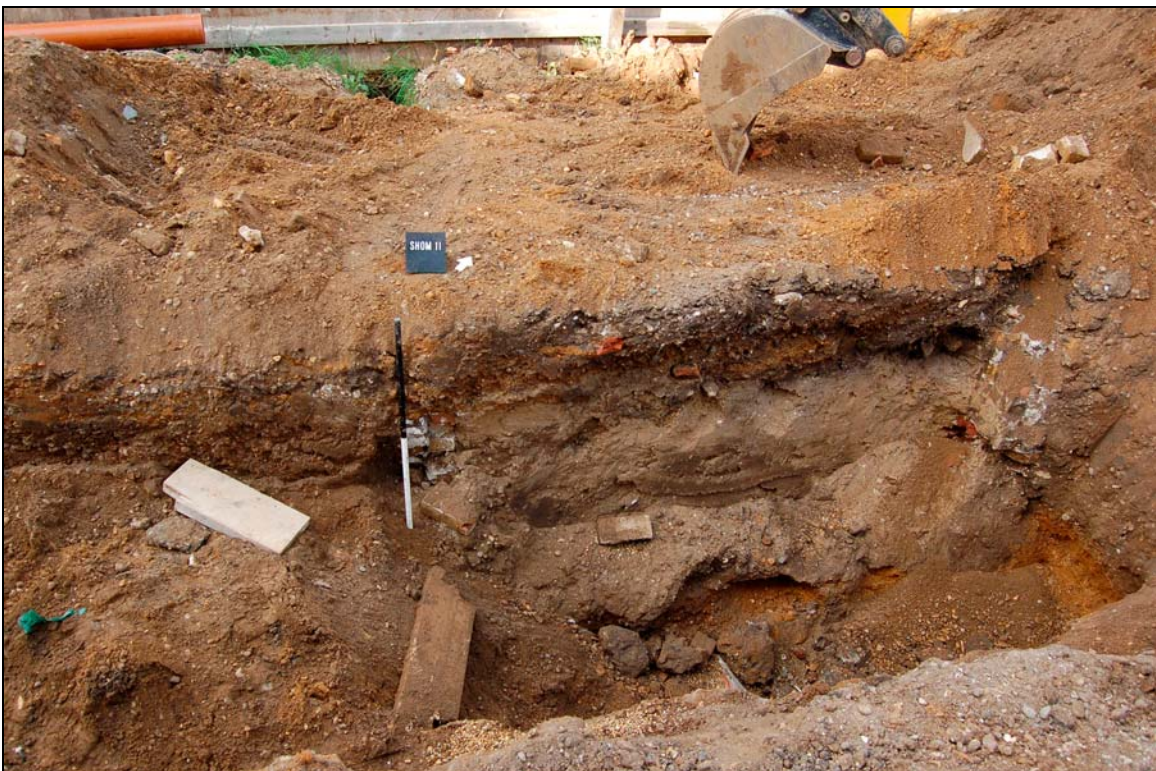
pieces of late 19th century 'Willow Pattern' pottery were collected from their construction cuts.

Plate 4. Large 'bunker' viewed at south-west end of storm drain trench

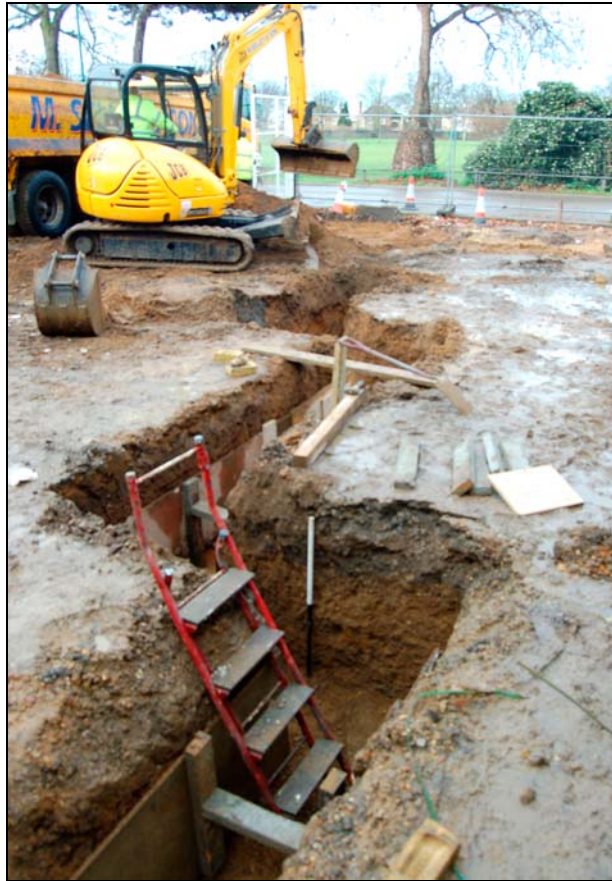
The wall trench between Plots 3 and 4 was 0.6m wide and c.1.15m deep, and was cut into natural gravel (plate 5). A modern cut feature was partially observed under the former concrete driveway to the Mess. It contained a mixed brown silt and re-deposited gravel with rare chalk fragments. It was not bottomed and no indication of overall extent, function or date was obtained.

Plate 5. Boundary wall trench between plots 3 and 4

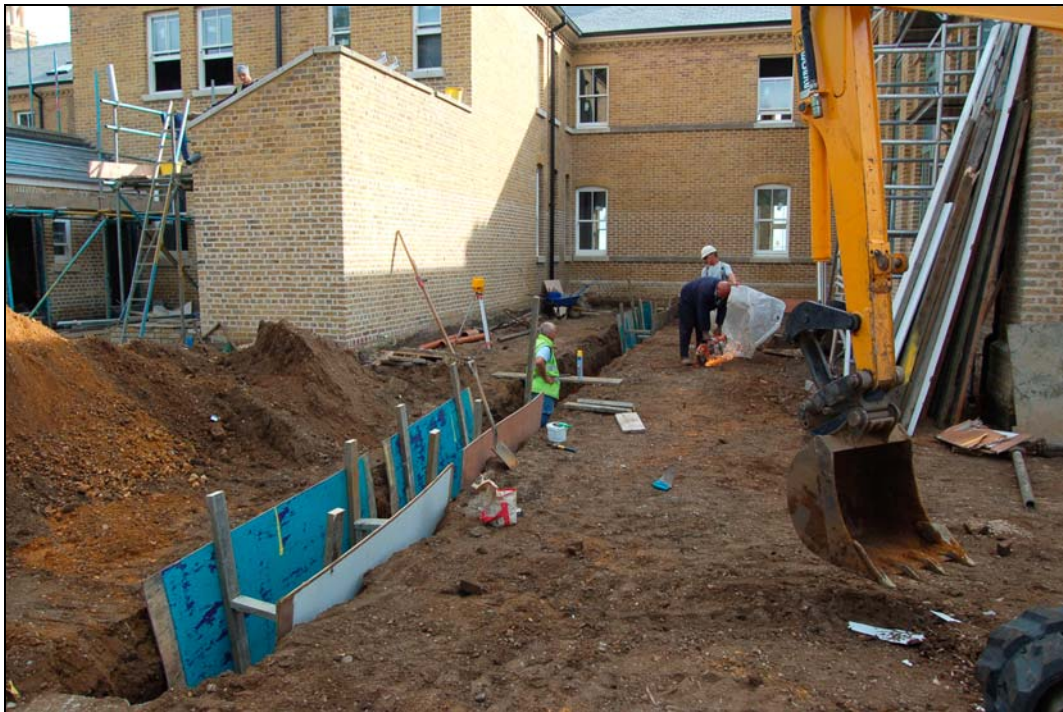
The wall trench between Plots 7 and 8 was undisturbed between the two existing buildings and revealed topsoil and subsoil deposits overlying narrow ditch 31 (figs. 2 & 3, plate 6). This ditch was found at a depth of c.1.1m below ground level and ran on a NE-SW alignment. No dating evidence was retrieved from its fill, but it is likely to predate the Officers Mess and may be contemporary with archaeological remains discovered in the evaluation on the other side of Mess Road. No evidence of its continuation was found in the building extension foundation trenches either side, which were heavily-disturbed.

Plate 6. Boundary wall trench between plots 7 and 8
