**THE FORMER WATER TOWER
CHURCH ROAD, BRIGHTLINGSEA
ESSEX**

HISTORIC BUILDING RECORD

December 2010

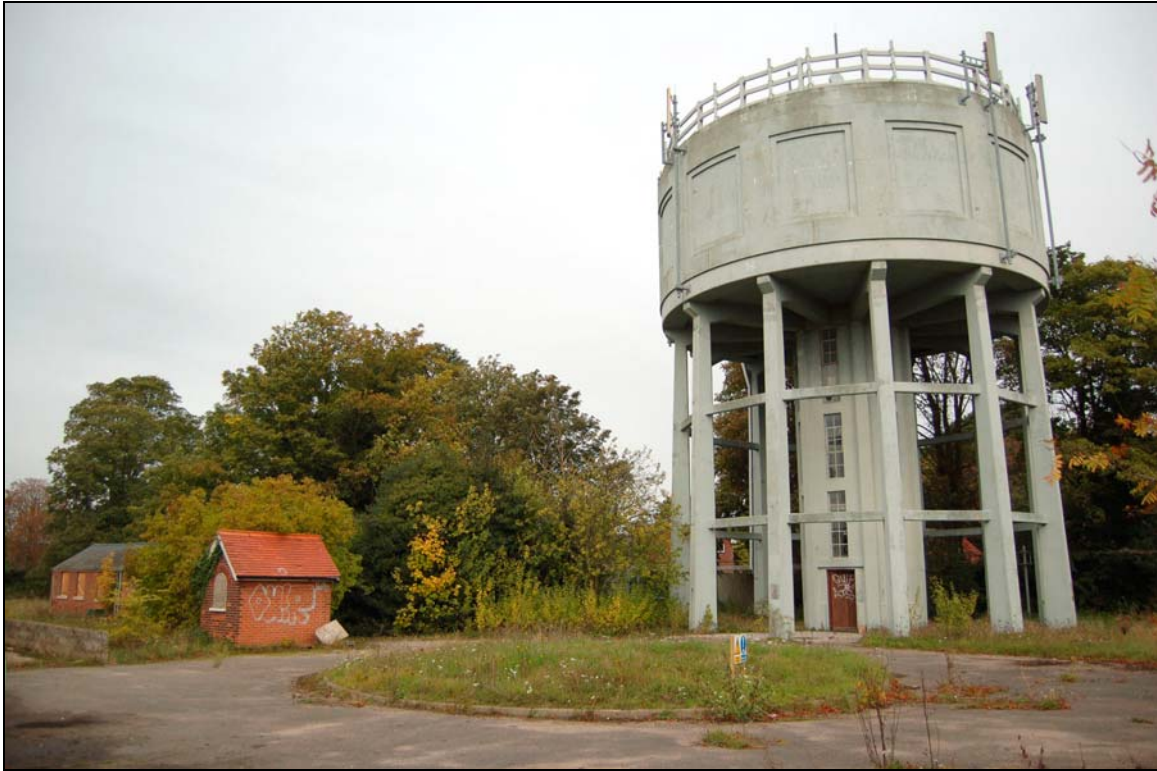
The structure has a circular plan form built from reinforced concrete, with the water tank supported on tall concrete columns (plate 1). The interior is laid out on five levels accessed by steel ladders, including the tank itself and a small roof turret. Machinery and technical features have been removed from inside the building and mobile phone masts have been added to the roof, connected to relay stations built to the west (fig. 1). The toilet block stands close to the site of the Victorian water tower (fig. 1) and the pump house further to the west, in an area of overgrown lawn surrounded by mature trees (plate 1).

Plate 1 Water tower and Victorian ancillary buildings viewed to north-west

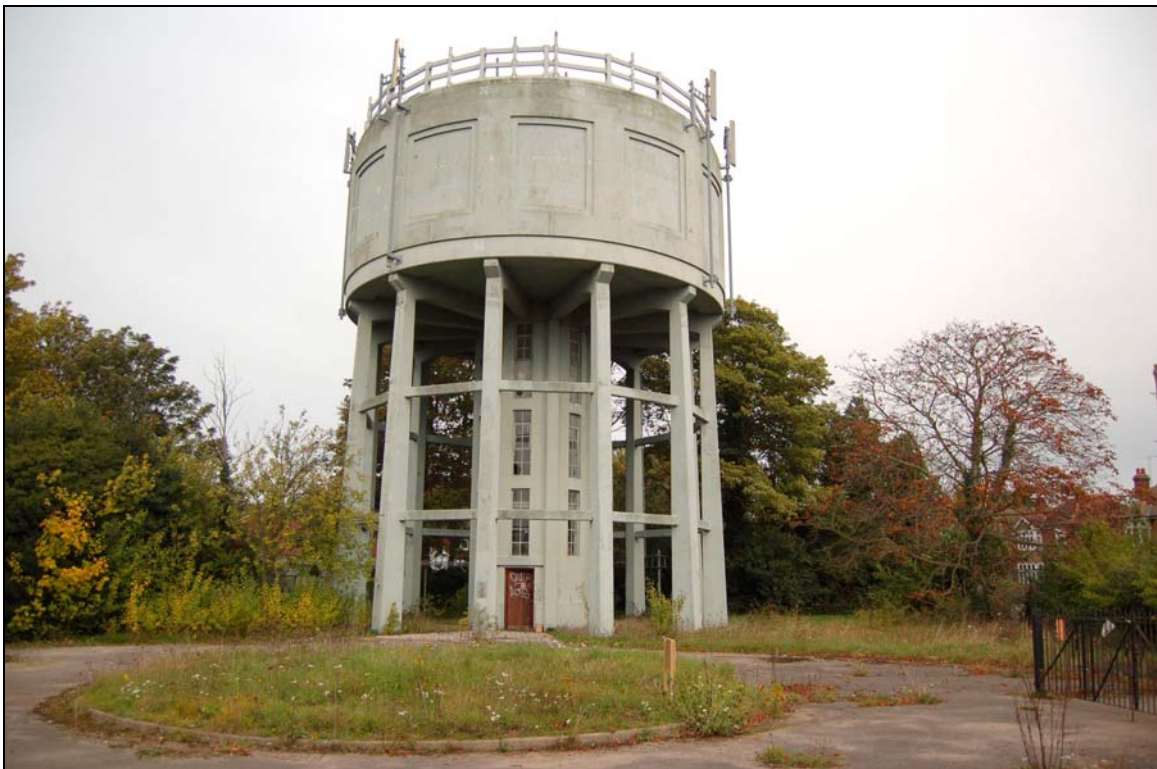
The water tower is 19.4m high and stands on a twelve-sided concrete foundation with the large circular tank on top supported on tall concrete columns around a central core (plate 2). The core contains an engineer's room at the base and pipework up to the tank and also a small turret that provides access to the tank and roof.

Twelve tapering square columns support a large concrete drum containing the tank, whose base sits on concrete ribs radiating outwards from the central core (fig. 4). Horizontal ribs between the tall columns prevent the legs spreading from the weight above (plate 2).

The columns form a circle around the central core, which provides the only access into the building. Entry is by a doorway on the south side set below a concrete lintel (plate 2) within

Plate 2 Water tower viewed to north

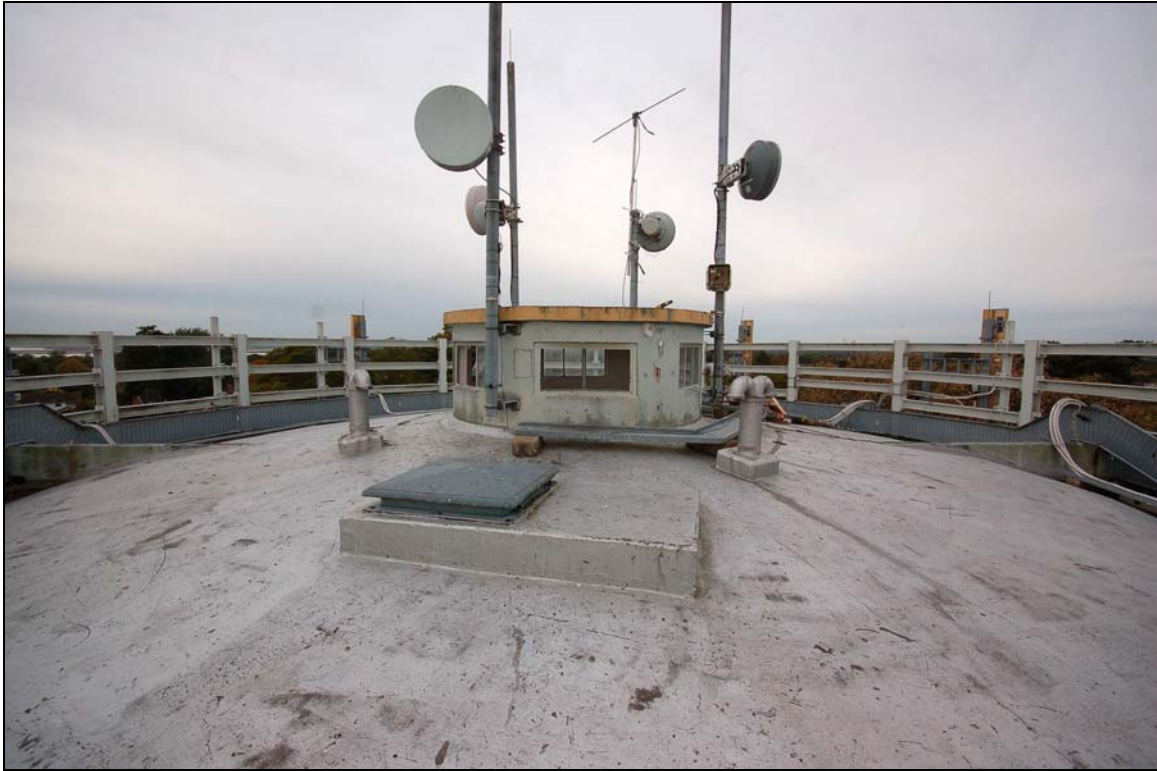
The tank has recessed square panels around its outer wall and steel rails around the edge of the roof to hold the mobile phone masts. The roof itself is convex for rain run-off and featureless apart from a circular turret that protrudes from the centre, three regularly-spaced curved breather pipes and two inspection covers into the tank below (plate 3).

Plate 3 Roof of water tower

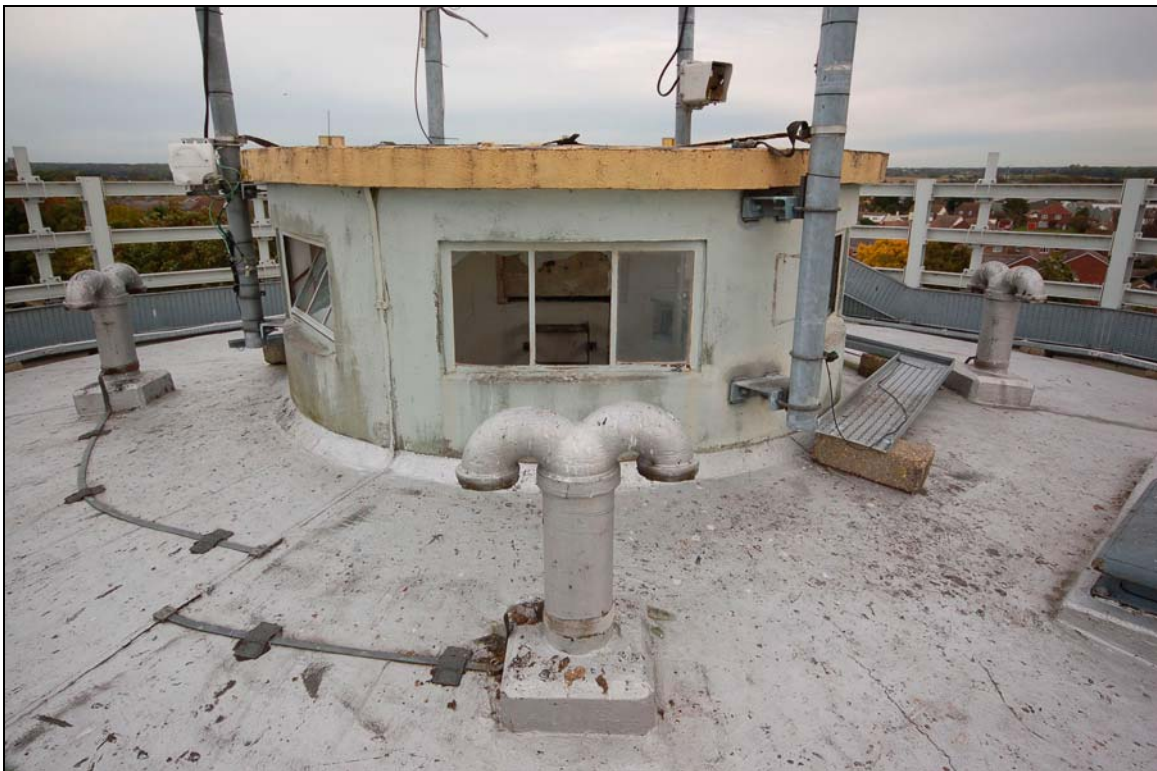
The turret (plate 4) is fenestrated with three-pane steel windows, on all but the eastern side where a small hatch provides access onto the roof. Although locked during the survey, access onto the roof was possible through one of the windows.

Plate 4 Roof turret

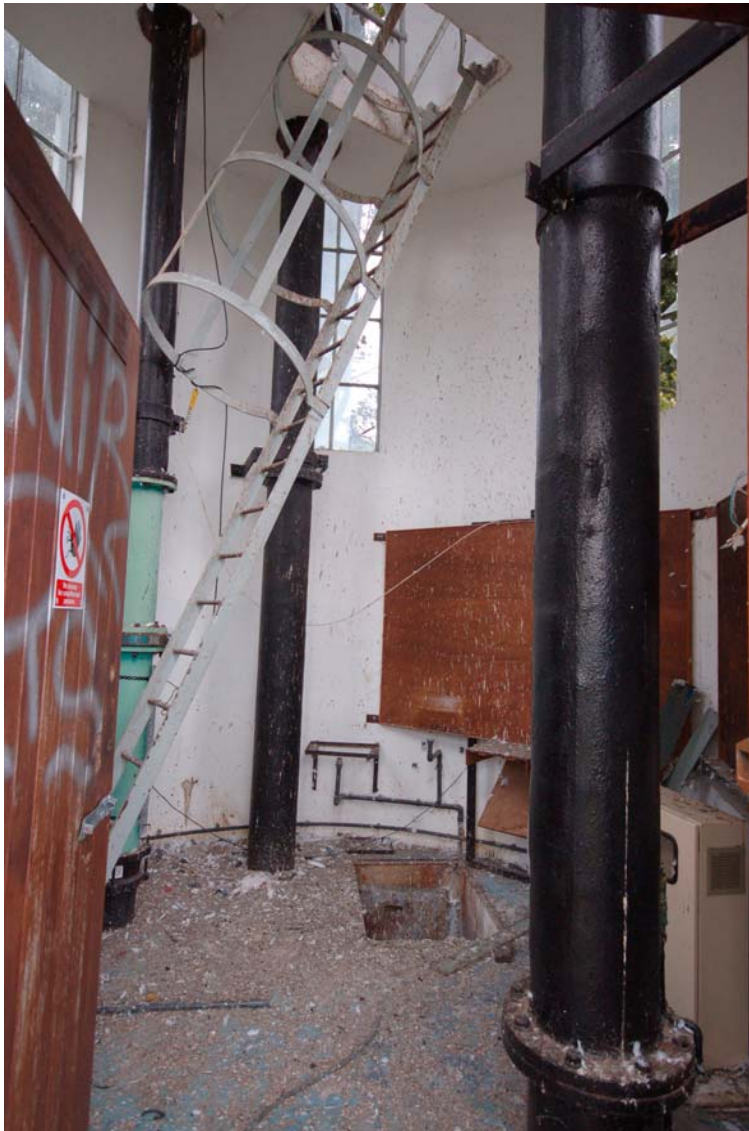
The ground floor **engineer's room** (fig. 4, plate 5) has an inner area of only 3.7m (4 feet) diameter and a height of 4.2m (fig. 3). The main features are three cast iron pipes that controlled delivery (from the pump house), washout and overflow and inlet/outlet (to the treatment works) (ERO D/UBr Pb6/11). The washout and overflow pipe leads away through a steel-covered void under the floor (fig. 3). There are some empty information boards attached to the walls and modern electrical fixtures and fittings.

Plate 5 Engineer's room viewed to north

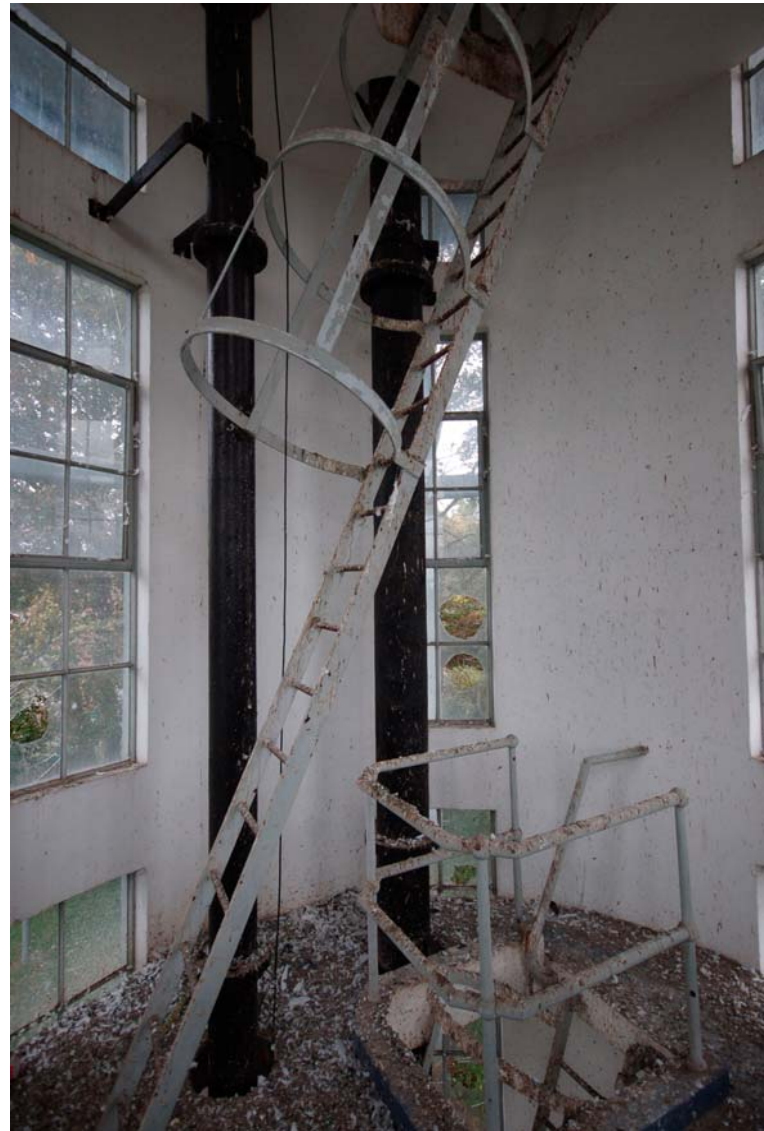
A steel ladder leads up through the concrete ceiling onto the floor above (**level 1**, plate 6) which acts as a staging post between the engineer's room and valve room (level 2) and has the same proportions as the former.

Plate 6 Level 1 viewed to north

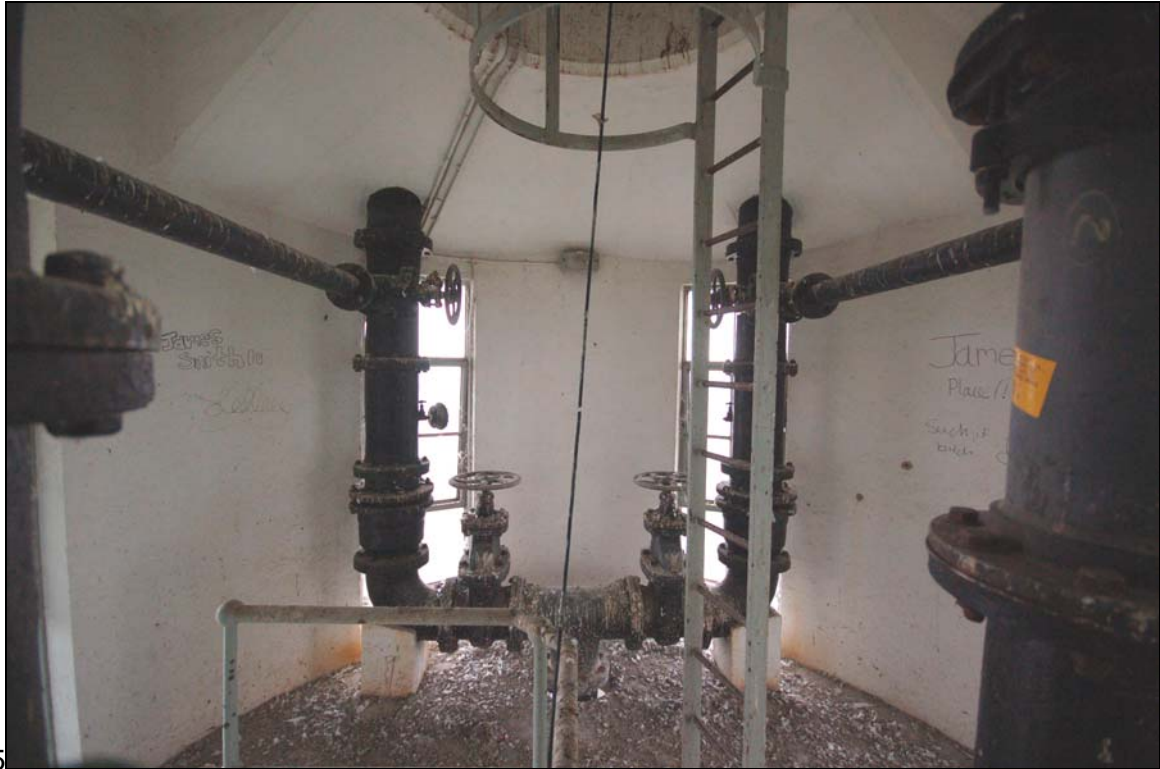
The **valve room** above (**level 2**) is situated immediately below the tank and it is from here that water flow was regulated. The valves (manufactured by 'Glenfield') regulated the inlet/outlet pipe which forks on this level (plate 7) connecting to two drains in the tank floor (figs. 3 & 5). On the other side of the room are smaller valves that control water from the washout/overflow pipe through 4-inch horizontal pipes that connect to the inflow/outflow pipe (plate 8).

Plate 7 Inlet and outlet pipes in valve room (level 2)

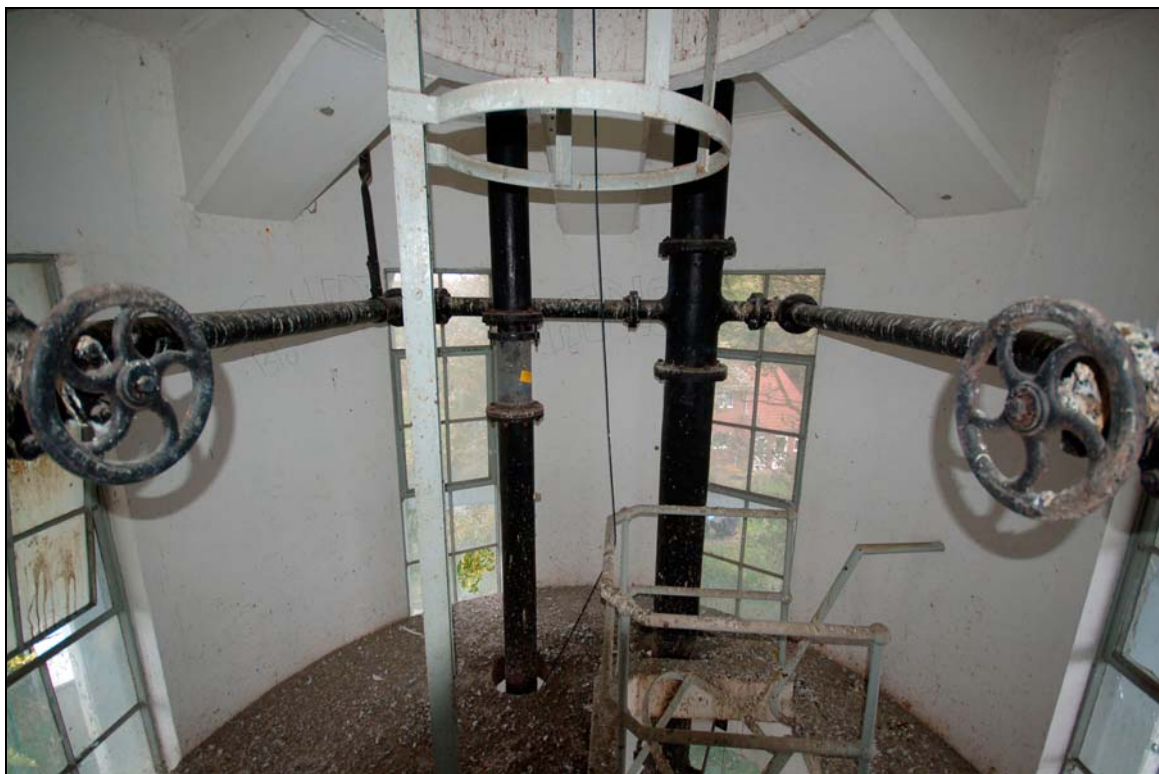
Plate 8 Delivery and washout/overflow pipes in valve room (level 2)

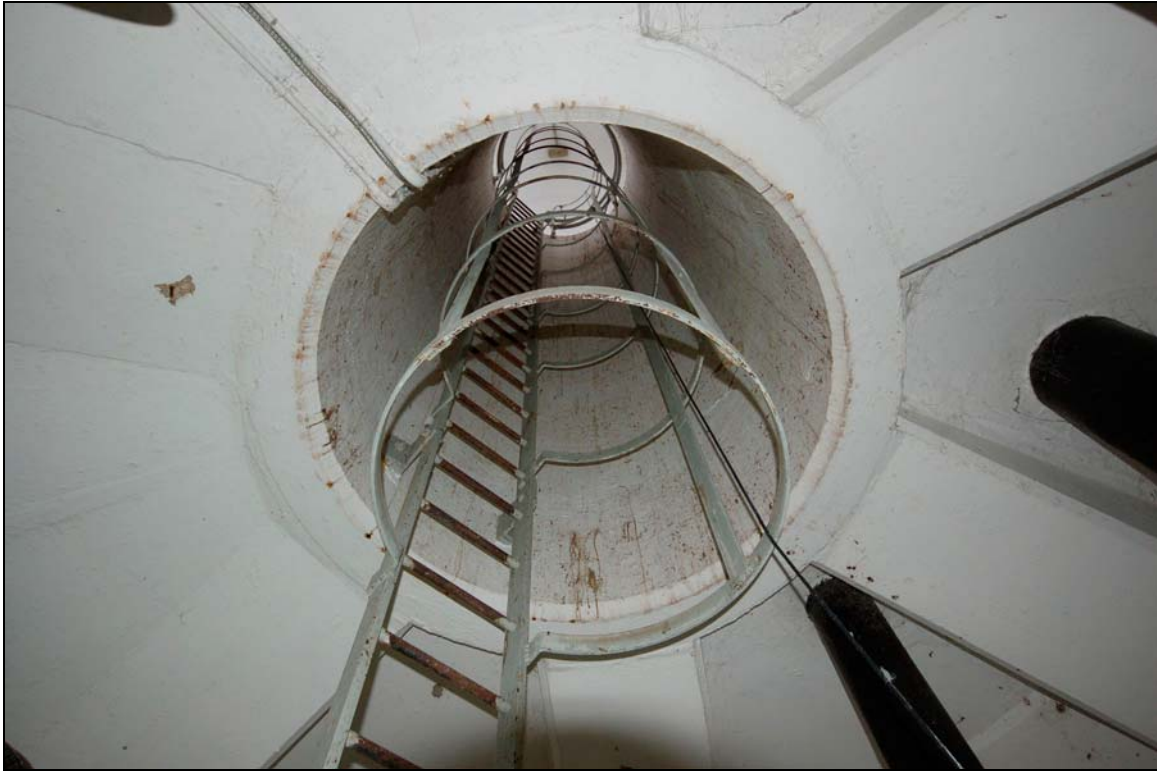
A vertical ladder offers access via a narrow shaft through the centre of the tank (plate 9) and into the roof turret.

Plate 9 Access shaft through tank from level 2

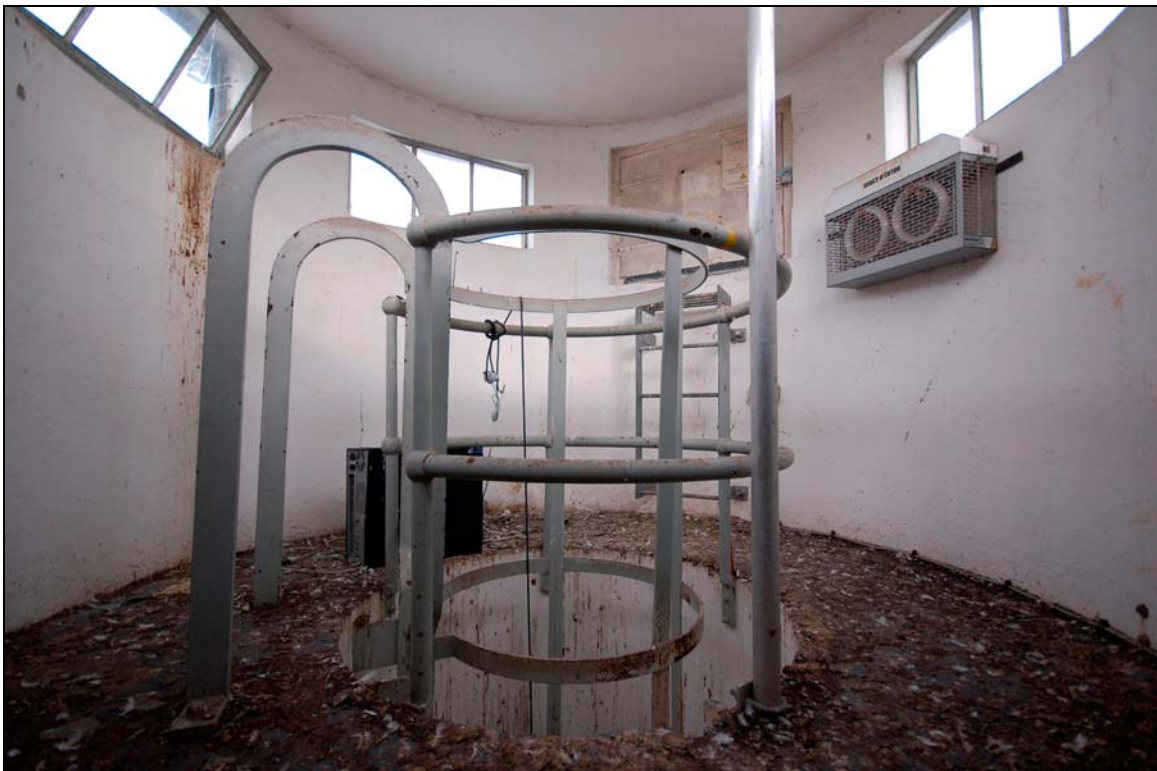
The **roof turret on level 4** (plate 10) provides access both onto the roof and into the tank. The simple clean circular lines of the ladder railings have a somewhat geometric 'modern' form that matches the style of the building (plate 11). A short ladder on the north side leads to an external hatch out onto the roof, which was locked during the survey. A modern fly-killing machine situated beside the door (plate 10) is the only other feature. At floor level on the opposite side are the doors into the tank (plate 11, right).

Plate 10 Turret room viewed to north

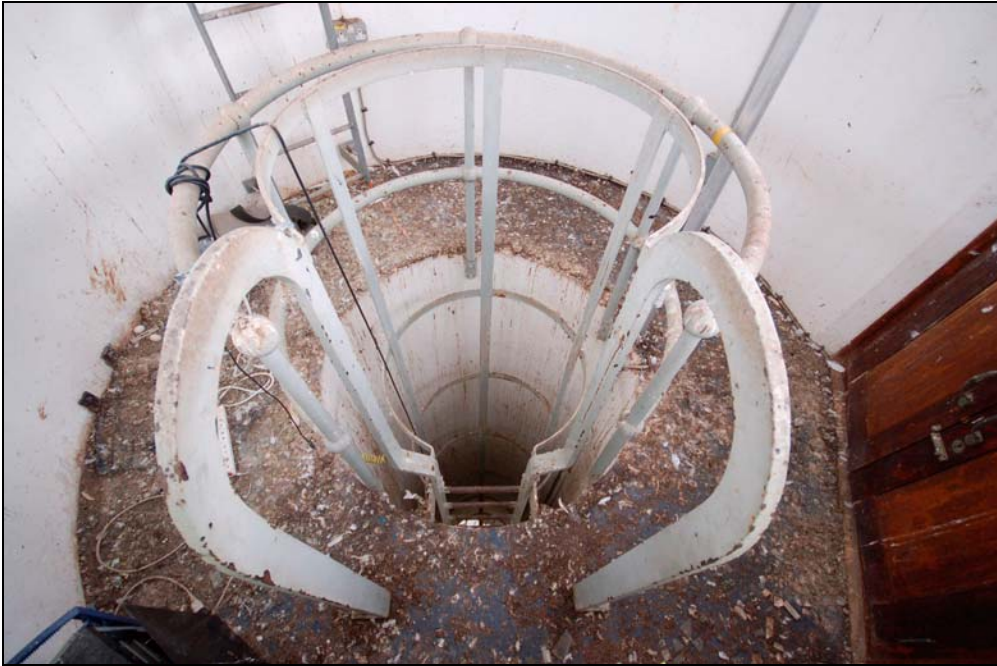
Plate 11 View down access shaft from turret room

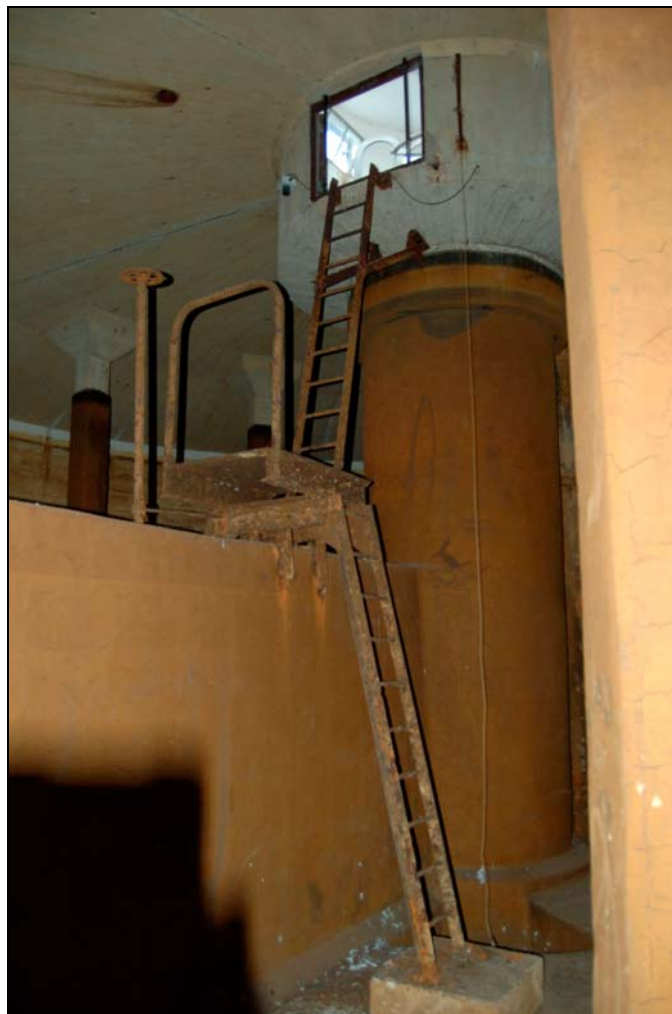
Access into the **tank (level 3)** is down a steel ladder that leads from the roof turret onto a small inspection/maintenance platform set on top of a concrete dividing wall (plate 12). Separate steel ladders lead down on either side onto the tank floor. The tank (plate 13) is large, with a c.15m diameter and 6m depth, providing a volume of c.106m³ and a capacity of 106,000 litres, approximately 23,000 gallons. It is split in two by a dividing wall that enabled one side to be drained at a time for periodic cleaning and inspection. Emptying the tanks was controlled by a valve on a long pipe operated from the platform (plate 12) which let the water pass through either of two drains each side of the wall, close to the core (fig. 5, plate 14) and down the inlet/outlet pipes below in the valve room. The roof is supported on twelve square concrete columns whose tapered heads are painted white to indicate the maximum fill level. There are no features apart from the delivery and washout/overflow pipes that finish where the ladder shaft joins the turret (fig. 3, plate 13) and ventilation panels in the ceiling.

Plate 12 View of doorway into tank and platform

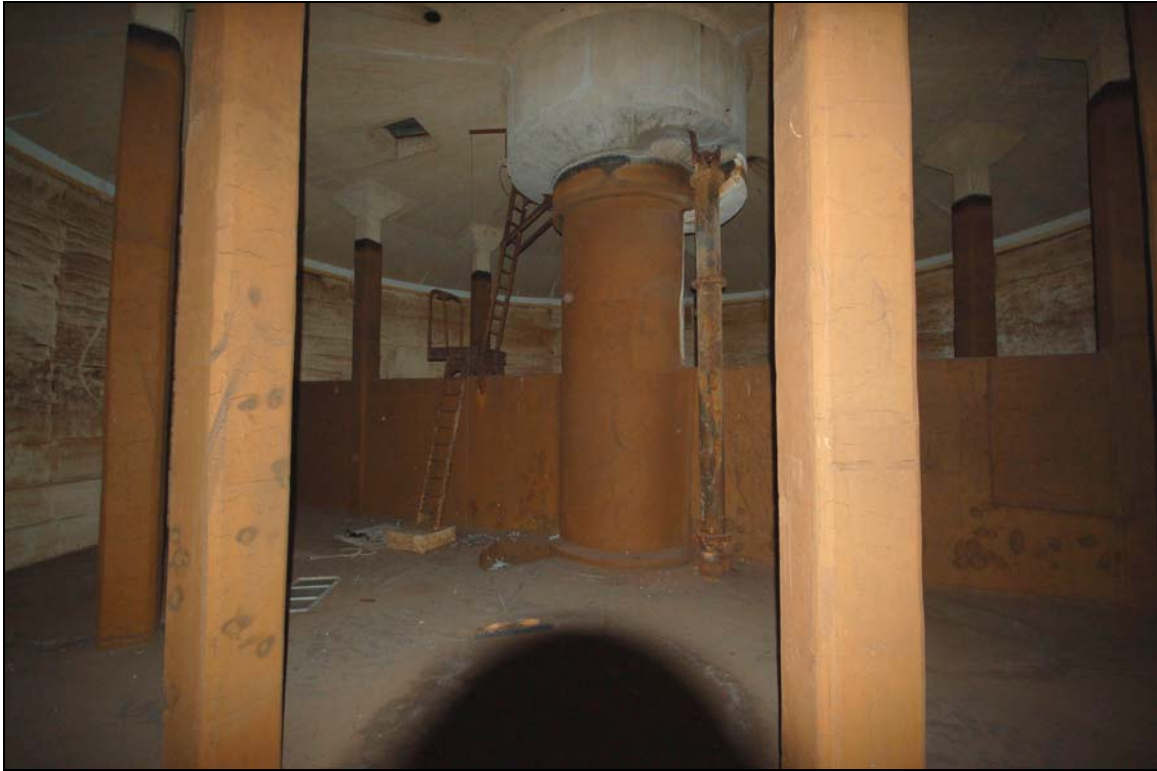
Plate 13 General interior of tank

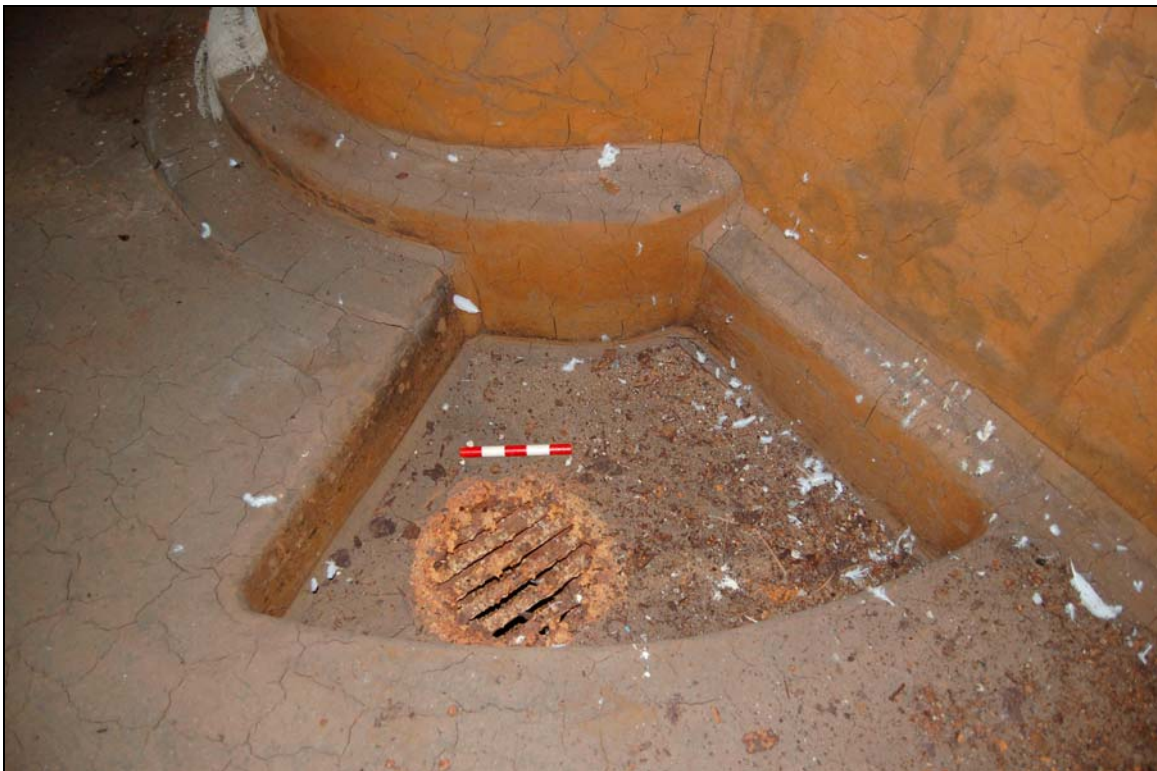
Plate 14 Drain to inlet/outlet pipe (0.25m scale)

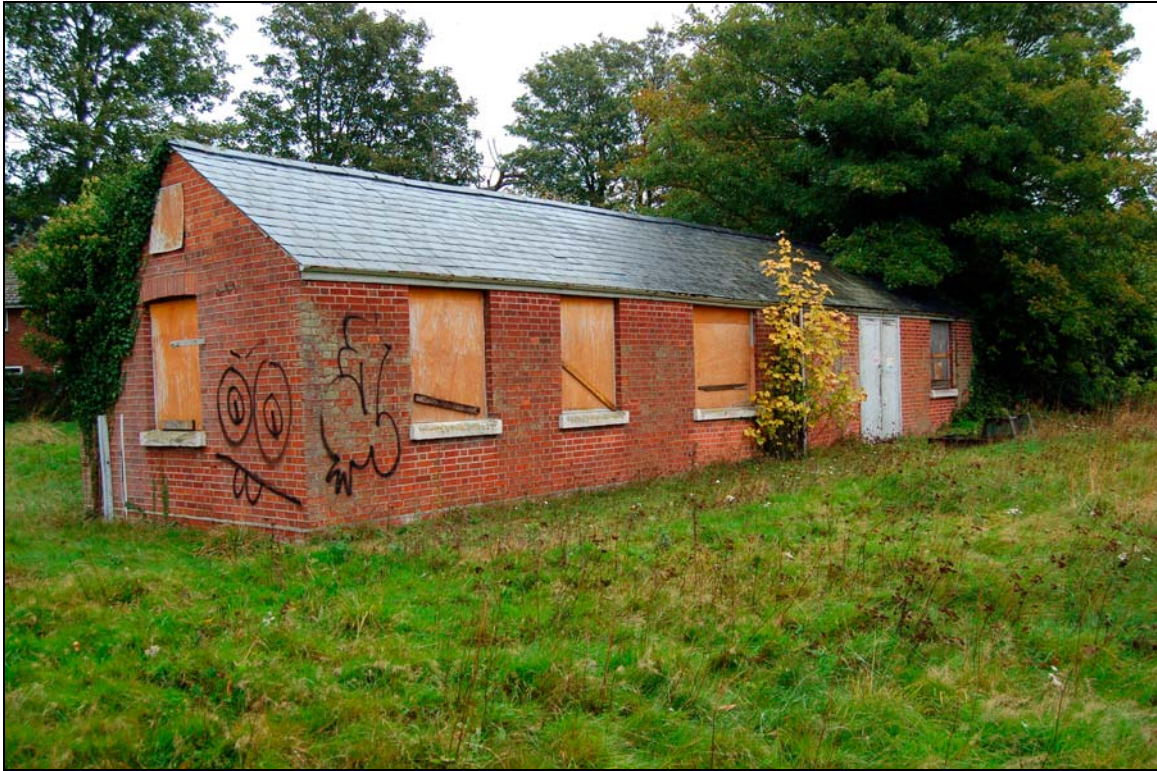
The pump house is a three-bay linear structure to the west of the water tower that contains two pump rooms and a small office. It is built of red brick arranged in Flemish bond beneath a pitched slate roof. The only entry point is on the south elevation (plate 15) where a pair of double doors lead into the first of two pump rooms that contain the wells. The windows are boarded but were seen from the inside as moulded nine-pane vented types (plate 16). They are arranged at regular intervals on both sides and the western end (office). In addition, the gables have tilting windows also.

Plate 15 Pump house viewed to north-east

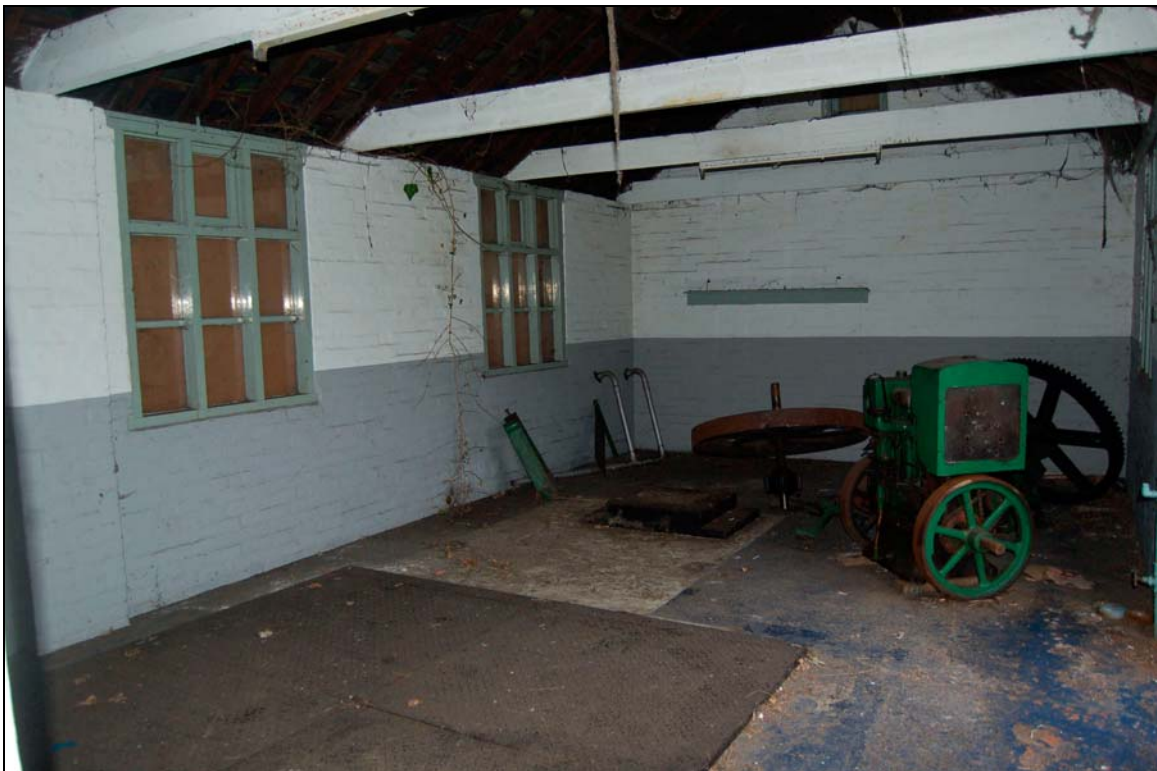
Inside are the two pump rooms and an office. Décor in the pump rooms is basic and functional, with a concrete floor and grey/white-painted brickwork. Steel covers have been placed over the wells for safety purposes. The eastern room (plate 16) contains a 'Lister' pump that was used in the later period after the much larger pumps were removed (R. Smith pers. comm.). The simple nailed collar roof frame is made from machine-sawn planks and is typical of the period.

Plate 16 Interior of eastern well room, viewed to north-east

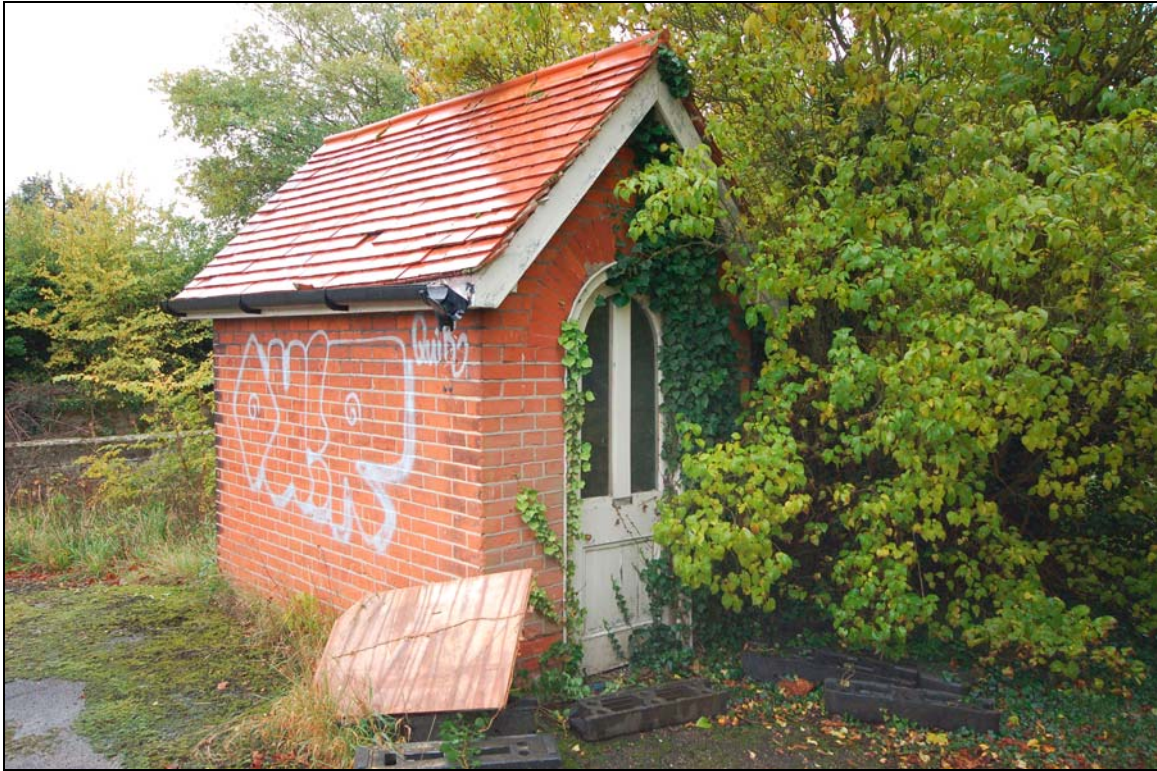
A small outside toilet is situated a short distance to the west side of the water tower. It is an attractive building with neat, well-pointed red brick laid in stretcher bond, and a plain red tile roof. The sole entrance, on the eastern side, has an arched gauged-brickwork doorway and a semi-glazed door (plate 17). The interior (plate 18) remains largely unaltered, with wash area at the front and toilet to the rear.

Plate 17 Washroom/toilet viewed to south-west

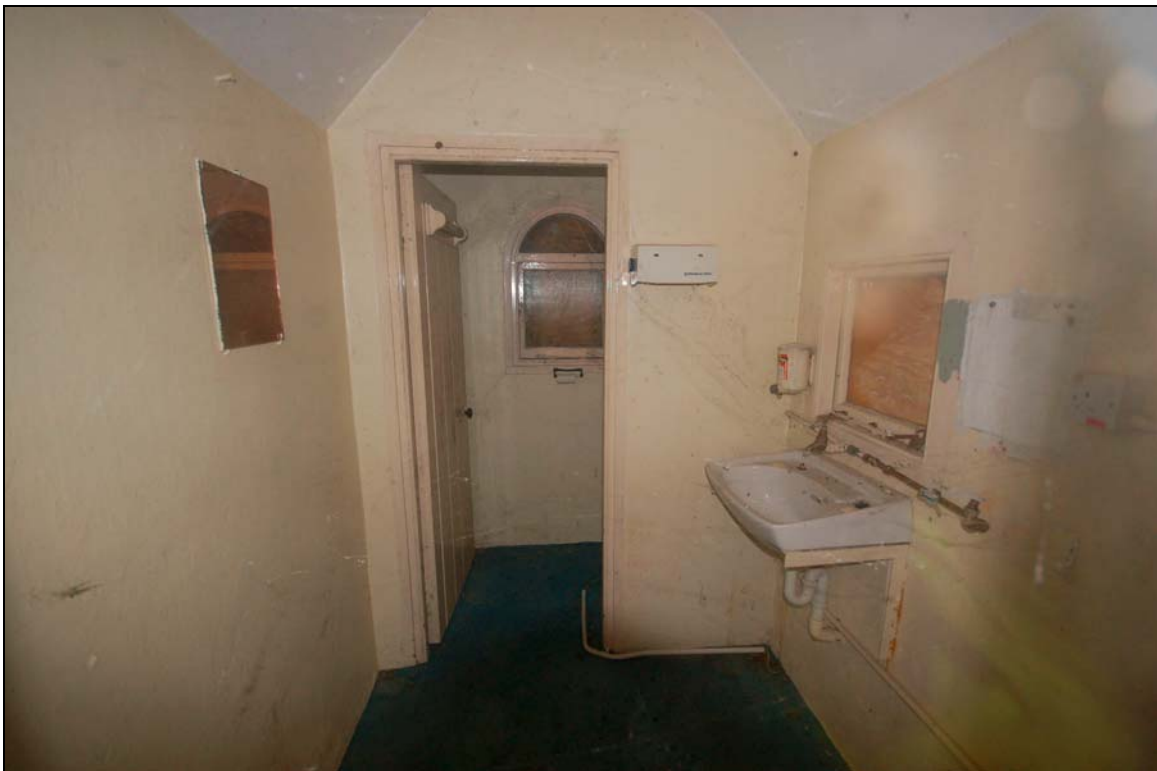
Plate 18 Interior of washroom/toilet
