**BAYLEYS  
BROOK STREET  
LITTLE DUNMOW  
ESSEX:  
ARCHAEOLOGICAL MONITORING**

**Essex County Council  
FIELD ARCHAEOLOGY UNIT  
December 2010**

Client: Mr. C. Horne  
FAU Project No.: 2347  
OASIS Ref: 88990  
Planning Application No.: UTT/0562/10  
Site Code: LDBY10  
Dates of Fieldwork: 10th December 2010

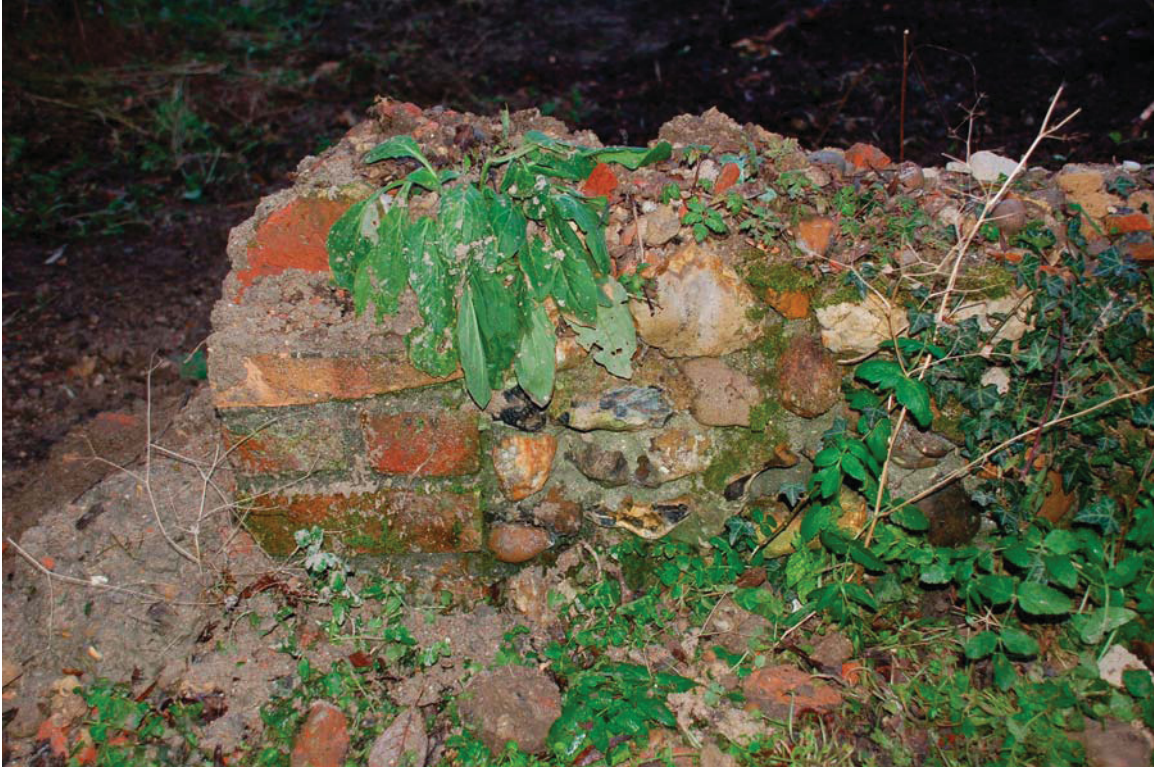
Plate 5. South-western wall of 'Tile End' building. Looking north-east.

The south-western wall of the demolished 19th century building still stands to a height of 0.5m (four courses) to the south-west of the excavated area (Plate 5). It comprises a core of flint nodules in lime mortar with red bricks laid at the corners and is probably indicative of the nature of the wall represented by foundation 8
