**TYPE T2 AIRCRAFT HANGER AT WOODHOUSE FARM  
AND OTHER WWII STRUCTURES  
RIVENHALL AIRFIELD  
ESSEX**

**HISTORIC BUILDING RECORD**

**December 2010**

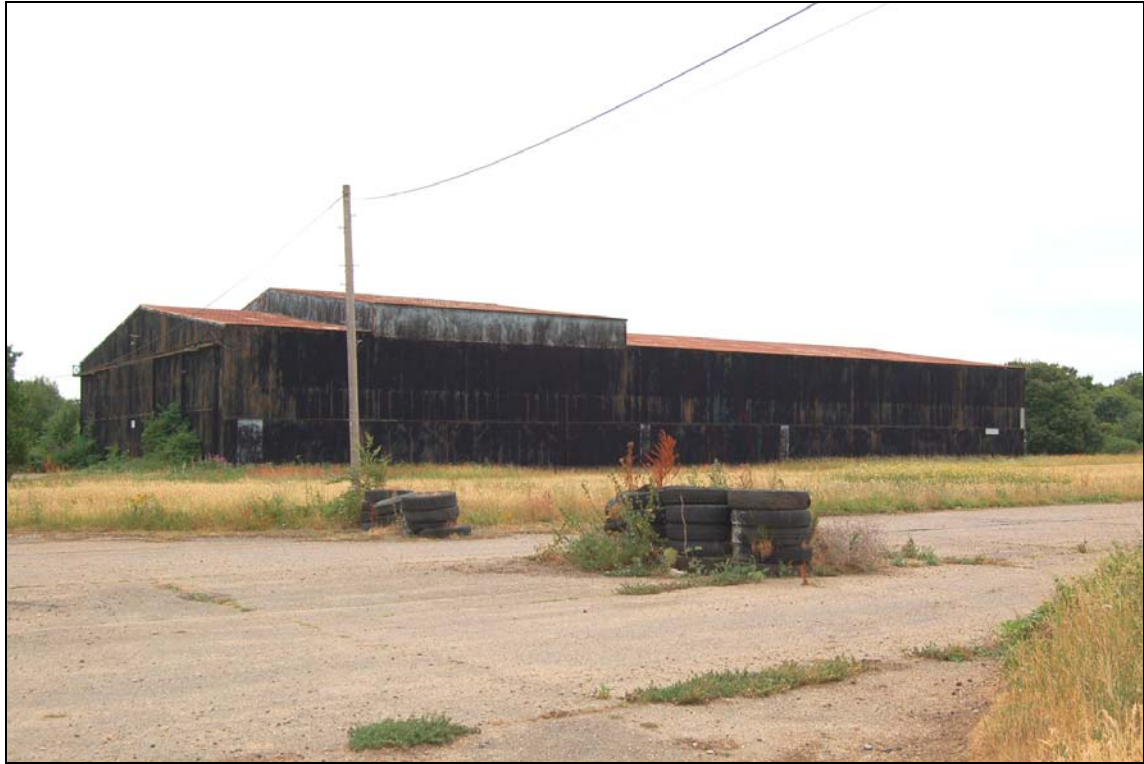
The long north-west elevation (plate 1) is largely featureless apart from a small doorway positioned at the north corner (fig. 3). Some panels have been replaced on the opposite south-east side and post-war tin sheds added (plate 3). There is a small doorway close to the south corner.

Plate 1 Hanger 1 viewed to south

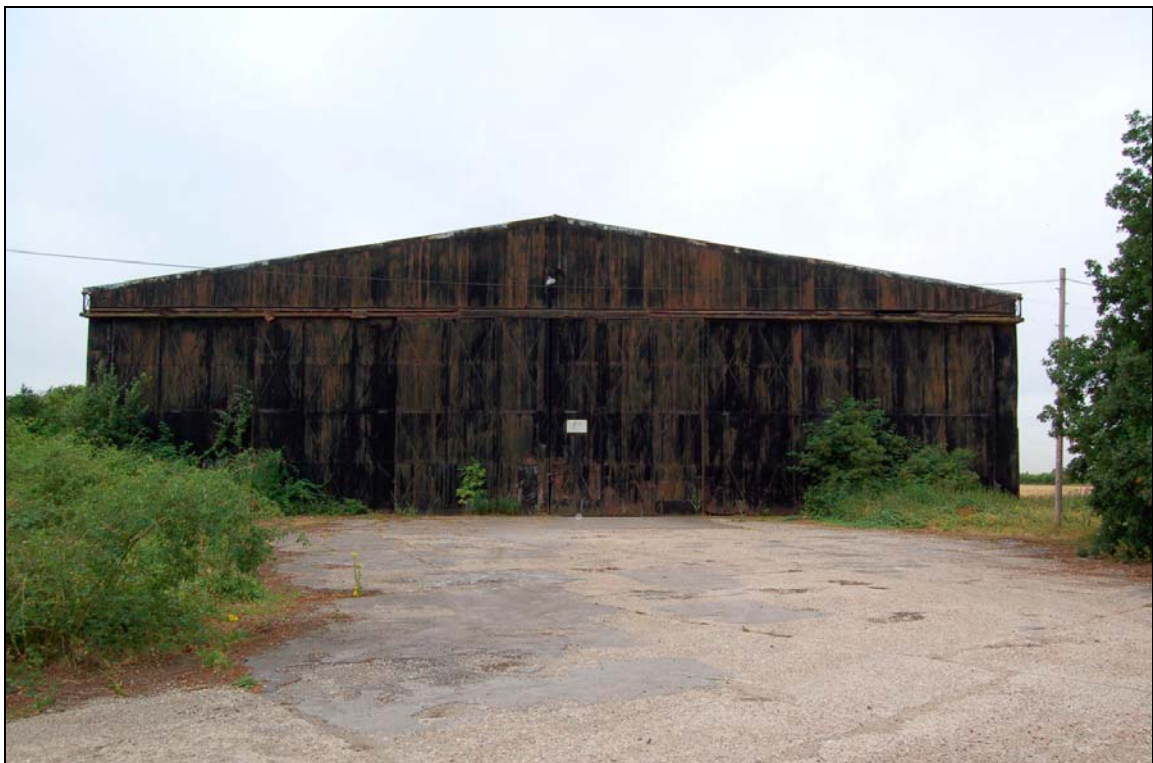
The gable ends to north-east and south-west contain the wide hanger doors and broad low pitched (8°) roof (fig. 4, plates 1 & 2). The guide racks either end of the doors have disappeared, so the doors cannot now be moved as far as they should (fig. 4). There are six wheel-mounted doors (plate 4) that ran on three iron roller tracks set into concrete bases either side (fig. 3). Each 6m-wide door component comprises nine corrugated tin sections braced with 4" angle iron (shown best in plate 3). A smaller doorway was fitted in the middle section for day-to-day personnel access (fig. 3).

Plate 2 North-east hanger doors

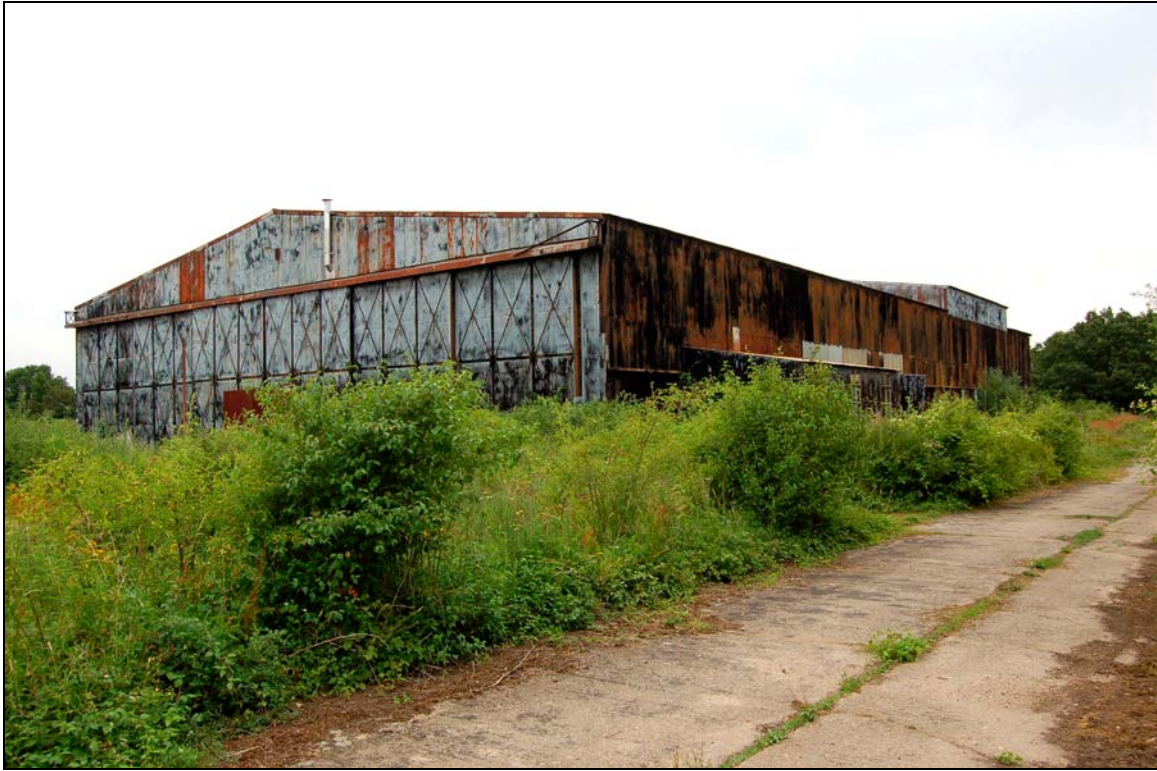
Plate 3 Hanger 1 viewed to north

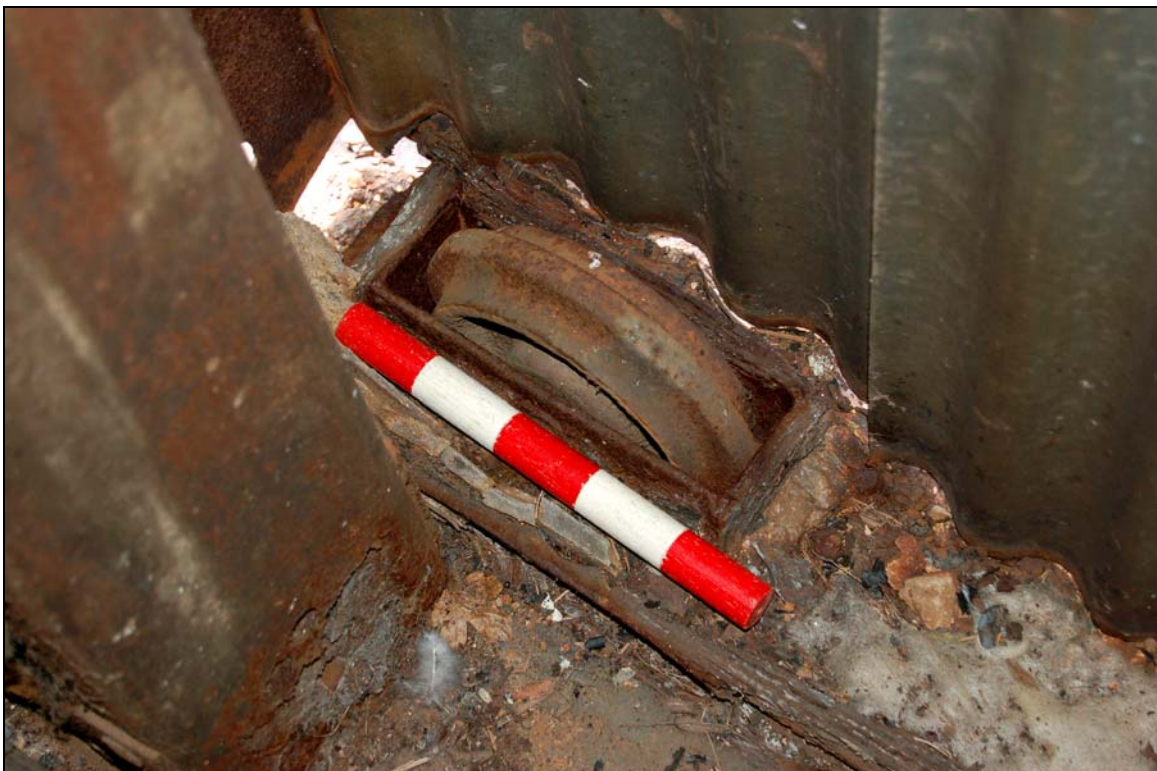
Plate 4 Roller-track door mechanism

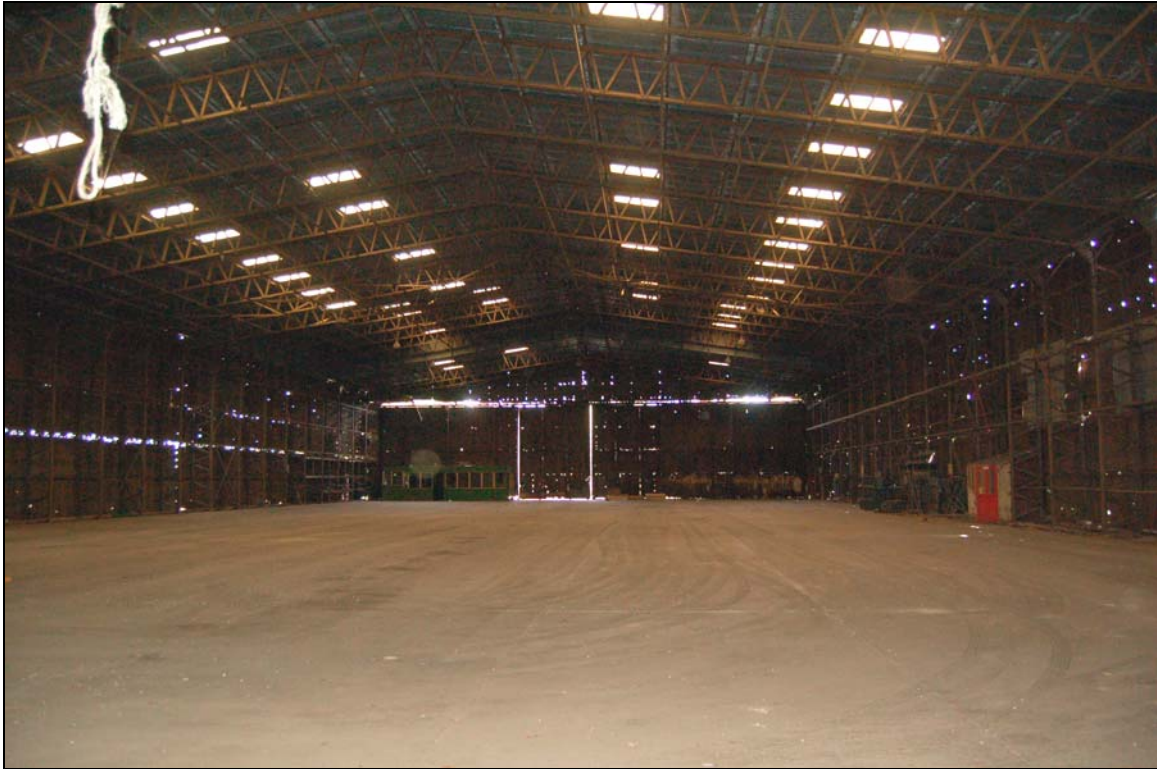
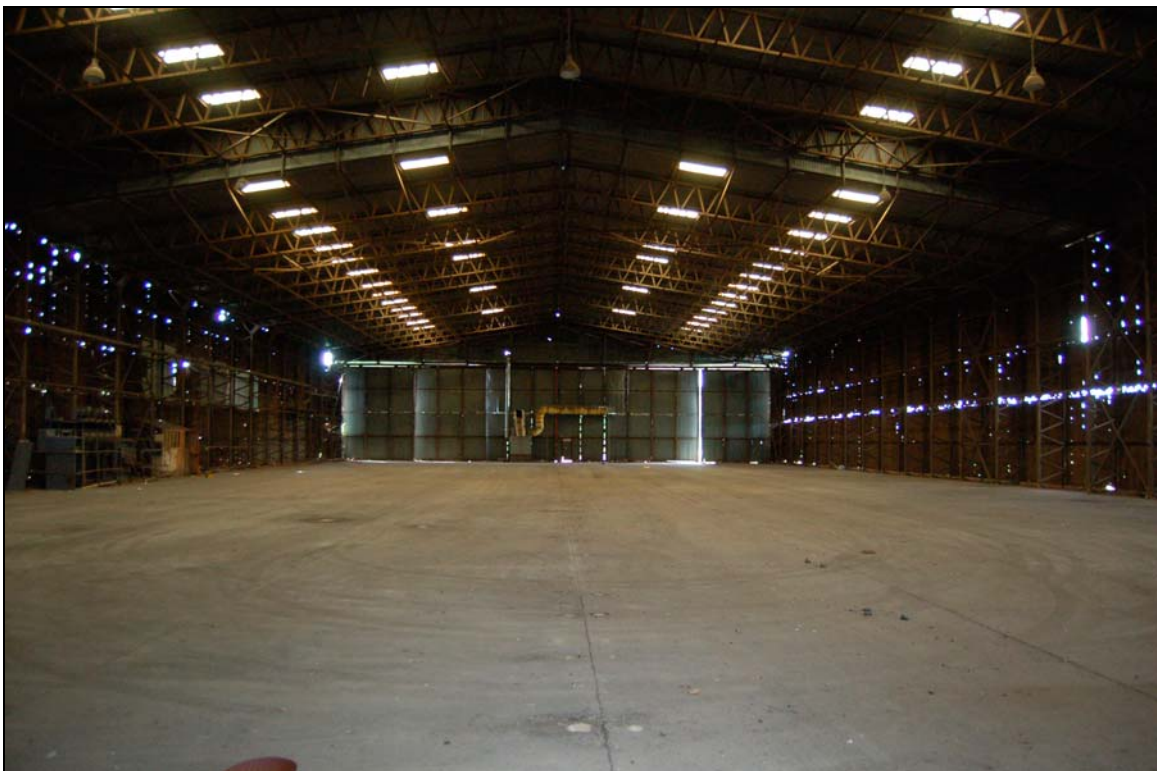
Views from either end (plates 5 & 6) show the construction of the hanger quite clearly. 3.6m Sections of steel lattice framing are bolted together to form the wall and roof frames connected by standard eaves and ridge units (MOD 1995), onto which the walls and roofs are attached long angle iron sheeting rails, rafters, purlins and vertical wind bracing. The large internal space is lit by two rows of roof lights either side of the ridge and utilitarian steel lamps suspended from the steel frame. Each column sits on a small concrete pad beneath the concrete floor (fig. 4).

Plate 5 Interior of hanger 1 viewed to north-east

Plate 6 Interior of hanger 1 viewed to south-west

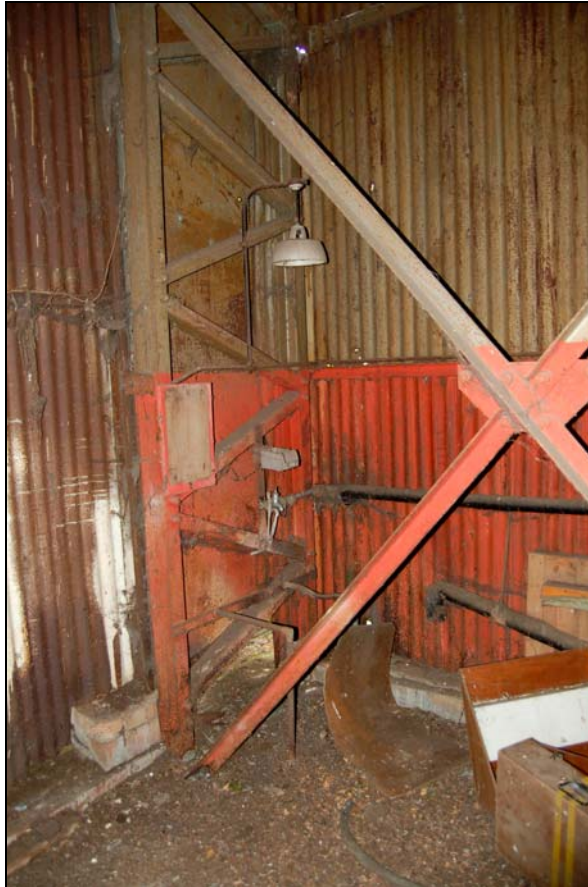
Located in the north corner are a green Marconi store and office and three-tiered wooden racks (labelled G-K) built between the wall frames that would have extended to the centre of the building (plate 5, fig. 3). In the eastern corner is a washing area (fig. 3) consisting of a tap, mounted soap dish and the steel frame to a former sink overlooked by a 1940s-style lamp (plate 7).

Plate 7 Washing area

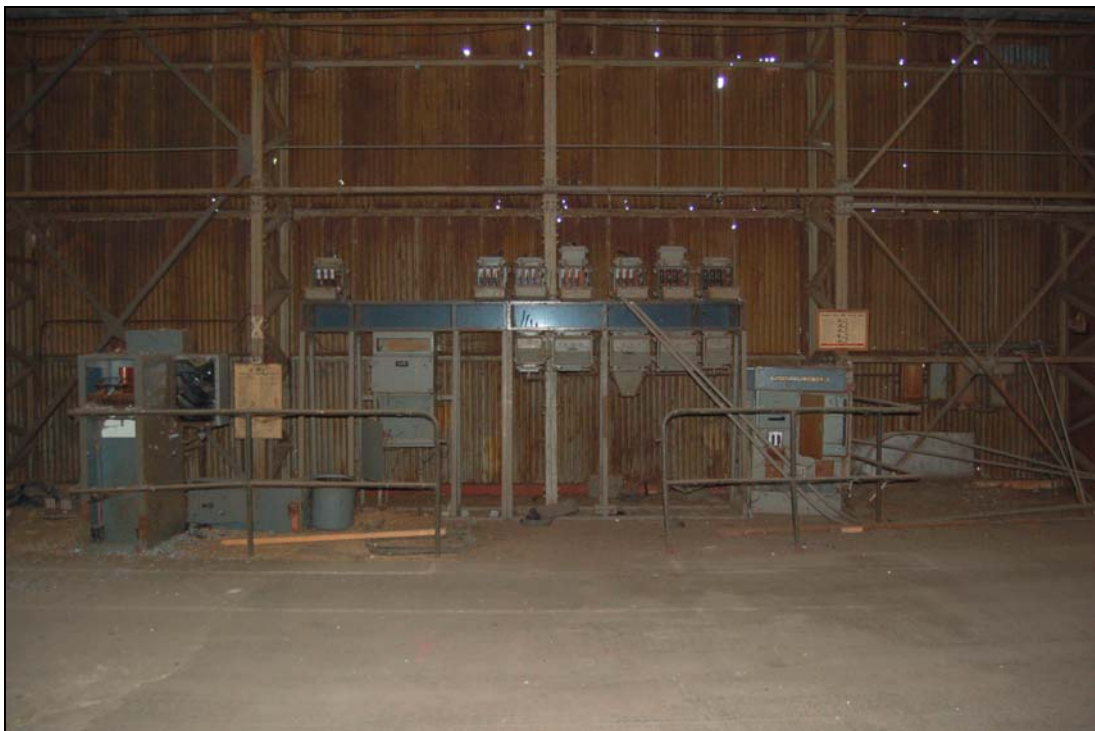
Electricity was supplied to the hanger from a sub-station located in bays 9-11 along the north-west wall (fig. 3, plate 8). Most of the various switch and fuse boxes are modern (and are likely to have been installed by Marconi) but those with the 'English Electric' sunburst design (plate 9) could potentially date from the war era, as they are also found in WWII buildings on the Sheepcotes Farm site. Health and safety notices around the sub-station deal with factory regulations (1944 Act) and reviving persons from electric shock (plate 10) and are likely to be from the Marconi era.

Plate 8 Electricity sub-station/switch box

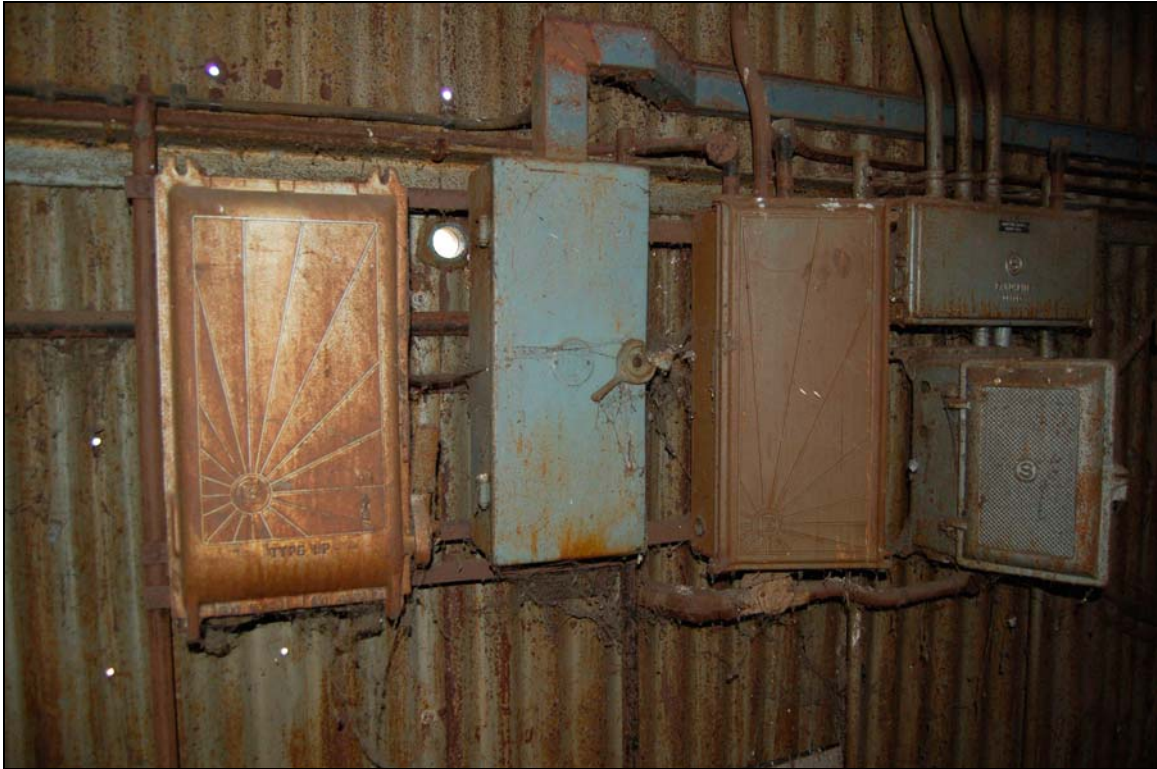
Plate 9 1940s Fuse boxes

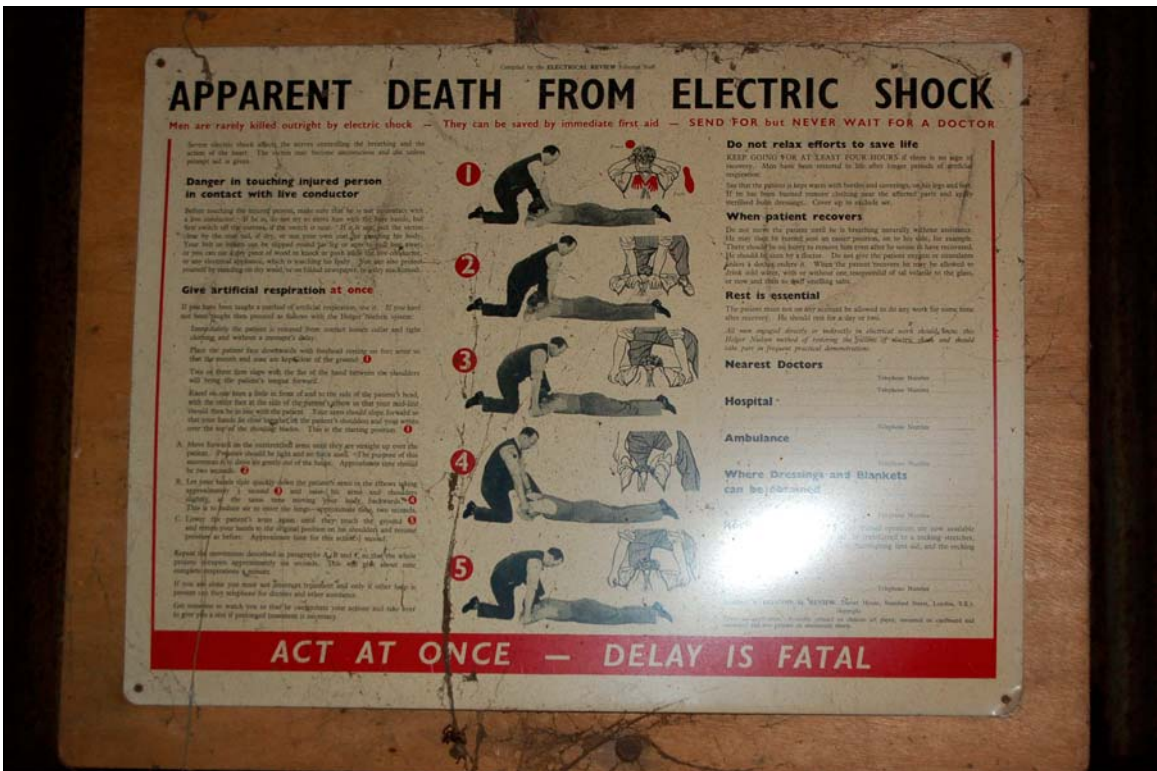
Plate 10 Health and Safety notice

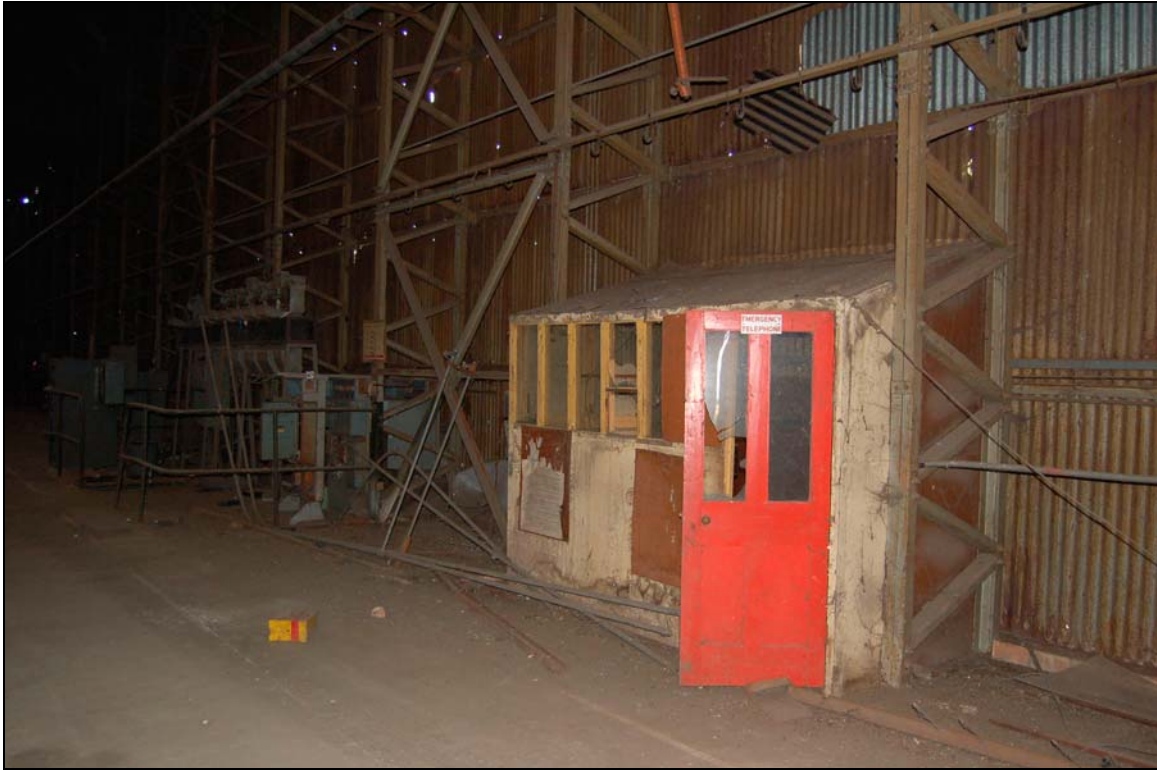
Beside the sub-station is the Emergency Telephone booth (plate 11), a simple boarded structure with a semi-glazed door that is also perhaps war-era. The telephone and any other fixtures and fittings have been removed. There are some health and safety notices attached to the exterior- one of which describes penalties for spying, unauthorised use of uniforms, etc), which could apply to both wartime or post-war Marconi usage. With so much available space such features can survive quite easily. Along the wall to the north-east is a c.3m-high viewing platform bounded by safety rails (plate 12). The pipework in plate 12 is modern and associated with grain storage.

Plate 11 Emergency telephone booth

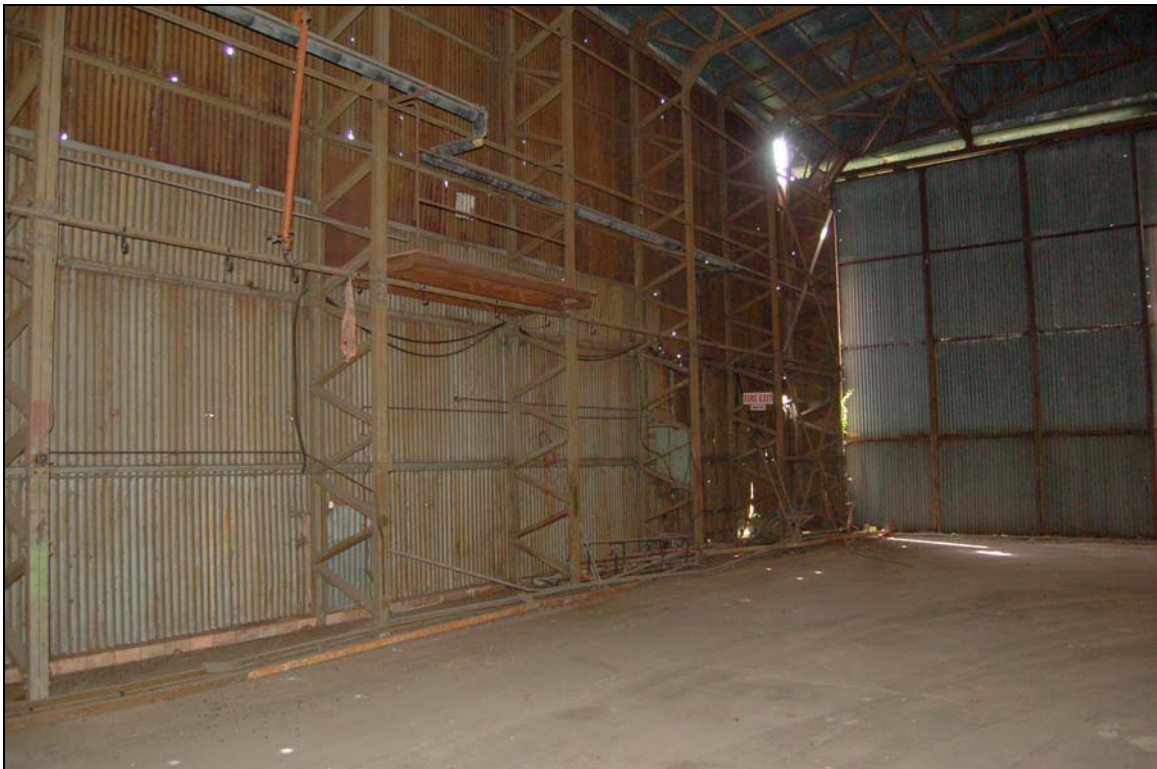
Plate 12 Platform on south-east wall of hanger

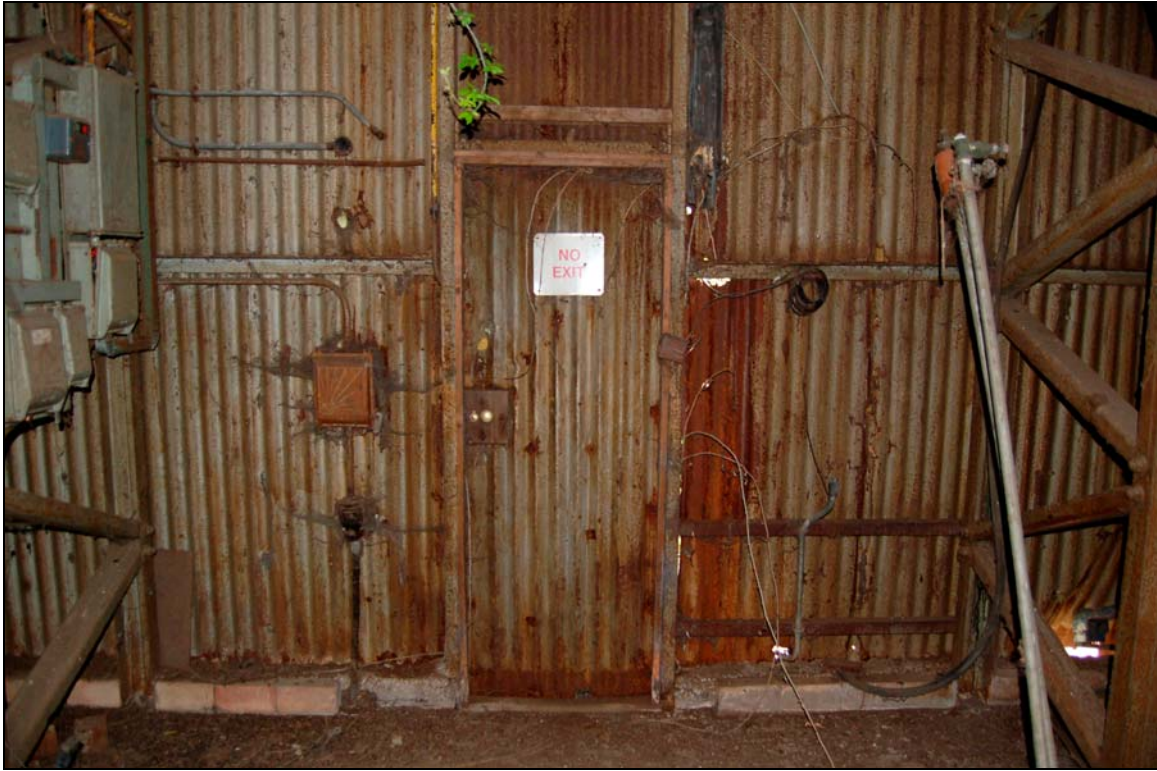
More permanent fixtures and fittings include the personnel doors on each of the four sides, two of which form part of the hanger door sections. In keeping with the overall utilitarian/temporary nature of the structure, the doors are made of corrugated steel sheets fitted with brass door knobs and locks (plate 13).

Plate 13 Personnel door on south-east wall

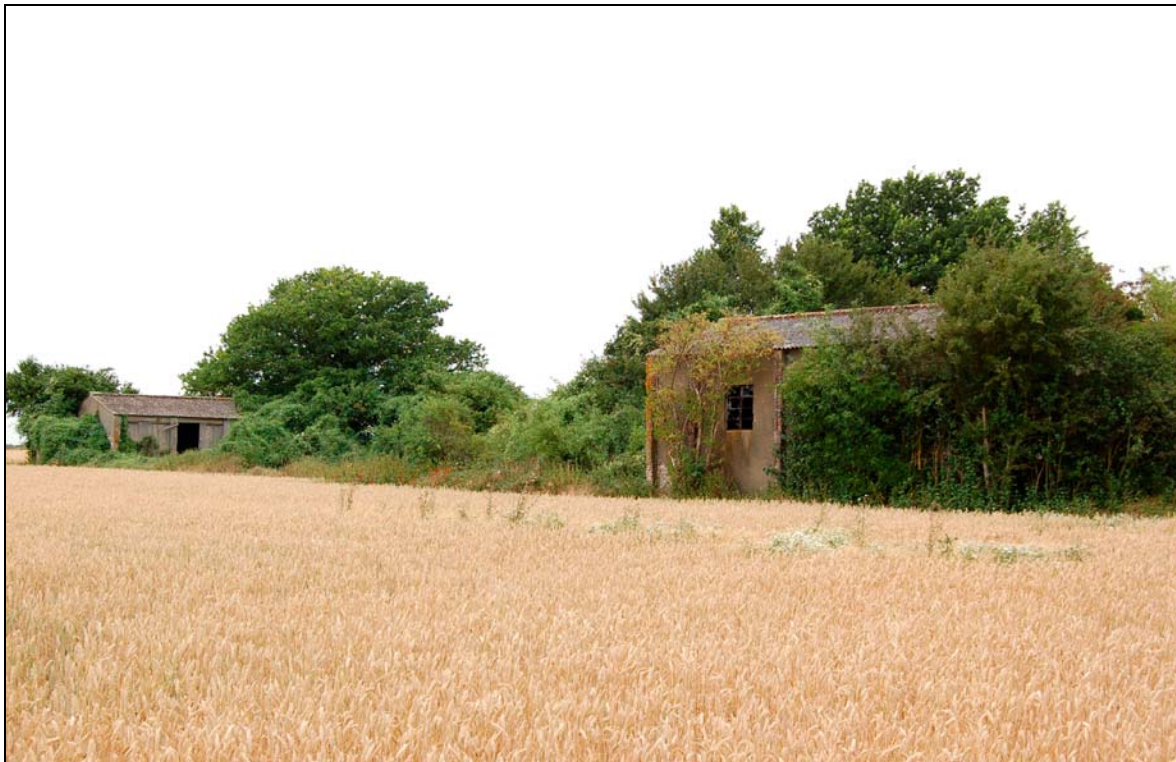
These are typical 'temporary brick style' buildings (drawing number 12411/41) standing to the north-west of the hanger (fig. 2a). They have thin walls made from a single skin of Fletton bricks joined by buttresses and rendered-over in cement for greater strength. Each have angled iron roof frames, concrete floors, Crittalls iron-framed vented windows and pitched asbestos roofs (plate 14).

The Floodlight Trailer and Tractor Shed (plate 14, right) has dense undergrowth covering its tractor/trailer doorways at either end, the south-western one of which was blocked in the post-war period. The interior (plate 17) is three bays long and contains no features of interest.

Plate 14 Buildings 2 and 3 viewed to north-west

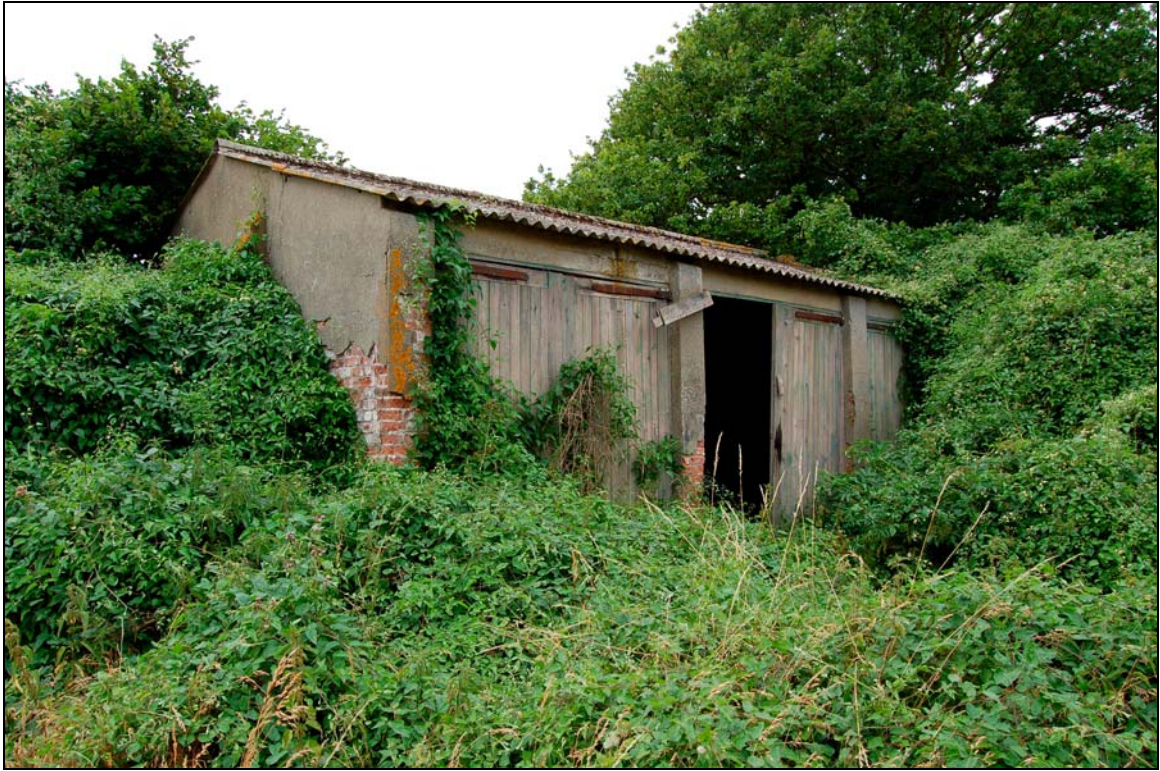
The NFE (Night Flying Equipment) store was used for storing floodlights, beacons and flares, etc (Buchan Innes 1995). Three large doorways face the north-east for quick access onto the concrete roadway (plate 14 left & 15). The interior is three bays wide with a single (boarded) doorway on the north-west side and black-out boards over the windows (plate 16).

Plate 15 NFE Store 2 viewed to west

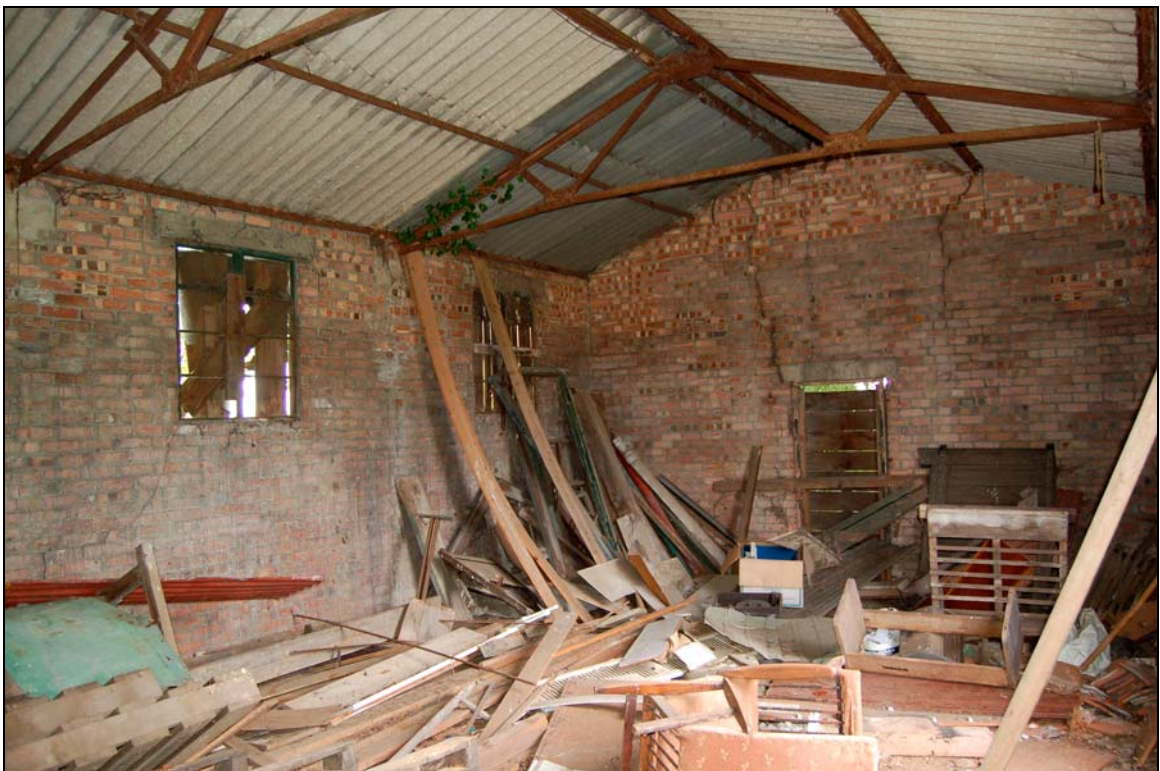
Plate 16 Interior of NFE Store viewed to west

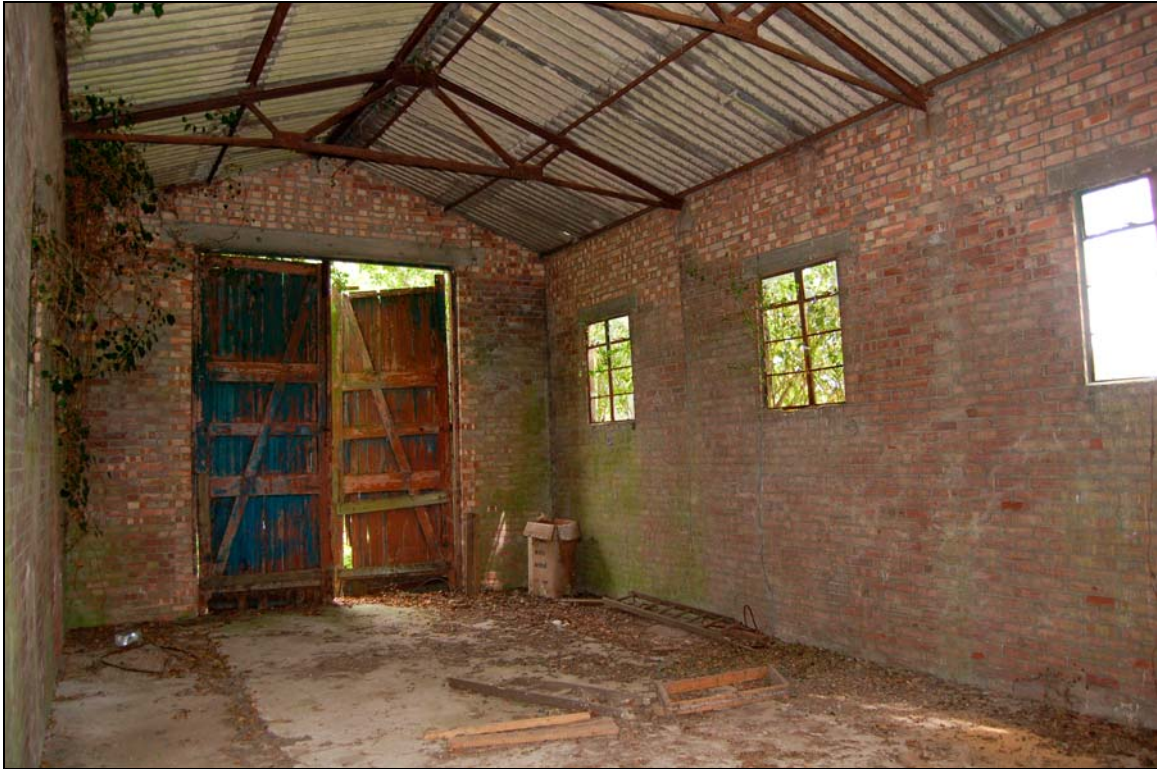
Plate 17 Interior of Floodlight Trailer and Tractor Shed 3

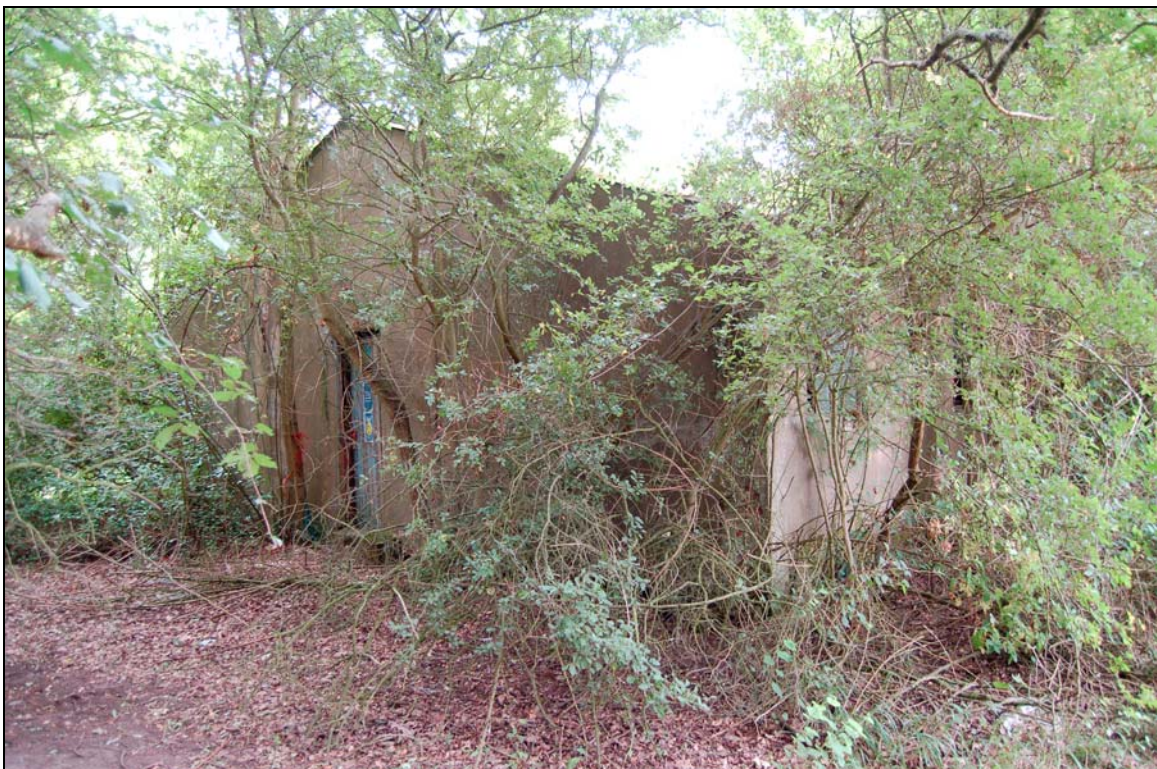
The entrance is at the south-east end (plate 18) that leads through a long corridor with the offices either side, the doors of which are stencilled to indicate the officer's rank or other function (flight stores, etc). In rare cases names are added too (plate 19). Almost each room is decorated with umber and white walls, green-painted Crittalls casement windows and fitted with a concrete base for a heating stove (plate 20). The general structural condition of this building is poor due to root damage and settlement of the buildings foundations over time.

Plate 18 Entrance to Squadron Offices and Flight Offices 4 viewed to west

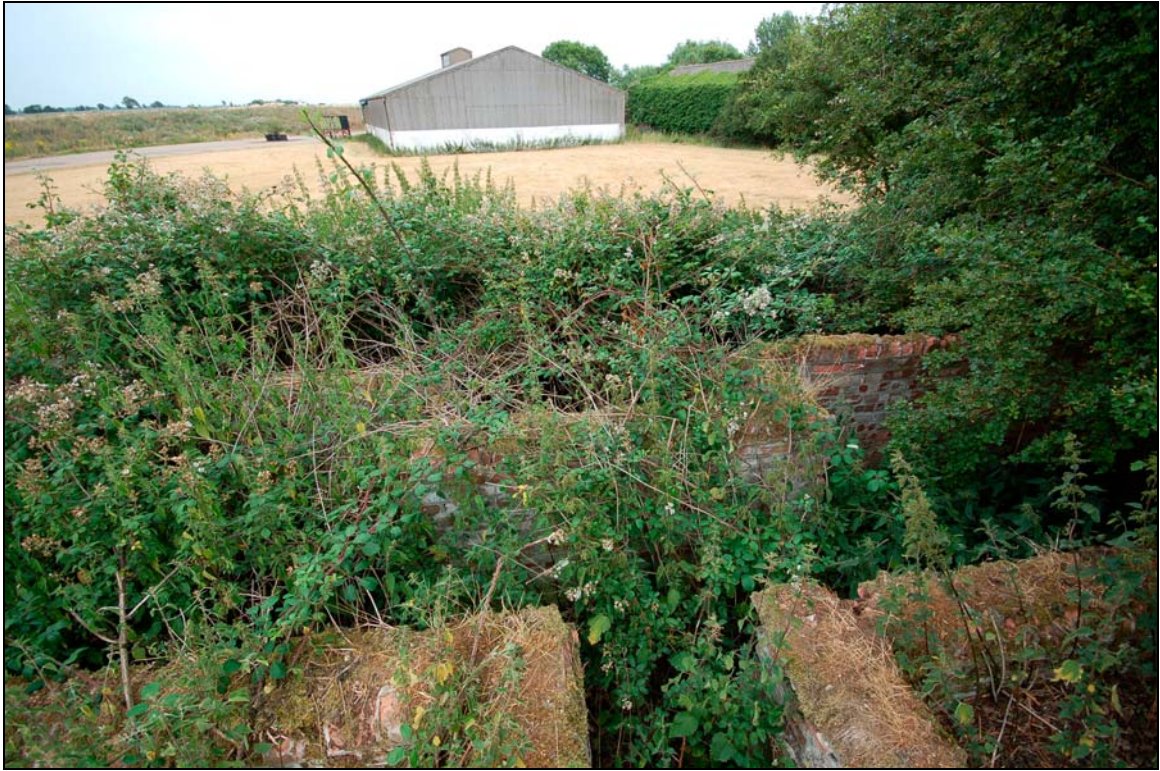
Plate 21 Blast shelter 5 viewed to north

The blast shelter (no drawing ref.) afforded some protection from bomb blast for the occupants of the nearby offices, though with its open roof would not survive a direct hit (Buchan Innes 1995). It is a cruciform-plan brick structure surrounded by an overgrown earth mound with entrance points to north and south (plate 21), completely overgrown. There were several others located around the airfield.

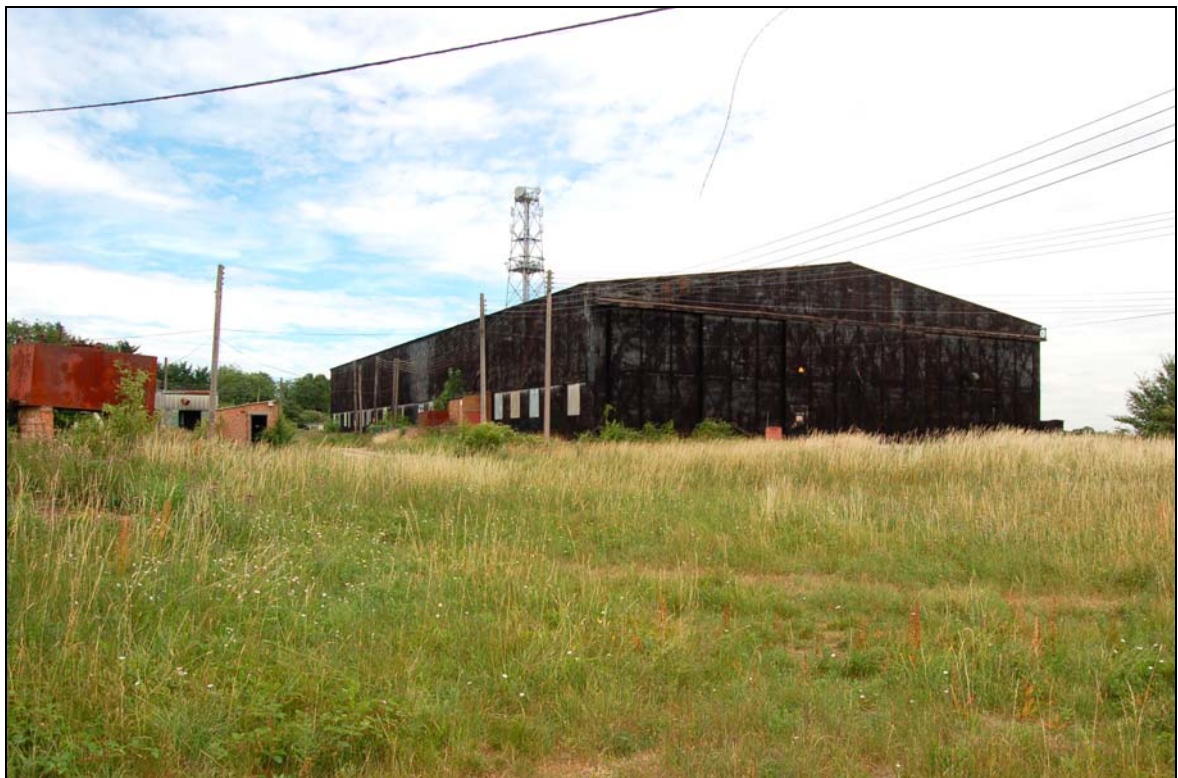
This hanger (plate 22) is the same 23-bay 'home standard T2' (upgraded version) type as hanger 1 at Woodhouse Farm and stands in a similar position close to the dispersal loops and runway for most effective use (fig.2b). It is in better general condition than its counterpart, though it too is missing the door frame extensions (HER 14183). Inside, the southern half was later divided up into workshops by Marconi (plate 23).

Plate 22 Hanger 7 viewed to north

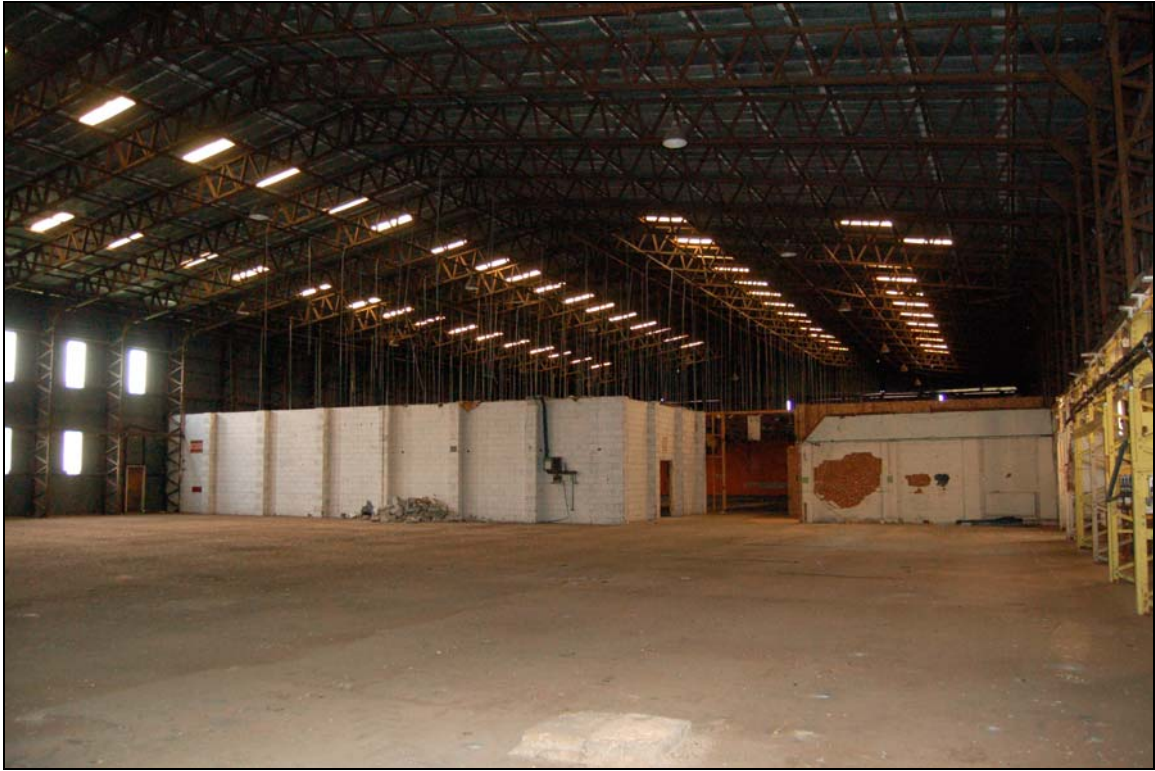
Plate 23 Interior of hanger 7 viewed to south-east

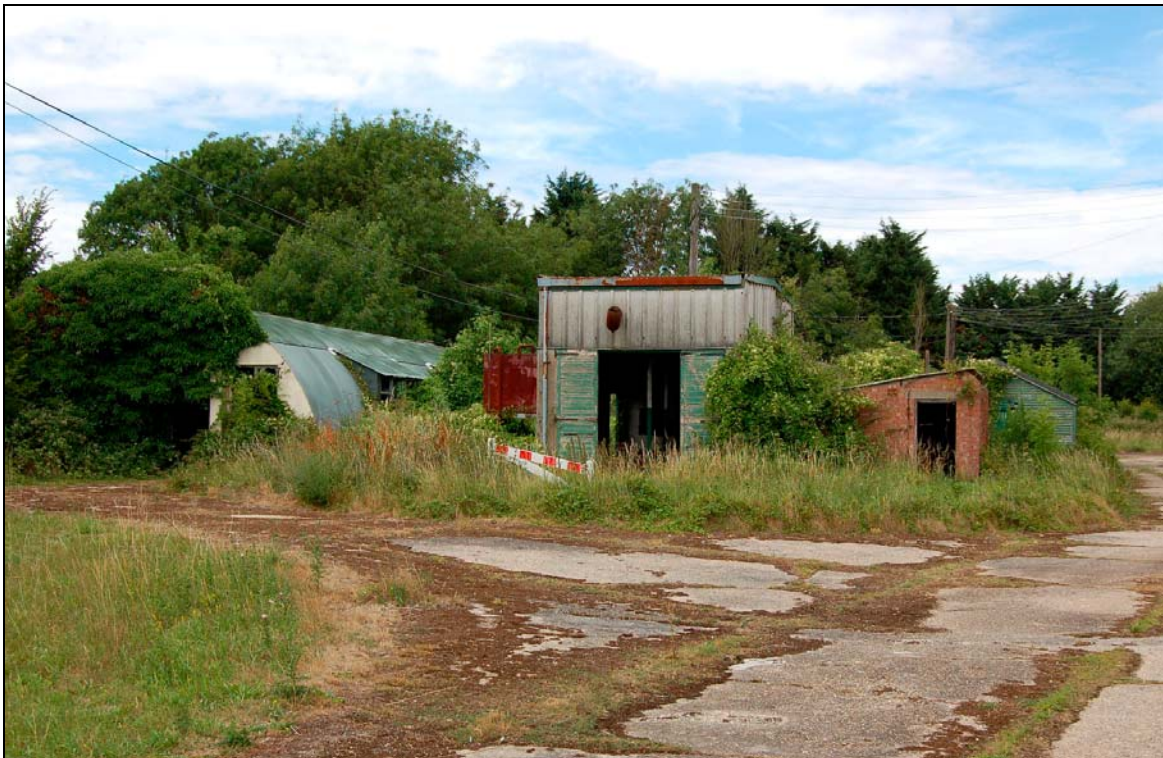
Building 8 (plate 24, left) is a type 12777/41 standard 24ft by 126ft long Nissen hut. Typical in form, it is built of twenty-one 6ft corrugated steel sections bolted to an iron frame with buttressed brick end-walls. Steel-framed Crittalls windows remain at the two

Plate 24 Armoury and Maintenance Unit 8 to left of Marconi structures, viewed to north

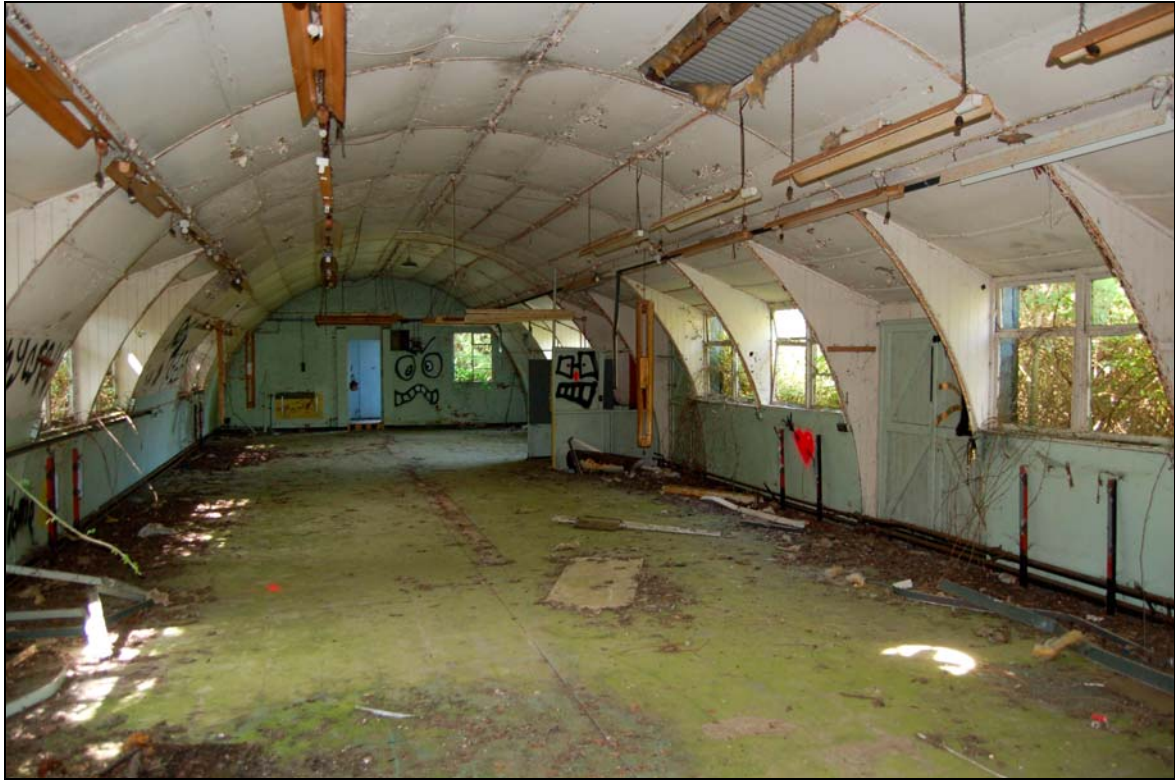
ends but the windows on the long sides were replaced with wooden casements in the Marconi era and a toilet block added to the north end. Cast-iron English Electric switch boxes with the same Sunburst design as hanger 1 are prevalent. Plate 25 shows the interior at the time of the survey.

Plate 25 Interior of Armoury and Maintenance Unit viewed to north-west

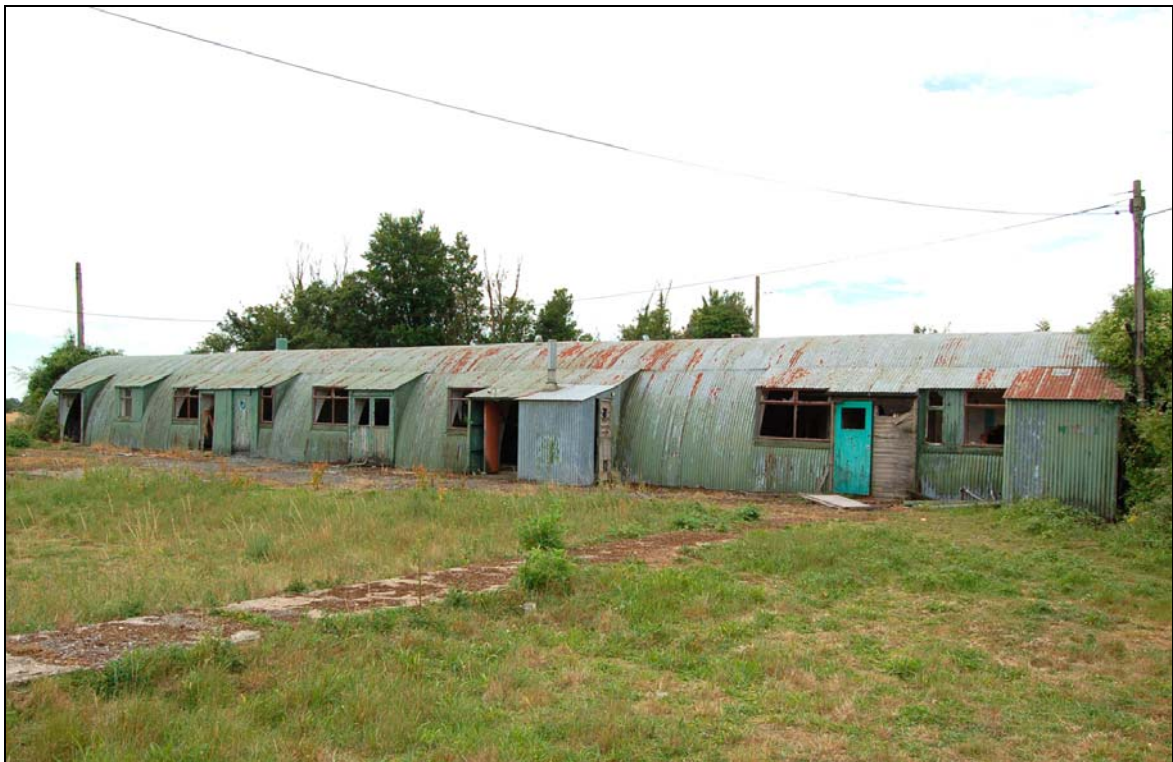
Plate 26 Maintenance Unit Block 9 viewed to south

The exact function of this building is uncertain, but during the Marconi era it was the canteen. It is the same type and design as building 8 but with a different arrangement of standard window and door units (plate 26). In the post-war era, the eating area formed most of the floor plan, with kitchen to the south and toilets to the north. An orange-painted telephone booth is located at the north end of the canteen (plate 27).
