**TYPE T2 AIRCRAFT HANGER AT WOODHOUSE FARM  
AND OTHER WWII STRUCTURES  
RIVENHALL AIRFIELD  
ESSEX**

**HISTORIC BUILDING RECORD**

**December 2010**

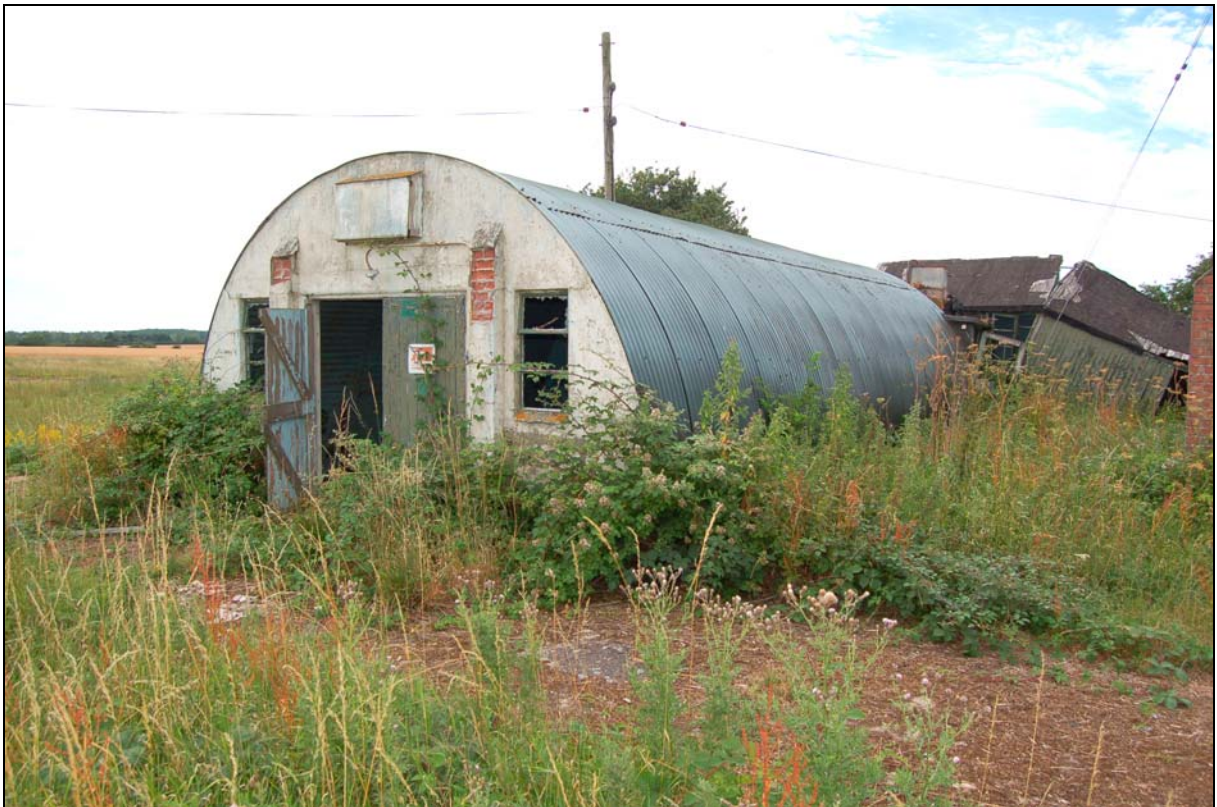
Plate 28 General Purpose Hut 10 viewed to south-west

The general purpose hut is one of several of type 2963/10 design that was augmented in the post-war period by a corrugated iron shed, which is now collapsing (plate 28). The 2963/10 design was a narrower 16 ft span Nissen form which produced a more rounded rather than semi-circular profile. This example is 6 bays long. The Crittalls windows remain intact and the lighting fixtures inside may be also be original, but the interior has been adapted by Marconi for alternative use (plate 29).

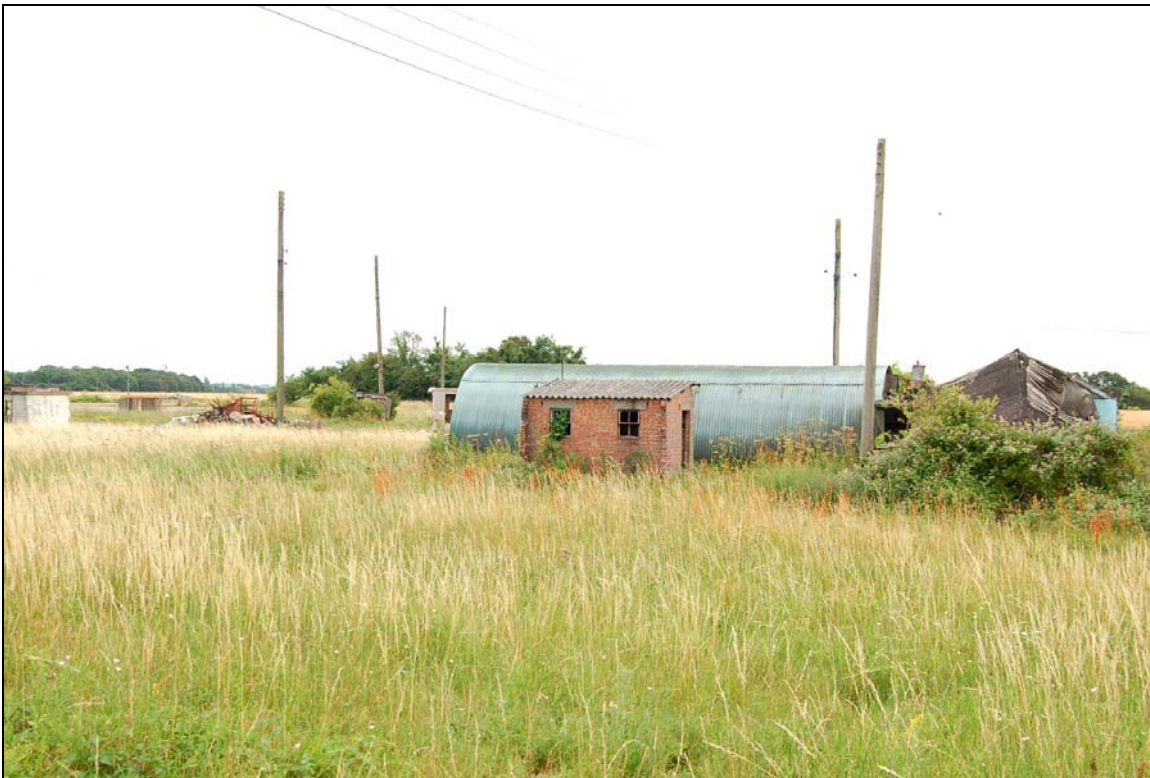
Plate 30 Latrines/sub-station 11 viewed to south-west in front of General Purpose Hut

The only other WW II structure is a small temporary brick type latrine alongside the general purpose hut (plate 30). Its design (9026/41) was clearly adaptable as this structure was changed to become a small sub-station that contains 'wartime-era' fuse boxes and other electrics.
