**HISTORIC BUILDING SURVEY OF
A BARN AT GREAT BROCKHOLDS FARM
RADWINTER
ESSEX**

February 2011

FAU Project No.: 2324

NGR: TL 6132 3535

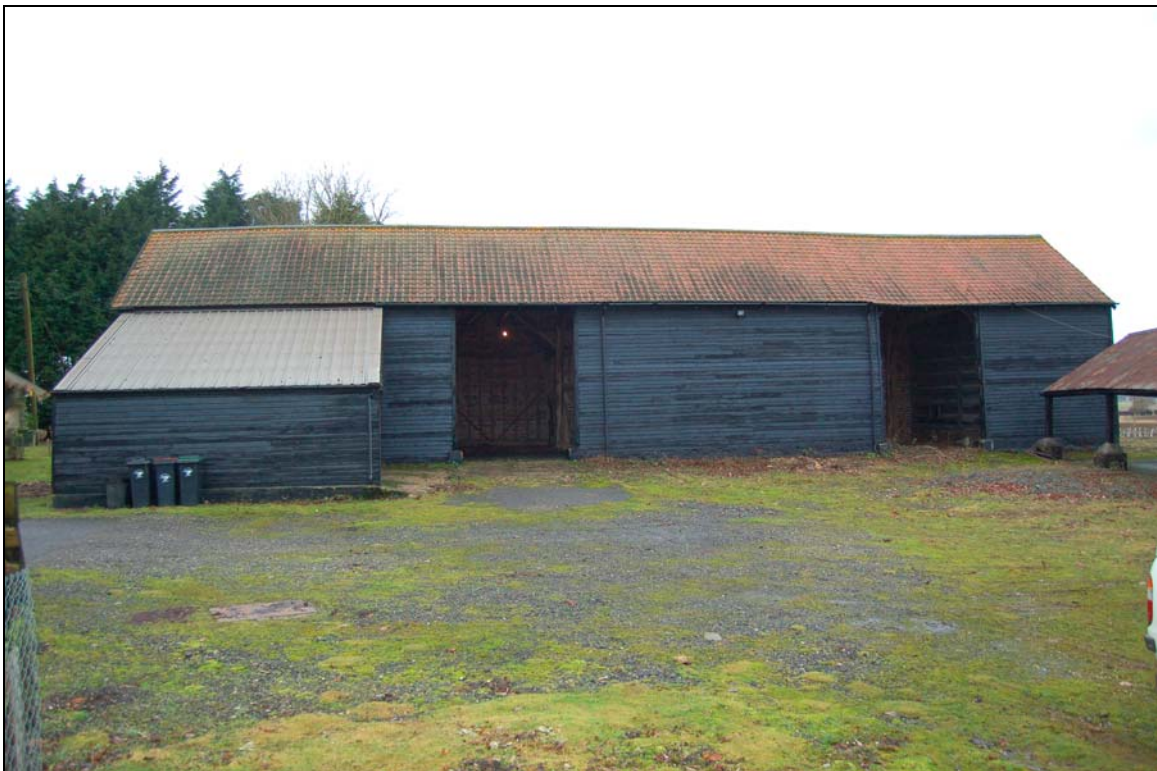
Plate 2 North-west elevation, facing the yard

The **south-east elevation** faces onto the yard and originally held large cart doors on the third and sixth bays. These were probably removed in the modern period to admit vehicles to the grain silo, leaving large openings (plate 2). Pintels and rebates are evident on the jambs for hinges, door battens and the lock-bar, which all typical features. Concrete bases have been added around the door posts (plate 3). Shed 1a has modern cladding and a profiled steel sheet roof. The internal studwork is also modern but may incorporate timbers from the late 19th century shed that it replaced.

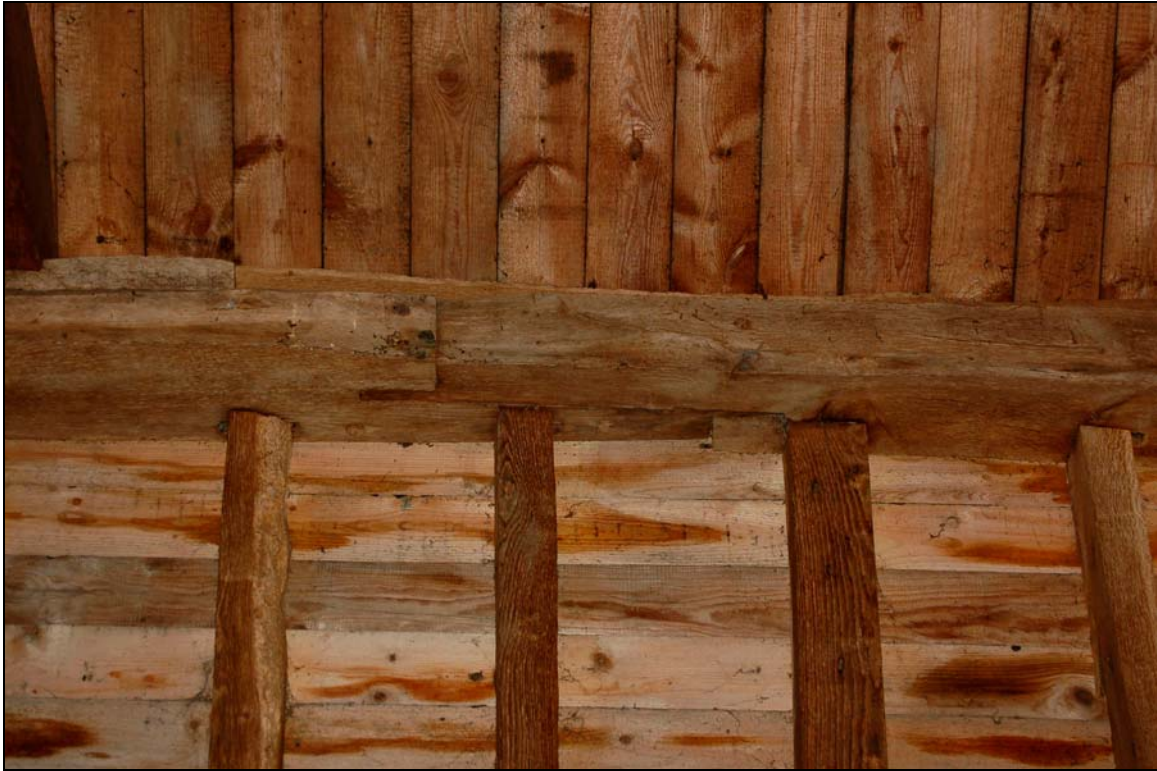
Wall plates are commonly of one bay lengths and connected by double-pegged edge-faced and bladed scarf joints, the common post-medieval form (fig. 6, plate 7). Secondary plates were added on top to level the new roof when it was replaced. The ground sills are lap-jointed (plate 8) and are mainly contemporary with the brick plinth, though some have been replaced in the rebuilt areas.

Plate 7 Typical face-halved and bladed scarf joint in wall plate

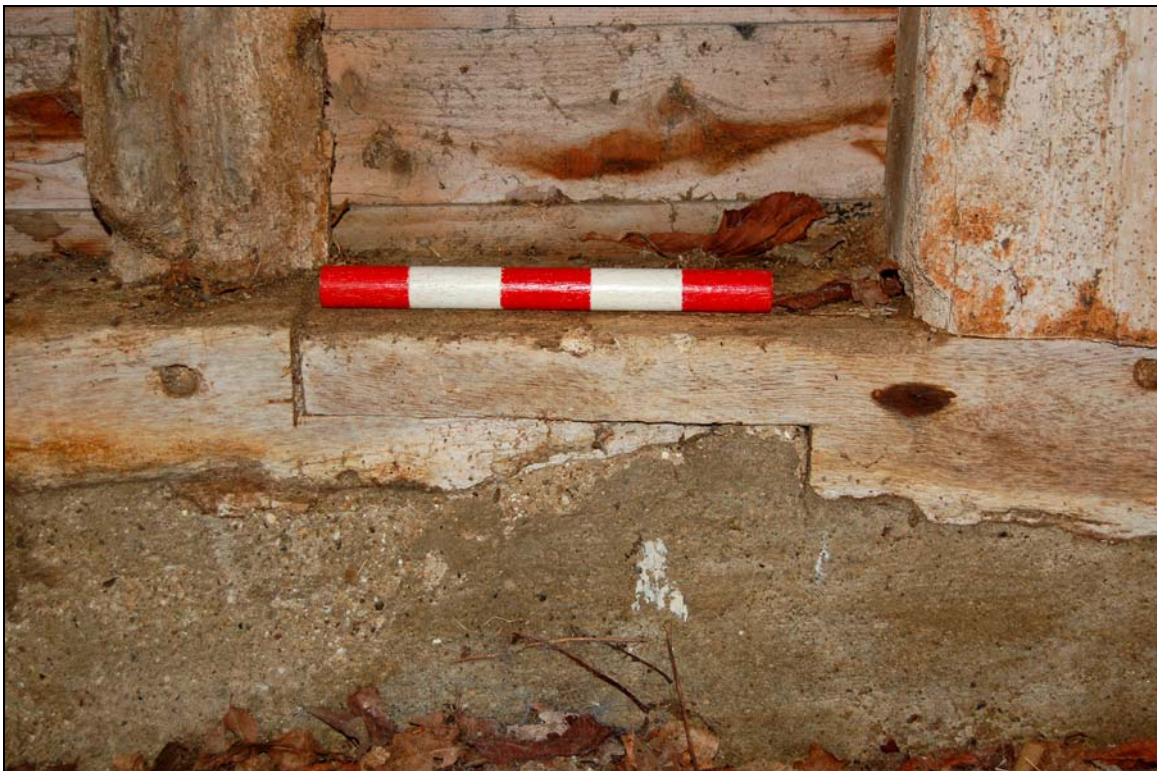
Plate 8 Typical lapped scarf joint in sill plate

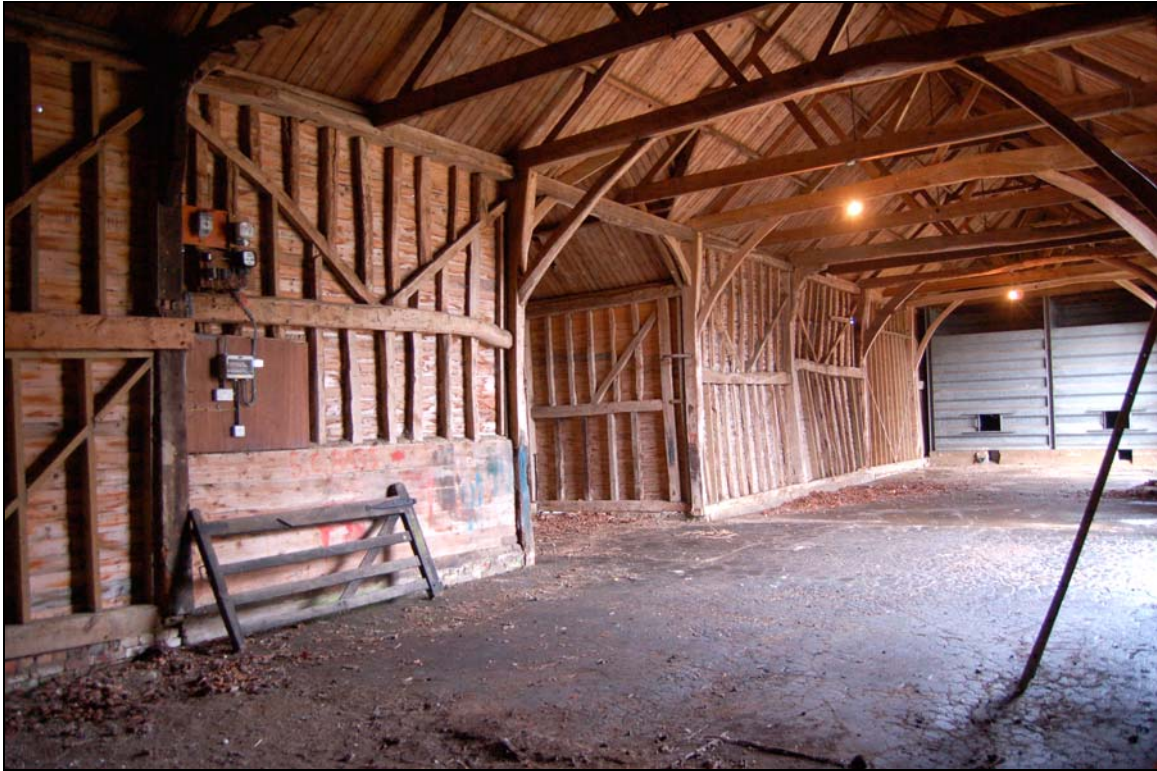
Plate 9 Interior of barn viewed towards porch (north)

Much of the framing along the south-east wall (plate 10) remains intact. The bay 1 wall of the north-west wall and the adjoining gable has been rebuilt in the modern period and it is likely the second midstrey (bay 6, plate 9, by silo) was blocked at a similar time when its corresponding porch was lost. The character of the wall behind the silo was only partially observed, but is assumed to be in keeping with the rest of the barn.

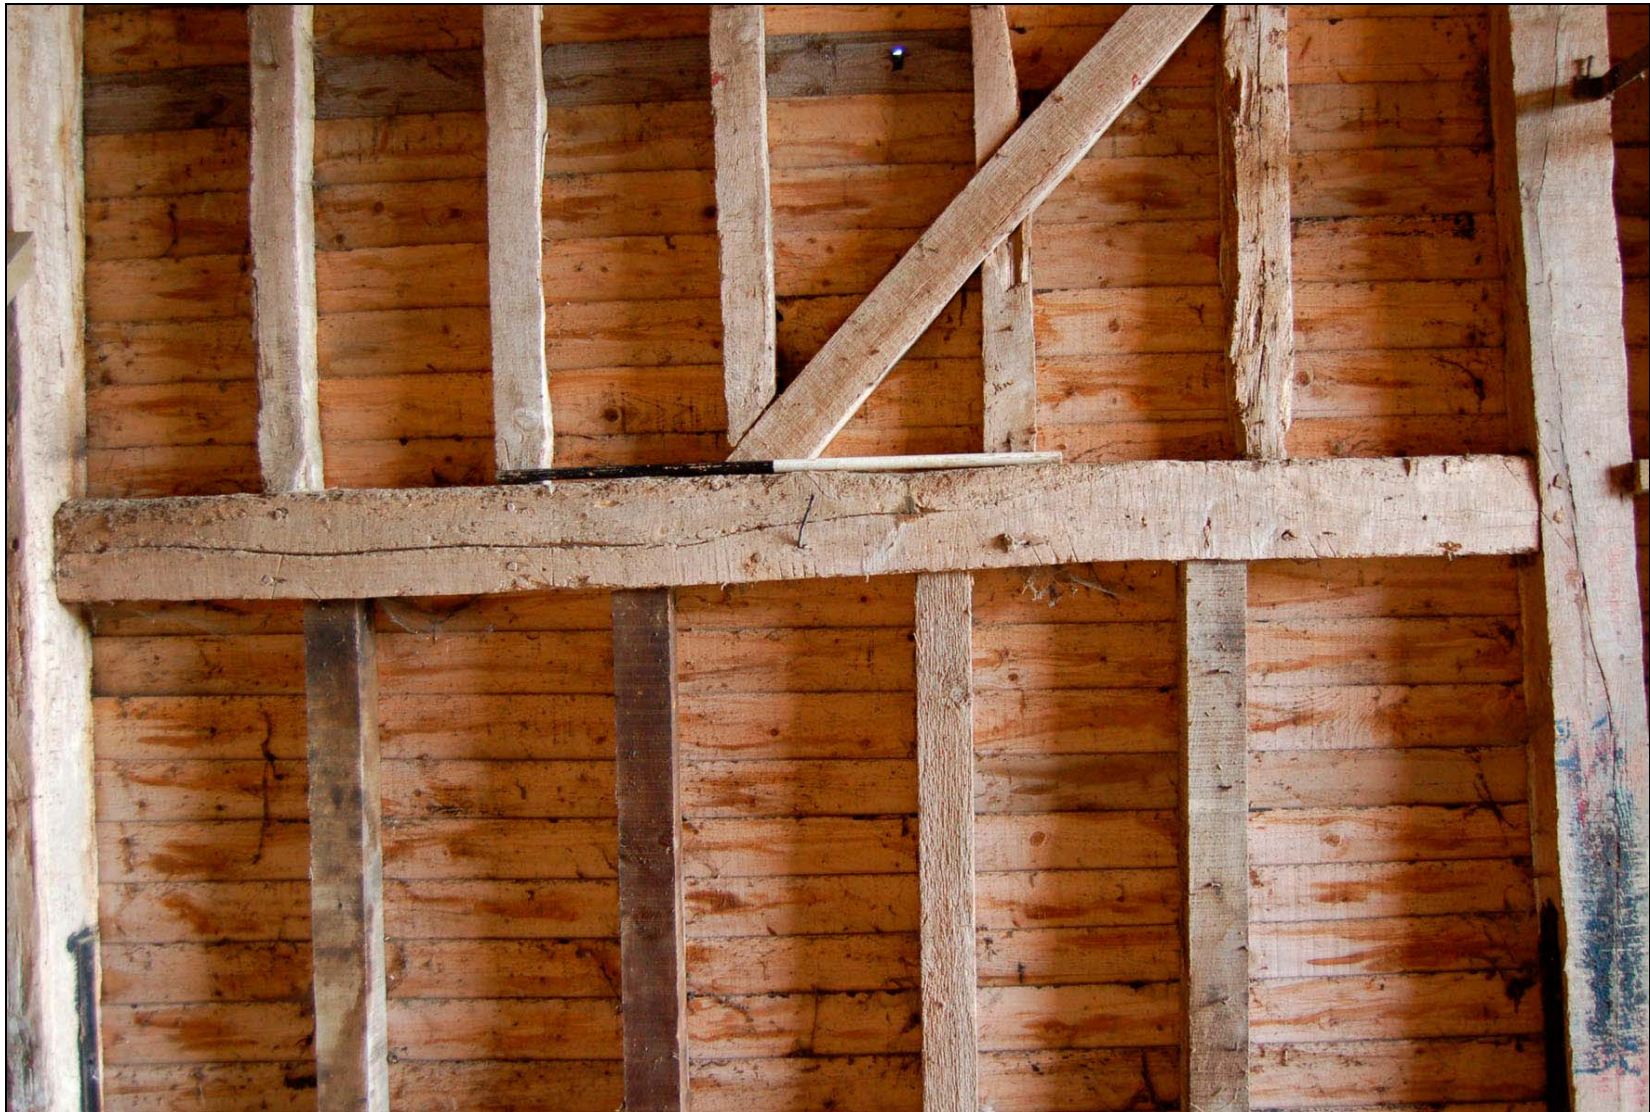
The surviving **porch** has been largely rebuilt but contains some interesting features. The gable wall has been rebuilt across the entrance but the extent of the old cart doors can still be seen thanks to the remaining door post (fig. 6, plate 3) and the slot for the second one on the opposite side. In construction terms the porch is the same as the main part of the barn but although there has always been a porch here, it is only 'tied-in' to the building at the sill and top plate, rather than braced to the main structure (plate 9). This design fault may have been a factor in the demise of the second porch. Close analysis of the north-east midrail shows a sequence of scored carpenters marks to earlier studwork of the lower register, running from 1 to 6 from corner post to stud (plate 11). The bay post on the opposite side bears a carpenters mark for either the number 10 or 40, depending on whether the outer lines are natural or man-made (plate 12). Its location and the fact that the mark is scored rather than chiselled suggests the timber is reused.

Plate 11 Carpenters marks in porch (1-6 from right to left)

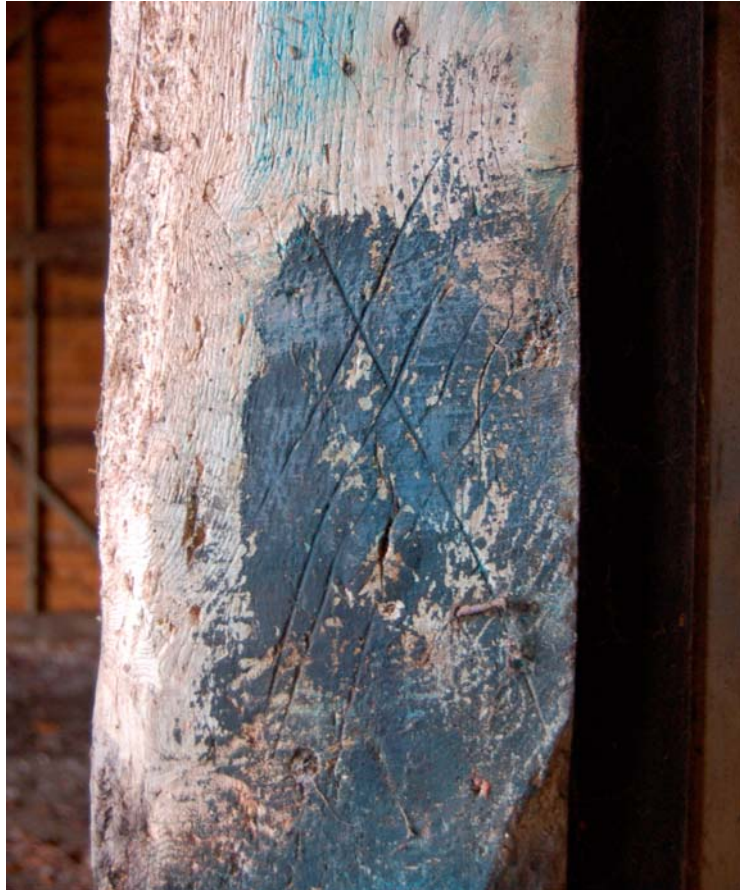
Plate 12 Carpenters mark on T3 midstrey/porch post

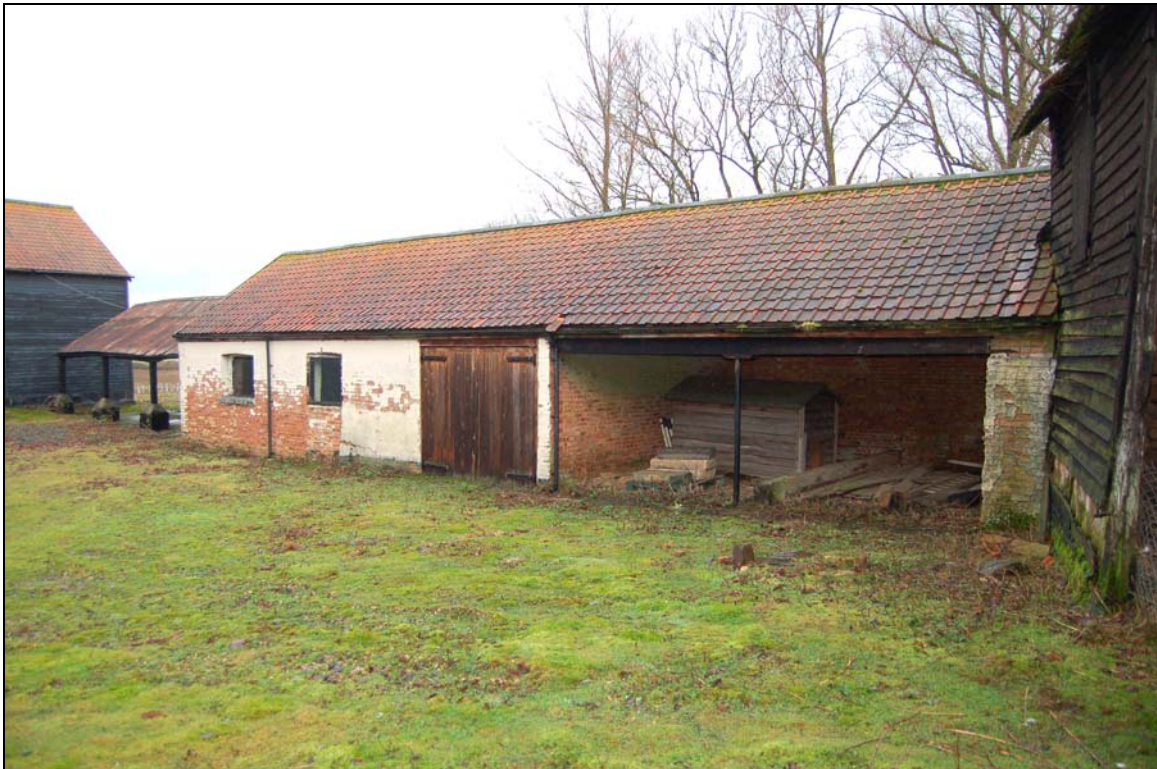
Plate 13 North range (buildings 2 and 3) viewed to north-west

An open-sided 20th-century timber-framed and weatherboarded shed built from machine-sawn timbers with a corrugated iron roof (plates 4 & 13) that replaced part of the Victorian north range.

This is the second part of the 20th-century north-east range (plate 13). It is a modern Fletton brick-built structure of two parts, probably a dairy/milking shed and cattle shed. It has a pantile roof.

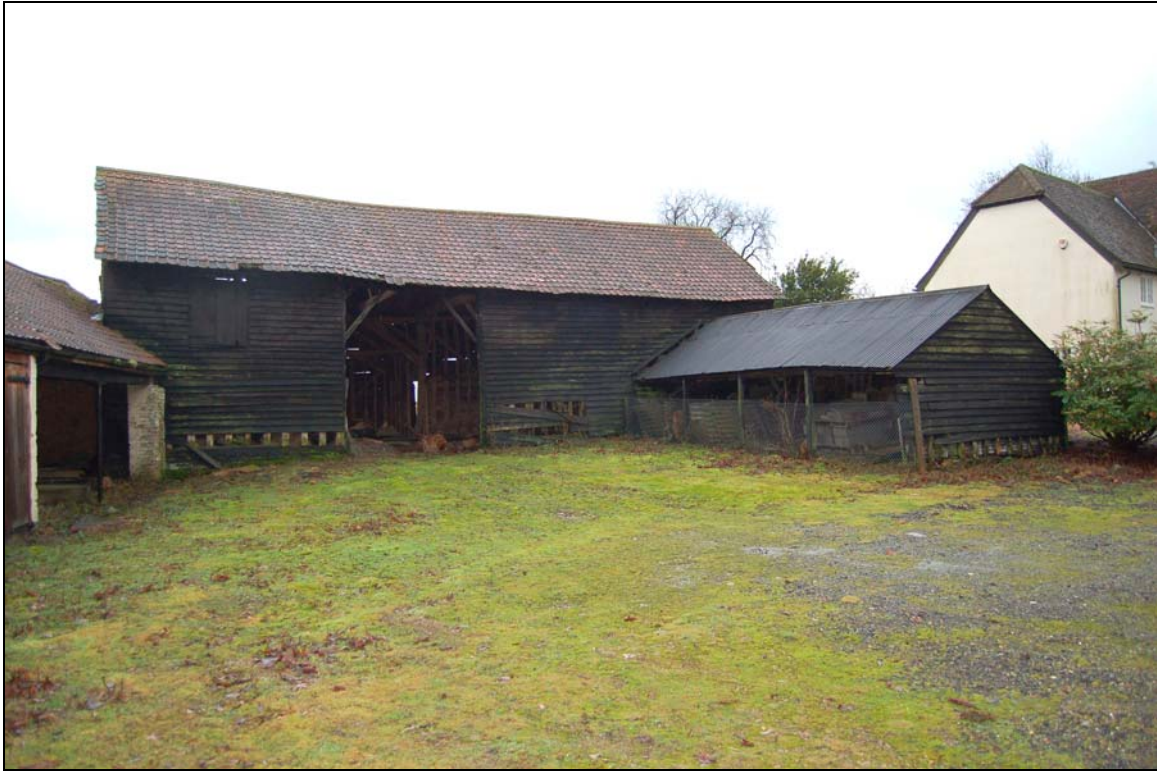
Plate 14 Barn 4 and shed 5 viewed to south

A smaller, five bay barn contemporary with barn 1, with a porch to the south-east. Like barn 1, the roof has been replaced, although it retains its old weatherboarding and doors/hatches on the outer walls. It is generally in poor condition (plates 14 & 15).

Shed 5 is another late Victorian structure. It stands open onto the yard and is now used for storage purposes (plate 14).
