**LAND TO THE REAR OF 36 ORCHARD STREET  
CHELMSFORD  
ESSEX**

**ARCHAEOLOGICAL MONITORING AND RECORDING**

**FIELD ARCHAEOLOGY UNIT**

**May 2011**

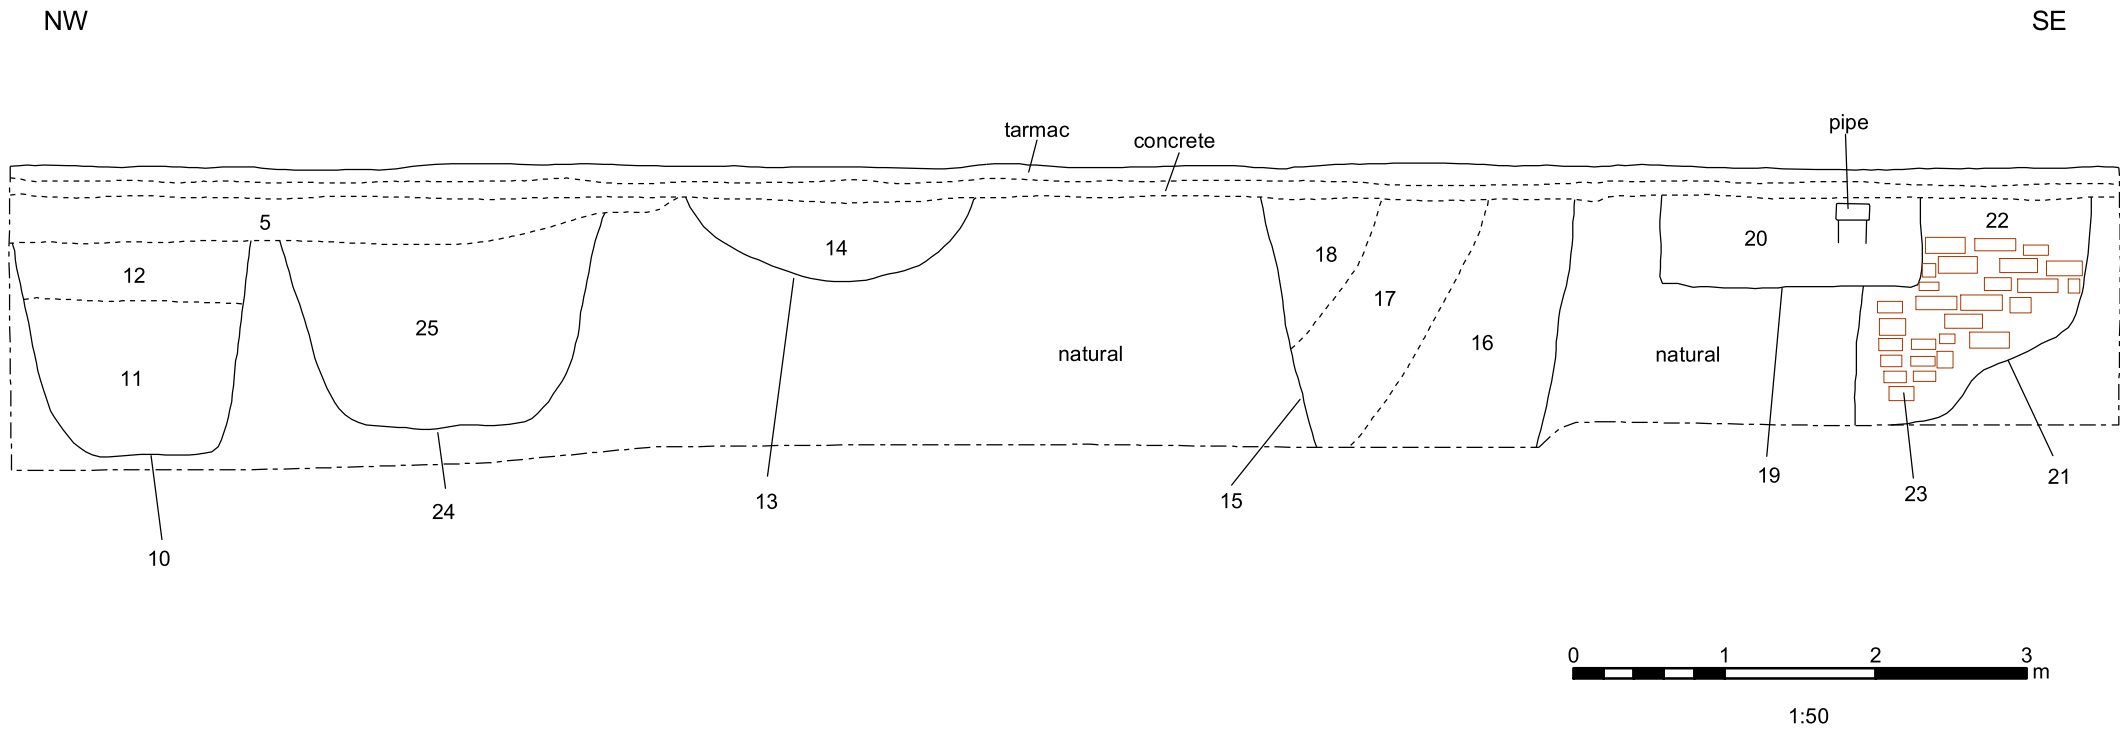
Fig.4. Section 1

Similarly, the majority of the later post-medieval pits (6, 10, 13, 21, 24, 26, 32, 34, 42, 44, 49 and 51) were on average between 1.5 and 2.0m wide and 1.5m deep (Fig. 4). The base of pit 26 was not reached as it was deeper than the footings and hand-excavation was impossible due to the unstable trench edges (Plate 1). Their shapes in plan could not be identified as they all extended beyond the 0.5m-wide footing trenches. Finds were not retained from all of the pits, although they all contained very similar assemblages of post-medieval finds, including large quantities of pottery, brick and tile, bottle glass, animal bone and oyster shell. Pottery and bricks from pits 6 and 13 were quite closely datable to the 18th-19th centuries, but material from other pits was later, dating to the 19th century.

A made-ground layer (5) was present across much of the north and western part of the site (Fig. 4). Layer 5 contained a large quantity of 19th century material along with residual earlier post-medieval pottery and Roman sherds.

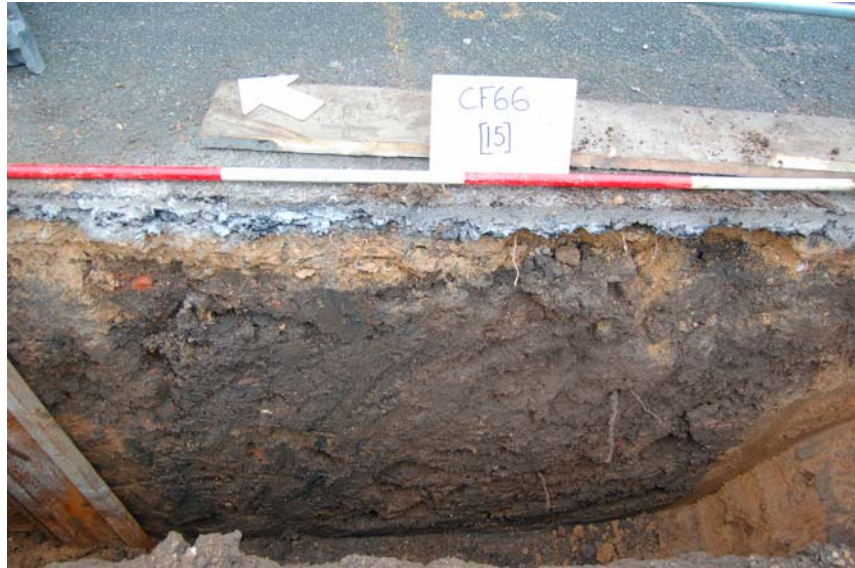
The earliest features on site were pits 15 and 28 in Building Footprint 1, which contained late 15th/16th-century Tudor red earthenware, 16th-century red earthenware and post-medieval

tile fragments (a modern brick fragment is considered intrusive). They represent a group of contemporary, possibly intercutting, pits as they were recorded in adjacent foundation trenches and each contained joining pottery sherds from the same Tudor red earthenware vessel. Both pits were at least 2m wide and over 1.5m deep (their bases were below the bottom of the foundation trench) with near-vertical sides (Fig. 4) and were filled with loose sandy silt. A relatively high quantity of late 15th/16th-century Tudor Red Earthenware was present in the fills of several other pits (pit 6/fill 7, pit 13/fill 14 and pit 26/fill 27) indicating that deposits of this date had been disturbed by later pitting.

Plate 1. Pit 15, dated to the 16th century, looking north-east. 2m scale

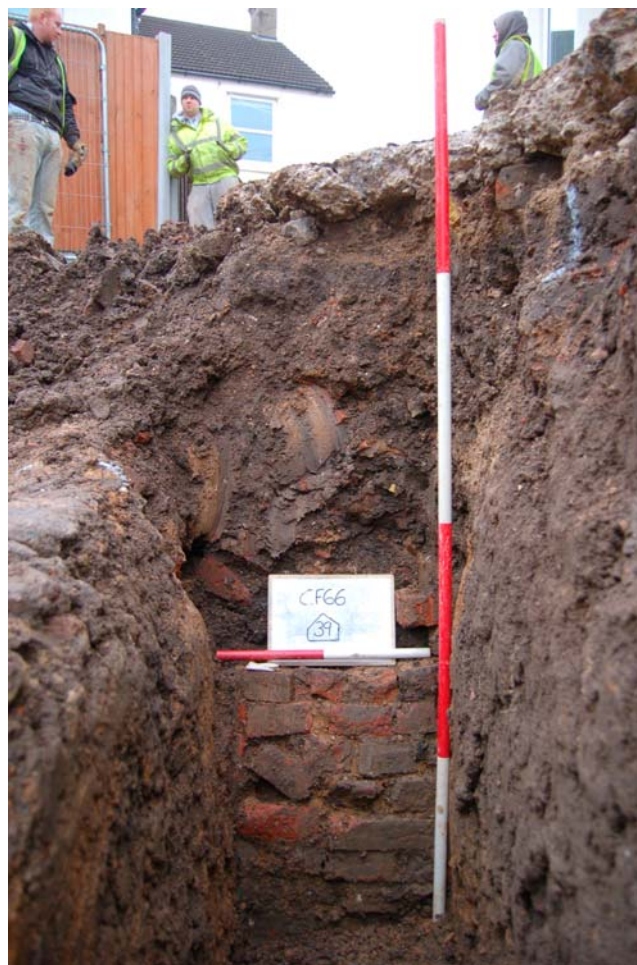
Wall footings 39/40 and 57 at the south-eastern end of Building Footprint 1 were constructed using red frogged brick on a south-west to north-east alignment, indicating that they formed the south-eastern extent of the former building shown on the 2nd edition Ordnance Survey map of 1897. A brick sample taken from footing 39/40 dates to the late 19th century (Plate 2). A possible entranceway between the two wall footings might have existed as footing 40 only extended a short distance into the trench (Fig. 3). Wall footing 53, present in the south-

Plate 2. Late 19th-century wall footing 39, looking south-east. 2m and 0.5m scale

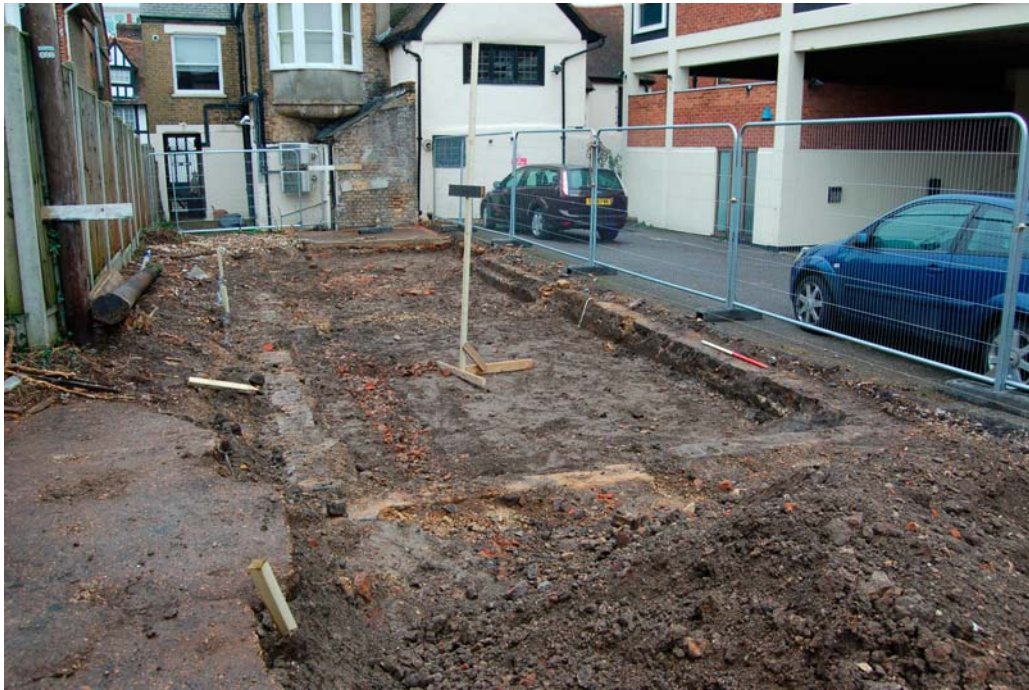
Wall footings 1 and 2 (Plate 3) and drain 3 (Plate 4) were cut into made-ground layer 5 (Fig. 2). Wall footing 1 contained red frogged bricks and wall footing 2 comprised bricks bonded with lime mortar and therefore predated 1850. The bricks within wall footing 2 must have been re-used from an earlier structure (either on the site or in the vicinity) as the wall corresponds with the north-western external wall of the early 20th century building shown on the 1921 Ordnance Survey map. Wall footing 2 cut through the top of drain 3 which contained 19th and 20th century pottery sherds, brick and tile and animal bone, none of which were retained for further analysis.

Plate 3. Modern walls 1 and 2 and drain 3 looking north. 1m scale.

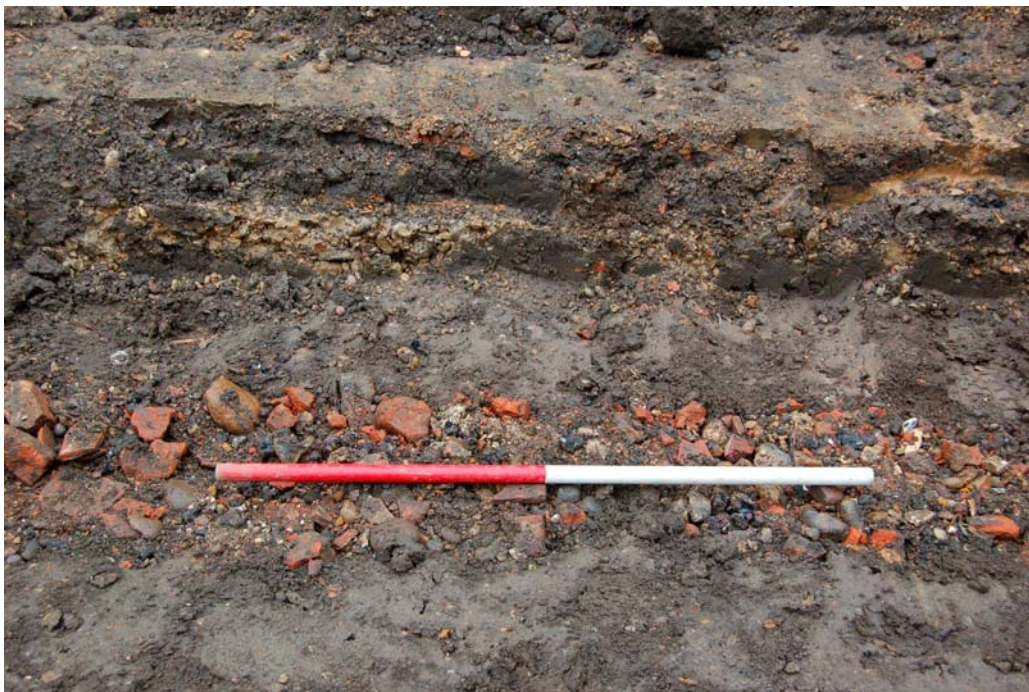
Plate 4. Drain 3 looking south-west. 1m scale.
