Falcon House, 2 Stortford Road, Standon, Herts.

HN1200

Report No. 943

Falcon House, 2 Stortford Road, Standon

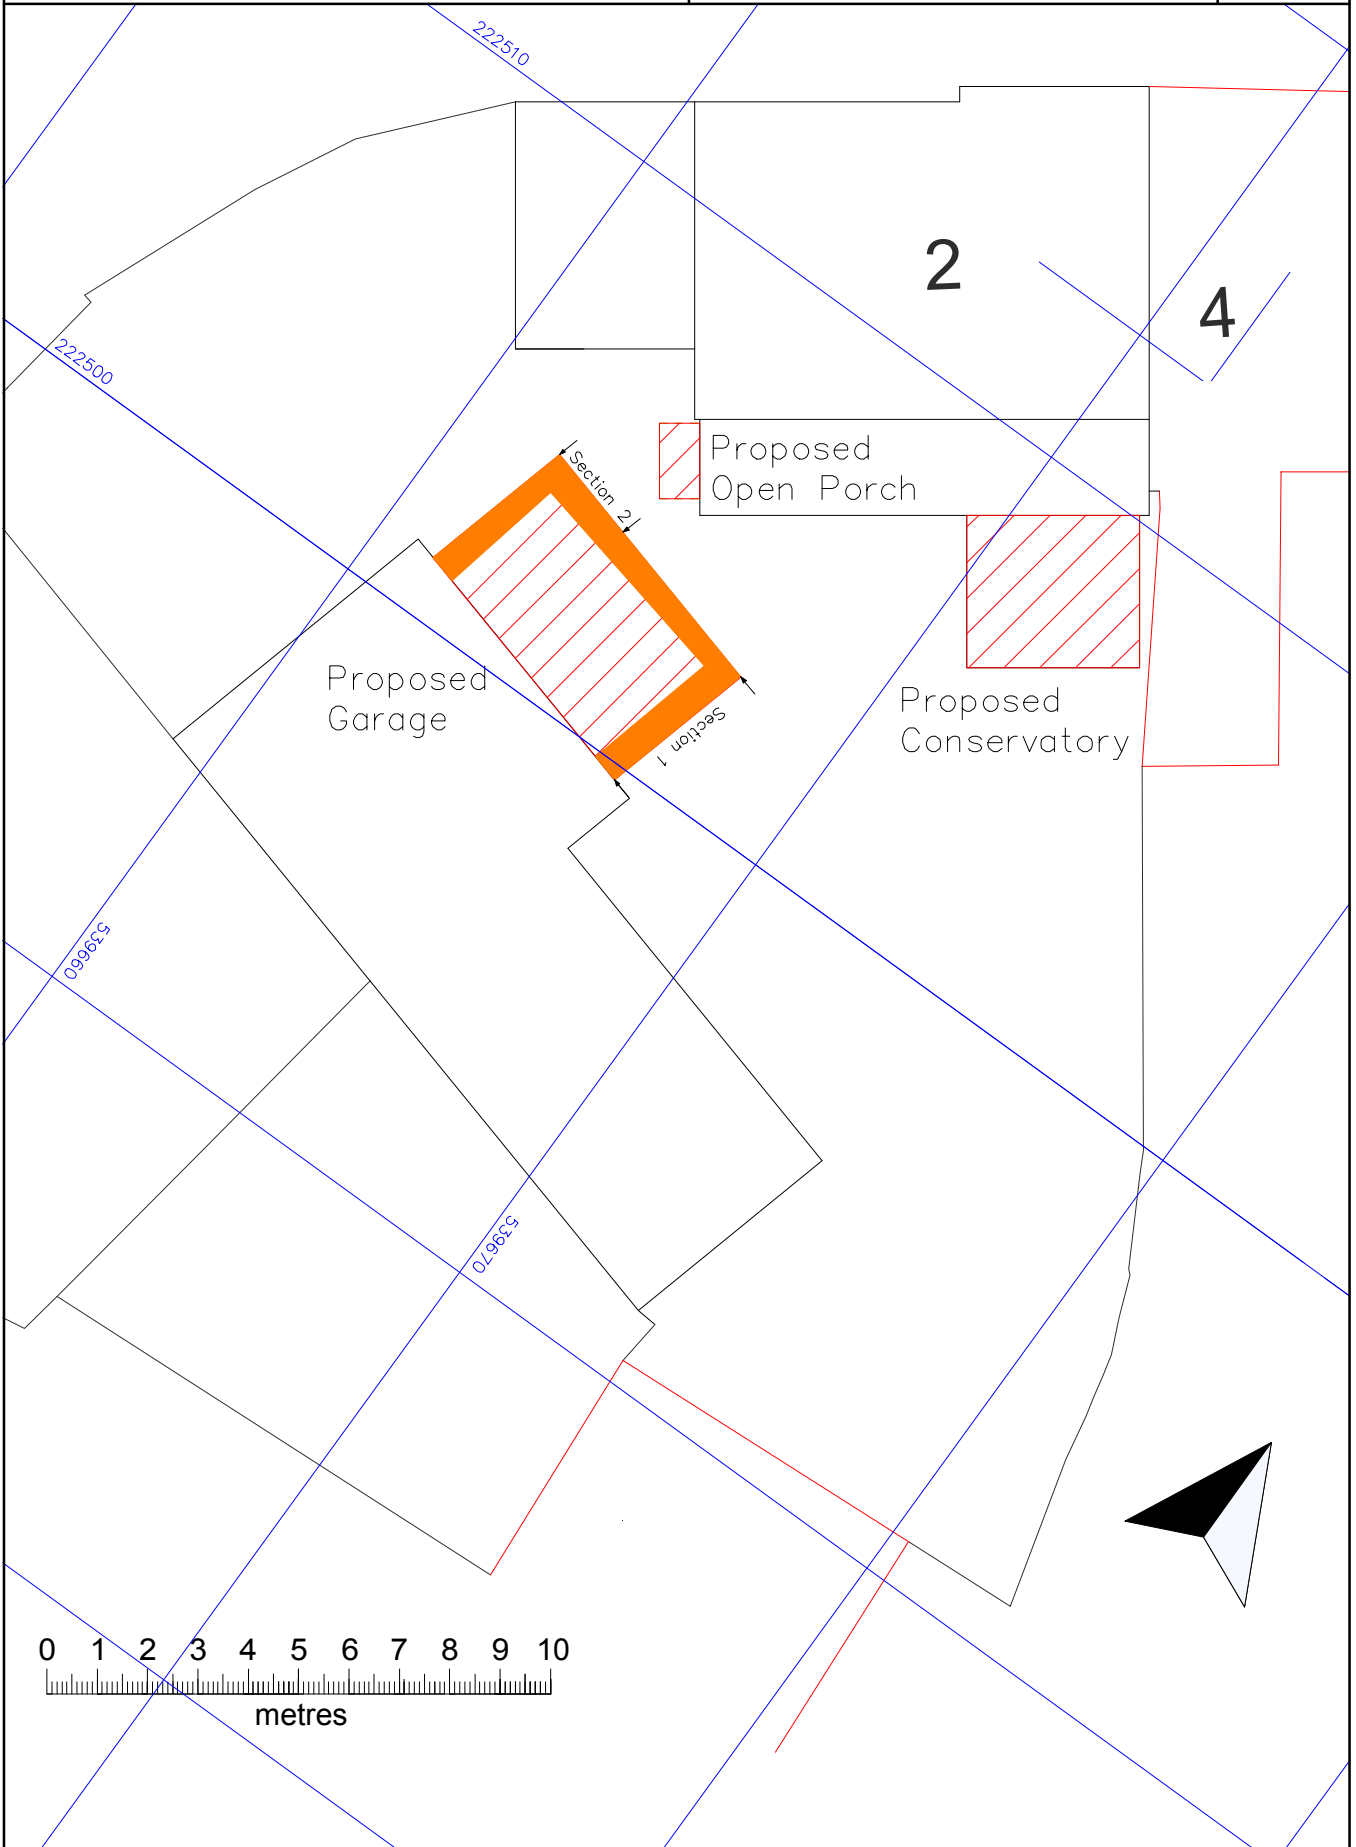
Figure 2

The clients have decided not to build the proposed conservatory at the present time, and the proposed porch required no groundworks. Accordingly, the groundworks consisted of a single U-shaped trench (Figure 2) excavated using a 0.8 tonne tracked 360-degree excavator. The trench was 0.6m wide, between 1.1m and 1.5m deep and had a total length of 11.55m. No archaeological features were seen in the trench. A late 19th century or early 20th century red brick service chamber was encountered in the south-eastern arm of the trench along with a 20th drain and concrete building footings.

Site layout

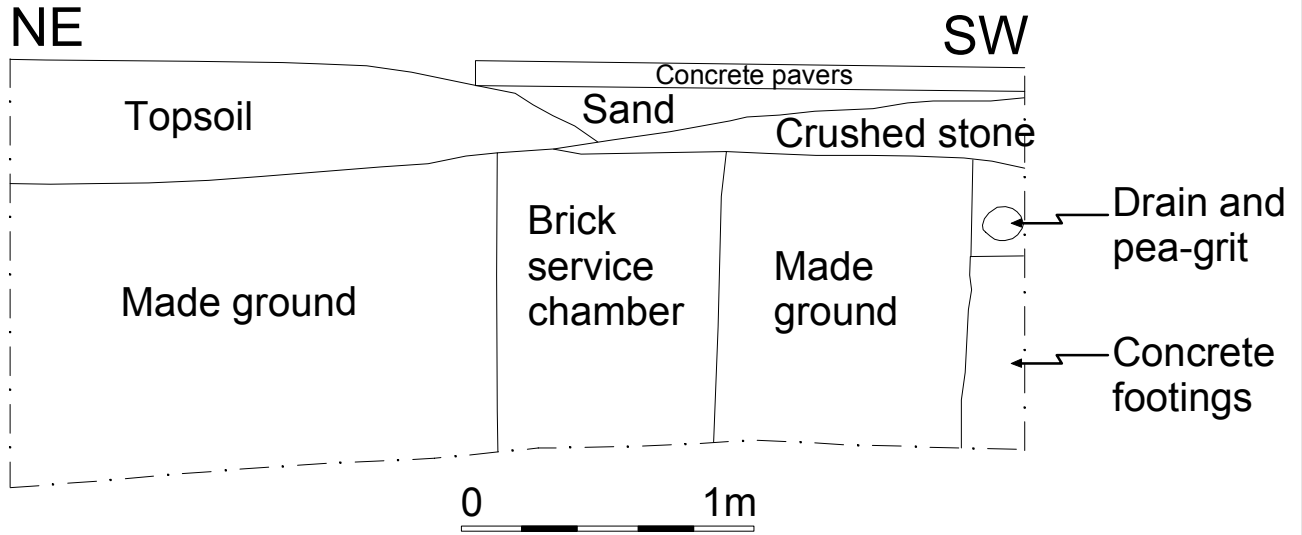
Section 1

The stratigraphy observed in the trench consisted of a very dark grey (10YR 3/1) silty sand topsoil, up to 0.2m in thickness. This overlay a deposit of made ground, a brown (10YR 5/3) silty sand, up to 0.9m in thickness. The natural, where seen, was a mixed deposit of white chalk (10YR 8/1) and strong brown (10YR 4/6) sandy

clay. Cut into the topsoil along most of the length of the trench were modern block pavers bedded on layers of sand and crushed stone.

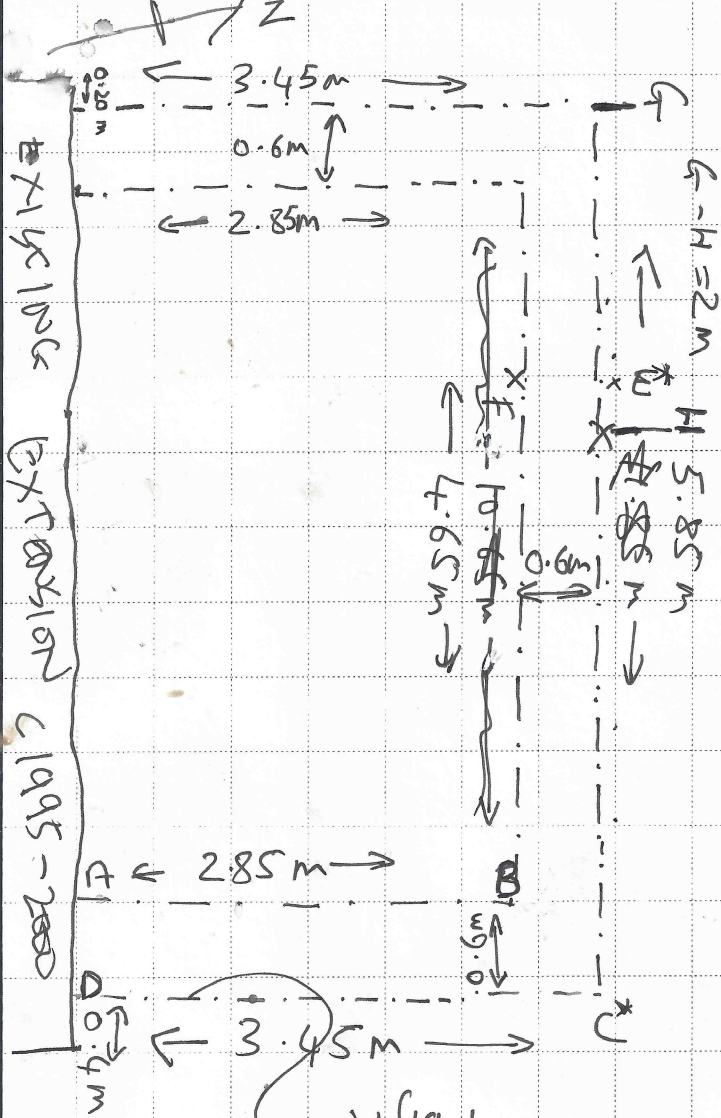
Footings plan

C-C* USED TO LOCATE SOME COLOUR DIGITAL PHOTOS.

mid lg + cement mortared
8 lined unexcavated
Red brick manhole
structure clipped by
trench - bricks not
broken so don't know
y projected. Prog(20)

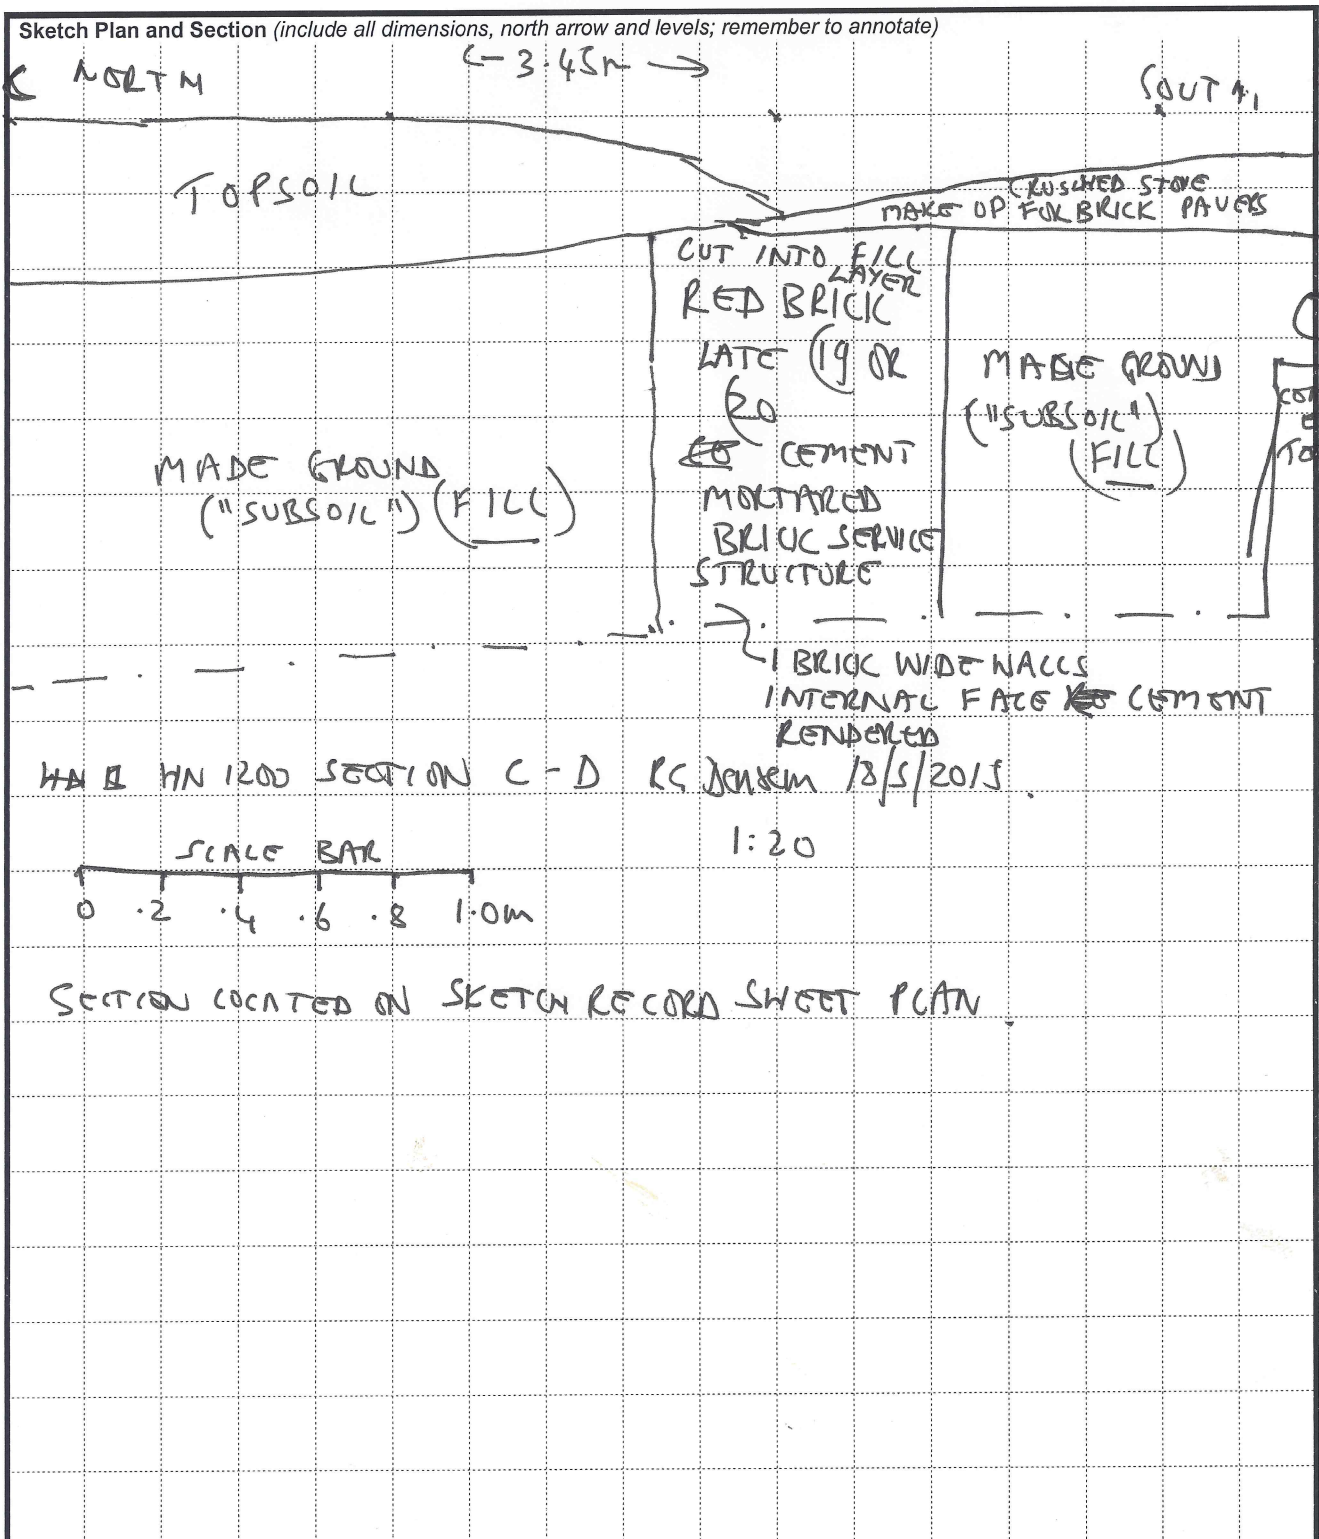
Discussion and interpretation			
Section 1			
Scale	1:20		
Signature	RGD		
Date	18/5/2015		
Sheet	1	of	
Checked

~~TOPSOIL~~ ~~MAKED OVER~~ MAKE-UP FOR (REMOVED) BRICK PAVERS (20, FROGGED) OVER LATE (19 OR 20) RED BRICK BUILT CORNER OF A ~~POST~~ STRUCTURE THAT WAS A SINGLE BRICK WIDE & WHICH WAS BUILT OF CEMENT MORTARED BRICKS & THAT WAS ~~CONCRETE~~ CEMENT FACED INTERNALLY. BRICK STRUCTURE CUT INTO FILL THAT HAD RARE TILE & POST-MED BRICK FRAGS & 1x STAMPED LETTERED CHAR BOTTLE FRAG (19+) - NONE KEPT.

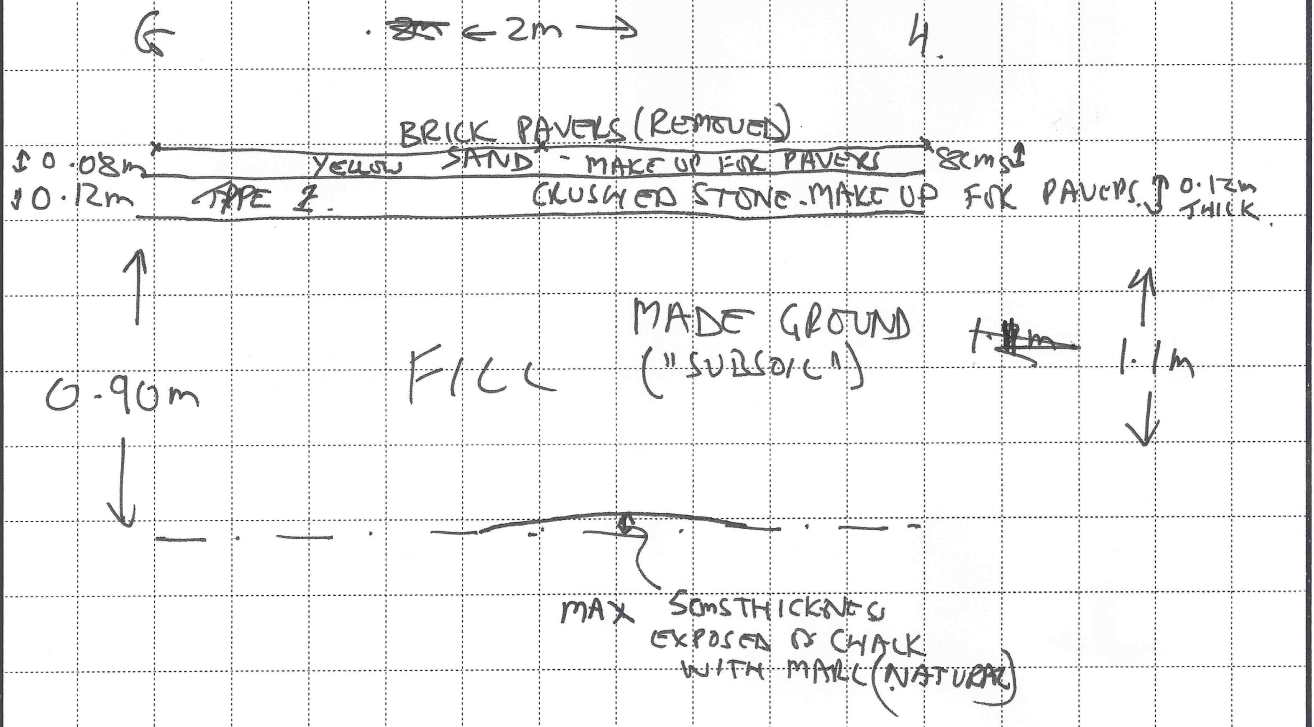
Section 2

SECTION G-H, LOCATED ON SKETCH RECORD PLAN
