**PRIORY HOUSE,
33 High Street South,
Dunstable, Beds.**

HN924

***ARCHAEOLOGICAL
MONITORING REPORT***

Project Ref.: HN924
Luton Museum Accession no: 2011.63
LPA ref.: CB/10/01935/LB

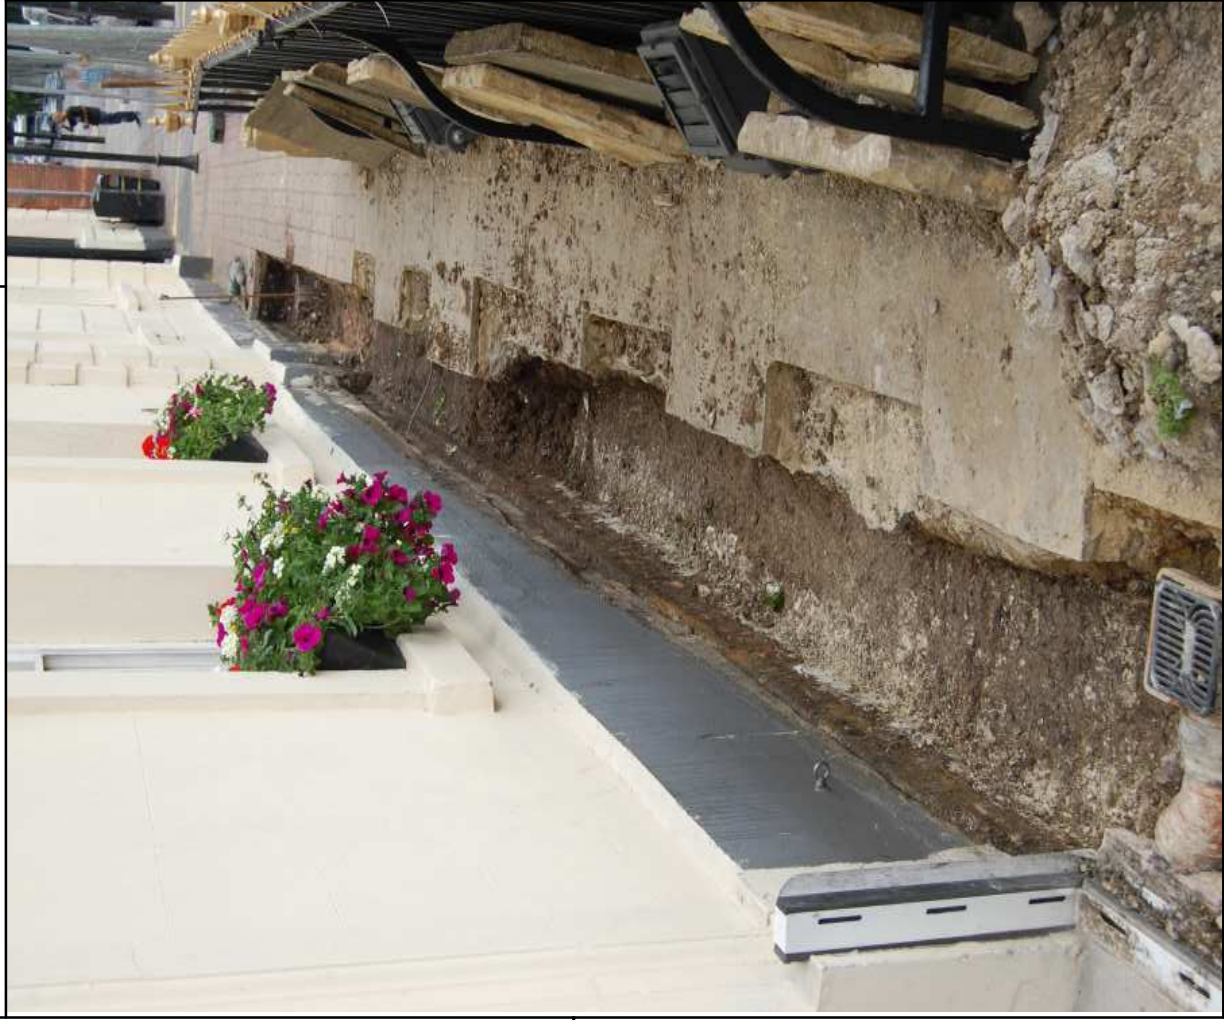
Plate 1: View of French drain, looking southeast.

2.7 The lifting of the paving stones at the northern end of the study area exposed a layer of concrete. Excavation for the French drain revealed that this was 0.14m thick (Plate 1). Below the concrete was a layer of crushed mortar, sand and modern brick and tile fragments, 0.25m thick. Further south, the paving slabs were replaced by brick paving (Plate 2). This was set on a layer of building sand, approximately 0.30m thick. The natural chalk was exposed at a depth of between 0.35 and 0.40m below the present ground surface.

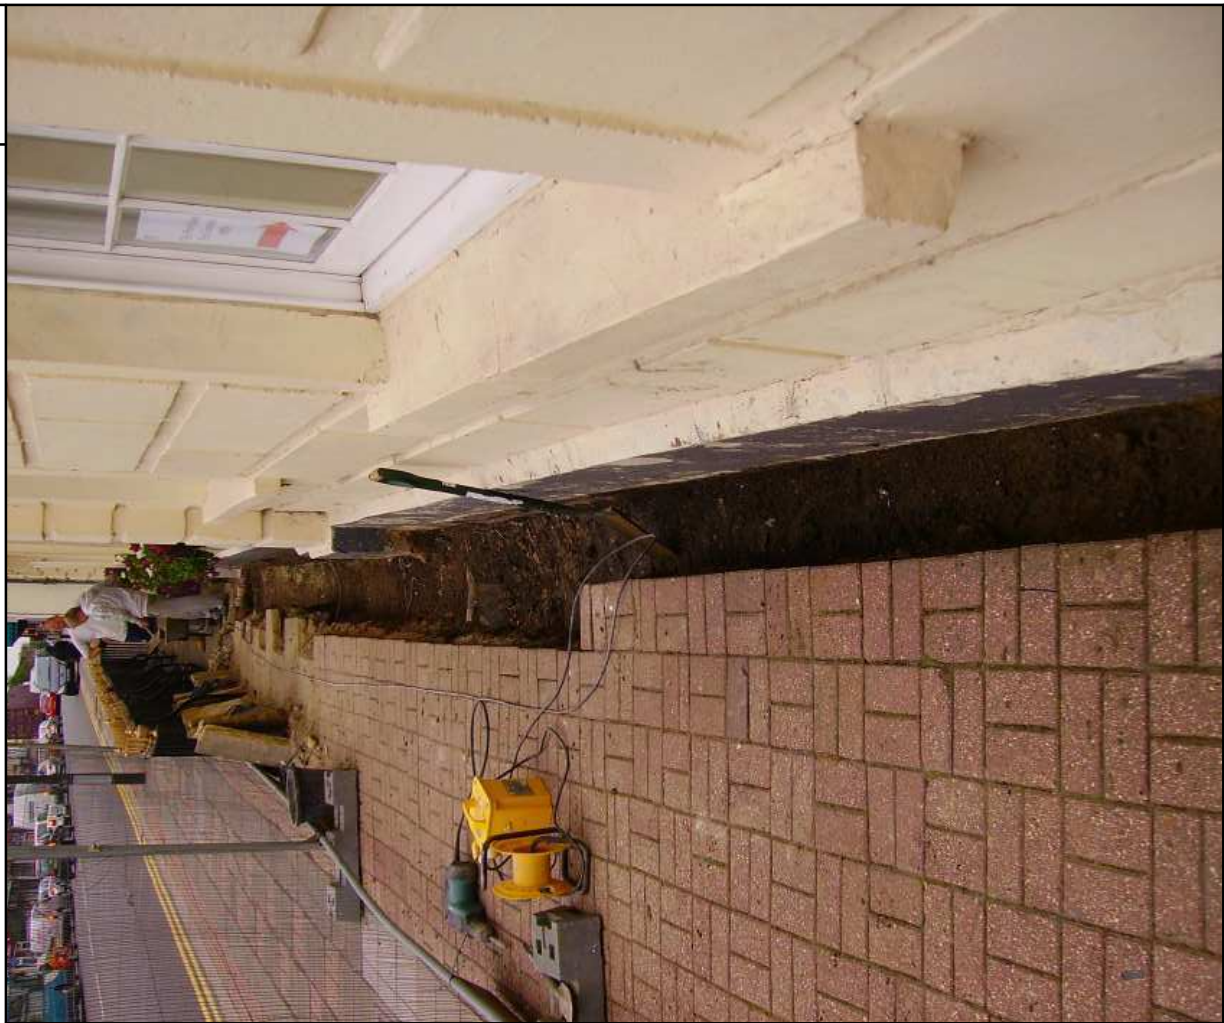
Plate 2: View of French drain, looking northwest.

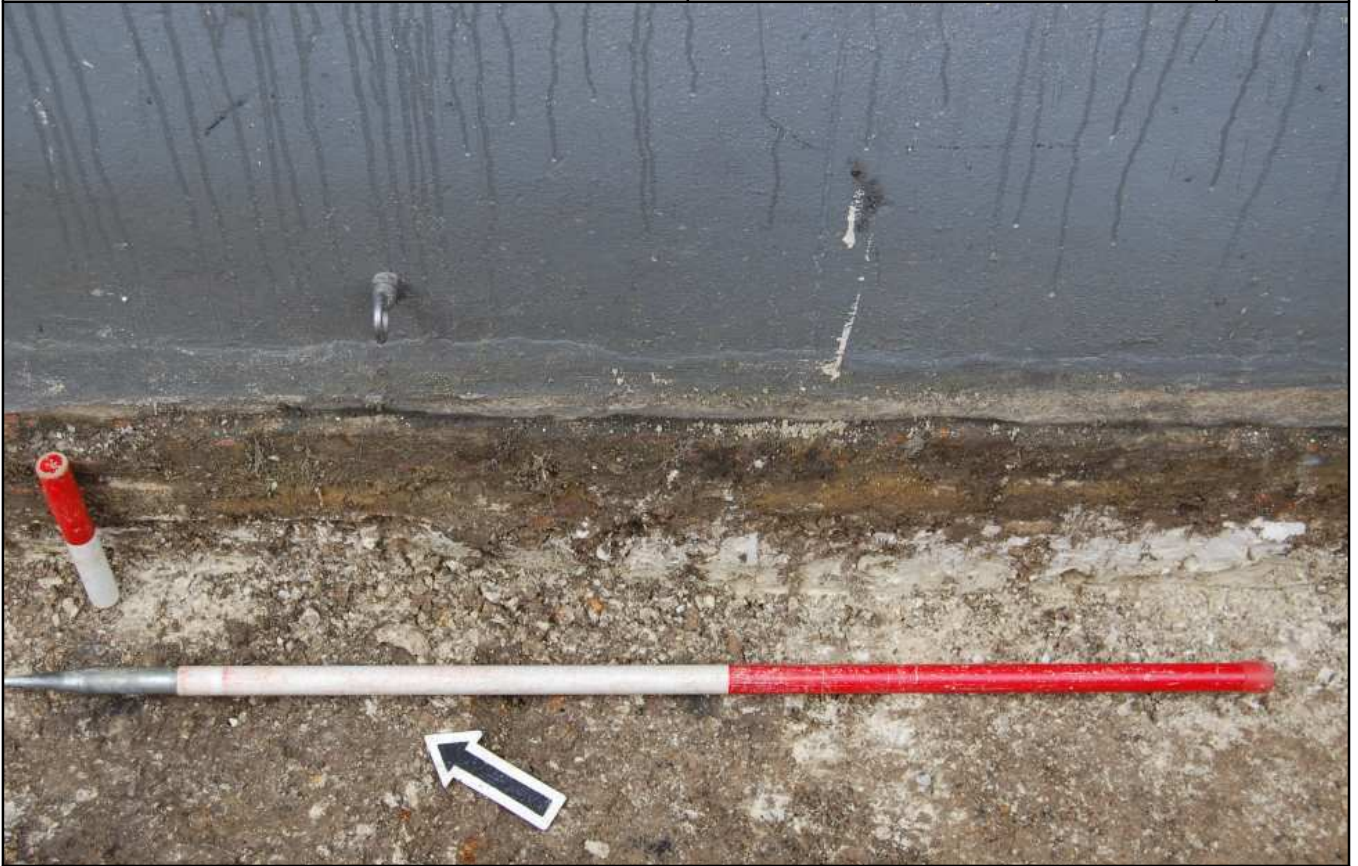
Plate 3: Exposed brickwork resting on natural chalk, looking northeast.

2.8 The brickwork of the front wall was rendered to a level approximately 0.20m below the existing ground level. Below the render were two courses of exposed brick resting on natural chalk (Plate 3).

3.6 It was considered that the present project had the potential to contribute to an understanding of a number of aspects of the development of the town, including its character in the Roman period, the development of the Priory, and the relationship between the medieval town and the Priory. Collected evidence was limited, however, to a demonstration that the 18th century brick frontage sits on natural chalk, and not on earlier (monastic) masonry.
