THE CHURCH OF ST MARY Ware, Hertfordshire

ARCHAEOLOGICAL MONITORING REPORT

Project ref: HN925
Planning Ref.: 3/10/0660/FP
HER Enquiry ref: 67/11

Archaeological Monitoring Report

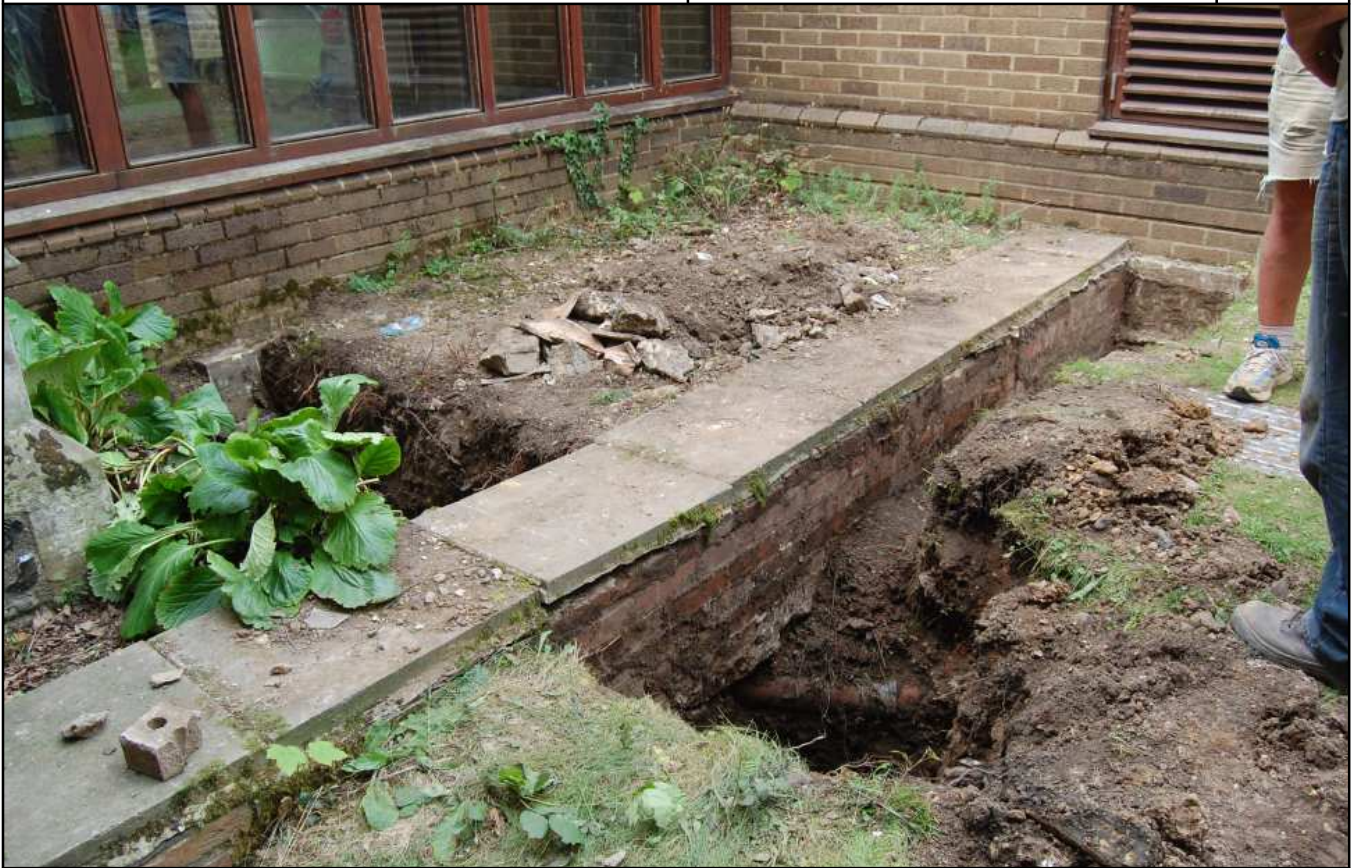
Plate 1: Extension footing, looking northwest.

2.7 The deepest excavations on the site were the footings for the extension to the lobby of the Church Hall. These revealed a stratigraphic sequence that began with at least 0.10m of yellowish brown (10YR 5/6) silty sand natural with moderate chalk flecks. Above this was 0.70m of dark greyish brown (10YR 4/2) sandy silt with frequent brick, tile, stone and cement fragments. The majority of the site was covered by 0.20m of black (10YR 2/1) sandy silt topsoil with frequent stones.

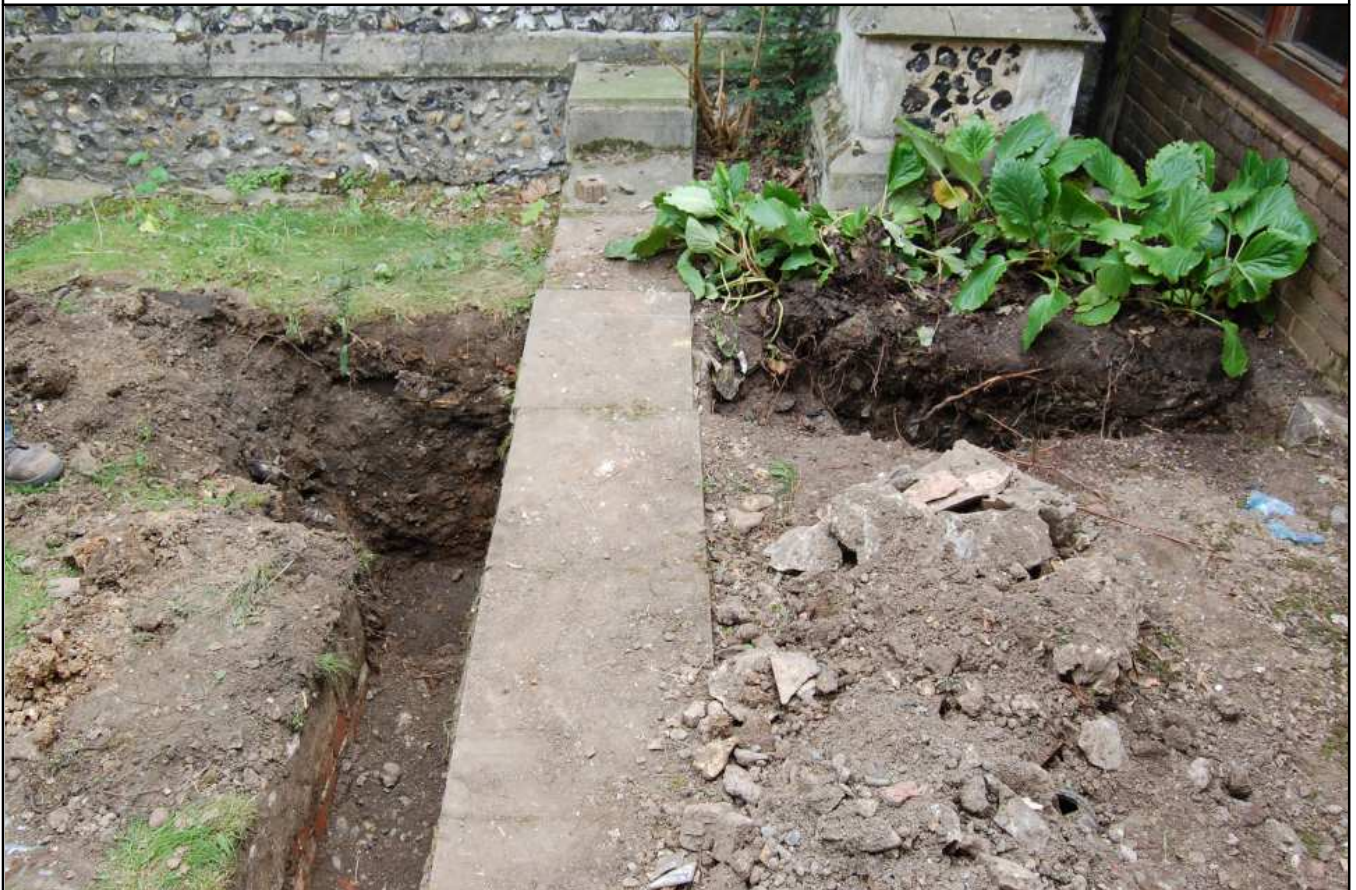
Plate 2: Extension footing, looking south.

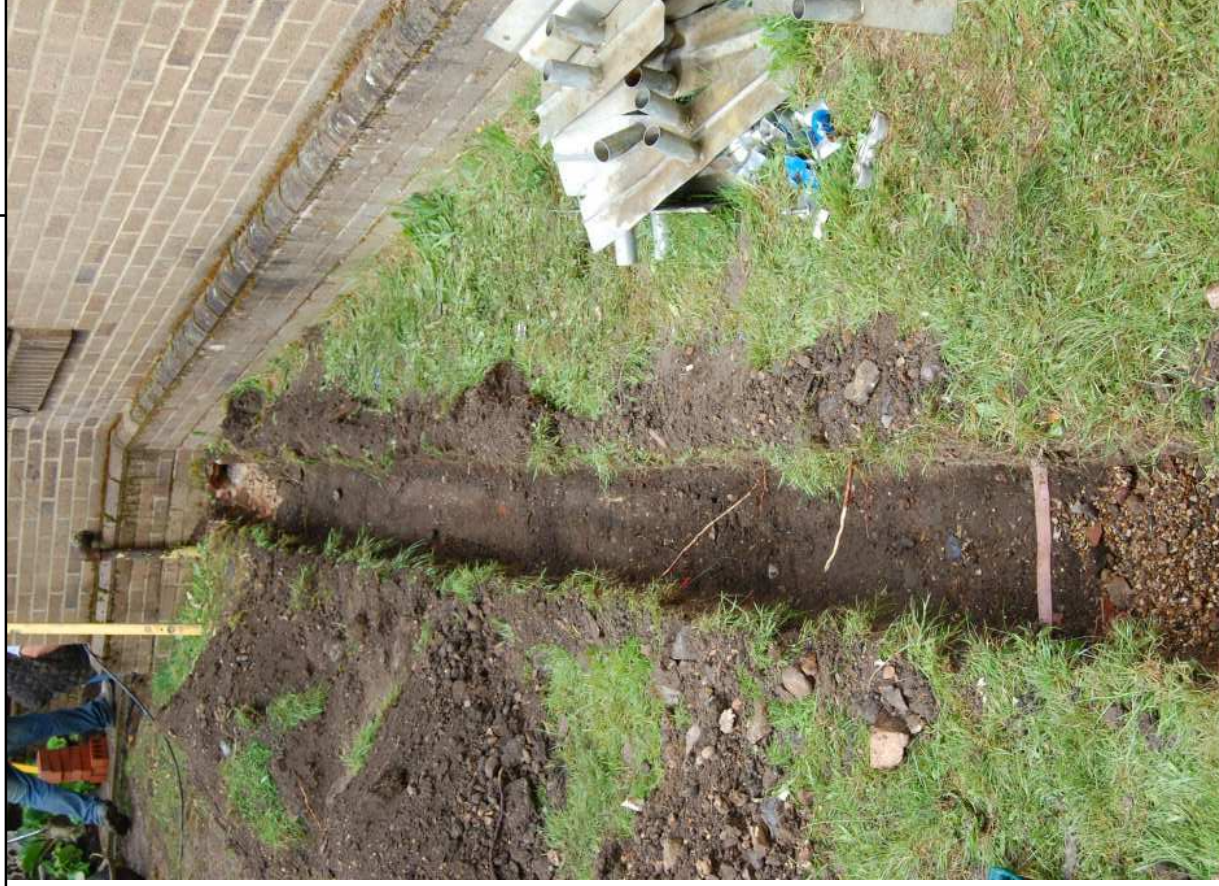
Plate 3: Service trench, looking west.

2.8 A service trench was excavated from the southeast corner of the Church Hall, along the southeast and east sides, to the north of the building. This trench was excavated to a maximum depth of 0.45m and exposed topsoil and the upper part of the graveyard soil below. No archaeological features or deposits were revealed during the groundworks.

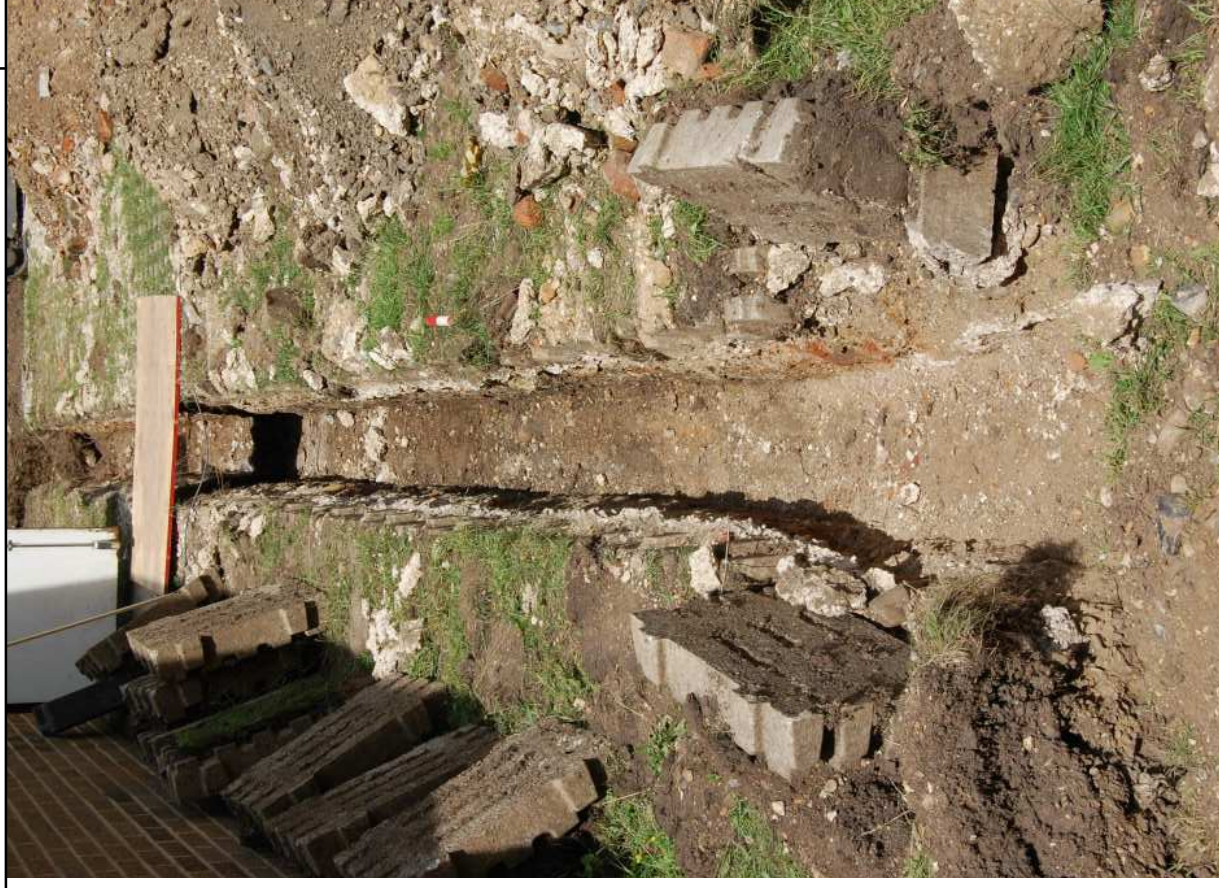
Plate 4: Service trench, looking north.

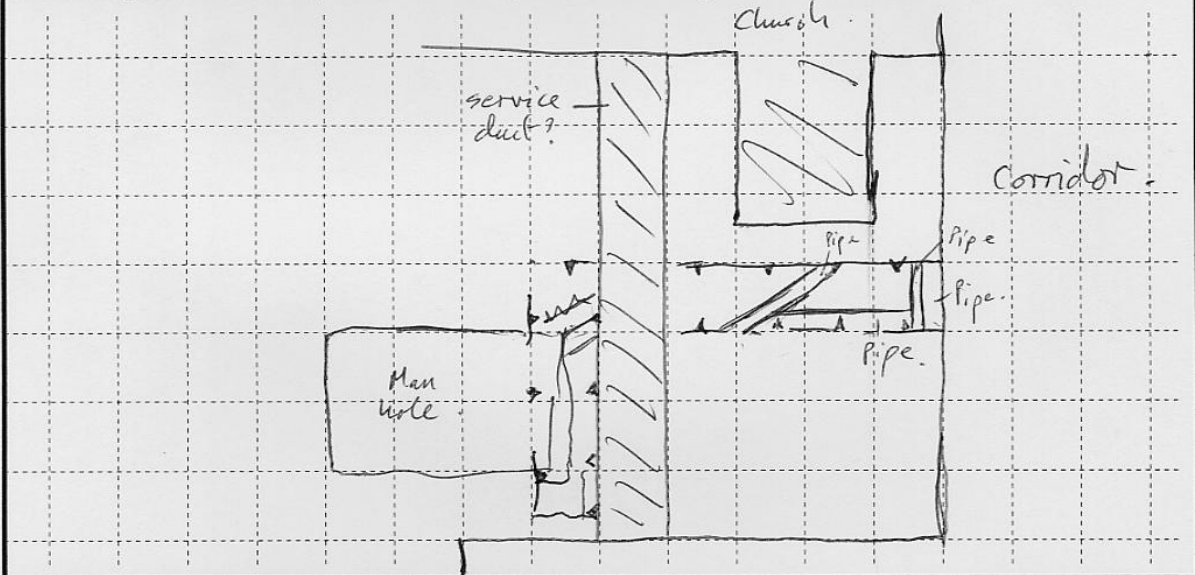
Sketch Plan (include all dimensions, north arrow and levels; remember to annotate)

SITE CODE HN 925.	Site Name	Map/plan reference	Project Phase	PLOT No 1
	Length 2.8 m x 2.5 m	Width c. 0.9 m	Depth 1 m	
	Machine Type 1/2 ton 360	Bucket Size 45cm.

Present land use:		Visibility (circle):	Poor	Moderate	Good			
Topsoil/ Overburden								
Colour Black	Composition sandy silt frequent stone	Depth	0.20 m.					
Subsoil								
Colour Dark greyish brown	Composition sandy silt + frequent stone, bricks, tile, frequent	Depth	0.70 m.					
Natural								
Colour Mid yellowish brown	Composition silty sand + mod chalk flecks	Depth	> 0.10 m.					
Observations (circle)	Archaeology	Root activity	Structure	Contaminat'n	Unstable	Land-drain	Other:
	Bur'd horizon	Burrows	Services	Flooding	Blank	Plough

Area very disturbed by former construction + services
