SHENLEY WATER TOWER **Shenley, Herts.**

Historic Building Report

Historic Building Record

Prepared on behalf of Fieldrise Homes Ltd.

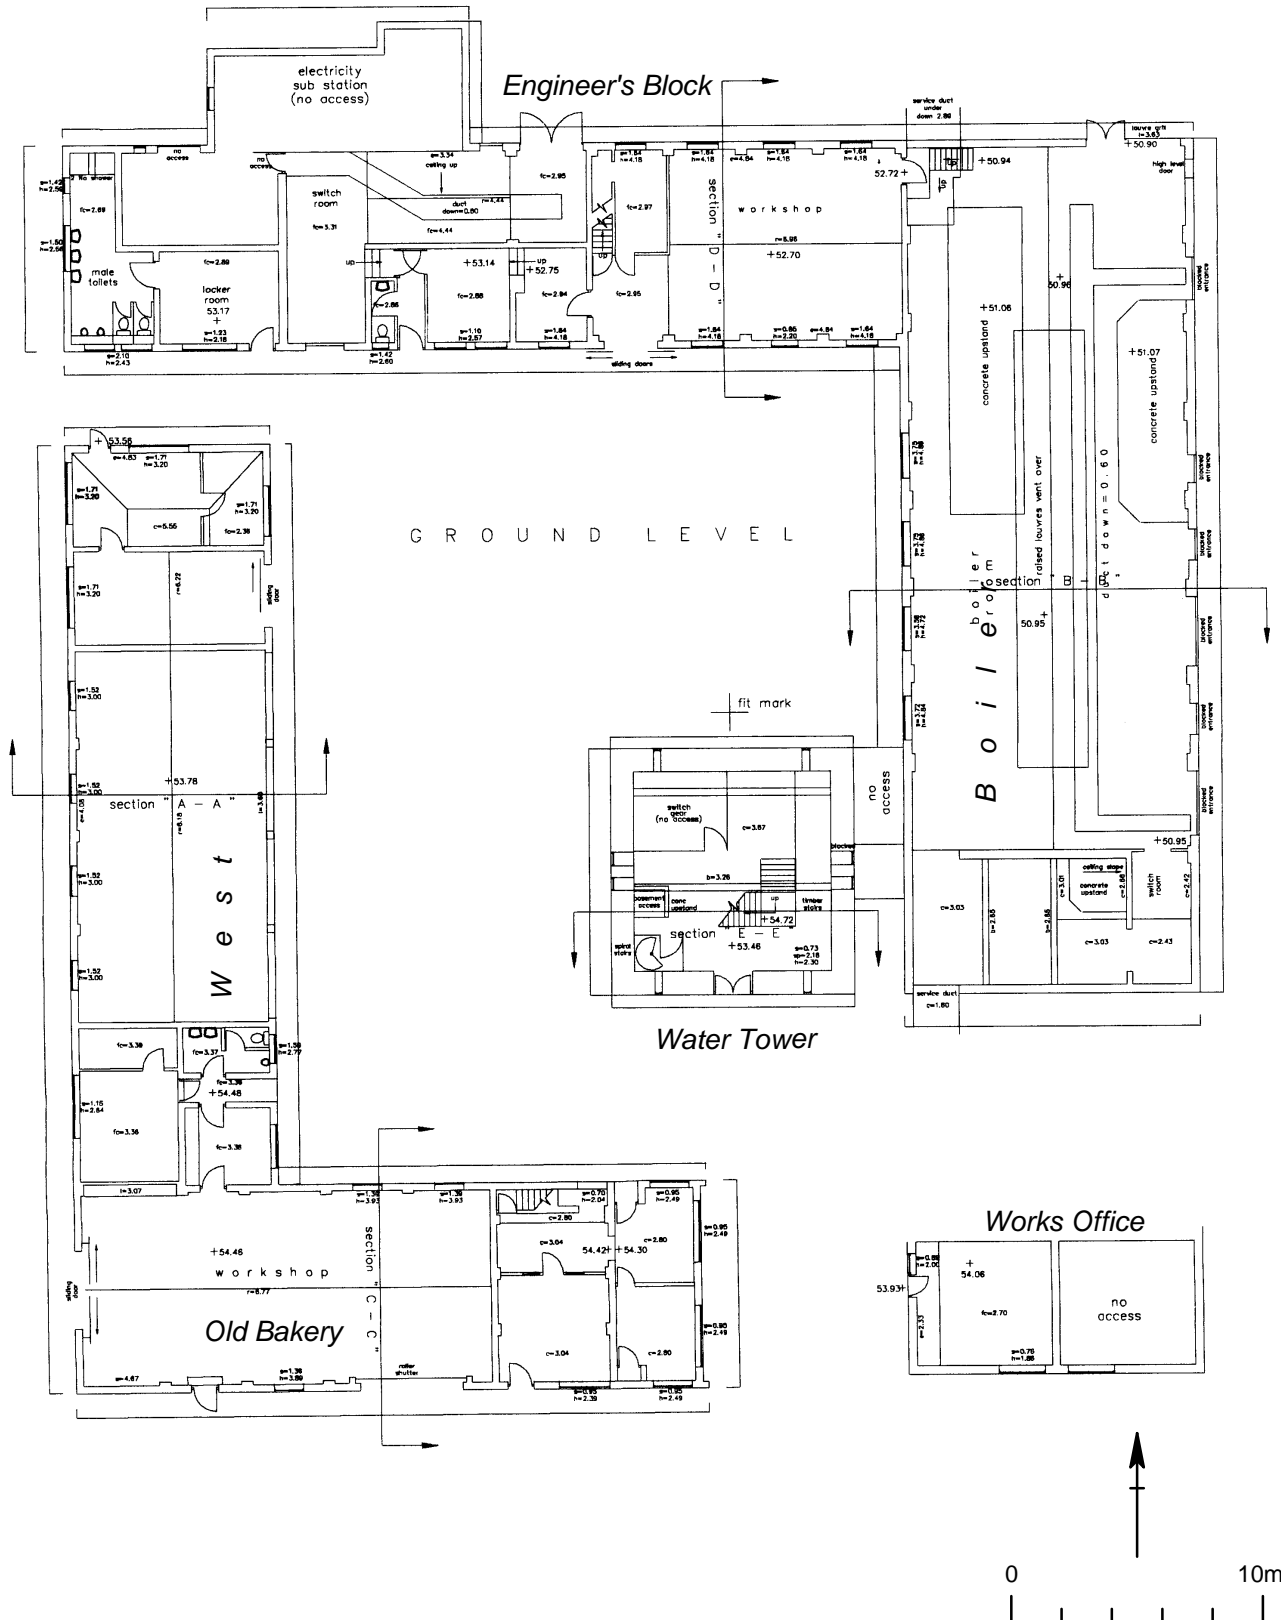
Figure 3

Site layout
(Courtesy of Derek Dredge Architects)

4.1 Shenley Water Tower and its ancillary buildings form one of the last surviving remnants of the Shenley Hospital Complex (Fig.3). The complex is located at the top of rising ground to the north-west of the village of Shenley and the water tower has long represented a landmark which can be seen for many miles in all directions.

4.27 Originally known as the Engineer's Block, the North Range now contains a workshop, offices, a kitchen, a store room, a locker room and a shower room (Fig.3).

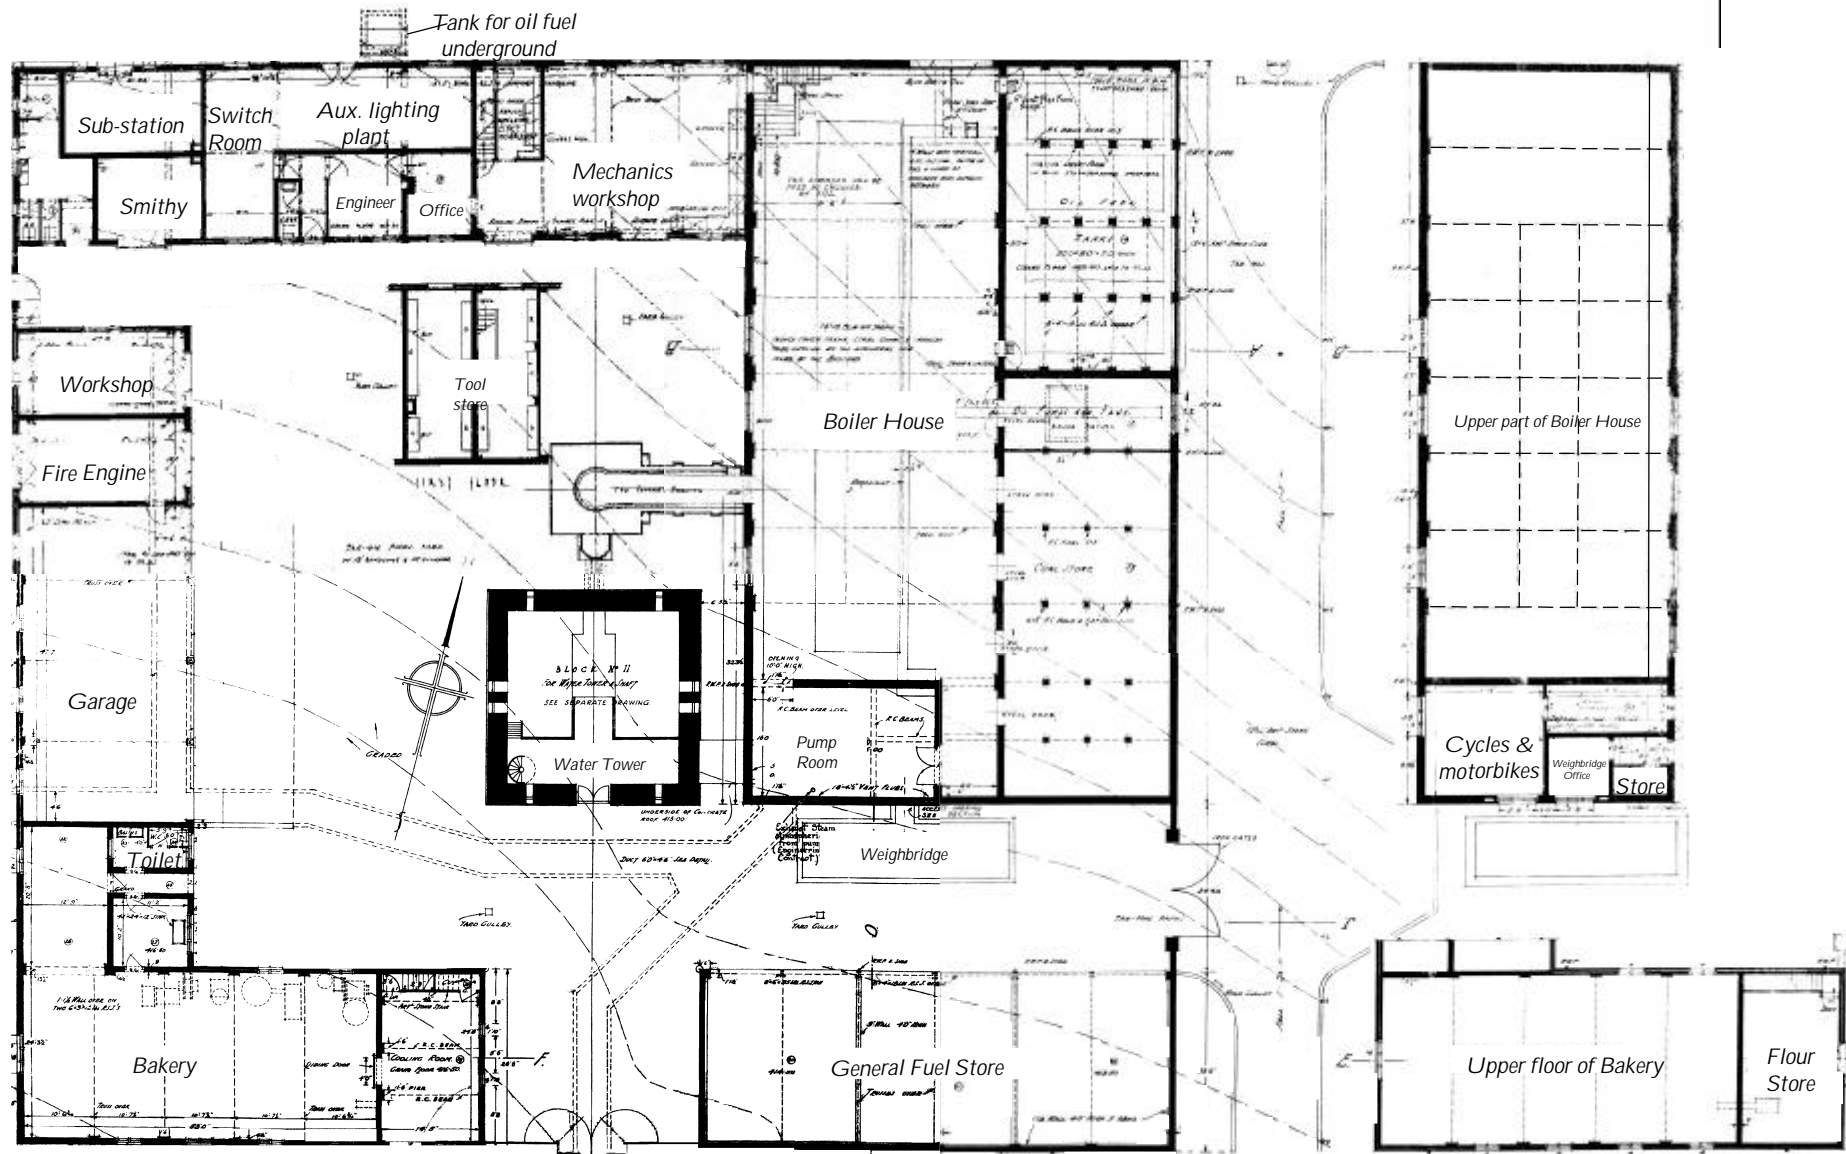
Figure 4

1935 Site Plan
(Based on original drawings held at the LMA)

4.2 The ancillary buildings occupy a footprint approximately 50m square with the water tower at the centre of the complex, but set slightly to the south (Fig.4). The eastern range is occupied by the boiler house, which originally incorporated fuel stores that have now been demolished. The northern range originally included the mechanics workshop (with a tool store above), a smithy and electrical plant. The western range incorporated a workshop, fire engine house, a garage and a scullery leading into the bakery, which occupied the western end of the southern range. Also in the southern range is a free standing building originally used as a fuel store and later converted to offices.

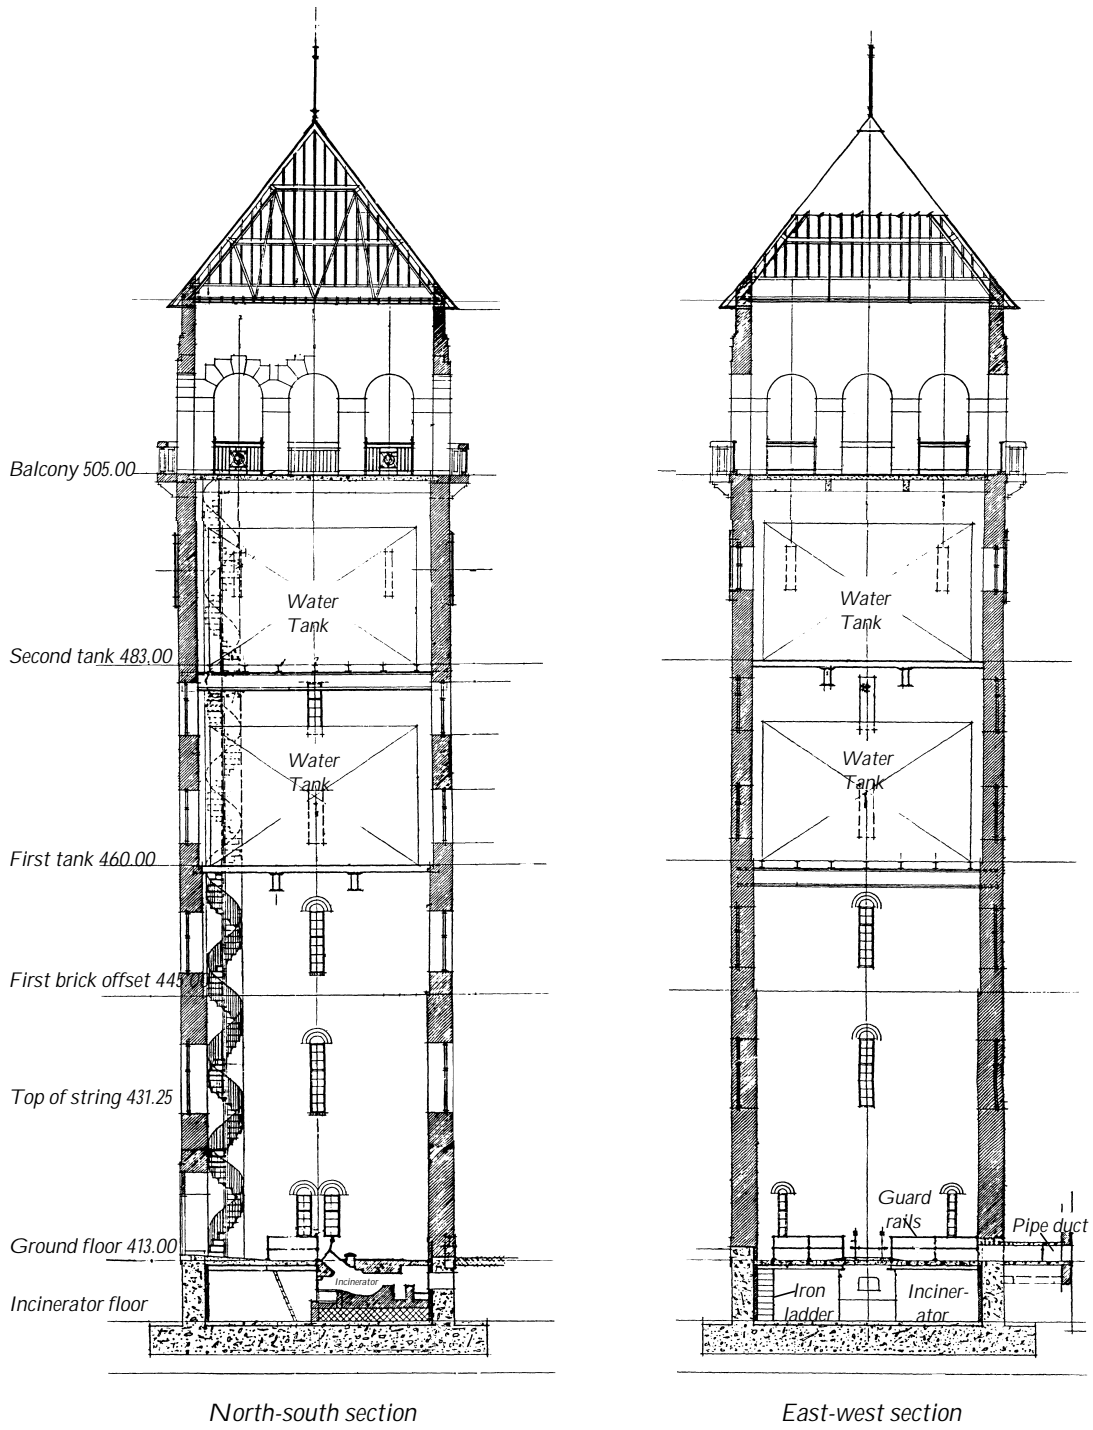
Figure 5

Water Tower: sections

4.6 The Water Tower was originally constructed to house both the water tanks and the hospital incinerator. The incinerator, which was in the basement, was linked to the chimney by a semi-subterranean flue. The bricked in remains of this are evident in the north wall of the Tower. As the basement was only accessible by an iron ladder, the incinerator was fed from the ground floor (Figs.5&8).

4.7 The water tanks, which measured approximately 7.40 x 7.40 x 5.0m, were located on two levels towards the top of the tower (Fig.5). The water was pumped from the wellhead in Queens Way, to the south of Shenleybury House, and supplied both Shenley and Harperbury Hospitals.

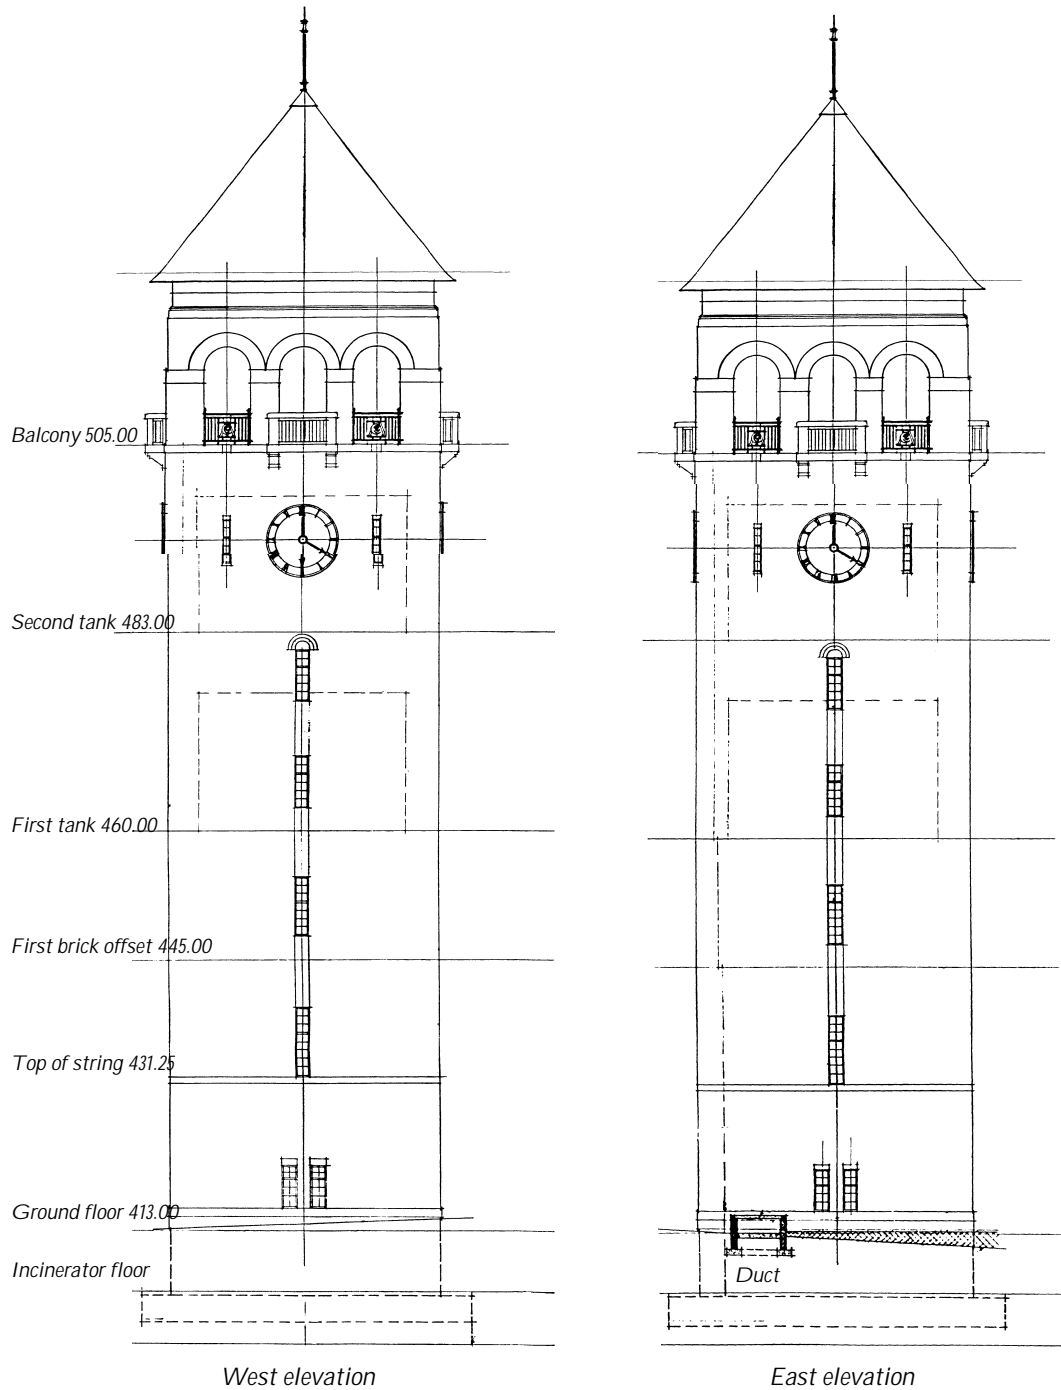
Figure 6

Water Tower: west and east elevations

4.10 The second tank level, which lies below the upper floor, has a clock on all but the north elevation (Figs.6&7). The clocks are flanked by a tall, narrow 5-light window on either side. Similar windows are present in the same location on the north elevation.

4.12 The east and west elevations have two neighbouring 10-light windows in the centre of the ground floor (Fig.6), which is not the case in the other elevations. The central area in the south elevation is occupied by an arched door with an artificial stone surround (Fig.7). Narrow 5-light windows lie on either side. The same window layout is maintained in the north elevation, but here the door is replaced by semi-subterranean duct leading to a chimney that was demolished between 1987 and 1989 (Fig.7).

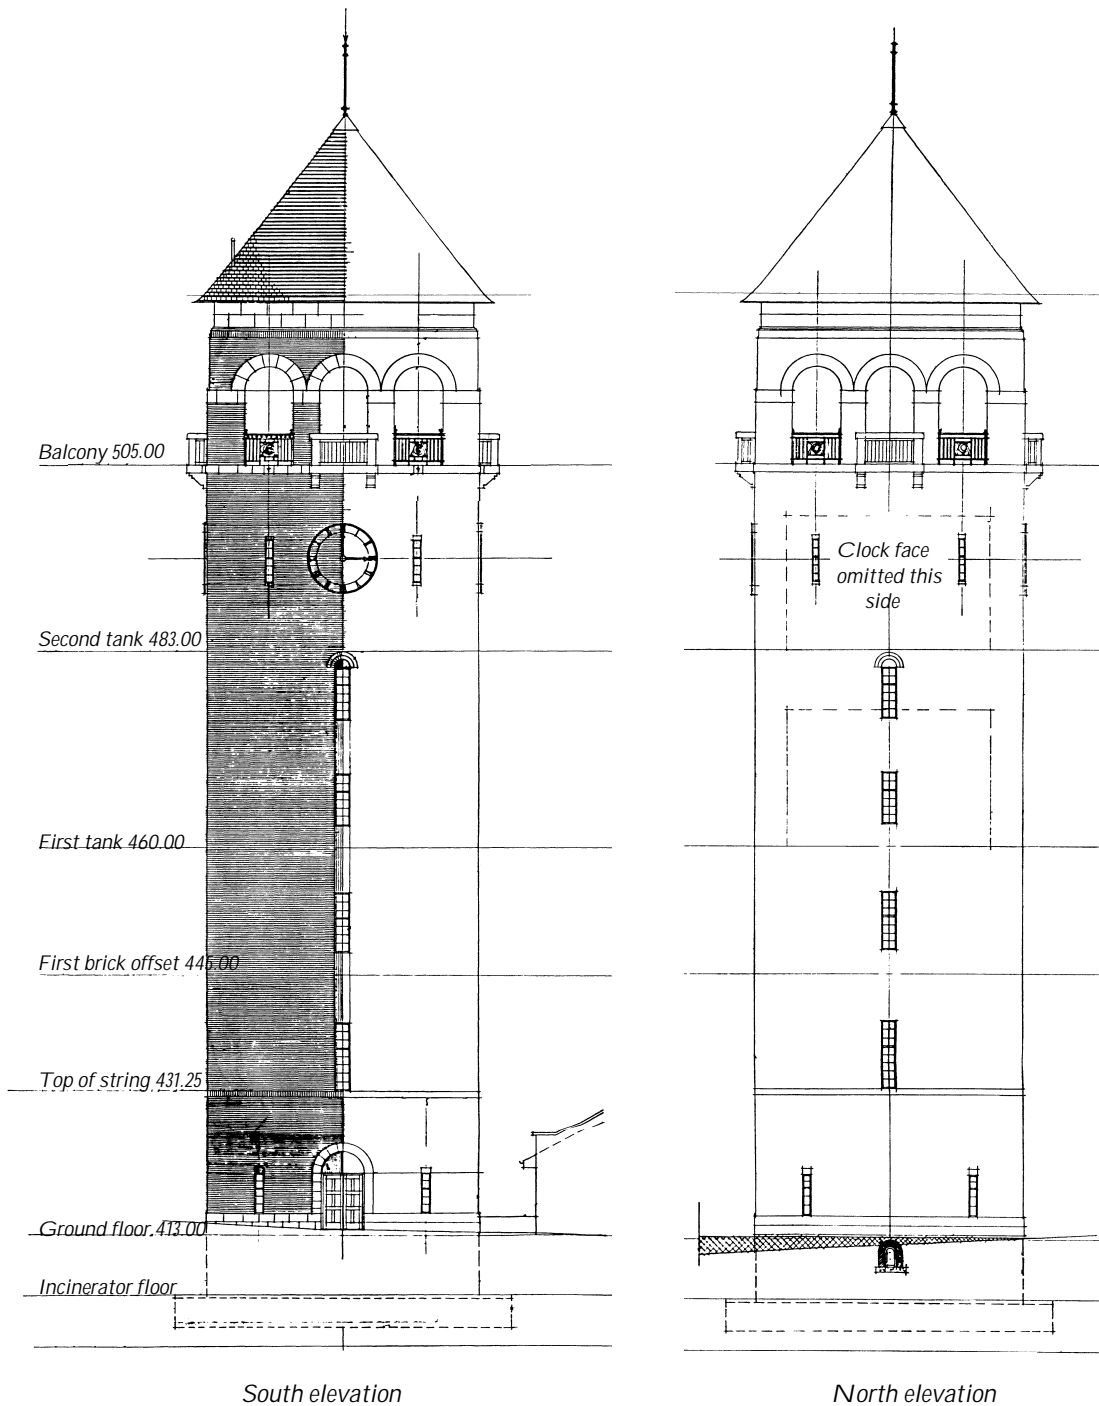
Figure 7

Water Tower: north & south elevations

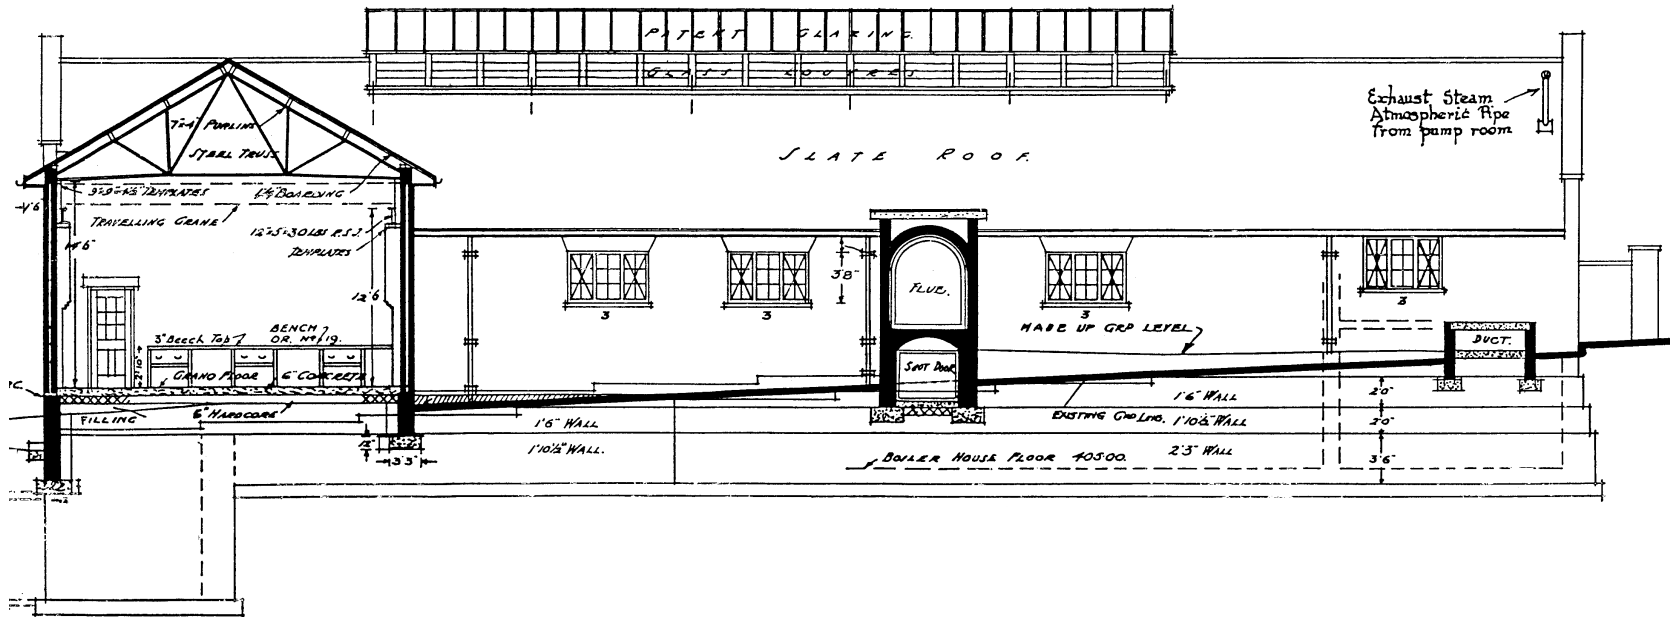
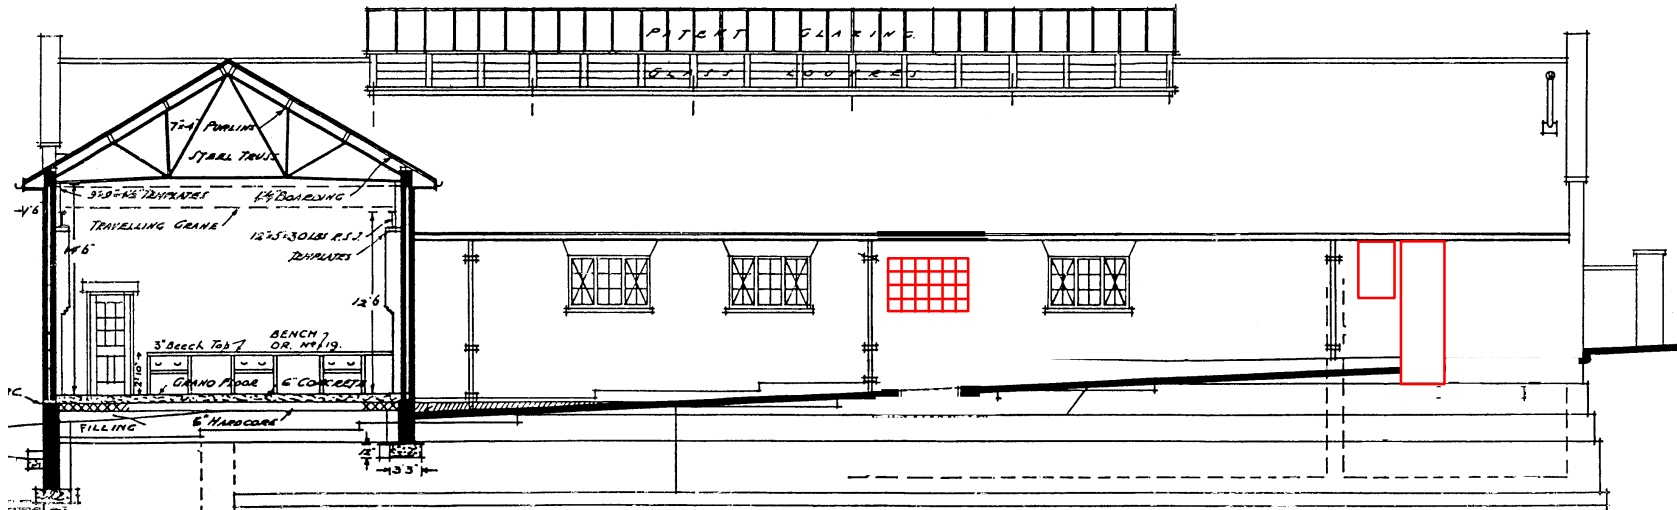
Figure 10

Boiler House: west elevation

4.25 The floor above the Pump Room originally housed a store, an area for bicycles and motorbikes and a weighbridge office. The weighbridge, for which there is no remaining evidence, was located immediately south of the range. Behind the weighbridge office and store was a room of unspecified function, which contained a ramp and shelves. No evidence for the original layout and function of these rooms survives as there is now only a single room, which may have latterly served as an office. An original 18-light window was replaced at the southern end of the west elevation by a new window and door to provide direct access into this office (Fig.10).

4.31 There are a series of buttresses in the north and south walls, which combine straight arrises in the upper part with rounded arrises in the lower part. The upper part is stepped out from the lower, and has a platform which supported RSJs which, in turn, appear to have supported a travelling crane (Fig.10).

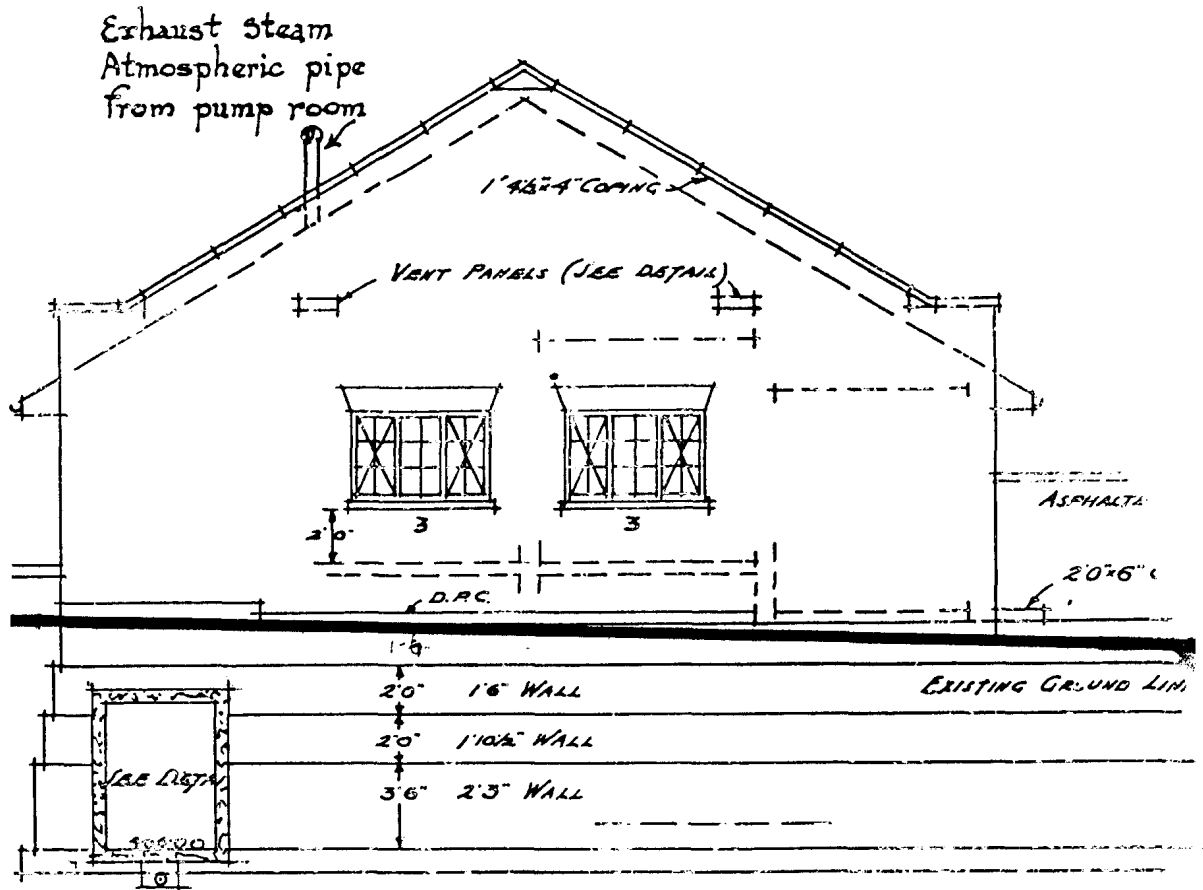
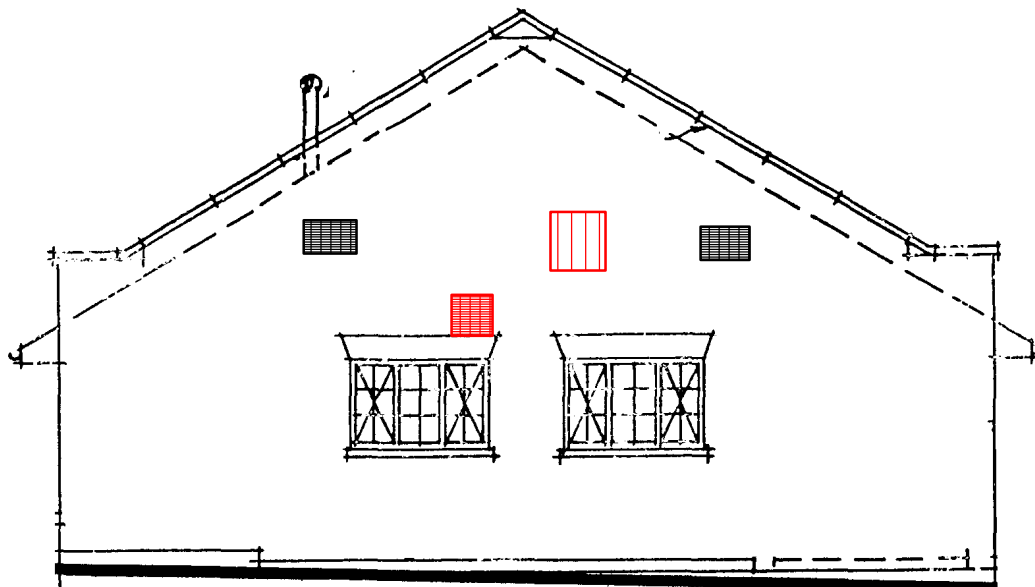
Figure 11

Boiler House: south elevation

4.26 A small door was added to the south elevation some time after 1935 drawings were completed. It is located above the eastern window and may have been associated with the weighbridge office (Fig.11).

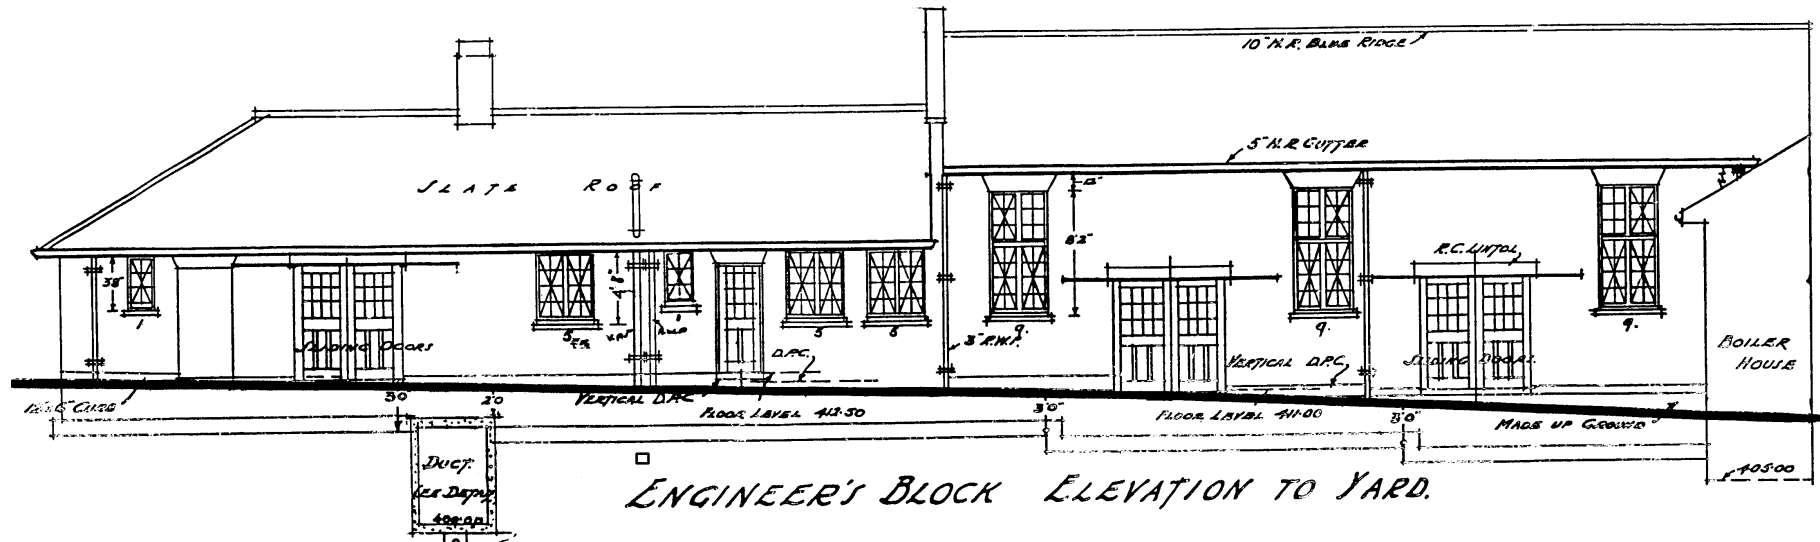
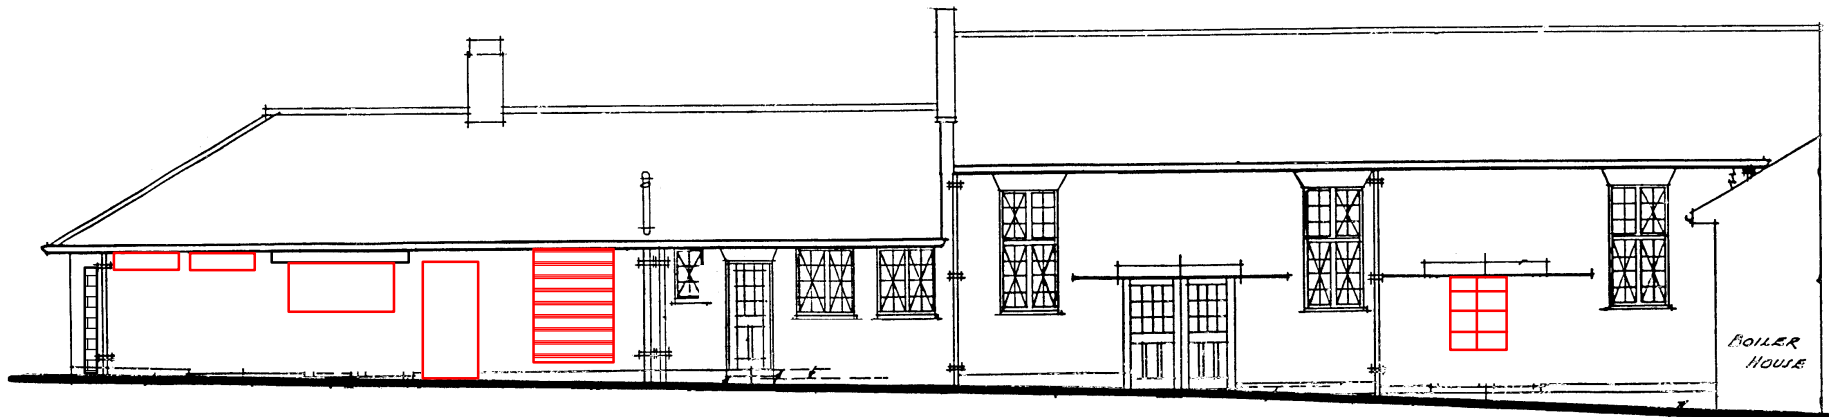
Figure 12

Engineer's Block: south elevation

4.28 The workshop, which is two- storey height, lies at the eastern end of the range. This was originally the mechanics' workshop and was entered by two sliding doors in the south elevation (Fig.12). A workbench was located at the eastern end of the room.

4.30 There are three tall 28-light windows in both long elevations and an additional 8-light window in the south elevation where a sliding door used to be (Figs.12&13). The lower part of the original windows are casements, and the upper part opens with a winding mechanism.

4.40 This was originally a smithy, which was accessed by a sliding door in the south elevation. This door has now been replaced by a single door and a modern window to its west (Fig.12).

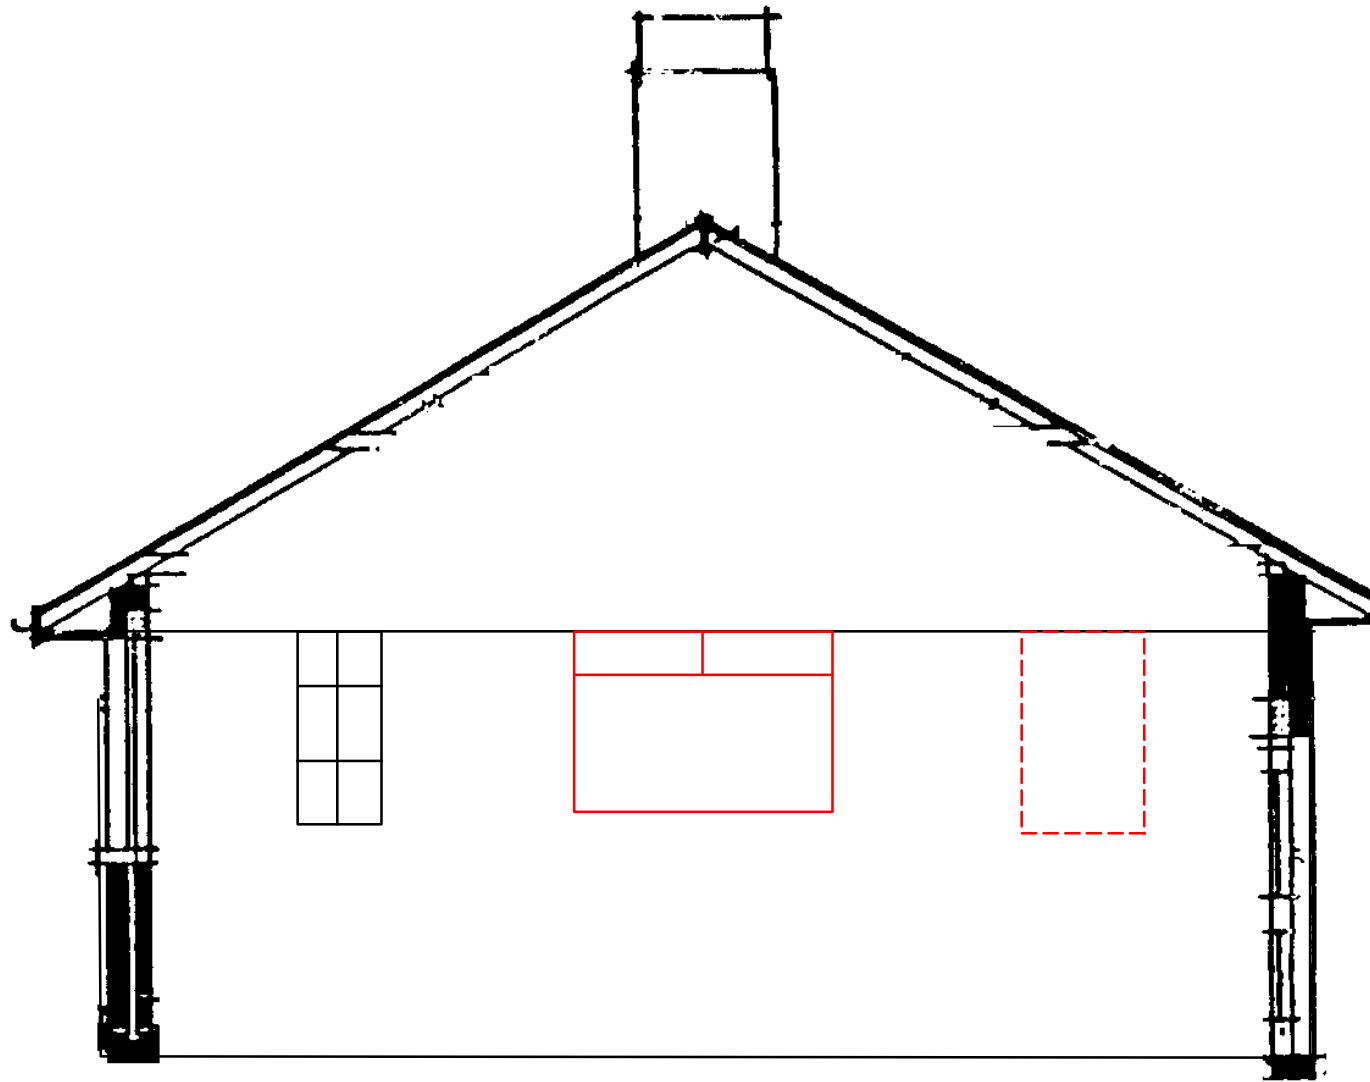
Figure 14

Engineer's Block: west elevation (2003)

4.43 Although the function of this room has remained fundamentally the same, a number of alterations have occurred to the fittings and the structure. Whereas it was originally accessed by a passage in the south elevation, it now has a door from the Locker Room and the passage has been converted to provide two toilets. Two small single light windows have replaced the original 6-light window in the south elevation (Fig.12). A further modern window has been added in the west wall above the basins. To the north of this is an original 6-light window, and to its south is a window of similar size, which may have been bricked up when this part of the room was converted to house urinals (Fig.14).

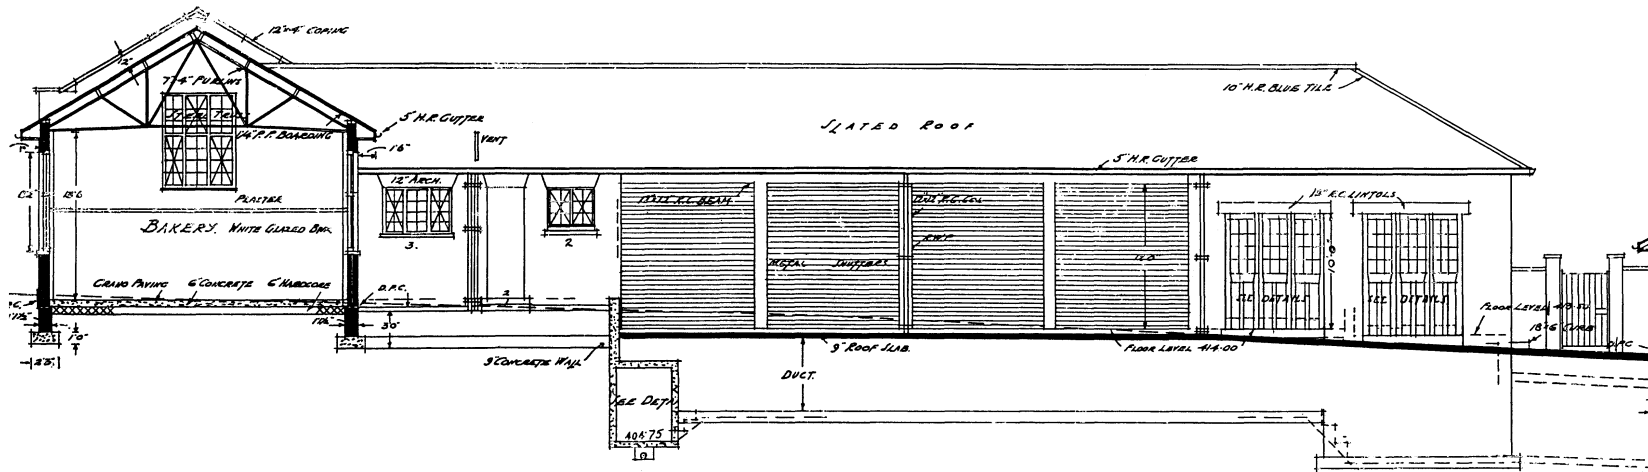
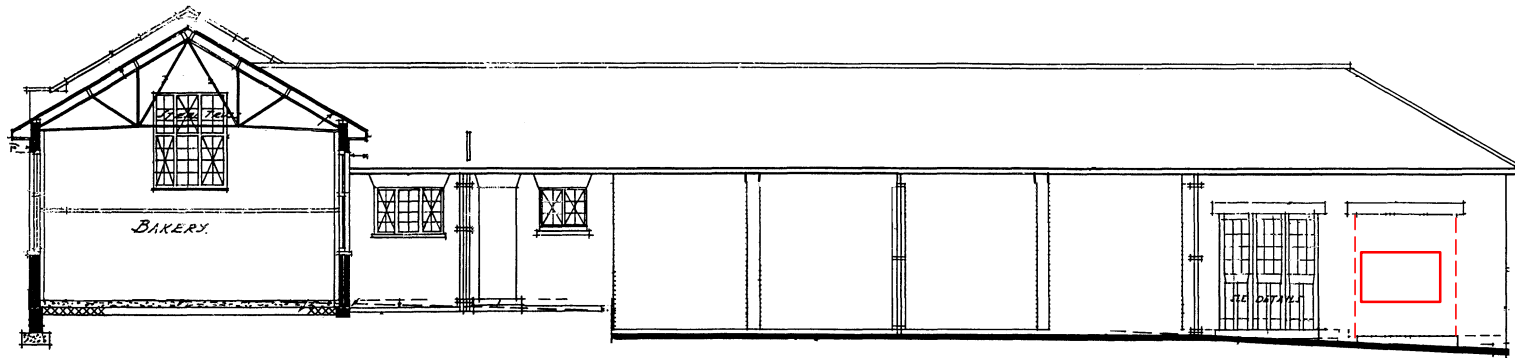
Figure 15

West Range: east elevation

4.47 The Old Workshop originally had a sliding door in the east wall, a 16-light window in the west wall with a workbench below it and an inspection pit in the centre of the floor. The door has been replaced by a modern window, which could not be inspected as it is now protected by plywood on the outside and the room is inaccessible. The window in the west elevation has been replaced by a 5-light window in a metal frame. Although it is clear from the original plans that a door has been inserted into the north elevation, it is not certain whether the window has been replaced, as is suggested by the addition of the concrete lintels (Figs.15-17).

4.50 This was originally the fire engine house and had sliding doors in both the east and west elevations (Figs.15&17). Although that in the east elevation has survived, the sliding door in the west elevation has been replaced by a window similar to that in the west elevation of the Old Workshop. A blocked door in the south wall leads into the open fronted garage.

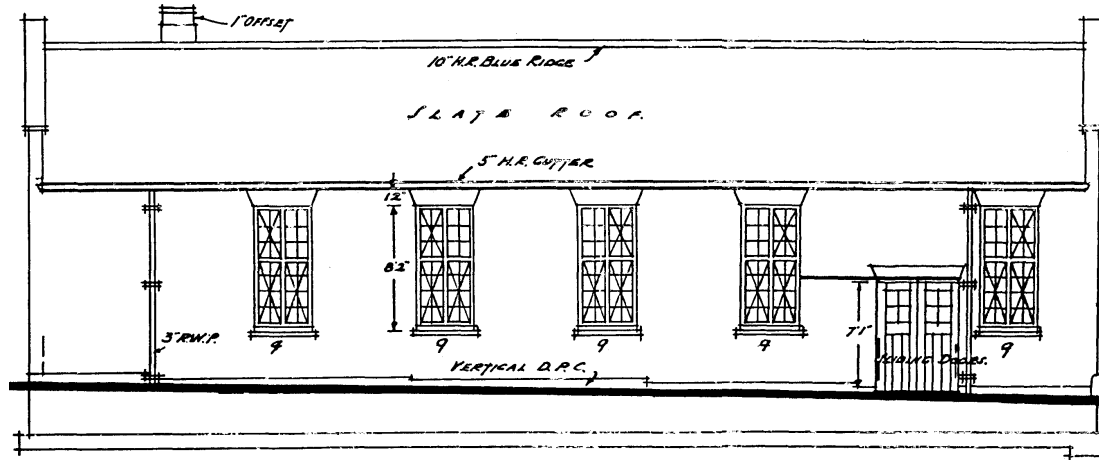
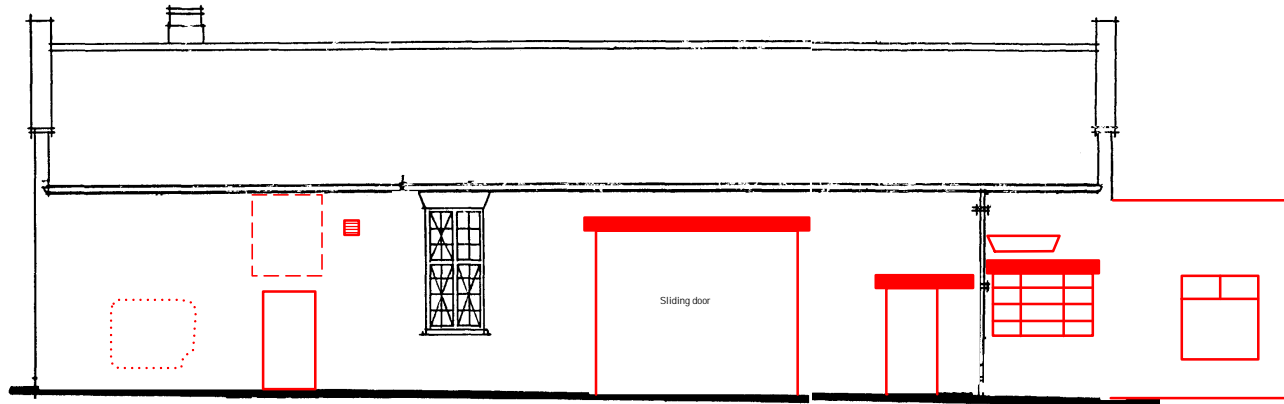
Figure 18

Old Bakery: south elevation

4.63 The south elevation has undergone considerable alteration (Fig.18). Two of the original 28-light windows have been replaced by a sliding door and the original sliding door has been replaced by a single door. The original window at the western end of the elevation has also been replaced by a single door. Between this door and the end of the external wall is an area that has been painted, and within this the outer skin of brickwork has been removed. An undated photograph supplied by the clients' architects shows that there was an extension to the west of the original window, which has now been demolished (Plate 3).

4.65 This was originally the cooling room with a staircase in the north-west corner. The original sliding door and 28-light window in the south elevation have been replaced by a single door and a 12-light window set in a metal frame (Fig.18). This window may be a second replacement as the relieving arch above it is too low to have been over the original window. A 16-light casement window in a metal frame has been inserted into the north elevation (Fig.19). Below this is a basin set into the recess under the stairs.

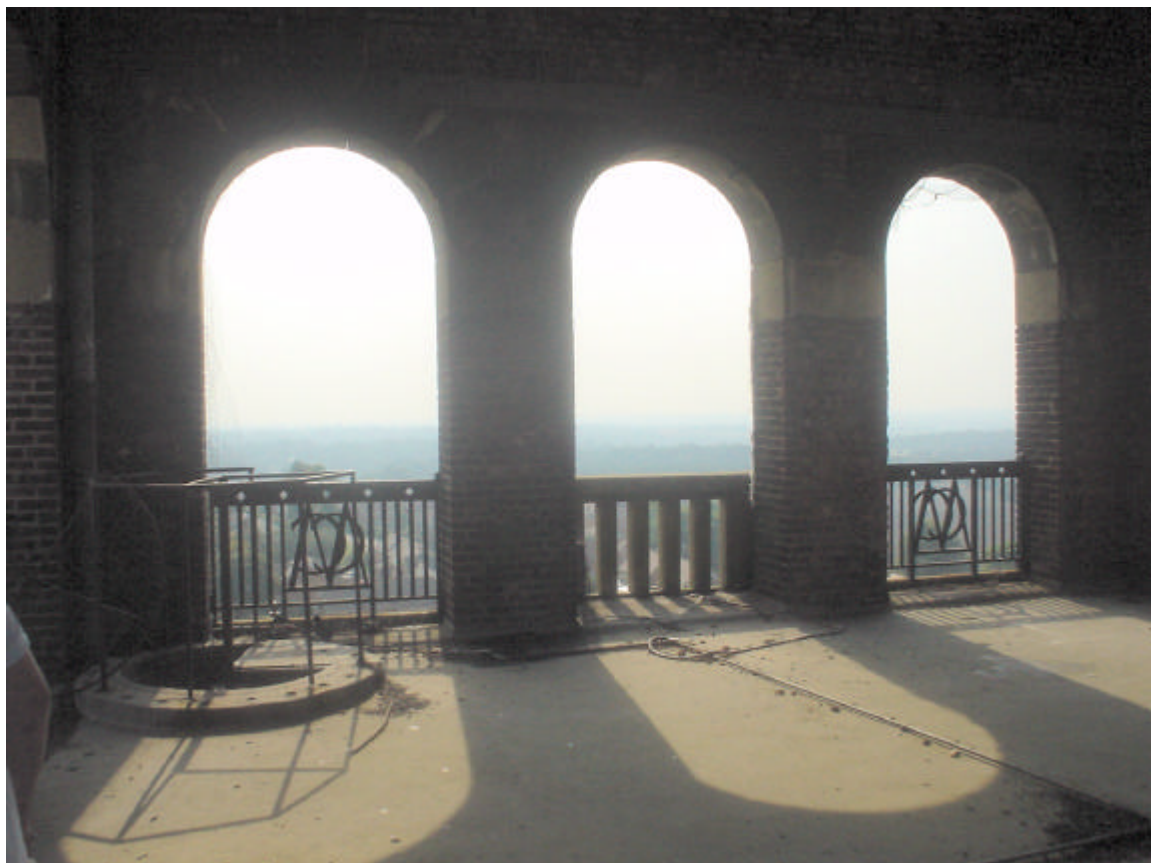
Plate 1b

Tower arches
(Courtesy of the Robert Lombardelli Partnership)

4.9 The upper floor of the Tower has three arched openings on each side, the central one of which leads onto a short balcony. The half-height iron railings in the neighbouring arches are decorated with the initials MCC (Pls.1b&3b). The arches and the frieze below the roof are all made of artificial stone.

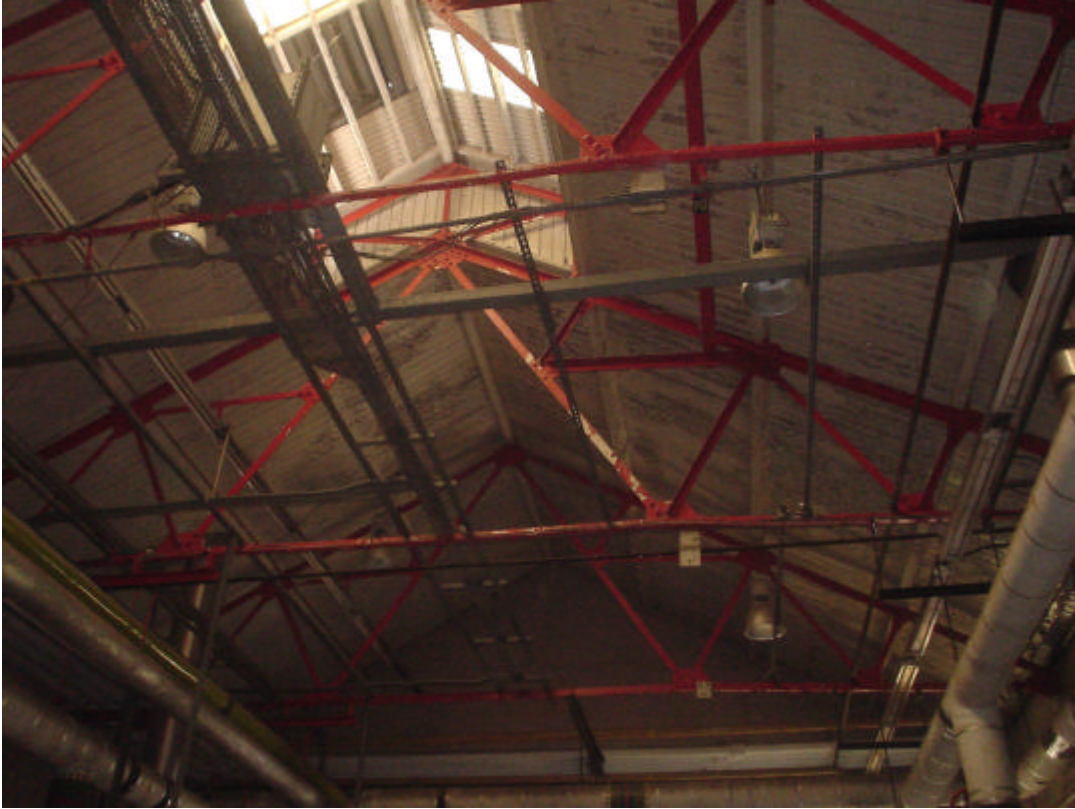
Plate 2a

Boiler House roof truss
(Courtesy of the Robert Lombardelli Partnership)

4.16 The walls are painted (probably white originally) and the floor is concrete, with steel plates covering the ducts. The wooden ceiling, which is also painted white, has three purlins on either side. The whole is supported by metal trusses that have been painted red (Pl.2a).

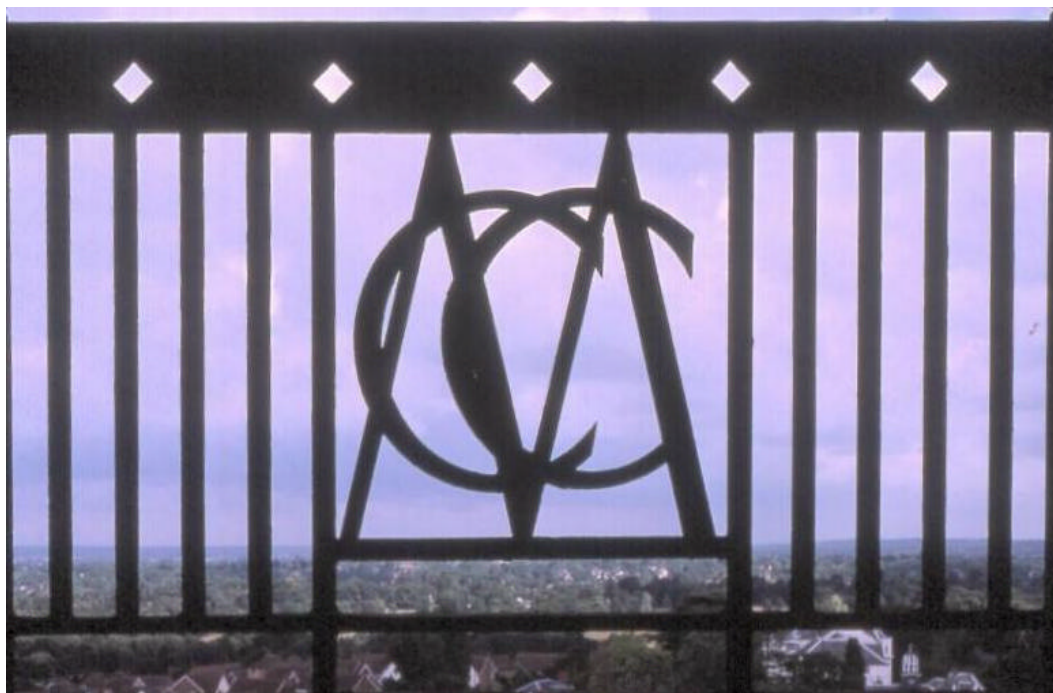
Water Tower: balcony level railing detail (photo reversed)
