HARLOW MILL GOODS YARD, Harlow, Essex

Archaeological Monitoring Report

Prepared on behalf of Aggregate Industries UK Ltd

Report no.221

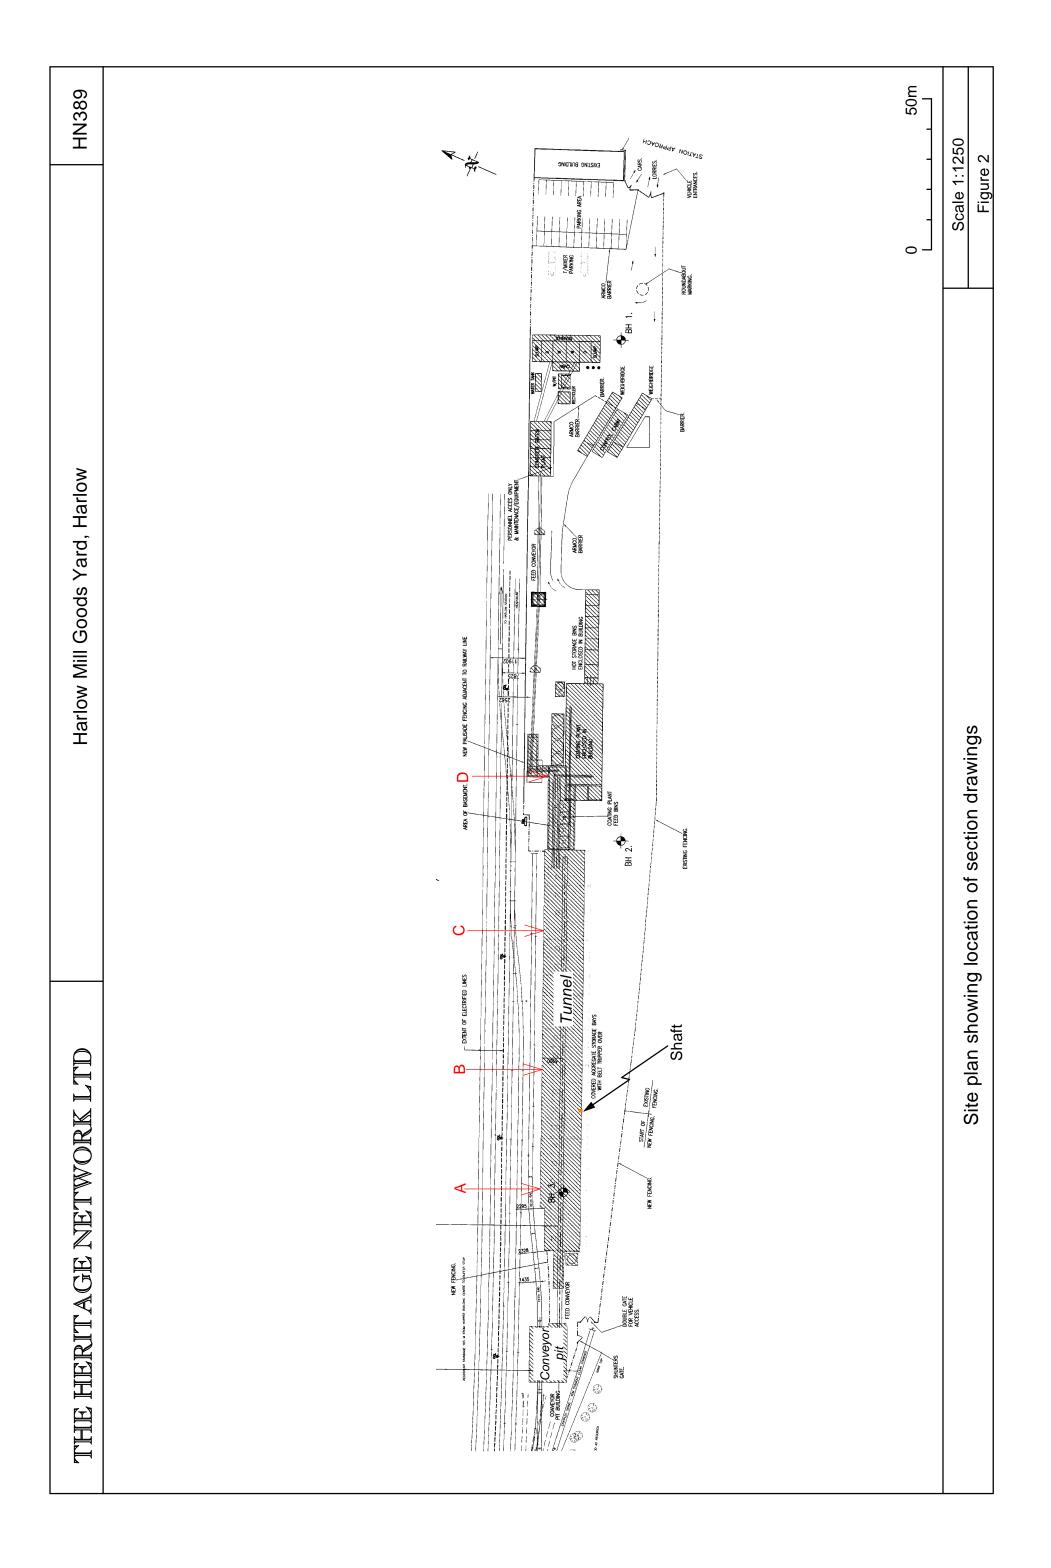
1.2 The site is located immediately to the south of the main railway line and southwest of Harlow Mill Station, centred on NGR TL 4700 1220 (see Figure 1). The site consisted of a disused railway siding which had previously been redeveloped with light industrial units on its northern half and open storage areas on the southern half. The present development involved the construction of a rail-fed aggregates discharge facility, an asphalt plant, a concrete batching plant, and ancillary facilities (see Figure 2).

2.1 The site covers an area of approximately 2 hectares, and consists of a narrow strip of land measuring approximately 550m east to west and a maximum 50m north to south (see Figure 2). The site is situated on level ground to the south of the River Stort, at approximately 50mOD.

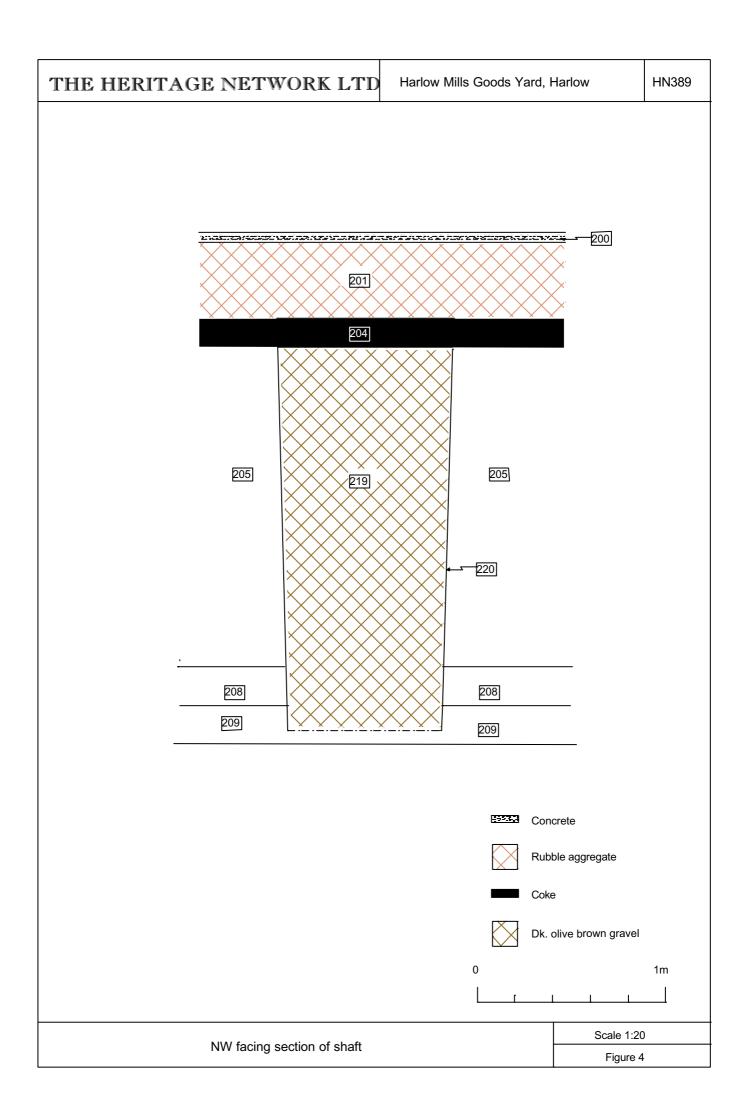
3.9 A single modern feature [220] was observed in the conveyor tunnel (see Figure 4). The feature appeared to be sub-circular with steep straight sides and measured approximately 0.95m wide by at least 2.00m deep. It was cut through the modern levelling deposits from below the ash and coke layer, (204), and continued below the limit of excavation for the tunnel. The feature contained a single fill (219), which consisted of a dark olive brown gravel. The purpose of the feature is unclear.
