REDBOURN VICARAGE
Church End, Redbourn, Herts.

HN462

Archaeological Evaluation Report

Report No.239

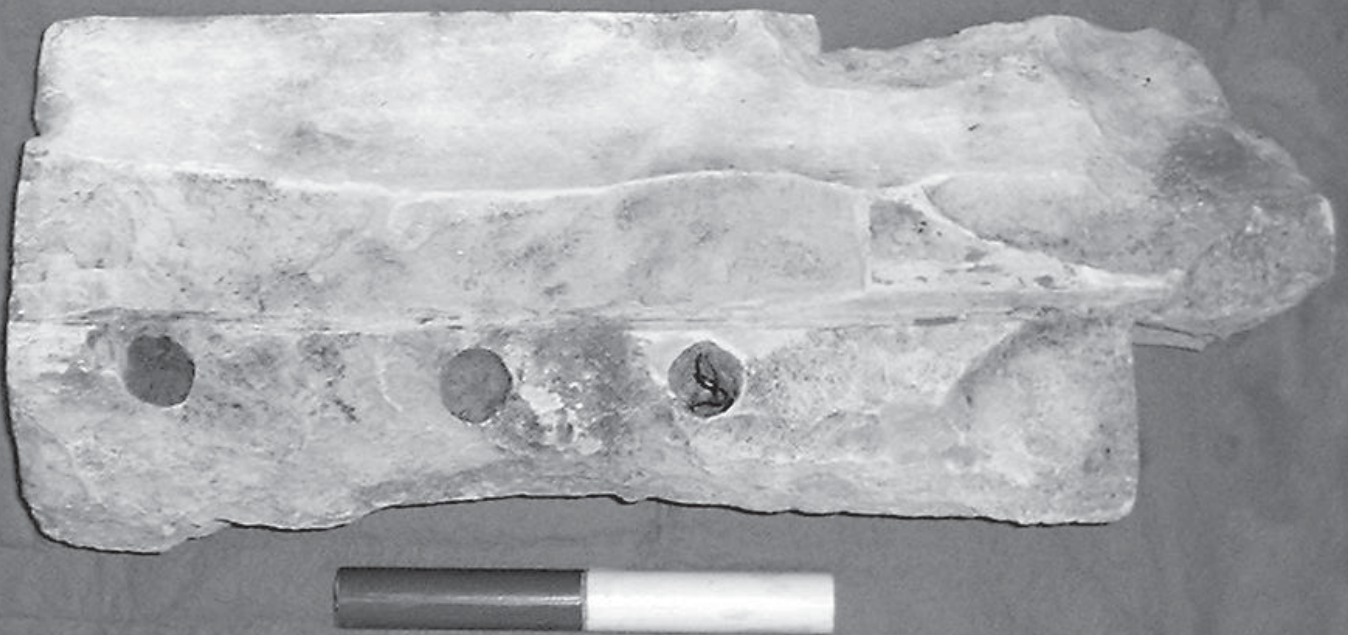
The cover photo shows a fragment of window mullion formed from Totternhoe church, recovered from the site

2.29 A single large fragment of worked clunch was recovered from context (204). The fragment measures 490mm long by 210mm wide by 100mm deep, and is of Totternhoe clunch, and is probably of 14th century date. It has three holes passing through its rear which are possibly for transoms, one of which still contains a fragment of clunch plug, glazing grooves are apparent on both sides. The fragment most likely represents a piece of window tracery, probably a central mullion, and may have originally been either part of the church structure or of an earlier vicarage.

3.7 A probable Victorian outhouse was recorded, but no direct evidence for the medieval parsonage which is believed to lie on or close to the site of the present vicarage. It is possible, however, that the fragment of stone window mullion recovered from the infill of the Victorian outhouse, may derive from the parsonage or another nearby contemporary building.
