## **BOUNCES FARM BARN** **Gosfield, Essex**

***HISTORIC BUILDING  
RECORD***

Project ref: HN950  
Site Code: BFGF11  
Planning refs: 09/00807/FUL

Report no.771

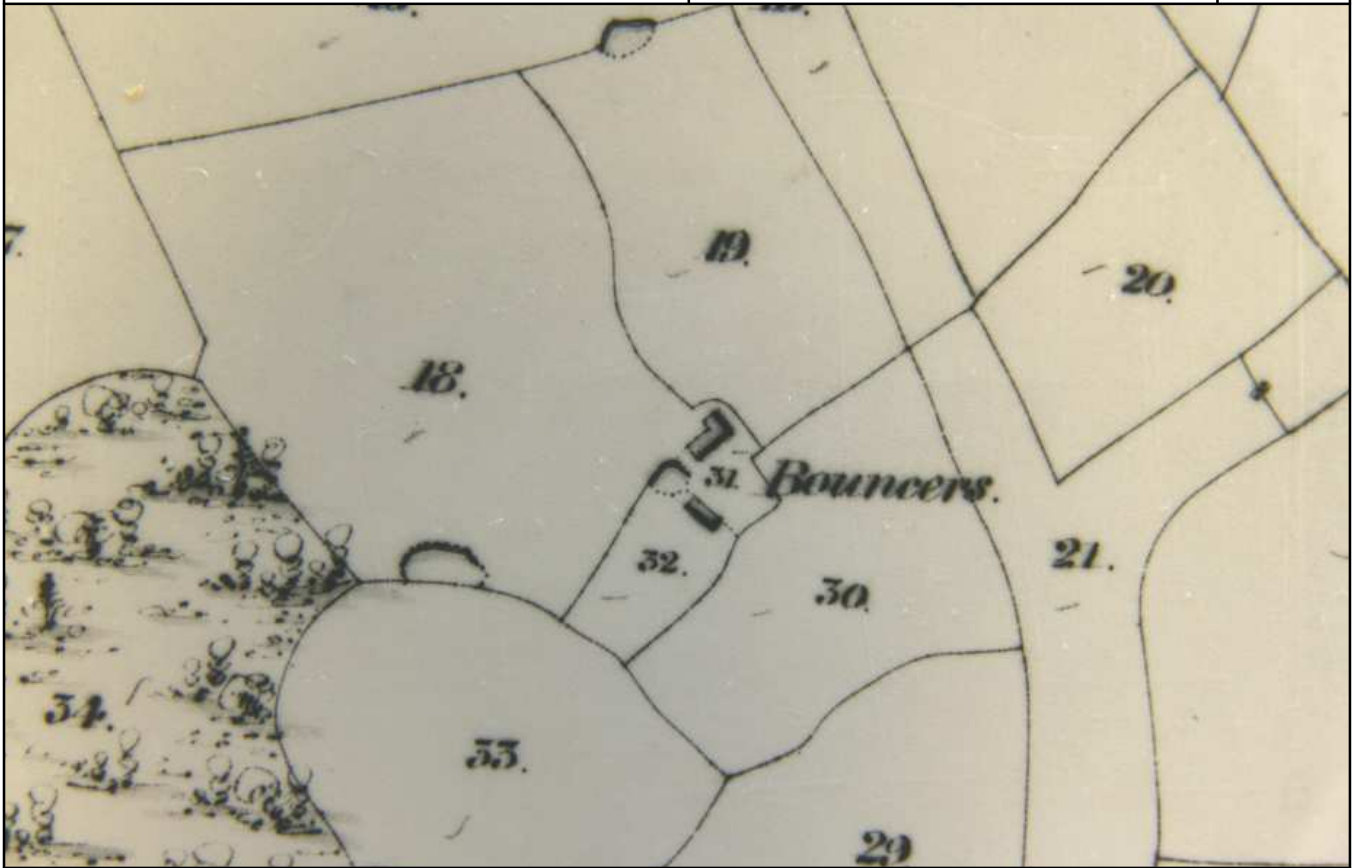
Figure 4

**2.11** The Tithe map of 1844 (ERO D/CT 151B) shows the site in some detail (Figure 4). An L-shaped building is marked, with a rectangular structure to the south. A pond is shown at the angle between the long range of the L-shaped building and the rectangular structure. At this period the farm is called 'Bouncers'.

Gosfield Tithe Map, 1844  
(ECRO D/CT 151B)

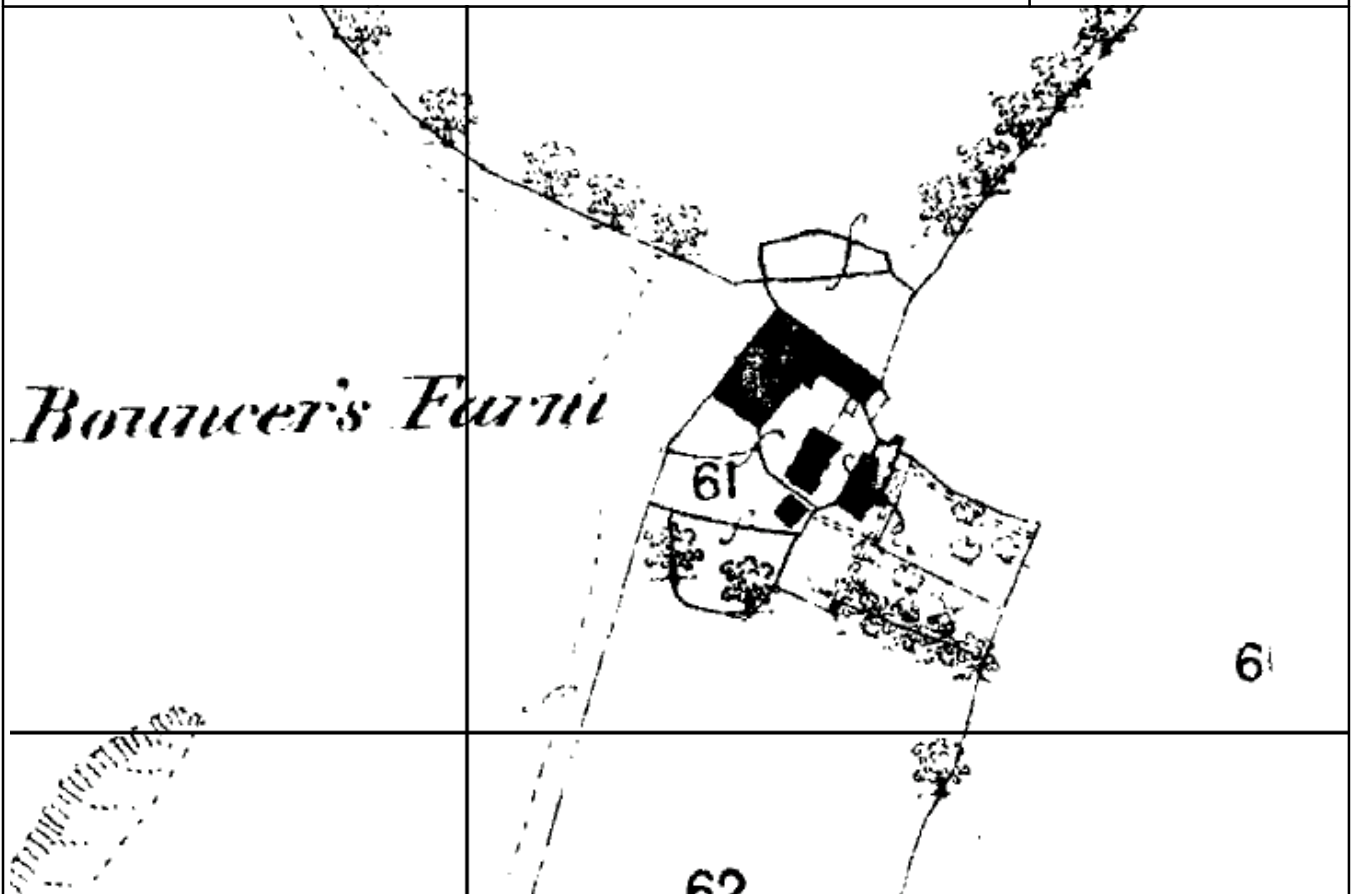
Figure 7

**2.14** The OS 1<sup>st</sup> edition 25" County Series map, dated 1876, shows significant change to the layout of the farm with the pond and the boundaries providing constant indices (Figure 7). The building to the east of the pond has disappeared and the L-shaped building in the north-west corner of the farmyard has been replaced by another, larger, L-shaped building on a different orientation. Buildings 1 – 4 form the western range to this structure, while Building 6 occupies part of the eastern range.

Ordnance Survey, 25" County Series, 1st Edition, 1876

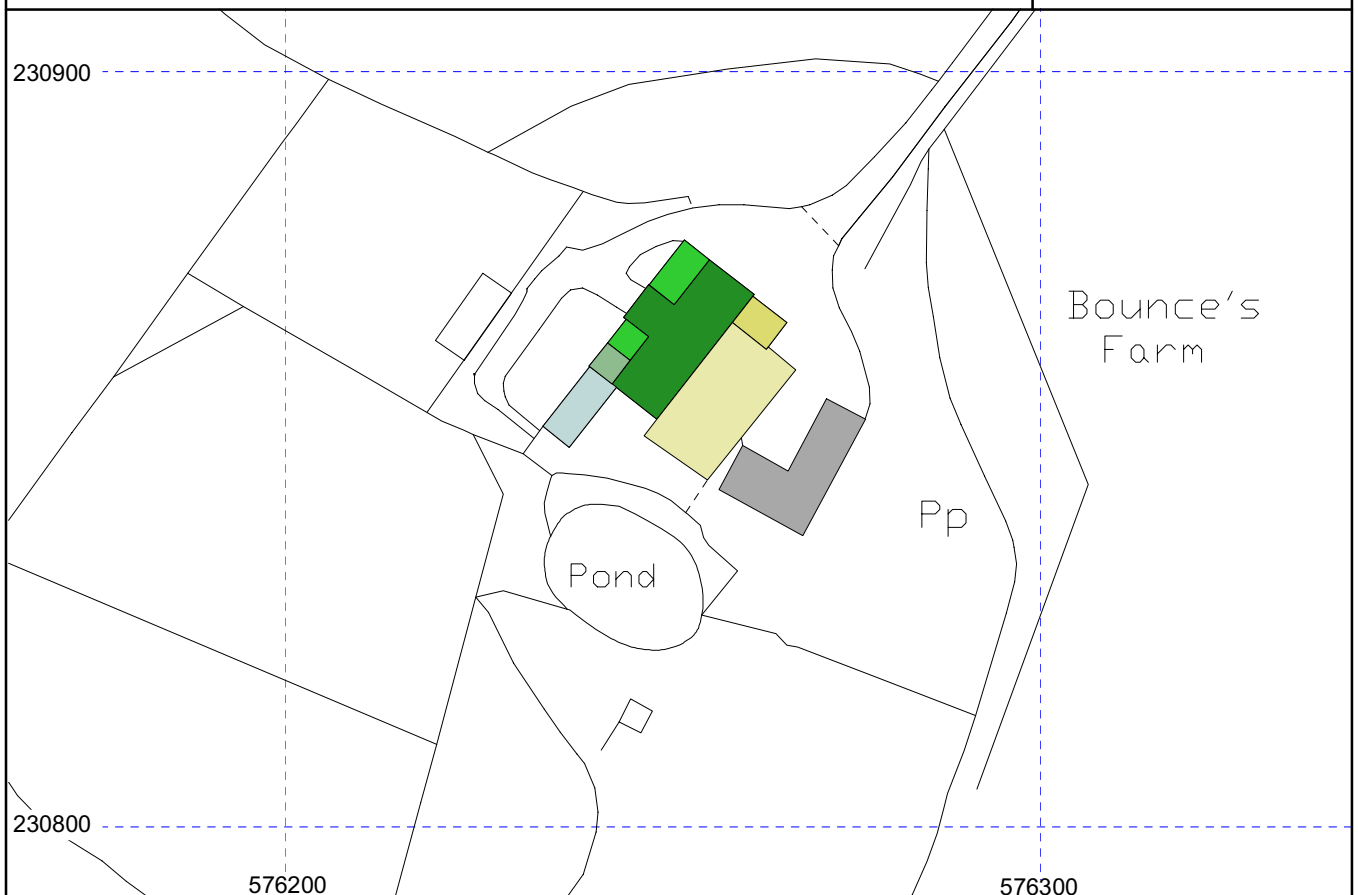
Figure 11

**2.18** The OS plan of 2011 shows significant change to the layout of the barn and its immediate environs (Figure 11). A large new building, which occupies the area of the former farmyard, has been added to the south-eastern elevation of the barn (Building 7).

**2.18.1** The eastern range to Building 1 has been demolished and replaced with a square block (Building 6). The building record demonstrates that this is a modern single storey garage.

Ordnance Survey, 2011

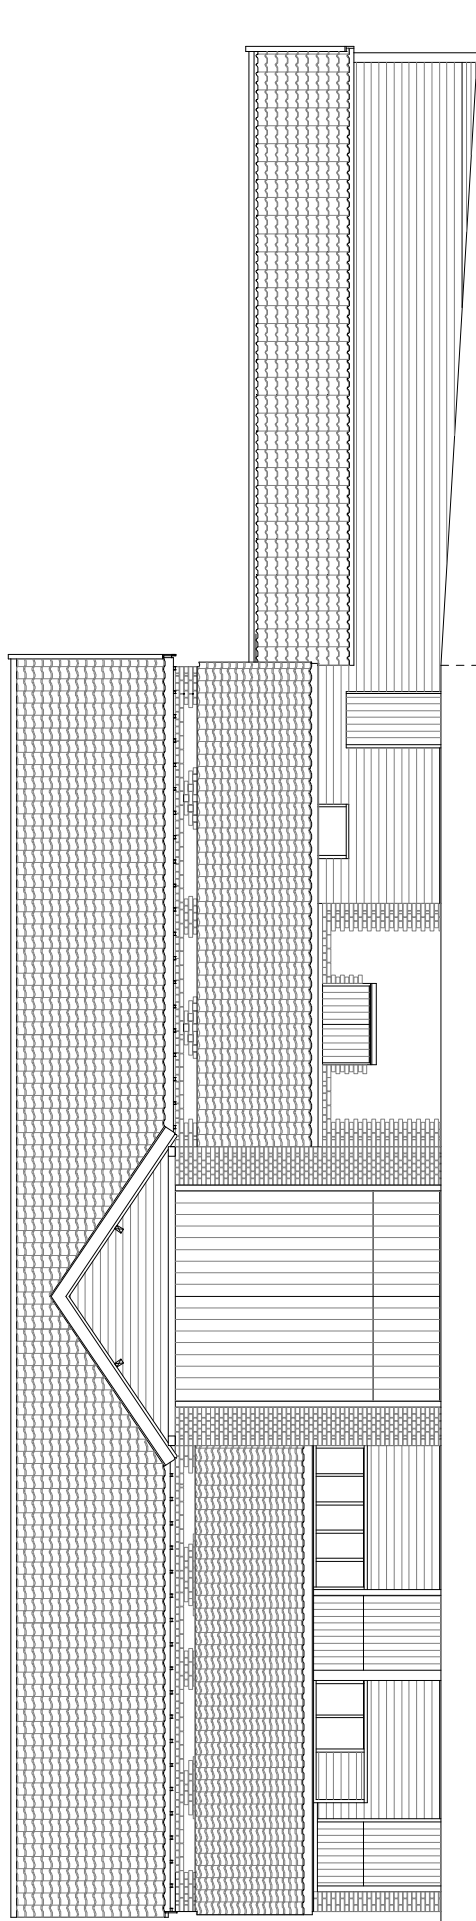
NORTH WEST ELEVATION

**3.7** Much of the north-west elevation of the main barn is obscured by lean-to extensions (Buildings 2, 3 & 4) that flank the midstrey (Plate 4). The midstrey has two pairs of boarded, ledged and braced doors, the lower doors being approximately a quarter of the height of the opening, the upper doors being three quarters of the height of the opening (Plate 5). The gable is weatherboarded (probably elm) with a bitumen coating. Behind Building 2 it is possible to see that the elevation of the main barn is formed of brick piers infilled with panels of flint, which show signs of crude repair where ventilation panels have been infilled. This can be more clearly seen in the interior elevation. Behind Buildings 3 & 4, brick piers and infill panels of flint can also be seen, but here the ventilation panels survive.

**3.8** The north-west elevation to Building 2 is weatherboarded, with a pent roof. A stable door is located at the northern end, abutting the brick quoin, and there is another stable door offset to the south of the centre of the elevation (Plate 6). This door is flanked by windows: a two-light casement to the left, and a glazed panel of five lights to the right. This elevation is shown as open on the OS map of 1897.

**3.9** To the south of the midstrey is Building 3, a lean-to with brick piers and an infill of roughly coursed flint (Plate 7). A window in the centre of the elevation has wooden shutters to the exterior (Plate 8). Beyond Building 3 is Building 4, a timber-framed lean-to, with exterior weatherboarding and a boarded door at the southern end, that continues to the end of the line Building 1 (Plate 9). Both lean-tos were in existence in 1876, but appear to be additions to the original structure.

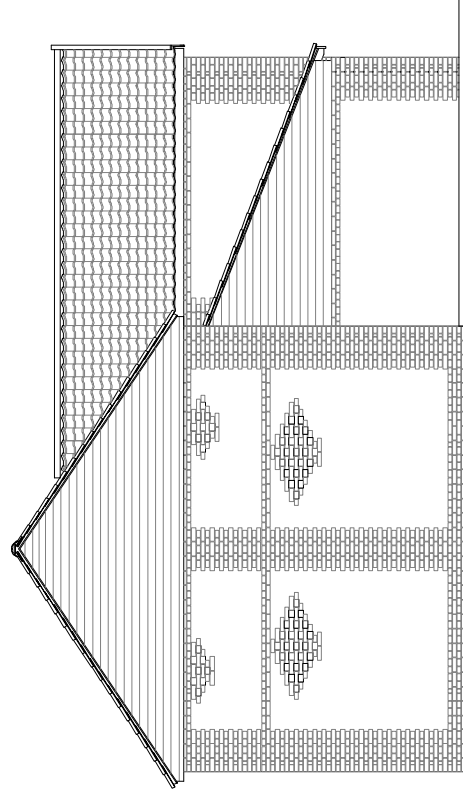
NORTH EAST ELEVATION

**3.3** The north-east exterior elevation of Building 1 is gabled with three equally spaced brick piers infilled with roughly coursed flint (Plate 1). At the base is a red brick plinth approximately 6 courses above existing ground level and partly cement rendered. Sixteen bricks below the level of the eaves, there is a two brick high lacing course that runs the width of the wall. Eight putlog or timber holes are visible with timbers still present in some, indicating that there was formerly a lean-to against this elevation and these holes supported the roof timbers. Below the lacing course in both flint panels, a diamond shaped ventilation panel of brick can be seen (Plate 2). Immediately below the eaves band in each panel is a similar smaller diamond shaped brick ventilation panel. Above the eaves the gable is weatherboarded. The timber is recent.

**3.4** The bricks in the pilasters to the main barn are red handmade bricks measuring 8¾" x 4¼" x 2¼". They are laid in English bond. Approximately 18 courses above ground level the brickwork changes with more regular bricks in the upper courses, though these still appear to be handmade. The upper bricks measure 8½" x 4¼" x 2½".

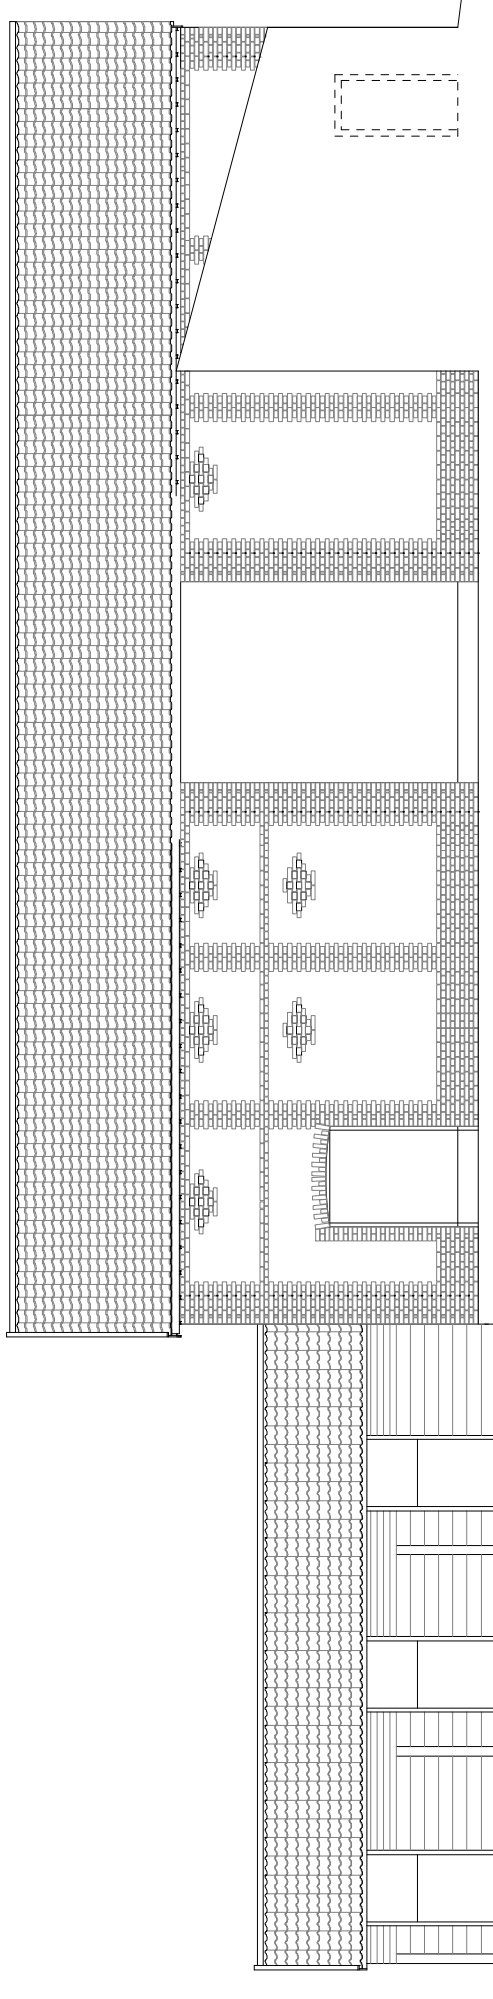
SOUTH EAST ELEVATION

**3.12** The south-east elevation is visible inside the modern portal-framed barn (Building 7) that sits adjacent to it and abuts it. This elevation also has brick piers and flint panels – the flint panels having diamond shaped brick ventilation panels set within them. A similar brick lacing course separates the top quarter of the face, and in this elevation, there is a brick offset at the base with further flint panelling below (Plate 13). A door is set in the south-westernmost bay, with a shallow arched head and brick jambs (Plate 14). This opening is occupied by a wide boarded, ledged and braced door. The central bay, opposite to the midstrey, has another tall opening which would originally have been closed by doors (Plate 15). Surviving pintles indicate that these doors opened outwards and were split in the same way as the doors in the midstrey, being one quarter height at the bottom and three-quarter height at the top (Plate 16).

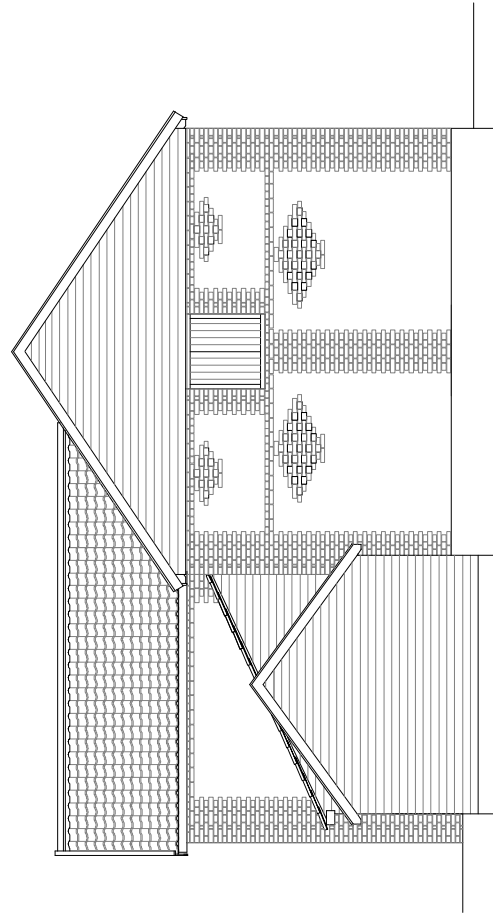
SOUTH WEST ELEVATION

**3.11** The south-west elevation of Building 1 is of similar form to that noted for the north-east elevation, with the addition of a centrally placed pitching door above the brick lacing course and below the eaves band (Plate 12). The pitching door is flanked by brick jambs. Above this the gable end is weatherboarded, with older weatherboard on this elevation, but probably not original.

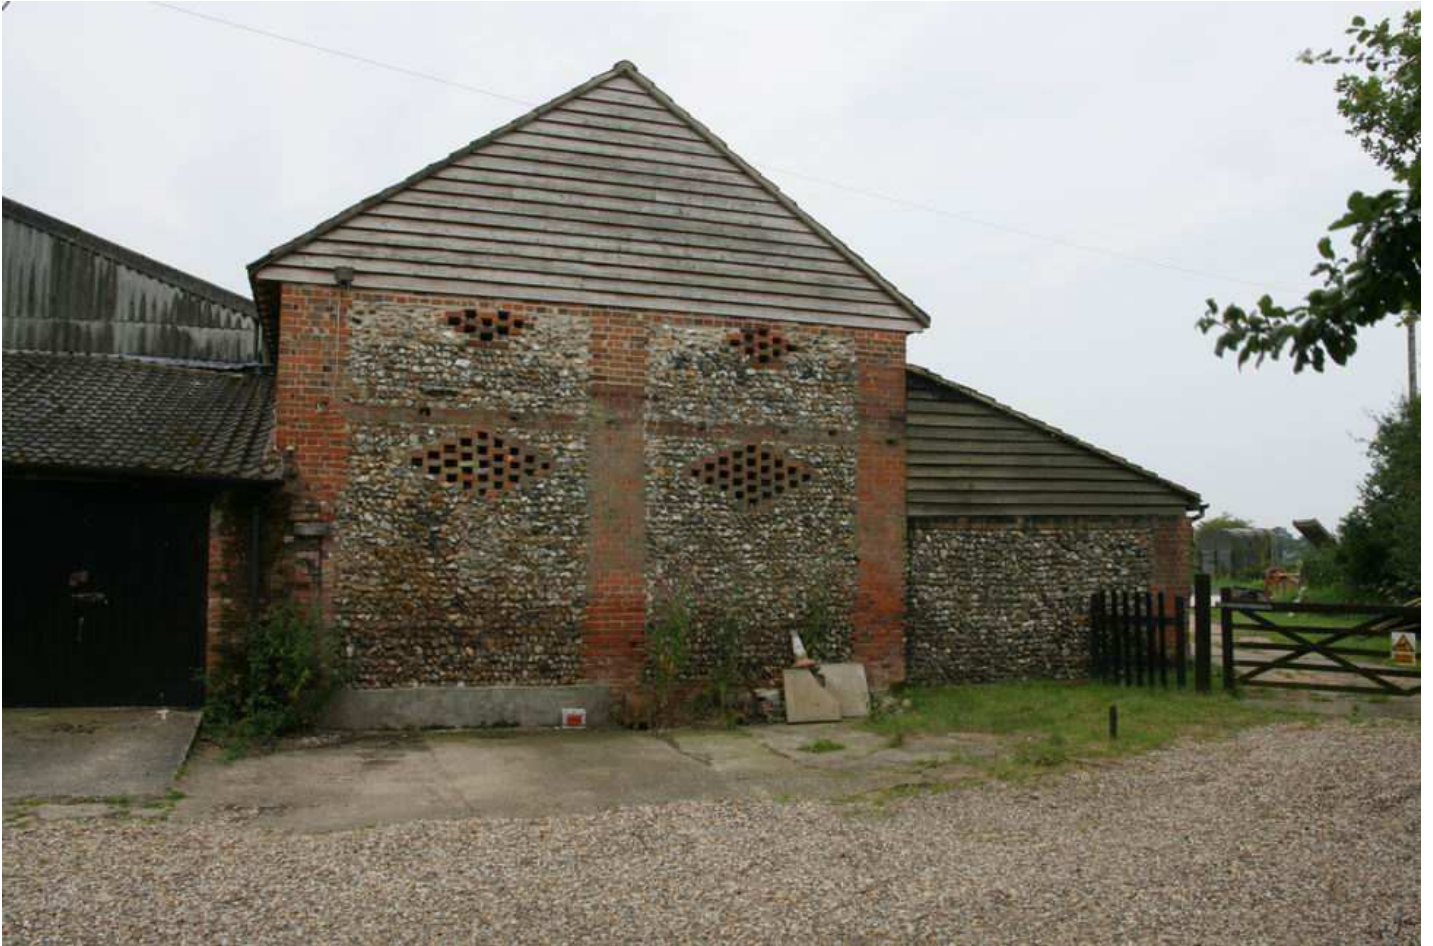
Plate 01 - Building 1, NE elevation

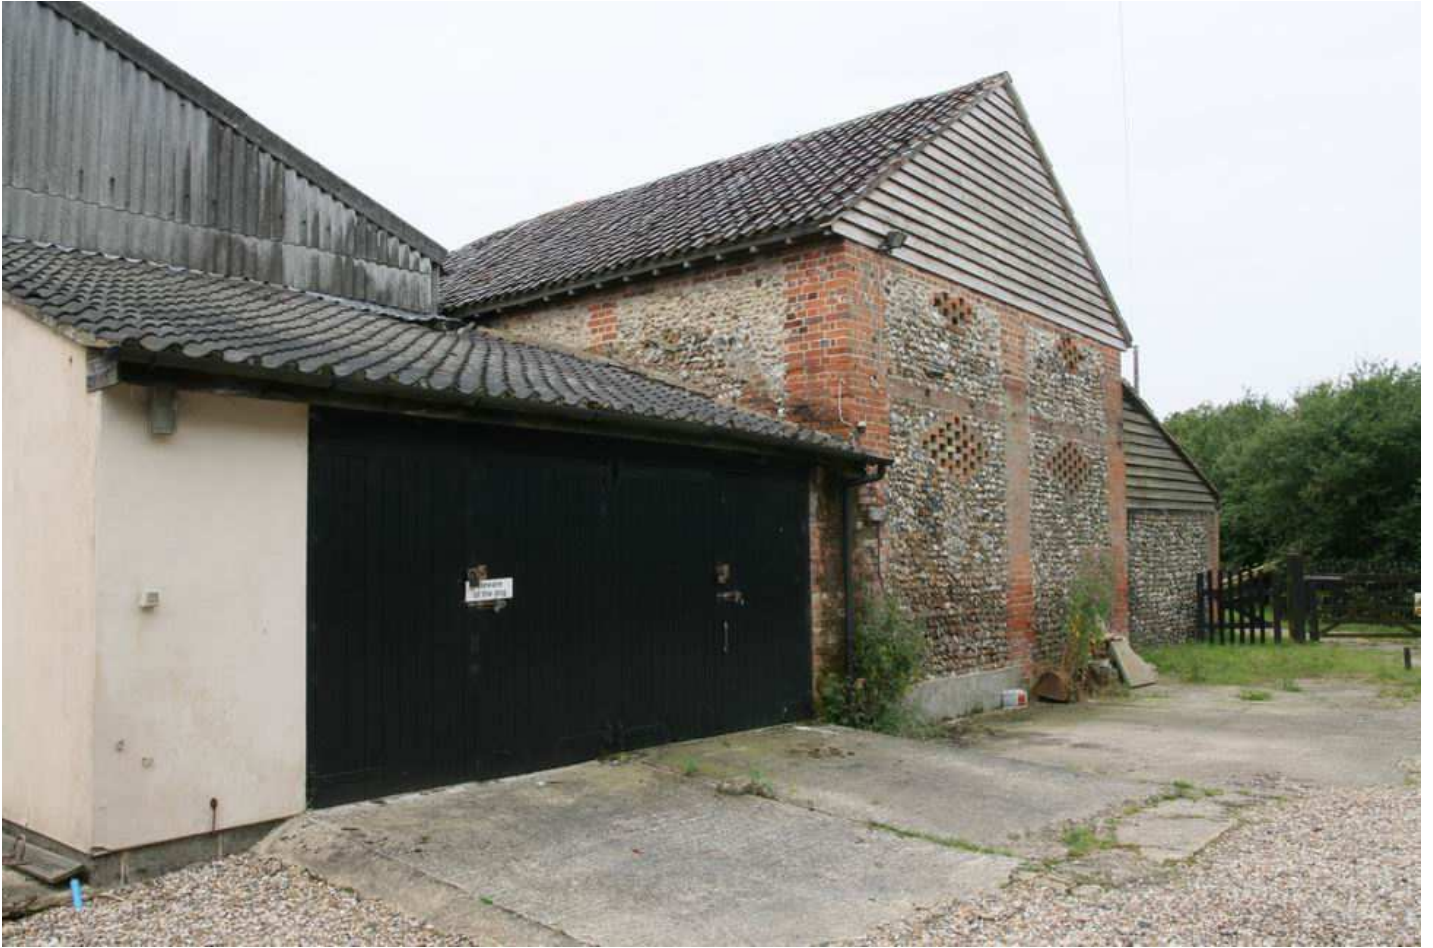
**3.6** The left hand end of this elevation comprises Building 6, a modern lean-to garage with a pent roof (Plate 3).

Plate 03 - Building 6, NE elevation

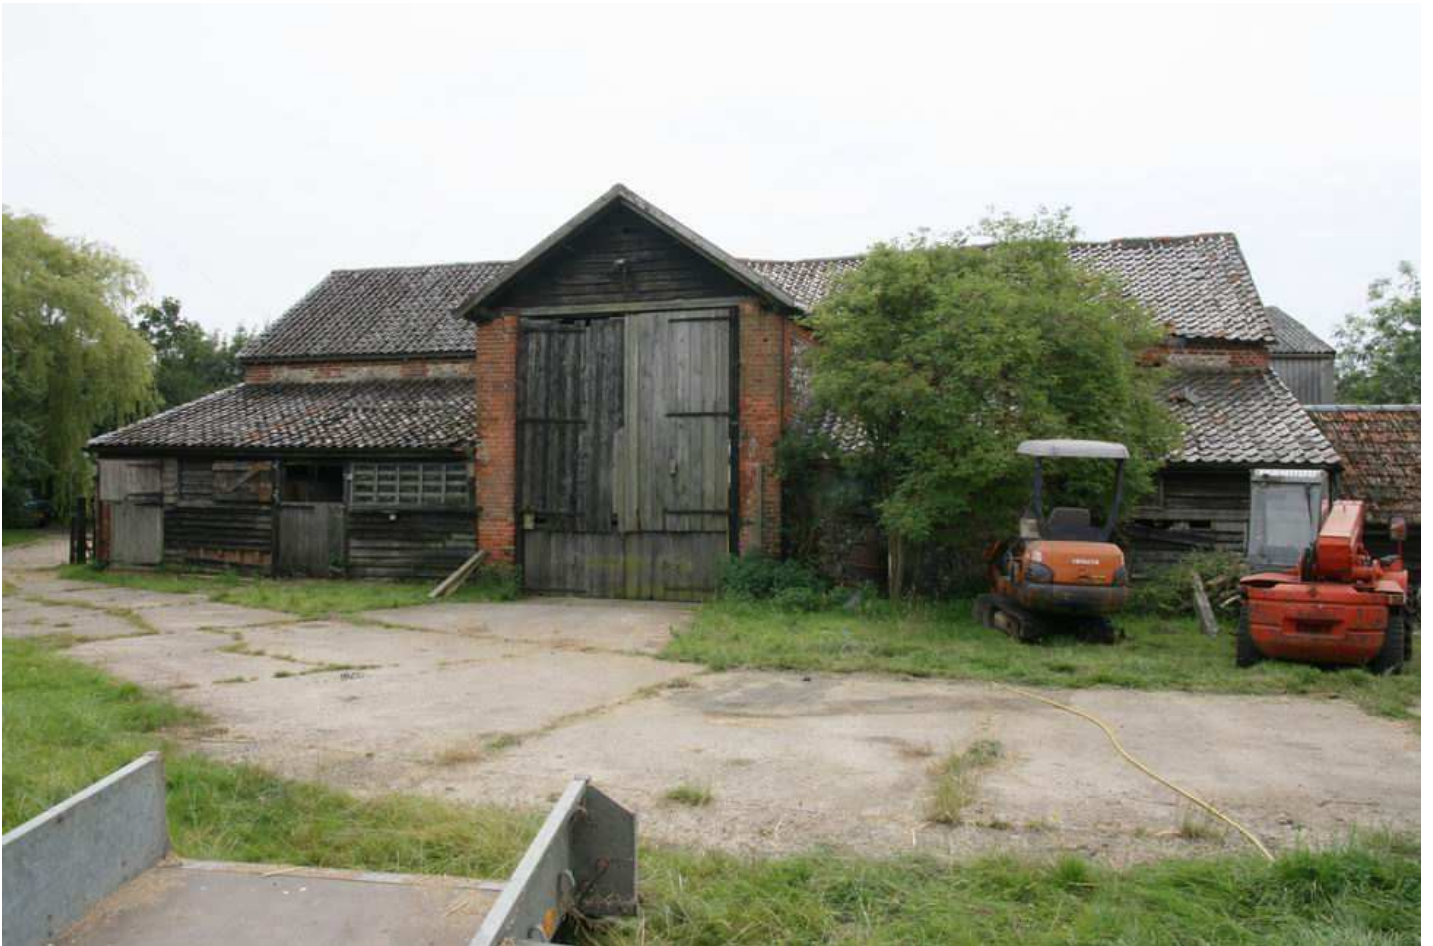
Plate 04 - Buildings 1 to 4, NW elevation

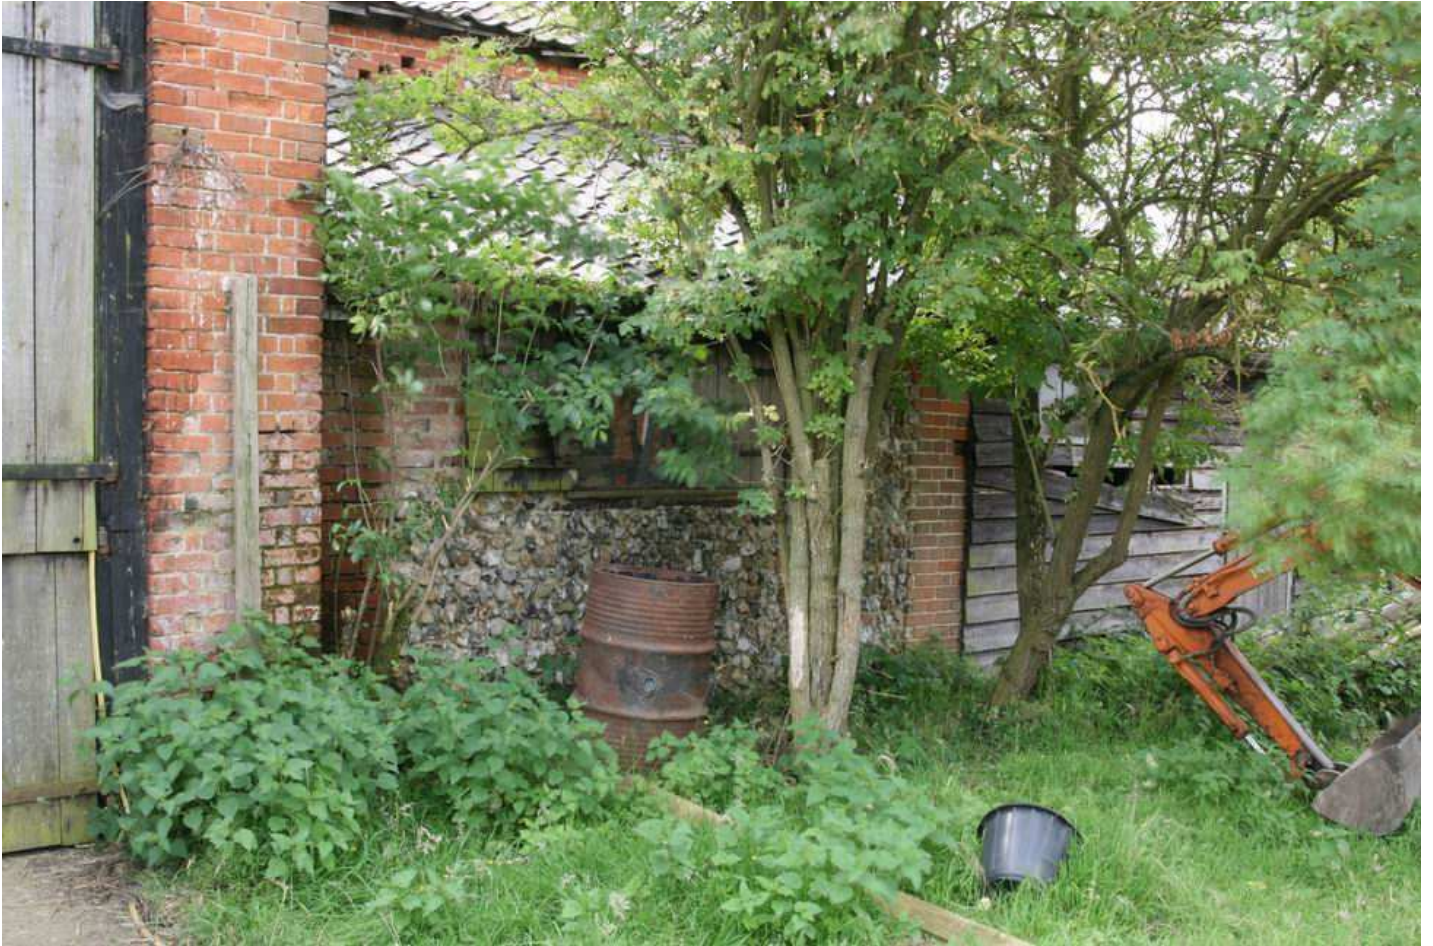
Plate 07 - Building 3, NW elevation

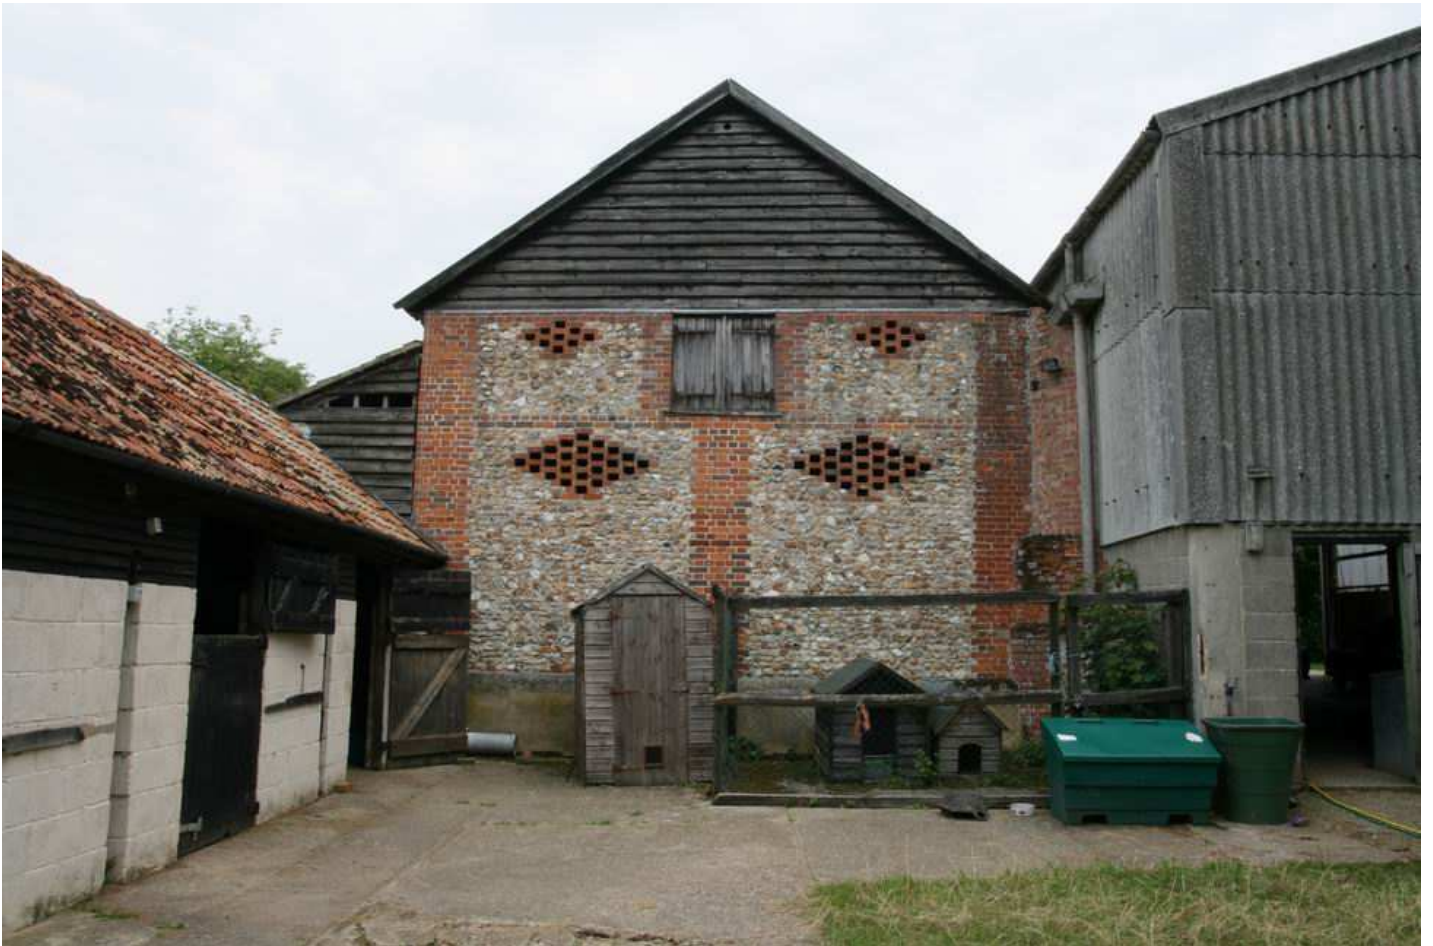
Plate 12 - Building 1, SW elevation

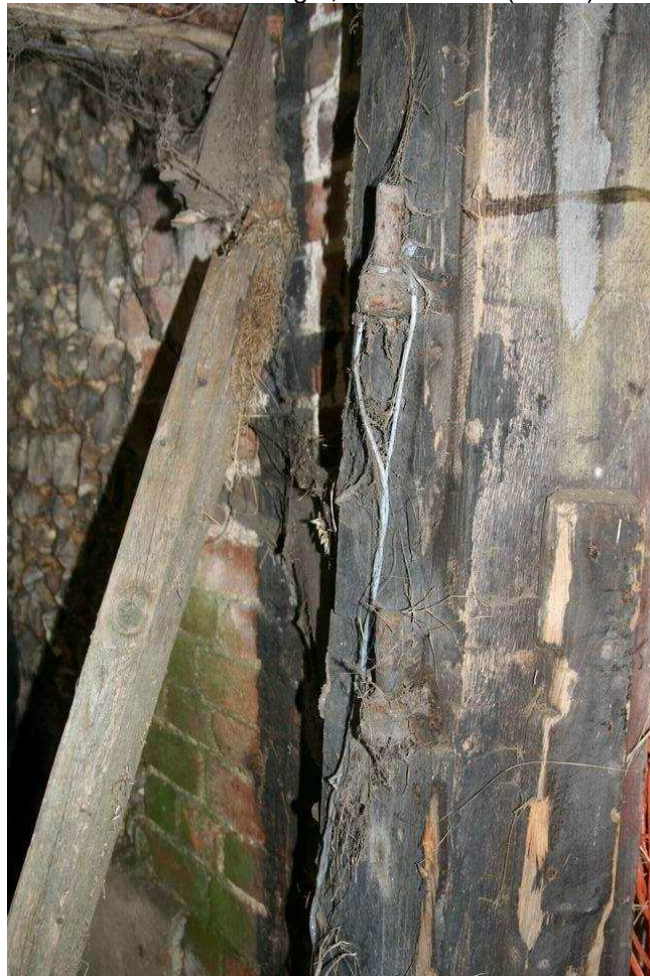
Plate 16 - Building 1, hinge detail

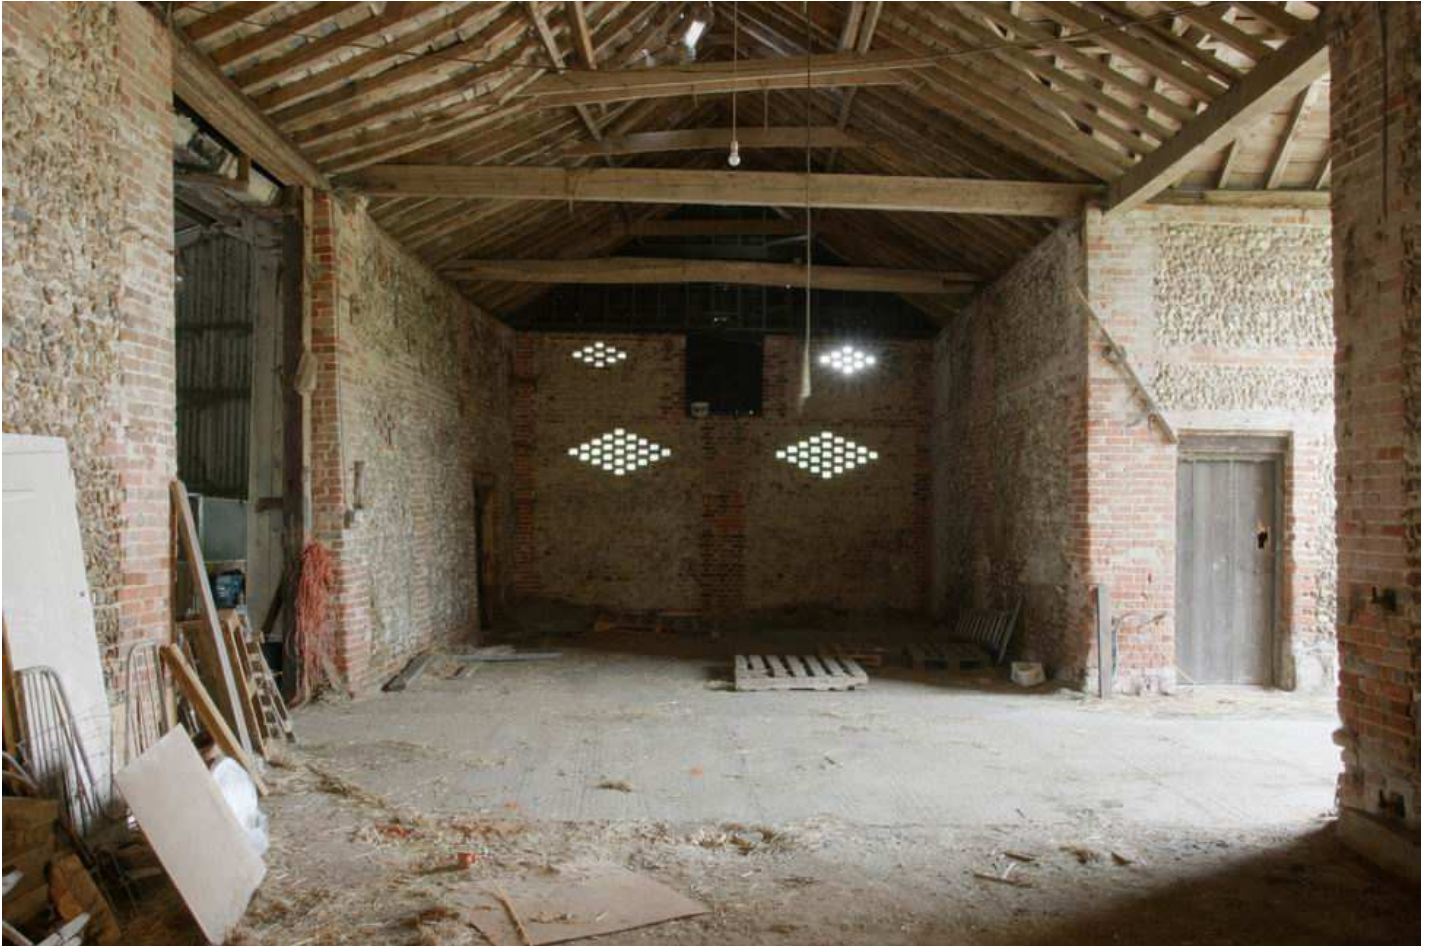
**3.13** The interior of Building 1 has a concrete floor (Plate 17) and the roof, half of which has been replaced, is formed of paired rafters, on a fairly shallow pitch, meeting at a ridge plate, with a single purlin in each slope braced by nailed collars (Plate 18).

Plate 17 - Building 1, interior looking SW

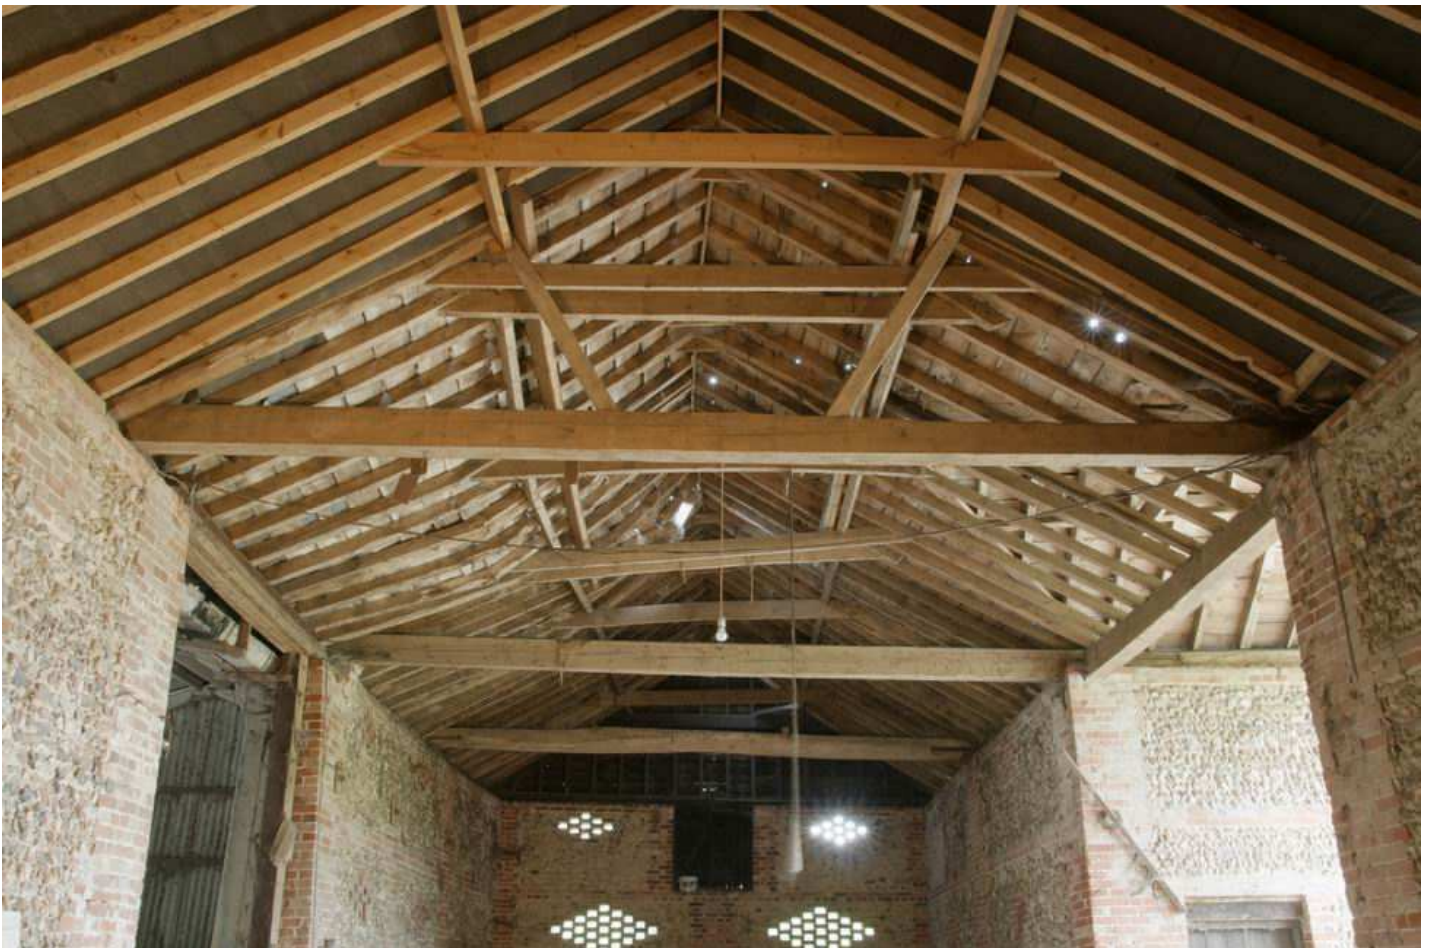
Plate 18 - Building 1 roof structure

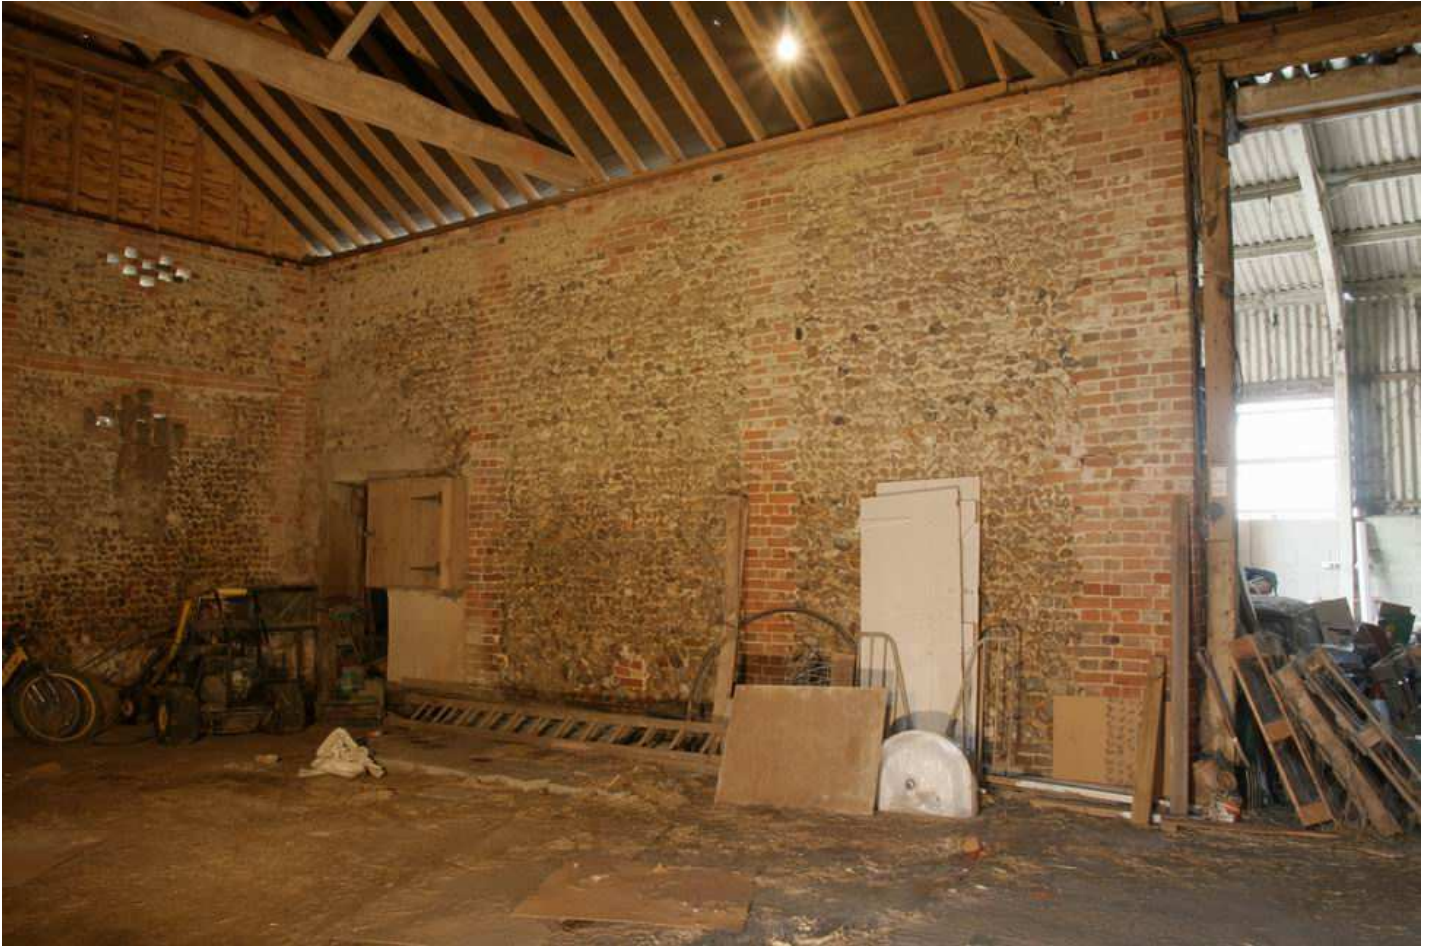
**3.14** The north end of the south-east elevation appears not to have the same brick lacing course that the remaining elevations display (Plate 19). It does, however, have diamond shaped ventilation grilles but these have been infilled. It is possible that this part of the elevation has been rebuilt, as the eastern corner does show signs of reconstruction, and the roof structure at this end of the barn has been replaced (Plate 20).

Plate 19 - Building 1, SE interior elevation (N end)

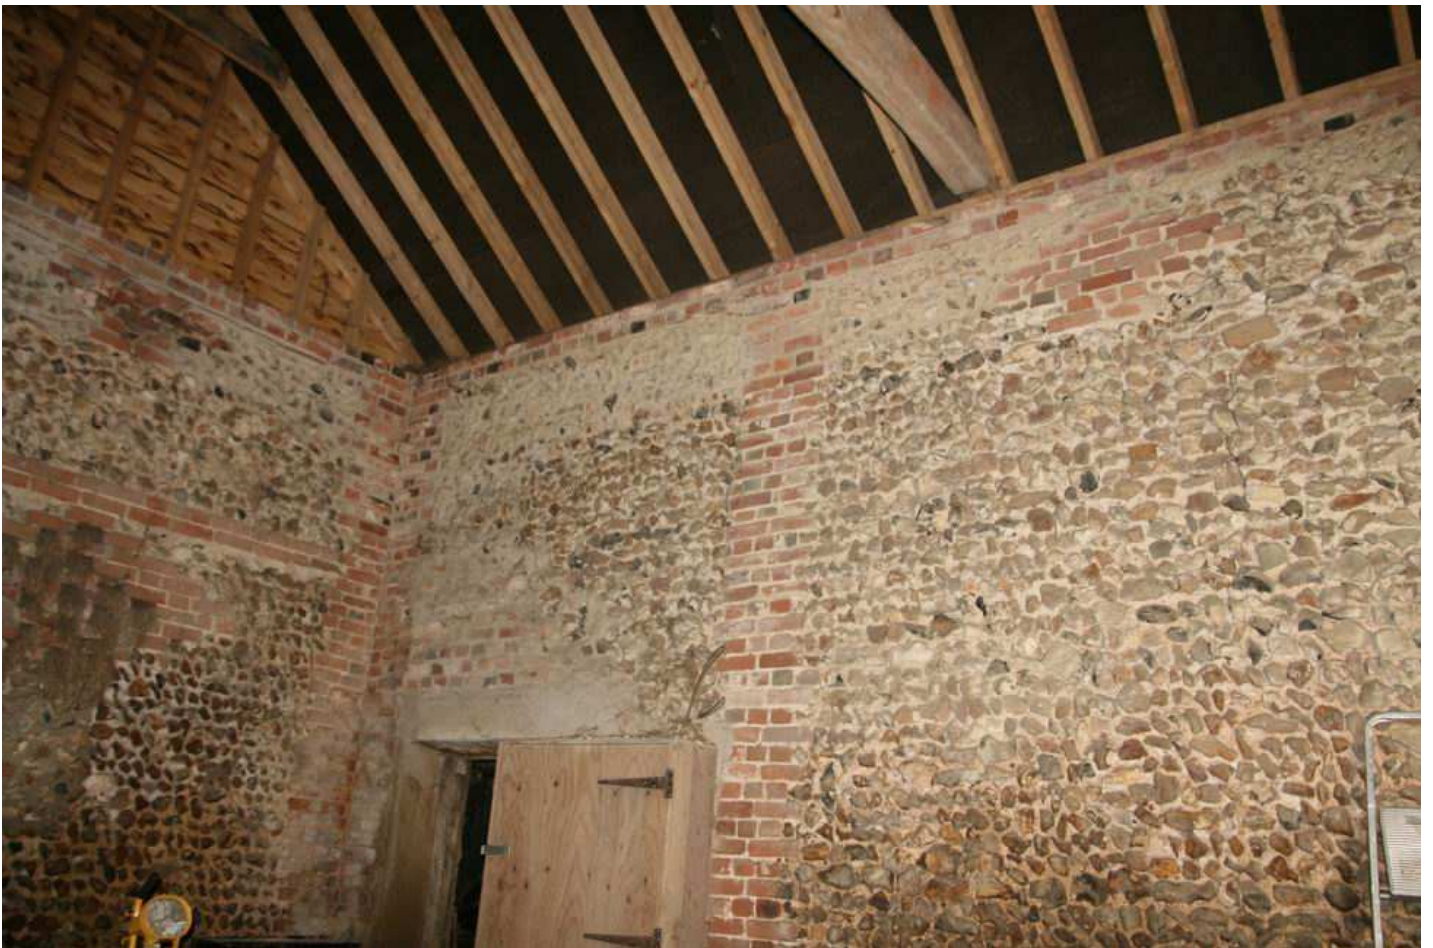
Plate 20 - Building 1, NE corner

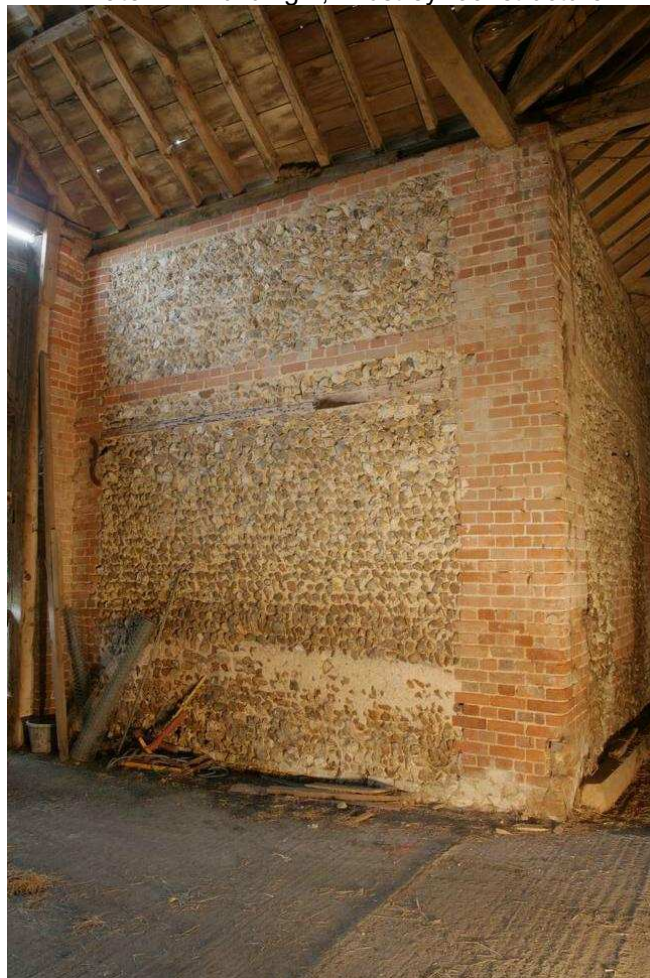
**3.16** The midstrey has, in addition to the brick lacing course noted elsewhere in the structure, a timber levelling strip 2 to 3 brick widths below the lacing course (Plate 22). In the south-west elevation of the midstrey this timber levelling strip rests upon the timber lintel to a door that gives access to the extension south-west of the midstrey (Plate 23). Graffiti can be seen in the internal quoins of the midstrey and these appear to represent a tally.

Plate 22 - Building 1, midstrey, NE interior elevation
