## **BOUNCES FARM BARN** **Gosfield, Essex**

***HISTORIC BUILDING  
RECORD***

Project ref: HN950  
Site Code: BFGF11  
Planning refs: 09/00807/FUL

Report no.771

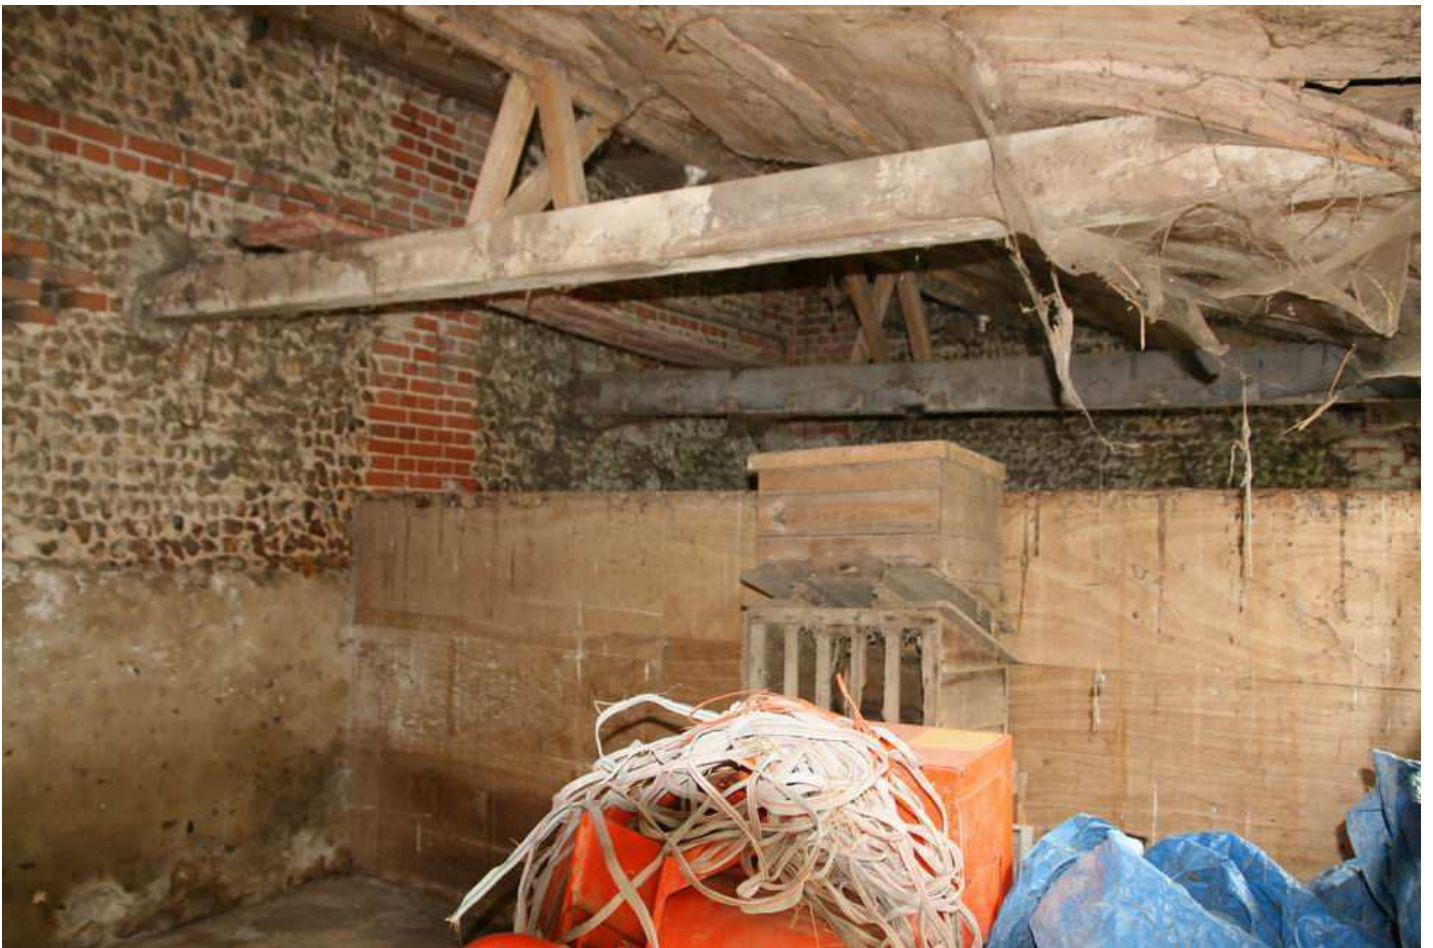
**3.17** Building 2 is of three bays with the roof structure supported on two substantial tie beams set into the north-west elevation of Building 1 (Plate 24). The interior is bisected by a modern half-height partition.

Plate 24 - Building 2, looking S

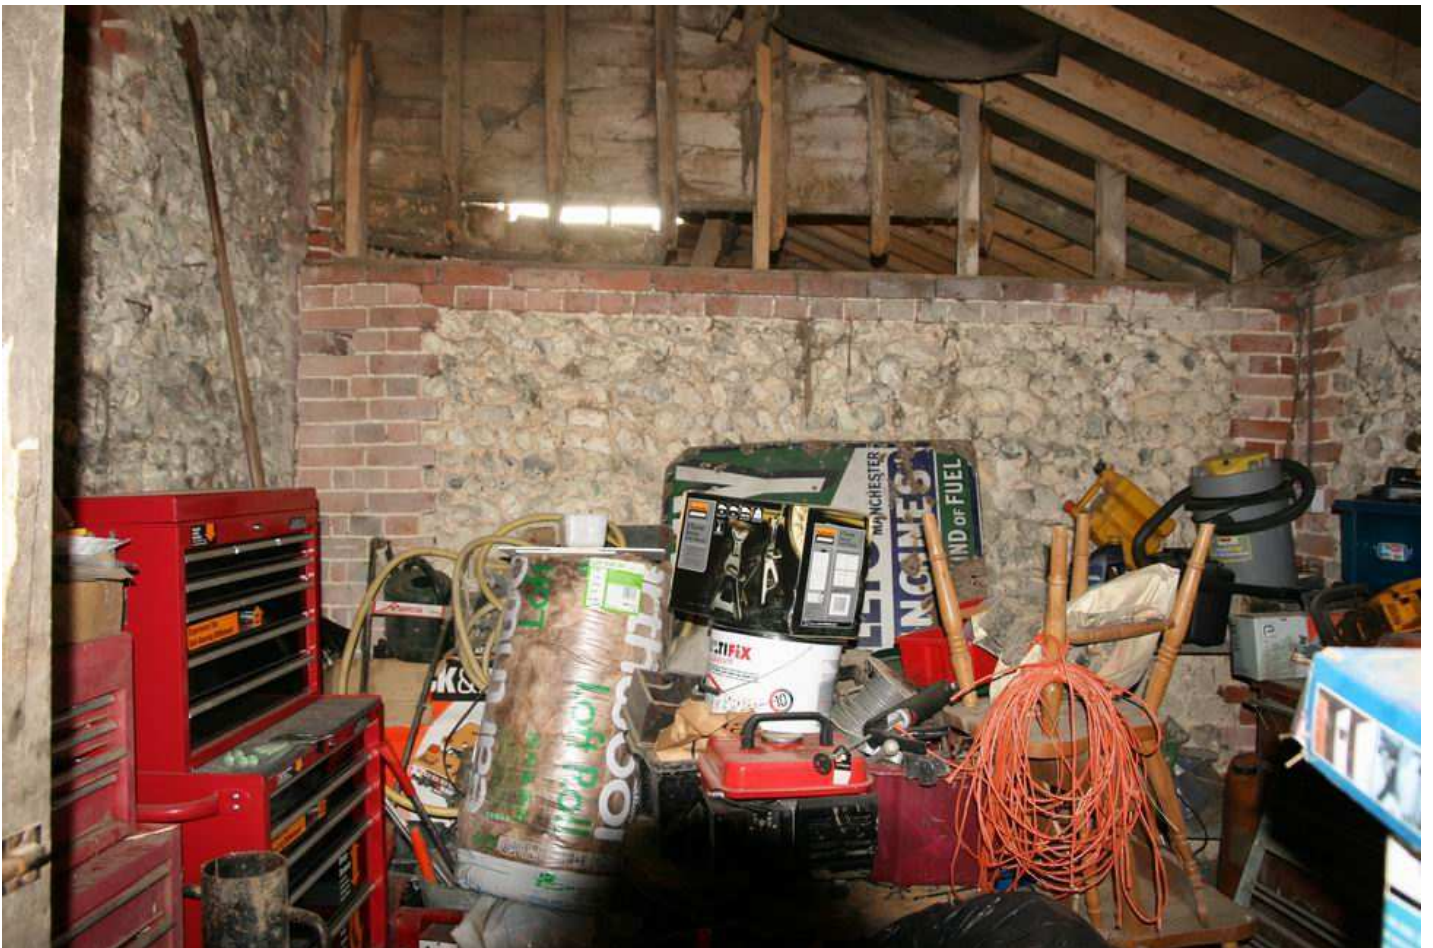
**3.18** Building 3 has a modern softwood roof structure, concrete floor, and the shuttered window noted in the exterior elevation. The plate that supports the summit of the roof sits on wooden blocks cut into the north-west elevation of Building 1, in a manner similar to that noted in the north-east exterior elevation of Building 1 (Plate 25). The flint walls in the north-west and south-west elevations are very clearly abutted to the walls of the main barn and are clearly of a later date (Plate 26).

Plate 26 - Building 3, looking SW

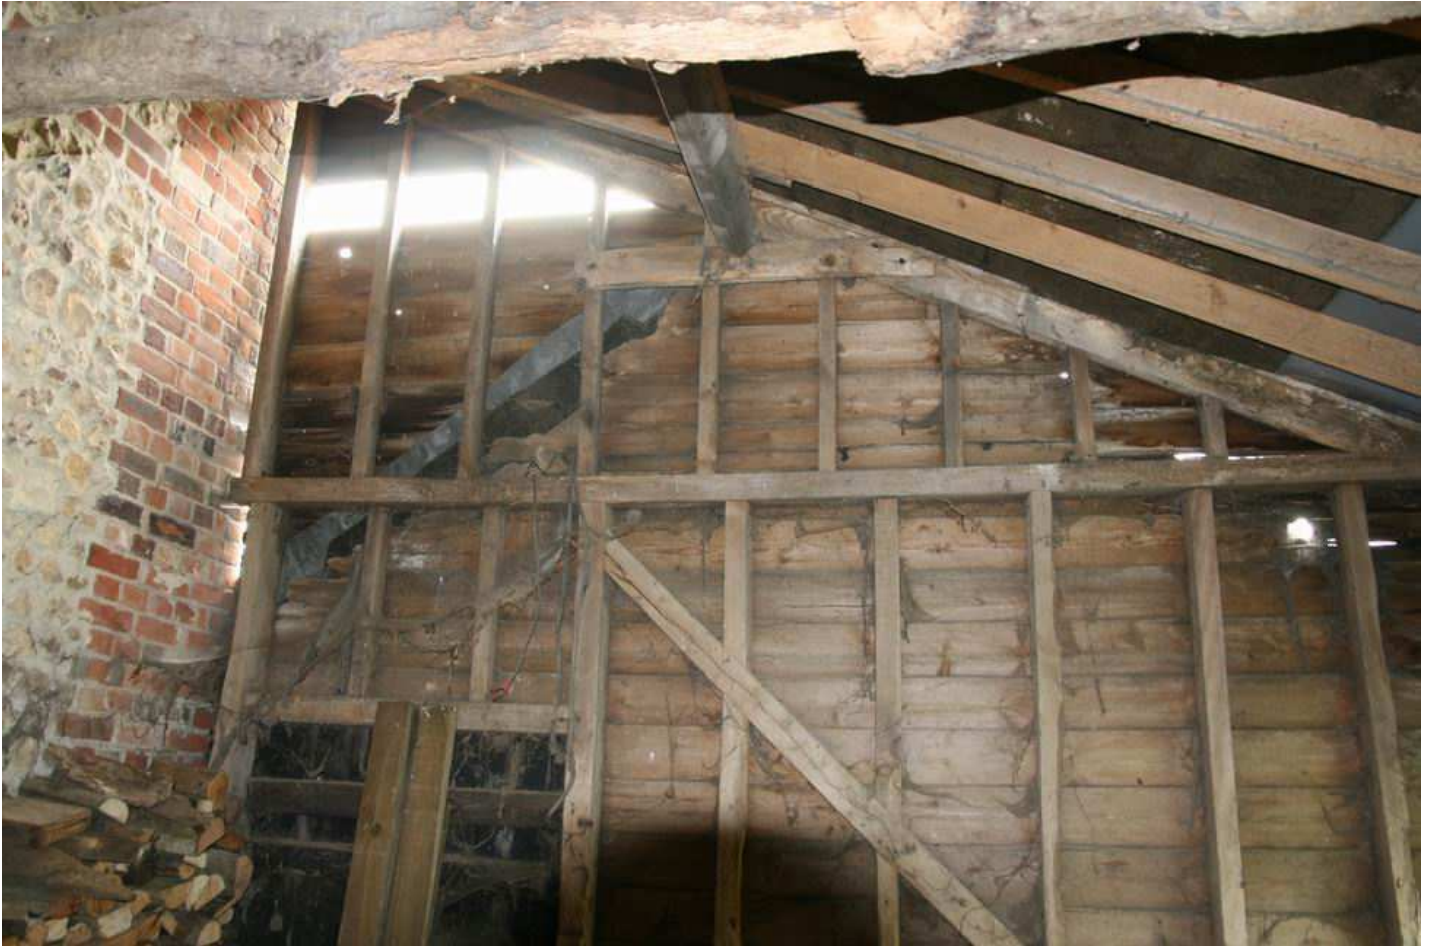
**3.19** The timber lean-to extension beyond Building 3 is constructed of pieces of wood apparently salvaged from a number of sources (Plate 27), the tie beam being formed from a branch of a tree, unfinished with bark still adhering, and inserted into one of the brick ventilation holes in the wall of the barn (Plate 28). The roof is of modern softwood.

Plate 27 - Building 4, looking SW

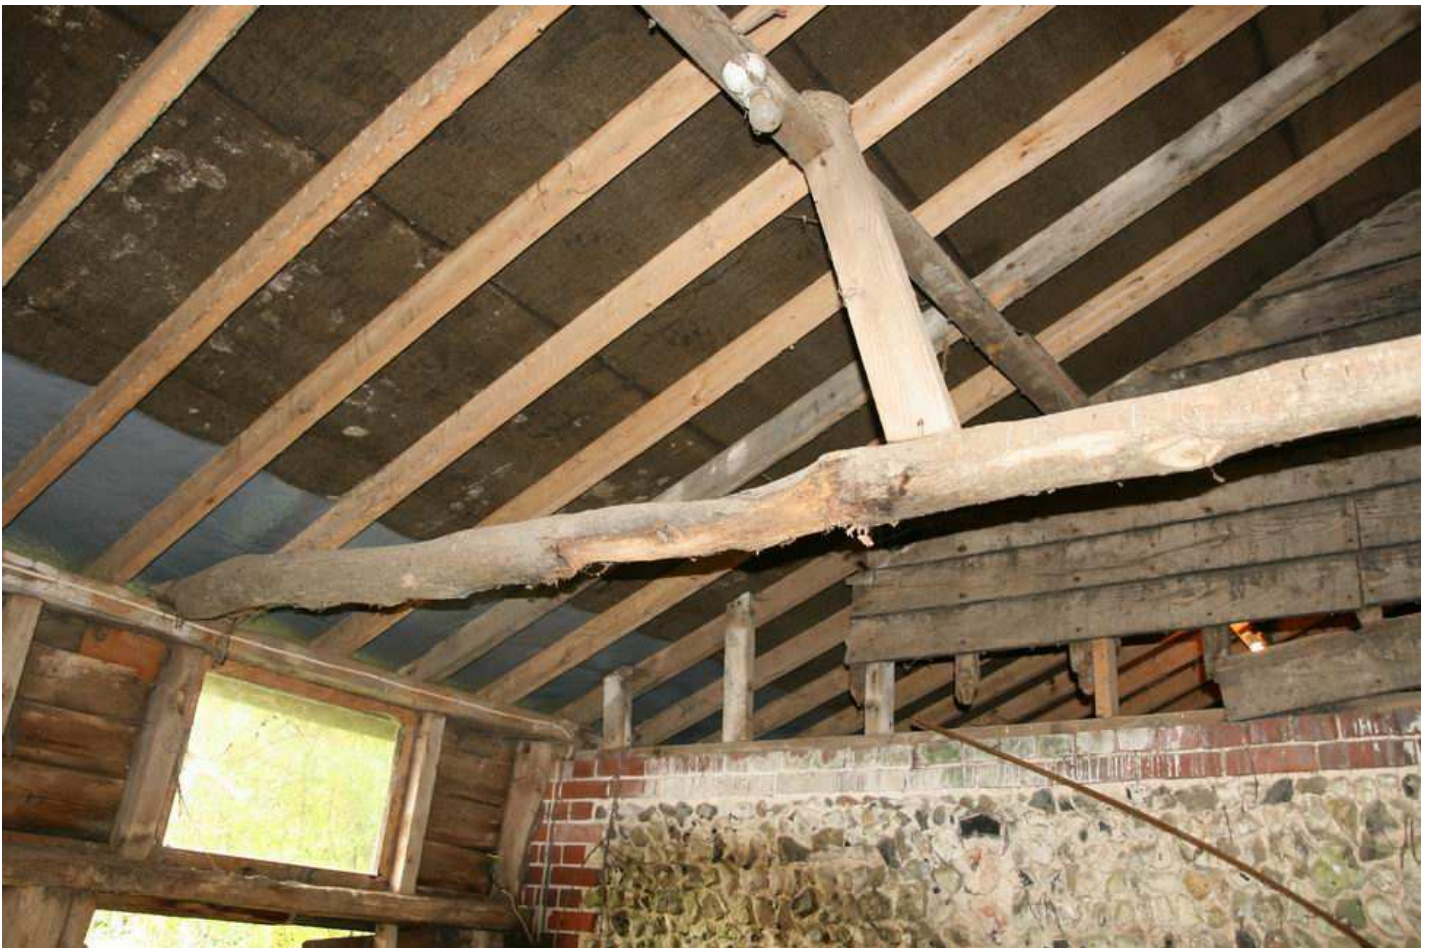
Plate 28 - Building 4 roof structure

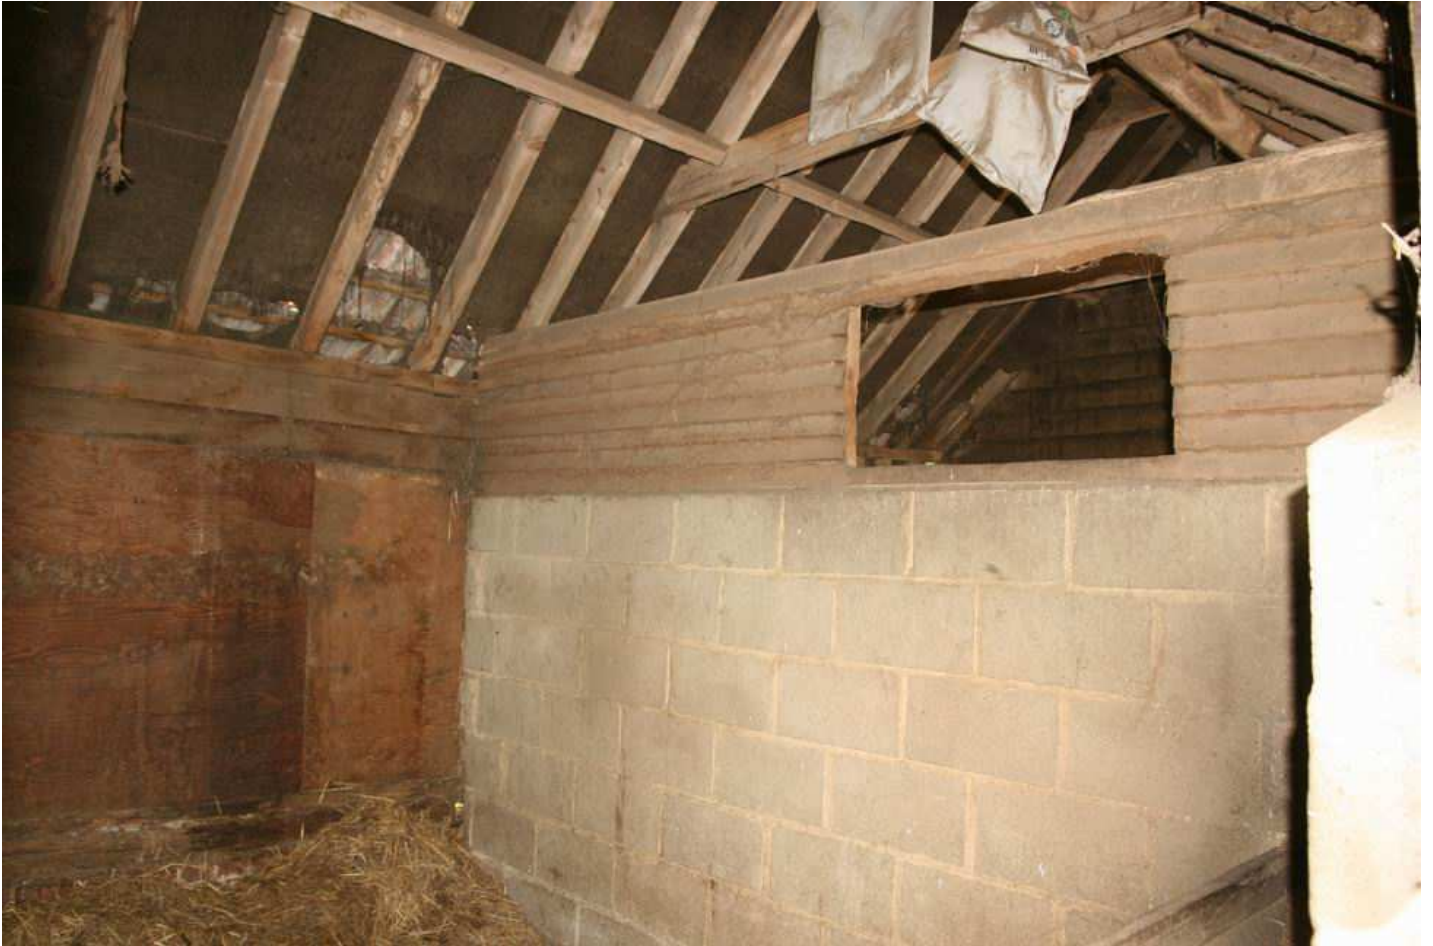
**3.20** In Building 5, the stable block that forms the south-western range, the bays are partitioned with cement blocks and the internal elevations are boarded (Plate 29). The roof and the gable ends demonstrate that the construction is relatively modern, with softwood rafter pairs meeting at a ridge and a single purlin in each slope supported on collars (Plate 30). This range is shown as open-fronted on mapping between 1897 and 1955.

Plate 29 - Building 5, partition between Bays 3 & 4
