THE GOSPEL HALL, Orchard Road, Baldock, Herts.

***HISTORIC BUILDING RECORD &
ARCHAEOLOGICAL MONITORING***

Historic Building Record & Archaeological Monitoring Record

Report no.714

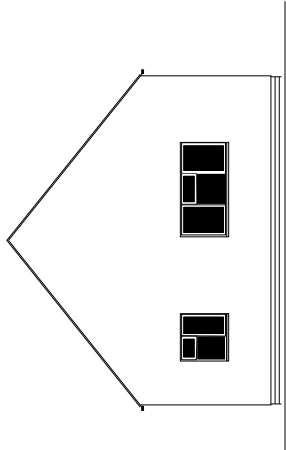
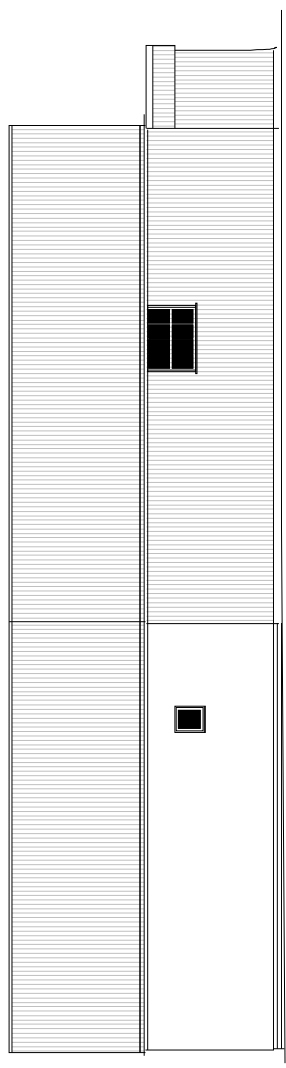
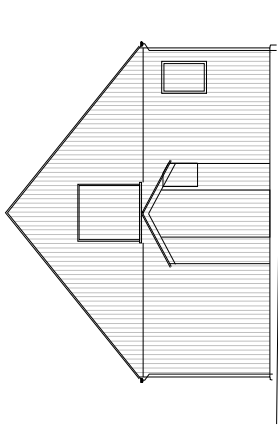
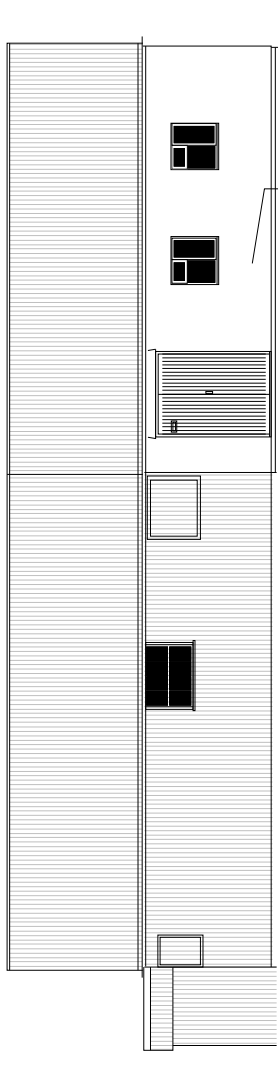
3.4 The south-east gable end, which faces on to Orchard Road, has a centrally placed corrugated iron porch with a centrally placed gabled door faced with corrugated iron, which opens inwards. The porch sits on a brick plinth, but this is not chamfered. Above the porch, and on the eaves line, is a centrally placed window opening, which has been blocked with hardboard (Figure 4; Plate 1).

3.5 The north-east elevation, facing on to Jackson Street, has a horizontal sliding sash window, approximately centrally placed in the front half (Figure 4; Plate 2). Adjacent to the junction between the front and rear halves is a modern double door, opening inwards and accessed by a concrete ramp from the pavement. Two modern two light wooden casement windows occupy the remainder of this elevation beyond the door.

3.6 The north-west gable end has a modern two light casement window to the left and a modern three light casement to the right, lighting the WC and kitchen respectively (Figure 4; Plate 3).

3.7 In the south-west elevation a horizontal sliding sash window is approximately central to the front half of the building (Figure 4; Plate 4). There is a blocked single doorway in the rear half, adjacent to the junction between the front and rear halves. To the left of this is a small single light window.

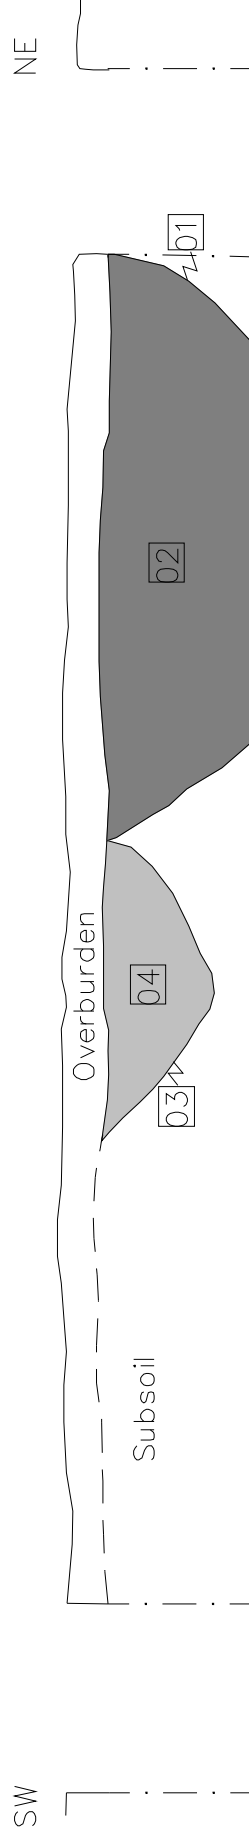
Groundworks Section

4.7 Located parallel and to the immediate west of [01] was a second linear feature, cut [03] (04) (Figures 5 & 6). It measured 1.3m in width, 0.7m in depth, and was over 8m in length, being observed to run along the full length of the footprint. Fill (04) consisted of dark greyish brown (10YR 4/2) soft chalky silt and contained no finds.

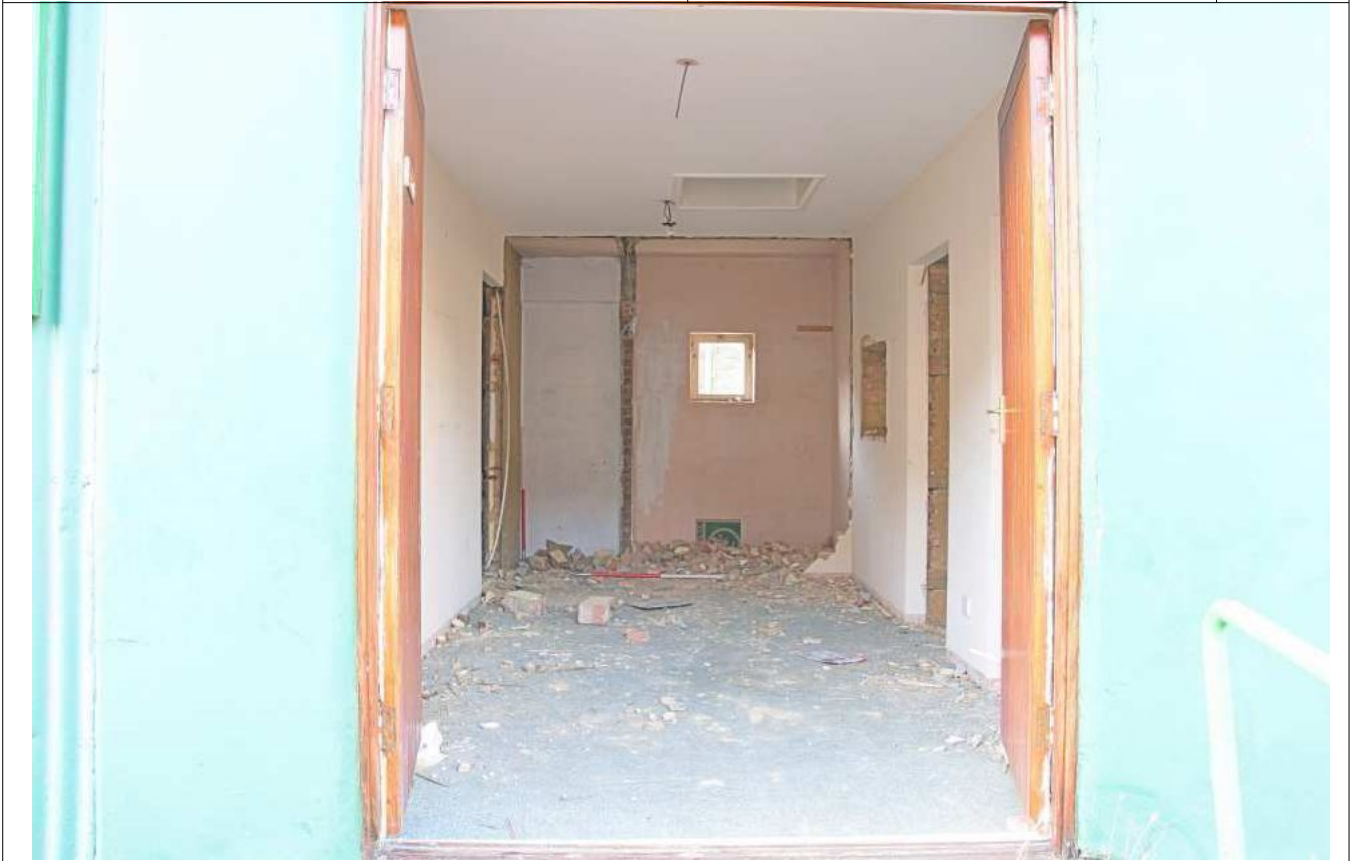
Plate 5: Lobby through main entrance, looking SW

3.8 The door in the north-east elevation opens into a lobby area (Figure 4: Plate 5). To the south-east two openings lead through to the hall. To the north-west one opening leads to the WC, another to the kitchen (Plate 6). The partition walls between these areas have now been demolished. A third opening forms a serving hatch.

3.9 In the south-west elevation is a single light, bottom hinged, wooden window. Brick partitions, subdividing the SW end of the lobby, have been demolished (see Plate 5).

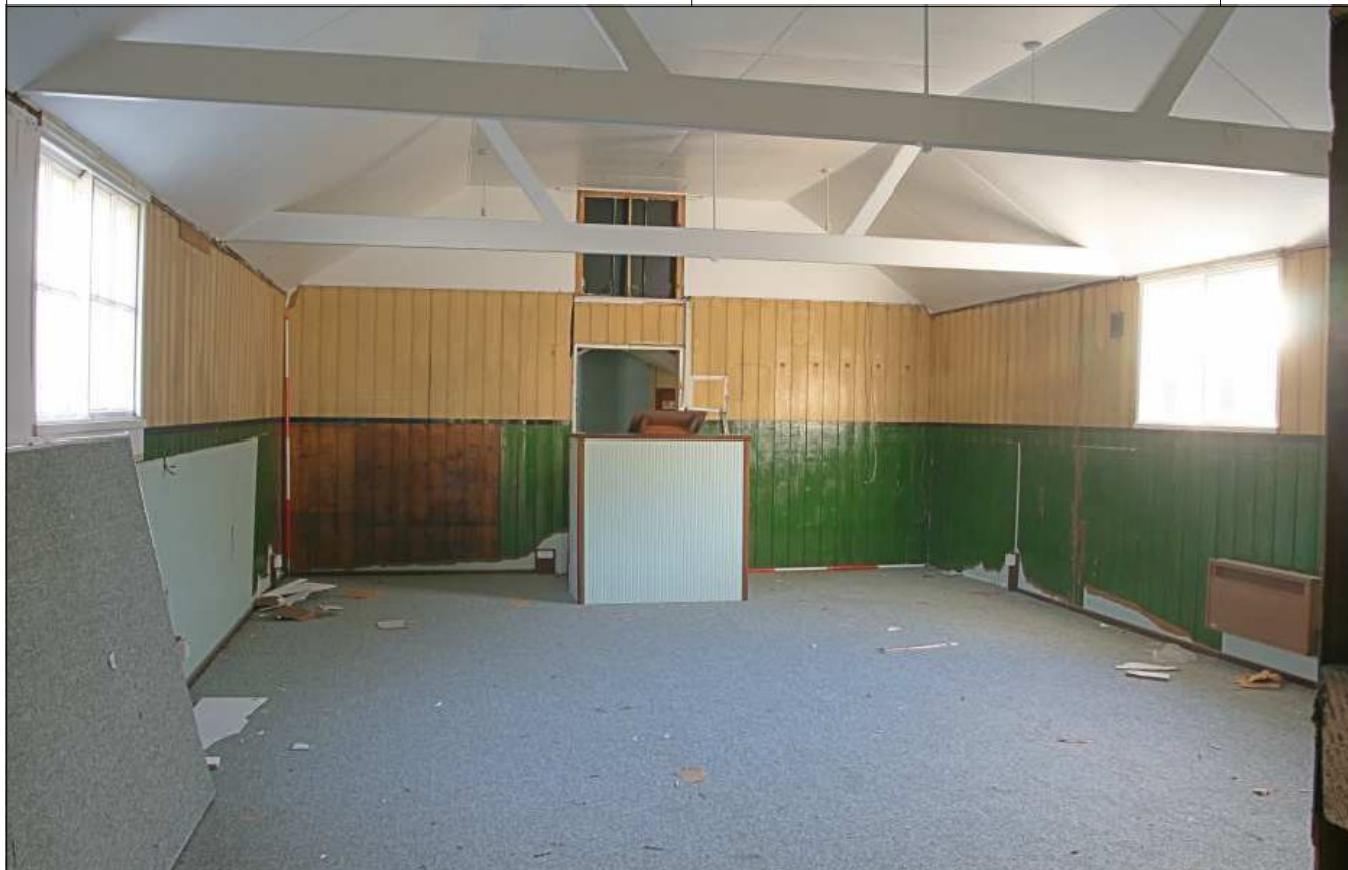
Plate 7: The Hall, looking SE

3.10 The hall is of three bays. At the south-east end is a modern pulpit, essentially a raised plinth enclosed on three sides, with a lectern, which stands in front of the porch noted on the exterior with the blocked window above (Plate 7). This is a single light, centre pivoting, window of six panes. A similar window is located in the north-western elevation (Plate 8). In the south-west elevation a two light horizontal sliding sash is offset towards the south-east end of the middle bay (Plate 9). A similar window is offset towards the north-west end of this bay in the north-east elevation (Plate 10).

3.11 Reeded hardboard panelling has been stripped from the walls, revealing beaded tongue and groove panelling beneath on 6 inch centres, with a plain, slightly chamfered, skirting below (see Plates 7-10).

3.12 A fibreboard covering to the ceiling has been locally removed to show that the ceiling is lined with similar tongue and groove panelling mounted horizontally (Plate 11). The panelling is painted green below the bottom line of the window and custard yellow above, with a 4cm wide dividing line in black (see Plates 7, 9-10).

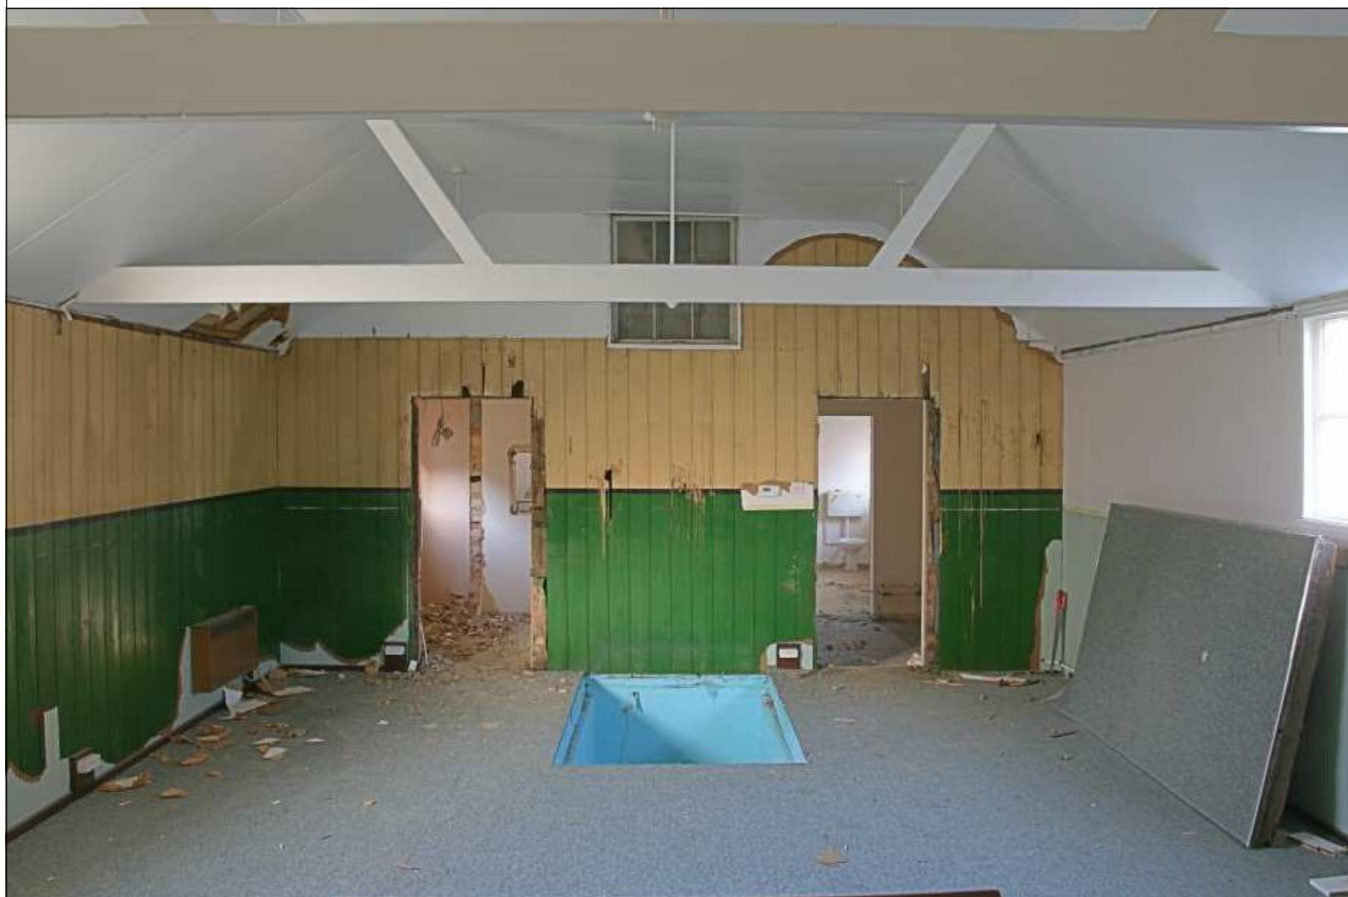
Plate 12: The Hall, looking NW

3.13 Two roof trusses are exposed. These appear to be prefabricated with raking queen struts, stop chamfered on the edges and central steel king bolts (Plate 12).

3.15 In the middle of the north-west elevation of the hall, flanked by the entrance doors, is a baptismal pool set into the floor (see Plate 12). This measures 1.35m (4'4") wide by 2.25m (7'4") long and 1.10m (3'6") deep. In the southern corner four steps descend into the pool (Plate 13). A tap is located in the north-western elevation of the pool, above a drain hole.

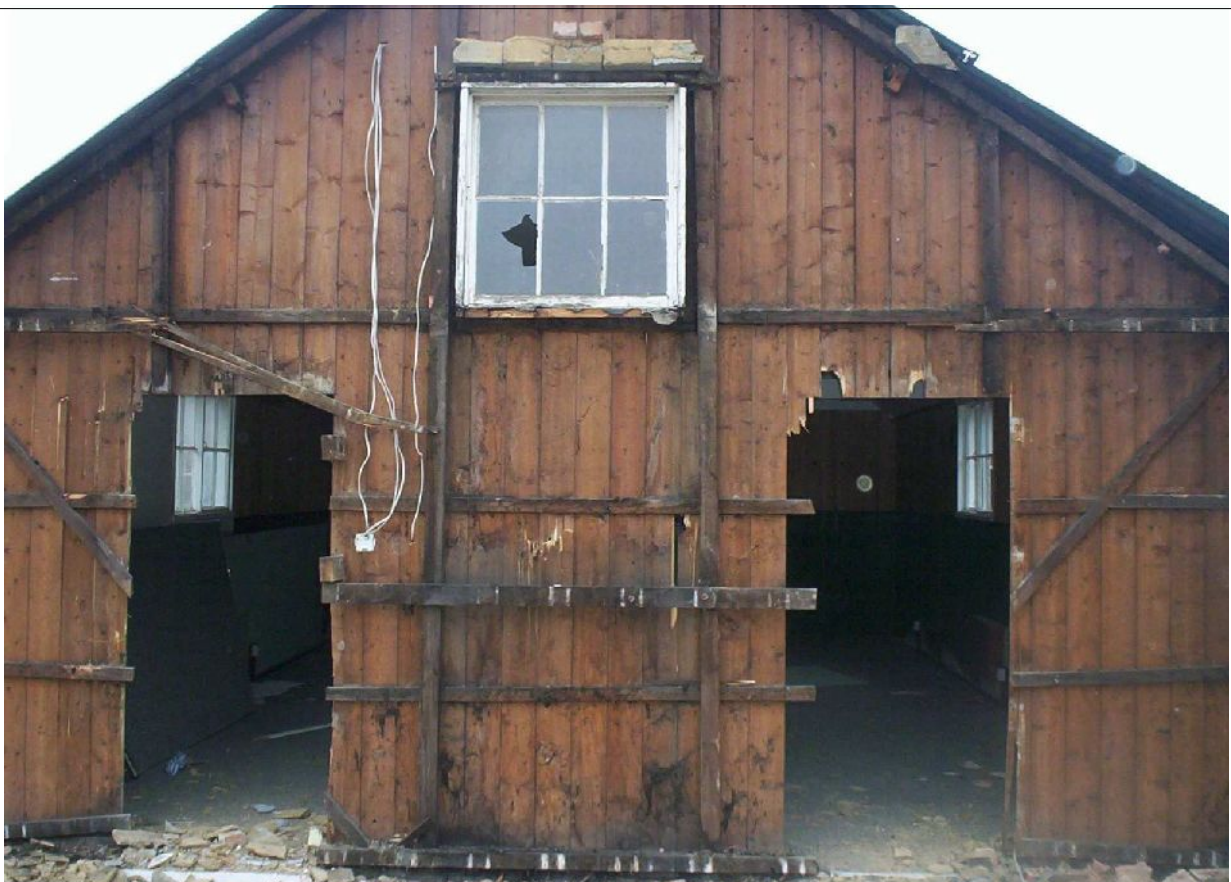
Plate 14: North-west gable end of The Gospel Hall after demolition of the extension

3.16 Overall the Gospel Hall is built on a frame of 3 x 2" softwood uprights, on 50-inch (1.27m) centres in the gable ends and 68-inch (1.72m) centres in the side elevations, with diagonal bracing to the inside on the gable ends (Plate 14). The outer covering is of corrugated iron supported on battens on 48-inch (1.22m) centres (lower to middle batten) and 65-inch (1.65m) centres (middle to upper battens). The inner lining is of timber panelling supported on four battens on 34-inch (0.87m) centres (see Plate 14).

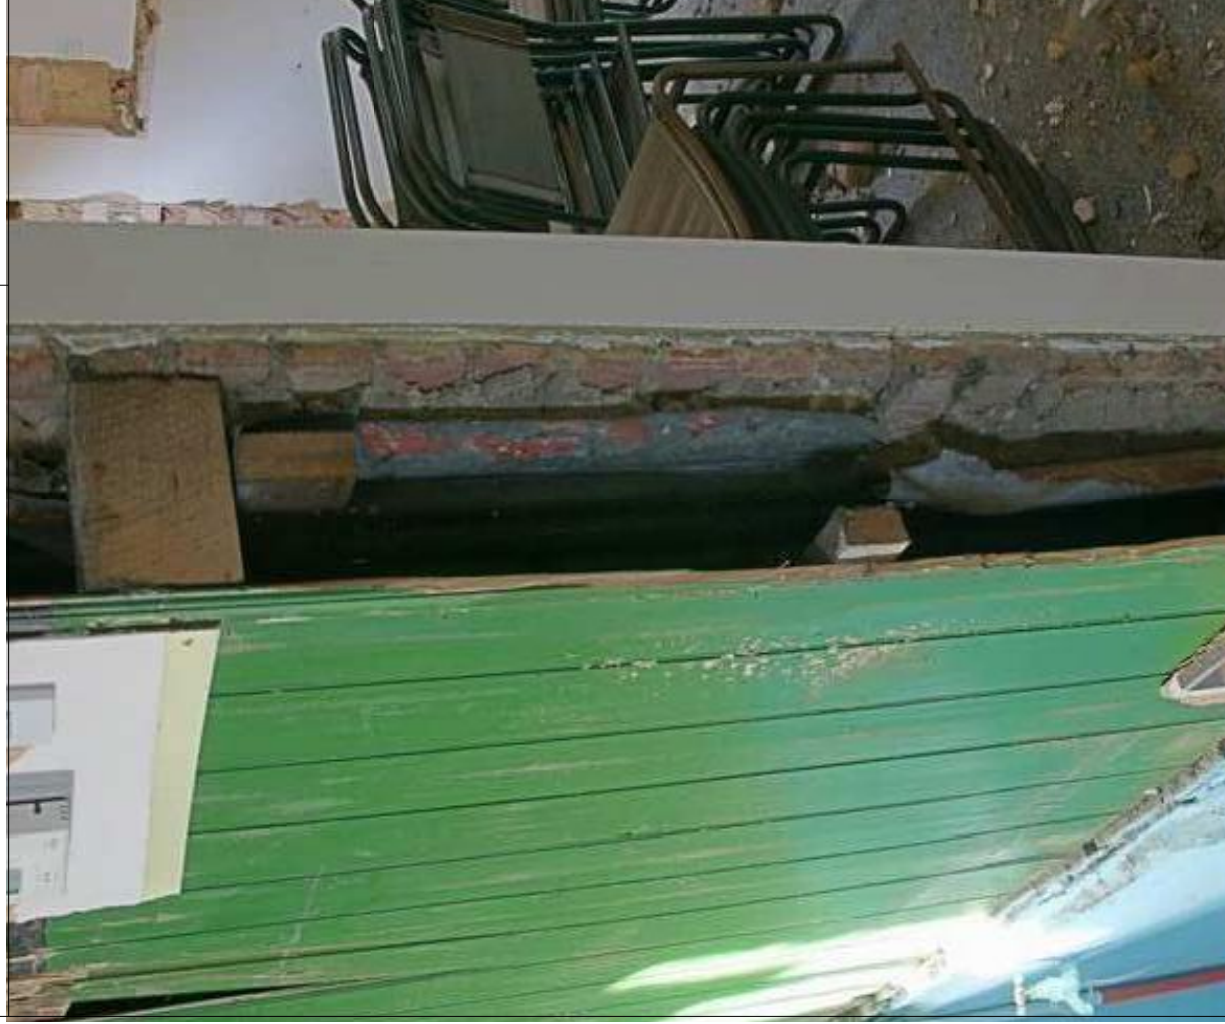
3.17 The doorways flanking the pool are likely to be contemporary with the construction of the rear half of the building, judging by the way the battens and braces have been sawn through and the corrugated iron bent back (Plate 15).

Plate 15: Section through north-west gable wall showing cut battens and interior and exterior wall facings

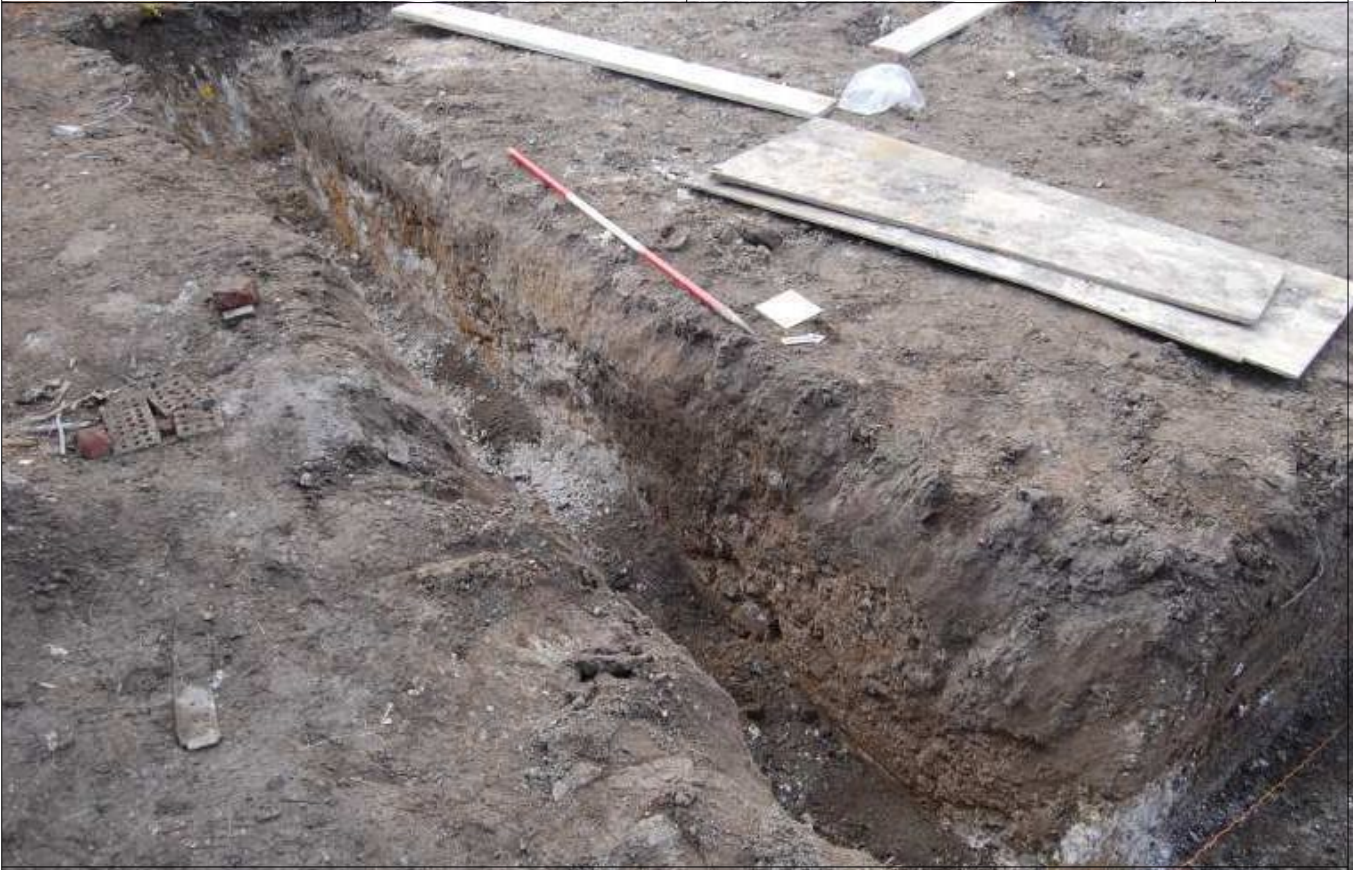
Plate 16: Linears [01], (02), [03] & (04) looking W

4.6 In the south-eastern corner, machining revealed a two parallel linear features, both of which were aligned N-S. The larger of the two features, cut [01], measured over 2m in width at its widest point (overall width assumed to be c.2.5m), over 0.6m in depth (overall depth assumed to be c.1m) and was over 8m in length, being observed to run along the full length of the footprint. (Figures 5 & 6, Plates 16 & 17). The fill (02) consisted of dark greyish brown (10YR 4/2) soft chalky silt. Finds collected included 4 Roman pottery sherds with a date range from the late 1st century to the early 5th century AD, and 122 animal bone fragments, consisting of 30 of sheep/goat, 1 of pig, 1 of cattle bone and 90 unidentified. Two of the bones recovered displayed evidence of butchery.
