6 WALNUT TREE ROAD Pirton, Hertfordshire

HN971

ARCHAEOLOGICAL MONITORING REPORT

Report no. 713 *March 2012*

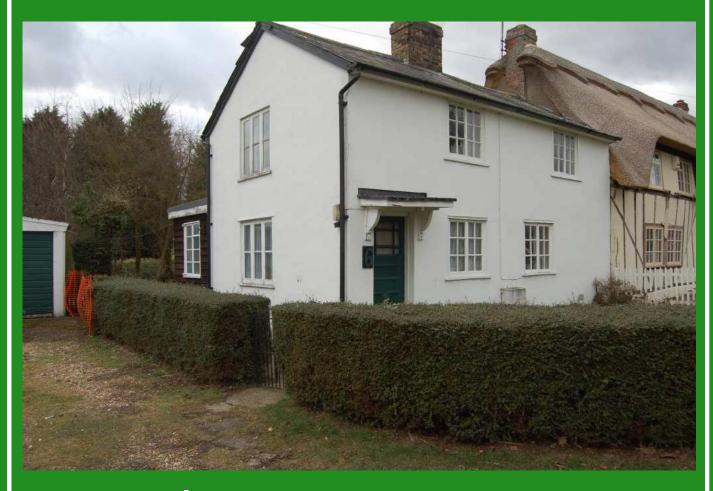
The cover photograph shows the site prior to groundworks, looking northwest

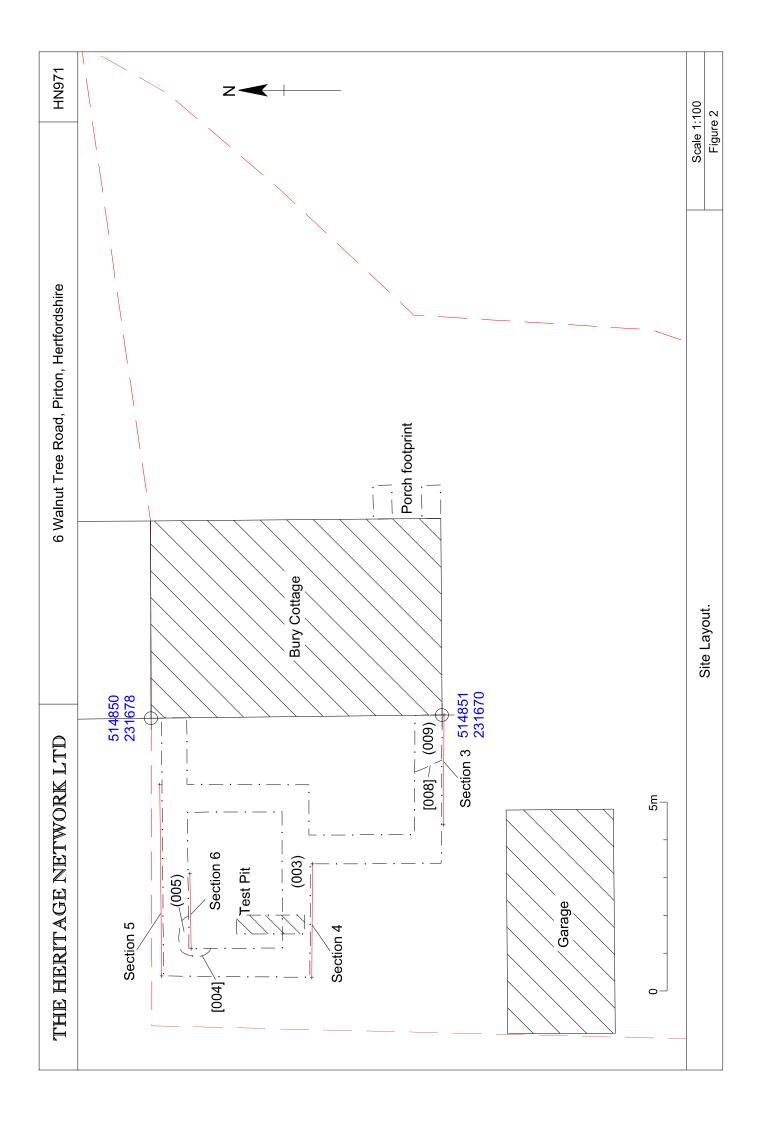
| Figure 1 | Site Location |
|---|--|
| Figure 2 | Site Layout |

- 2.9 Following the demolition of the existing single storey extensions/outbuildings, the footings for the new extension were excavated to a depth of 1m below the present ground level (Figure 2).
- 2.10 In the southeast corner of the extension footings, the profile of a pit or ditch [008] was revealed in section (Figure 3; Plate 4). This feature was at least 1.5m wide and more than 0.5m deep and contained a fill of greyish brown (10YR 5/2) clayey silt (009) with occasional chalk and charcoal flecks.

2.8 A test pit, 0.50m wide by 1.80m long and 0.80m deep, was excavated in advance of the demolition of the existing single storey extensions/outbuildings (Figure 2). This revealed the overall stratigraphic sequence with the addition of a 0.20m thick layer of yellowish brown (10YR 5/6) sandy silty clay, overlying the subsoil (002). This was initially interpreted as possible upcast from the excavation of the pond immediately to the west of the development. However, monitoring of the extension footings demonstrated that this represents material from scouring the pond which was then used to consolidate the pond bank.

2.13 The porch footprint comprised two east-west oriented trenches, 0.5m wide by 0.90m long and 1.0m deep (Figure 2; Plates 7 & 8). The trenches revealed 0.60m of overburden above the natural silty clay natural. No archaeological features or deposits were revealed in these trenches.

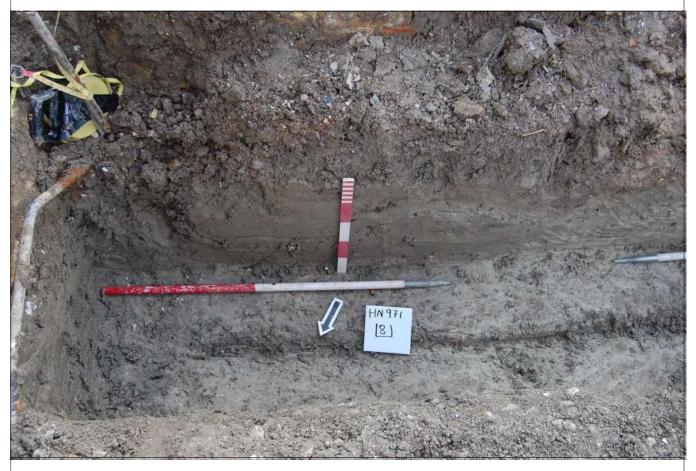
Plate 4: Section 3, looking south.

2.7 The stratigraphy, which was uniform across the site, consisted of a lower deposit of light grey (2.5Y 7/2) silty clay natural (003), at least 0.65m deep. This was overlain by 0.15m of greyish brown (10YR 5/2) clayey silt subsoil (002), sealed below 0.20m of very dark grey (10YR 3/1) clayey silt topsoil (001) (Plates 2 & 4).

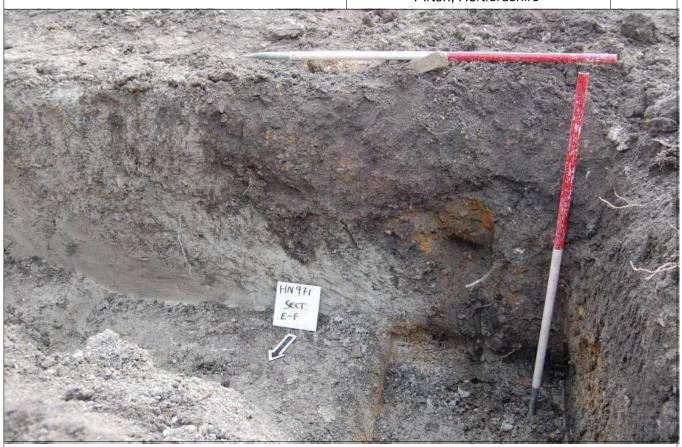
Plate 5: Section 4, looking south.

- 2.11 In the northwest corner of the footing was an irregular sub-oval feature [005], filled with greyish brown (10YR 5/2) clayey silt (005) (Figure 3; Plate 5). This probably represents tree root disturbance.
- 2.12 Along the western edge of the footprint was a north-south aligned cut feature [006] with a very irregular stepped side (Figure 3; Plate 6). This was filled with subsoil (002), mixed dark greyish brown (10YR 3/2) clayey silt and yellowish brown (10YR 5/6) sandy silty clay which was sealed below the topsoil (001), which thickened to the west. It has been interpreted as the former line of the pond that lies to the west.
