ST. MARY THE VIRGIN **Ashwell, Hertfordshire**

ARCHAEOLOGICAL ***MONITORING REPORT***

Project no.: HN979

Archaeological Monitoring Report

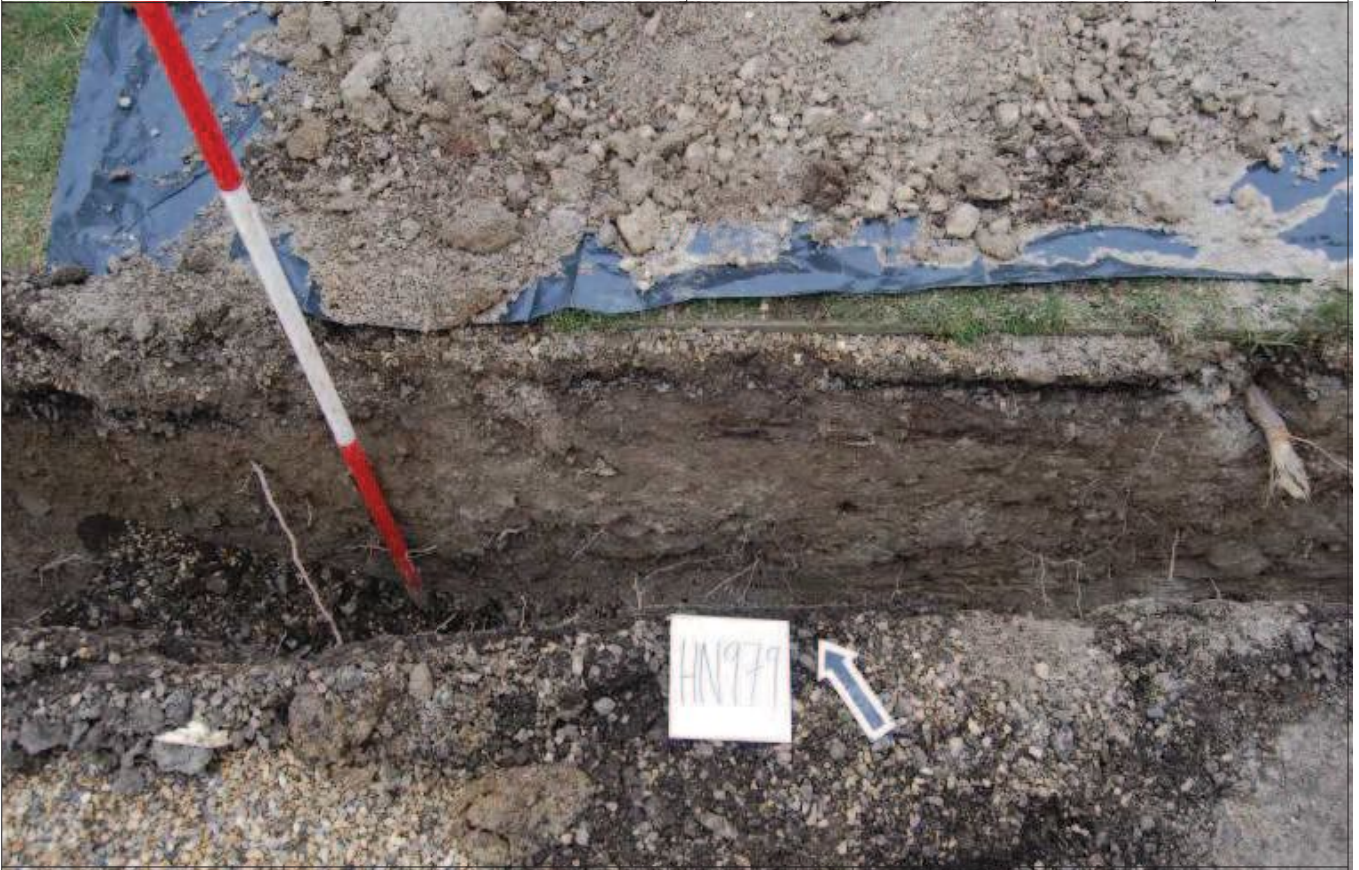
2.8 The observed stratigraphy on the site consisted of a c.0.6m layer of grey (5YR 6/1) to light grey (5Y 7/1) clay silt with chalk graveyard soil under turf (Plate 1). The underlying natural substratum consisted of white (5Y 8/1) chalk.

Plate 1: Waterpipe trench stratigraphy looking north

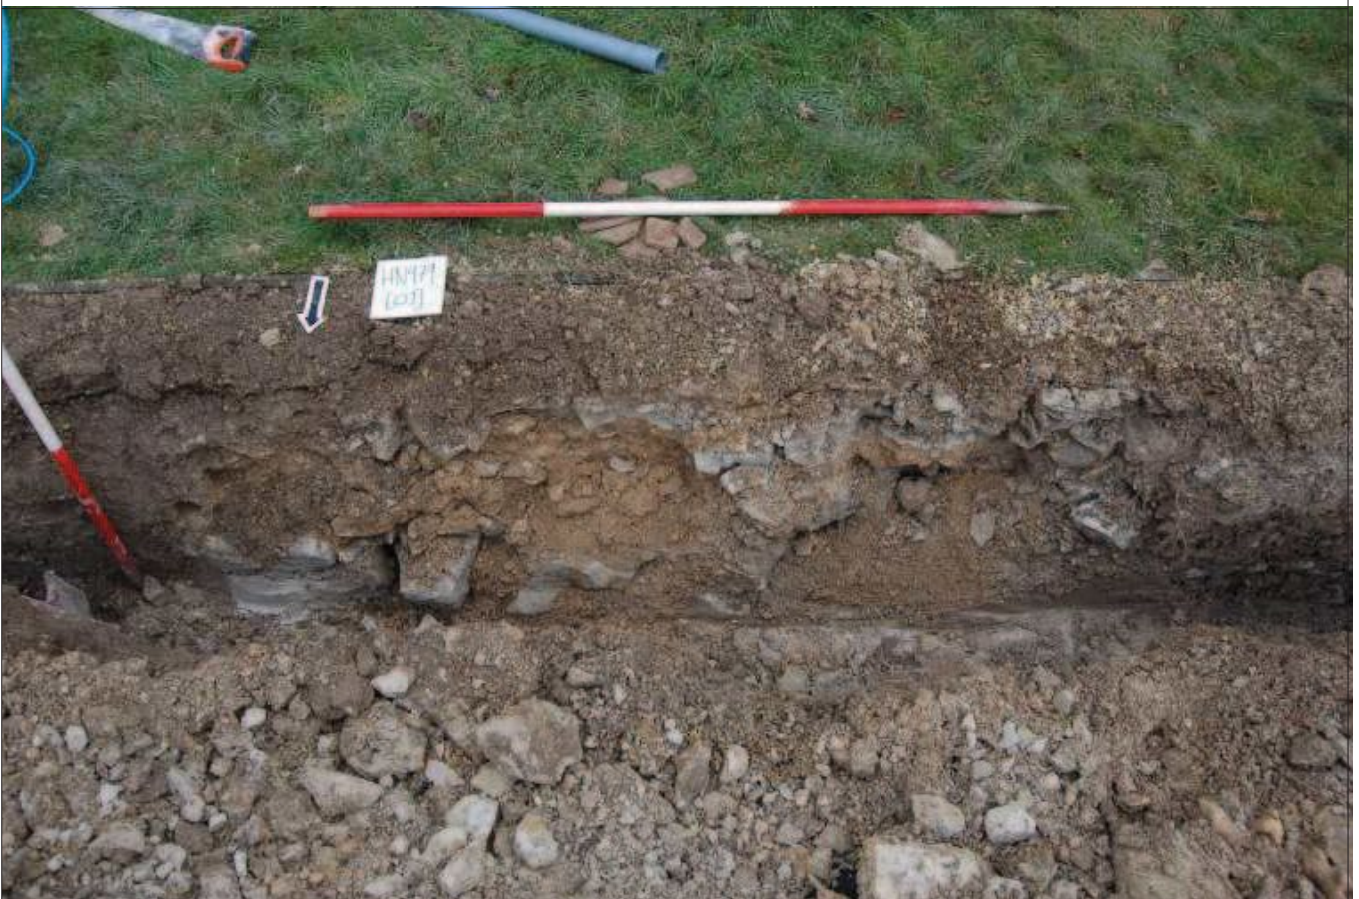
2.10 Immediately below the footpath, 5.5m west from the northeast corner of the north aisle and in line with an existing buttress, a stone foundation [01] was revealed, measuring c.1.25m wide by 0.65-0.70m thick (length unknown) (Figure 2, Plates 2 & 3). The foundation were

composed of clunch rubble in a sand matrix, and included at least 7 medieval tile fragments (Plates 2 & 4). It was laid on the natural clay substratum. No clear foundation cut was observed during the groundworks.

Plate 2: Stone foundation [01] looking south

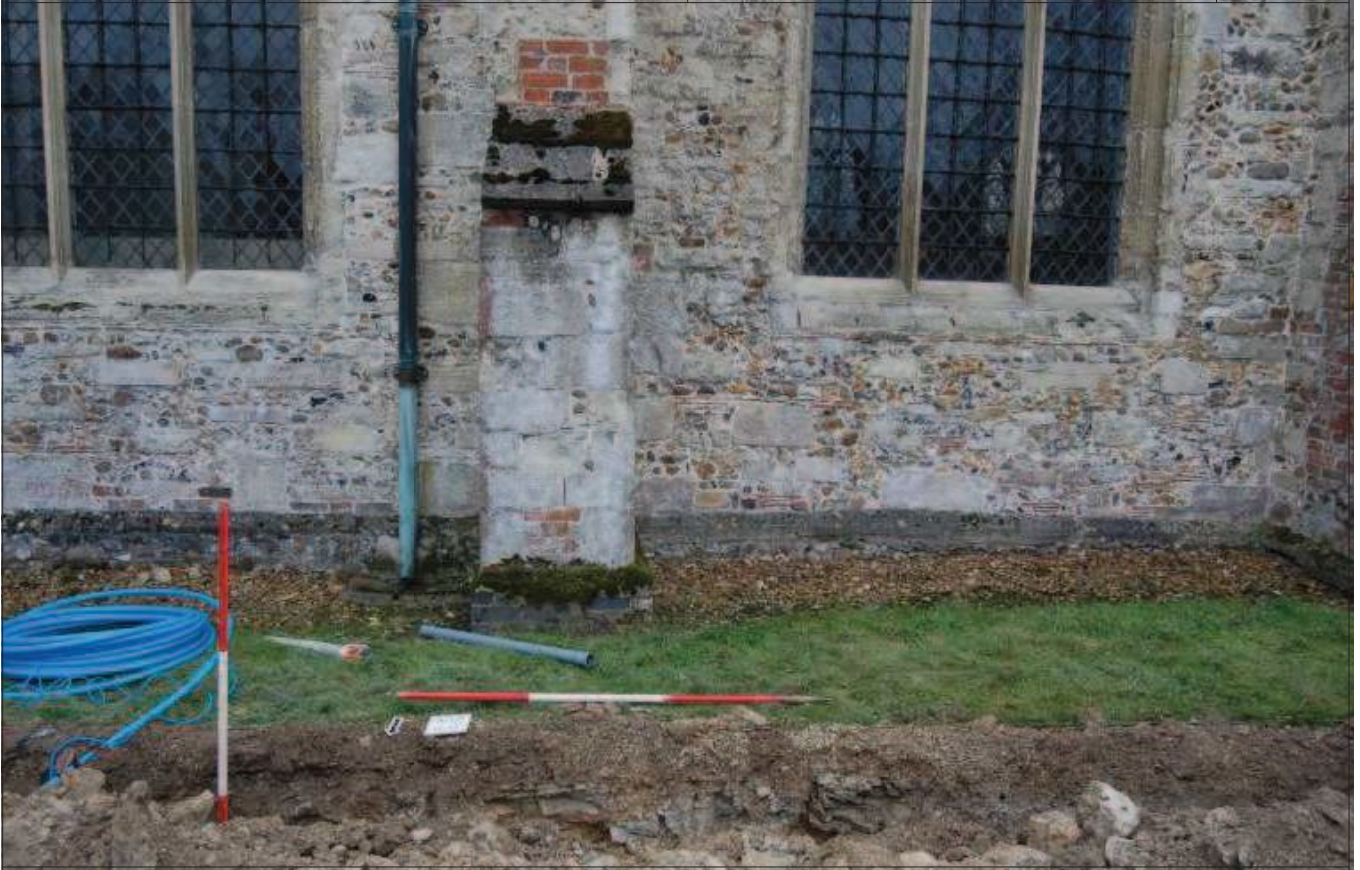
Plate 3: Stone foundation [01] in context looking south

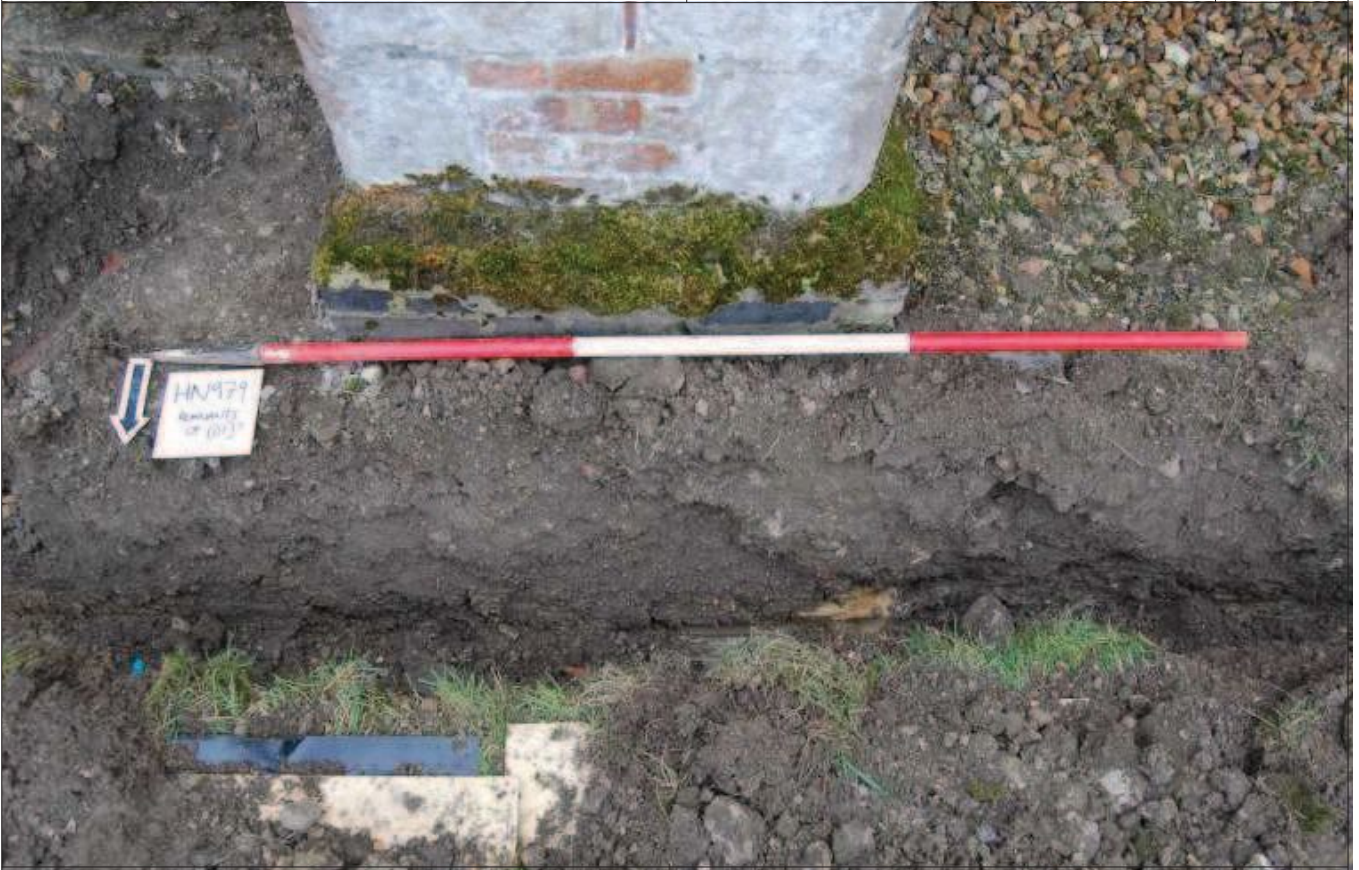
2.12 Drain trench 1 ran along the north side of the north aisle from the north porch to its northeast corner, before turning northeast to join up with Soakaway 2. It was anticipated that the trench would cross the line of foundation [01] and might reveal further evidence that would link it to the church building. No such evidence was uncovered although it is possible that the excavation of the original drainage trench had removed it. It is possible that foundation [01] represents a base for a lost funerary monument (Plate 5).

Plate 5: Re-excavated drain trench on line of foundation [01] looking south

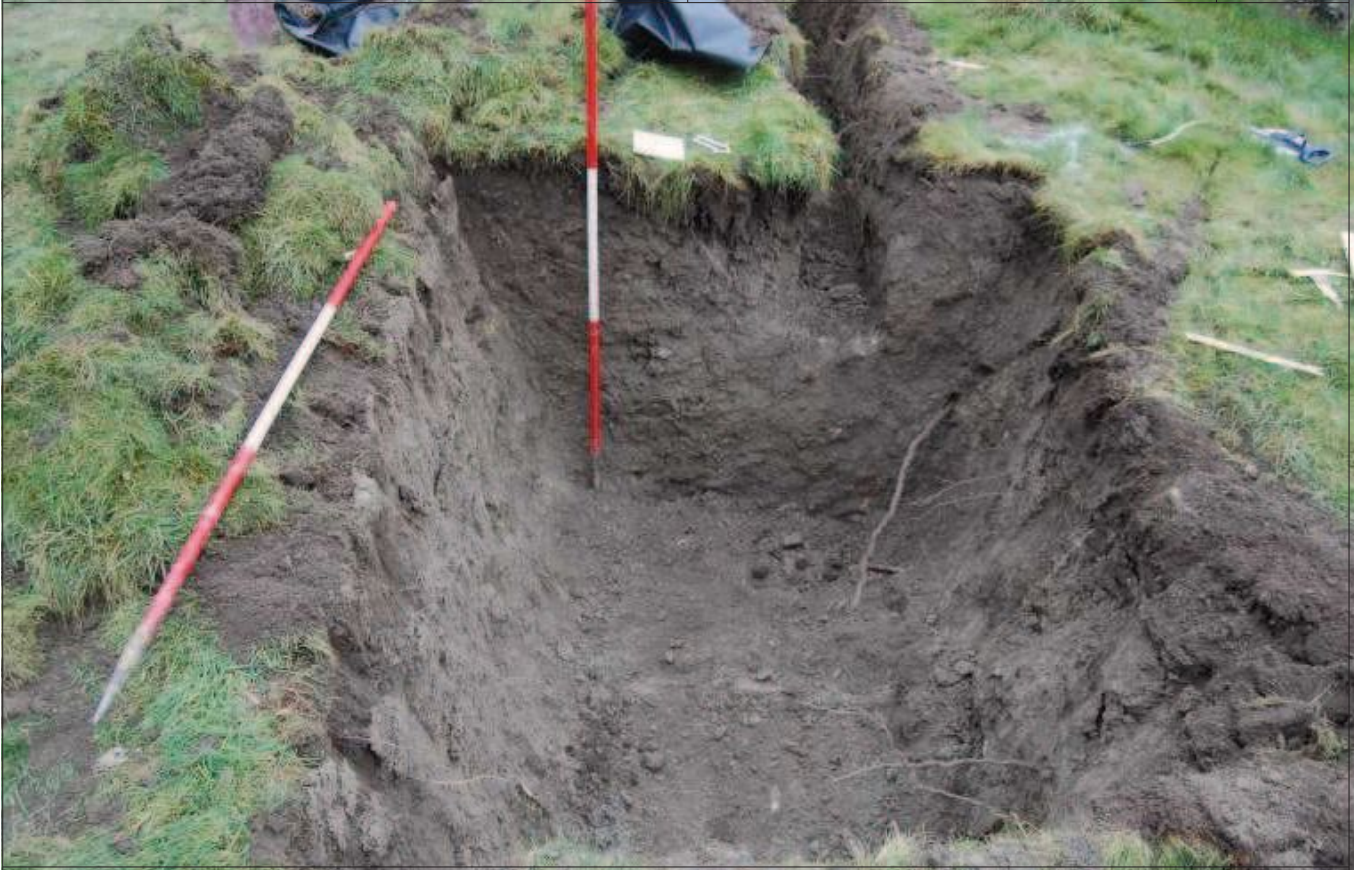
2.13 Soakaway 2 was 2m square, and was excavated to a depth of c.1.5m. The stratigraphy in the soakaway consisted of grey (5YR 6/1) chalky silt below turf. From a depth of c.0.6m, disarticulated and broken human bone fragments were observed and collected (Plates 7&8).

Plate 7: Soakaway 2 looking SW

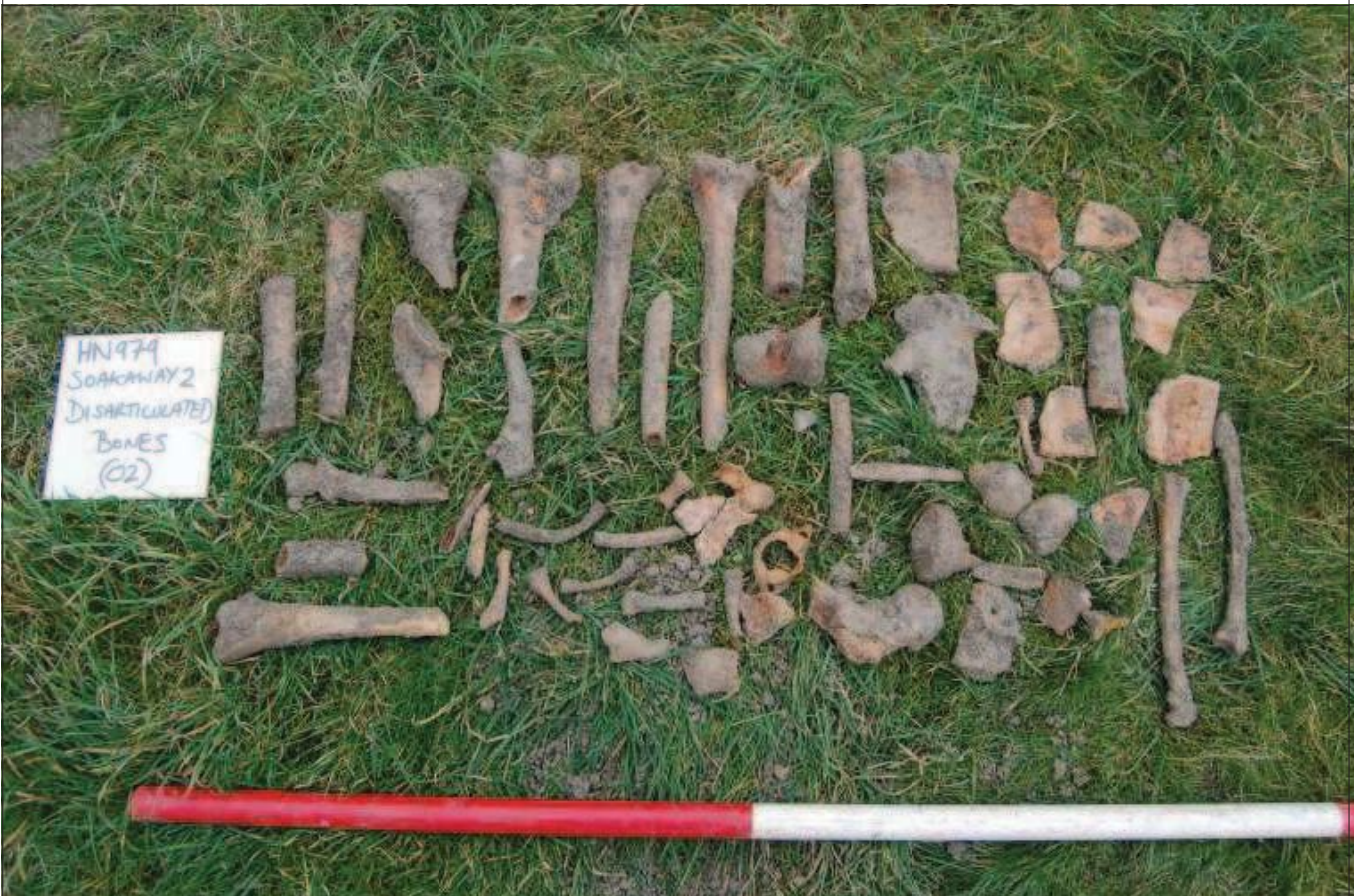
2.17 The bones were in a poor condition and it was generally not possible to determine age at death or gender. On-site examination of the bones showed they consisted of part of the cranium, mandible, parts of both arms and legs (Plate 8). It is highly likely that the bones represent an number of disturbed burials. No evidence to date the bones was present, though they are likely to predate the marked burials.

Plate 8: Disarticulated bones (02)

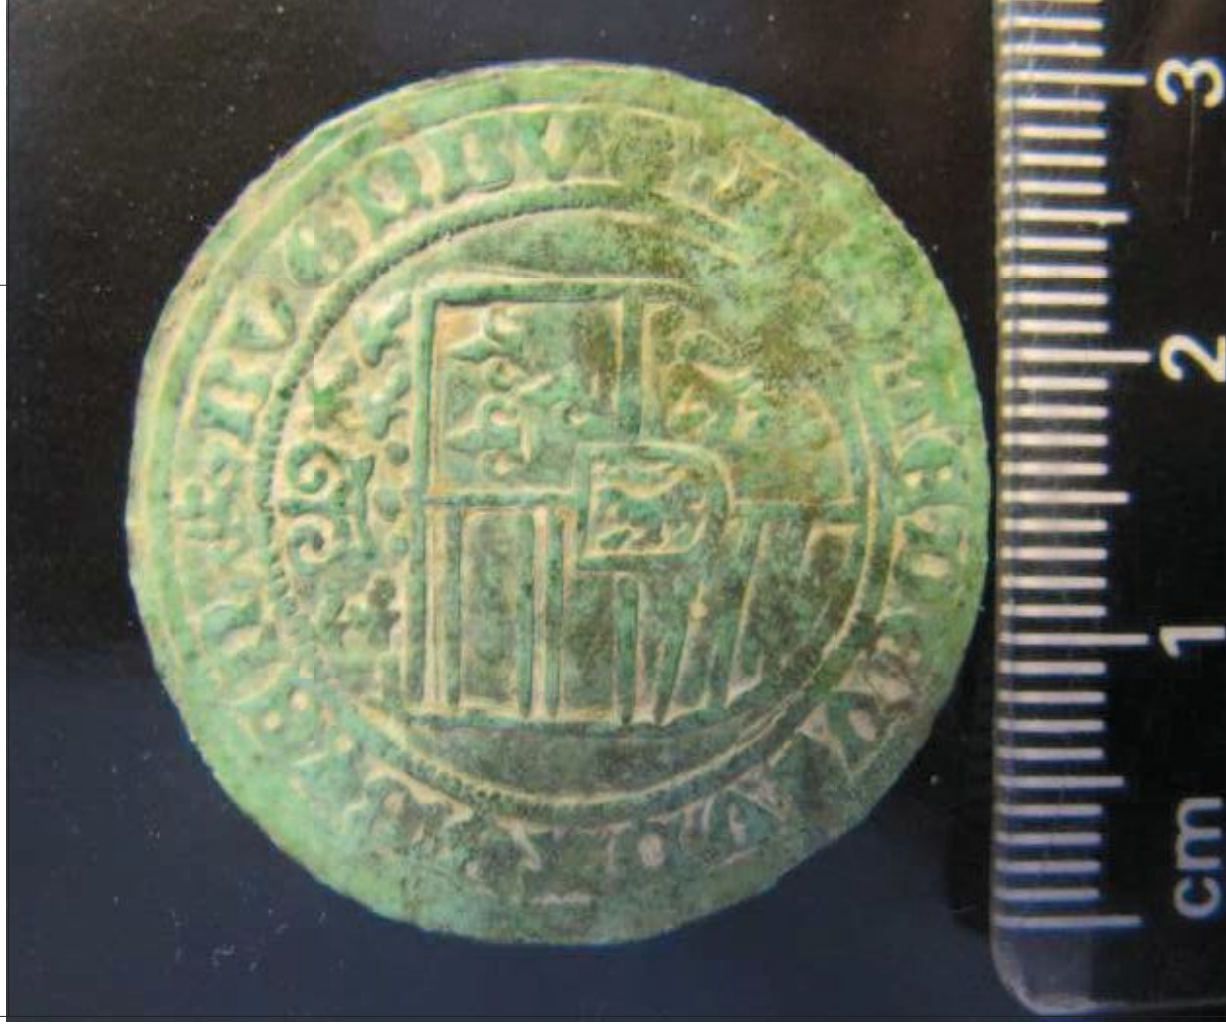
2.20 A copper alloy jetton was found by the contractors during hand-excavation on the east side of the north porch (Plates 9 & 10). This has been identified by Gil Burleigh, former Keeper of Field Archaeology at North Hertfordshire Museums, as a 'Venus' penny jetton struck in the Low Countries between about 1490 and 1550, probably either Antwerp or Tournai. It is closer to the original prototypes than many and probably is earlier rather than later in date, perhaps circa 1500.

2.21 The obverse shows an Austro-Burgundian shield (1482-1555) in five parts:

1. Austria (fesse) - represented by 3 horizontal lines.
2. Burgundy modern - 3 lis in a frame.
3. Burgundy ancient (bendy) - 3 oblique lines.
4. Brabant (sable: lion rampant) - lion rampant with 2 pellets in field.
5. Escutcheon of Flanders (lion rampant) overall.

2.22 Surmounting the shield is a crown flanked by Burgundian emblems consisting of steel, flints and sparks. The whole is encircled by a fictitious legend.

Plate 9: 'Venus' penny jetton, obverse

2.25 The jetton is in the care of the PCC. It is the recommendation of Gil Burleigh, that it should be given to Ashwell Museum, subject to the agreement of the Chancellor of the Diocese.

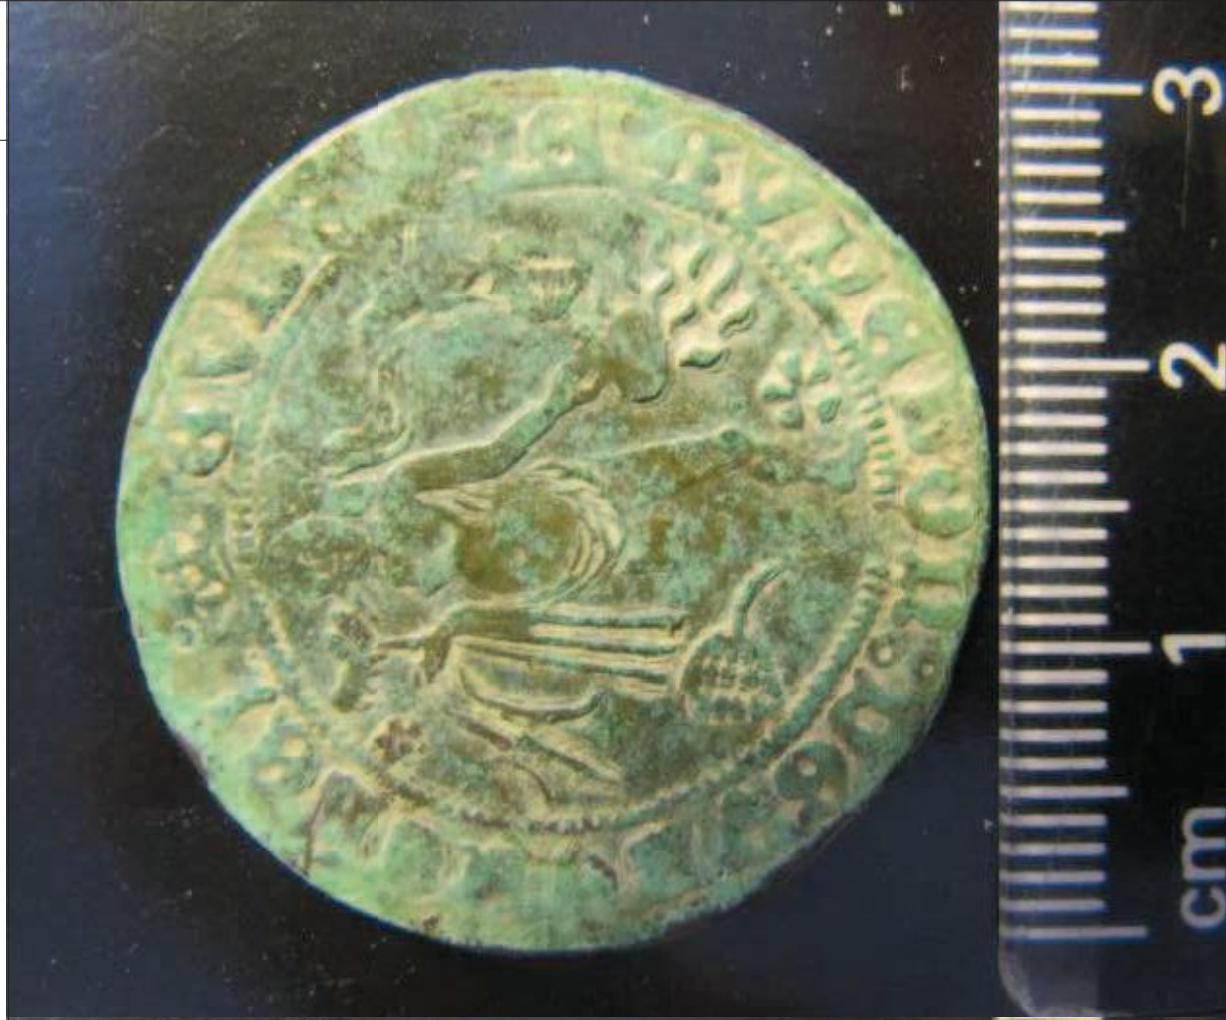
2.23 The reverse shows a standing woman (originally allegorical 'Peace - Hope - Justice - Love': latterly 'Venus') facing with long flowing hair tied by a bow and wearing only a drape. Her lowered left hand holds a pot from which she waters the flowers in the field. A bird, with wings closed and facing away from her, perches on her raised right hand, in which she also holds a single flower. The end of the drape depends from her right wrist. There are flowers in the field, a sign of an earlier issue. Her feet are within the inner circle with a rosette. The whole is encircled by a fictitious legend.

Plate 10: 'Venus' penny jetton, reverse
